DATE: June 25, 2019

SUBJECT: Tree Inventory for 84 Nancy St, Bolton

PROJECT: C14-0252

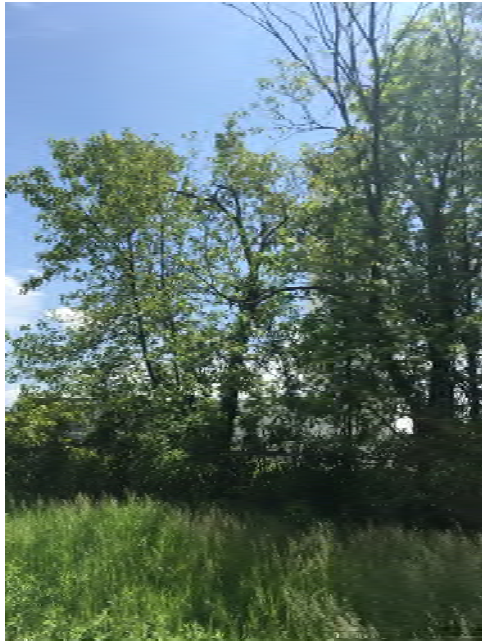
Trees #39 through #40

39	Silver Maple	±40	F	
40	Silver Maple	±40	P	Significant deadwood in canopy
41	Dead Deciduous	±30	D	
42	Black Walnut	±30	F	
43	Dead Deciduous	±40	D	2 stem
44	Cedar sp.	13	F	
45	Stump	40		
46	Stump	12
