VISUAL CONDITION ASSESSMENT REPORT

September 18, 2020

RVA 195072

Re: Coventry Bridge Visual Condition Assessment
Final Report

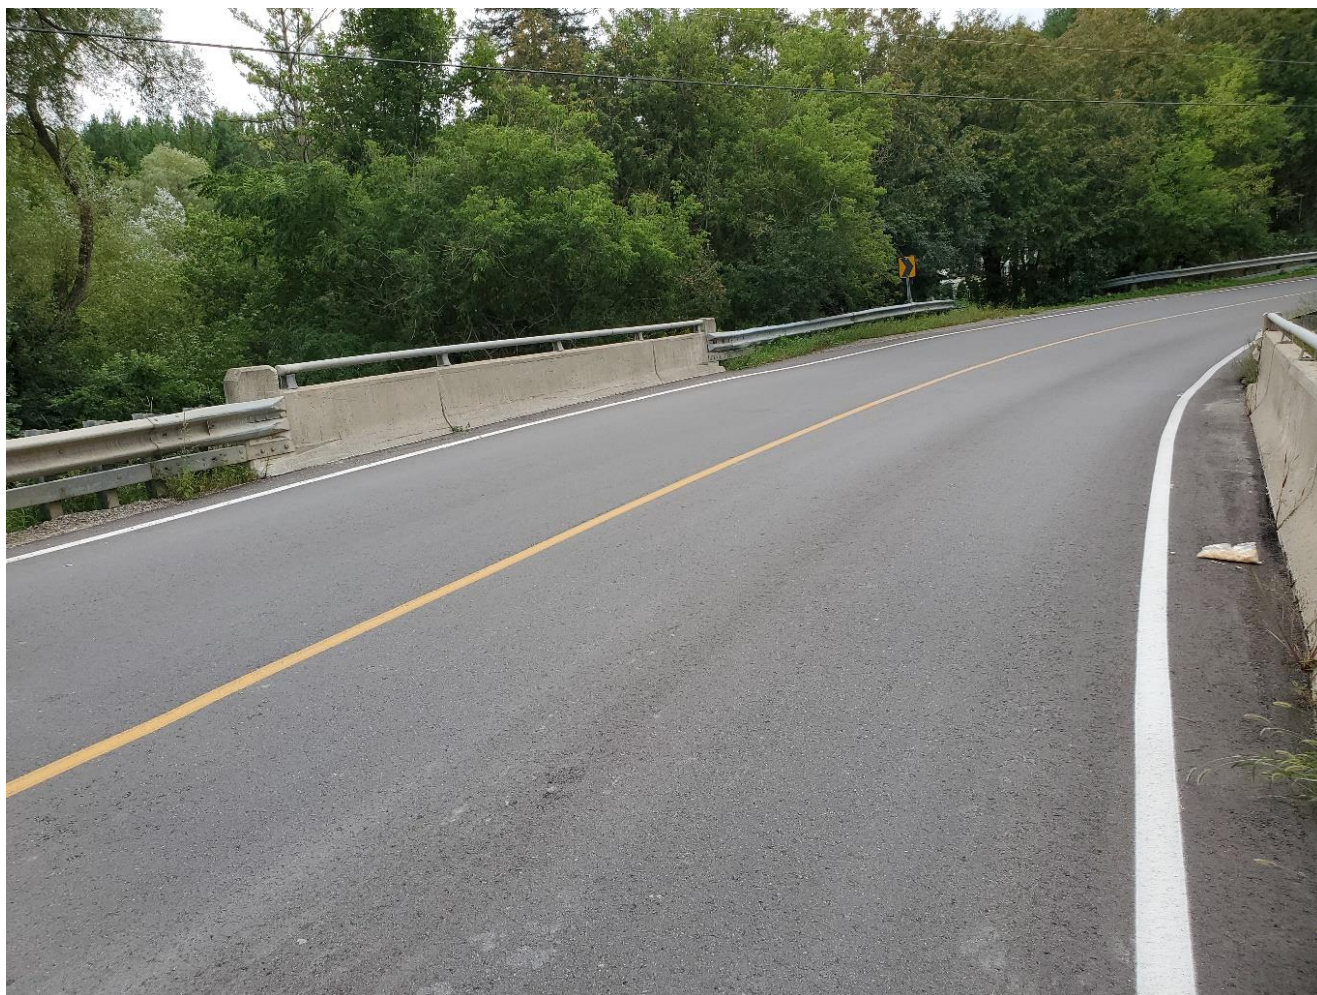
Figure 1 – View of Bridge, looking West

There was perceptible settlement of the roadway at the approach, nor any visible erosion to approaches to the bridge (See [Figure 1](#) and [Figure 7](#)).

The wearing surface (See [Figure 1](#)) was replaced in Summer 2020, and no concerns were noted. Previously observed cracking in the wearing surface prior to repaving is no longer present. The wearing surface is in good condition.

The parapet walls were observed to be in good condition. Some minor staining was observed. Shrinkage cracks which are typically present on this type of parapet wall were observed (See [Figure 1](#), [Figure 6](#), [Figure 10](#), and [Figure 12](#)).

The southwest guiderail is in poor condition from what appears to be collision damage (see [Figure 15](#)). All other guiderails are in good condition. (See [Figure 1](#) and [Figure 7](#))

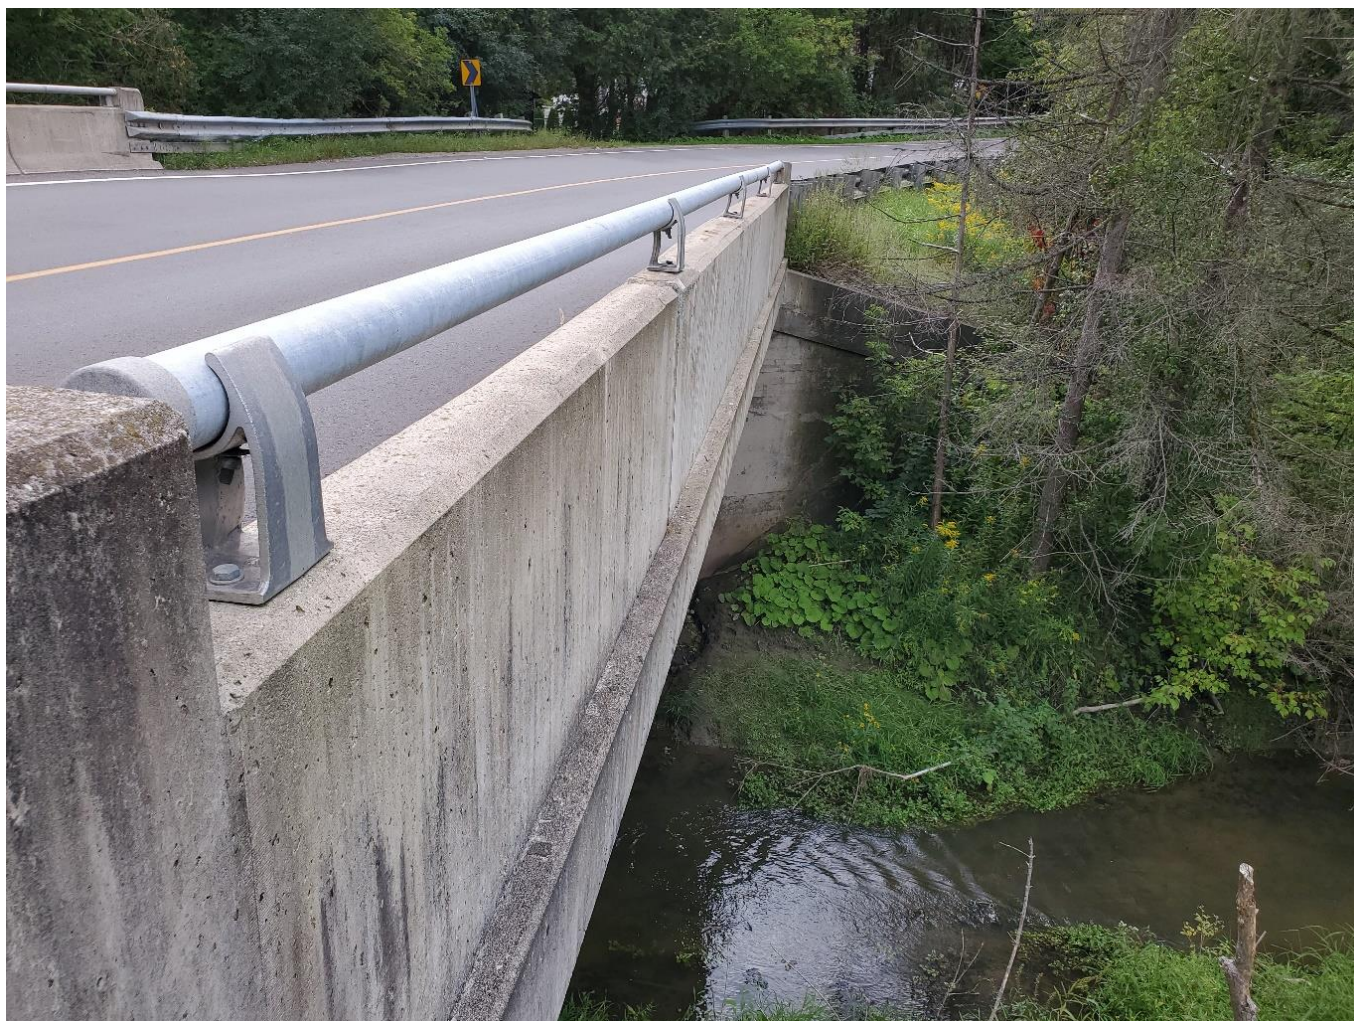
Figure 2 – North Parapet Wall and Railing, Northwest Wingwall

The railings were in good condition. The current railing height is set for pedestrians (1070 mm) and does not meet requirements for protecting cyclists (1400 mm). (see [Figure 2](#) and [Figure 10](#))

Moderate cracking of the face of the southwest abutment was observed (See [Figure 10](#) and [Figure 12](#)). Minor cracking and spalling of the northwest and northeast wingwalls was observed (See [Figure 2](#) and [Figure 3](#)).

Minor erosion was observed at the northwest embankment (See [Figure 2](#)). All other embankments appeared to be in good condition (See [Figure 6](#), [Figure 10](#) and [Figure 12](#)).

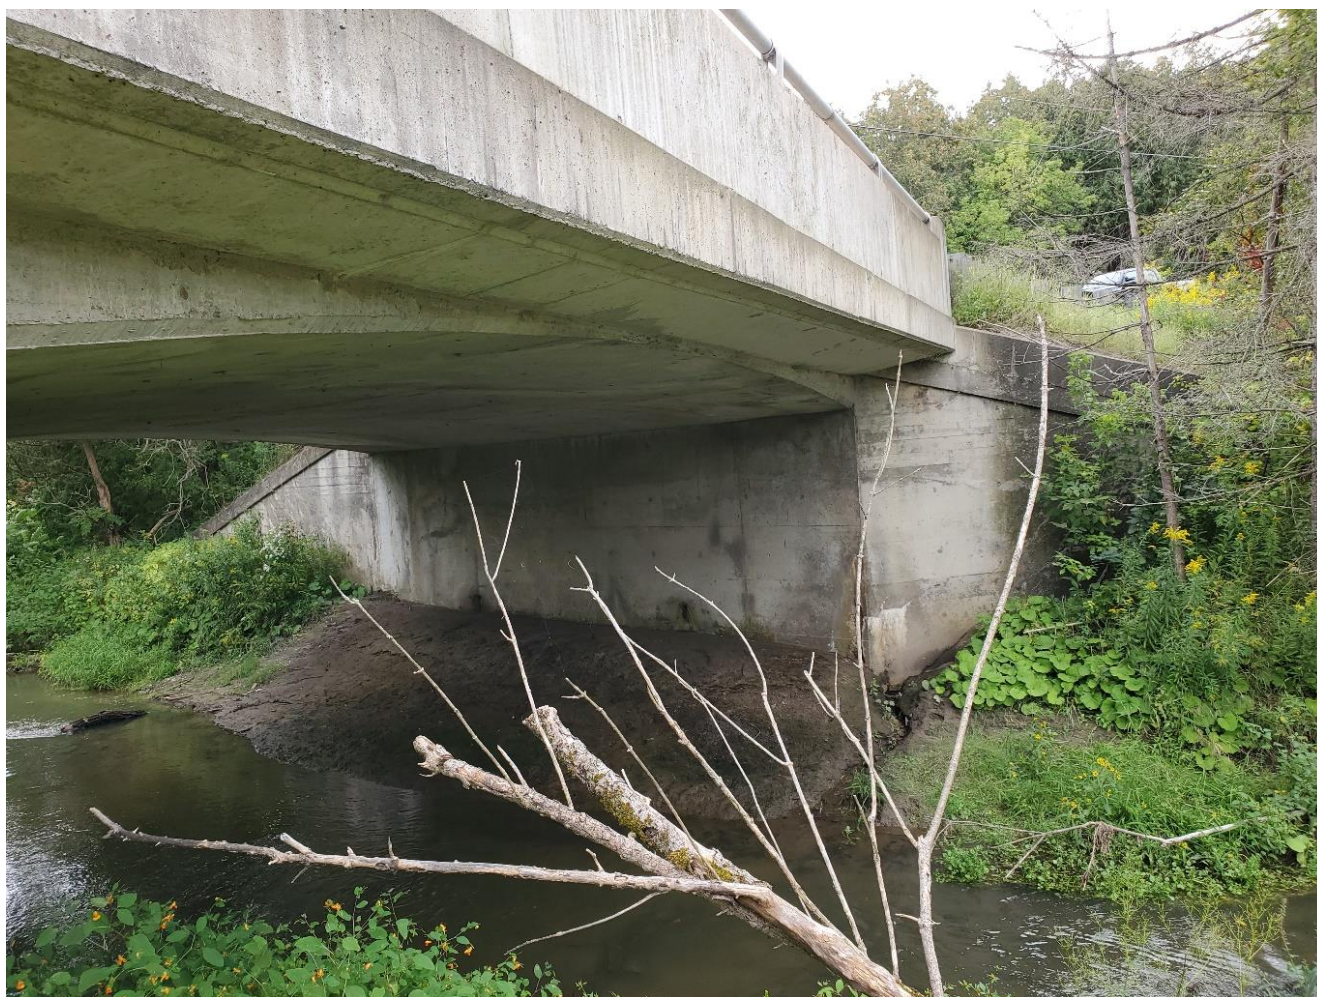
Figure 4 – Underside of Bridge, looking west

The deck fascia on the south side is in poor condition with major spalling observed (See [Figure 10](#) and [Figure 14](#)). The deck fascia on the north side is in good condition (See [Figure 4](#)).

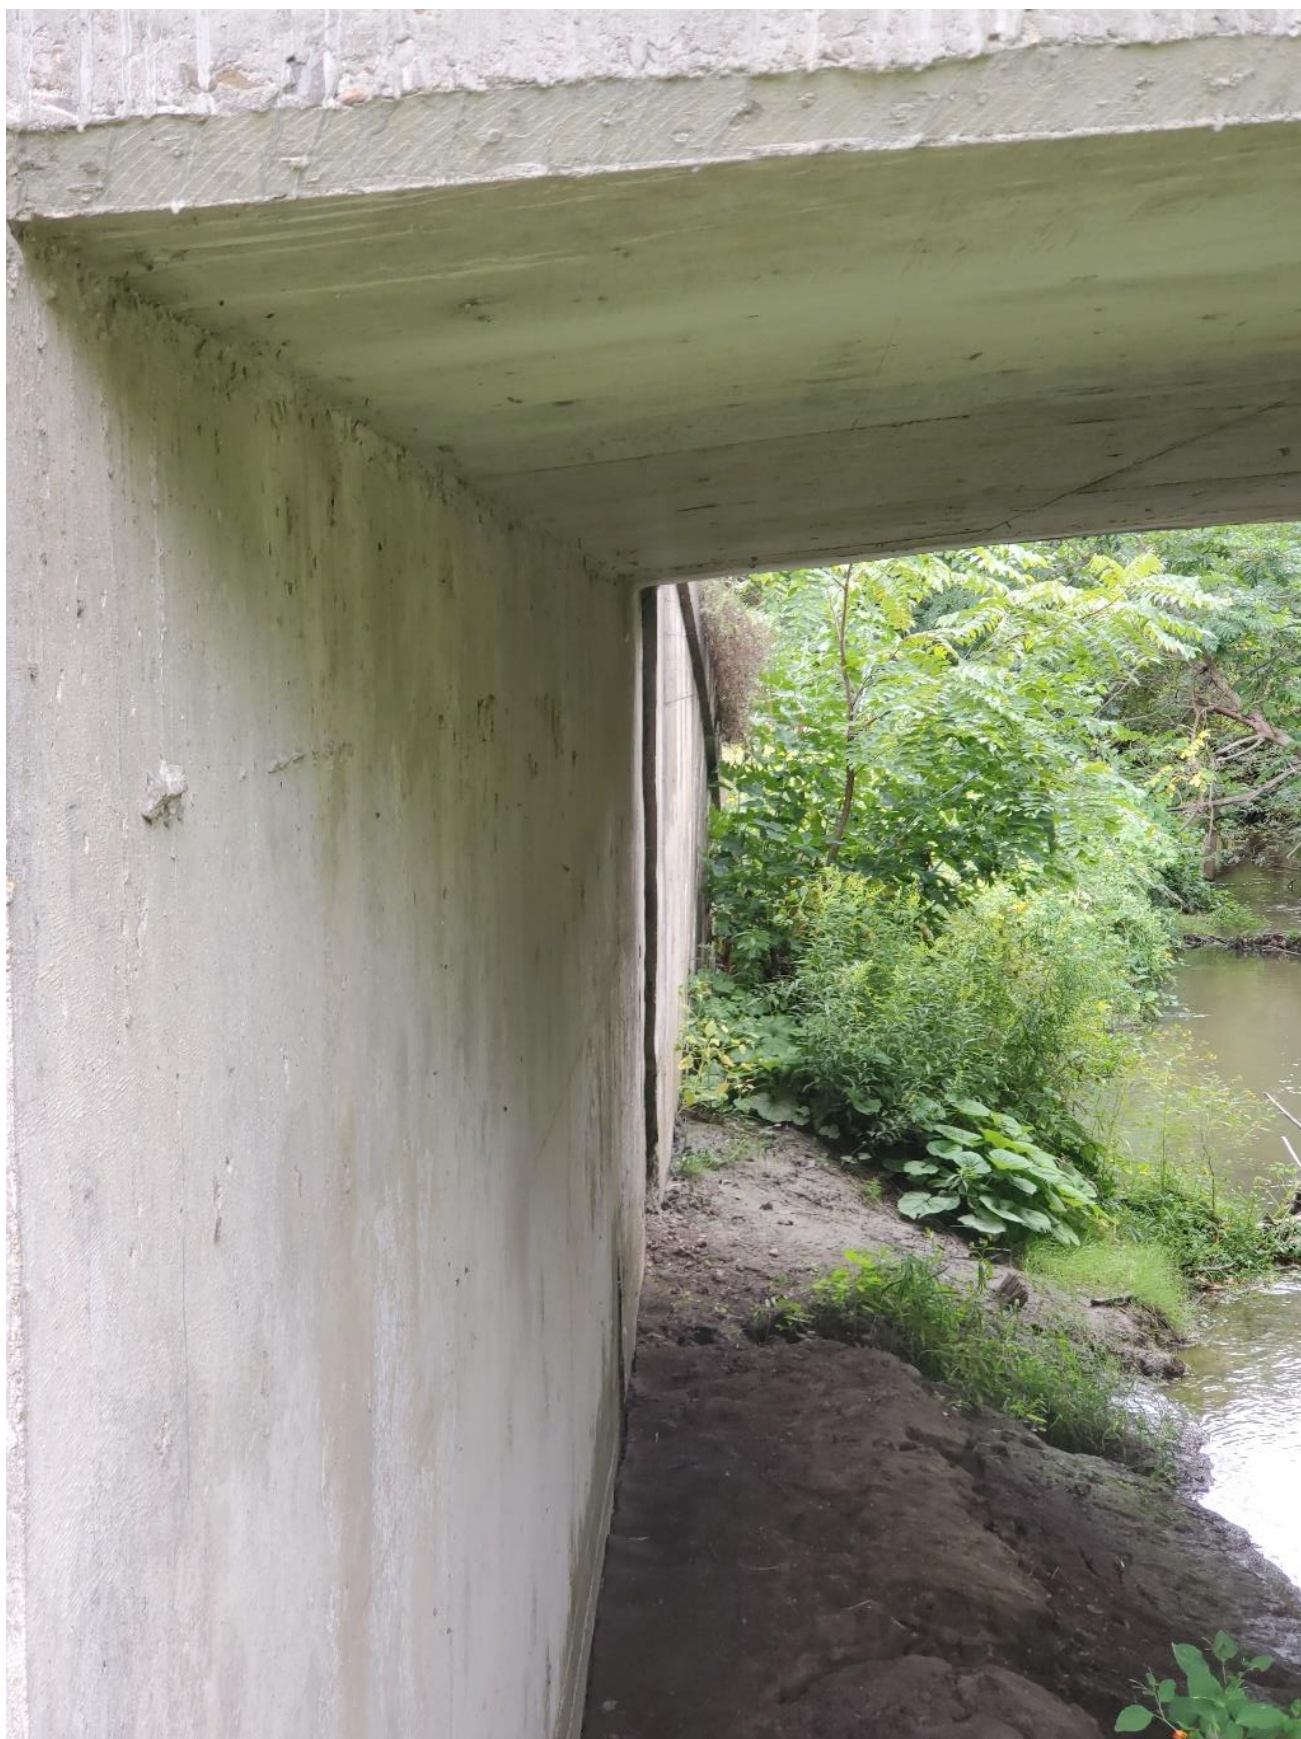
The east abutment is in good condition (See [Figure 8](#)). The west abutment is in fair condition, with a few areas of spalling, and exposed, corroded reinforcing steel (See [Figure 9](#)).

The connection between the southeast wingwall and the south abutment has failed. Movement of the wingwall exceeding 50 mm was observed (See [Figure 8](#) and [Figure 11](#)). This is believed to be a structural failure of the connection caused by forces acting on the wingwall and transferred into the joint, which does not have adequate structural capacity to withstand the applied load.

The deck soffit is in fair condition, with minor spalling visible (See [Figure 8](#)). The west abutment is in fair condition, with a few areas of spalling and exposed, corroded reinforcing steel. (See [Figure 9](#))

Figure 8 – East abutment, looking south shifted southwest abutment visible)

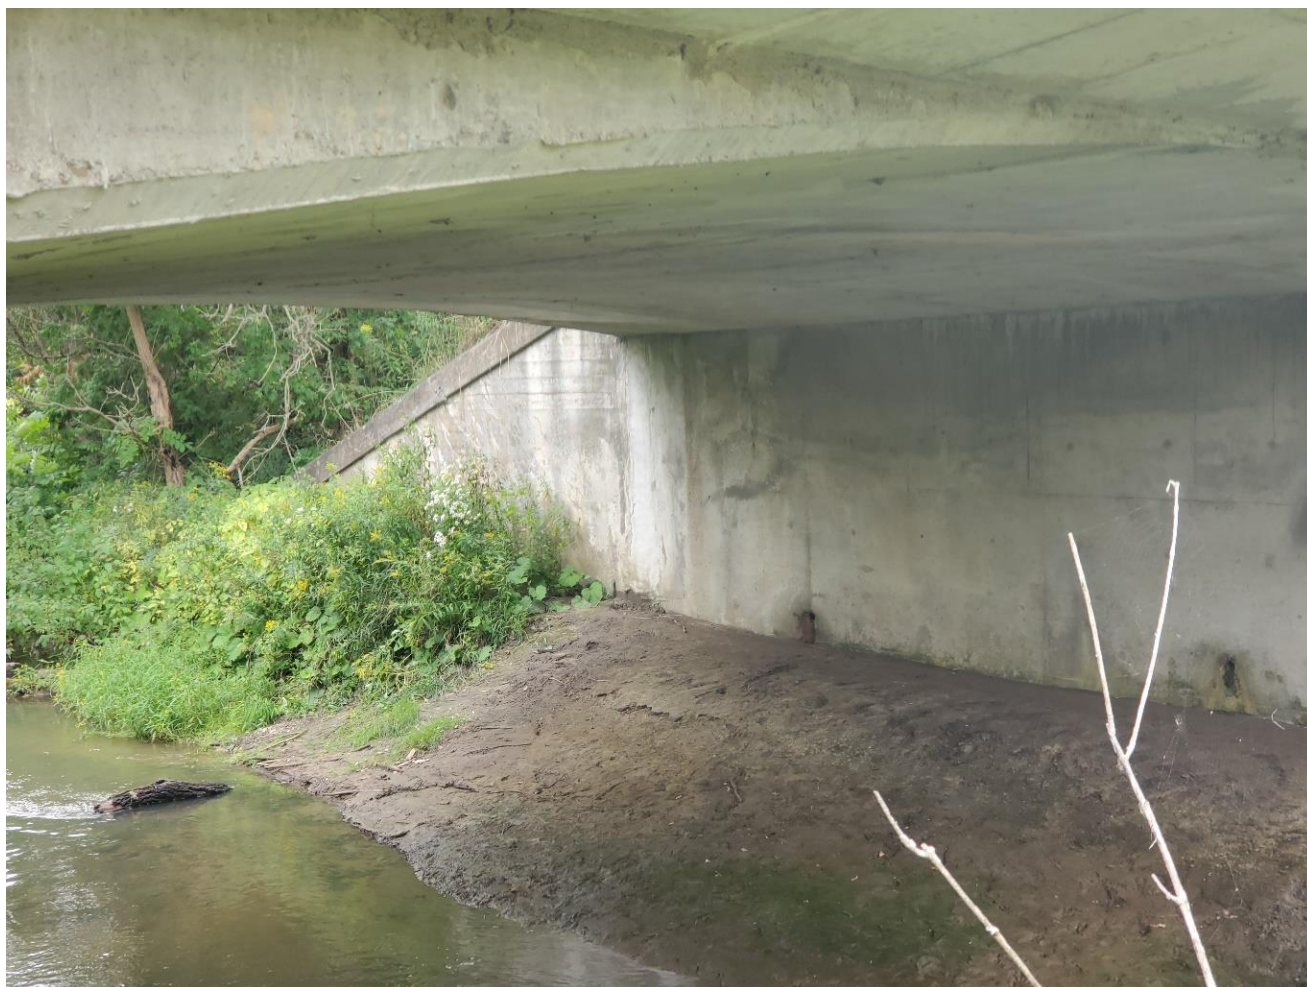
The deck soffit is in fair condition with minor spalling observed (See [Figure 9](#) and [Figure 14](#))

Figure 9 – West abutment and soffit, looking west

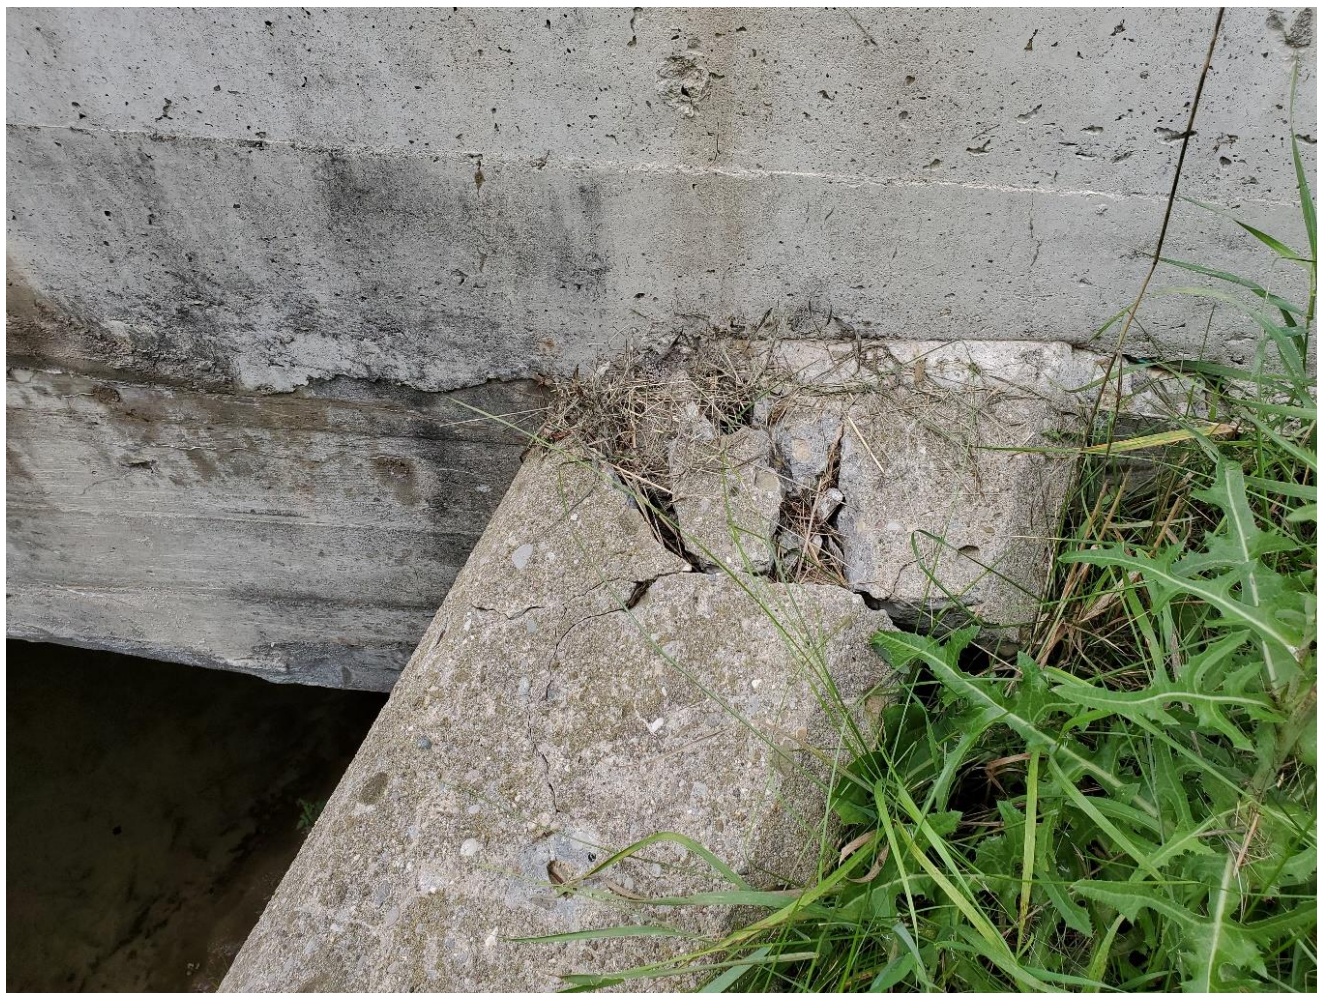
Of particular concern is the structural failure of the connection between the southeast wingwall and the east abutment. This joint is no longer restraining movement of the wingwall, and further movement of the wingwall could result in slope erosion and / or settlement of the road.

Figure 11 – Structural failure at connection between east abutment and southeast wingwall

- Carry out detailed structural analysis for the southwest and southeast wingwalls. If the wall(s) are determined to be structurally adequate, they should be modified or replaced.
- Replace the southwest guiderail and all other guiderails that have sustained damage at the time of the rehabilitation work. At this time, the end treatments should also be replaced if they have been determined to have sustained impact damage. This would provide the Town an opportunity to use SoftStop or other current standard end treatments.
- Carry out repairs to all spalling of the abutments, wingwall, soffit and fascia.
- Clean all staining from the concrete and steel bridge components and apply sealer.
- Clean and touch up any corrosion on existing railings with zinc rich primer or replace railings with bicycle-height railings.

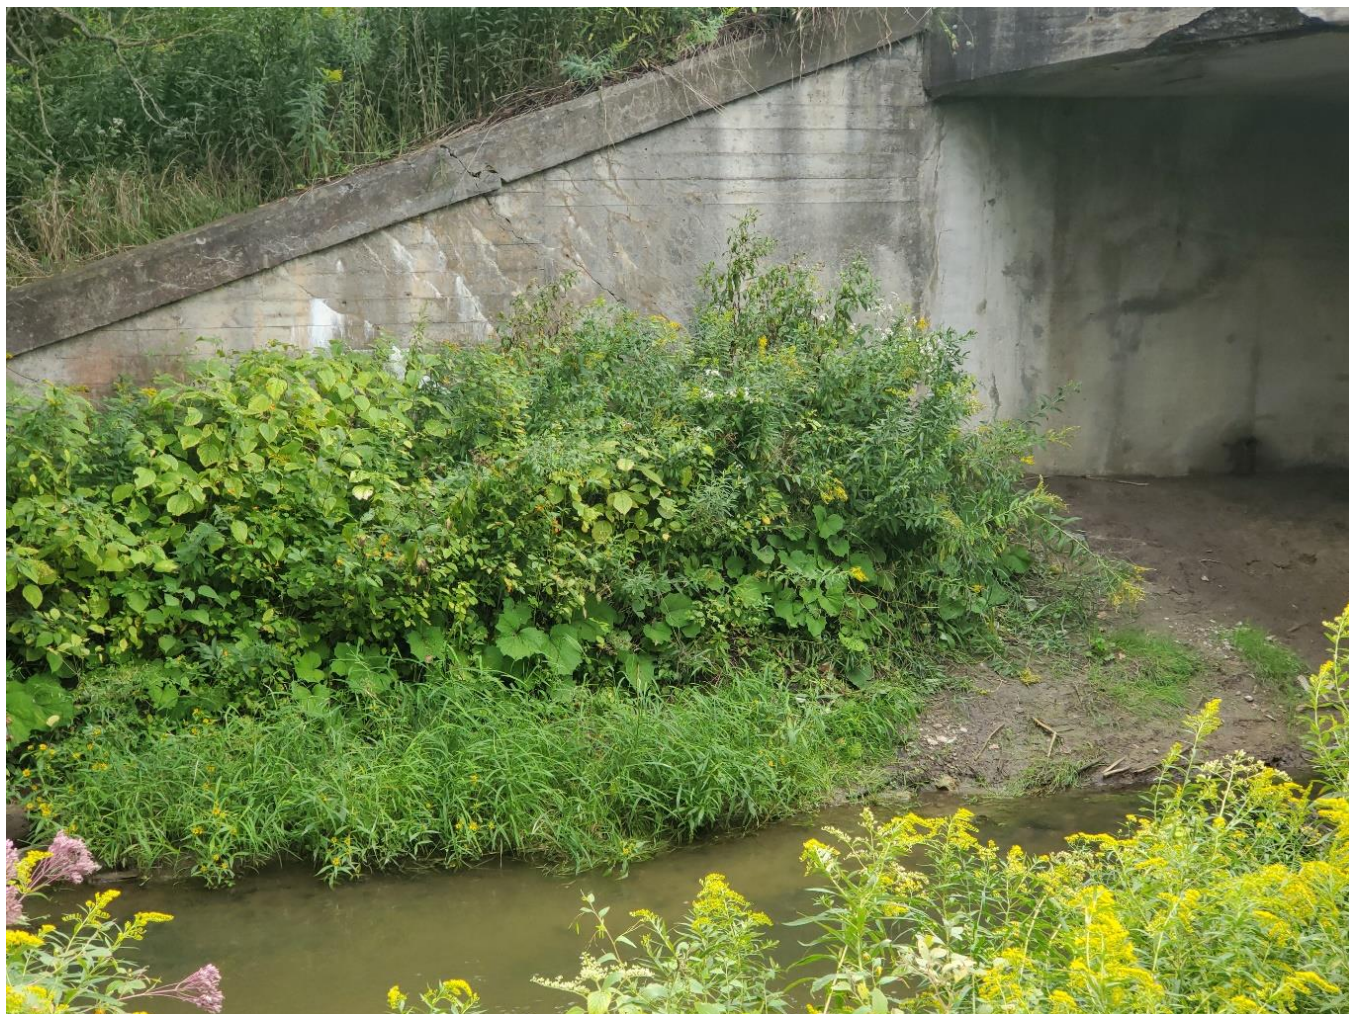
Figure 13 – Southwest wingwall (cracking visible)

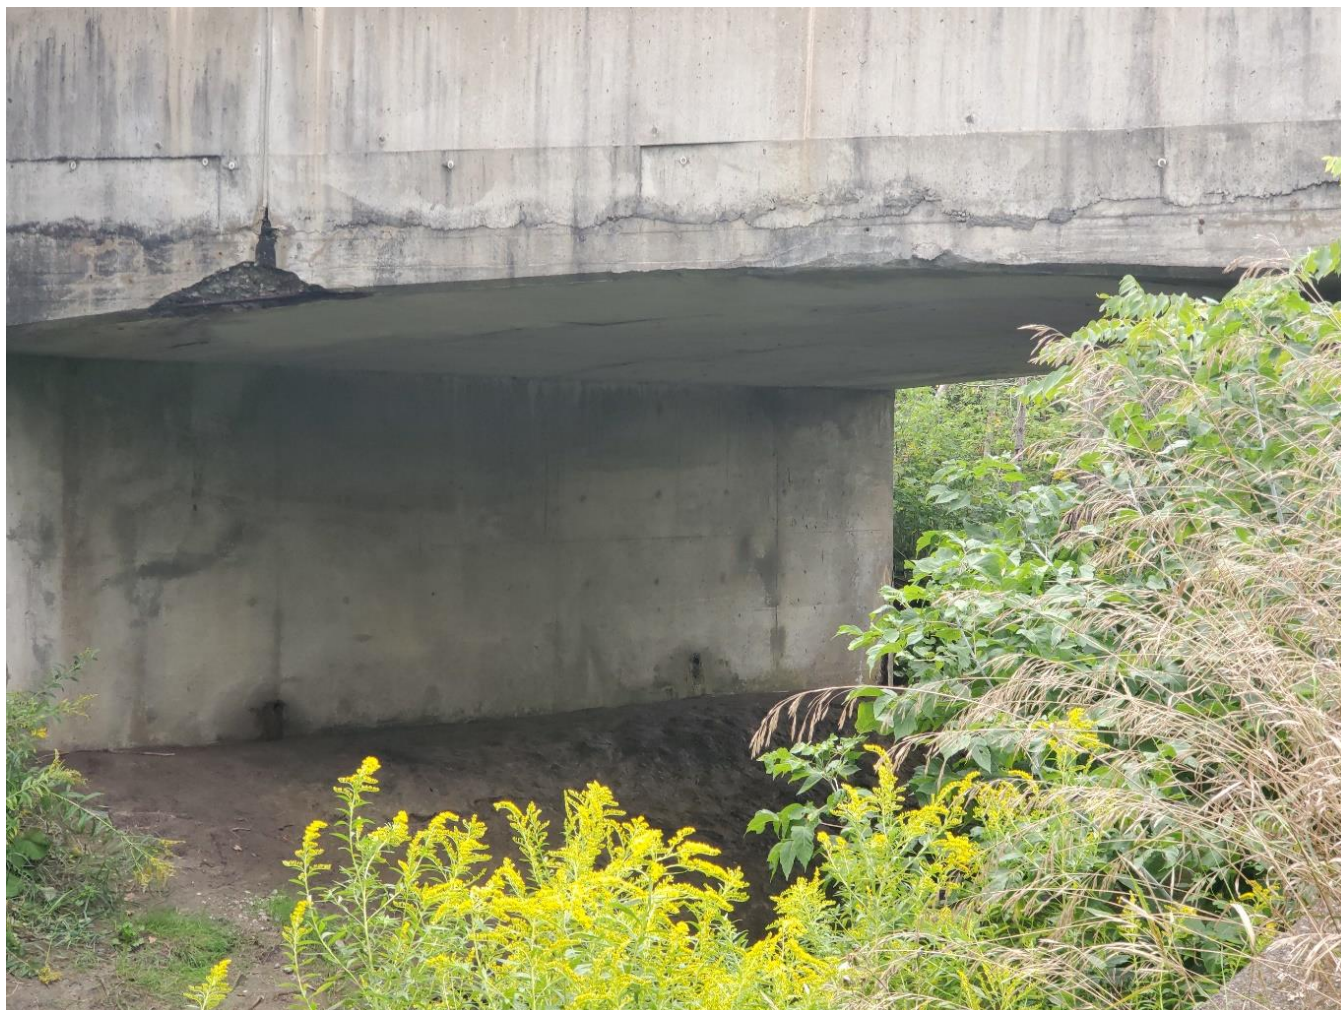
Figure 14 – Soffit of bridge looking north (spalling visible)

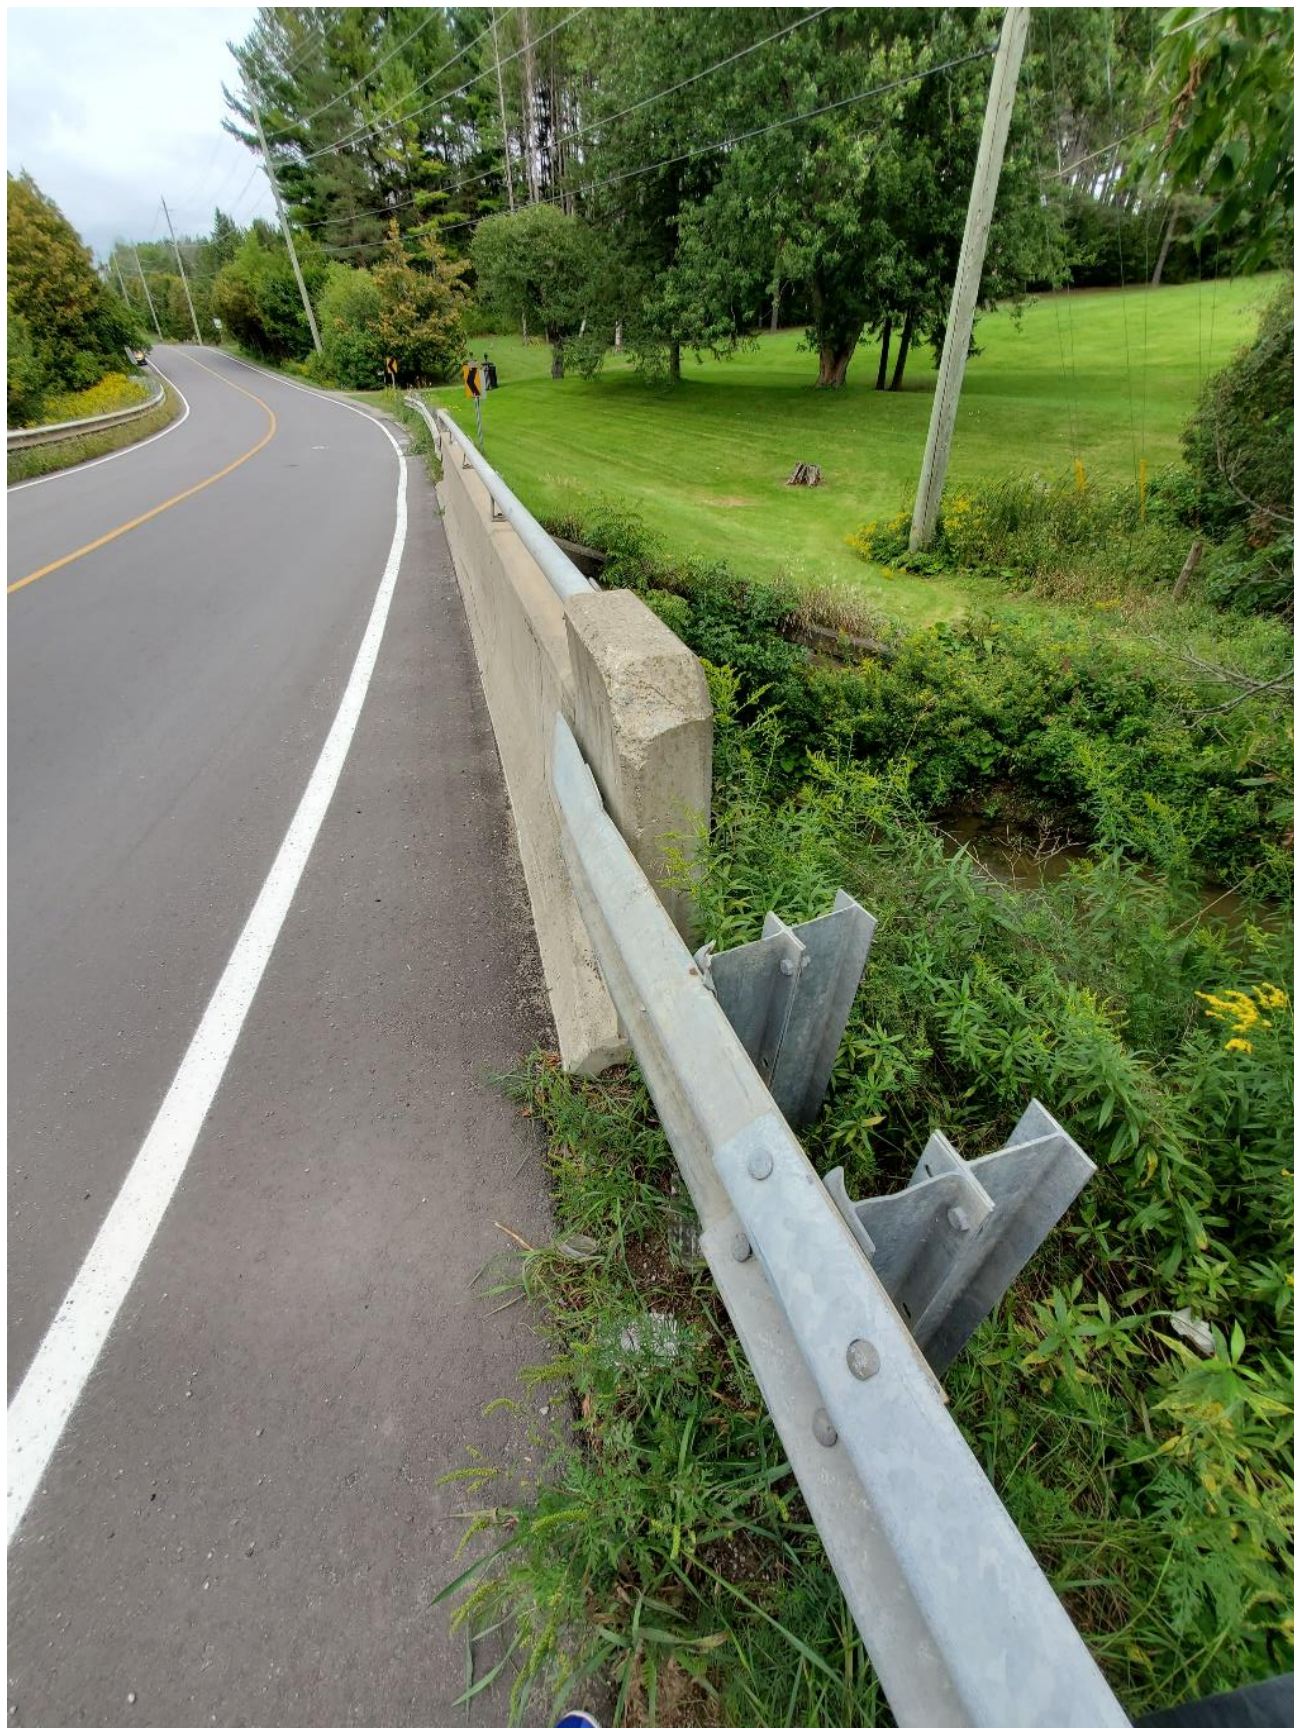
Figure 16 – Damaged southwest guiderail
