**LIFE CYCLE COST ANALYSIS**

**TO:** Arash Olia **RVA:** 195072  
**FROM:** Sardar A Nabi/ Prakash Nadesparan  
**DATE:** July 28, 2021  
**SUBJECT:** Life Cycle Cost Analysis (LCCA) of the Coventry Bridge

Re: Coventry Bridge Visual Condition Assessment  
Final Report

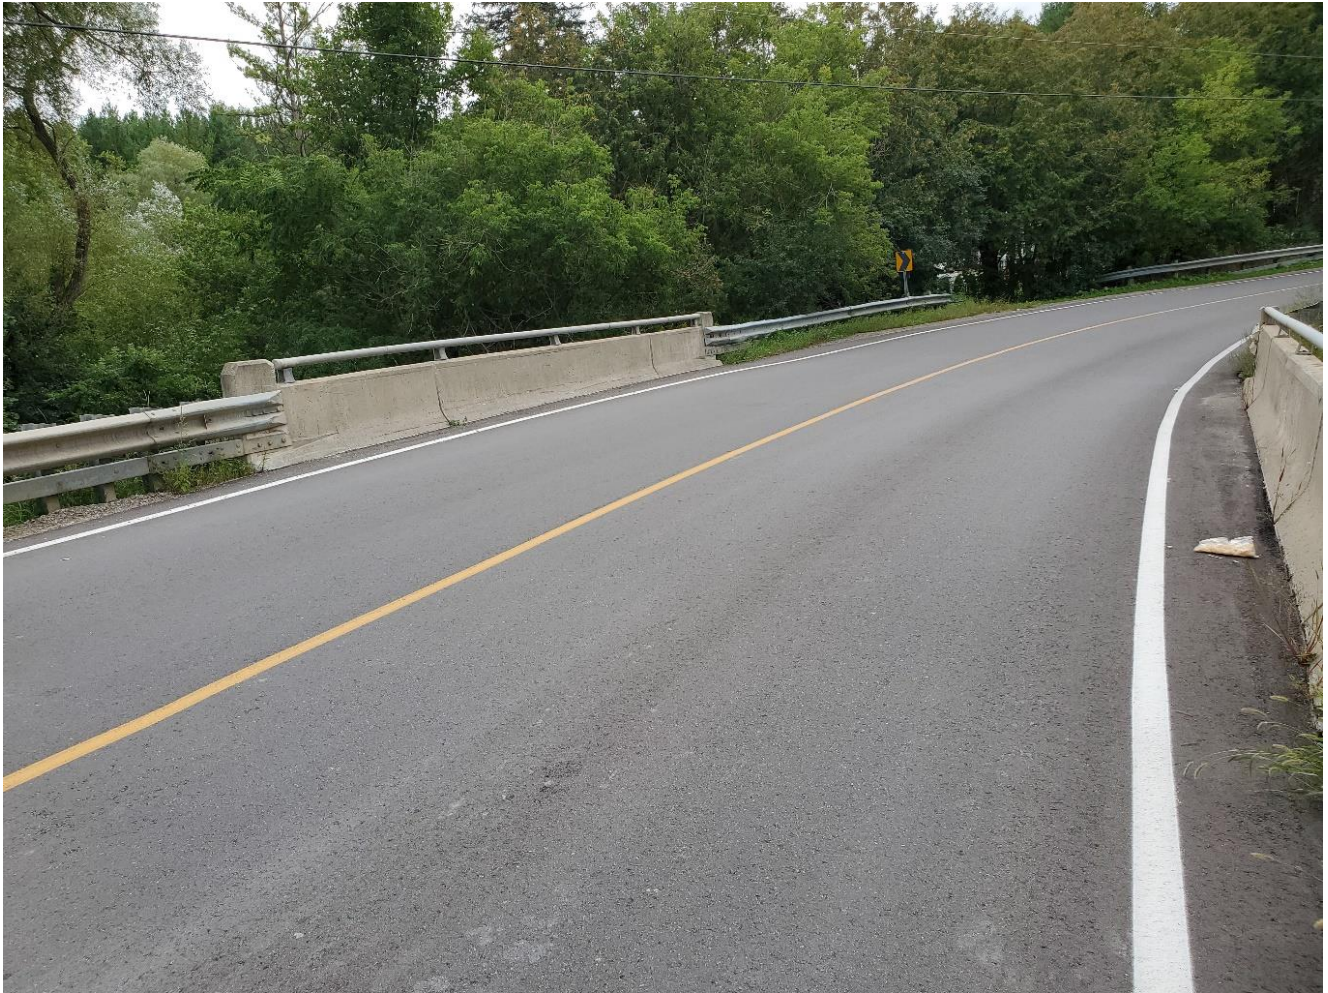
There was perceptible settlement of the roadway at the approach, nor any visible erosion to approaches to the bridge (See [Figure 1](#) and [Figure 7](#)).

The wearing surface (See [Figure 1](#)) was replaced in Summer 2020, and no concerns were noted. Previously observed cracking in the wearing surface prior to repaving is no longer present. The wearing surface is in good condition.

*Figure 1 – View of Bridge, looking West*

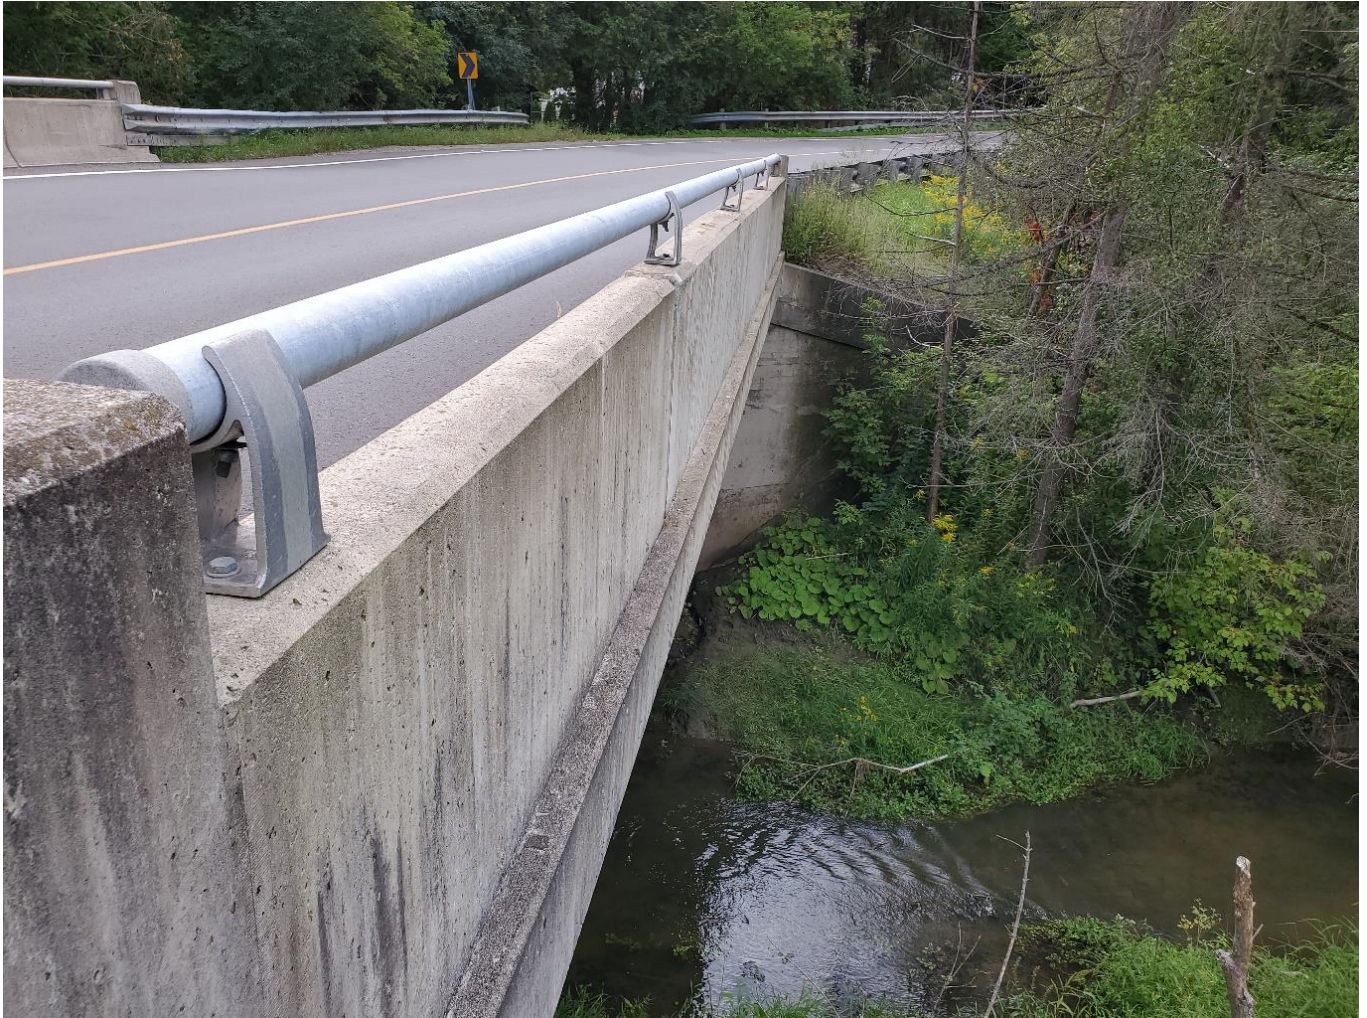
The railings were in good condition. The current railing height is set for pedestrians (1070 mm) and does not meet requirements for protecting cyclists (1400 mm). (see [Figure 2](#) and [Figure 10](#))

Minor erosion was observed at the northwest embankment (See [Figure 2](#)). All other embankments appeared to be in good condition (See [Figure 6](#), [Figure 10](#) and [Figure 12](#)).

*Figure 2 – North Parapet Wall and Railing, Northwest Wingwall*

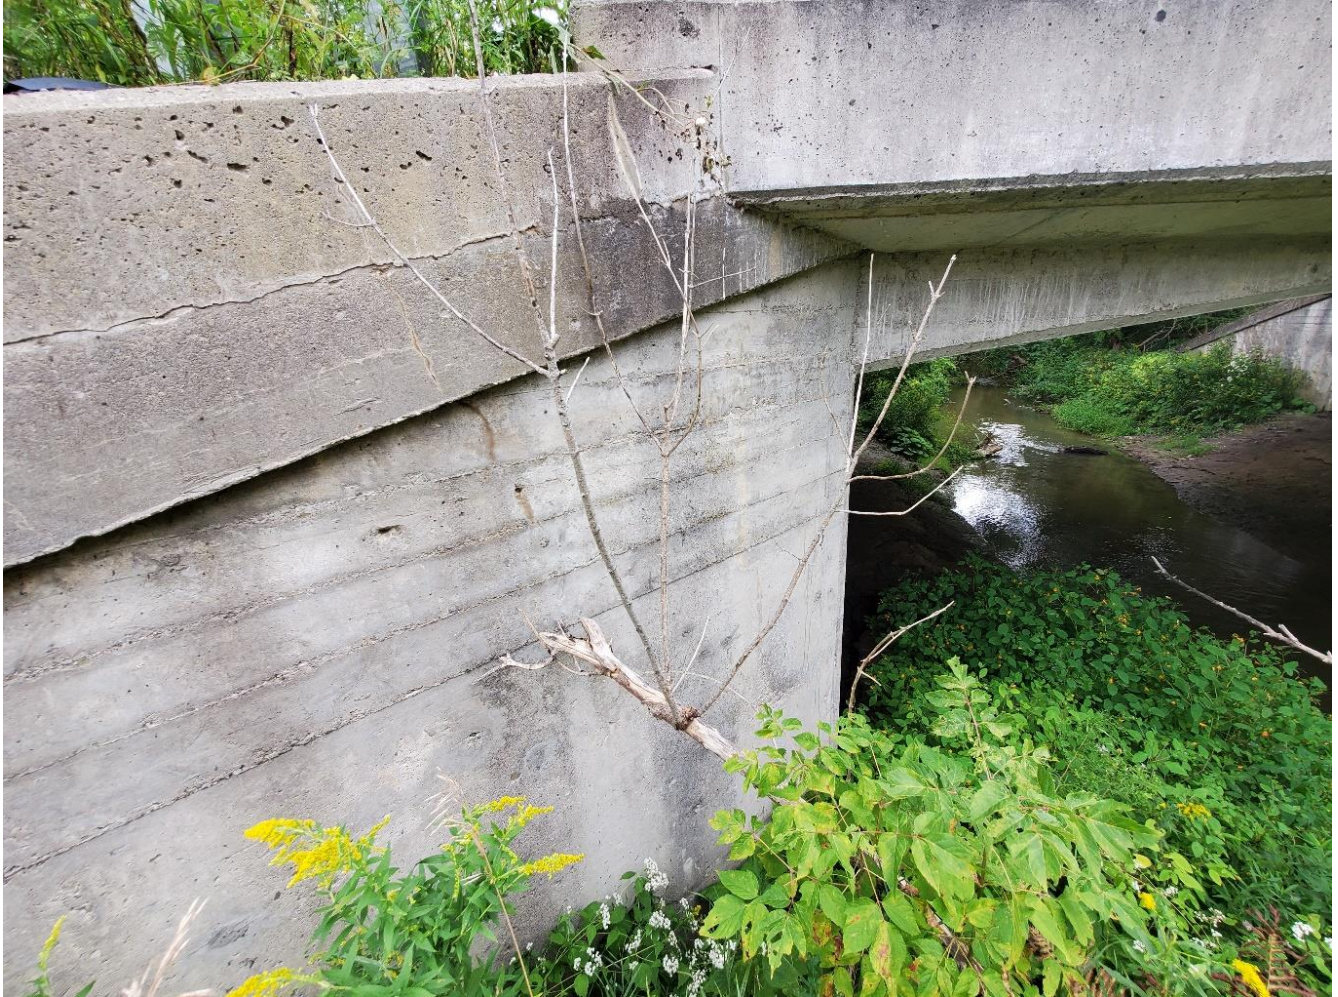
Moderate cracking of the face of the southwest abutment was observed (See [Figure 10](#) and [Figure 12](#)). Minor cracking and spalling of the northwest and northeast wingwalls was observed (See [Figure 2](#) and [Figure 3](#)).

*Figure 3 – Northeast Wingwall at Abutment*

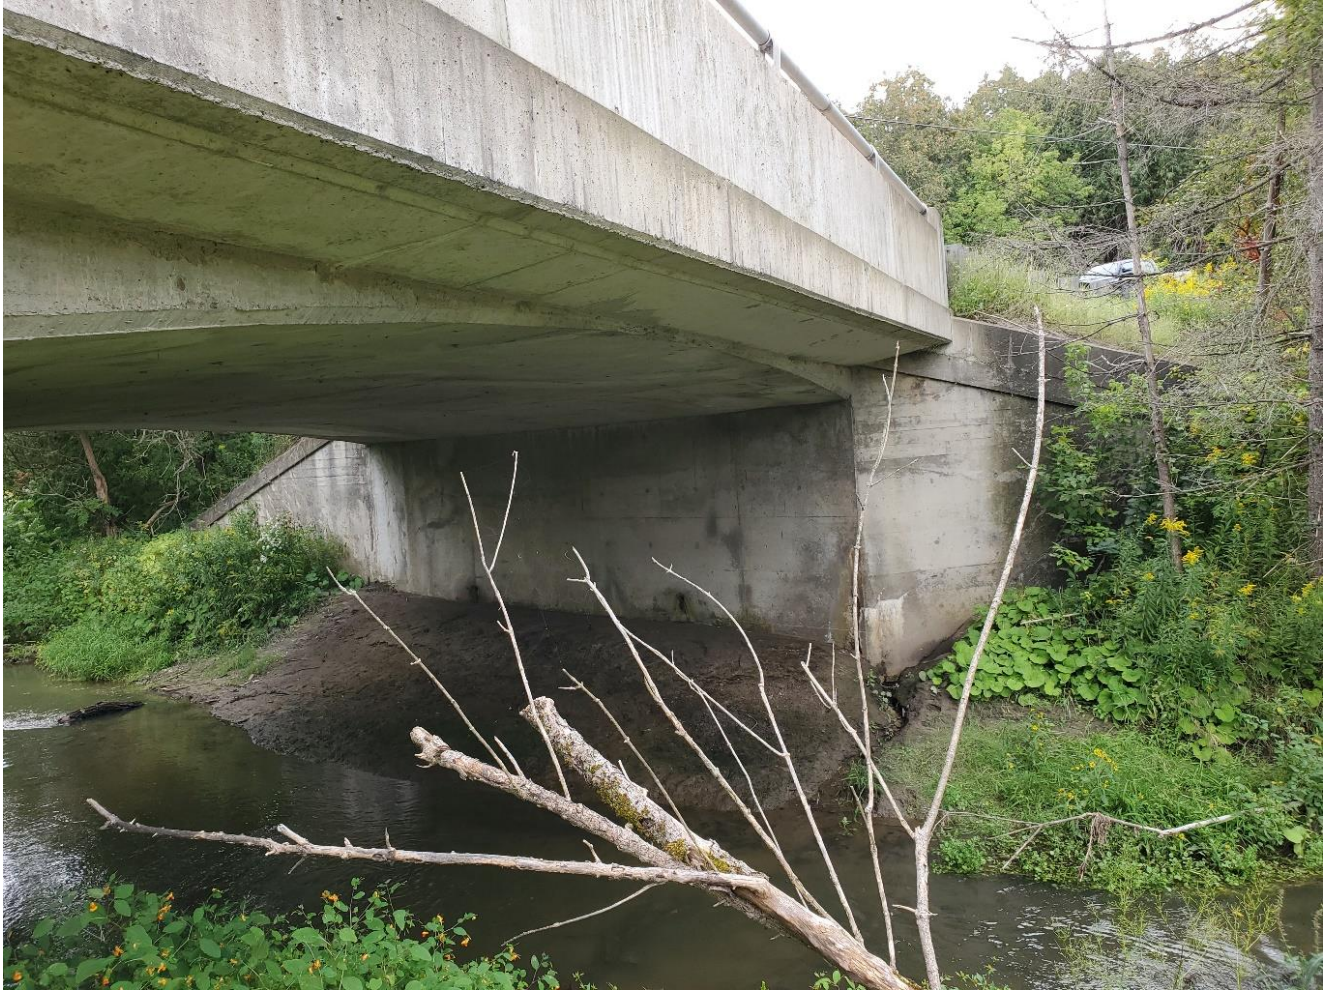
The deck fascia on the south side is in poor condition with major spalling observed (See [Figure 10](#) and [Figure 14](#)). The deck fascia on the north side is in good condition (See [Figure 4](#)).

*Figure 4 – Underside of Bridge, looking west*

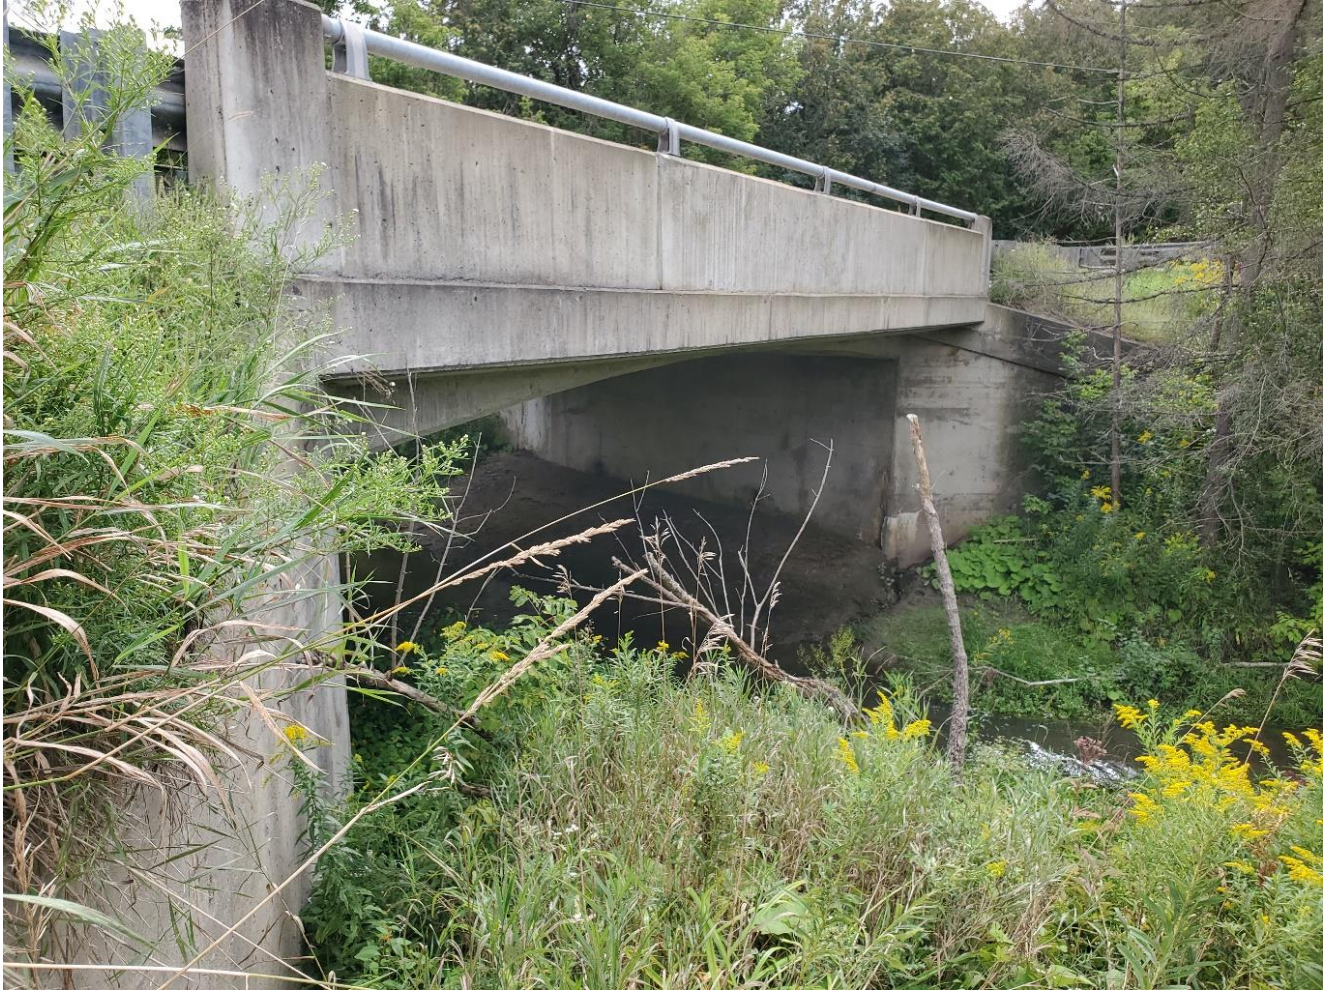
The parapet walls were observed to be in good condition. Some minor staining was observed. Shrinkage cracks which are typically present on this type of parapet wall were observed (See [Figure 1](#), [Figure 6](#), [Figure 10](#), and [Figure 12](#)).

*Figure 6 – North Elevation of Bridge*

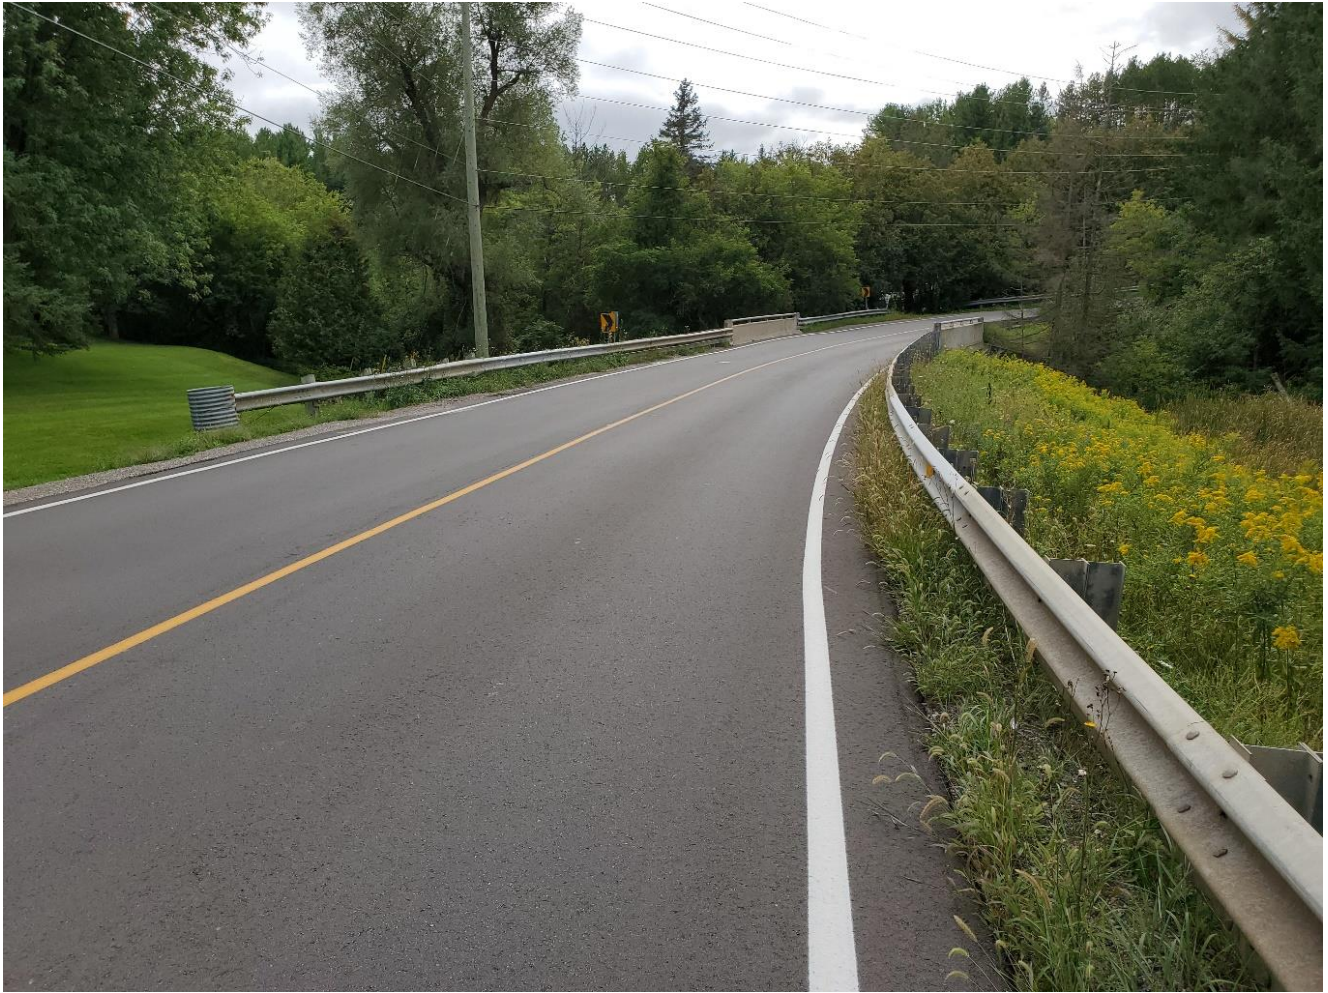
The southwest guiderail is in poor condition from what appears to be collision damage (see [Figure 15](#)). All other guiderails are in good condition. (See [Figure 1](#) and [Figure 7](#))

*Figure 7 – Guiderails at east side of Bridge*

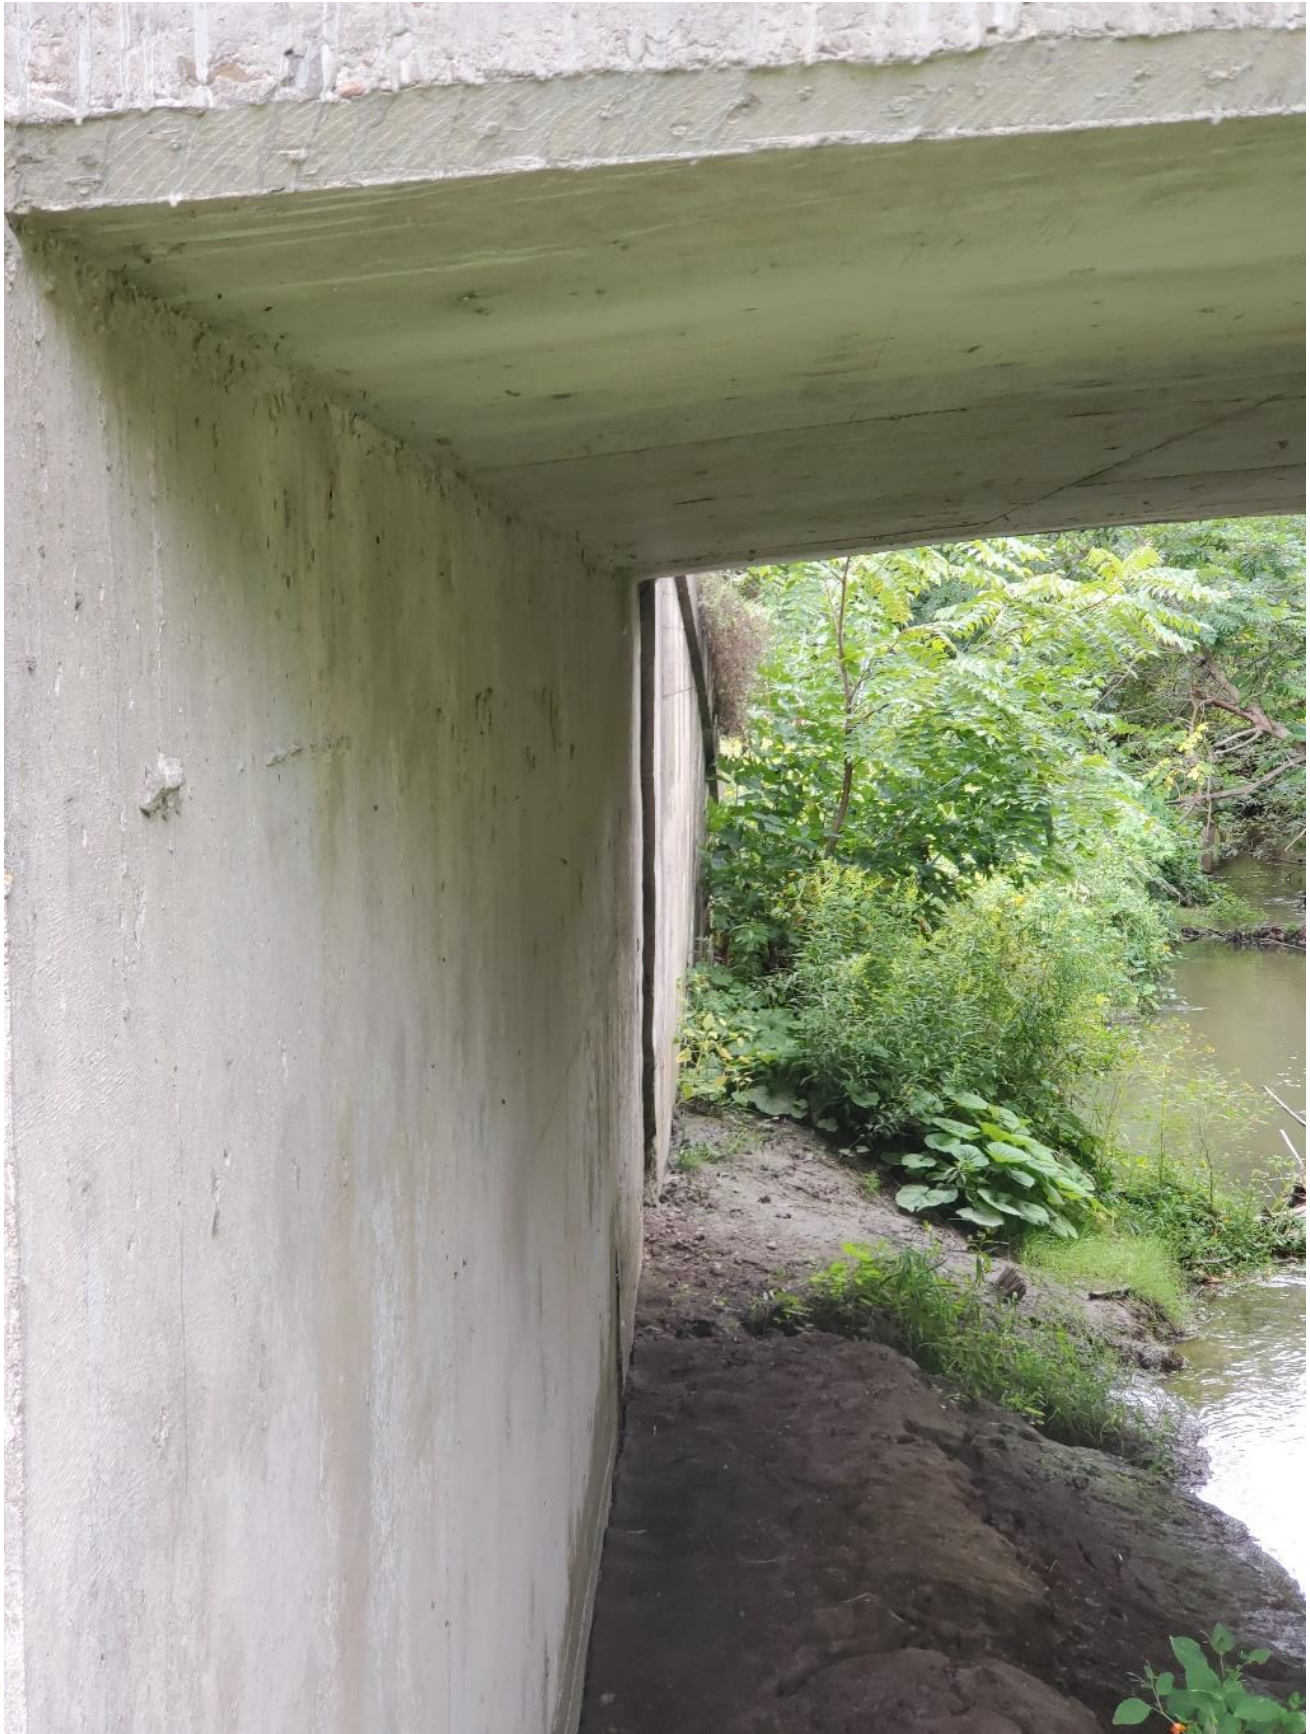
The east abutment is in good condition (See [Figure 8](#)). The west abutment is in fair condition, with a few areas of spalling, and exposed, corroded reinforcing steel (See [Figure 9](#)).

The deck soffit is in fair condition, with minor spalling visible (See [Figure 8](#)). The west abutment is in fair condition, with a few areas of spalling and exposed, corroded reinforcing steel. (See [Figure 9](#))

*Figure 8 – East abutment, looking south shifted southwest abutment visible)*

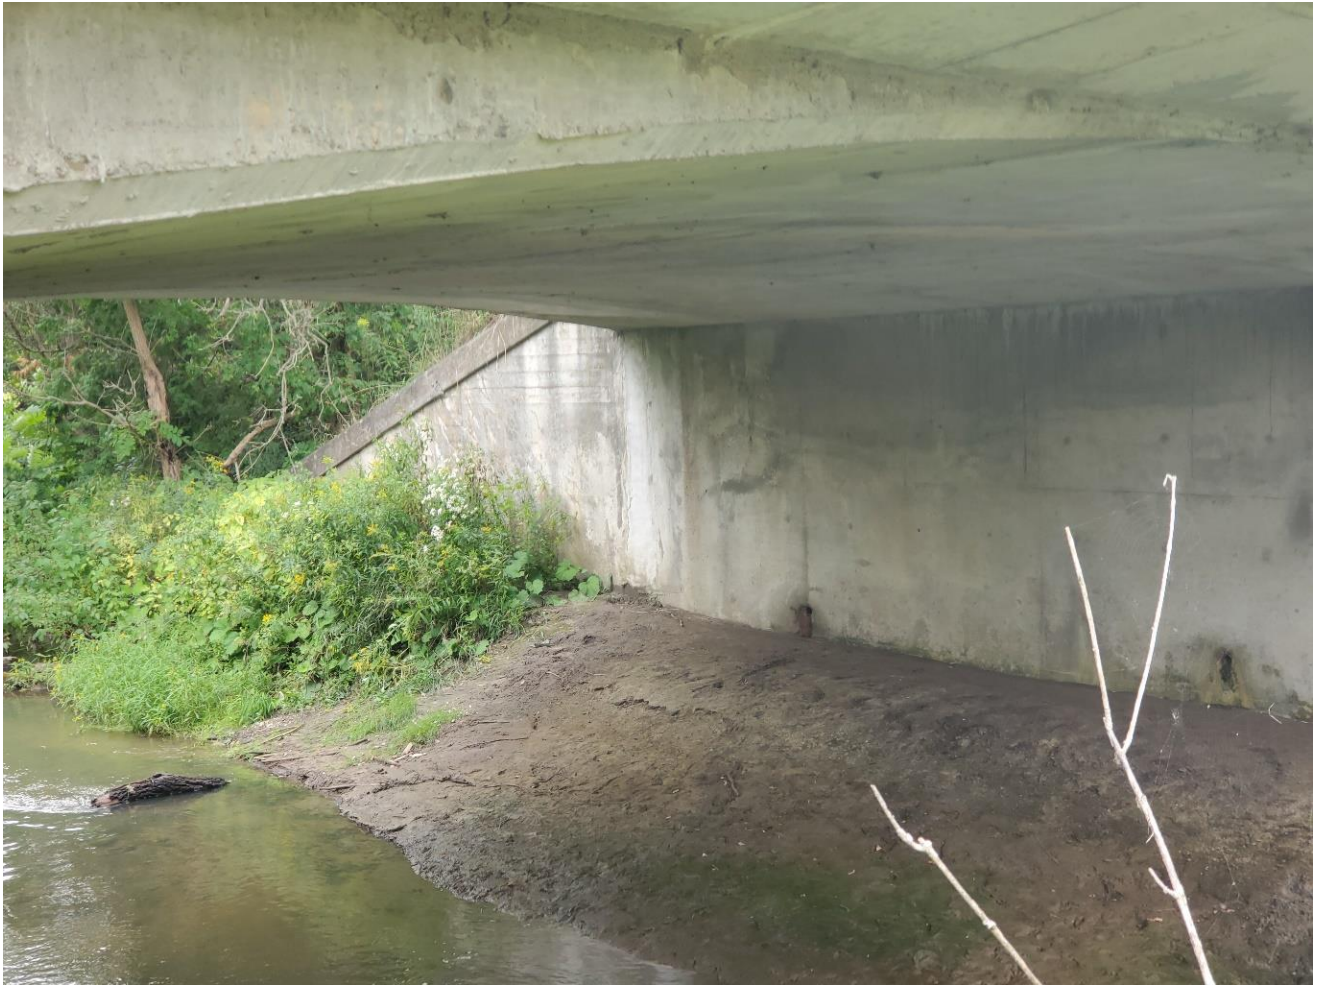
The deck soffit is in fair condition with minor spalling observed (See [Figure 9](#) and [Figure 14](#))

*Figure 9 – West abutment and soffit, looking west*

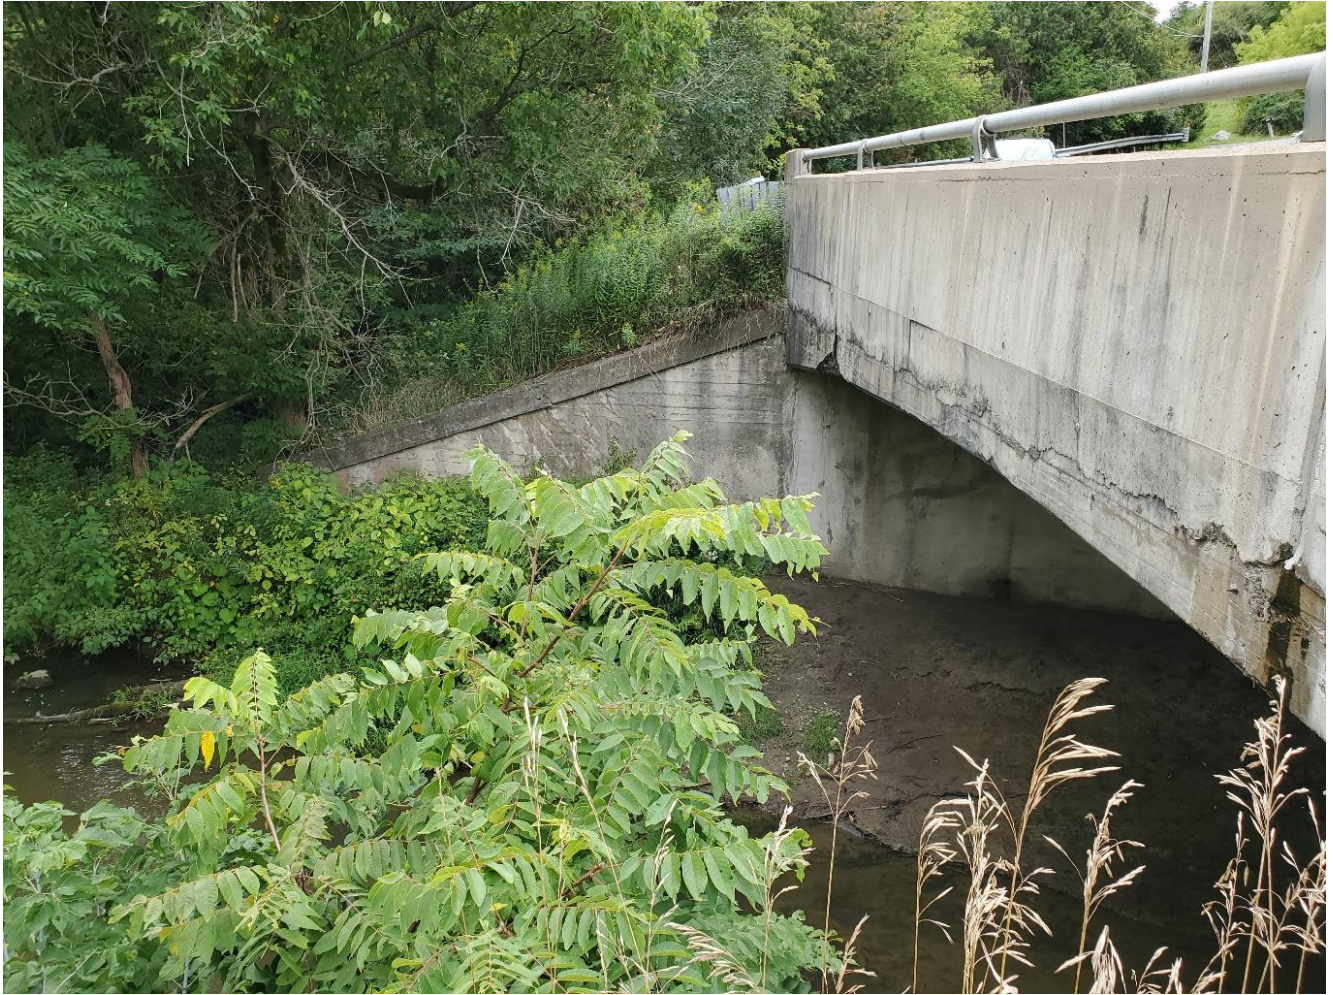
*Figure 10 – South side of bridge, southwest wingwall*

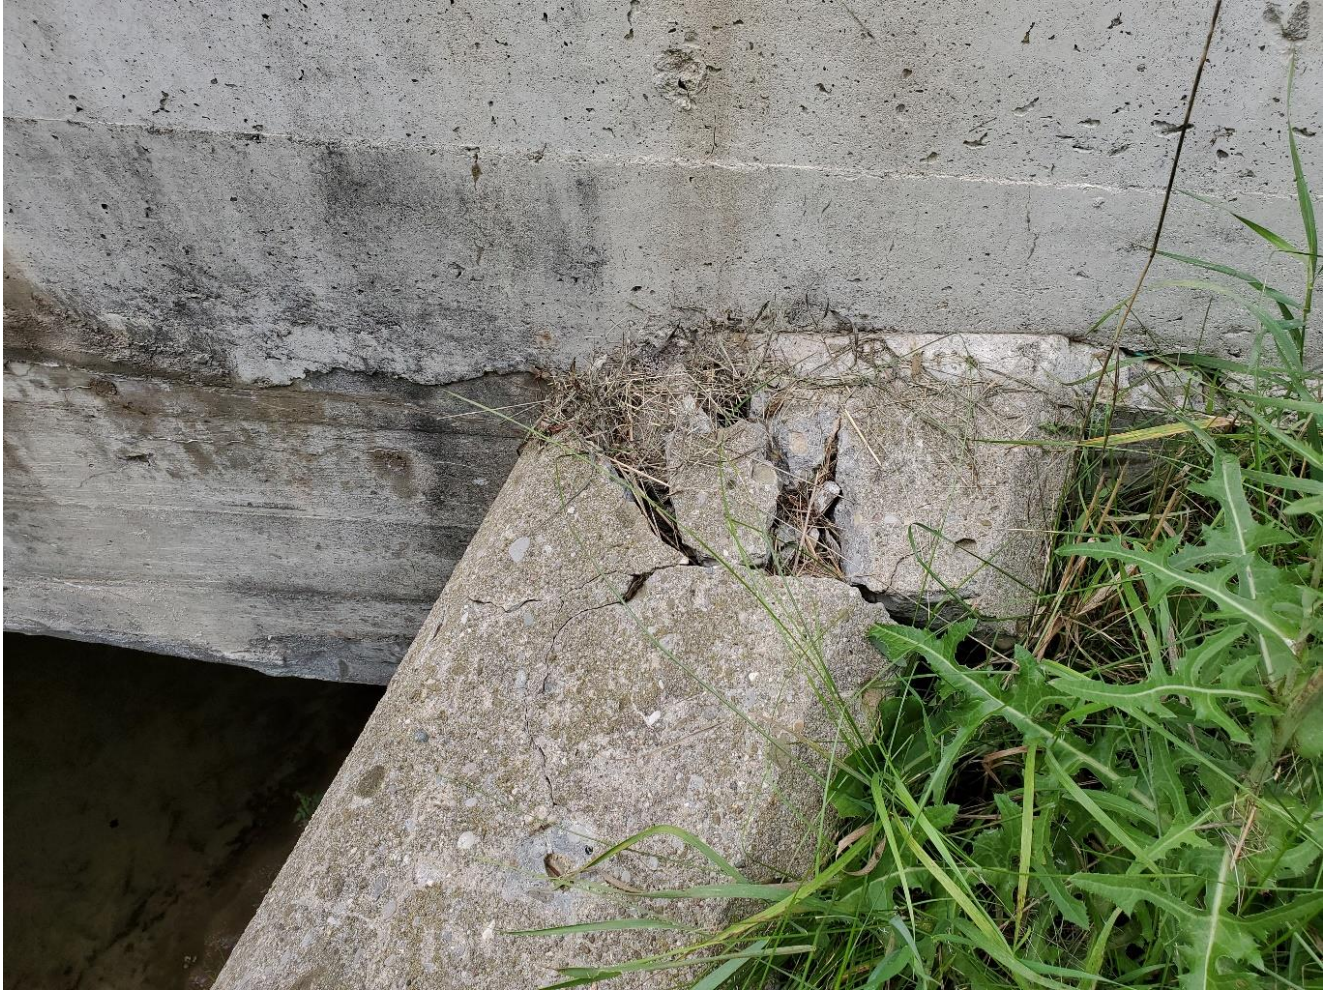
The connection between the southeast wingwall and the south abutment has failed. Movement of the wingwall exceeding 50 mm was observed (See [Figure 8](#) and [Figure 11](#)). This is believed to be a structural failure of the connection caused by forces acting on the wingwall and transferred into the joint, which does not have adequate structural capacity to withstand the applied load.

Of particular concern is the structural failure of the connection between the southeast wingwall and the east abutment. This joint is no longer restraining movement of the wingwall, and further movement of the wingwall could result in slope erosion and / or settlement of the road.

*Figure 11 – Structural failure at connection between east abutment and southeast wingwall*

- Carry out detailed structural analysis for the southwest and southeast wingwalls. If the wall(s) are determined to be structurally adequate, they should be modified or replaced.
- Replace the southwest guiderail and all other guiderails that have sustained damage at the time of the rehabilitation work. At this time, the end treatments should also be replaced if they have been determined to have sustained impact damage. This would provide the Town an opportunity to use SoftStop or other current standard end treatments.
- Carry out repairs to all spalling of the abutments, wingwall, soffit and fascia.
- Clean all staining from the concrete and steel bridge components and apply sealer.
- Clean and touch up any corrosion on existing railings with zinc rich primer or replace railings with bicycle-height railings.

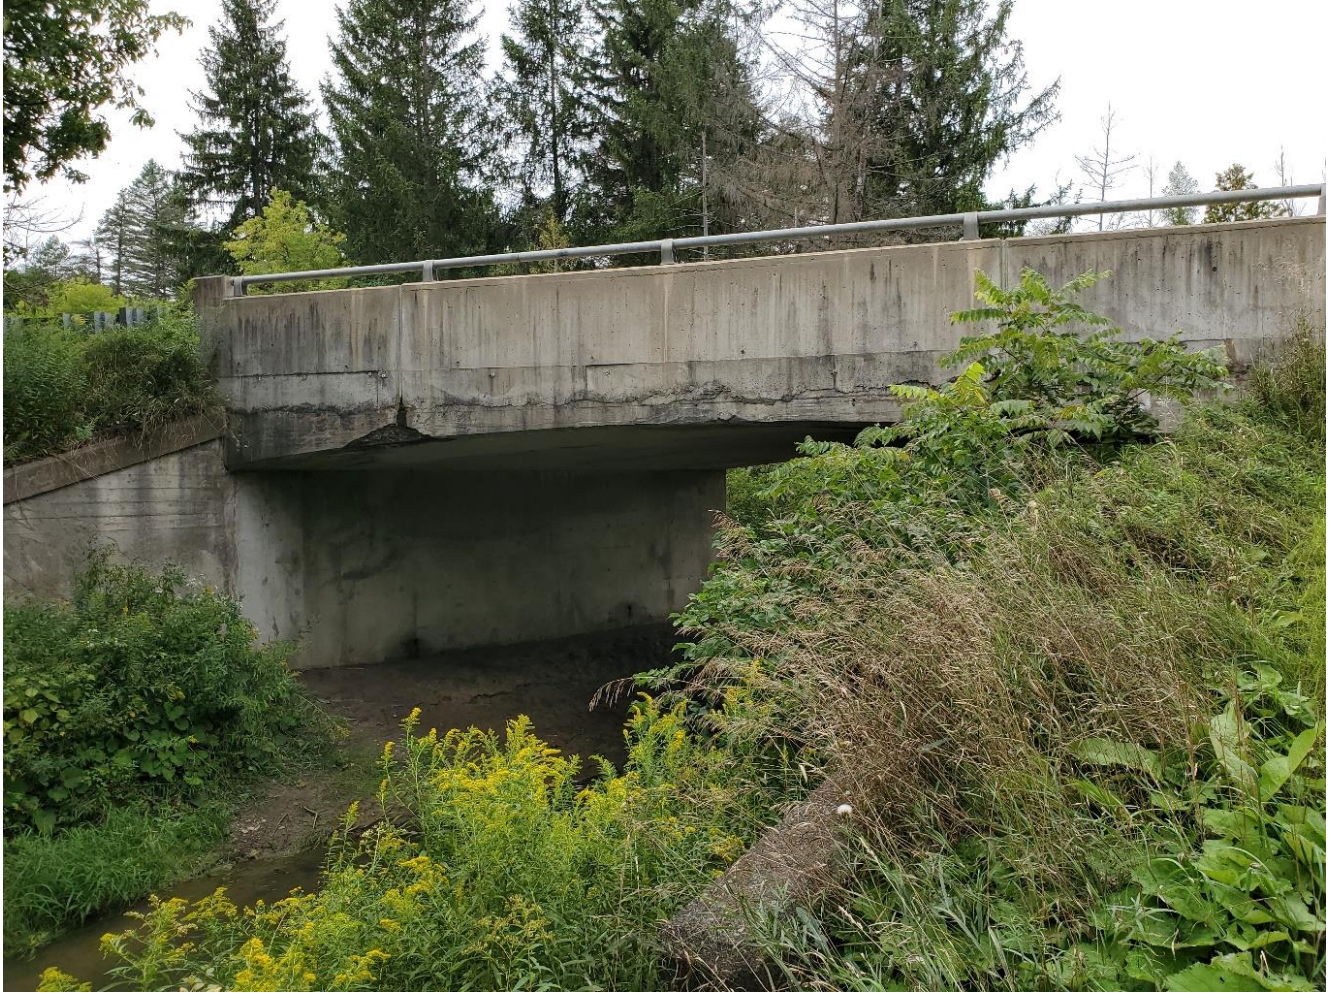
*Figure 12 – South elevation of Bridge*

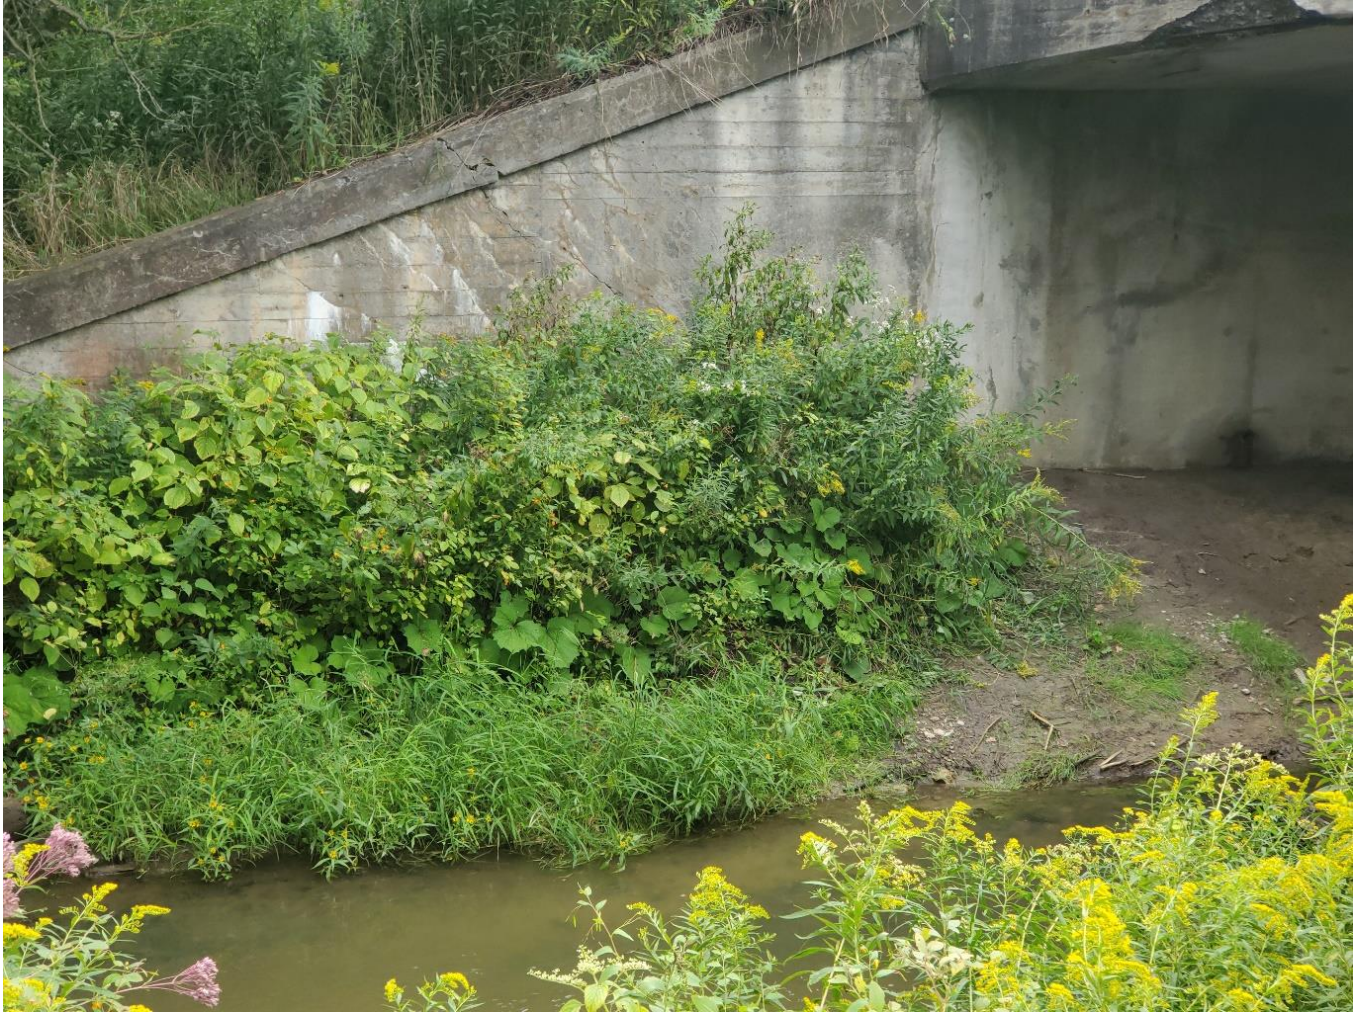
*Figure 13 – Southwest wingwall (cracking visible)*

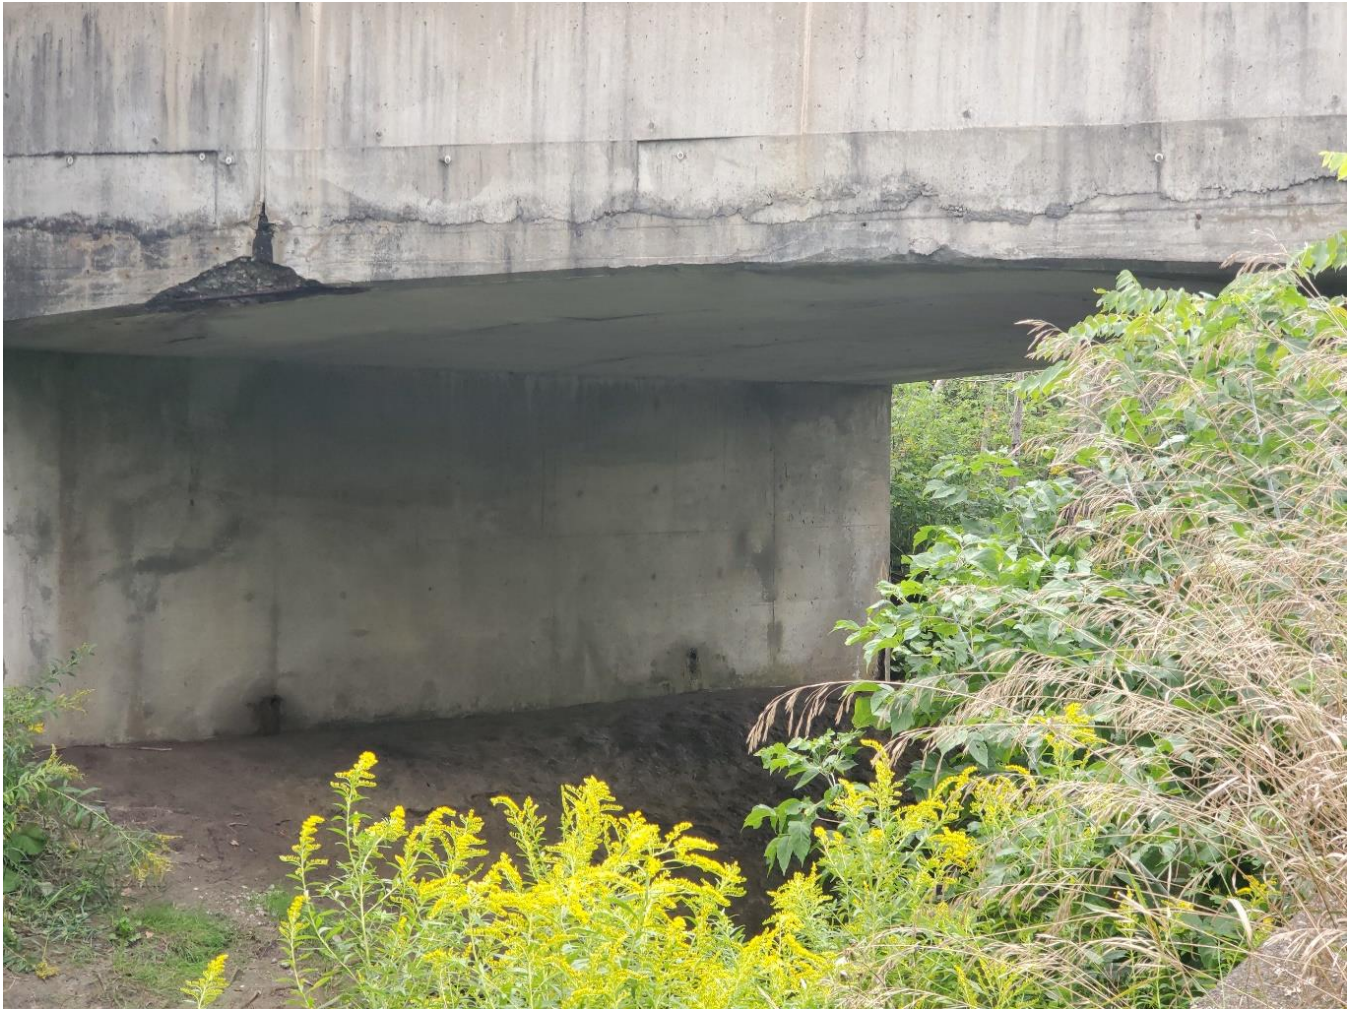
*Figure 14 – Soffit of bridge looking north (spalling visible)*

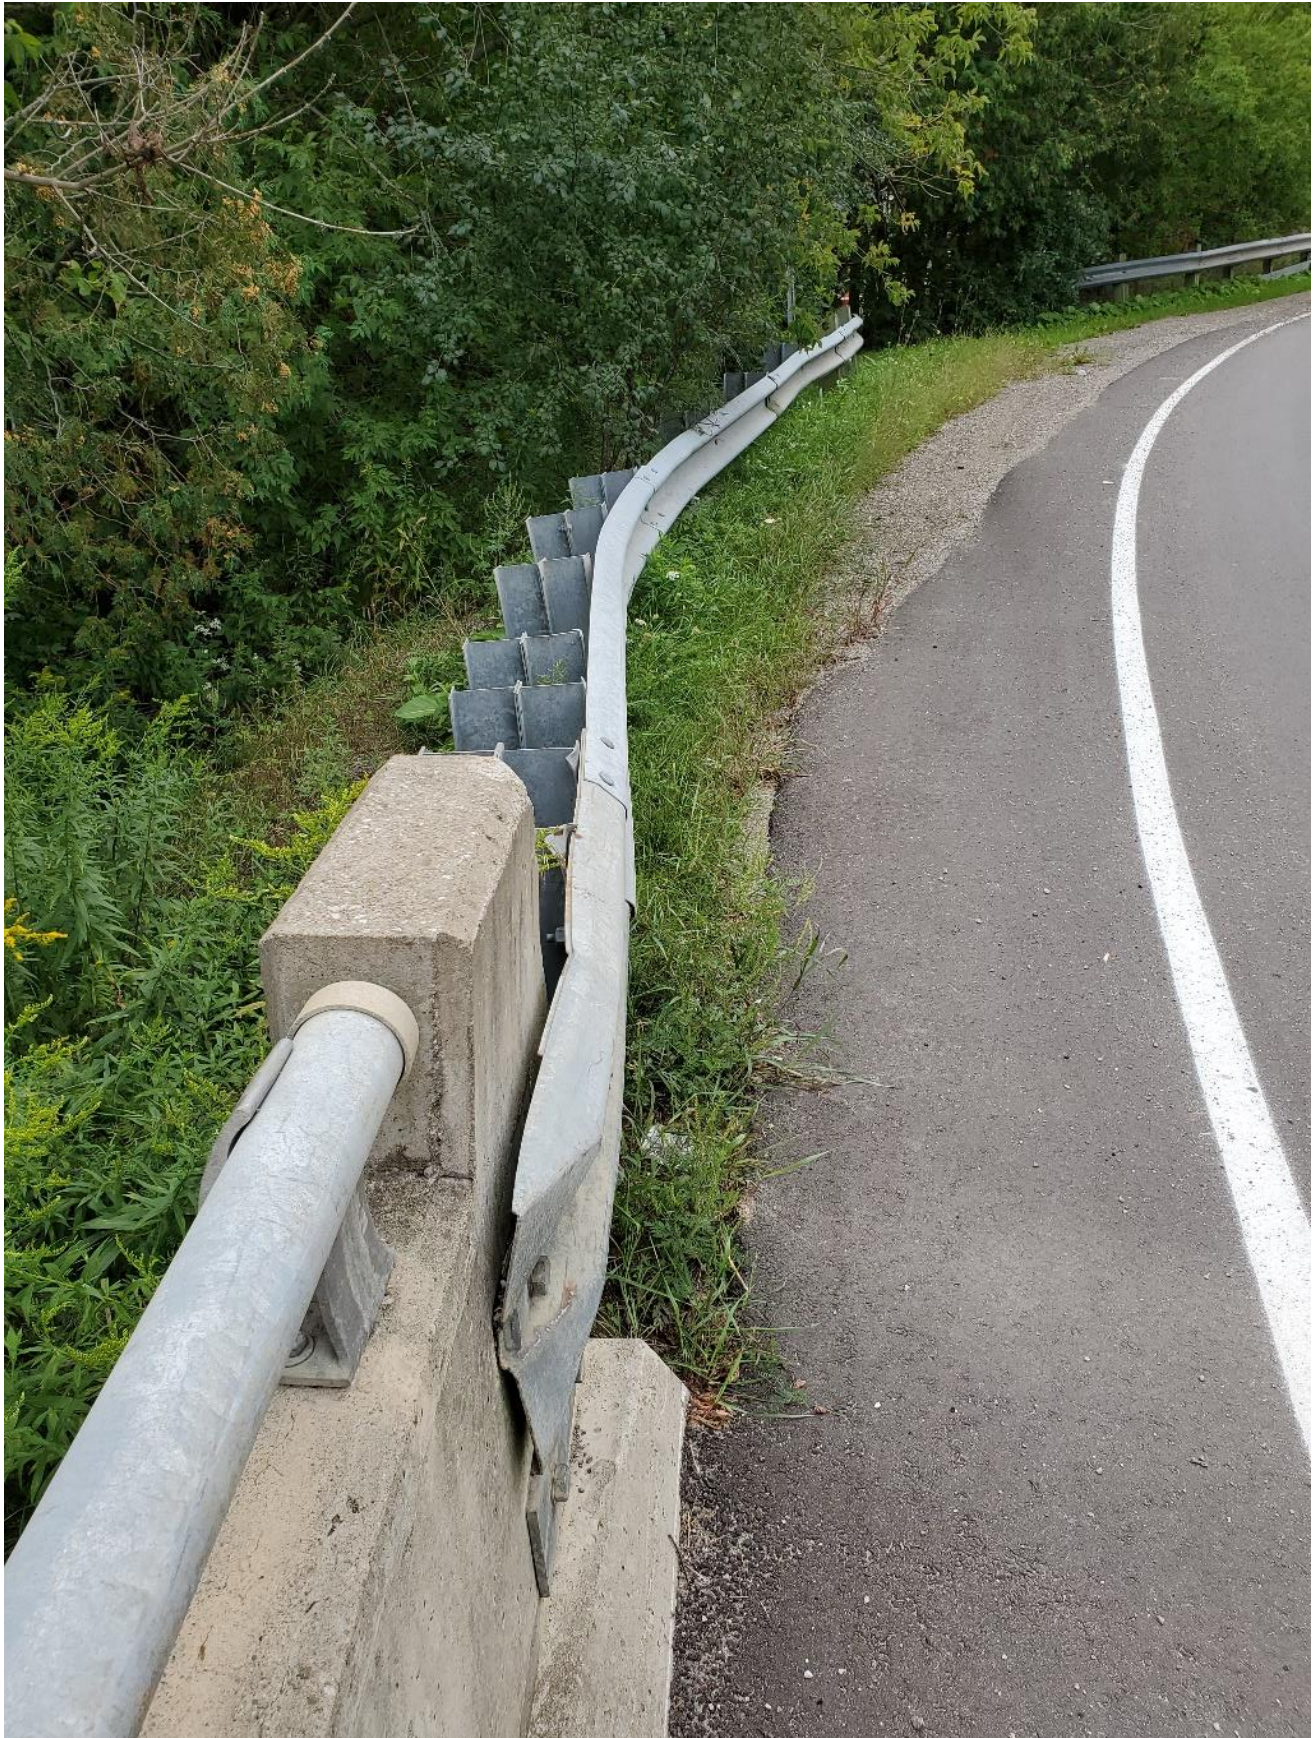
*Figure 15 – Damaged southwest guiderail*
