**LIFE CYCLE COST ANALYSIS**

**TO:** Arash Olia **RVA:** 195072  
**FROM:** Sardar A Nabi/ Prakash Nadesparan  
**DATE:** July 28, 2021  
**SUBJECT:** Life Cycle Cost Analysis (LCCA) of the Coventry Bridge

Re: Coventry Bridge Visual Condition Assessment  
Final Report

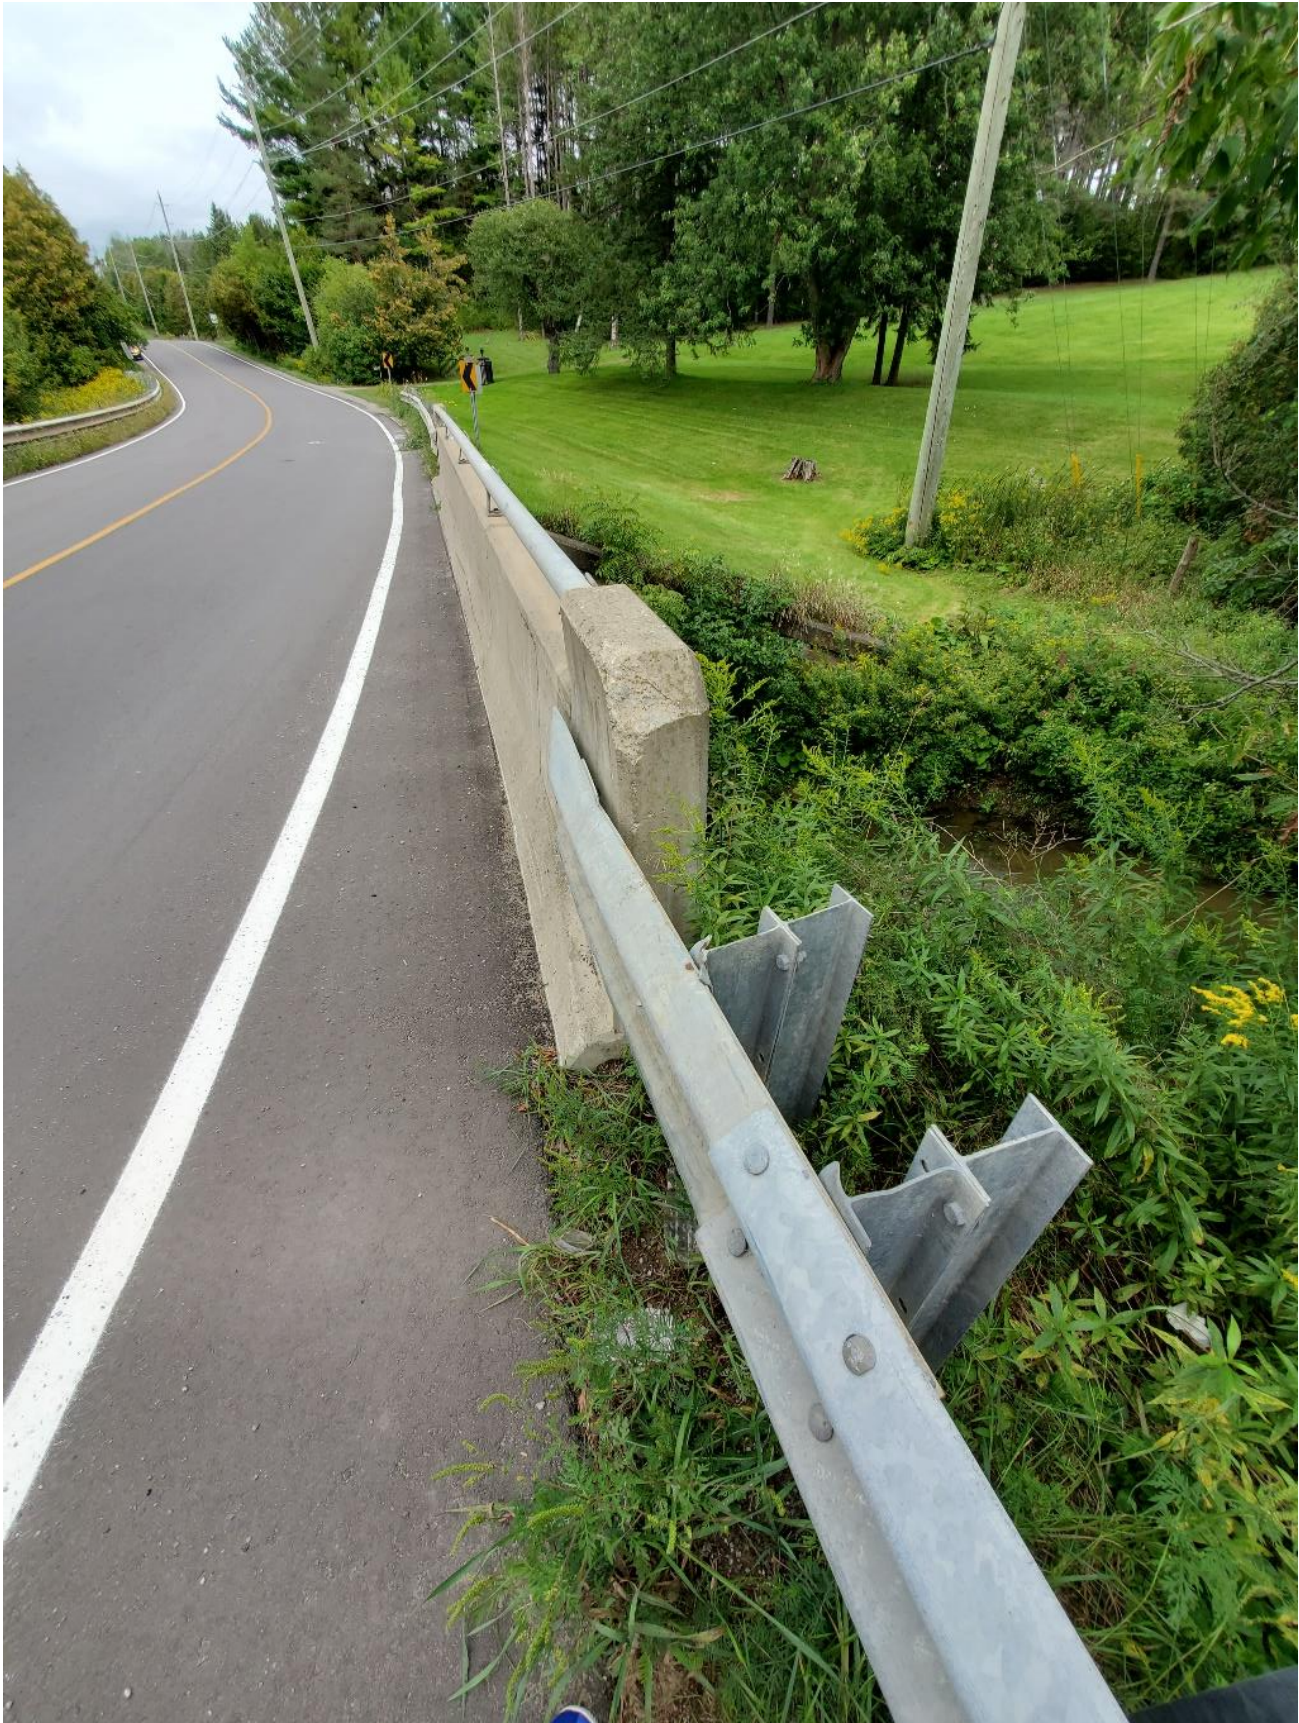
Figure 16 – Damaged southwest guiderail

- Carry out detailed structural analysis for the southwest and southeast wingwalls. If the wall(s) are determined to be structurally adequate, they should be modified or replaced.
- Replace the southwest guiderail and all other guiderails that have sustained damage at the time of the rehabilitation work. At this time, the end treatments should also be replaced if they have been determined to have sustained impact damage. This would provide the Town an opportunity to use SoftStop or other current standard end treatments.
- Carry out repairs to all spalling of the abutments, wingwall, soffit and fascia.
- Clean all staining from the concrete and steel bridge components and apply sealer.
- Clean and touch up any corrosion on existing railings with zinc rich primer or replace railings with bicycle-height railings.
