ARBORIST REPORT

Hunsden Sideroad Residential

10249 Hunsden Sideroad
Caledon, Ontario

June 2, 2022

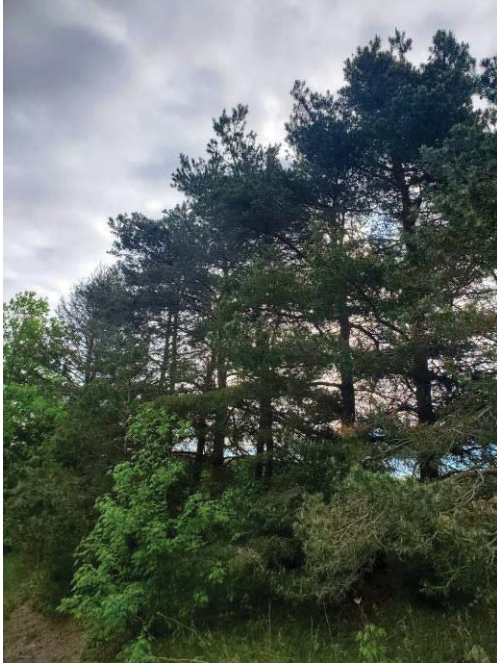
Figure 3: Trees of group 1.

Tree Number	Species	DBH (cm)	Canopy diameter (m)	Biological Health	Structural Condition	Recommended Action	Comments	Location
1a	Pinus sylvestris (Scots Pine)	33	7	H	MH	P	Multibranch node and backfilled.	M
1b	Pinus sylvestris (Scots Pine)	21	7	H	H	P	Backfilled.	M
1c	Pinus sylvestris (Scots Pine)	24	7	H	H	P	Backfilled.	M
1d	Pinus sylvestris (Scots Pine)	15, 14	5	H	M	P	Multi-leader with included bark from 0.15m-0.3m ht. and backfilled.	M
1e	Pinus sylvestris (Scots Pine)	26	7	H	H	P	Backfilled.	M
1f	Pinus sylvestris (Scots Pine)	22	6	H	H	P	Backfilled.	M
1g	Pinus sylvestris (Scots Pine)	20	6	H	H	P	Backfilled.	M
1h	Pinus sylvestris (Scots Pine)	22.5	6	H	H	P	Backfilled.	M
2	Picea glauca (White Spruce)	44	8	M	H	P	Branch tips with dieback of 30% of canopy.	M
3	Acer negundo (Manitoba Maple)	41, 33, 31	12	M	M	P	Three leaders, approx. 20 medium-sized dead branches, emerging included bark at the main union.	M
4	Pinus sylvestris (Scots Pine)	~15	n/a	D	D	P	Dead.	M

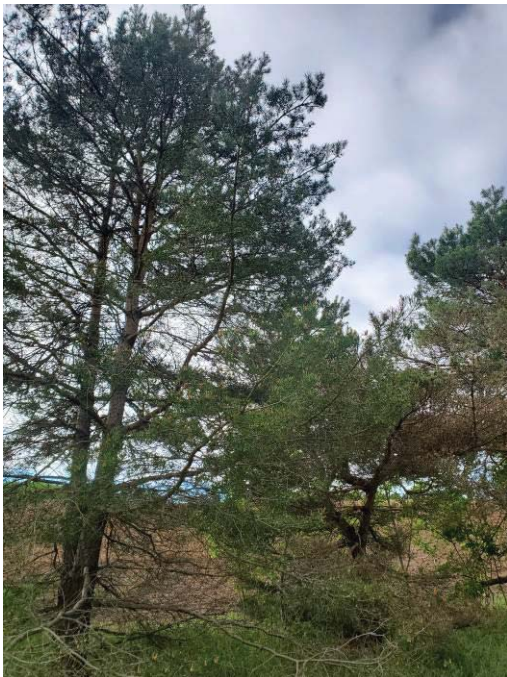
Figure 5: Tree 8.

6	Pinus sylvestris (Scots Pine)	39	7	H	M	P	Large limb of 15cm dia. Torn off with ripping wound, co-dominant leaders, and backfilled.	M
7	Pinus sylvestris (Scots Pine)	21	4	ML	M	P	Backfilled, canopy 60% dead.	M
8	Pinus sylvestris (Scots Pine)	21.5, 25	6	H	M	RC	Co-dominant leaders with included bark (10cm length), backfilled, medium branch fused with 2 leaders.	M
9	Pinus sylvestris (Scots Pine)	32	6	H	MH	RC	Large broken limb, branch stubs with ripping wound.	M
10	Acer negundo (Manitoba Maple)	25.5	7	H	M	P	Multiple limbs cut at base.	M
11	Pinus sylvestris (Scots Pine)	31.5	6	MH	H	P	Some defoliation on twigs, 1 limb broken at branch collar.	M
12	Pinus sylvestris (Scots Pine)	21	4	ML	ML	P	Unbalanced canopy to west, zig zag branch from on leader. Wound on leader with 30% trunk circumference.	M
13	Pinus sylvestris (Scots Pine)	29.5	6	H	MH	P	Co-dominant leaders.	M
14	Pinus sylvestris (Scots Pine)	46	9	H	M	P	Co-dominant leaders with included bark from 4m to 5.5m ht.	M

Of those trees that are over 15cm DBH on the subject site, remove trees #8, 9, 53, and 54 for construction as identified on the Tree Inventory & Preservation Plan. This is a total of 4 trees.

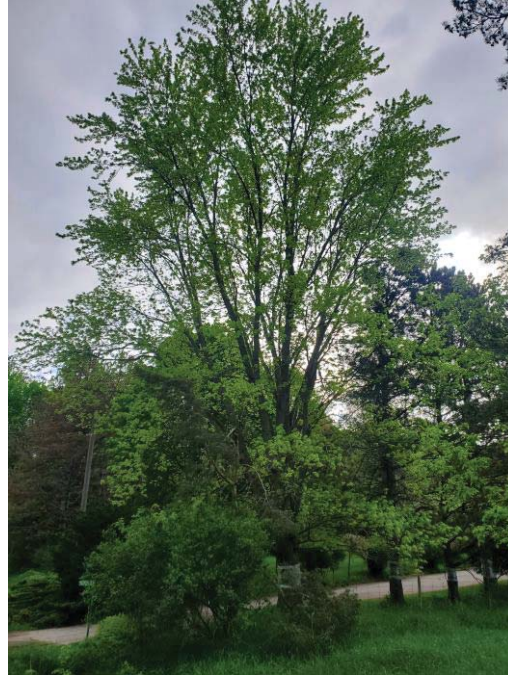
Figure 8: Trees 16 in foreground

15	Pinus sylvestris (Scots Pine)	17	5	M	M	P		M
16	Acer saccharinum (Silver Maple)	~70	14	MH	M	P	Multiple leaders from 2m ht., included bark at 6m ht. Has wrap on trunk for pest.	N
17	Pinus nigra (Austrian Pine)	~45	7	M	M	P	Co-dominant leaders from 6m ht. with medium sized branch fused between them and browning foliage. Has wrap on trunk for pest.	N
18	Pinus nigra (Austrian Pine)	~30	5	M	M	P	Unbalanced canopy to west and browning foliage. Has wrap on trunk for pest.	N
19	Pinus nigra (Austrian Pine)	~50	7	MH	H	P	Browning foliage and has wrap on trunk for pest.	N
20	Picea glauca (White Spruce)	~25	5	H	H	P	Has wrap on trunk for pest.	N
21	Picea glauca (White Spruce)	~25	5	MH	H	P	Suppressed branches at 10 - 15m from #22 but top is in leaf. Has wrap on trunk for pest.	N

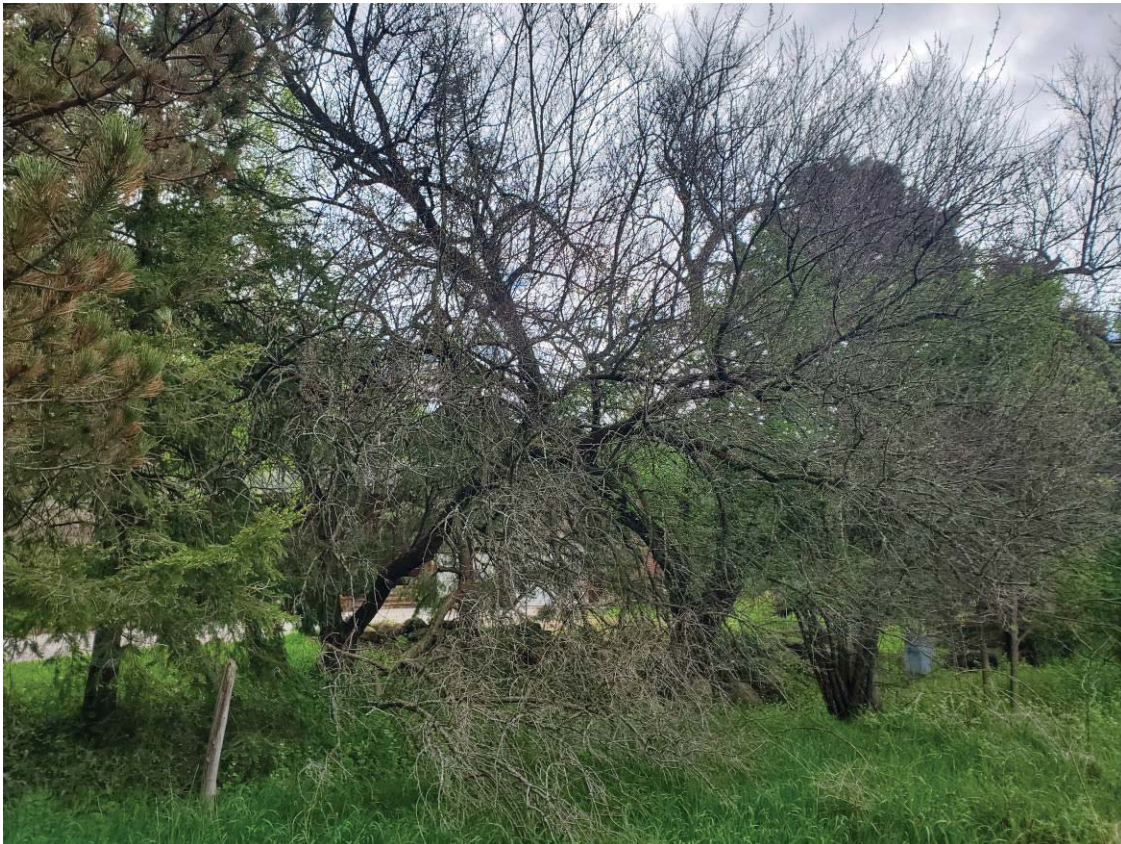
Figure 9: Trees 21-24

22	Eleagnus angustifolius (Russian Olive)	~25, ~20	10	ML	M	P	Co-dominant, limb/trunk leans 45° to east and to west, slower canopy has a lot of dieback (50%).	N
23	Eleagnus angustifolius (Russian Olive)	~45, ~25	11	M	M	P	Fusing branch on trunk, 3 leaders, leans 45° to north and west, and grown on stone slope.	N
24	Pinus nigra (Austrian Pine)	~60	8	MH	MH	P	Co-dominant leaders, and wrap on trunk for pest.	N
25	Picea glauca (White Spruce)	~40	6	H	H	P		N
26	Picea glauca (White Spruce)	~35	6	H	H	P		N
27	Picea glauca (White Spruce)	~35	6	H	H	P		N
28	Picea glauca (White Spruce)	~20	4	H	H	P		N
29	Picea glauca (White Spruce)	~35	5	H	H	P		N
30	Picea glauca (White Spruce)	~30	5	H	H	P		N
31	Picea glauca (White Spruce)	~20	4	M	H	P	Suppressed at top 4m.	N
32	Acer negundo (Manitoba Maple)	40.5	10	H	M	P	Unbalanced canopy to west, leans 10° to west, and included bark at main union.	N
33	Picea glauca (White Spruce)	~35	5	H	H	P	Unbalanced canopy to east.	N

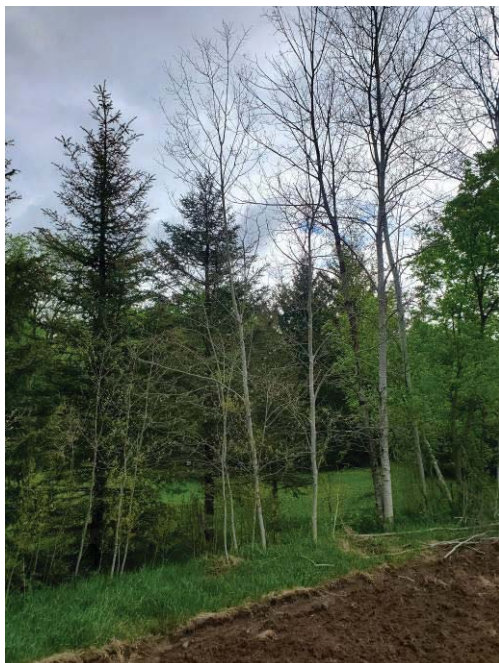
Figure 11: Trees around tree 37

34	Picea glauca (White Spruce)	~30	5	H	H	P	Unbalanced canopy to southwest.	N
35	Picea glauca (White Spruce)	~20	4	H	H	P		N
36	Picea glauca (White Spruce)	~18	4	H	H	P	Has wrap on trunk for pest.	N
37	Populus tremuloides (Trembling Aspen)	20	5	ML	ML	P	Co-dominant leaders with one leader dead, remaining leader has 25% dead branches in lower canopy.	S
38	Populus tremuloides (Trembling Aspen)	18	4	MH	MH	P	Wound with rot at 0.3m ht.	S
39	Populus tremuloides (Trembling Aspen)	20	5	MH	MH	P	One leader cut at the base with fungus fruiting bodies and 20% of canopy dead particularly in lower canopy.	S

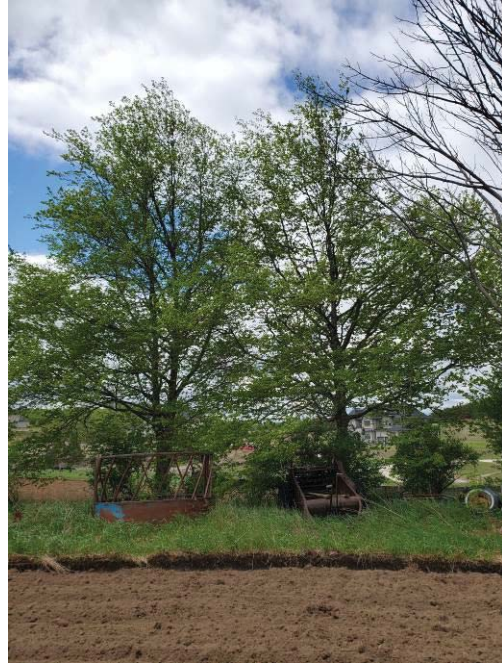
Figure 14: Trees 55 to 56

52	Acer saccharum (Sugar Maple)	65	9	MH	M	RC	Co-dominant leaders, with included bark at base to 4m ht and larger trunk has fallen.	S
53	Acer saccharum (Sugar Maple)	60, 51	12	M	ML	P	One (1) leader is dead and 2 leaders remain with included bark between, a wound of 50% trunk circumference and a few large dead branches.	S
54	Prunus serotina (Black Cherry)	52	11	MH	MH	P	Approximately 5 large dead branches.	S
55	Tilia americana (Basswood)	54, 57	10	ML	ML	P	One (1) leader remains with five (5) large broken or fallen trunk and four (4) large dead branches.	S
56	Ostrya virginiana	28, 27	8	H	H	P		S

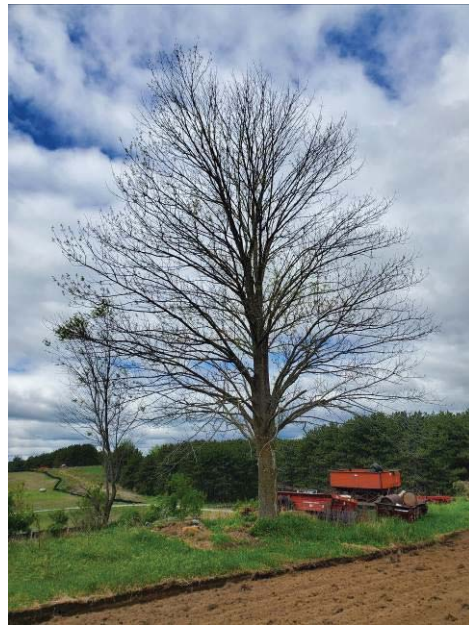
Figure 16: Tree 59

(Ironwood)							
57	<i>Ostrya virginiana</i> (Ironwood)	31, 30	8	H	M	P	Co-dominant leaders with included bark.	S
58	<i>Ostrya virginiana</i> (Ironwood)	35	10	H	H	P		S
59	<i>Fraxinus</i> sp. (Ash)	~30 x4	6	D	D	R	Dead	S
60	<i>Tilia americana</i> (Basswood)	24	6	H	H	P		S
61	<i>Fraxinus</i> sp. (Ash)	65	10	L	L	R	Dying, 50% canopy is dead.	S
B1	<i>Juglans cinerea</i> (Butternut)	13	5	MH	M	P	Has a wound of 30% of trunk circumference from a fallen tree, rot is apparent, but growth is showing at all branch tips.	S
B2	<i>Juglans cinerea</i> (Butternut)	18	5	H	MH	P	Fusing branch with trunk leaving wound and growth showing at all branch tips.	S
