# ARBORIST REPORT

## Hunsden Sideroad Residential

10249 Hunsden Sideroad  
Caledon, Ontario

Revised: October 26, 2023

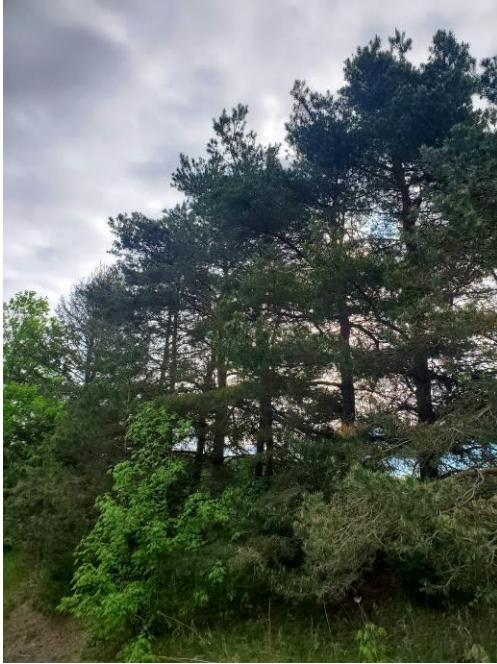
Figure 3: Trees of group 1.

Tree Number	Species	DBH (cm)	Canopy diameter (m)	Biological Health	Structural Condition	Recommended Action	Comments	Location
1a	Pinus sylvestris (Scots Pine)	33	7	H	MH	P	Multibranch node and backfilled.	M
1b	Pinus sylvestris (Scots Pine)	21	7	H	H	P	Backfilled.	M
1c	Pinus sylvestris (Scots Pine)	24	7	H	H	P	Backfilled.	M
1d	Pinus sylvestris (Scots Pine)	15, 14	5	H	M	P	Multi-leader with included bark from 0.15m-0.3m ht. and backfilled.	M
1e	Pinus sylvestris (Scots Pine)	26	7	H	H	P	Backfilled.	M
1f	Pinus sylvestris (Scots Pine)	22	6	H	H	P	Backfilled.	M
1g	Pinus sylvestris (Scots Pine)	20	6	H	H	P	Backfilled.	M
1h	Pinus sylvestris (Scots Pine)	22.5	6	H	H	P	Backfilled.	M
2	Picea glauca (White Spruce)	44	8	M	H	P	Branch tips with dieback of 30% of canopy.	M
3	Acer negundo (Manitoba Maple)	41, 33, 31	12	M	M	P	Three leaders, approx. 20 medium-sized dead branches, emerging included bark at the main union.	M
4	Pinus sylvestris (Scots Pine)	~15	n/a	D	D	P	Dead.	M

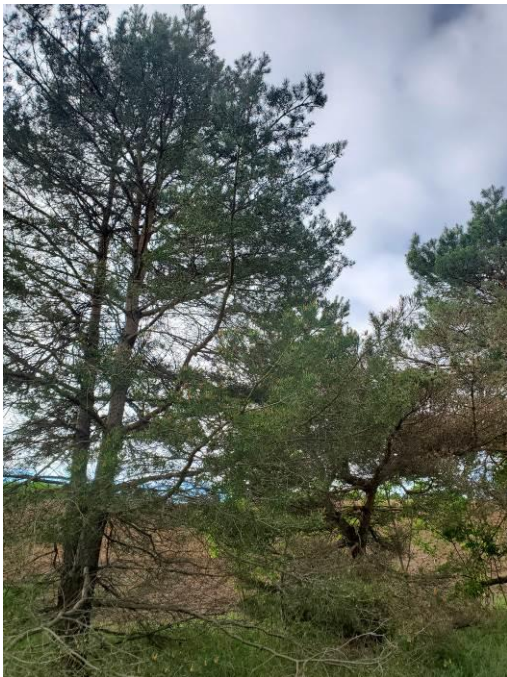
Figure 5: Tree 8.

6	Pinus sylvestris (Scots Pine)	39	7	H	M	P	Large limb of 15cm dia. Torn off with ripping wound, co-dominant leaders, and backfilled.	M
7	Pinus sylvestris (Scots Pine)	21	4	ML	M	P	Backfilled, canopy 60% dead.	M
8	Pinus sylvestris (Scots Pine)	21.5, 25	6	H	M	RC	Co-dominant leaders with included bark (10cm length), backfilled, medium branch fused with 2 leaders.	M
9	Pinus sylvestris (Scots Pine)	32	6	H	MH	RC	Large broken limb, branch stubs with ripping wound.	M
10	Acer negundo (Manitoba Maple)	25.5	7	H	M	P	Multiple limbs cut at base.	M
11	Pinus sylvestris (Scots Pine)	31.5	6	MH	H	P	Some defoliation on twigs, 1 limb broken at branch collar.	M
12	Pinus sylvestris (Scots Pine)	21	4	ML	ML	P	Unbalanced canopy to west, zig zag branch from on leader. Wound on leader with 30% trunk circumference.	M
13	Pinus sylvestris (Scots Pine)	29.5	6	H	MH	P	Co-dominant leaders.	M
14	Pinus sylvestris (Scots Pine)	46	9	H	M	P	Co-dominant leaders with included bark from 4m to 5.5m ht.	M

Of those trees that are over 15cm DBH on the subject site, remove trees #8, 9, 49, 50, 51, 52, 53 and 54 for construction as identified on the Tree Inventory & Preservation Plan. This is a total of 8 trees.

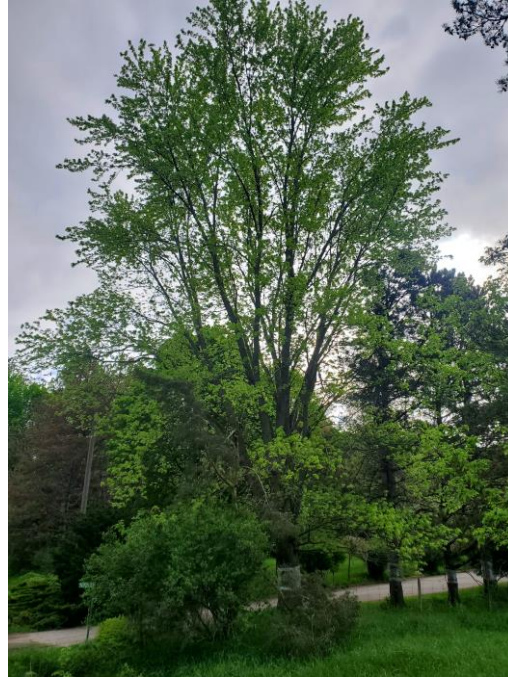
Figure 8: Trees 16 in foreground

15	Pinus sylvestris (Scots Pine)	17	5	M	M	P		M
16	Acer saccharinum (Silver Maple)	~70	14	MH	M	P	Multiple leaders from 2m ht., included bark at 6m ht. Has wrap on trunk for pest.	N
17	Pinus nigra (Austrian Pine)	~45	7	M	M	P	Co-dominant leaders from 6m ht. with medium sized branch fused between them and browning foliage. Has wrap on trunk for pest.	N
18	Pinus nigra (Austrian Pine)	~30	5	M	M	P	Unbalanced canopy to west and browning foliage. Has wrap on trunk for pest.	N
19	Pinus nigra (Austrian Pine)	~50	7	MH	H	P	Browning foliage and has wrap on trunk for pest.	N
20	Picea glauca (White Spruce)	~25	5	H	H	P	Has wrap on trunk for pest.	N
21	Picea glauca (White Spruce)	~25	5	MH	H	P	Suppressed branches at 10 - 15m from #22 but top is in leaf. Has wrap on trunk for pest.	N

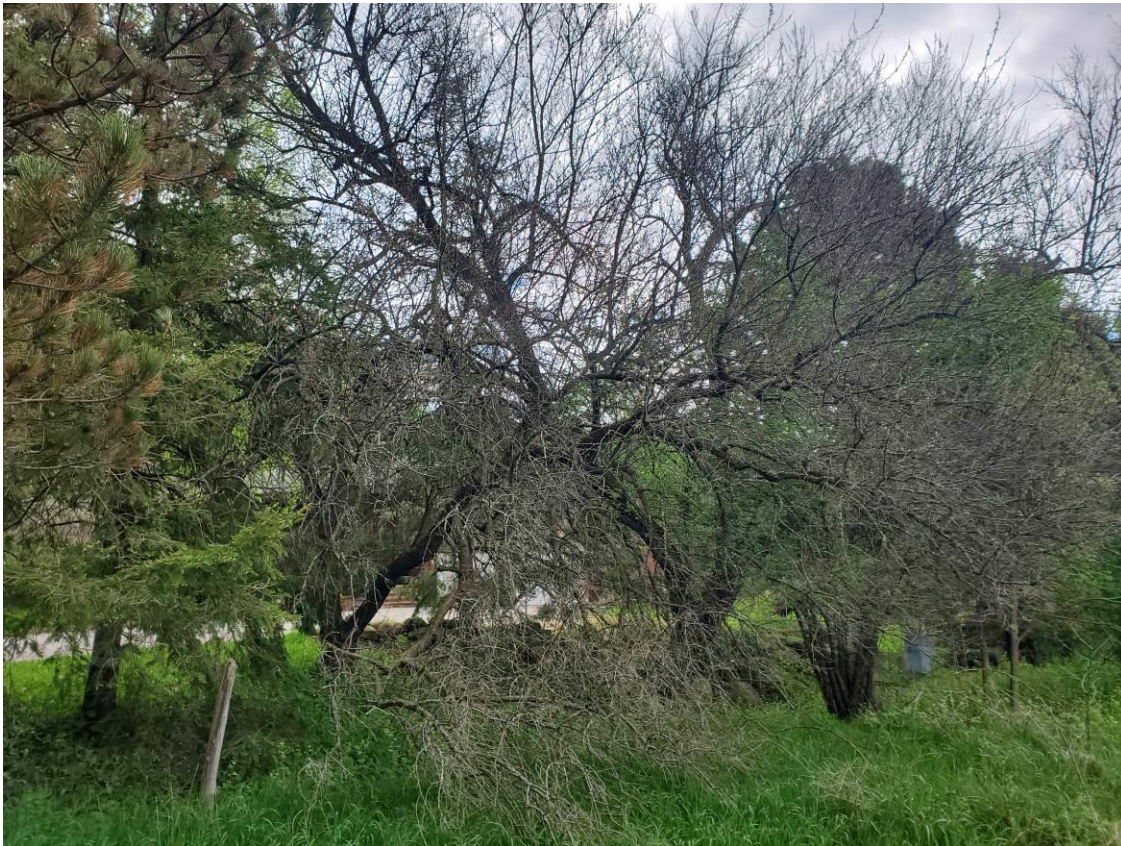
Figure 9: Trees 21-24

22	Eleagnus angustifolius (Russian Olive)	~25, ~20	10	ML	M	P	Co-dominant, limb/trunk leans 45° to east and to west, slower canopy has a lot of dieback (50%).	N
23	Eleagnus angustifolius (Russian Olive)	~45, ~25	11	M	M	P	Fusing branch on trunk, 3 leaders, leans 45° to north and west, and grown on stone slope.	N
24	Pinus nigra (Austrian Pine)	~60	8	MH	MH	P	Co-dominant leaders, and wrap on trunk for pest.	N
25	Picea glauca (White Spruce)	~40	6	H	H	P		N
26	Picea glauca (White Spruce)	~35	6	H	H	P		N
27	Picea glauca (White Spruce)	~35	6	H	H	P		N
28	Picea glauca (White Spruce)	~20	4	H	H	P		N
29	Picea glauca (White Spruce)	~35	5	H	H	P		N
30	Picea glauca (White Spruce)	~30	5	H	H	P		N
31	Picea glauca (White Spruce)	~20	4	M	H	P	Suppressed at top 4m.	N
32	Acer negundo (Manitoba Maple)	40.5	10	H	M	P	Unbalanced canopy to west, leans 10° to west, and included bark at main union.	N
33	Picea glauca (White Spruce)	~35	5	H	H	P	Unbalanced canopy to east.	N

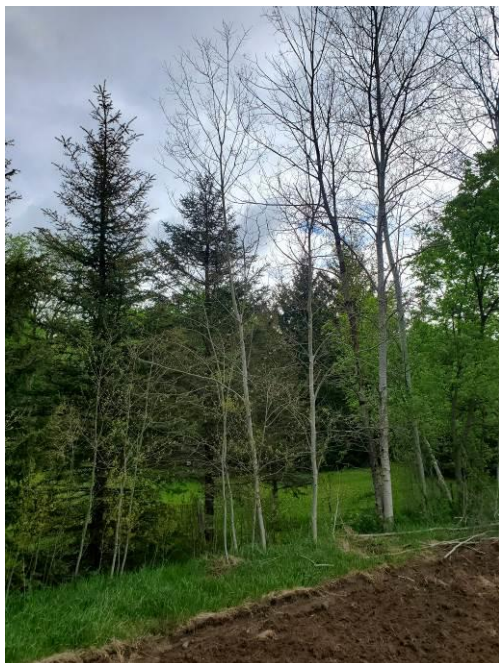
Figure 11: Trees around tree 37

34	Picea glauca (White Spruce)	~30	5	H	H	P	Unbalanced canopy to southwest.	N
35	Picea glauca (White Spruce)	~20	4	H	H	P		N
36	Picea glauca (White Spruce)	~18	4	H	H	P	Has wrap on trunk for pest.	N
37	Populus tremuloides (Trembling Aspen)	20	5	ML	ML	P	Co-dominant leaders with one leader dead, remaining leader has 25% dead branches in lower canopy.	S
38	Populus tremuloides (Trembling Aspen)	18	4	MH	MH	P	Wound with rot at 0.3m ht.	S
39	Populus tremuloides (Trembling Aspen)	20	5	MH	MH	P	One leader cut at the base with fungus fruiting bodies and 20% of canopy dead particularly in lower canopy.	S

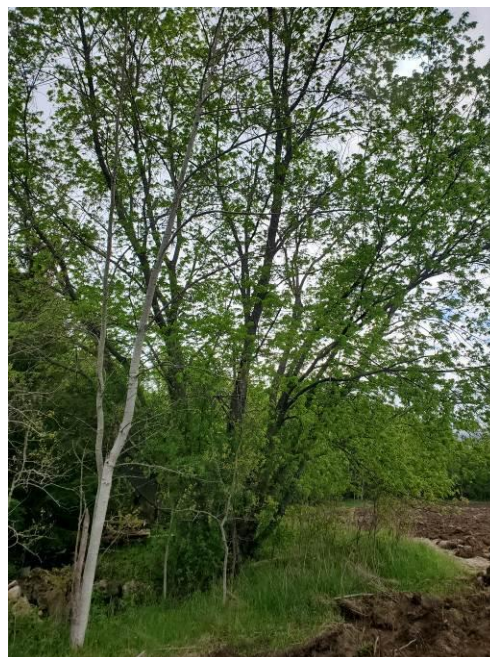
Figure 12: Trees 42 - 49.

40	Populus tremuloides (Trembling Aspen)	20	7	M	ML	P	Multiple leaders with included bark at base to 0.3m ht. One leader has 75% of canopy dead 2 leaders are in satisfactory health.	N
41	Acer saccharinum (Silver Maple)	~35 x1, ~30 x1, ~25 x2, ~20 x3, ~15 x3, ~10 x6	14	H	M	P	Multiple leaders with numerous points of fusing.	N
42	Picea glauca (White Spruce)	~20	4	M	M	P	Leader with dieback and new leader emerging.	N
43	Picea glauca (White Spruce)	~15	5	H	H	P		N
44	Acer platanoides (Norway Maple)	~45	9	H	H	P		N
45	Acer platanoides (Norway Maple)	~25, ~25	9	H	M	P	Co-dominant leader and included bark.	N
46	Acer platanoides (Norway Maple)	~50	9	H	H	P		N
47	Tilia americana (Basswood)	52, 28, 58	10	H	M	P	Three leaders with included bark.	S
48	Acer saccharum (Sugar Maple)	48	8	H	MH	P	Unbalanced canopy to northwest.	S
49	Acer saccharum (Sugar Maple)	25, 67	12	MH	M	RC	Co-dominant leaders with included bark. The smaller leader is hollow with wound of 25% trunk circumference and main leader leans 10° to south.	S

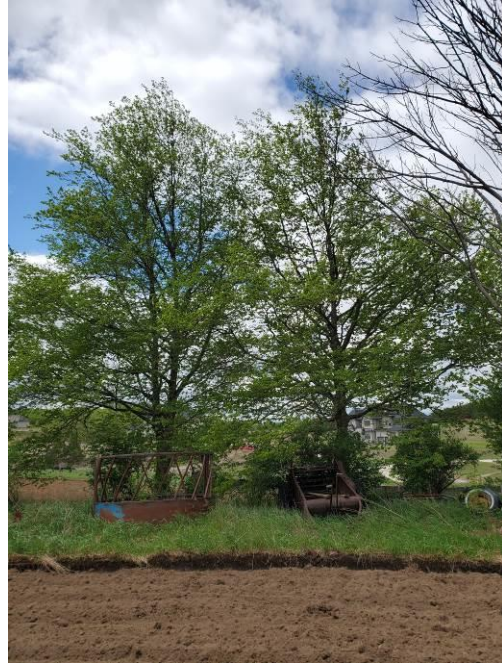
Figure 14: Trees 55 to 56

54	<i>Ostrya virginiana</i> (Ironwood)	28, 27	8	H	H	RC		S
55	<i>Ostrya virginiana</i> (Ironwood)	31, 30	8	H	M	P	Co-dominant leaders with included bark.	S
56	<i>Ostrya virginiana</i> (Ironwood)	35	10	H	H	P		S
57	<i>Fraxinus</i> sp. (Ash)	~30 x4	6	D	D	R	Dead	S
58	<i>Tilia americana</i> (Basswood)	24	6	H	H	P		S
59	<i>Fraxinus</i> sp. (Ash)	65	10	L	L	R	Dying, 50% canopy is dead.	S
B1	<i>Juglans cinerea</i> (Butternut)	13	5	MH	M	P	Has a wound of 30% of trunk circumference from a fallen tree, rot is apparent, but growth is showing at all branch tips.	S
B2	<i>Juglans cinerea</i> (Butternut)	18	5	H	MH	P	Fusing branch with trunk leaving wound and growth showing at all branch tips.	S
