November 17, 2022

Carringwood Homes
101 Regent Street
Richmond Hill, Ontario
L4C 9P4

RE: Channel Stability and Erosion Hazard Assessments, 10249 Hunsden Sideroad Property, Caledon

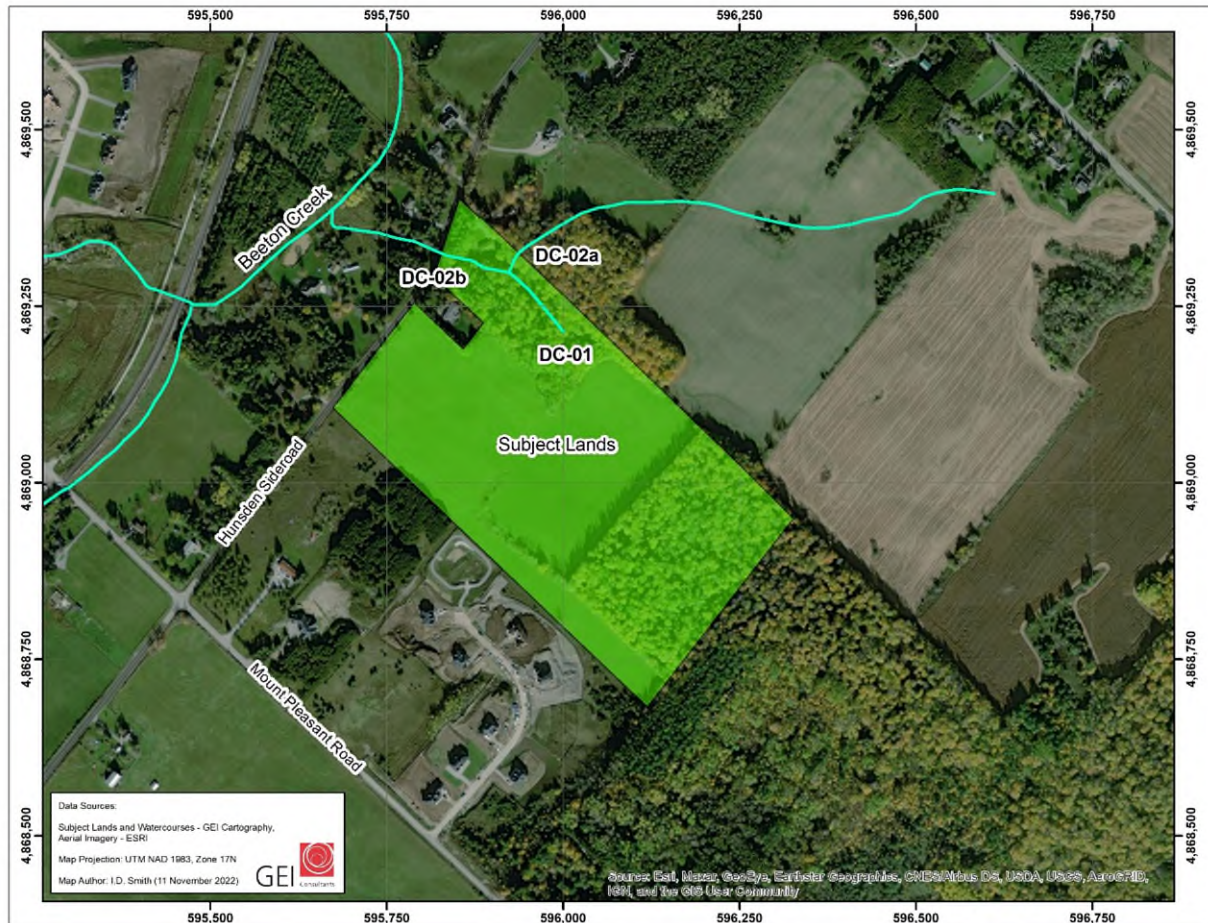
Figure 2: Reaches within the Subject Lands.

- **Reach DC-01:** Begins within the northeast woodlot of the Subject Lands, flowing northwest from the woodlot area towards an existing residence. This short drainage feature consists of less than 120 metres of poorly defined channel. Reach DC-01 terminates at the confluence with Reach DC-02a.

- **Reach DC-02a:** Begins some 720 metres east of the approximate property line for the Subject Lands. It flows across mostly agricultural lands (with photogrammetric evidence of being tilled or ploughed through) and into the woodlot of the subject lands. The channel is well defined in the woodlot area but exits to a manicured lawn that shows little definition beyond that of a shallow swale. Reach DC-02a flows for approximately 30 metres from the Subject Lands' property line to the confluence with Reach DC-01.

- **Reach DC-02b:** Begins at the confluence of Reaches DC-01 and DC-02a, flowing northwestward to the Hunsden Sideroad culvert crossing at the edge of the Subject Lands. This poorly defined channel flows next to manicured lawn areas but is situated at the edge of the Subject Lands' woodlot area.

- All three reaches exhibit regular accumulations of leaf litter with some fallen large woody debris (LWD). There is no evidence of erosional scour within any of the more defined and visible channel segments, with no evidence of entrenchment whatsoever. The accumulation of leaf litter in the channel itself would indicate that little stream power exists within any of the reaches to drive erosional forces.

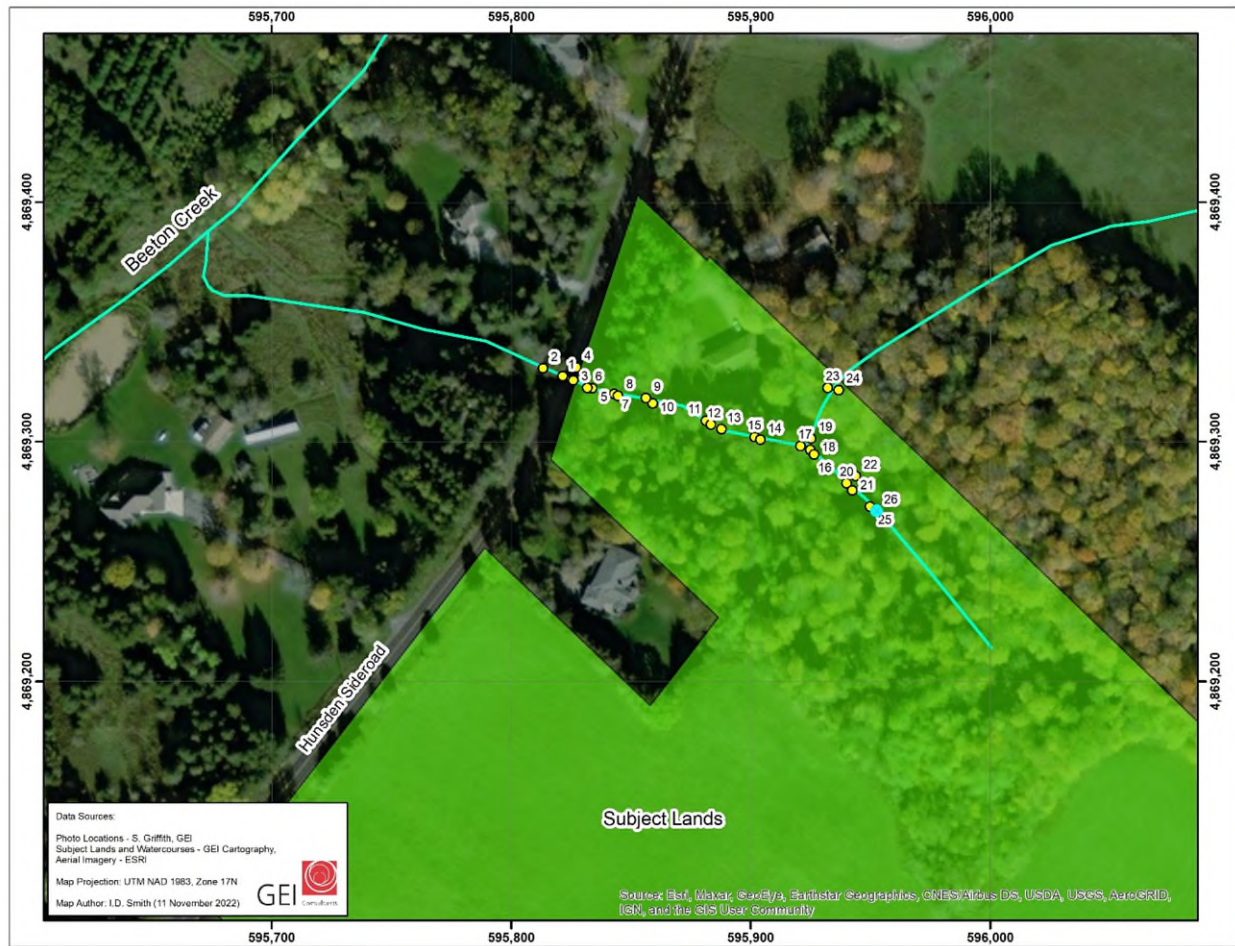
Figure 3: Site Condition Photo Locations Created During the Site Visit of November 11, 2022.

From the photo record, it is apparent that the drainage features that exist within the Subject Lands are currently experiencing no evidence of erosion (degradation) or sediment accumulation (aggradation). All channels, where well defined, appear to be stable in cross section and well graded in slope. Morphologically poorly defined channels and drainage features are similarly stable and graded. Furthermore, there is no evidence of channel widening due to changes in hydrologic driving conditions or evidence of planimetric form adjustment via changing sinuosity due to changes in driving factors.

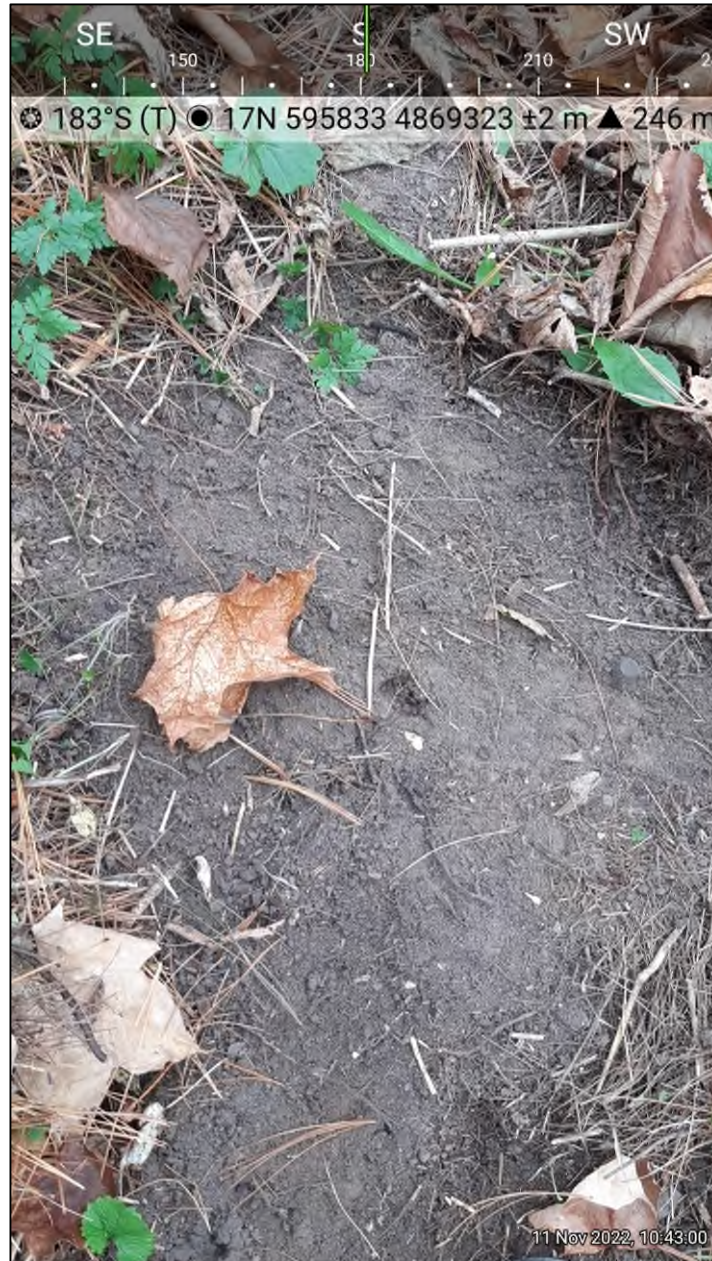
Soils for each of the three Reaches are noted to be dominated by Pontypool type soils, non-colloidal sandy loam soils (Hoffman & Richards, 1953). **Figure 4** shows the soils of the channel (Reach DC-02b at Photo Location 7):

Figure 4: Pontypool type soil, non-colloidal sandy loam within Reach DC-02b, photo location 7.

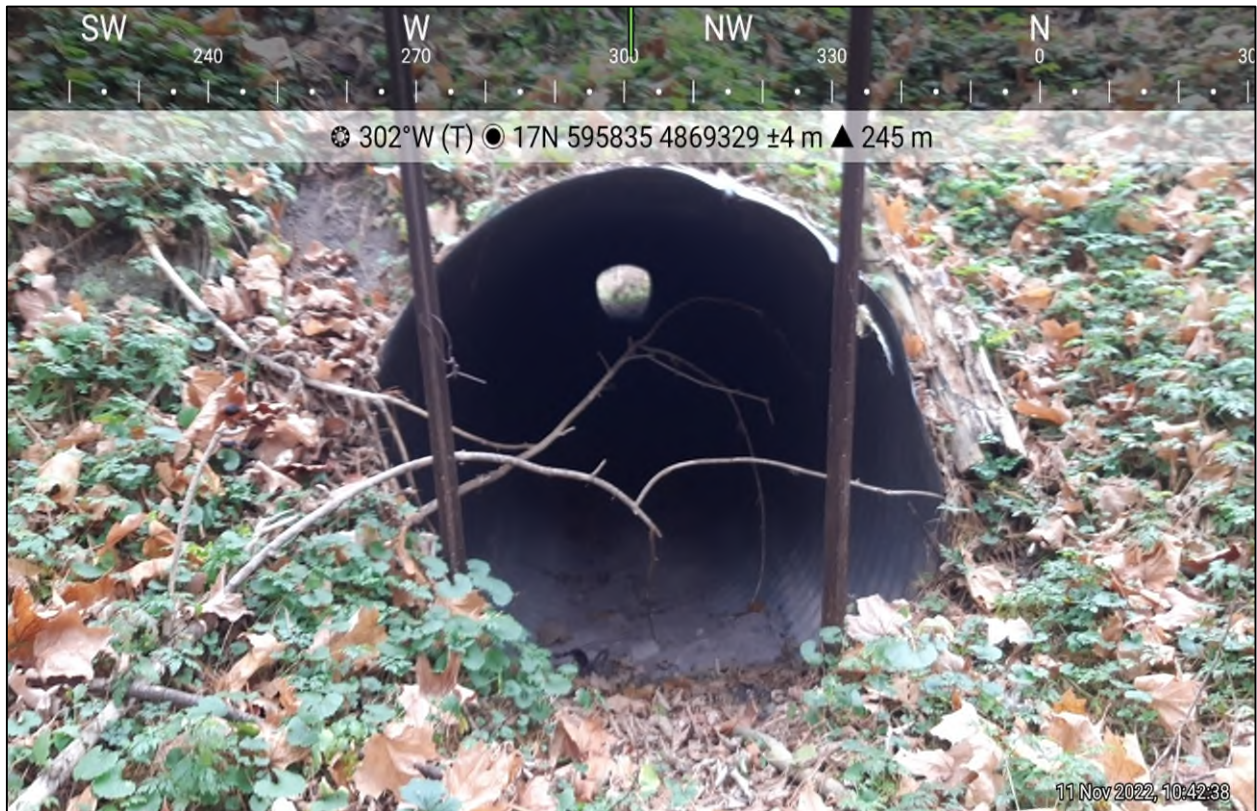
The culvert crossing of the Hunsden Sideroad consists of an elliptical (or partially deflected) corrugated steel pipe (CSP) that is approximately 0.61 metres in diameter (24 inches). There is no evidence of inlet or outlet scour at the culvert (contraction or expansion pools). The culvert appears to be free of aggraded sediment and appears to have no extra-structural or flanking flow within the culvert bedding or roadbed. **Figure 5 and 6** show the culvert crossing:

Figure 5: Culvert crossing of the Hunsden Sideroad, looking downstream from the Subject Lands, into the culvert inlet.

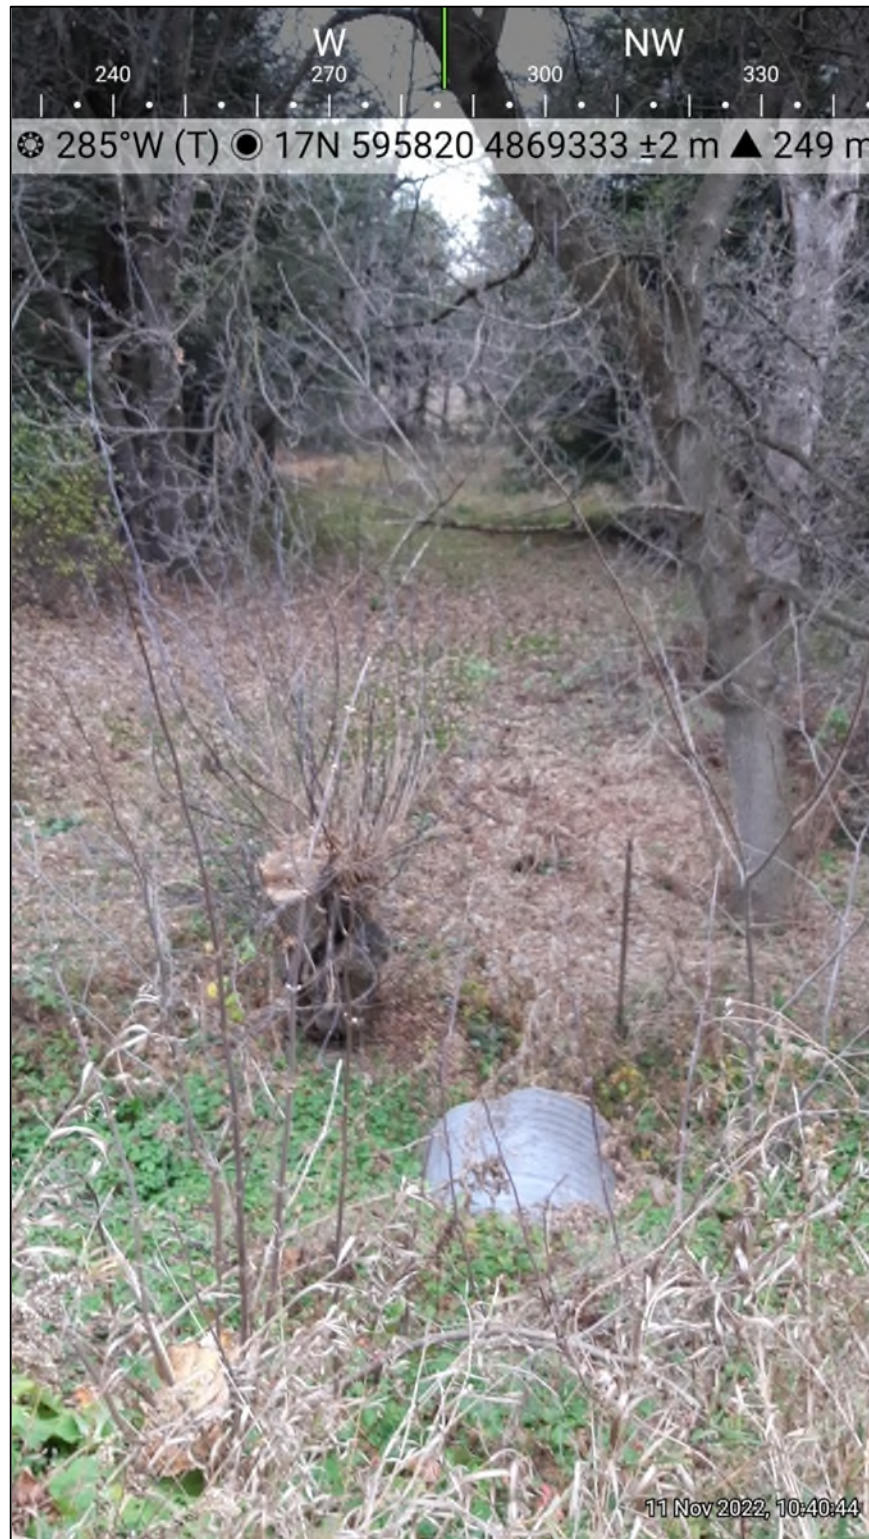
Figure 6: Culvert crossing of the Hunsden Sideroad, looking downstream from the Subject Lands, at the culvert outlet.
