CULTURAL HERITAGE IMPACT ASSESSMENT (CHIA)

for
0 & 12245 Torbram Road
'Tullamore Lands' - Part of Lot 18, 19, 20 Concession 6.
Town of Caledon, Ontario

GBCA Project No: 21012

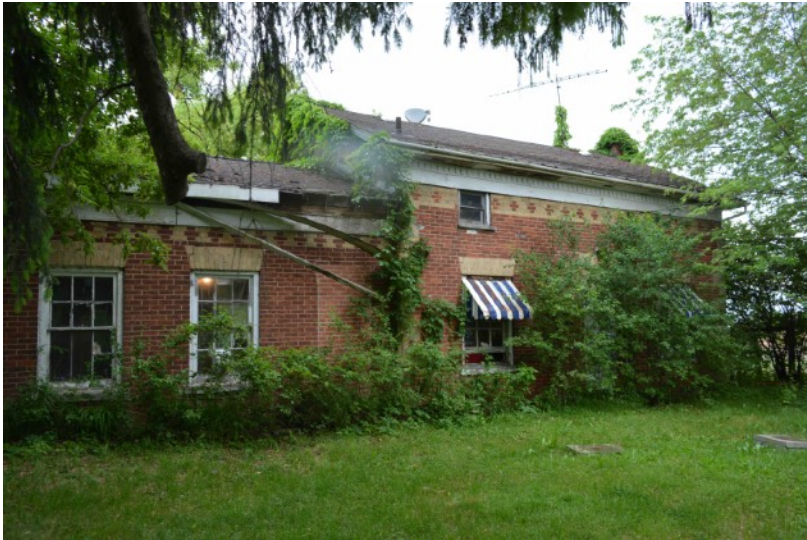
12245 Torbram Road, 2021 (GBCA). West Elevation. Top left window added at a later date. The central door opening is inaccessible, and side window of the lower addition is closed in.

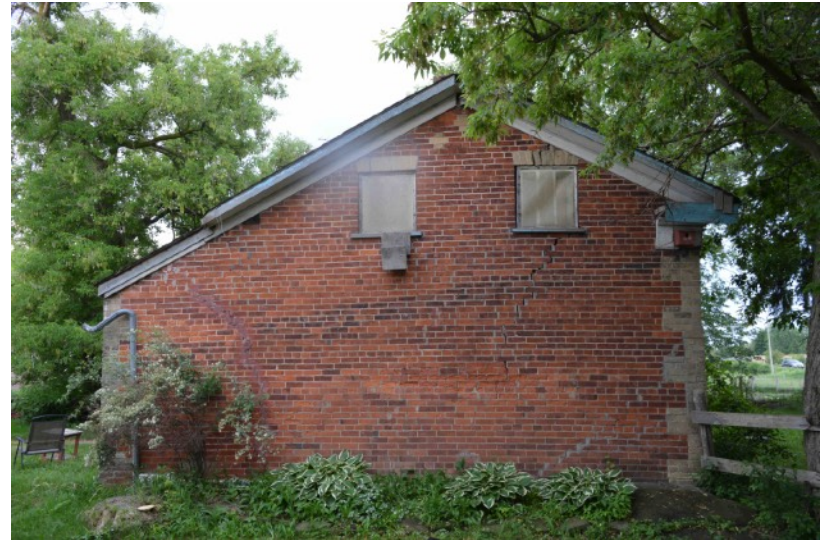
12245 Torbram Road, 2021 (GBCA). North Elevation. Blank wall with closed window openings and buttress to the left. Open joints in the masonry are noticeable from a distance. The buff-brick quoins are clearly visible on this elevation.

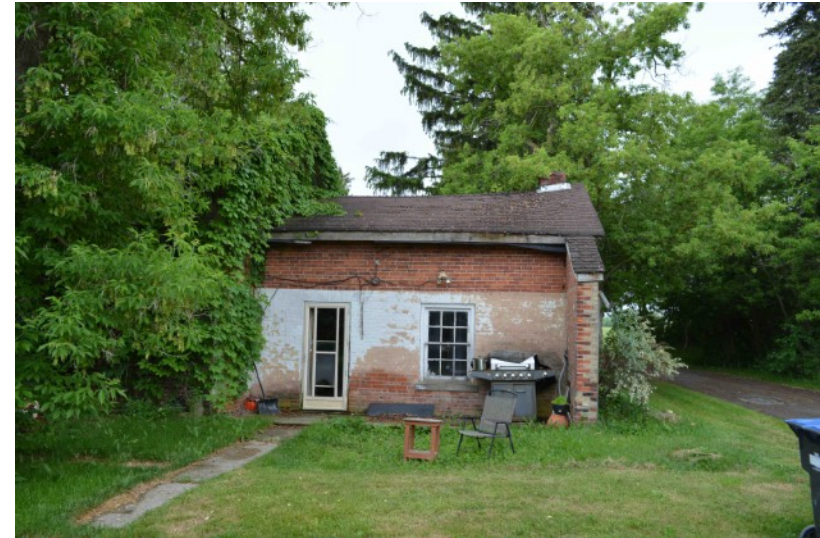
12245 Torbram Road, 2021 (GBCA). East Elevation (rear), showing current entrance to house with a brick buttress extending from the elevation, and structural deflection noticeable at gable ridge.

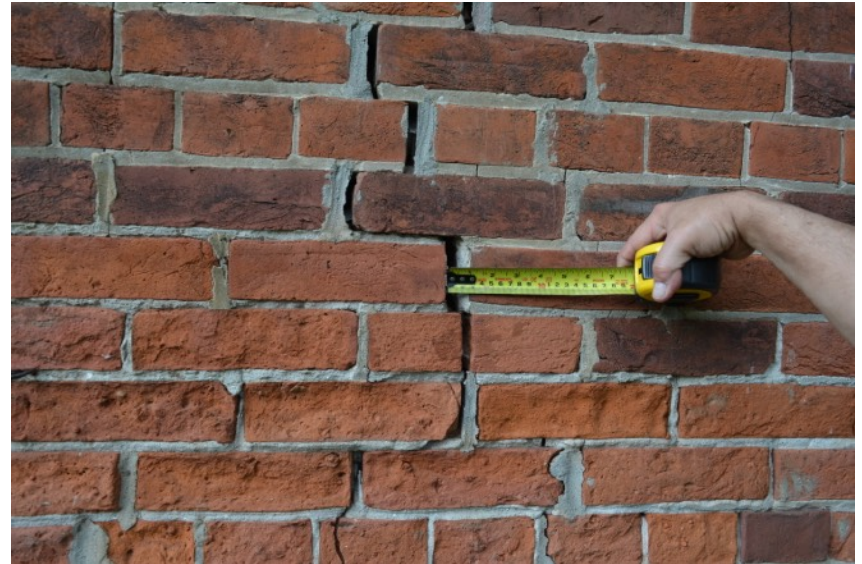
The visual review of the building revealed progressing structural deterioration throughout the building. This is seen most notably through numerous instances of pronounced step cracks along the north elevation, along with other localised cracks in other portions of the east and west walls. Furthermore, there is a gap in excess of 1" at the gable, and sagging/deformation of lateral support members of the roof. The presence of these issues, viewed together, suggests that the structure of the exterior walls is severely compromised.

Side wall cracks typically correspond to the "bending" or rotation of the structure due to soil conditions, compounded by settlement cracking due to the deformation of the structure, will continue to progress if the structure is not stabilised.

Numerous instances of pronounced step cracks ($\pm 1"$ and up to 2" or more) along the north elevation, along with other localized cracks in other portions of the east and west walls

Based on these initial impressions and evidence of immediate structural concerns, GBCA recommended that a Structural Engineer provide a more fulsome review. These findings are available in Appendix III.

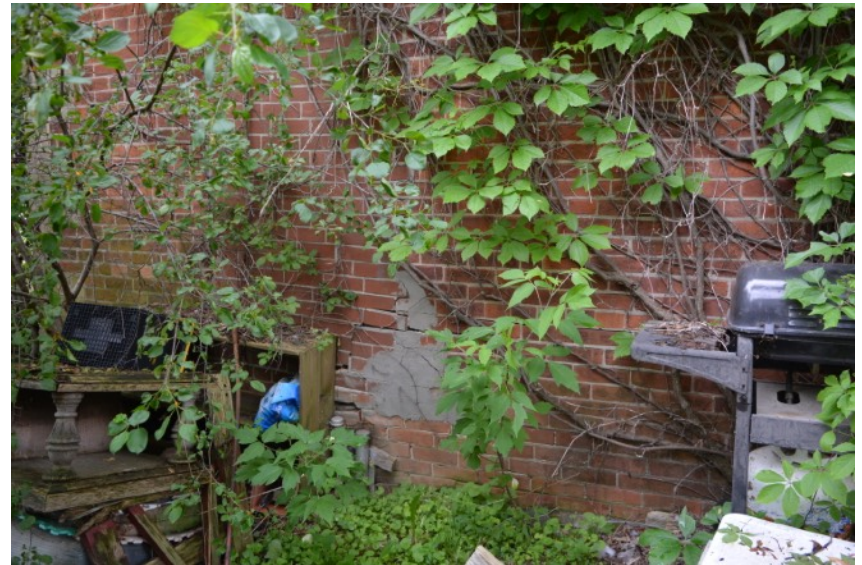
Parging applied to the masonry on the east elevation next to open joints. Ingress water damage and deterioration is likely present in these areas.

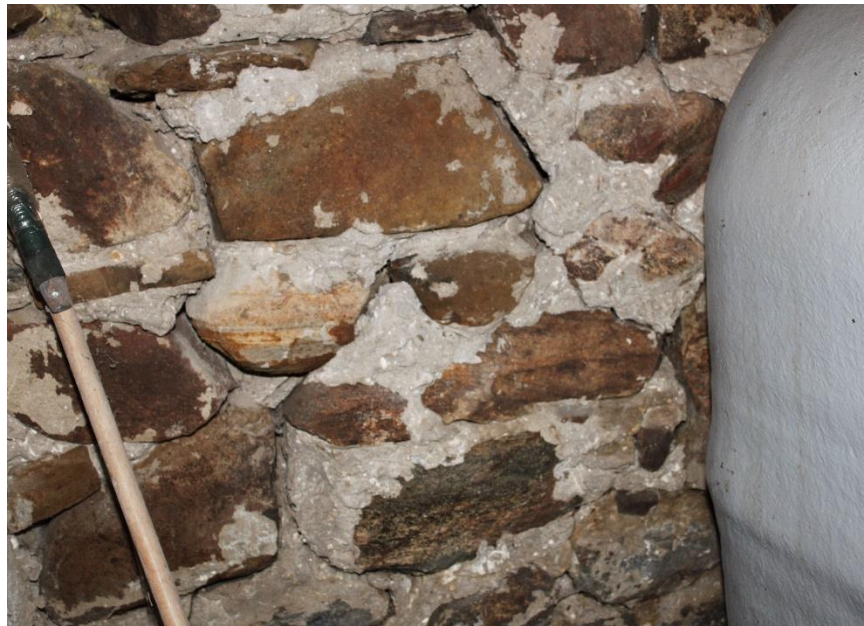
Figure 2: Typical Condition of Stone Foundation Wall

The exterior rubble stone foundation walls are in fair to poor condition. Some of the mortar joints are cracked. In general, lime mortar is friable and is slowly turning into sand. Figure 2 below illustrates the typical condition of foundation wall. It should be noted that no remedial work on foundation walls will be required if the house is moved to different location.

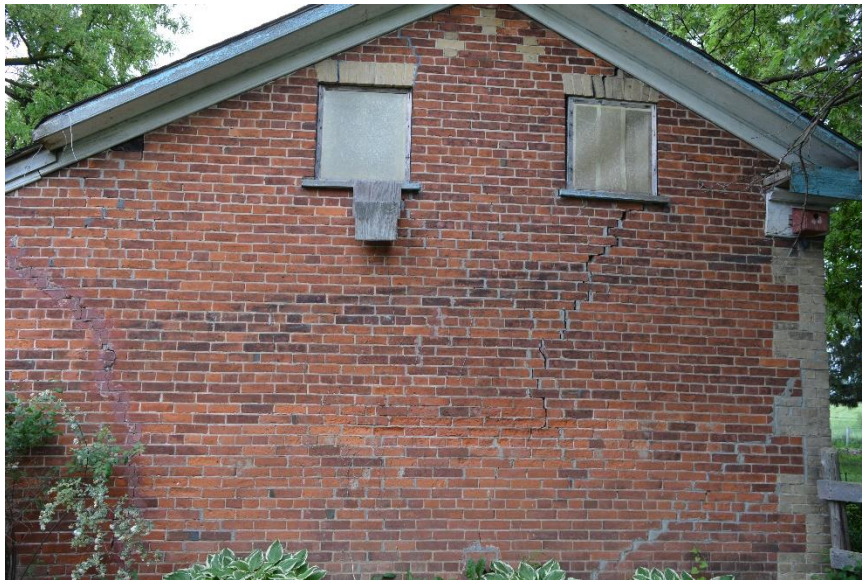
Figure 5: West Wall Damage

Some of the bricks show frost damage, but this is not something that causes safety concern at this moment or is critical for the house relocation.

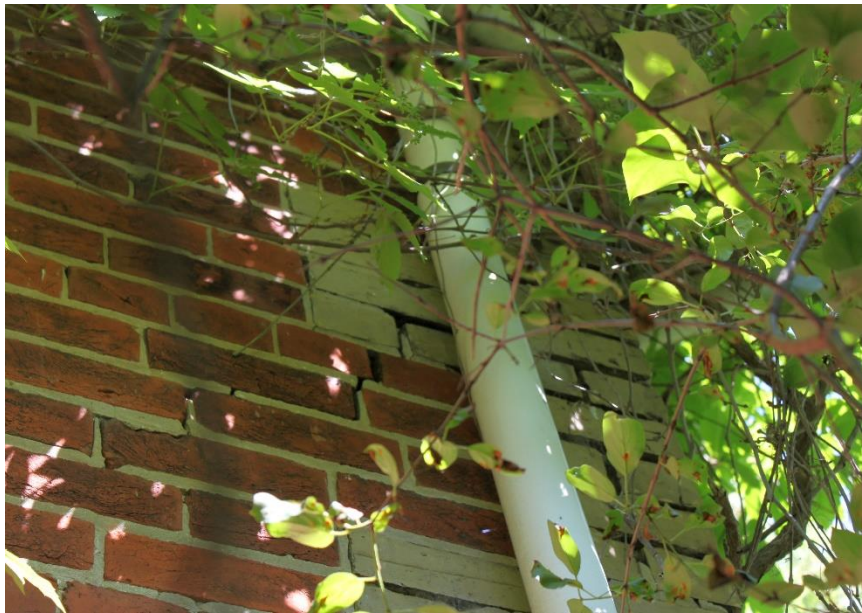
Figure 7: Hidden Deterioration Behind the Vine

A sample of hidden deterioration of brick wall behind the vine is shown in Figure 7. The wall corner seems to be bulging out. The wide open cracks allow for water infiltration and damage to the wall below. It was not possible to inspect the damage closer.

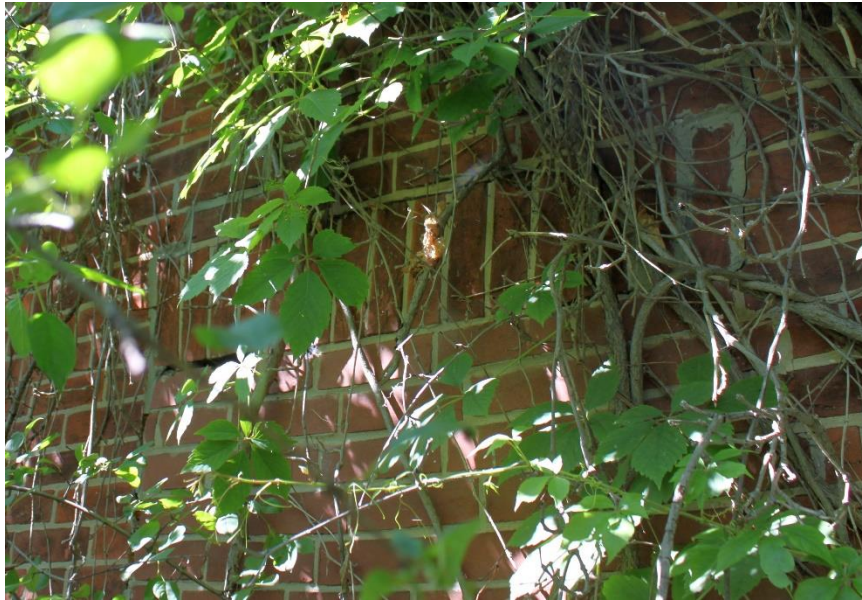
Figure 8: Bricked-in Opening

years. This condition does not pose imminent threat to the occupants but may be critical for the house relocation.

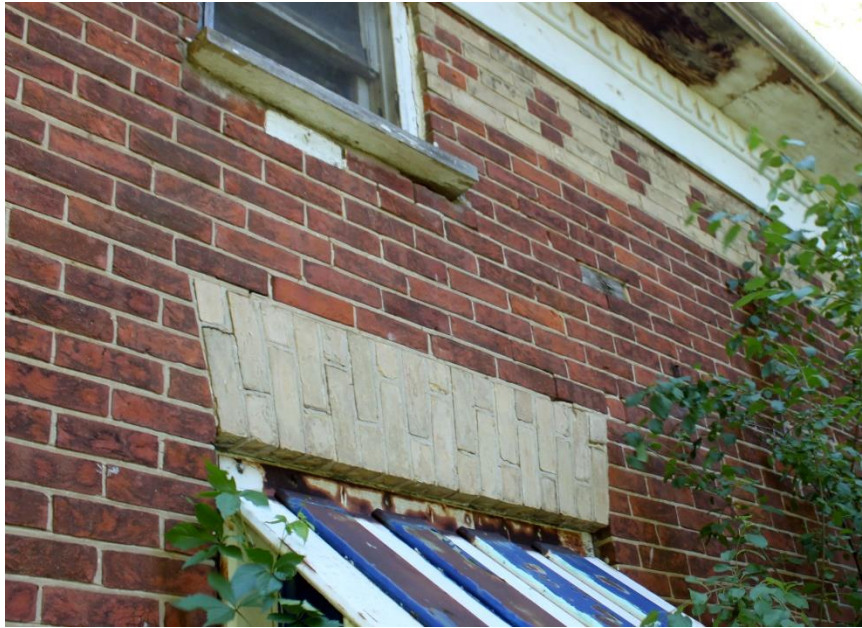
Figure 10: Wood Inserts in South Facade

Wood inserts are installed instead of every fifth brick for the full length of the taller building on the south side. It is likely that they served as anchor blocks for a wood porch roof when the house was built. Please see Figure 10.

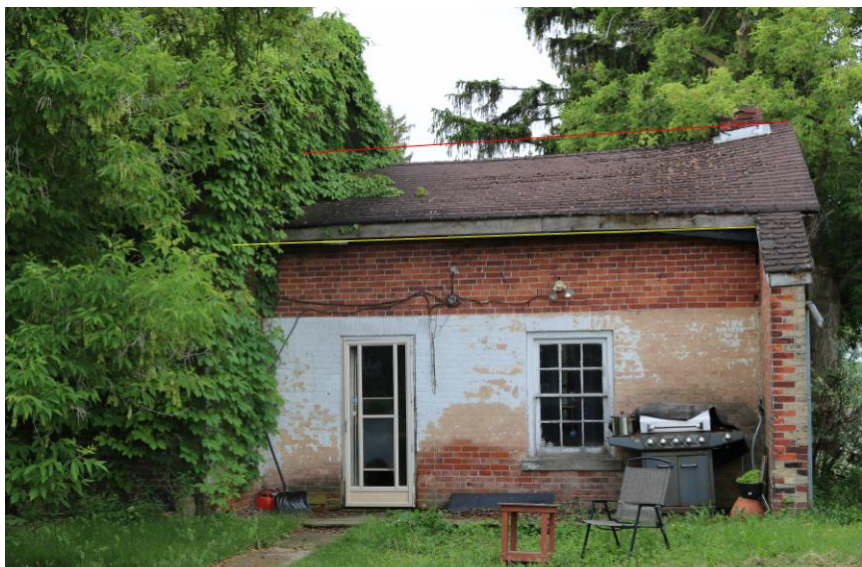
Figure 12: Sagging Roof

This review did not include access to heights and detailed investigation of the roof framing was not possible. The most obvious condition is substantial sagging of the roof ridge of the west part of the house. Please see Figure 12.
