CULTURAL HERITAGE IMPACT ASSESSMENT (CHIA)

**0, 12245 Torbram Road and 12542 Airport
Road**

'Tullamore Lands' - Part of Lots 17 to 20, Concession 6.
Town of Caledon, Ontario

GBCA Project No: 21012

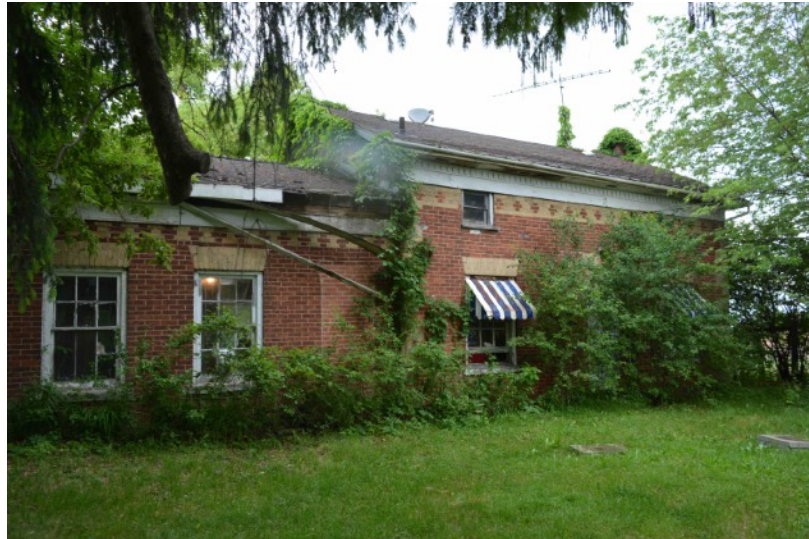
12245 Torbram Road, 2021 (GBCA). West Elevation. Top left window added at a later date. The central door opening is inaccessible, and side window of the lower addition is closed in.

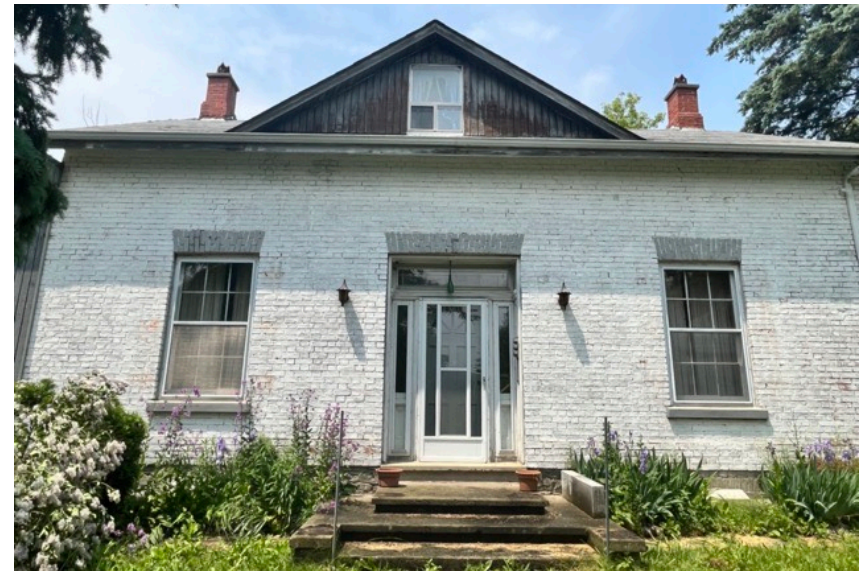
Non-original storm door with raised entrance. Side lights, transom flanked by 6-over-6 windows in good condition.

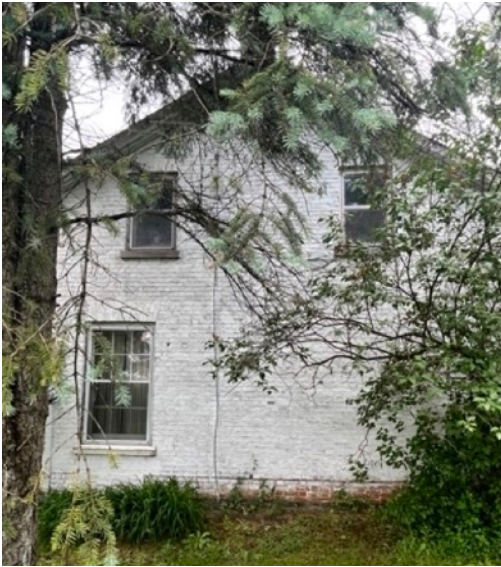
A view from the east elevation with randomly arranged windows. Evidence of potential ingress water at foundation is present given loss of white-wash.

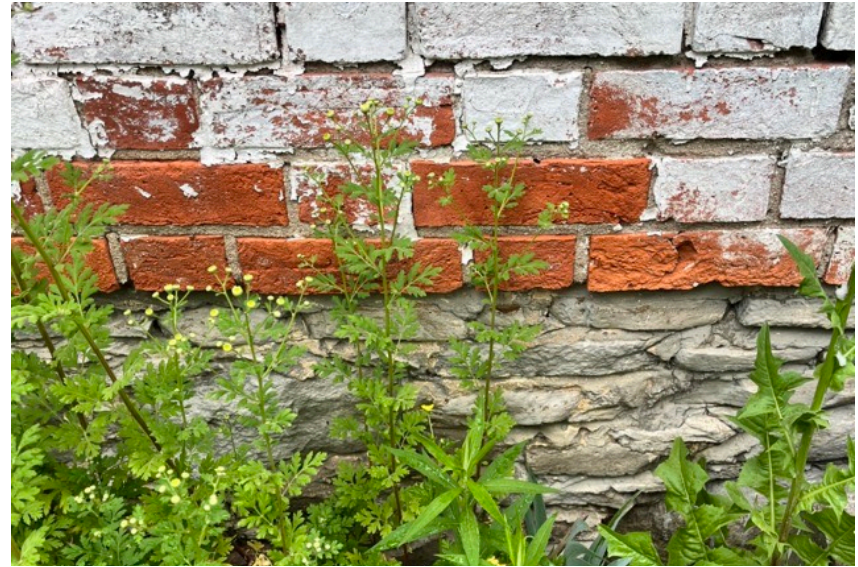
At the random rubble foundation, efflorescence is present.

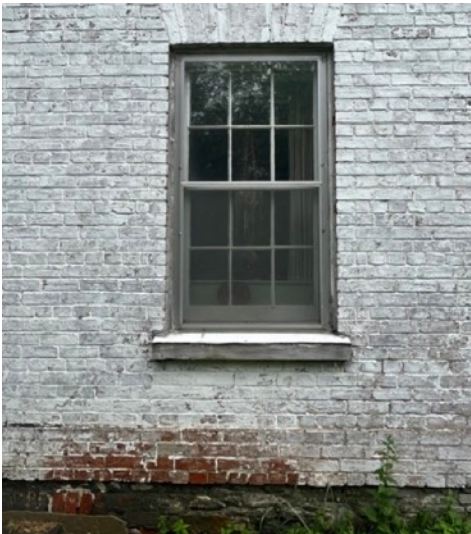
A view of the 6-over-6 ground floor windows. Evidence of potential ingress water at foundation is present given loss of white-wash.

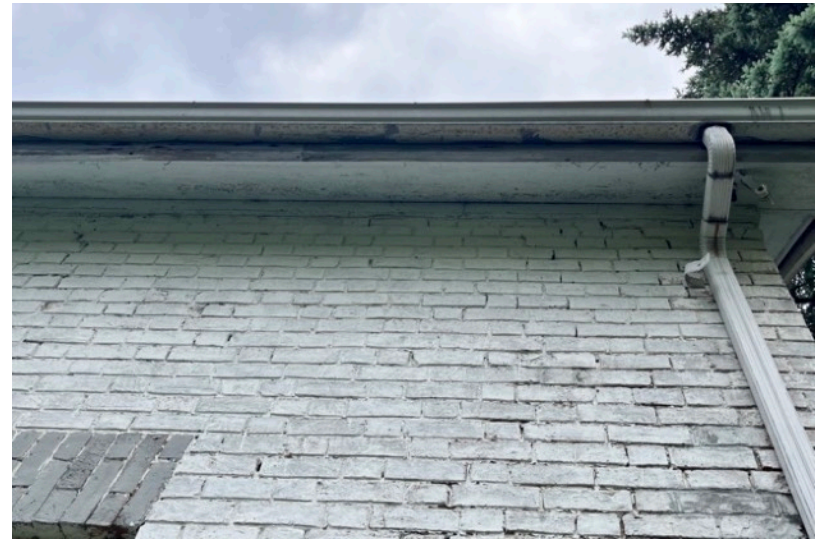
A view of the north elevation eaves, in good repair.

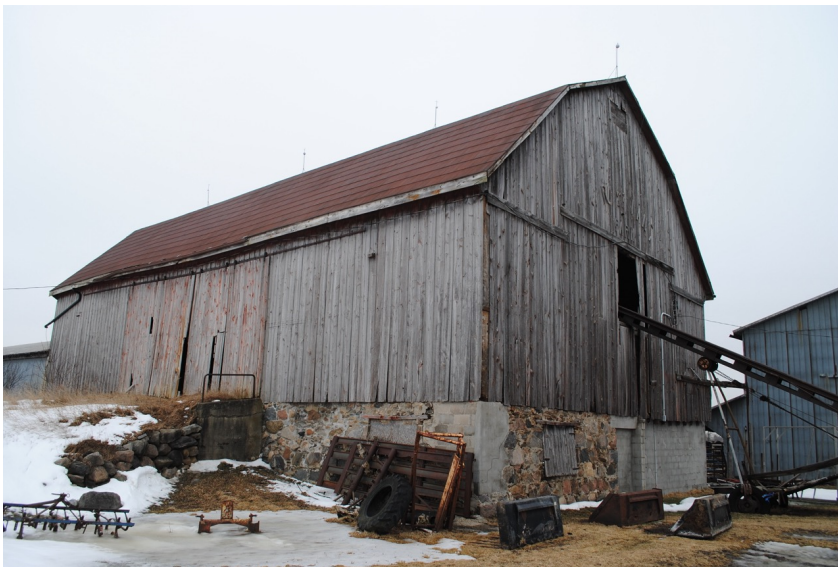
Figure 12: North wall of the main barn – the silo is located to the left. Note the foundation at the west, and north where blocks have been used for repairs to the stone. Boards are missing on the sliding wagon doors that are located at the mid-section of the barn on a rise of land. Foundations have been patched with a hard concrete surface -the concrete is typical of the post WWII era rather than the interwar period which would have had a higher lime content.

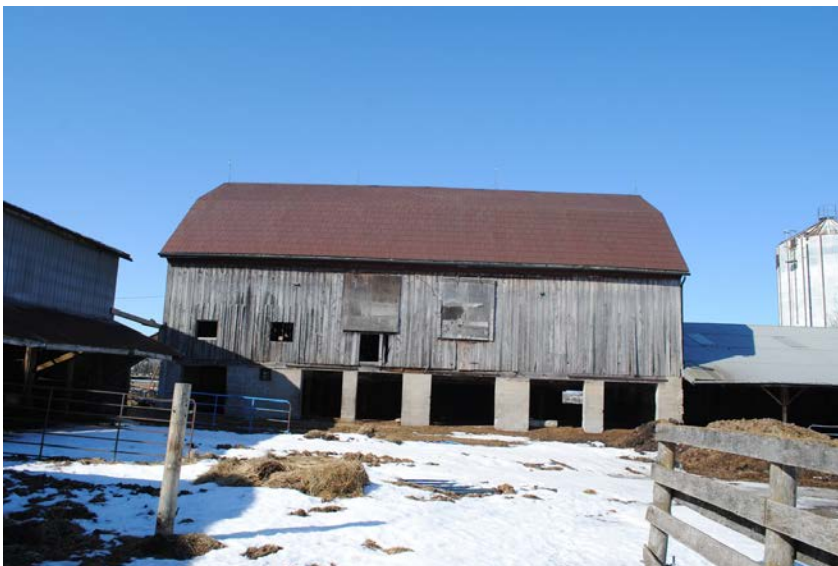
Figure 13: South wall of the main barn - the hay barn addition and silo are visible to the right. In this case, the forebay uses cinder blocks suggesting that the footprint and size of the barn was changed with renovations in the 20th century. The hay barn incorporates heavy framing timbers salvaged from an earlier structure so may have been constructed from framing members salvaged from an earlier barn on site.

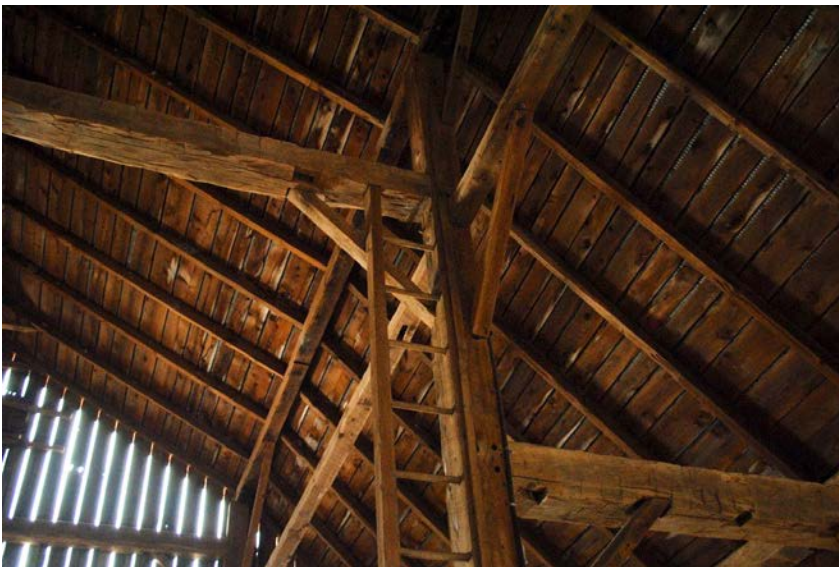
Figure 17: Straining beam shows evidence of double bracing due to empty mortise. These would have originally carried a double diagonal brace.

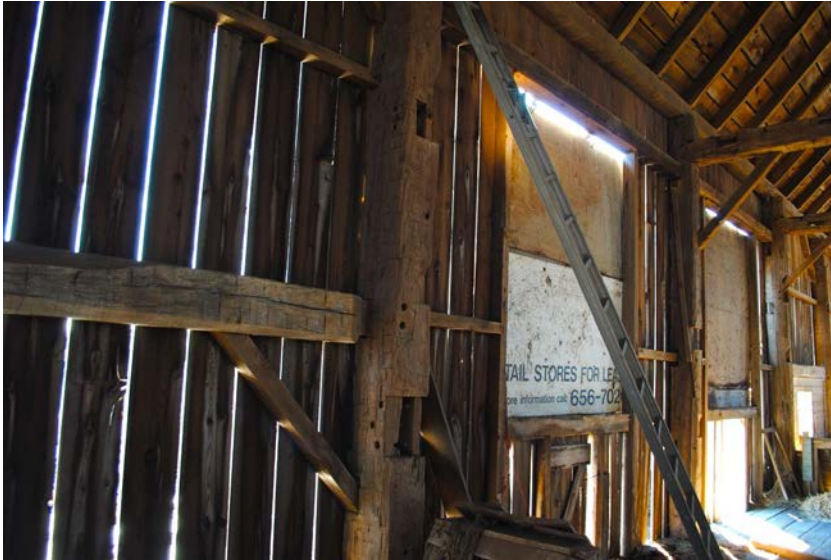
Figure 19: View of south wall, showing lack of significant bracing to the wall structure and empty mortises along the bent. The gaps between the planks provides considerable relief from wind loads.

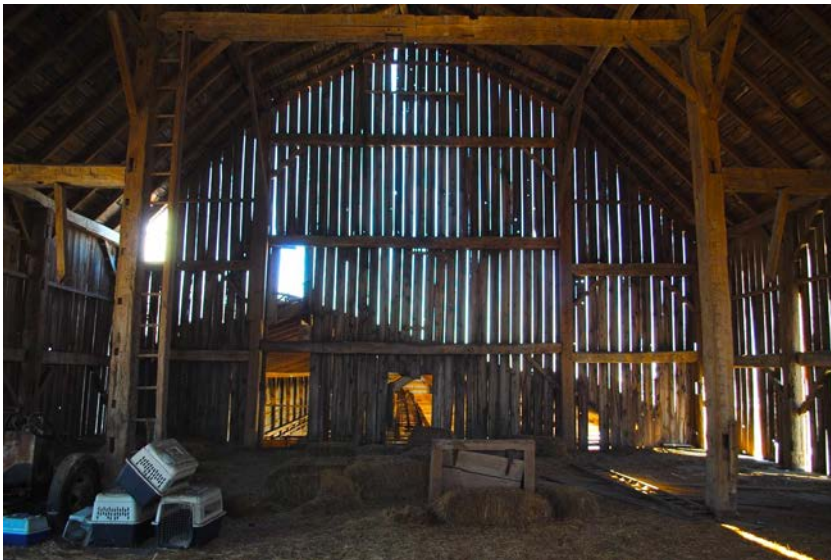
Figure 21: General interior view looking west from main threshing floor in the centre. Note the left and right tie beams have displaced braces.

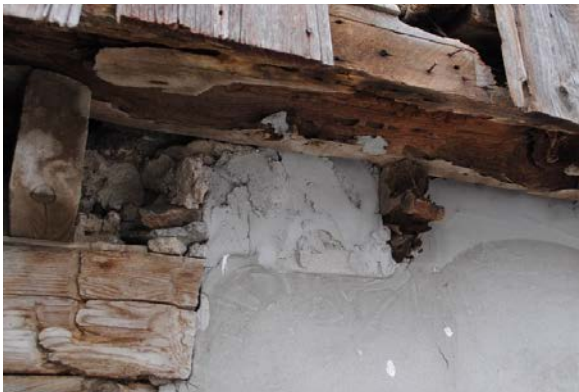
Figure 22: This type of repair is due to rot of the sill beam at this location due to its proximity to wet earth. The quality of the cinder suggests it was batched on site and was probably done in the early to mid twentieth century.
