Slope Stability Study

Tullamore Employment Lands

Mayfield Road & Torbram Road, Caledon, Ontario

February 18, 2022
Project No. 2100975

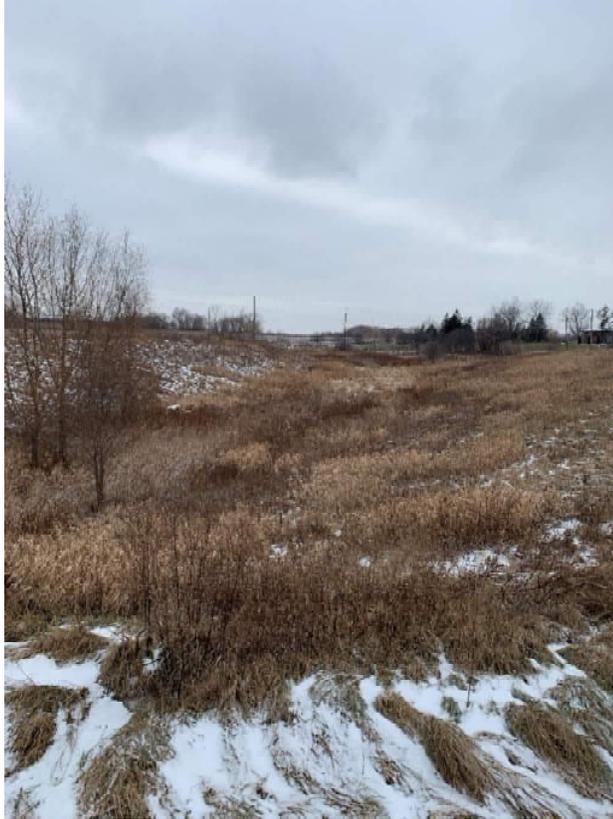
PHOTOGRAPH 17

No signs of slope instability were observed along the slopes. Some localized rills and gullies were observed from the top extending down the face of the slope due to concentrated runoff.

A view of the south slope of the southern drainage feature. Some rilling was observed on the slope face, due to concentrated runoff.

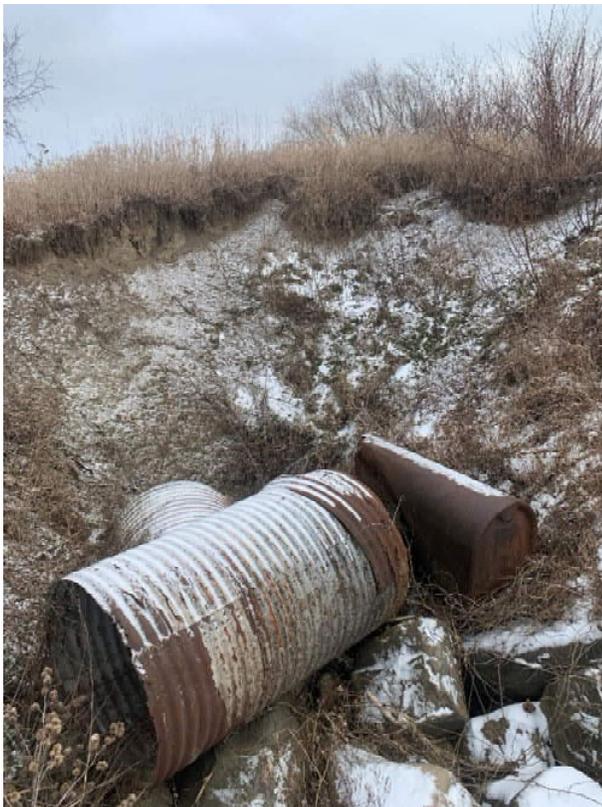
PHOTOGRAPH 24

The ponds are drained through culverts that extend beneath the dams. The culvert inlet at the upper pond is partially damaged or destroyed and the exact inlet location / configuration is unknown. Broken sections of CSP culverts are scattered near the assumed inlet location, along with some boulders and a metal tank. Erosion is occurring around the culvert inlet, and slope failures are occurring up to the embankment crest (slumping / sloughing of soil from the exposed face). It is possible the culvert was partially exposed due to piping erosion from water flowing along the outside of the culvert within the berm. The CSP culvert outlets into the tributary on the south side of the embankment dam, and erosion scarps and slumping were observed surrounding the outlet.

A view of the upper pond and damaged / destroyed culvert inlet that extends below the berm (upstream side of the upper pond).

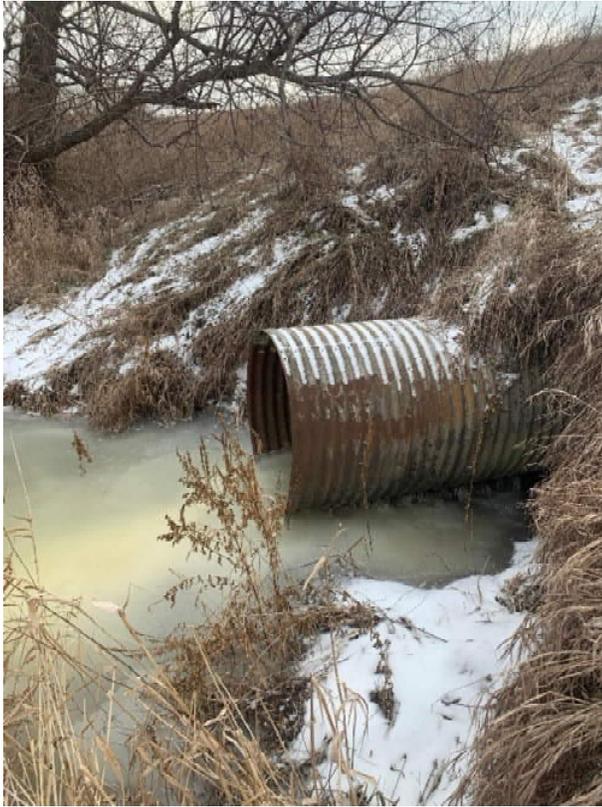
PHOTOGRAPH 25

A view of the damaged culvert and active erosion and slope failures (slumping) at the upstream face of the northern embankment dam (upper pond).

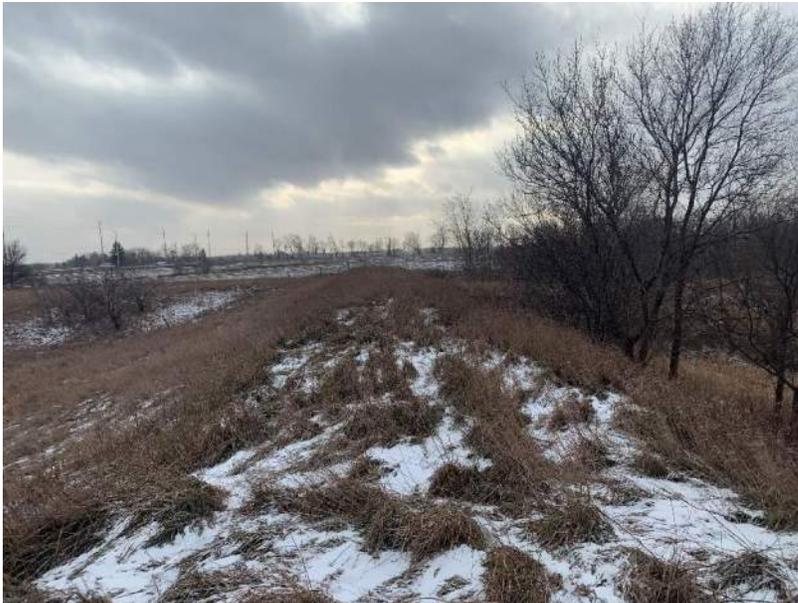
PHOTOGRAPH 30

There is also significant erosion at the culvert inlet for the southern embankment dam. The erosion has resulted in slope failures including slumping and sloughing of soil from the over-steepened slope face. A broken piece of CSP culvert and a pile of boulders are located at the assumed inlet location, however the culvert was not observed extending beneath the embankment. The assumed outlet location is eroding and the actual CSP was not observed.

A view of the damaged / destroyed culvert inlet at the upstream face of the lower pond embankment dam. There is erosion and slope failures around the inlet.
