12507 OLD KENNEDY ROAD ARBOR REPORT

TREE INVENTORY, ANALYSIS & PRESERVATION REPORT

12507 OLD KENNEDY ROAD,
CALEDON, ONTARIO

DECEMBER 2020
Updated to April 12, 2021

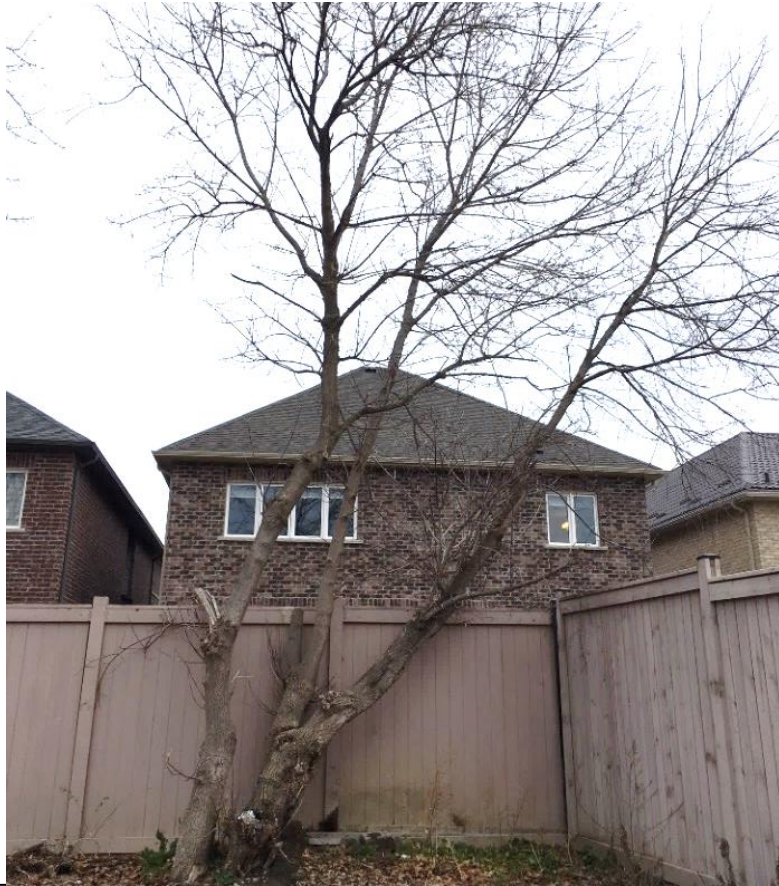
LEGroup staff observed three (2) Manitoba Maples (Trees Nos. 1, & 2) located in the southeast corner of the property all of which were assessed to have an overall poor health assessment (**Photo A, Appendix D**). The health defects included heavy epicormic branching, heavy leans, double stem starting at base, included bark and suspected interior decay. Towards the northwest portion of the subject site there is one (1) Manitoba Maple (Tree No. 5) and it also is in poor health as it resembled similar health characteristics as the other trees towards the south (**Photo D, Appendix D**).

Photo A: Photo of Tree Nos. 1-2 *Acer negundo* in south-east corner of property

Generally, LEG Group staff note that the five (5) individual trees (Tree Nos. 1-5) inventoried and assessed within the site are in declining health and rated in fair to poor condition as disclosed in **Appendix C: Tree Inventory and Assessment Table**. Structural and health concerns of these trees include but are not limited to included bark, multiple leaders, epicormic branching, one sided branching, suspected interior decay and compacted roots. There is a low likelihood of survival for the existing trees if demolition and construction of possible structures occur due to the trees already declining health assessments. In addition, all of the on-site trees conflict with the proposed lot layout. We therefore recommend that all inventoried trees on the subject site be removed (Tree Nos. 1-5).

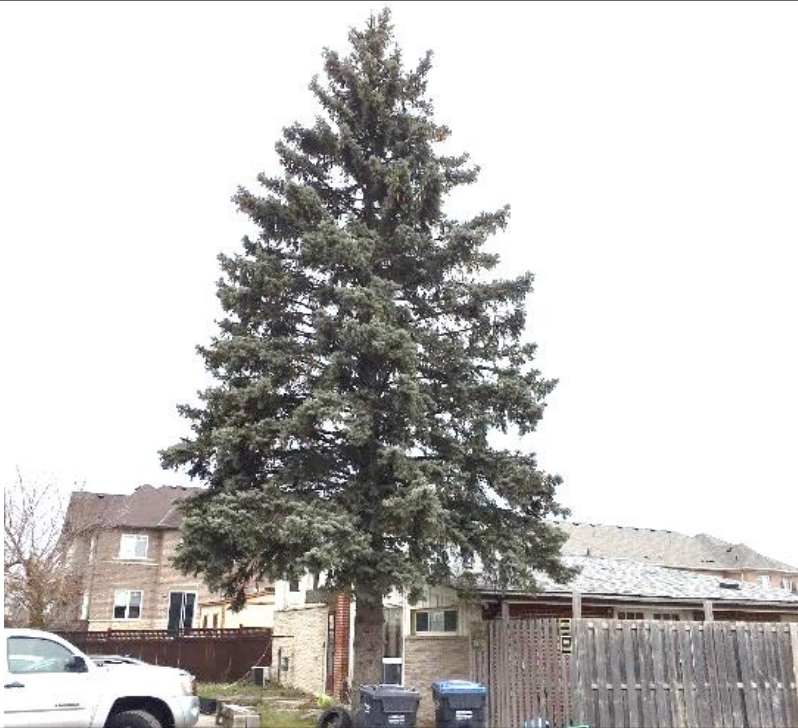
In front of the existing building LEGroup observed one (1) Colorado Blue Spruce (Tree No. 4) which was also in fair health (**Photo B, Appendix D**). The health defects of this tree included minor sap pitching, compacted roots and a minor sweeping trunk. This tree was close in proximity to the existing building and a concrete walkway which appear to be hindering its root growth.

Photo B: Photo looking north of Tree No. 4 *Picea pungens glauca*

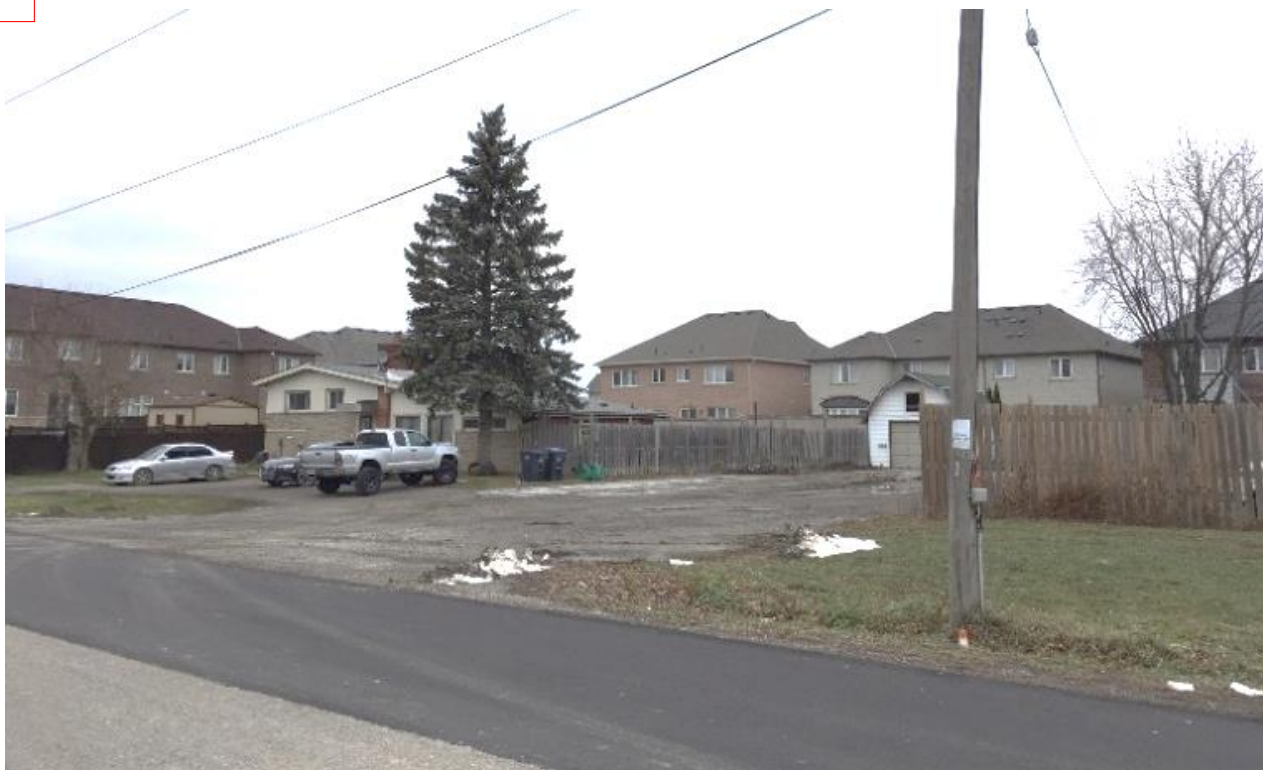
LEGroup staff observed the site to be relatively flat, with a gravel driveway occupying approximately half of the lot towards the south portion of site (**Photo C, Appendix D**). LEGroup staff noted that there was no existing trees exterior to the subject property that had canopies crossing the property lines.

Photo C: Photo of Driveway and gravel area in the front portion of the property.

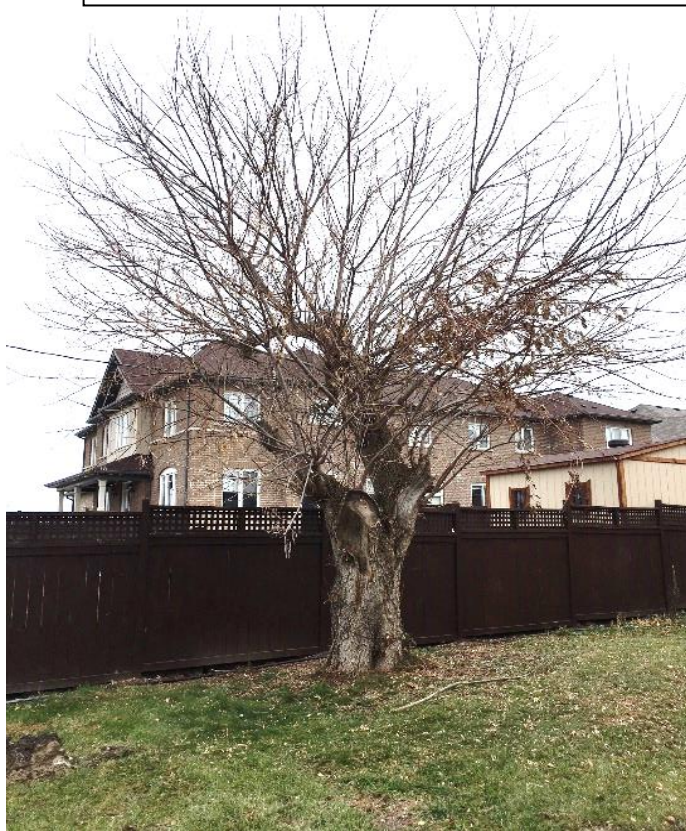
Photo D: Photo of Tree No. 5 *Acer negundo* in north-west portion of property.

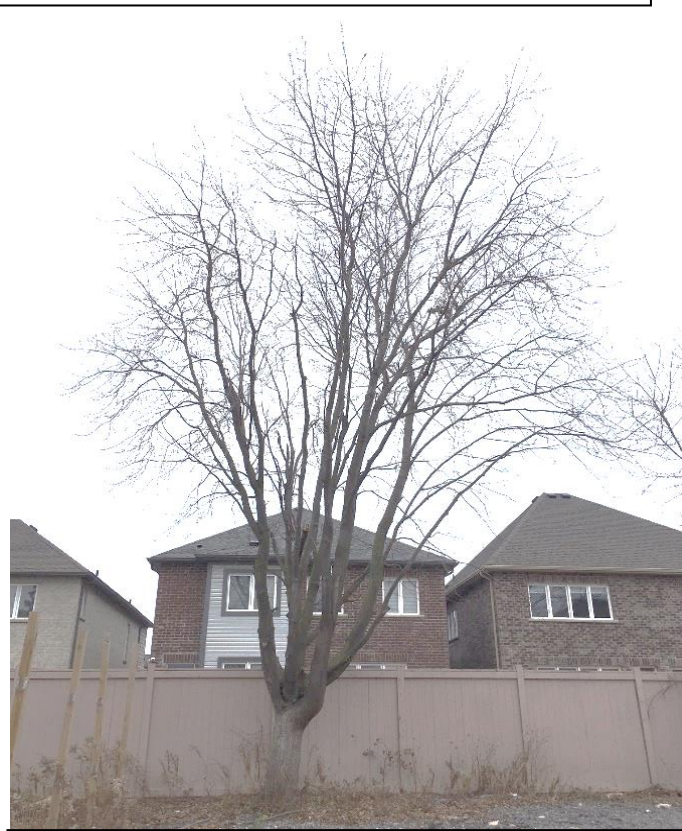
Along the east fence of the property LEGroup observed one (1) Silver Maple (Tree No. 3) which was in fair health (**Photo E, Appendix D**). The health defects this tree showed were dead leaders, soil compaction around root collar, and poor branch structure.

Photo E: Photo of Tree No. 3 *Acer saccharinum* along east fence of property.
