April 19, 2024 [Revised August 08, 2025]

ARBORIST REPORT

Humber Station Distribution Centre, Humber Station Road, Caledon, Ontario

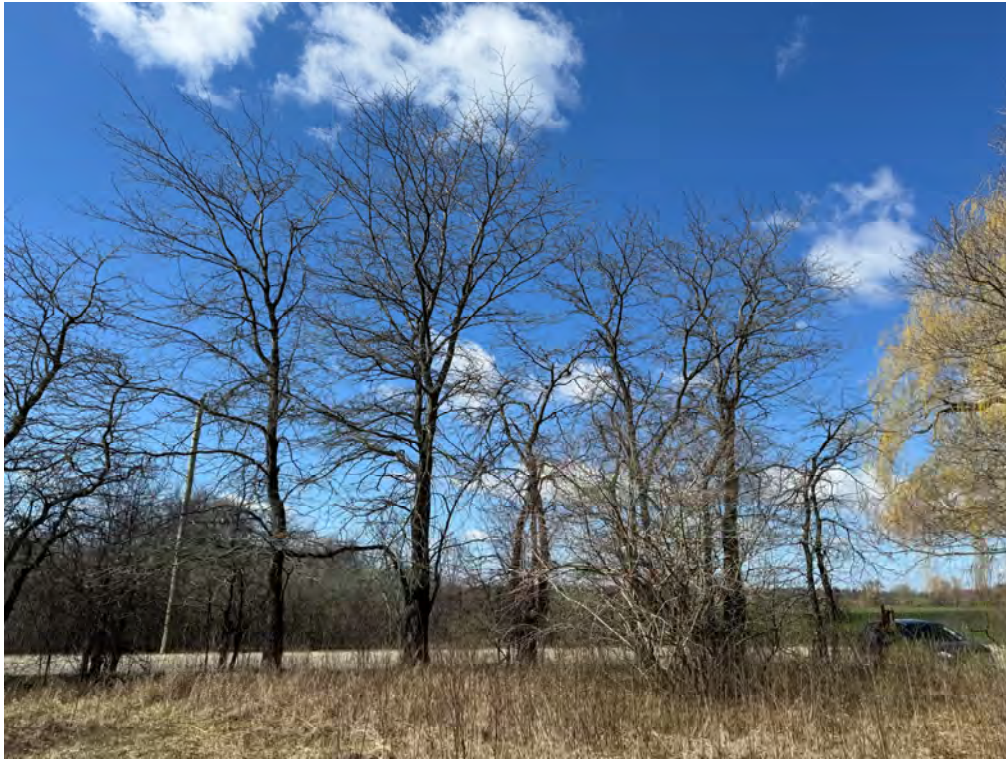
Trees 101 – 105

Tree #	Common Name	Botanical Name	Canopy (M)	DBH (CM)	Condition	Comments	Recommendation
101	Honey Locust	Gleditsia triacanthos	7	60	F	Minor to moderate deadwood throughout	Retain
102	Honey Locust	Gleditsia triacanthos	5	26	F/P	3 stem at 1.2 metres, cavity at main union, minor deadwood throughout	Retain
103	Honey Locust	Gleditsia triacanthos	6	25	F	Multi-stem, some stems fused together, minor deadwood throughout	Retain
104	Honey Locust	Gleditsia triacanthos	5.5	28	F	3 stem at 1.0 metre, cavity at union of 2 stems, minor deadwood throughout	Retain
105	Honey Locust	Gleditsia triacanthos	4	19	F	Co-dominant at 0.2 metres	Retain
106	Norway Maple	Acer platanoides	8	36	F		Retain
107	Norway Maple	Acer platanoides	6	23	F		Retain
108	Norway Maple	Acer platanoides	9	31	F		Retain
109	Norway Maple	Acer platanoides	10	41	F		Retain
110	Norway Maple	Acer platanoides	9	40	F		Retain
111	Norway Maple	Acer platanoides	10	44	F	Minor deadwood throughout	Retain

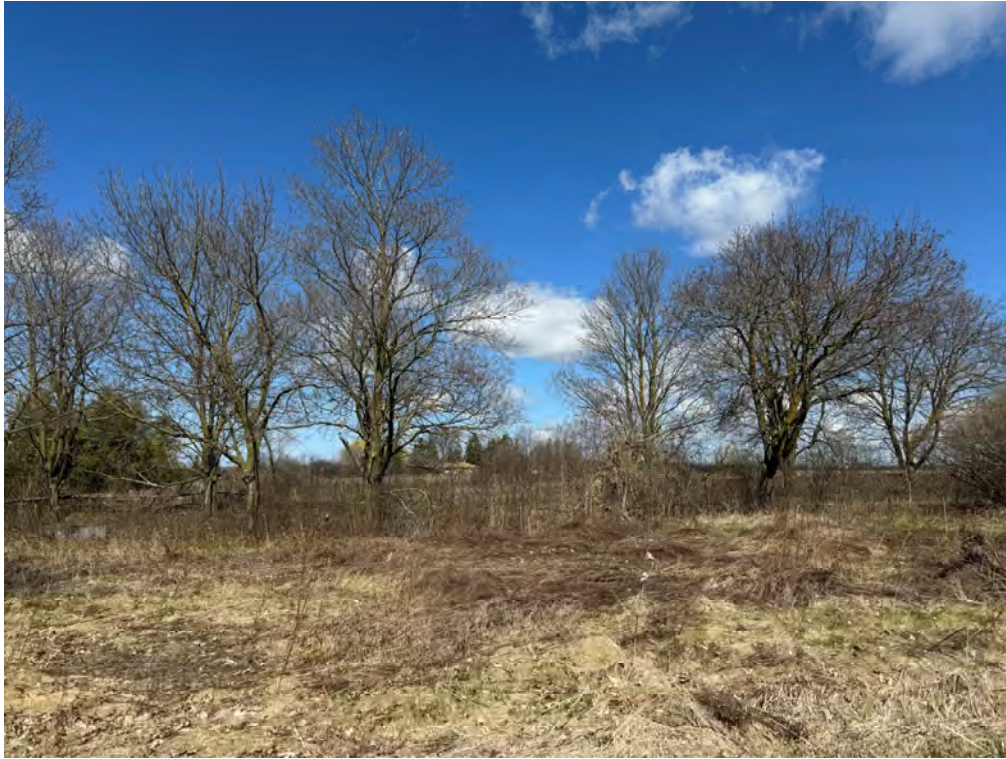
Trees 110 – 113

112	Norway Maple	Acer platanoides	-	~78	P/D	Tree is 90% dead and previously failed, water shoots throughout	Retain

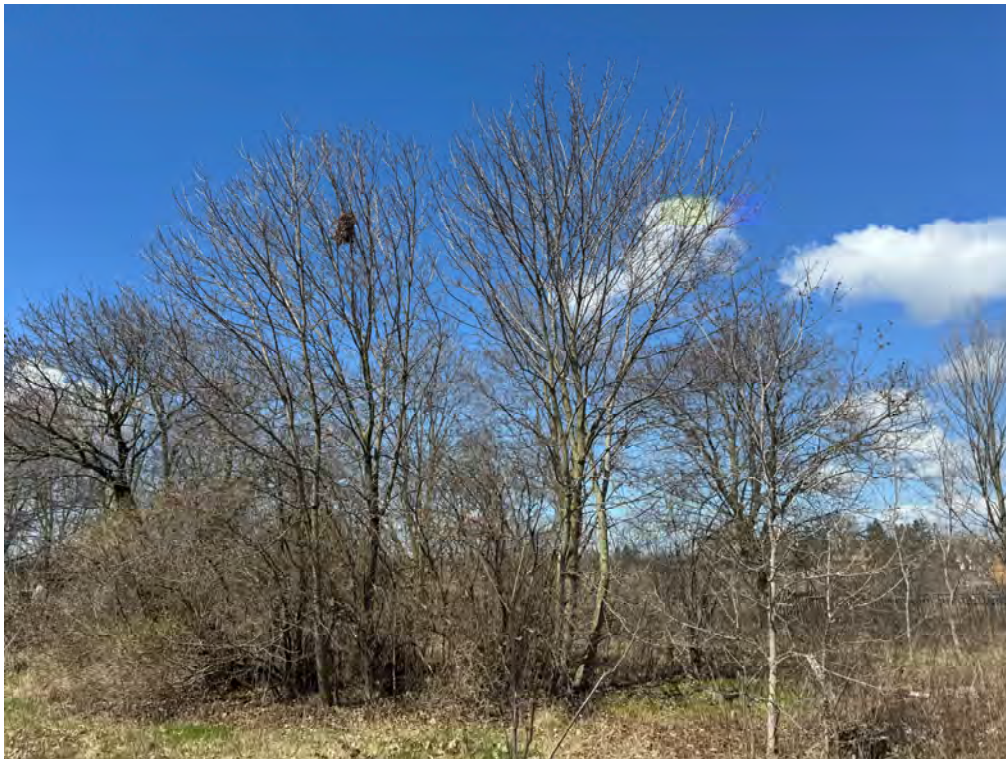
Trees 114 – 118

113	Norway Maple	Acer platanoides	11	44	F		Retain
114	Norway Maple	Acer platanoides	3	15	F		Retain
115	Norway Maple	Acer platanoides	5	19	F		Retain
116	Norway Maple	Acer platanoides	3	12	F	Mild lean	Retain
117	Norway Maple	Acer platanoides	6	21	F		Retain
118	Norway Maple	Acer platanoides	4.5	18	F		Retain
119	Norway Maple	Acer platanoides	10	41	F		Retain
120	Norway Maple	Acer platanoides	9	35	F/P	Co-dominant at 0.8 metres, split at main union, preciously co-dominant at 1.5 metres	Retain
121	Norway Maple	Acer platanoides	12	55	F		Retain
122	Sugar Maple	Acer saccharum	6	24	F		Retain
123	Norway Maple	Acer platanoides	11	51	F		Retain
124	Norway Maple	Acer platanoides	12	53	F	Minor deadwood throughout	Retain
125	Norway Maple	Acer platanoides	11	50	F	Minor deadwood throughout	Retain
126	Norway Maple	Acer platanoides	12	48	F	Multiple limbs previously failed	Retain
127	Norway Maple	Acer platanoides	12	53	F	Multiple limbs previously failed	Retain

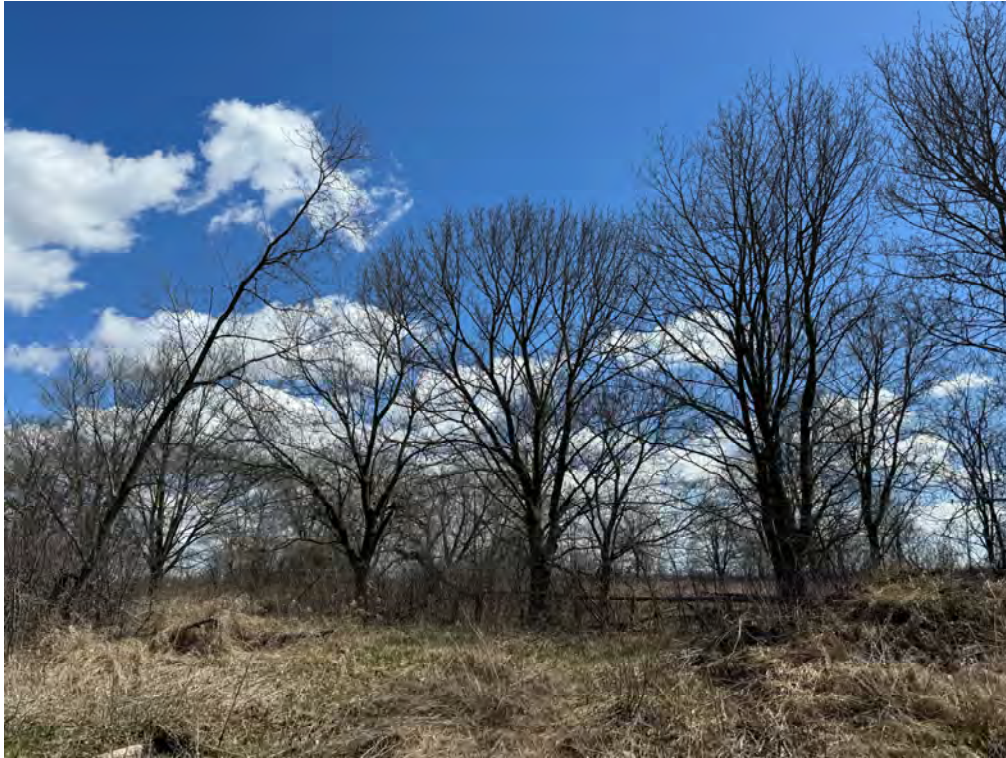
Trees 126 – 128, 130

128	Norway Maple	Acer platanoides	12	46	F		Retain
129	Norway Maple	Acer platanoides	13	53	F	Multiple limbs previously failed, minor deadwood in canopy	Retain
130	Manitoba Maple	Acer negundo	3	17	F	Mild to moderate lean	Retain
131	Willow Sp.	Salix Sp.	17	128	F	Typical issues for tree of this species and size, multiple limbs previously failed	Retain
132	Cedar Sp.	Thuja Sp.	5	28	F	Mild lean	Retain
133	Norway Maple	Acer platanoides	3	13	F		Retain

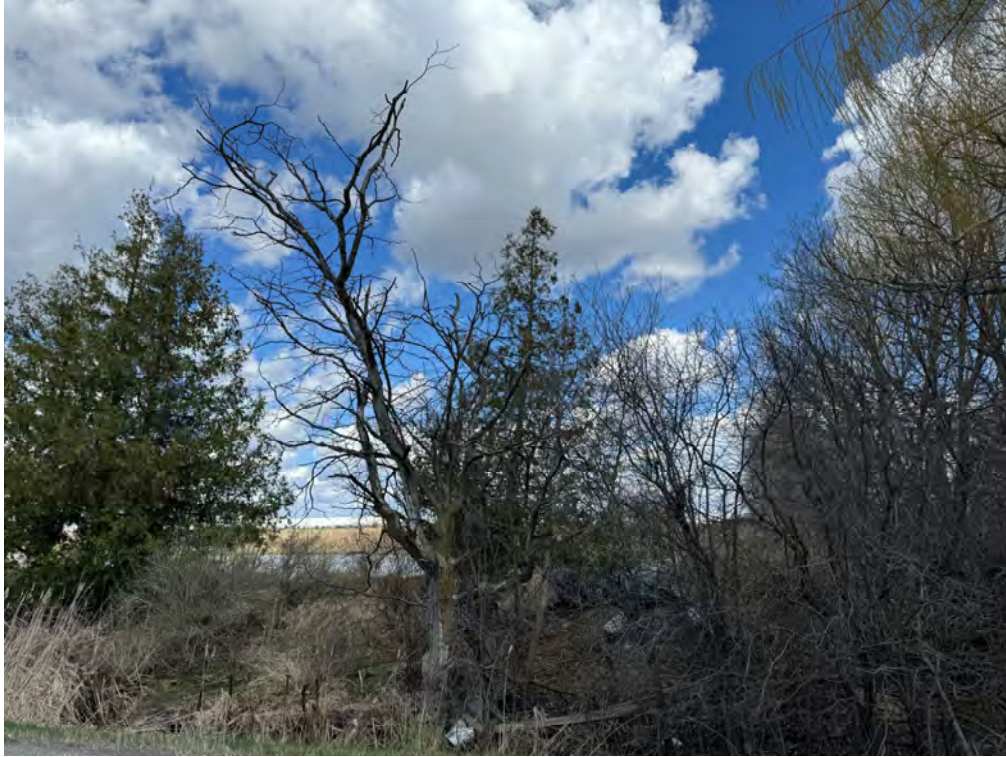
Trees 132 – 134

134	Honey Locust	Gleditsia triacanthos	7	46	F/P	Moderate deadwood throughout, imbalanced canopy, multiple limbs previously failed, base of trunk is swallowing fence	Retain
135	Ash Sp.	Fraxinus Sp.	3	12	D	Tree is 100% dead, signs of EAB	Retain
136	Cedar Sp.	Thuja Sp.	5	31	F		Retain
137	Cedar Sp.	Thuja Sp.	4	27	F		Retain
138	Cedar Sp.	Thuja Sp.	5	27	F		Retain
139	Cedar Sp.	Thuja Sp.	4.5	24	F		Retain
140	Cedar Sp.	Thuja Sp.	5	35	F		Retain
141	Cedar Sp.	Thuja Sp.	5	29	F	Minor deadwood throughout	Retain
142	Cedar Sp.	Thuja Sp.	4	22	F	Minor deadwood throughout	Retain
143	Cedar Sp.	Thuja Sp.	5	29	F	Minor deadwood throughout	Retain
144	Cedar Sp.	Thuja Sp.	5	32	F		Retain
145	Norway Maple	Acer platanoides	10	33	F	3 stem at 0.5 metres	Retain
146	Norway Maple	Acer platanoides	8	36	F	Main leader previously topped	Retain
147	Norway Maple	Acer platanoides	6.5	27	F		Retain
148	Norway Maple	Acer platanoides	12	58	F	Multi-stem at 1.7 metres	Retain

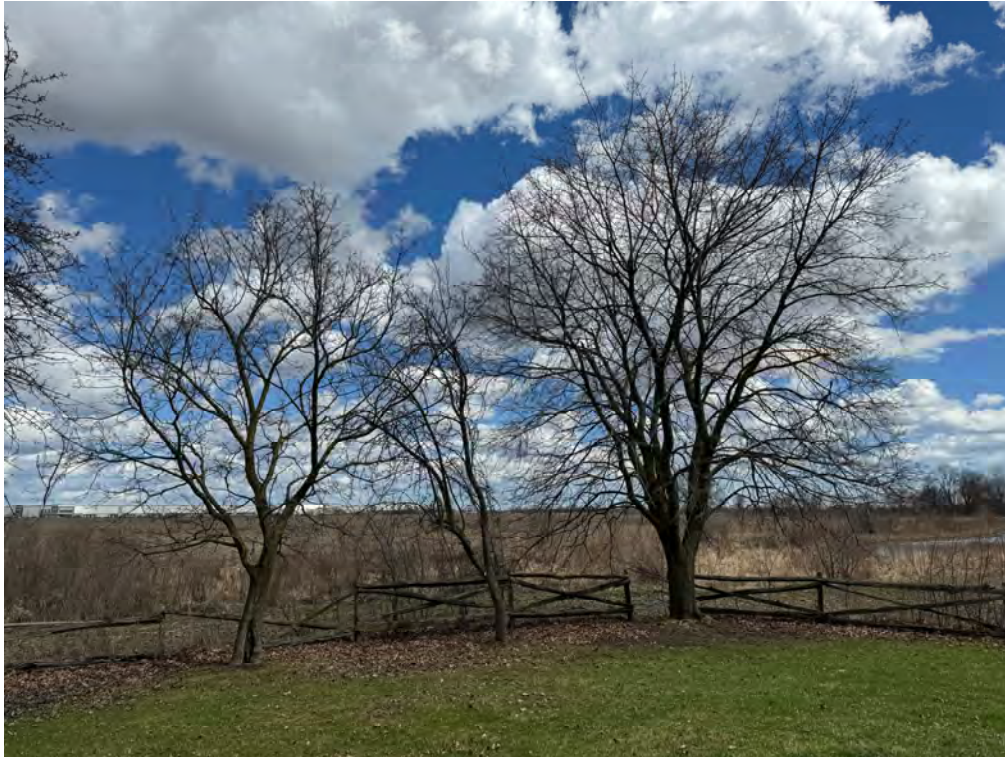
Trees 148 – 150

149	Flowering Crabapple Tree	Malus Sp.	3	14	F/P	Minor deadwood in canopy, mild lean, cavity at base callousing over	Retain
150	Norway Maple	Acer platanoides	7.5	29	F	Cavity at base callousing over	Retain
151	Flowering Crabapple Tree	Malus Sp.	6	27	F	2 stem at 0.5 metres	Retain
152	Flowering Crabapple Tree	Malus Sp.	3	17	F/P	Contorted limbs, previous limb failures, irregular form, suspected internal rot	Retain
153	Flowering Crabapple Tree	Malus Sp.	5.5	17	F/P	Minor to moderate deadwood in canopy	Retain
154	Silver Maple	Acer saccharinum	7.5	28	F		Retain

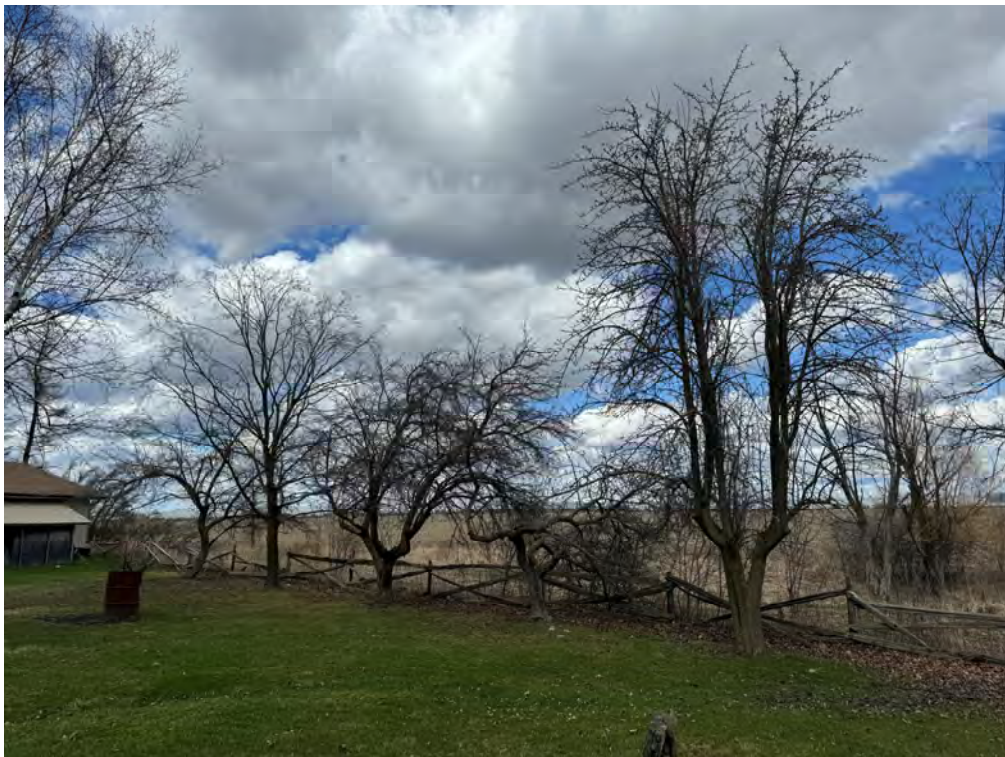
Trees 151 – 155

155	Flowering Crabapple Tree	Malus Sp.	8	23	F/P	Moderate deadwood in canopy, mild lean, bow in trunk	Retain
156	Spruce Sp.	Picea Sp.	3.5	28	D	Tree is 100% dead	Retain
157	Spruce Sp.	Picea Sp.	5.5	29	D	Tree is 100% dead	Retain
158	Willow Sp.	Salix Sp.	11	39	D	Tree is 100% dead	Retain
159	Willow Sp.	Salix Sp.	8.5	35	P/D	3 stem at 0.4 metres, tree is 85% dead, tree is in severe decline, moderate to significant deadwood throughout, multiple limbs previously failed	Retain
160	Willow Sp.	Salix Sp.	7	38	F	Co-dominant at 1.0 metre	Retain
161	Manitoba Maple	Acer negundo	3	17	F	Within grouping of buckthorn, mild lean, bow in trunk	Remove due to construction
162	Basswood	Tilia americana	7	28	F	Within grouping of buckthorn, 3 stem at 0.4 metres	Remove due to construction
163	Basswood	Tilia americana	2.5	13	F	2 stem at base	Remove due to construction
164	Basswood	Tilia americana	3.5	24	F	3 stem at 0.1 metres	Remove due to construction

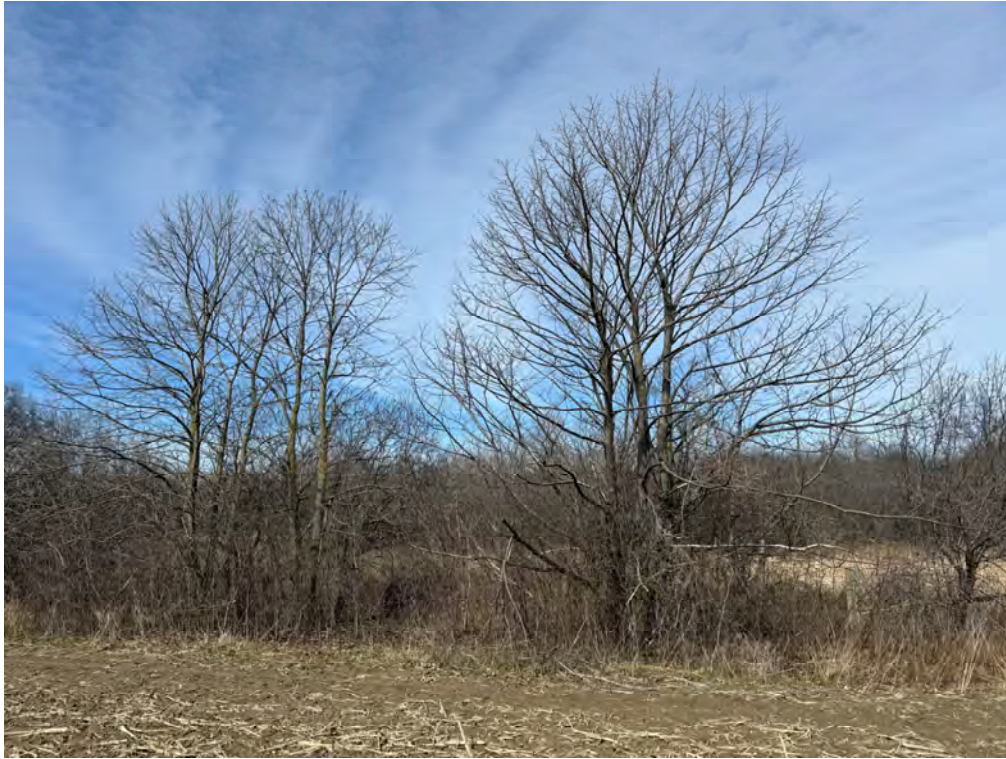
Trees 162 – 165

165	Basswood	Tilia americana	6.5	29	F	Within grouping of buckthorn, multi-stem at base	Remove due to construction
166	American Elm	Ulmus americana	1.5	9	F		Remove due to construction
167	Manitoba Maple	Acer negundo	4	18	F	Within grouping of buckthorn, 2 stem at 0.3 metres, minor deadwood throughout	Remove due to construction
168	Ash Sp.	Fraxinus Sp.	4	18	P	Within buckthorn grouping, signs of EAB	Remove due to grading
169	Ash Sp.	Fraxinus Sp.	3	14	F	Within buckthorn grouping, mild signs of EAB	Remove due to grading
170	Ash Sp.	Fraxinus Sp.	3	10	F	Within buckthorn grouping, mild signs of EAB	Remove due to construction
171	Ash Sp.	Fraxinus Sp.	3.5	16	F/P	Within buckthorn grouping, signs of EAB	Remove due to construction
172	Basswood	Tilia americana	3	10	F	Within buckthorn grouping, 3 stem at base	Remove due to grading

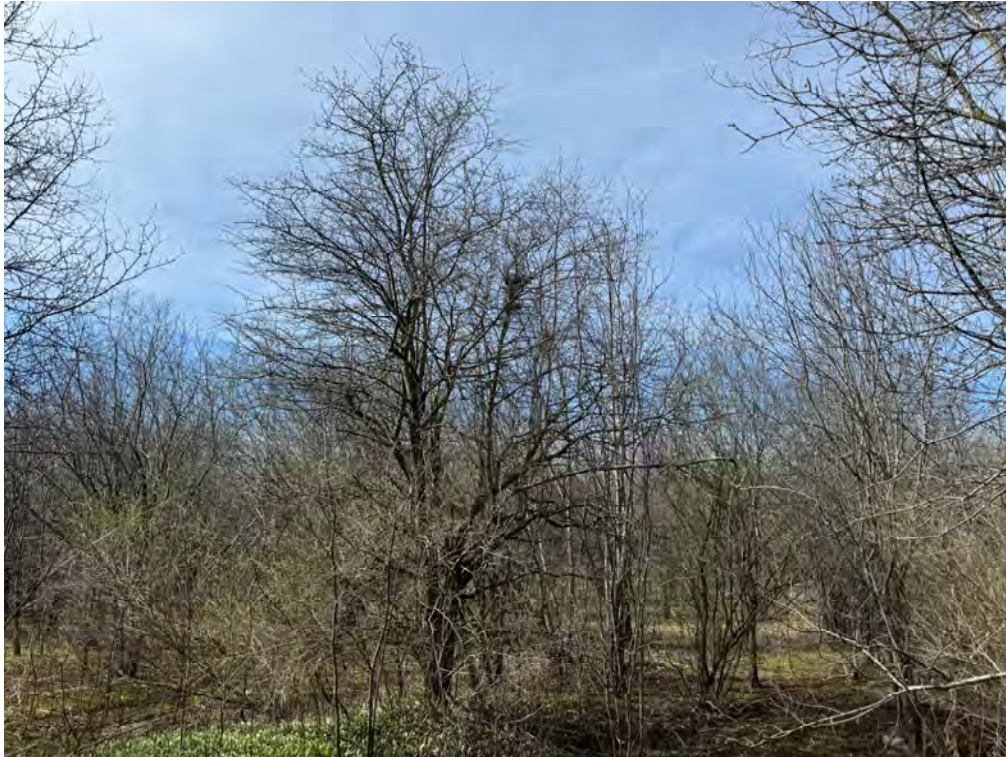
Trees 172 – 174

173	Basswood	Tilia americana	3	9	F/P	Within buckthorn grouping, multi-stem at base	Retain
174	Hawthorn Sp.	Crataegus Sp.	4	19	F/P	Within buckthorn grouping, moderate deadwood throughout	Retain
175	Basswood	Tilia americana	5	17	F	Within buckthorn grouping, 4 stem at 0.2 metres	Retain
176	Basswood	Tilia americana	2	10	F	Within buckthorn grouping	Retain
177	Basswood	Tilia americana	6	17	F	Within buckthorn grouping, 4 stem at 0.1 metres	Retain
178	Basswood	Tilia americana	5	15	F	Within buckthorn grouping, minor deadwood throughout, 3 stem at 0.3 metres	Remove due to construction
179	Ash Sp.	Fraxinus Sp.	2	11	P	Within buckthorn grouping, mild lean, signs of EAB	Remove due to construction
180	Basswood	Tilia americana	3	18	F	Within buckthorn grouping	Remove due to construction
181	Ash Sp.	Fraxinus Sp.	2.5	10	P	Within buckthorn grouping, signs of EAB	Remove due to construction
182	Basswood	Tilia americana	4	18	F	Within buckthorn grouping	Remove due to construction

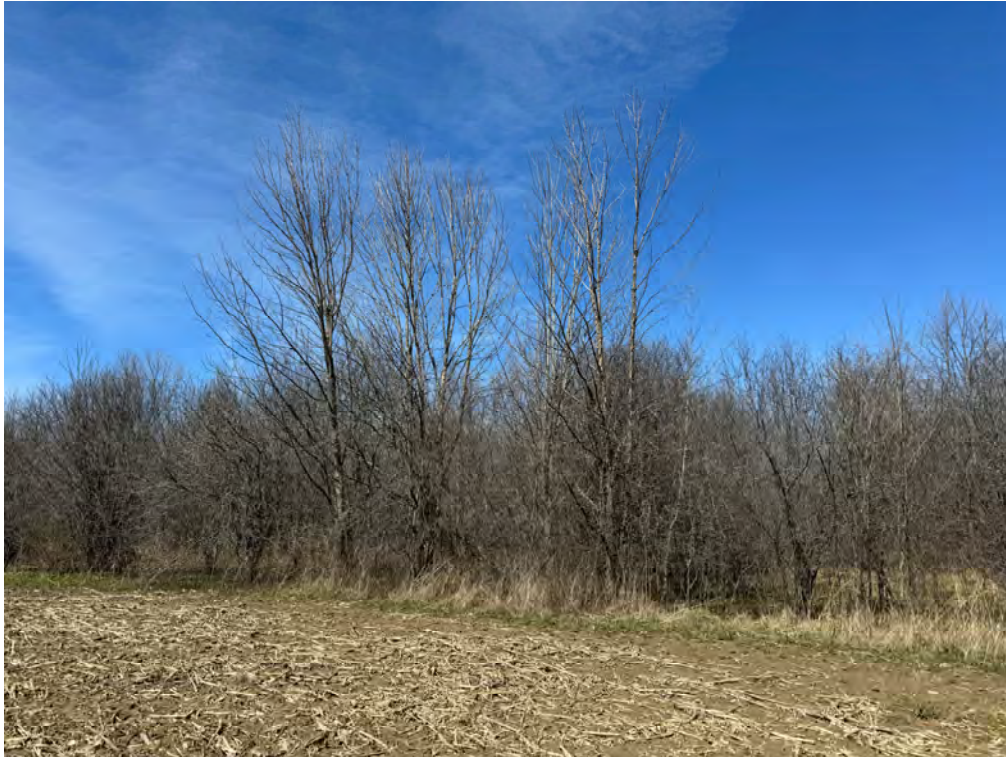
Trees 187 – 190

183	Basswood	Tilia americana	3	10	F	Within buckthorn grouping, 2 stem at base	Remove due to construction
184	Basswood	Tilia americana	3.5	17	F	Within buckthorn grouping	Remove due to construction
185	Basswood	Tilia americana	3.5	14	F	Within buckthorn grouping, multi-stem at base	Remove due to construction
186	Basswood	Tilia americana	4.5	21	F	Within buckthorn grouping, 3 stem at 0.1 metres	Remove due to construction
187	Ash Sp.	Fraxinus Sp.	5	19	P	Within buckthorn grouping, signs of EAB	Remove due to grading
188	Ash Sp.	Fraxinus Sp.	6	19	P	Within buckthorn grouping, signs of EAB	Remove due to grading
189	Ash Sp.	Fraxinus Sp.	8	21	P	Within buckthorn grouping, signs of EAB, 2 stem at 0.4 metres	Remove due to grading

190	Ash Sp.	Fraxinus Sp.	5	20	P	Within buckthorn grouping, signs of EAB	Remove due to grading
191	Manitoba Maple	Acer negundo	7	22	F	Minor deadwood throughout, multi-stem, potential boundary tree	Retain
192	Basswood	Tilia americana	6	17	F	Multi-stem	Retain
193	Basswood	Tilia americana	3	13	F	Multi-stem	Retain
194	Basswood	Tilia americana	4	13	F	Multi-stem	Retain
195	Basswood	Tilia americana	3	26	D	Tree is 100% dead, multiple limbs previously failed	Remove due to construction
196	American Elm	Ulmus americana	11	75	F	Minor deadwood throughout, 3 stem at 1.9 metres, potential boundary tree	Retain
197	Manitoba Maple	Acer negundo	8	18	P	Partial failure at base of main trunk and union, water shoots at base, minor deadwood throughout	Retain
198	Basswood	Tilia americana	3	13	F	Mild lean	Retain
199	Basswood	Tilia americana	7	18	F	Multi-stem at base	Retain
200	Manitoba Maple	Acer negundo	4	12	F/P	2 stem at 0.3 metres, moderate lean, minor deadwood in canopy	Retain

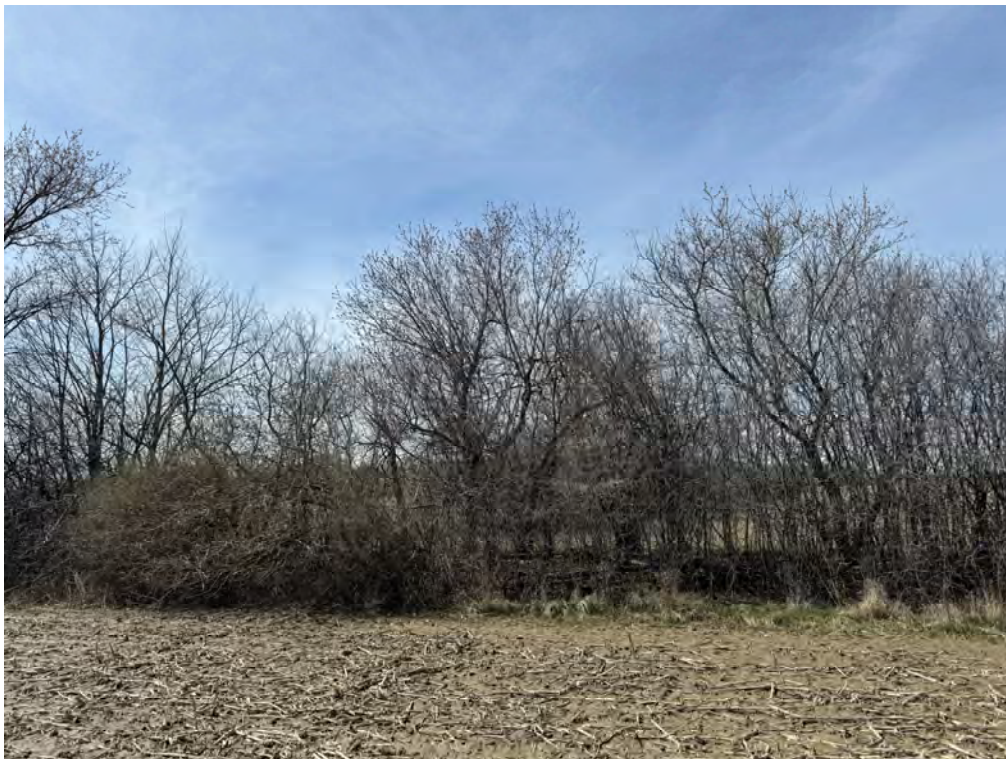
Trees 200 – 205

201	Manitoba Maple	Acer negundo	3	13	P	2 stem at base, one stem is dead with cavity at base, moderate lean	Retain
202	Manitoba Maple	Acer negundo	4	19	P	Main leader is dead and previously failed	Retain
203	Manitoba Maple	Acer negundo	8	26	F/P	2 stem at 0.6 metres, one stem is in decline, water shoots throughout	Retain
204	Manitoba Maple	Acer negundo	8	17	F/P	2 stem at 0.6 metres, minor deadwood throughout, water shoots throughout	Retain
205	Manitoba Maple	Acer negundo	7	23	F/P	2 stem at 0.2 metres, cavity at base, water shoots throughout	Retain

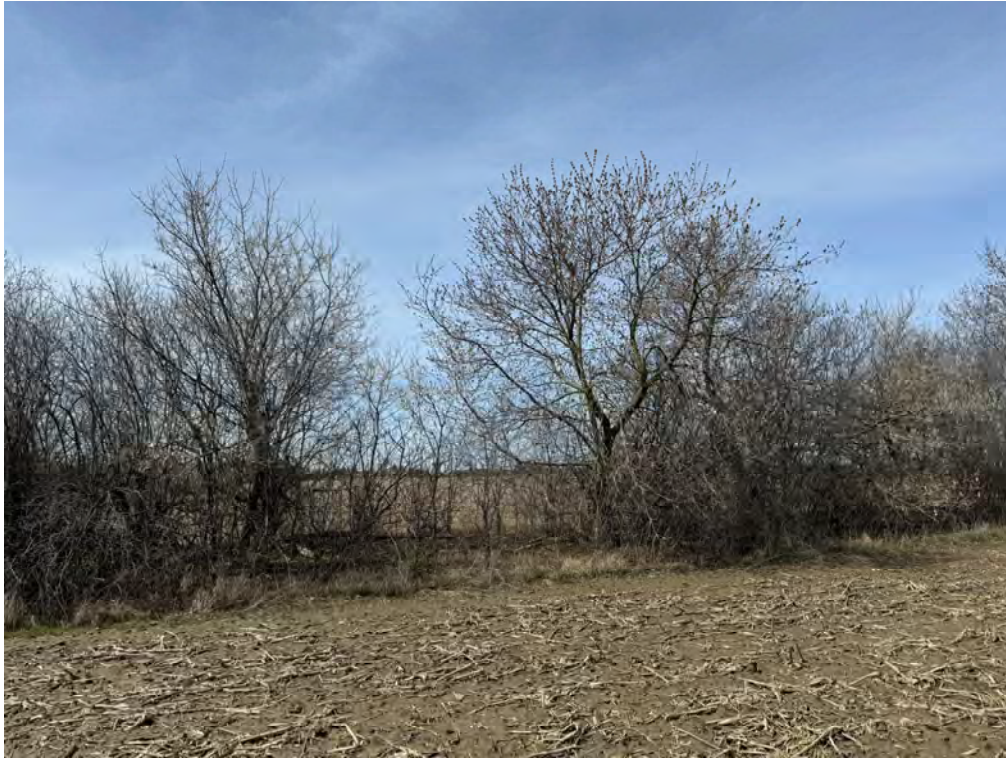
Trees 206 – 209

206	Manitoba Maple	Acer negundo	7	16	F	Multi-stem, water shoots throughout, minor deadwood throughout	Retain
207	Manitoba Maple	Acer negundo	4	18	F	Mild lean	Retain
208	Manitoba Maple	Acer negundo	7	25	F	Multi-stem	Retain
209	Manitoba Maple	Acer negundo	8	29	F		Retain
210	Hawthorn Sp.	Crataegus Sp.	7	19	F	Multi-stem	Retain
211	Manitoba Maple	Acer negundo	8	29	F/P	Multi-stem, multiple limbs previously failed, moderate deadwood in canopy, water shoots throughout	Retain
212	Manitoba Maple	Acer negundo	3	17	F/P	Bow in trunk, cavity at 1.0 metre	Retain
213	Shagbark Hickory	Carya ovata	3.5	14	F		Retain
214	Flowering Crabapple Tree	Malus Sp.	9	28	F/P	Multi-stem at 0.4 metres, cavity at stem union, minor to moderate deadwood in canopy	Retain
215	Flowering Crabapple Tree	Malus Sp.	6	26	F		Retain
216	Flowering Crabapple Tree	Malus Sp.	5	20	F	Multi-stem at 0.8 metres	Retain
217	Flowering Crabapple Tree	Malus Sp.	5	15	F	Multi-stem at base, cavity at base between all stems, main stem previously failed	Remove due to construction

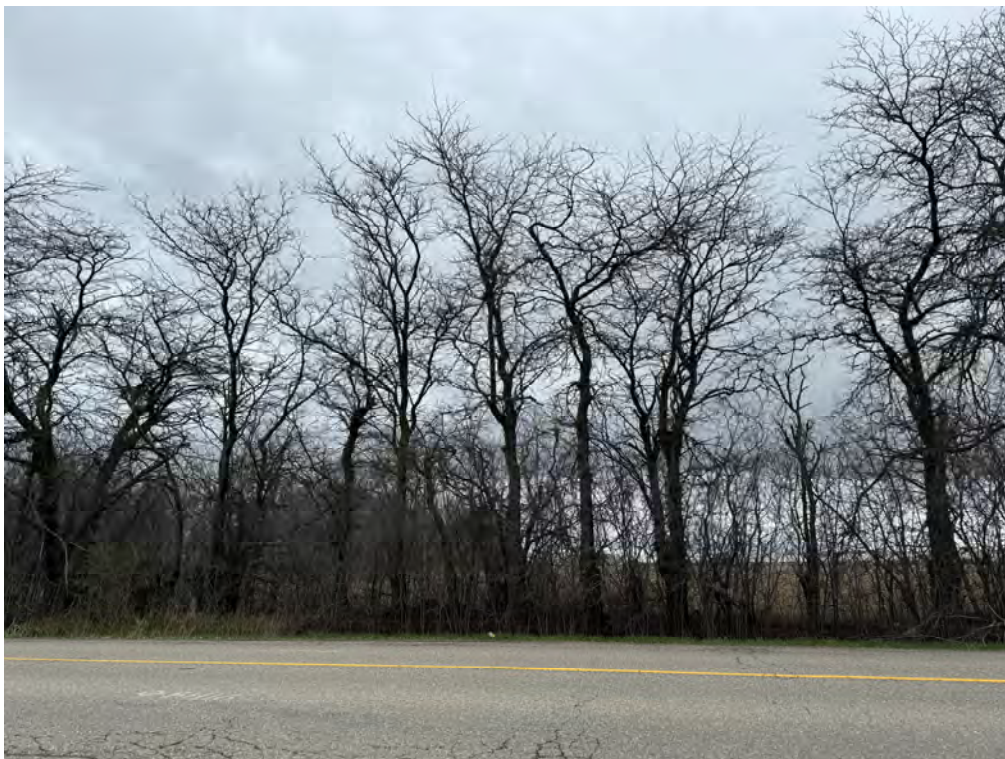
Trees 219 – 228

218	Flowering Crabapple Tree	Malus Sp.	7	29	F	2 stem at 0.6 metres	Remove due to construction
219	Honey Locust	Gleditsia triacanthos	2.5	15	P	Cavity at base, bow in trunk	Remove due to construction
220	Honey Locust	Gleditsia triacanthos	4	24	F		Remove due to construction
221	Honey Locust	Gleditsia triacanthos	2.5	17	F/P		Remove due to construction
222	Honey Locust	Gleditsia triacanthos	3	28	F	Bow in trunk	Remove due to construction
223	Honey Locust	Gleditsia triacanthos	3.5	26	F		Remove due to construction
224	Honey Locust	Gleditsia triacanthos	5	21	F/P	Significant lean	Remove due to construction
225	Honey Locust	Gleditsia triacanthos	5.5	39	F	Minor deadwood throughout	Remove due to construction

226	Honey Locust	Gleditsia triacanthos	6	30	P	Cavity in trunk	Remove due to construction
227	Honey Locust	Gleditsia triacanthos	7	27	F	Three stem at 1.3 metres	Remove due to construction
228	Honey Locust	Gleditsia triacanthos	3	12	P/D	Tree is 75% dead, 2 stem at 1.1 metre, 1 stem is 100% dead	Remove due to construction
229	Honey Locust	Gleditsia triacanthos	6	26	F	2 stem at 1.3 metres	Remove due to construction
230	Honey Locust	Gleditsia triacanthos	8	56	F	2 stem at 0.2 metres	Remove due to construction
231	Honey Locust	Gleditsia triacanthos	5	32	F		Remove due to construction
232	Honey Locust	Gleditsia triacanthos	8	28	F/P	3 stem at 1.3 metres, cavity at union, previous limb failures	Remove due to construction
233	Honey Locust	Gleditsia triacanthos	3	13	F		Remove due to construction
234	Flowering Crabapple Tree	Malus Sp.	8	24	F	Multi-stem	Retain
235	Flowering Crabapple Tree	Malus Sp.	8	17	F	Multi-stem	Retain

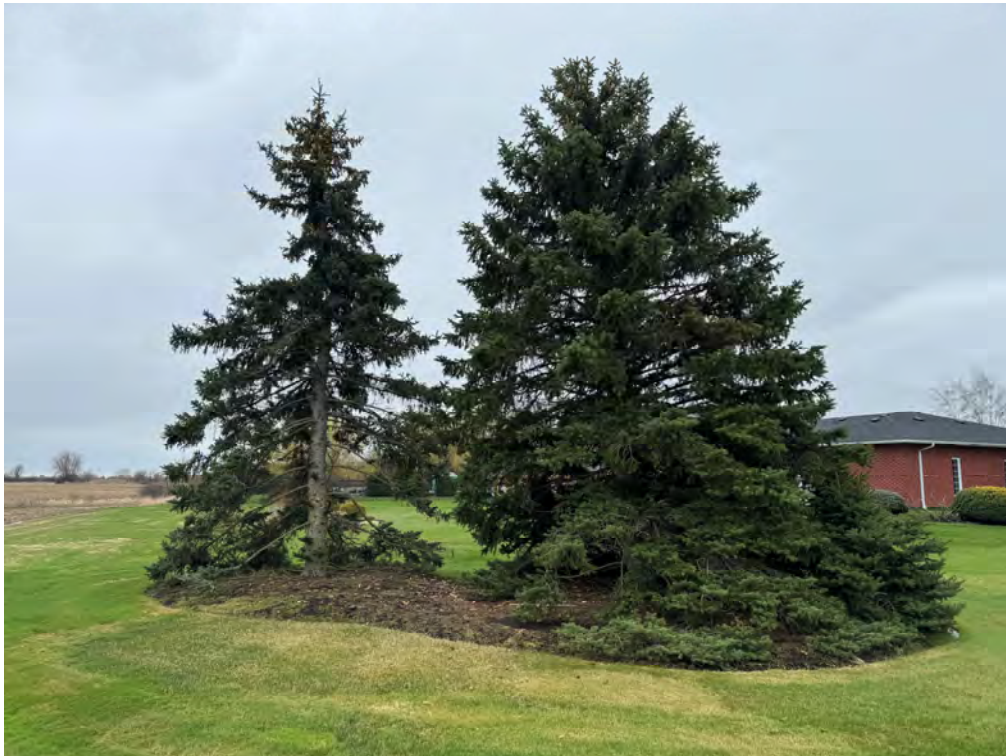
Trees 238, 239

236	Flowering Crabapple Tree	Malus Sp.	6	11	F	Multi-stem	Retain
237	Willow Sp.	Salix Sp.	4	31	F		Retain
238	Colorado Blue Spruce	Picea pungens var. glauca	4.5	34	F/P	Minor deadwood in canopy, imbalanced canopy at one side to 4 metres above grade	Retain
239	Colorado Spruce	Picea pungens	6	42	F	Mild lean	Retain
240	Willow Sp.	Salix Sp.	15	97	F/G		Retain
369	Honey Locust	Gleditsia triacanthos	3	17	P	Cavity in trunk, leader previously failed	Remove due to condition
370	Honey Locust	Gleditsia triacanthos	5	29	F		Remove due to construction
371	Honey Locust	Gleditsia triacanthos	7	38	F		Remove due to construction
372	Honey Locust	Gleditsia triacanthos	12	48	F		Remove due to construction
373	Honey Locust	Gleditsia triacanthos	2	13	P	Cavity in trunk, signs of internal rot	Remove due to construction
374	Honey Locust	Gleditsia triacanthos	5	25	F		Remove due to construction
375	Honey Locust	Gleditsia triacanthos	3	14	F/P		Remove due to construction

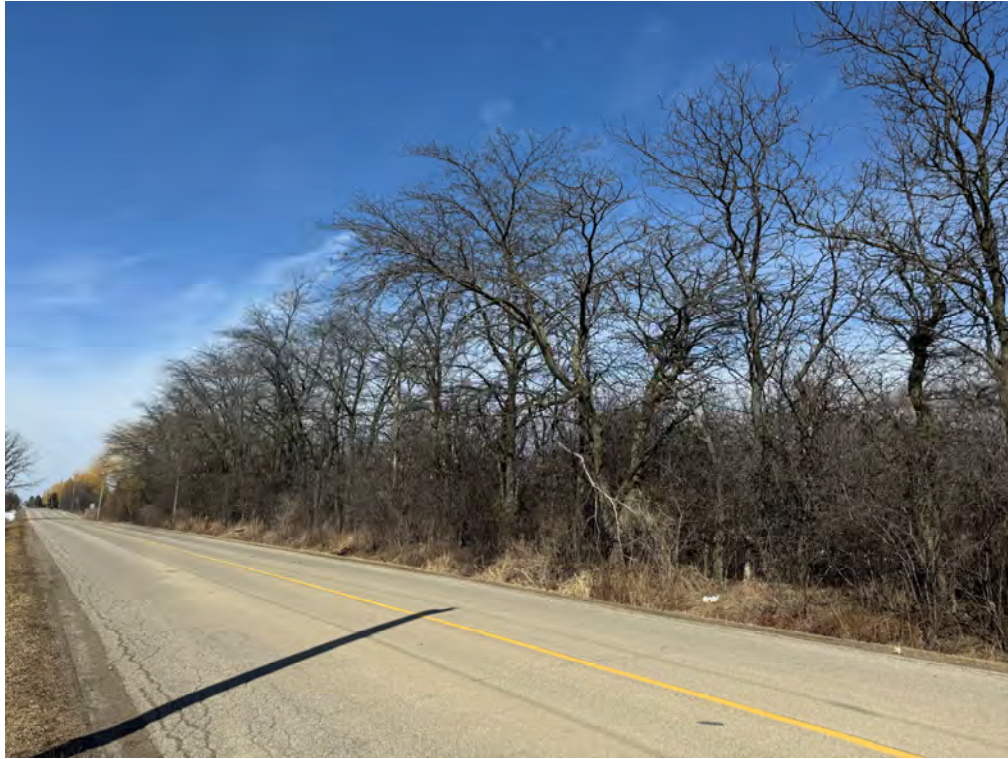
Trees 401 – 429

376	Honey Locust	Gleditsia triacanthos	11	45	F		Remove due to construction
377	Honey Locust	Gleditsia triacanthos	3	14	F		Remove due to construction
401	Honey Locust	Gleditsia triacanthos	8	35	F		Retain
402	Honey Locust	Gleditsia triacanthos	7	15	F/P	Hollow cavity in lower trunk, forked leaders	Retain
403	Honey Locust	Gleditsia triacanthos	10	28	F	2 stem at 1.1 metres	Retain
404	Honey Locust	Gleditsia triacanthos	8	42	F/P	Hollow cavity in lower trunk, multi-stem	Retain
405	Honey Locust	Gleditsia triacanthos	2	15	P	Moderate to significant deadwood in canopy, one stem previously failed	Retain
406	Honey Locust	Gleditsia triacanthos	-	10	D	Tree is 100% dead	Retain
407	Honey Locust	Gleditsia triacanthos	12	~52	F	Minor deadwood throughout	Retain
408	Honey Locust	Gleditsia triacanthos	7	45	F/P	Cavity at stem union	Retain
409	Cedar Sp.	Thuja Sp.	2	11	F		Retain
410	Honey Locust	Gleditsia triacanthos	4	17	F	Mild lean, minor deadwood in canopy	Retain

411	Honey Locust	Gleditsia triacanthos	11	40	F		Retain
412	Honey Locust	Gleditsia triacanthos	14	50	F	2 stem at 0.7 metres	Retain
413	Honey Locust	Gleditsia triacanthos	10	43	F		Retain
414	Honey Locust	Gleditsia triacanthos	12	32	F/P		Retain
415	Honey Locust	Gleditsia triacanthos	9	32	F		Retain
416	Honey Locust	Gleditsia triacanthos	9	38	F		Retain
417	Honey Locust	Gleditsia triacanthos	-	25	D	Tree is 100% dead	Retain
418	Honey Locust	Gleditsia triacanthos	14	53	F	Minor deadwood throughout	Retain
419	Honey Locust	Gleditsia triacanthos	17	58	F	Co-dominant at base	Retain
420	Honey Locust	Gleditsia triacanthos	5	27	F		Retain
421	Honey Locust	Gleditsia triacanthos	8	53	F		Retain

422	Honey Locust	Gleditsia triacanthos	7	30	F		Retain
423	Honey Locust	Gleditsia triacanthos	6	31	F		Retain
424	Honey Locust	Gleditsia triacanthos	5	22	F/P	Moderate deadwood throughout	Retain
425	Honey Locust	Gleditsia triacanthos	7	34	F		Retain
426	Honey Locust	Gleditsia triacanthos	7	42	F	Minor deadwood throughout	Retain
427	Honey Locust	Gleditsia triacanthos	5	16	F/P	Hollow cavity at forked union	Retain
428	Honey Locust	Gleditsia triacanthos	2	16	F/P	Multiple stems previously failed	Retain
429	Honey Locust	Gleditsia triacanthos	21	77	F	Minor deadwood throughout	Retain
430	Honey Locust	Gleditsia triacanthos	6	38	F	Mild lean	Retain
431	Honey Locust	Gleditsia triacanthos	12	27	F	2 stem at base	Retain
432	Honey Locust	Gleditsia triacanthos	14	33	F	Forked leaders	Retain
433	Flowering Crabapple Tree	Malus Sp.	4	17	F	Mild lean	Retain
434	Linden Sp.	Tilia Sp.	3	22	F/P	Moderate lean, moderate deadwood throughout	Retain

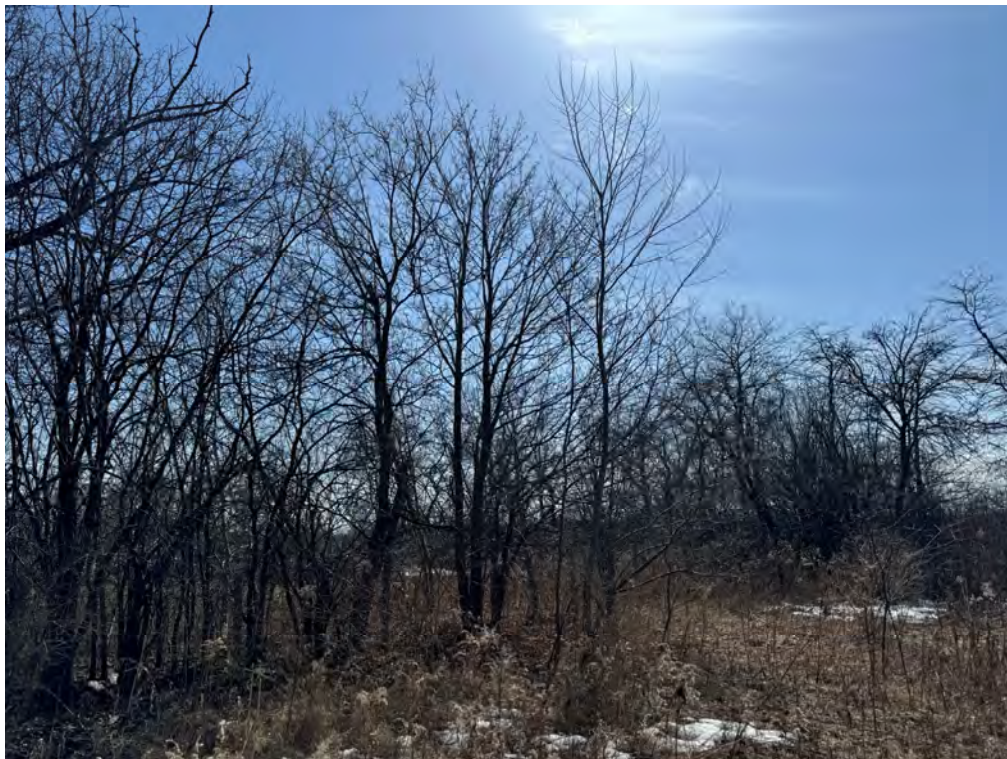
Trees 435 – 437

435	Poplar Sp.	Populus Sp.	3	11	F	Mild lean	Retain
436	Norway Maple	Acer platanoides	7	20	F		Retain
437	Manitoba Maple	Acer negundo	8	23	F/P	Minor to moderate deadwood throughout, previous limb failure	Retain
438	Norway Maple	Acer platanoides	14	51	F		Retain
439	Poplar Sp.	Populus Sp.	6	18	F	Mild to moderate lean	Retain
440	Poplar Sp.	Populus Sp.	9	57	P	Multiple past failures, major structural issues, mild lean, significant deadwood throughout	Retain
441	Ash Sp.	Fraxinus Sp.	-	18	D	Tree is 100 dead, signs of EAB	Retain
442	Manitoba Maple	Acer negundo	10	39	F		Retain
443	Poplar Sp.	Populus Sp.	11	36	F		Retain
444	Poplar Sp.	Populus Sp.	6	20	F		Retain
445	Poplar Sp.	Populus Sp.	5	17	F		Retain
446	Poplar Sp.	Populus Sp.	6	19	F		Retain

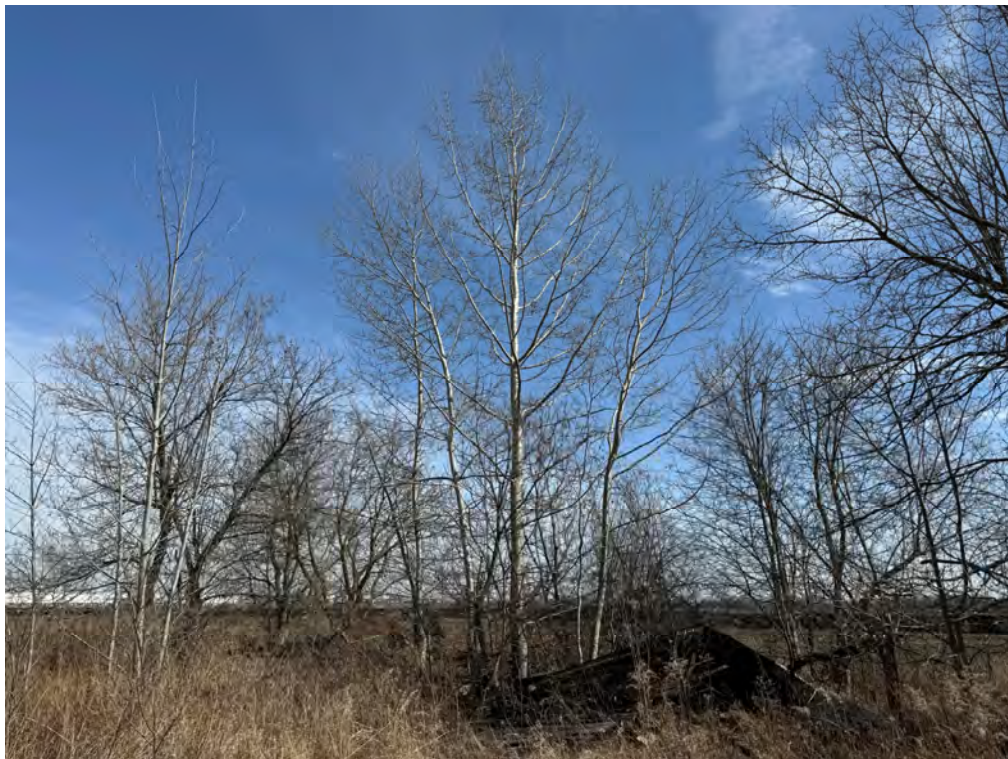
Trees 443 – 453

447	Manitoba Maple	Acer negundo	6	20	F/P	Significant deadwood throughout	Retain
448	Norway Maple	Acer platanoides	10	15	F		Retain
449	Manitoba Maple	Acer negundo	8	24	F/P	Moderate deadwood throughout	Retain
450	Manitoba Maple	Acer negundo	9	27	F	Minor deadwood throughout	Retain
451	Manitoba Maple	Acer negundo	4	30	F/P	Moderate to significant deadwood throughout	Retain
452	Manitoba Maple	Acer negundo	8	22	F/P	Moderate to significant deadwood throughout	Retain
453	Manitoba Maple	Acer negundo	8	20	F	Minor deadwood throughout	Retain
454	Manitoba Maple	Acer negundo	9	22	F/P	Significant deadwood throughout	Retain
455	Manitoba Maple	Acer negundo	5	18	F/P	Moderate to significant deadwood throughout, one stem dead	Retain
456	Manitoba Maple	Acer negundo	6	25	F	Minor deadwood throughout	Retain
457	Manitoba Maple	Acer negundo	6	26	F	Minor deadwood throughout	Retain
458	Manitoba Maple	Acer negundo	6	20	F	Minor deadwood throughout	Retain

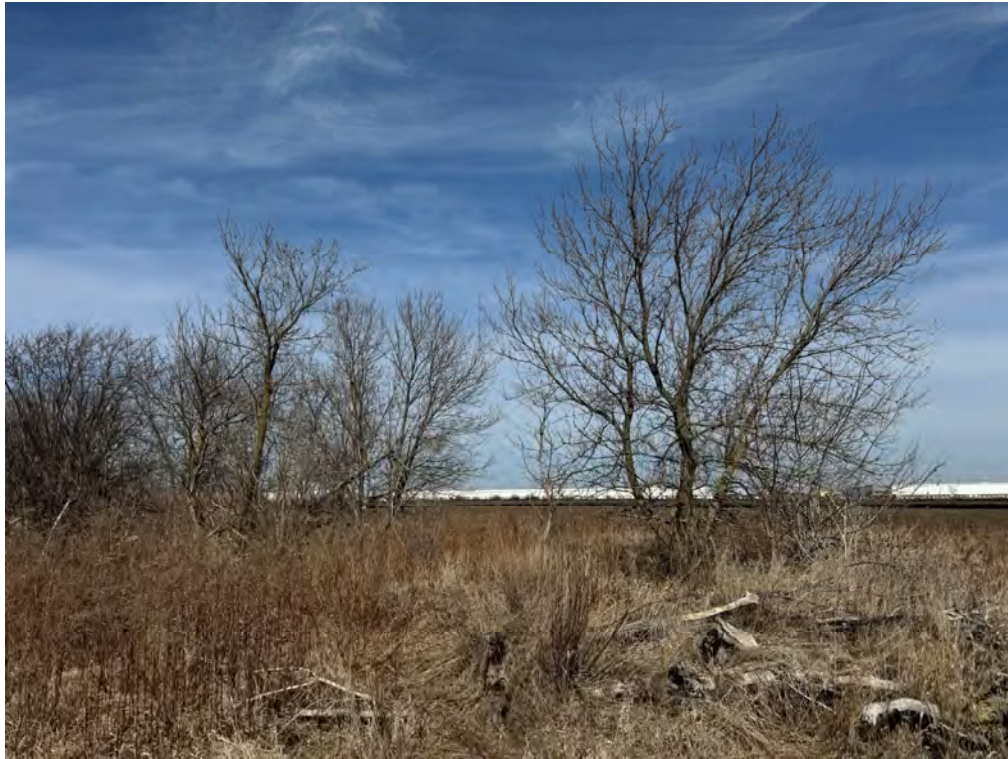
Trees 454 – 460

459	Manitoba Maple	Acer negundo	6	20	F	Significant lean and bow in structure	Retain
460	Manitoba Maple	Acer negundo	3	19	F	Minor deadwood throughout	Retain
461	Silver Maple	Acer saccharinum	18	42	F	Multi-stem at 0.6 metres	Retain
462	Silver Maple	Acer saccharinum	18	37	F	Multi-stem at 0.9 metres	Retain
463	Norway Maple	Acer platanoides	7	30	F	Previous limb failures	Retain
464	Norway Maple	Acer platanoides	6	27	F		Retain
465	Norway Maple	Acer platanoides	7	25	F	Mild lean	Retain
466	Norway Maple	Acer platanoides	8	29	F		Retain
467	Norway Maple	Acer platanoides	10	39	F	Signs of internal rot	Retain
468	Manitoba Maple	Acer negundo	11	54	P	Severe cavity at base resulting in poor structural integrity	Retain
469	Silver Maple	Acer saccharinum	17	63	F		Retain

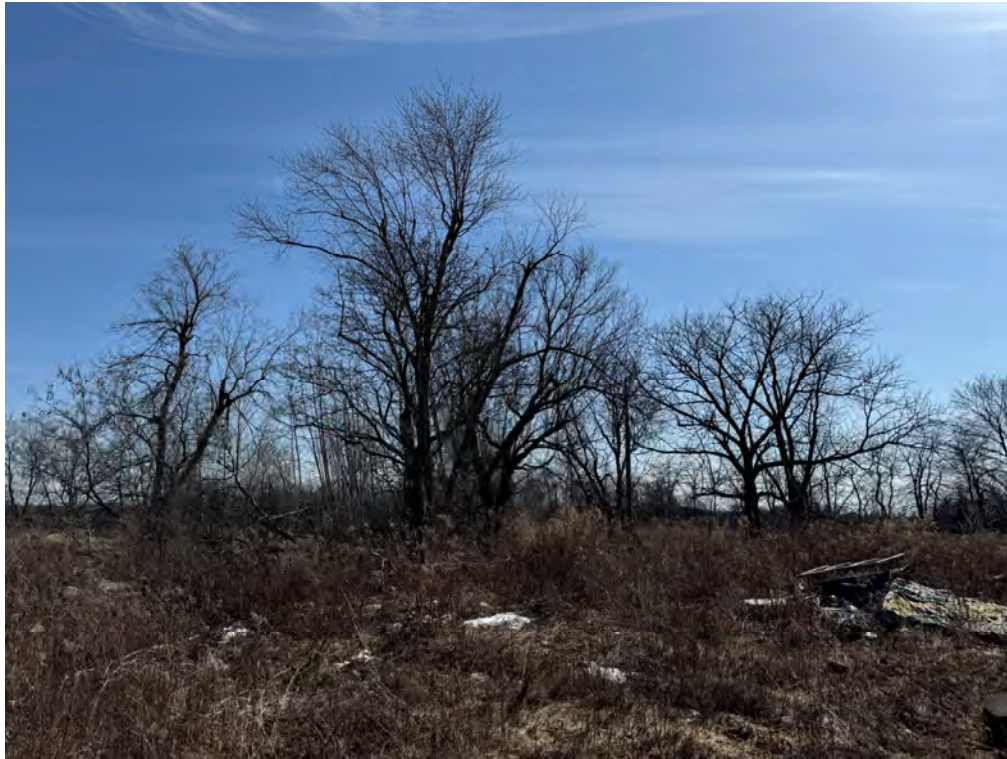
Trees 467 – 473

470	Manitoba Maple	Acer negundo	18	69	F/P	Suckers at base, minor to moderate deadwood throughout	Retain
471	Black Walnut	Juglans nigra	21	56	F		Retain
472	Silver Maple	Acer saccharinum	17	71	F	Minor deadwood throughout, suckers at base	Retain
473	Manitoba Maple	Acer negundo	15	34	F	Multi-stem, multiple previous limb failures, minor deadwood throughout	Retain
474	Poplar Sp.	Populus Sp.	7	33	F		Retain
475	Poplar Sp.	Populus Sp.	5	21	F	Mild to moderate lean	Retain
476	Poplar Sp.	Populus Sp.	11	35	F		Retain
477	Poplar Sp.	Populus Sp.	6	25	F		Retain
478	Poplar Sp.	Populus Sp.	5	30	F	Bow in upper structure	Retain
479	Poplar Sp.	Populus Sp.	5	21	F	Mild lean	Retain
480	Poplar Sp.	Populus Sp.	2	17	P	Significant deadwood throughout	Retain
481	Norway Maple	Acer platanoides	12	52	F	Minor deadwood throughout	Retain
A	Poplar Sp.	Populus Sp.	-	-	F	Poplar grouping, ~47 stems at 4-8cm DBH	Retain
