## ARBORIST REPORT

12519 & 12713 Humber Station Road, Caledon, Ontario  
21T-24014C & RZ 2024-0032  
Prologis Canada Holding 3 GP ULC

Nick Miele, Partner, MHBC

April 19, 2024 [*Revised March 27, 2026*]

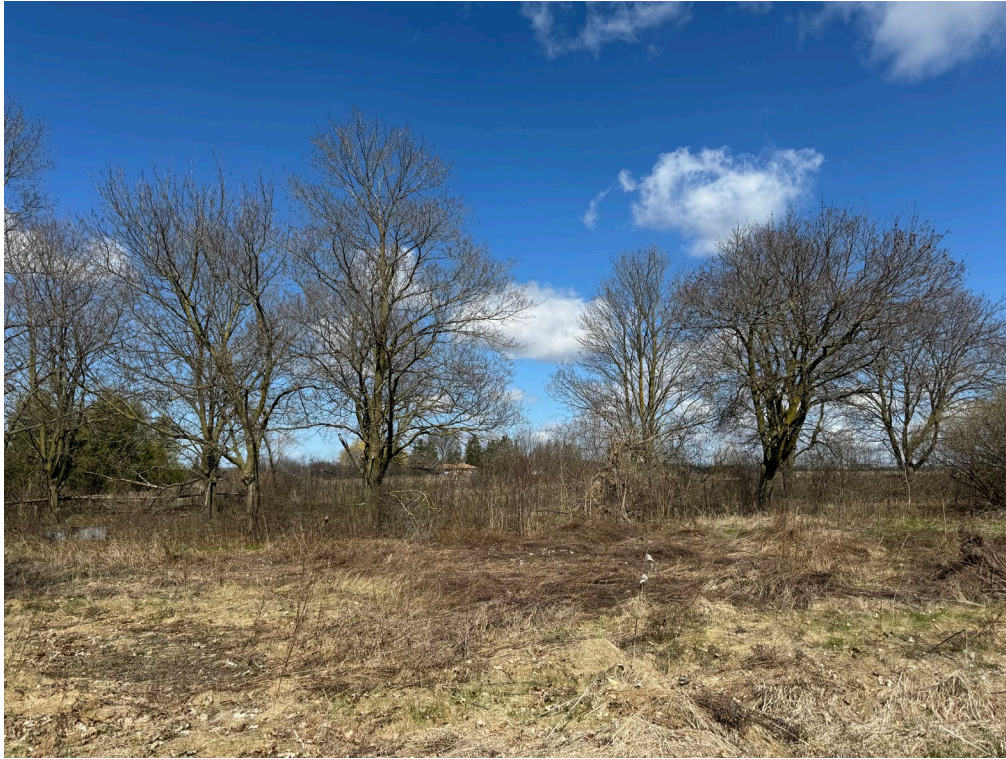
Trees 110 – 113

112	Private	Norway Maple	Acer platanoides	-	~78	5	P/D	Tree is 90% dead and previously failed, water shoots throughout	Retain
113	Private	Norway Maple	Acer platanoides	11	44	3	F		Retain
114	Private	Norway Maple	Acer platanoides	3	15	1	F		Retain
115	Private	Norway Maple	Acer platanoides	5	19	1	F		Retain
116	Private	Norway Maple	Acer platanoides	3	12	1	F	Mild lean	Retain
117	Private	Norway Maple	Acer platanoides	6	21	2	F		Retain
118	Private	Norway Maple	Acer platanoides	4.5	18	1	F		Retain
119	Private	Norway Maple	Acer platanoides	10	41	3	F		Retain
120	Private	Norway Maple	Acer platanoides	9	35	2	F/P	Co-dominant at 0.8 metres, split at main union, previously co-dominant at 1.5 metres	Retain
121	Private	Norway Maple	Acer platanoides	12	55	4	F		Retain
122	Private	Sugar Maple	Acer saccharum	6	24	2	F		Retain
123	Private	Norway Maple	Acer platanoides	11	51	4	F		Retain
124	Private	Norway Maple	Acer platanoides	12	53	4	F	Minor deadwood throughout	Retain

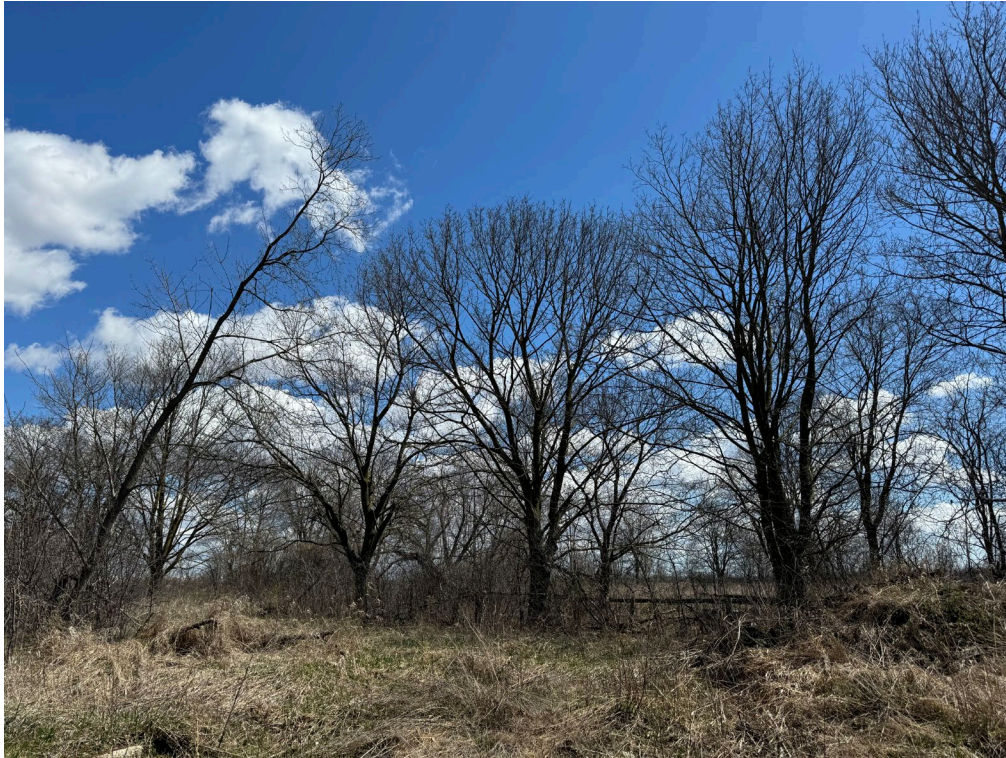
Trees 126 – 128, 130

125	Private	Norway Maple	Acer platanoides	11	50	3	F	Minor deadwood throughout	Retain
126	Private	Norway Maple	Acer platanoides	12	48	3	F	Multiple limbs previously failed	Retain
127	Private	Norway Maple	Acer platanoides	12	53	4	F	Multiple limbs previously failed	Retain
128	Private	Norway Maple	Acer platanoides	12	46	3	F		Retain
129	Private	Norway Maple	Acer platanoides	13	53	4	F	Multiple limbs previously failed, minor deadwood in canopy	Retain
130	Private	Manitoba Maple	Acer negundo	3	17	1	F	Mild to moderate lean	Retain
131	Shared (Private and Town)	Willow Sp.	Salix Sp.	17	128	5	F	Typical issues for tree of this species and size, multiple limbs previously failed	Remove due to construction
132	Private	Cedar Sp.	Thuja Sp.	5	28	2	F	Mild lean	Remove due to construction
133	Town	Norway Maple	Acer platanoides	3	13	1	F		Remove due to construction
134	Town	Honey Locust	Gleditsia triacanthos	7	46	3	F/P	Moderate deadwood throughout, imbalanced canopy, multiple limbs previously failed, base of trunk is swallowing fence	Remove due to construction

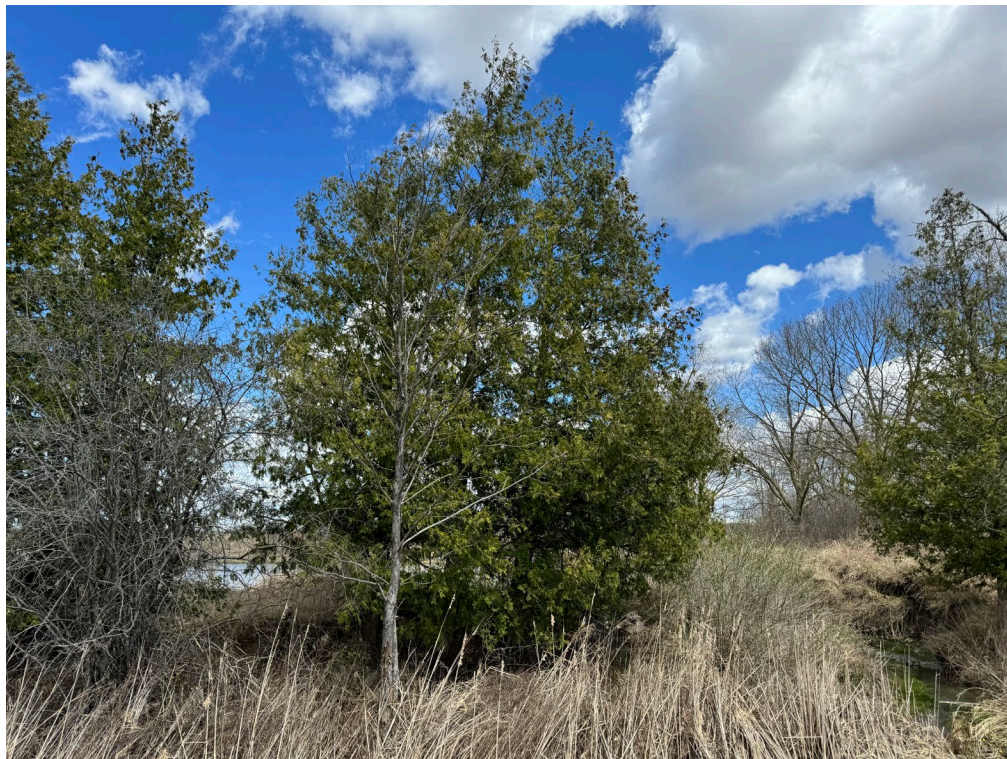
Trees 135 – 138

135	Town	Ash Sp.	Fraxinus Sp.	3	12	1	D	Tree is 100% dead, signs of EAB	Retain
136	Private	Cedar Sp.	Thuja Sp.	5	31	2	F		Retain
137	Private	Cedar Sp.	Thuja Sp.	4	27	2	F		Retain

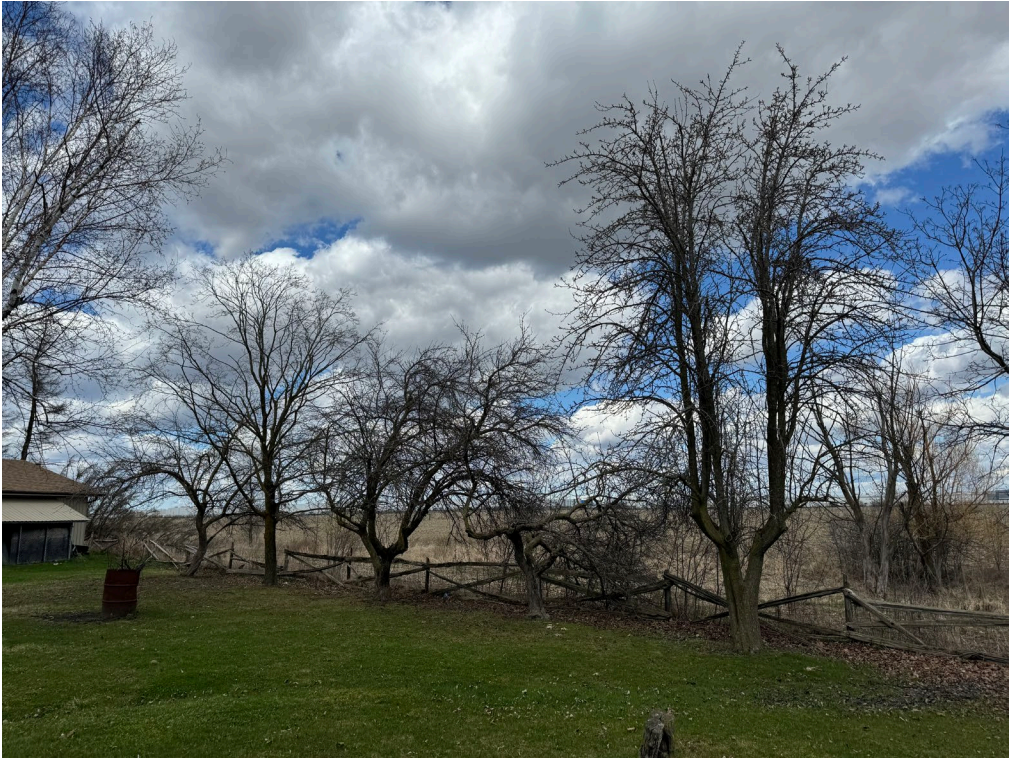
Trees 151 – 155

151	Shared (Private and Neighbour)	Flowering Crabapple Tree	Malus Sp.	6	27	2	F	2 stem at 0.5 metres	Retain
152	Neighbour	Flowering Crabapple Tree	Malus Sp.	3	17	1	F/P	Contorted limbs, previous limb failures, irregular form, suspected internal rot	Retain

153	Neighbour	Flowering Crabapple Tree	Malus Sp.	5.5	17	1	F/P	Minor to moderate deadwood in canopy	Retain
154	Neighbour	Silver Maple	Acer saccharinum	7.5	28	2	F		Retain
155	Neighbour	Flowering Crabapple Tree	Malus Sp.	8	23	2	F/P	Moderate deadwood in canopy, mild lean, bow in trunk	Retain
156	Neighbour	Spruce Sp.	Picea Sp.	3.5	28	2	D	Tree is 100% dead	Retain
157	Neighbour	Spruce Sp.	Picea Sp.	5.5	29	2	D	Tree is 100% dead	Retain
158	Private	Willow Sp.	Salix Sp.	11	39	3	D	Tree is 100% dead	Retain
159	Private	Willow Sp.	Salix Sp.	8.5	35	2	P/D	3 stem at 0.4 metres, tree is 85% dead, tree is in severe decline, moderate to significant deadwood throughout, multiple limbs previously failed	Retain
160	Private	Willow Sp.	Salix Sp.	7	38	3	F	Co-dominant at 1.0 metre	Remove due to construction
161	Private	Manitoba Maple	Acer negundo	3	17	1	F	Within grouping of buckthorn, mild lean, bow in trunk	Remove due to construction

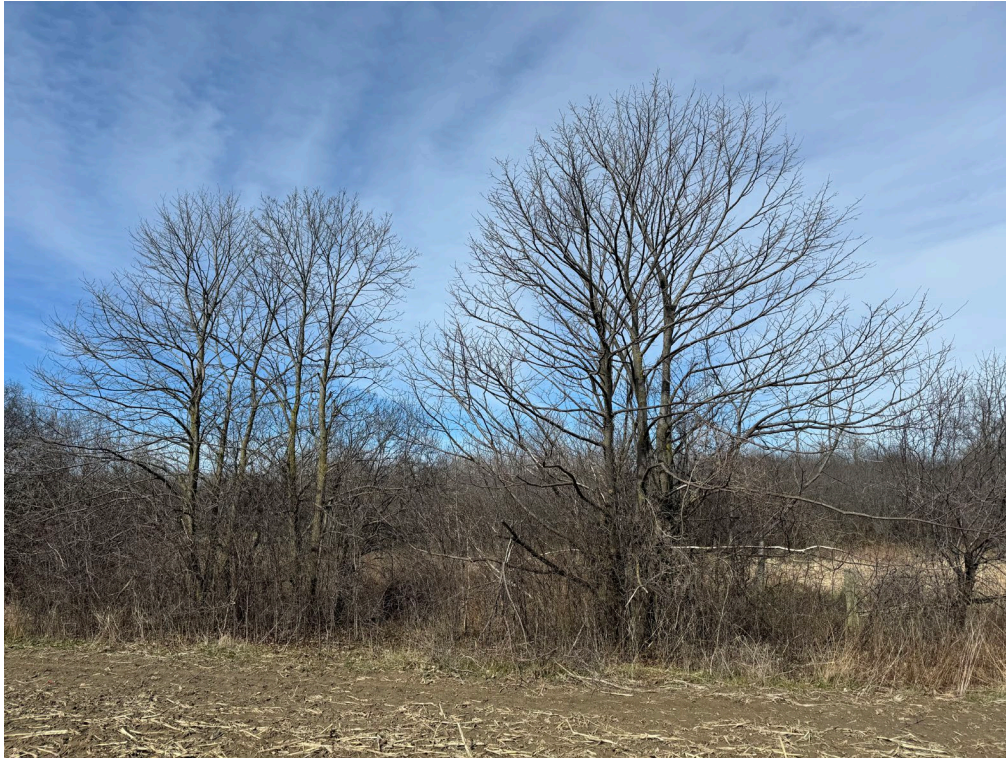
Trees 162 – 165

162	Private	Basswood	Tilia americana	7	28	2	F	Within grouping of buckthorn, 3 stem at 0.4 metres	Remove due to construction
163	Private	Basswood	Tilia americana	2.5	13	1	F	2 stem at base	Remove due to construction

164	Private	Basswood	Tilia americana	3.5	24	2	F	3 stem at 0.1 metres	Remove due to construction
165	Private	Basswood	Tilia americana	6.5	29	2	F	Within grouping of buckthorn, multi-stem at base	Remove due to construction
166	Private	American Elm	Ulmus americana	1.5	9	-	F		Remove due to construction
167	Private	Manitoba Maple	Acer negundo	4	18	1	F	Within grouping of buckthorn, 2 stem at 0.3 metres, minor deadwood throughout	Remove due to construction
168	Private	Ash Sp.	Fraxinus Sp.	4	18	1	P	Within buckthorn grouping, signs of EAB	Remove due to construction
169	Private	Ash Sp.	Fraxinus Sp.	3	14	1	F	Within buckthorn grouping, mild signs of EAB	Remove due to construction
170	Private	Ash Sp.	Fraxinus Sp.	3	10	1	F	Within buckthorn grouping, mild signs of EAB	Remove due to construction
171	Private	Ash Sp.	Fraxinus Sp.	3.5	16	1	F/P	Within buckthorn grouping, signs of EAB	Remove due to construction
172	Private	Basswood	Tilia americana	3	10	1	F	Within buckthorn grouping, 3 stem at base	Remove due to construction

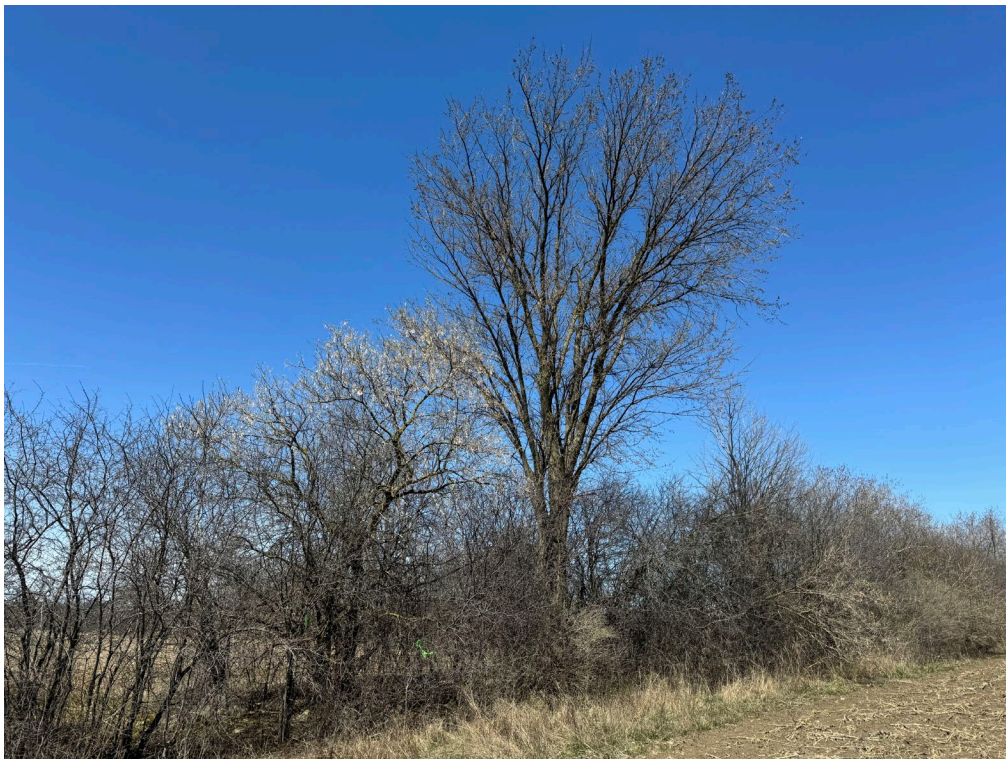
Trees 191, 196 – 199

197	Neighbour	Manitoba Maple	Acer negundo	8	18	1	P	Partial failure at base of main trunk and union, water shoots at base, minor deadwood throughout	Retain
198	Neighbour	Basswood	Tilia americana	3	13	1	F	Mild lean	Retain
199	Neighbour	Basswood	Tilia americana	7	18	1	F	Multi-stem at base	Retain

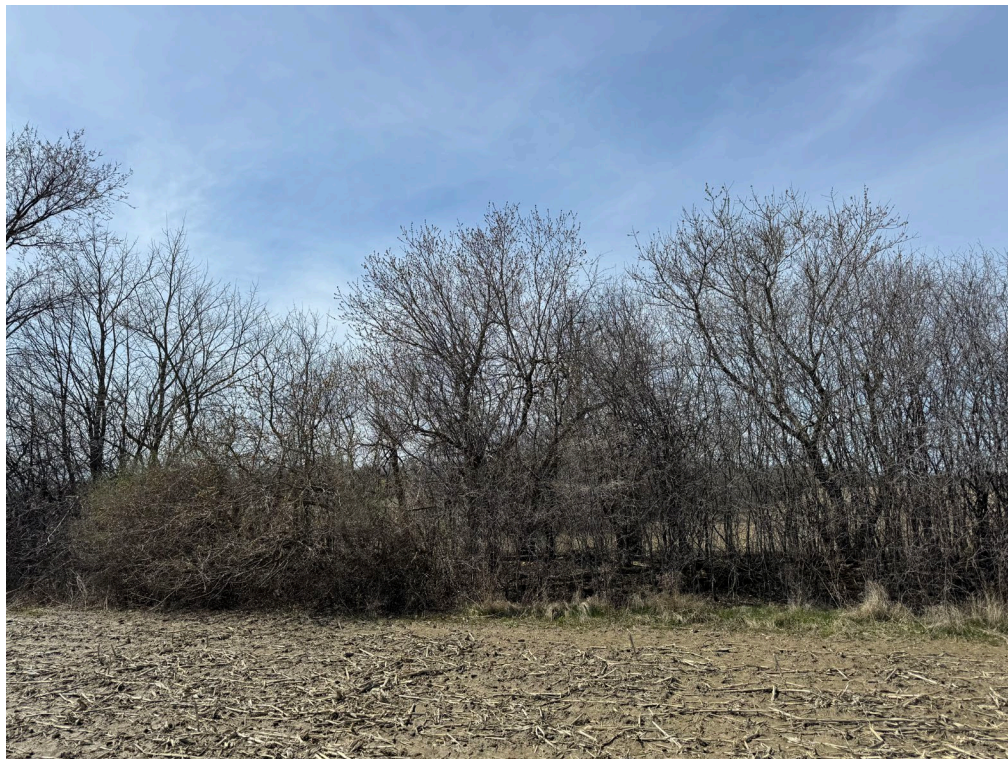
Trees 200 – 205

200	Neighbour	Manitoba Maple	Acer negundo	4	12	1	F/P	2 stem at 0.3 metres, moderate lean, minor deadwood in canopy	Retain
201	Neighbour	Manitoba Maple	Acer negundo	3	13	1	P	2 stem at base, one stem is dead with cavity at base, moderate lean	Retain
202	Neighbour	Manitoba Maple	Acer negundo	4	19	1	P	Main leader is dead and previously failed	Retain
203	Neighbour	Manitoba Maple	Acer negundo	8	26	2	F/P	2 stem at 0.6 metres, one stem is in decline, water shoots throughout	Retain
204	Neighbour	Manitoba Maple	Acer negundo	8	17	1	F/P	2 stem at 0.6 metres, minor deadwood throughout, water shoots throughout	Retain
205	Neighbour	Manitoba Maple	Acer negundo	7	23	2	F/P	2 stem at 0.2 metres, cavity at base, water shoots throughout	Retain
206	Neighbour	Manitoba Maple	Acer negundo	7	16	1	F	Multi-stem, water shoots throughout, minor deadwood throughout	Retain
207	Neighbour	Manitoba Maple	Acer negundo	4	18	1	F	Mild lean	Retain

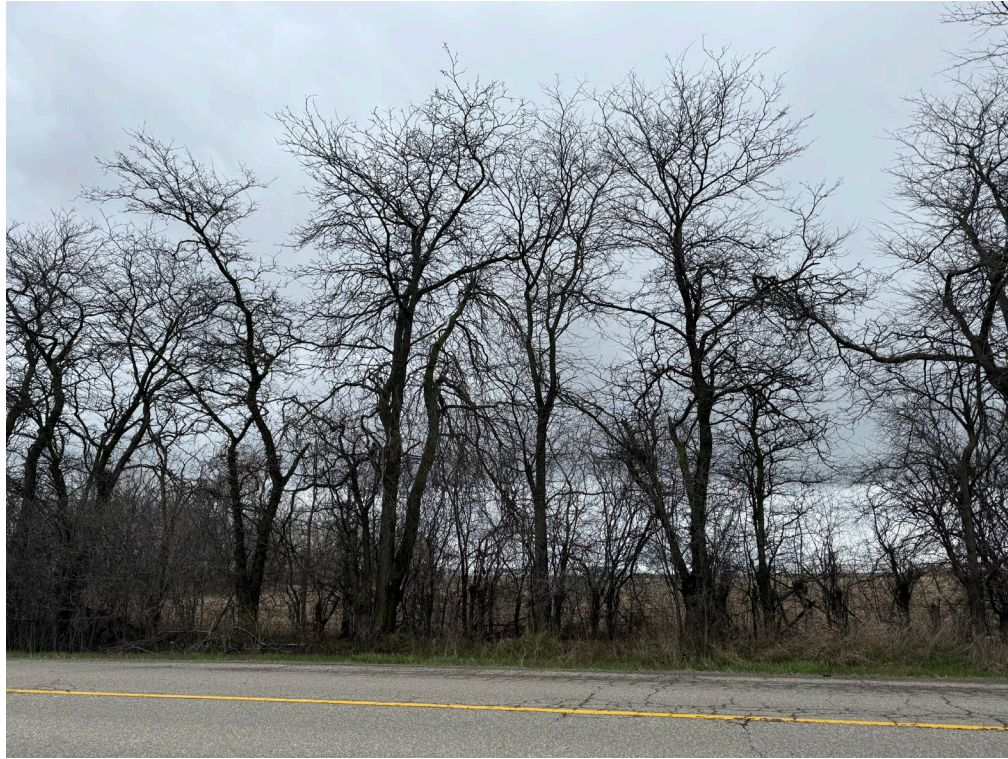
Trees 229 – 233

230	Town	Honey Locust	Gleditsia triacanthos	8	56	4	F	2 stem at 0.2 metres	Remove due to construction
231	Town	Honey Locust	Gleditsia triacanthos	5	32	2	F		Remove due to construction

232	Town	Honey Locust	Gleditsia triacanthos	8	28	2	F/P	3 stem at 1.3 metres, cavity at union, previous limb failures	Remove due to construction
233	Town	Honey Locust	Gleditsia triacanthos	3	13	1	F		Remove due to construction
234	Private	Flowering Crabapple Tree	Malus Sp.	8	24	2	F	Multi-stem	Retain
235	Private	Flowering Crabapple Tree	Malus Sp.	8	17	1	F	Multi-stem	Retain
236	Private	Flowering Crabapple Tree	Malus Sp.	6	11	1	F	Multi-stem	Retain
237	Private	Willow Sp.	Salix Sp.	4	31	2	F		Retain
238	Neighbour	Colorado Blue Spruce	Picea pungens var. glauca	4.5	34	2	F/P	Minor deadwood in canopy, imbalanced canopy at one side to 4 metres above grade	Retain
239	Neighbour	Colorado Spruce	Picea pungens	6	42	3	F	Mild lean	Retain
240	Neighbour	Willow Sp.	Salix Sp.	15	97	5	F/G		Retain
369	Town	Honey Locust	Gleditsia triacanthos	3	17	1	P	Cavity in trunk, leader previously failed	Remove due to construction
370	Town	Honey Locust	Gleditsia triacanthos	5	29	2	F		Remove due to construction

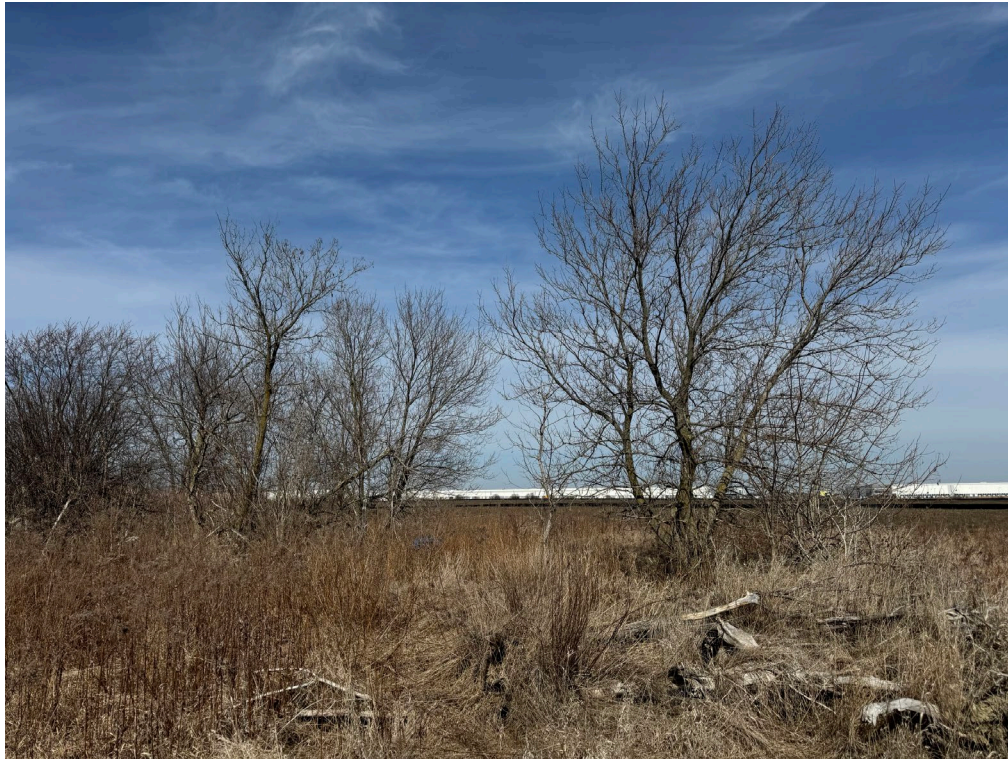
Trees 454 – 460

456	Private	Manitoba Maple	Acer negundo	6	25	2	F	Minor deadwood throughout	Remove due to construction
457	Private	Manitoba Maple	Acer negundo	6	26	2	F	Minor deadwood throughout	Retain

458	Private	Manitoba Maple	Acer negundo	6	20	1	F	Minor deadwood throughout	Retain
459	Private	Manitoba Maple	Acer negundo	6	20	1	F	Significant lean and bow in structure	Retain
460	Private	Manitoba Maple	Acer negundo	3	19	1	F	Minor deadwood throughout	Remove due to construction
461	Private	Silver Maple	Acer saccharinum	18	42	3	F	Multi-stem at 0.6 metres	Retain
462	Private	Silver Maple	Acer saccharinum	18	37	3	F	Multi-stem at 0.9 metres	Retain
463	Private	Norway Maple	Acer platanoides	7	30	2	F	Previous limb failures	Remove due to construction
464	Private	Norway Maple	Acer platanoides	6	27	2	F		Remove due to construction
465	Private	Norway Maple	Acer platanoides	7	25	2	F	Mild lean	Retain
466	Private	Norway Maple	Acer platanoides	8	29	2	F		Retain
467	Private	Norway Maple	Acer platanoides	10	39	3	F	Signs of internal rot	Retain
468	Private	Manitoba Maple	Acer negundo	11	54	4	P	Severe cavity at base resulting in poor structural integrity	Remove due to construction

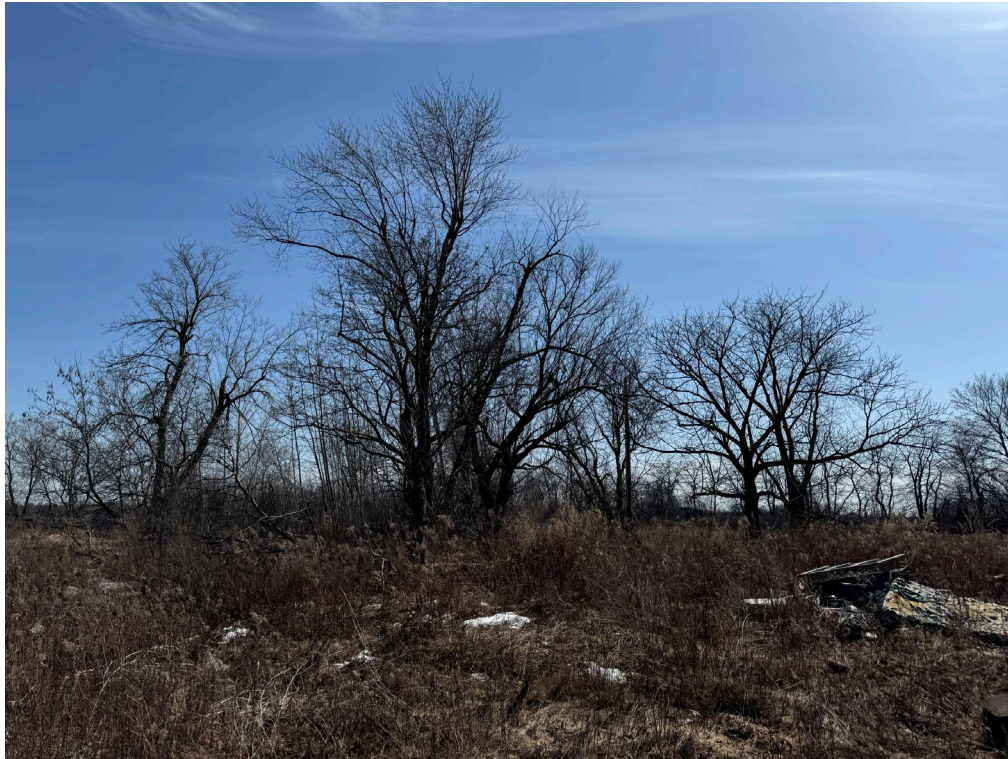
Trees 467 – 473

469	Private	Silver Maple	Acer saccharinum	17	63	4	F		Retain

470	Private	Manitoba Maple	Acer negundo	18	69	5	F/P	Suckers at base, minor to moderate deadwood throughout	Remove due to construction
471	Private	Black Walnut	Juglans nigra	21	56	4	F		Retain
472	Private	Silver Maple	Acer saccharinum	17	71	5	F	Minor deadwood throughout, suckers at base	Retain
473	Private	Manitoba Maple	Acer negundo	15	34	2	F	Multi-stem, multiple previous limb failures, minor deadwood throughout	Retain
474	Private	Poplar Sp.	Populus Sp.	7	33	2	F		Retain
475	Private	Poplar Sp.	Populus Sp.	5	21	2	F	Mild to moderate lean	Retain
476	Private	Poplar Sp.	Populus Sp.	11	35	2	F		Retain
477	Private	Poplar Sp.	Populus Sp.	6	25	2	F		Retain
478	Private	Poplar Sp.	Populus Sp.	5	30	2	F	Bow in upper structure	Retain
479	Private	Poplar Sp.	Populus Sp.	5	21	2	F	Mild lean	Retain
480	Private	Poplar Sp.	Populus Sp.	2	17	1	P	Significant deadwood throughout	Retain
481	Private	Norway Maple	Acer platanoides	12	52	4	F	Minor deadwood throughout	Retain

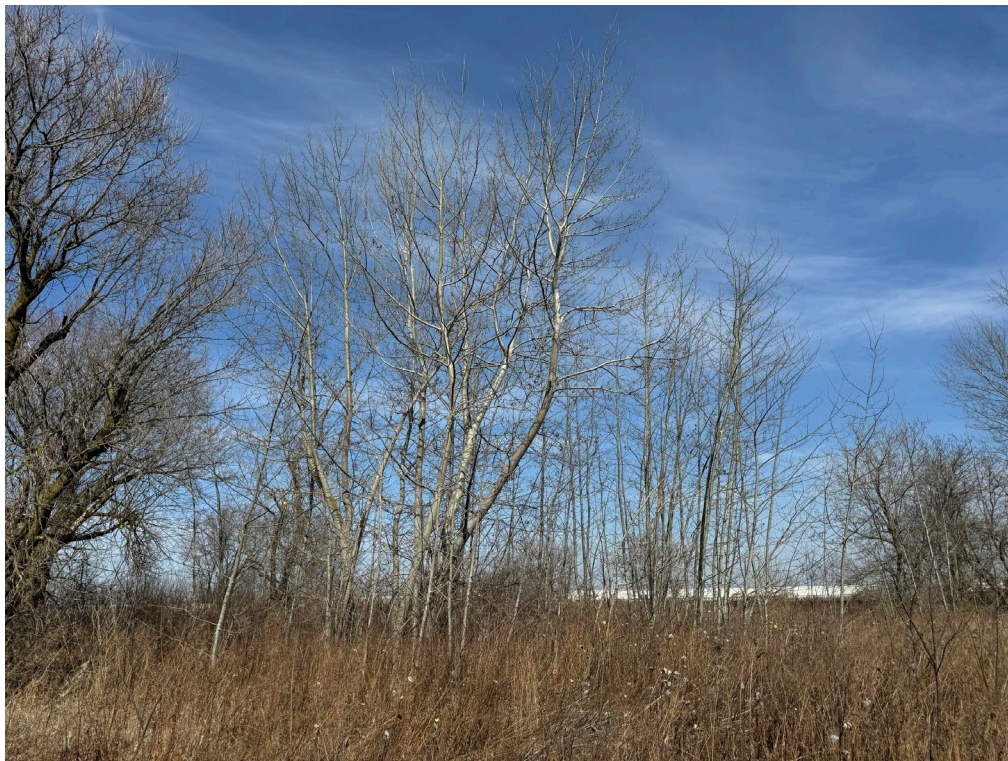
Trees 474 – 480, A

A	Private	Poplar Sp.	Populus Sp.	-	-	-	F	Poplar grouping, ~47 stems at 4-8cm DBH	Retain
