## ARBORIST REPORT

12519 & 12713 Humber Station Road, Caledon, Ontario

21T-24014C & RZ 2024-0032

April 19, 2024 [*Revised June 23, 2026*]

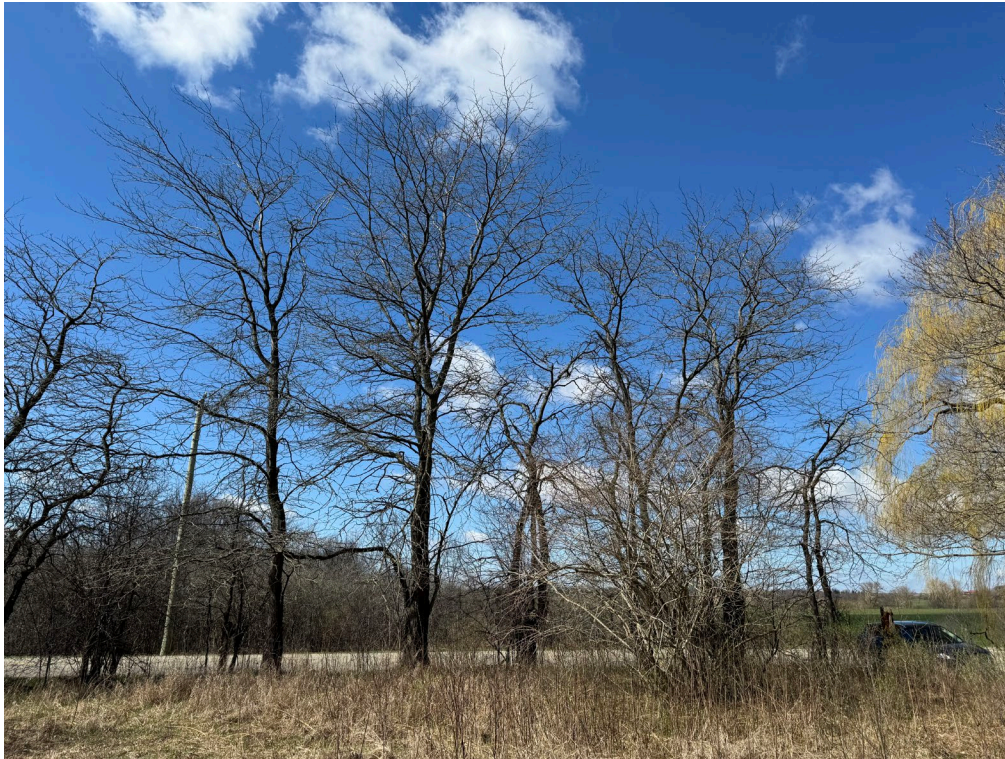
Trees 101 – 105

| Tree # | Ownership | Common Name | Botanical Name | Canopy (M) | DBH (CM) | Compensation Trees Required | Condition | Comments | Recommendation |
|---|---|---|---|---|---|---|---|---|---|
| 101 | Town | Honey Locust | Gleditsia triacanthos | 7 | 60 | 4 | F | Minor to moderate deadwood throughout | Retain |
| 102 | Town | Honey Locust | Gleditsia triacanthos | 5 | 26 | 2 | F/P | 3 stem at 1.2 metres, cavity at main union, minor deadwood throughout | Retain |
| 103 | Town | Honey Locust | Gleditsia triacanthos | 6 | 25 | 2 | F | Multi-stem, some stems fused together, minor deadwood throughout | Retain |
| 104 | Town | Honey Locust | Gleditsia triacanthos | 5.5 | 28 | 2 | F | 3 stem at 1.0 metre, cavity at union of 2 stems, minor deadwood throughout | Retain |
| 105 | Town | Honey Locust | Gleditsia triacanthos | 4 | 19 | 1 | F | Co-dominant at 0.2 metres | Retain |

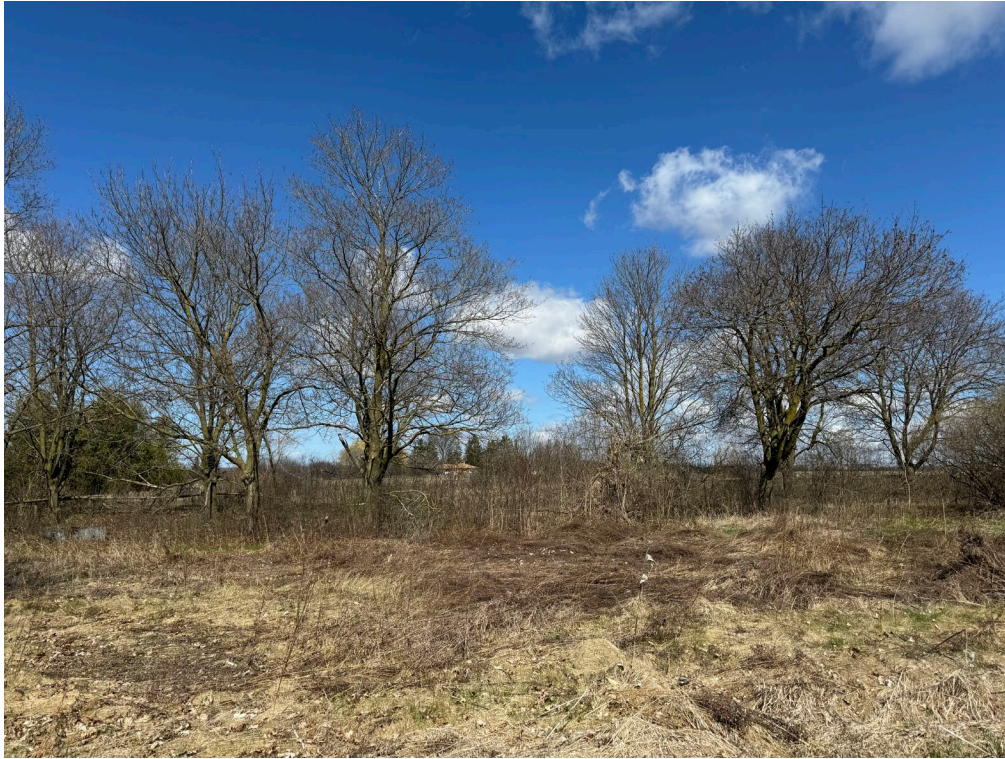
Trees 110 – 113

| Tree # | Ownership | Common Name | Botanical Name | Canopy (M) | DBH (CM) | Compensation Trees Required | Condition | Comments | Recommendation |
|---|---|---|---|---|---|---|---|---|---|
| 112 | Private | Norway Maple | Acer platanoides | - | ~78 | 5 | P/D | Tree is 90% dead and previously failed, water shoots throughout | Retain |

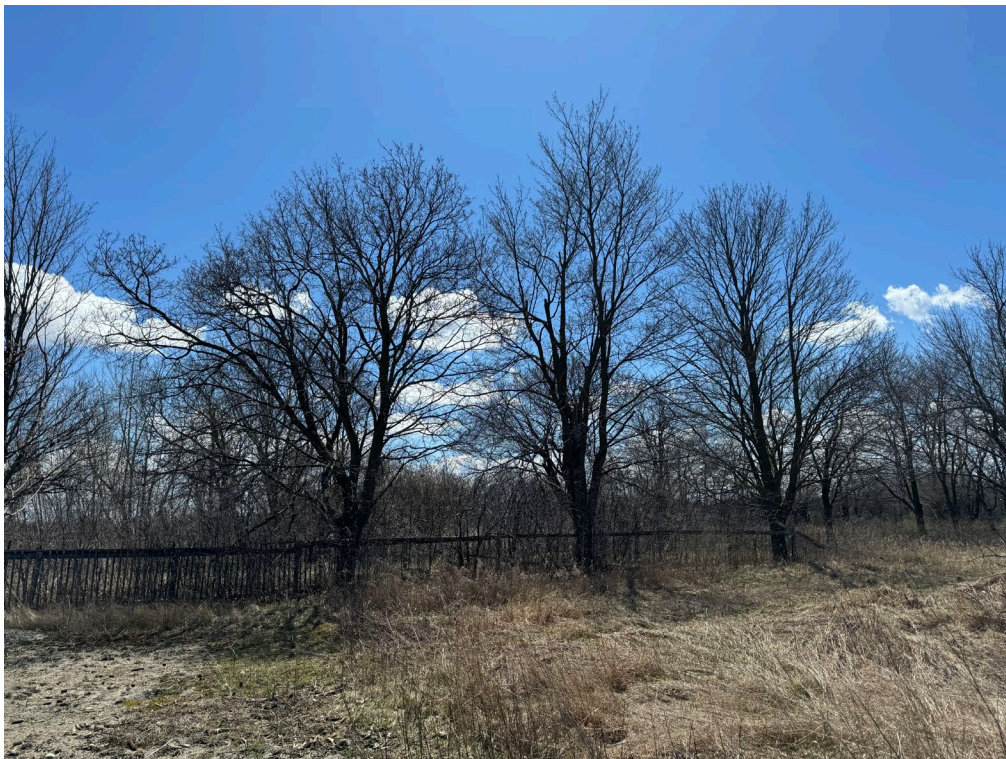
Trees 126 – 128, 130

| 126 | Private | Norway Maple | Acer platanoides | 12 | 48 | 3 | F | Multiple limbs previously failed | Retain |
| 127 | Private | Norway Maple | Acer platanoides | 12 | 53 | 4 | F | Multiple limbs previously failed | Retain |

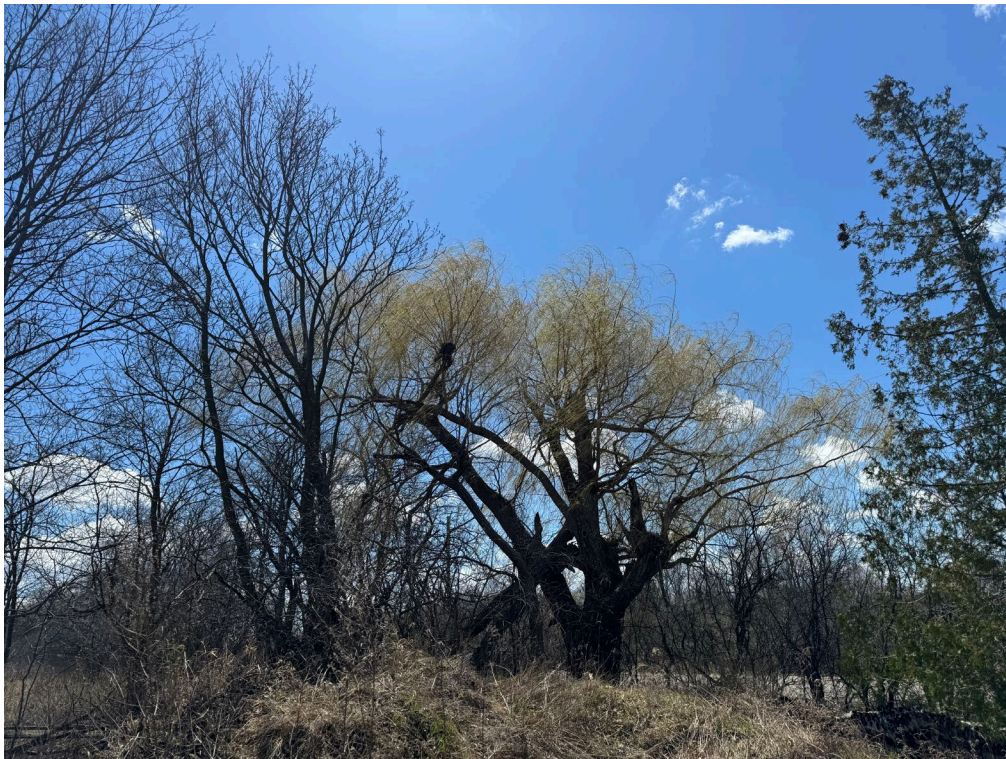
Tree 131

| 131 | Shared (Private and Town) | Willow Sp. | Salix Sp. | 17 | 128 | 5 | F | Typical issues for tree of this species and size, multiple limbs previously failed | Remove due to construction |

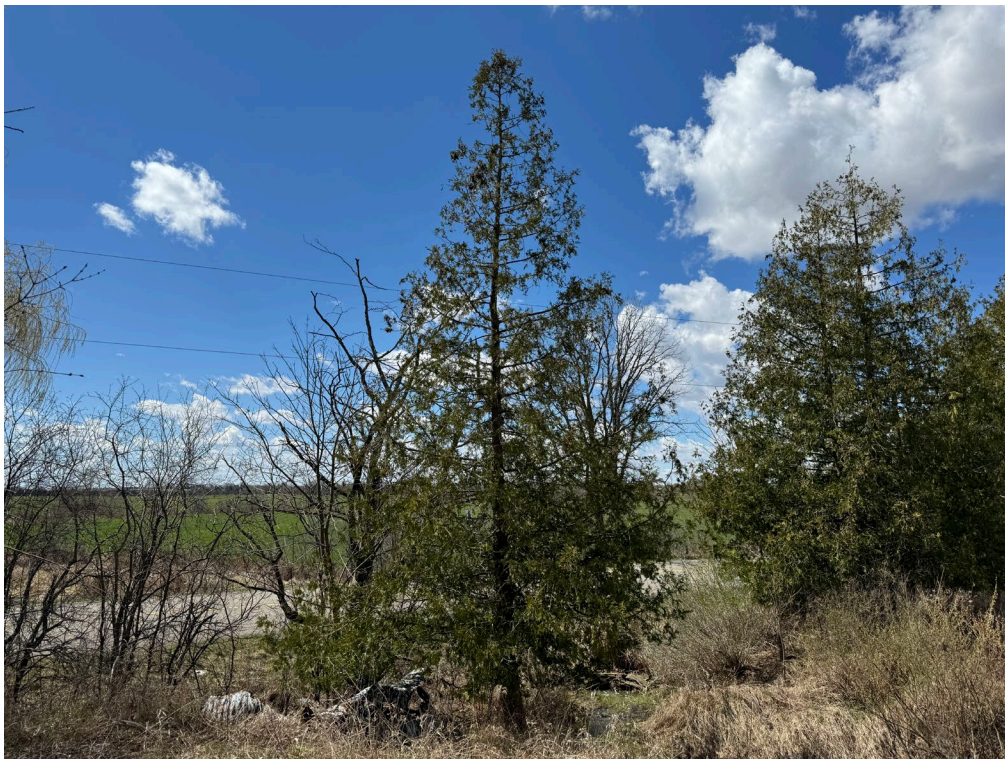
Trees 132 – 134

| 134 | Town | Honey Locust | Gleditsia triacanthos | 7 | 46 | 3 | F/P | Moderate deadwood throughout, imbalanced canopy, multiple limbs previously failed, base of trunk is swallowing fence | Remove due to construction |

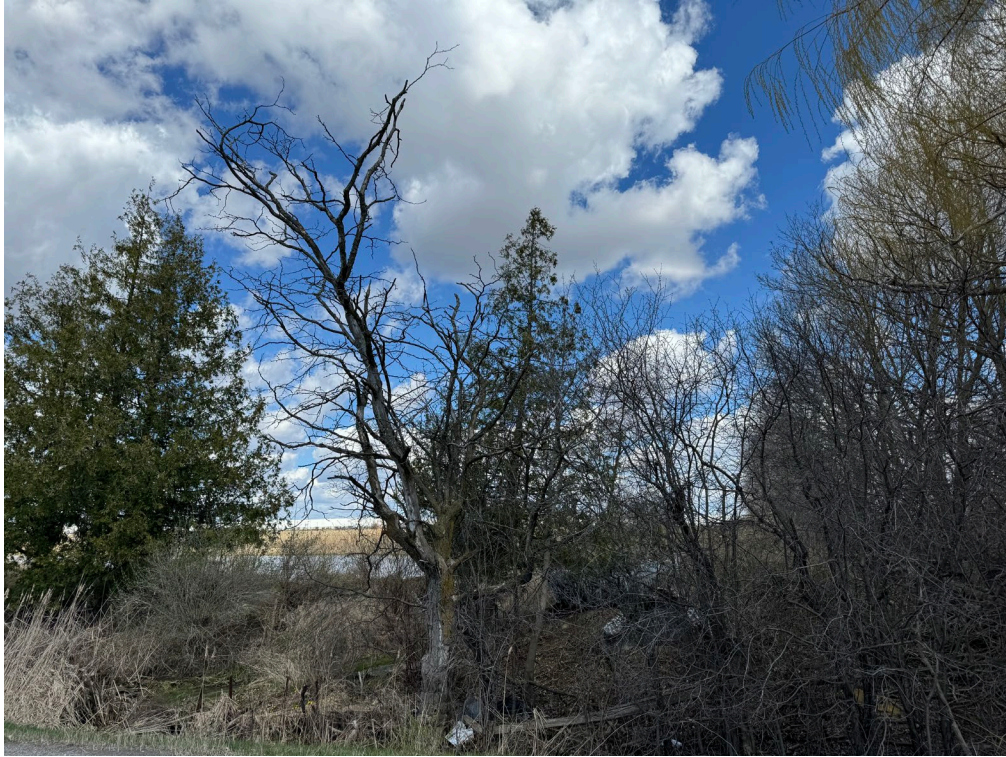
Trees 135 – 138

| 135 | Town | Ash Sp. | Fraxinus Sp. | 3 | 12 | 1 | D | Tree is 100% dead, signs of EAB | Retain |

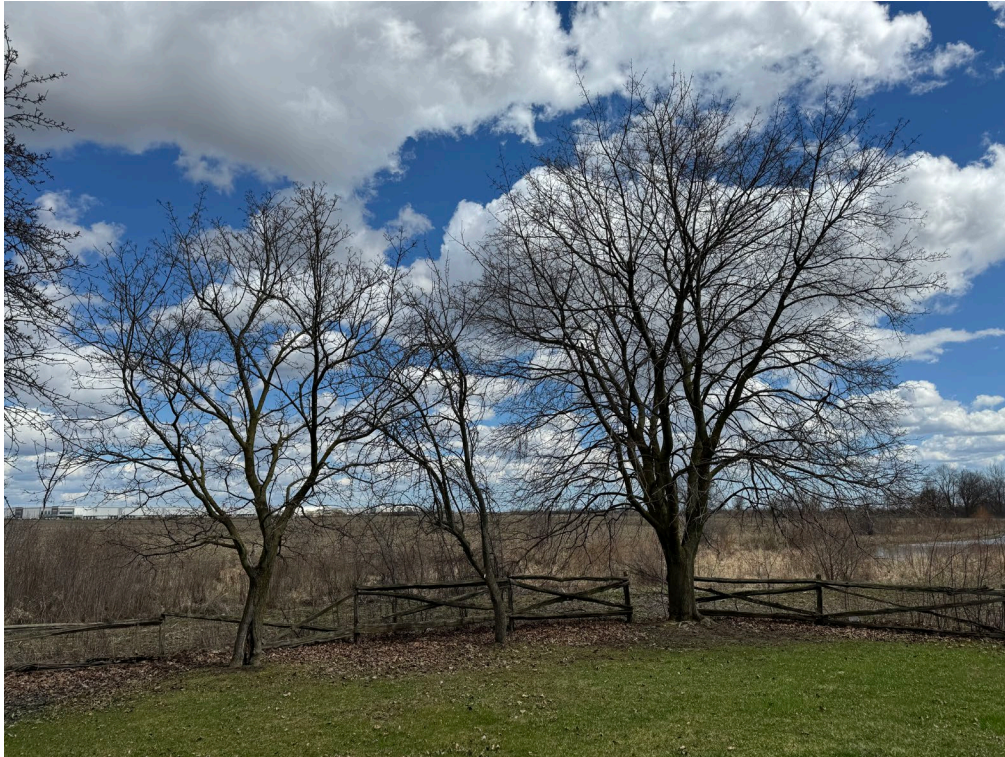
Trees 151 – 155

| 152 | Neighbour | Flowering Crabapple Tree | Malus Sp. | 3 | 17 | 1 | F/P | Contorted limbs, previous limb failures, irregular form, suspected internal rot | Retain |

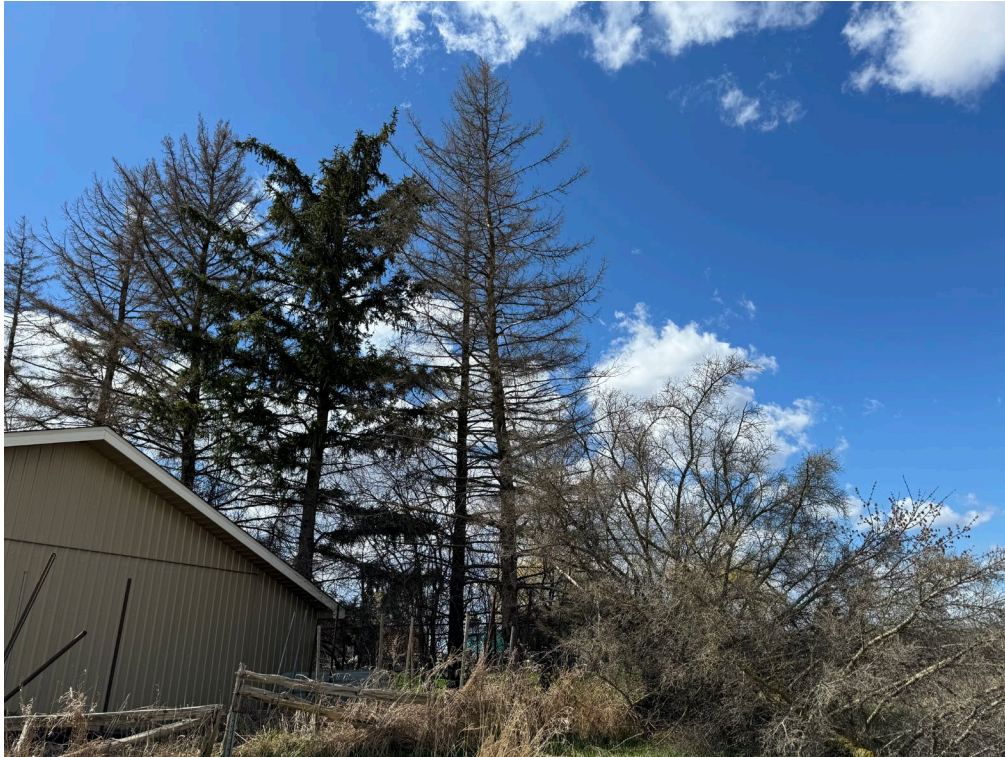
Trees 158, 159

| 158 | Private | Willow Sp. | Salix Sp. | 11 | 39 | 3 | D | Tree is 100% dead | Retain |
| 159 | Private | Willow Sp. | Salix Sp. | 8.5 | 35 | 2 | P/D | 3 stem at 0.4 metres, tree is 85% dead, tree is in severe decline, moderate to significant deadwood throughout, multiple limbs previously failed | Retain |

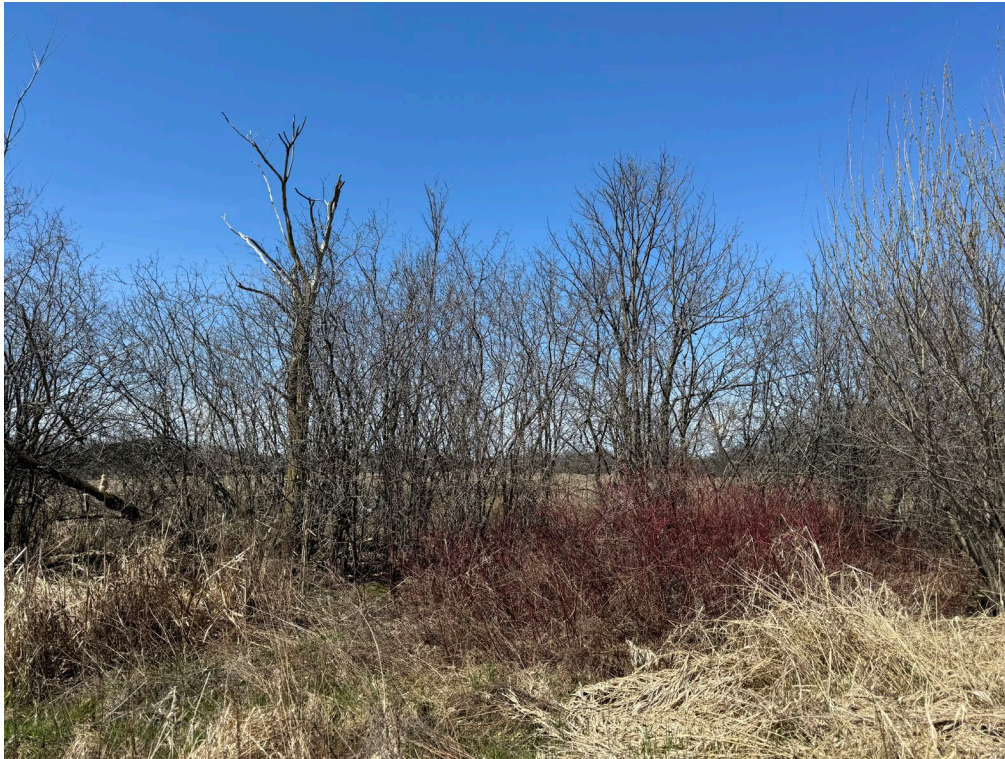
Trees 200 – 205

| 202 | Neighbour | Manitoba Maple | Acer negundo | 4 | 19 | 1 | P | Main leader is dead and previously failed | Retain |

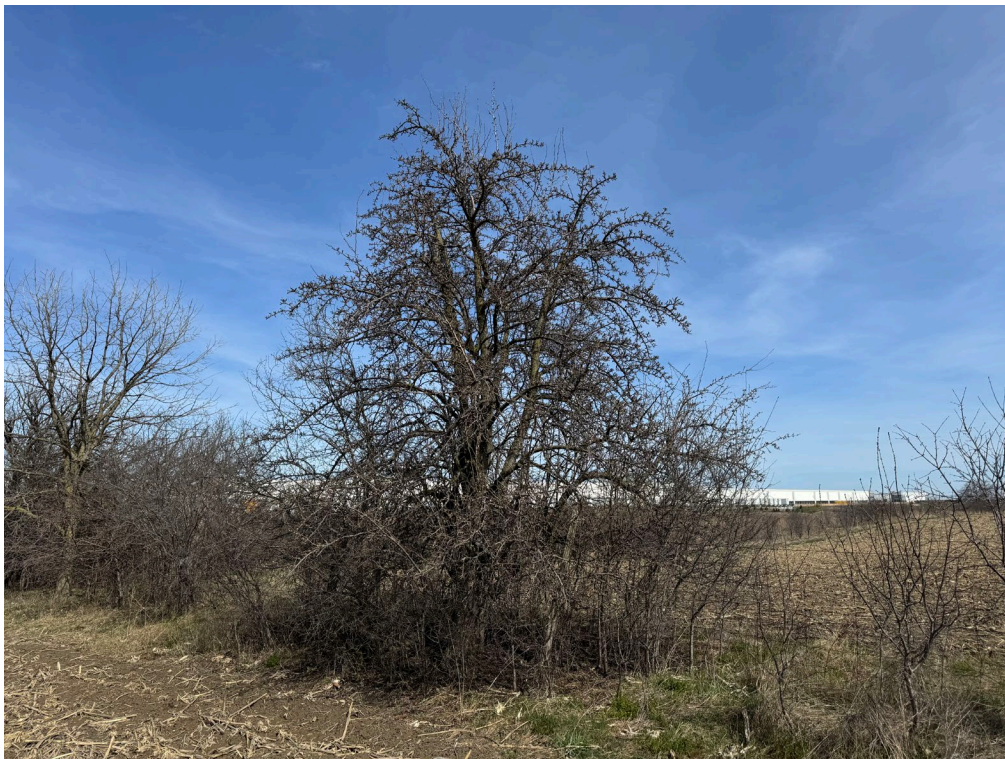
Trees 217, 218

| 217 | Private | Flowering Crabapple Tree | Malus Sp. | 5 | 15 | 1 | F | Multi-stem at base, cavity at base between all stems, main stem previously failed | Remove due to construction |

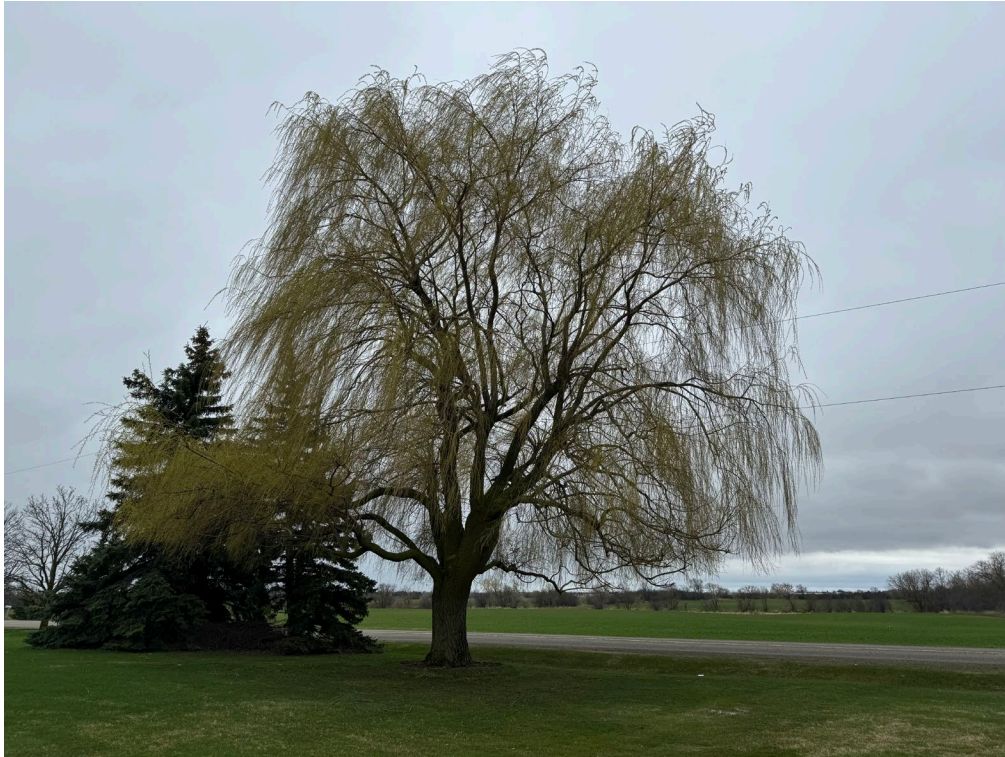
Trees 369 – 377

| 369 | Town | Honey Locust | Gleditsia triacanthos | 3 | 17 | 1 | P | Cavity in trunk, leader previously failed | Remove due to construction |
| 373 | Town | Honey Locust | Gleditsia triacanthos | 2 | 13 | 1 | P | Cavity in trunk, signs of internal rot | Remove due to construction |

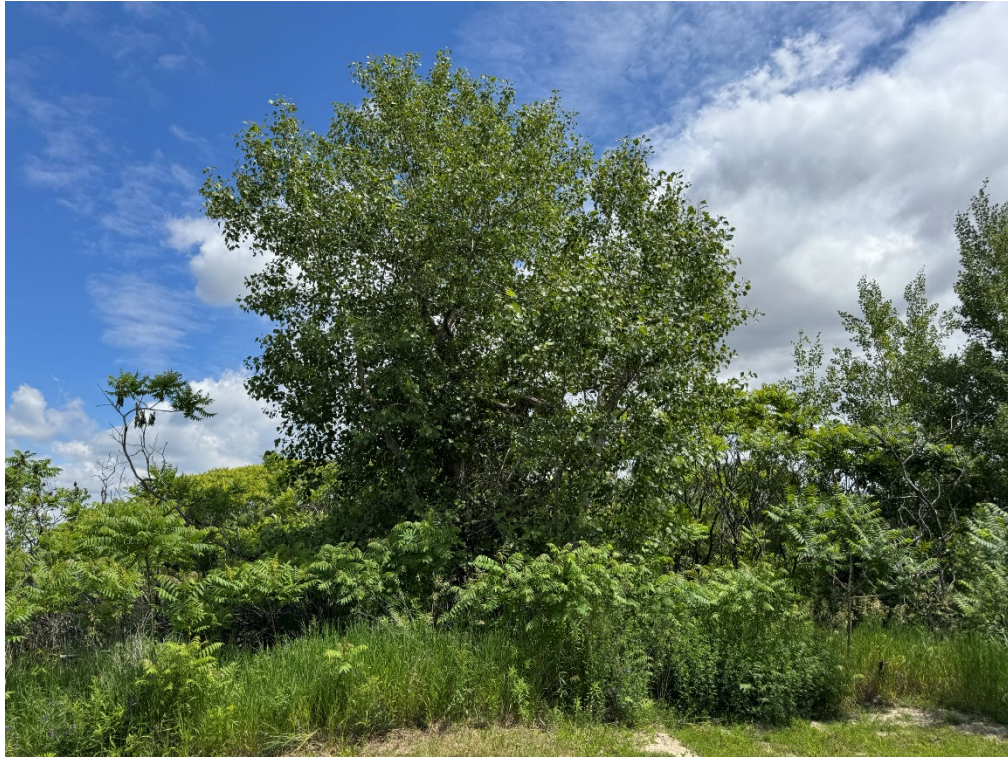
Tree 717

| 717 | Private | Poplar Sp. | Populus Sp. | 8 | 44 | 3 | Fair - Poor | Multiple previous limb failures evident | Remove due to construction |
