ARBORIST REPORT

12544 HIGHWAY 50,
Bolton, Ontario

BTEC File #: 6452-0002

Date: Nov. 19 2015

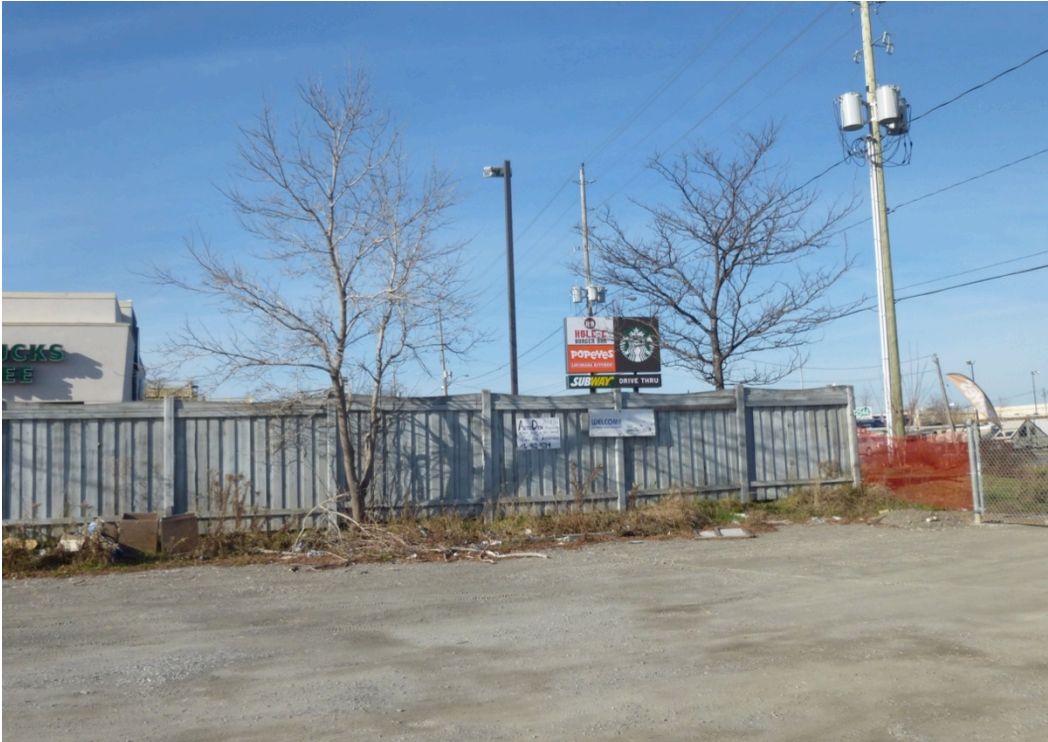
Photo 1. Tree 01 behind fence and Tree 02 in front of fence on subject site.

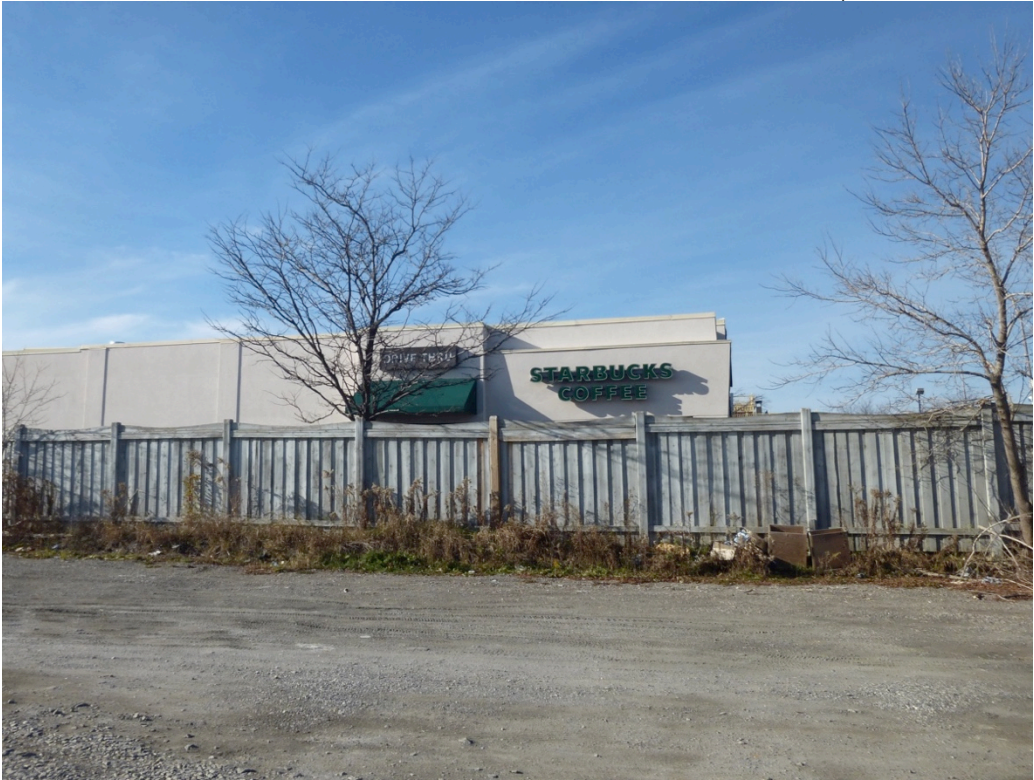
Photo 2. Tree 03, behind fence and Tree 02 (far right).

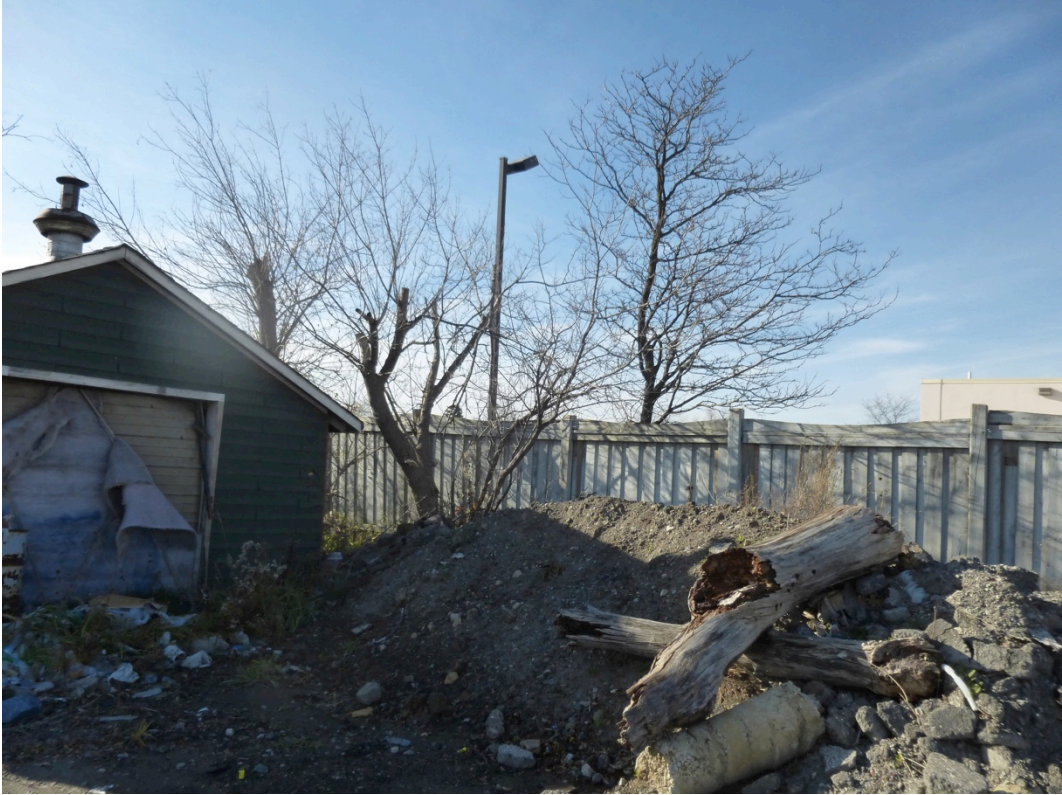
Photo 3. Trees 04 (behind fence), 05 and 06.

5	<i>Acer platanoides</i> (Manitoba maple)	31, 7, 7, 5	5	Poor	Growing within 10cm of fence; topped in past; large mushrooms in trunk; lean to south.	NA	Private, Subject site	Remove
6	<i>Acer platanoides</i> (Manitoba maple)	27.5	3	Poor	Topped; trunk on minor lean to east; growing at base of shed; poor structure; fair health.	NA	Private, Subject site	Remove
7	<i>Acer platanoides</i> (Manitoba maple)	12, 8.5	5	Poor	Codominant stems at ground level; within 10cm of fence; poor trunk structure; fair to poor crown structure; good health.	NA	Private, Subject site	Remove
8	<i>Acer saccharinum</i> (silver maple)	75	6	Poor	Advanced decline; large diameter cavities (20cm diameter) on east, west and south sides of trunk; leader dead; 15cm diameter dead limb extending south; 15% live crown.	NA	Private, Subject site	Remove
9	<i>Acer platanoides</i> (Manitoba maple)	21	4	Poor	10% live crown; main stem dead with suckering at base; slight lean to west.	NA	Private, Adjacent	Remove

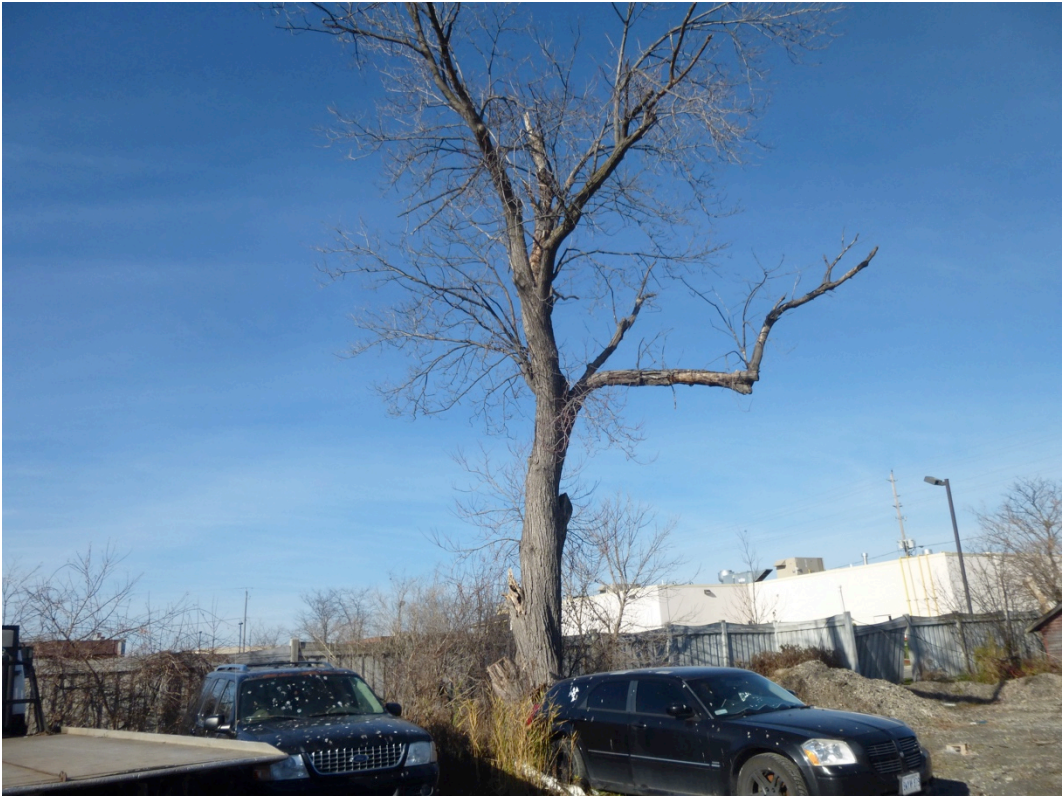
Photo 4. Tree 08.

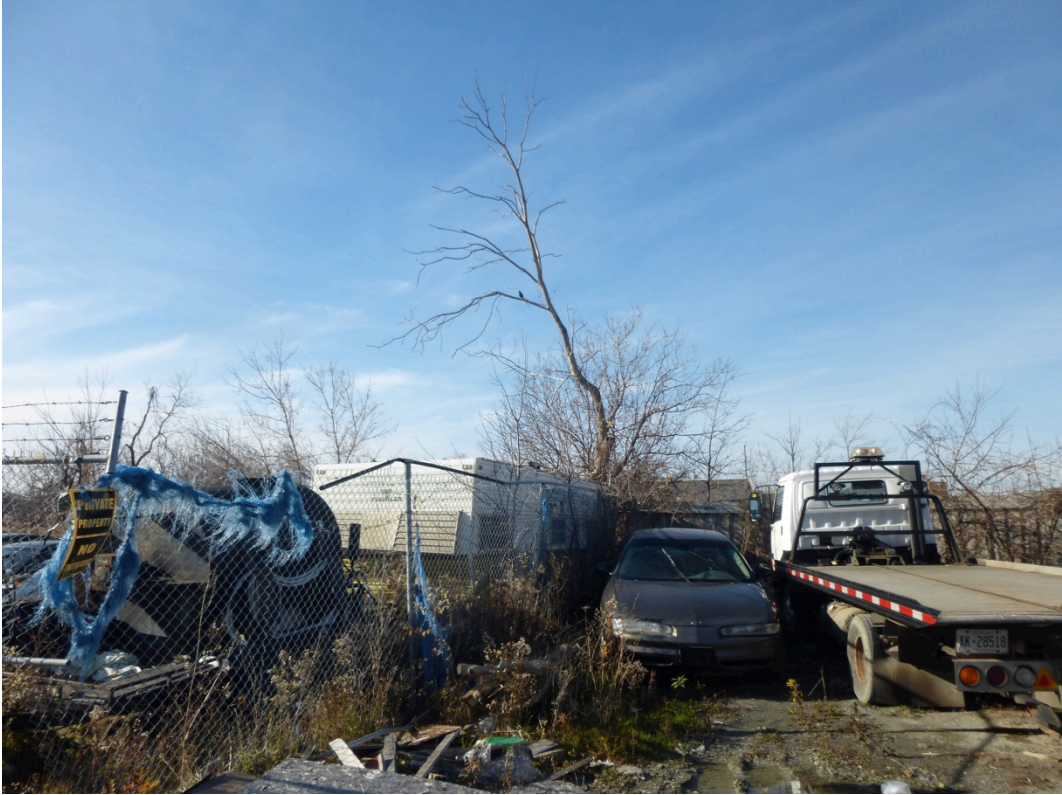
Photo 5. Tree 09, leader is dead.

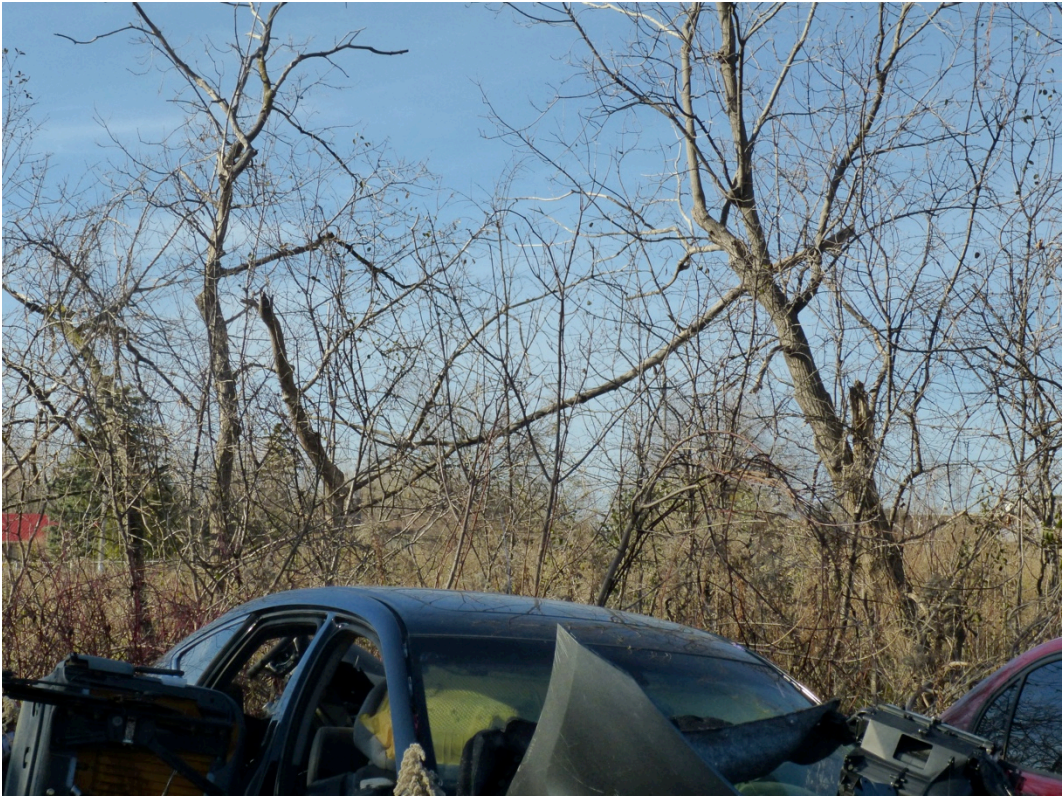
Photo 6. Trees 10 and 11.

10	<i>Acer platanoides</i> (Manitoba maple)	15-20	5	Poor	Multiple branch tear outs; poor structure; poor health.	NA	Private, Adjacent	Preserve
11	<i>Acer platanoides</i> (Manitoba maple)	30-35	6	Poor	Advanced decline; 20% live crown; multiple branch tear outs; trunk decay.	NA	Private, Adjacent	Preserve
12	<i>Salix</i> sp. (willow)	72, 50-60 x2, 40-50 x2	15	Fair - Poor	Growing at edge of pond with base of trunk partially submerged; multiple stems; debris piled to east; multiple broken branches up to 10cm diameter; fair health.	15	Private, Subject site	Preserve
13	<i>Acer platanoides</i> (Manitoba maple)	26.5, 20	6	Poor	Codominant stems at 1.2m with included bark; poor health.	NA	Private, Subject site	Remove
14	<i>Acer platanoides</i> (Manitoba maple)	27, 25, 24	8	Poor	Codominant at ground level with included bark; fourth stem decaying; poor structure; fair health.	NA	Private, Subject site	Remove

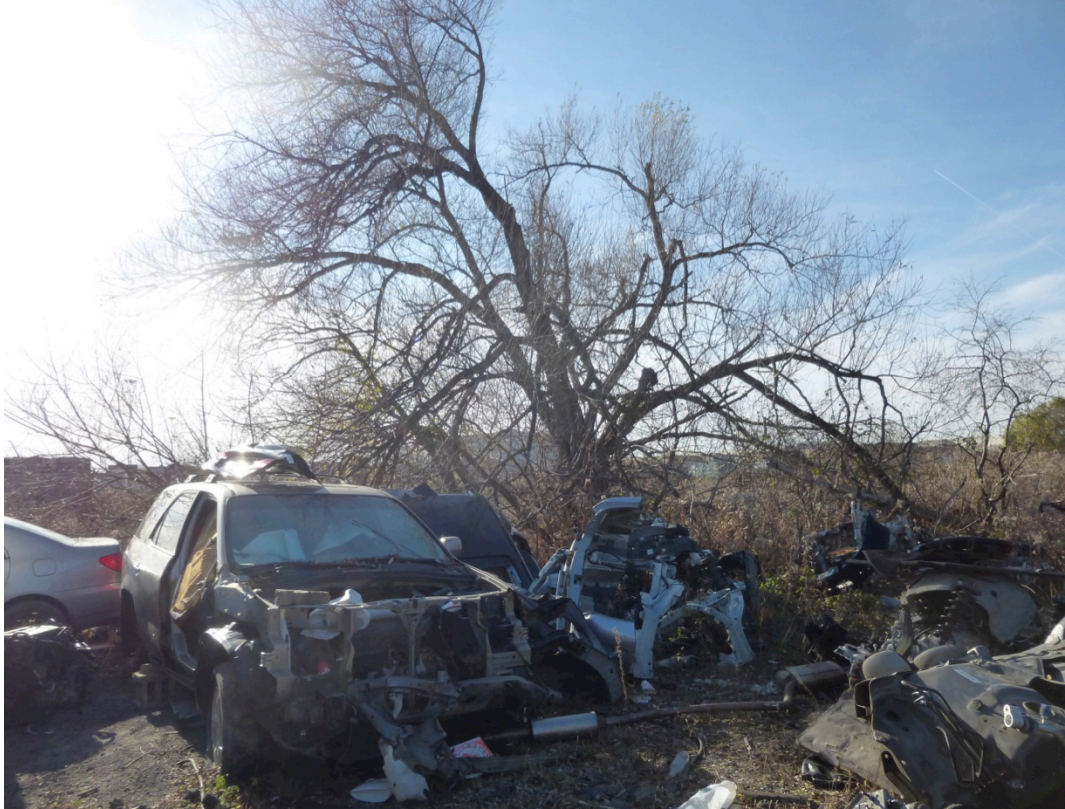
Photo 7. Tree 12.

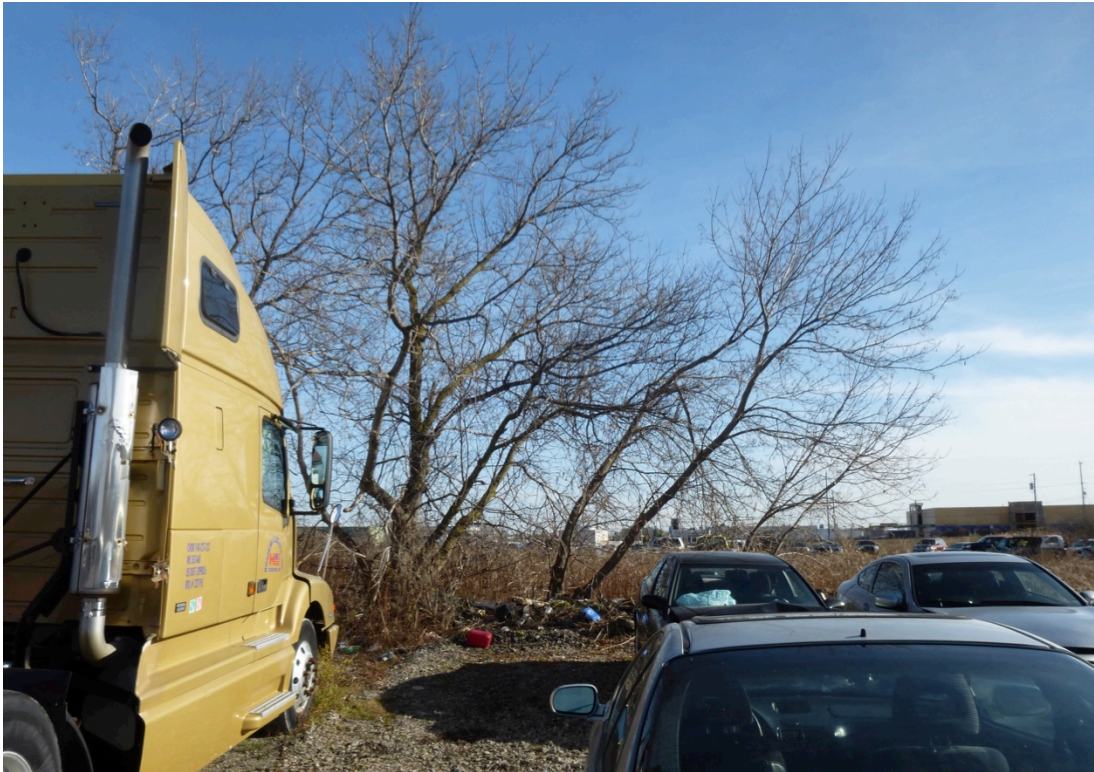
Photo 8. Trees 15 and 16.

15	<i>Acer platanoides</i> (Manitoba maple)	16, 14	5	Poor	Growing through page wire fence; leaning to west away from T16; poor structure; fair health.	NA	Private, Adjacent	Remove
16	<i>Acer platanoides</i> (Manitoba maple)	41, 17, 14, 13	12	Poor	Growing through page wire fence; codominant stems at ground with included bark; on lean to south; mushrooms on main stem; poor structure; fair to poor health.	NA	Private, boundary	Remove
17	<i>Acer platanoides</i> (Manitoba maple)	38, 33	8	Poor	Codominant stems with included bark; mushrooms from trunk; multiple branch tearouts; brush piled at base.	NA	Private, boundary	Remove
18	<i>Acer platanoides</i> (Manitoba maple)	44, 36	10	Poor	Growing from dirt mound; 50% crown tear out; multiple suckers; poor structure; fair vitality.	NA	Private, Subject site	Remove
19	<i>Acer platanoides</i> (Manitoba maple)	15-20	4	Poor	Growing approx. 1m from bottom of mound; lean to south away from T18.	NA	Private, Adjacent	Remove

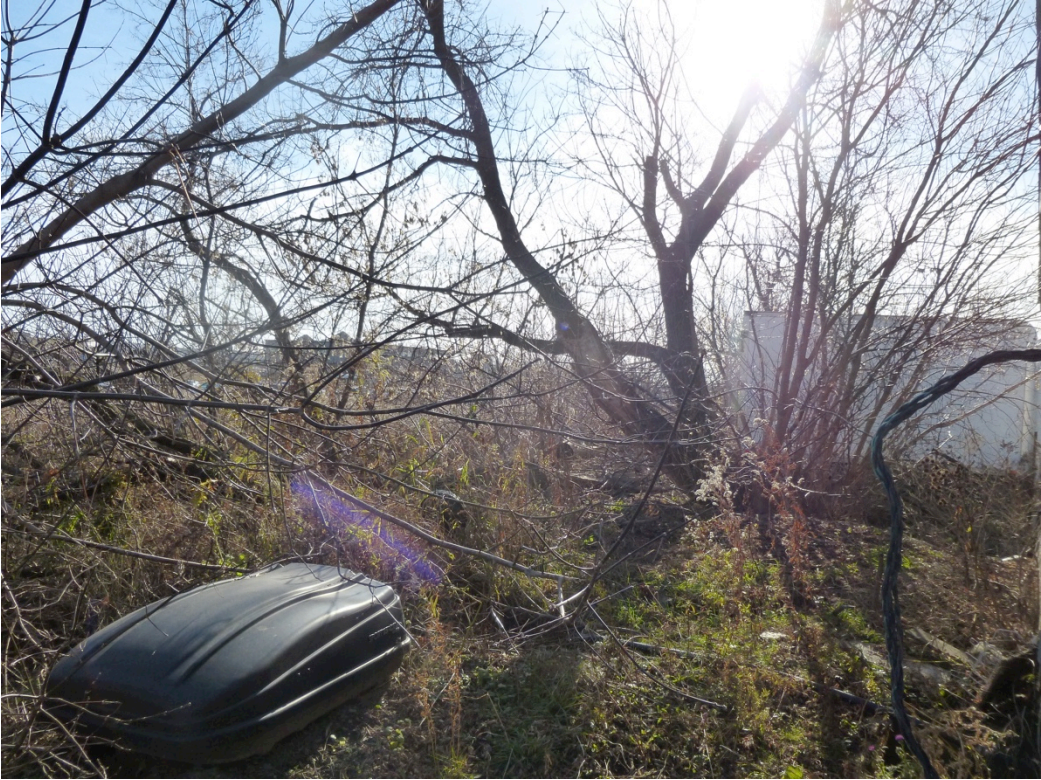
Photo 9. Tree 21.

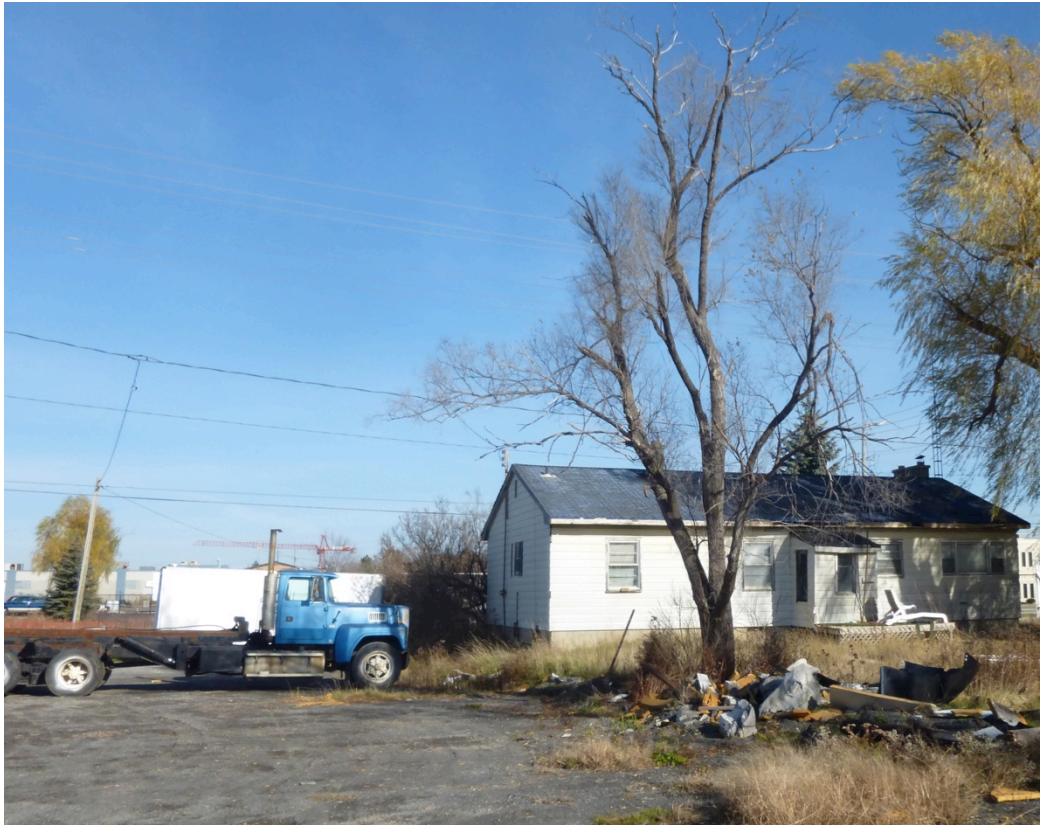
Photo 10. Tree 25.
