ARBORIST REPORT

Location:	13291 Airport Road, Caledon
Project:	Truck Trailer Parking
Project No:	GPI037
Prepared by:	Ning Huang, OALA CSLA ISA Certified Arborist (ON-1381A) The MBTW Group T: (416) 449-7767 Email: ning@mbtw.com 255 Wicksteed Avenue, Unit 1A Toronto, Ontario, M4H 1G8
Date Issued:	April 07, 2025

MBTW has been retained to prepare an Arborist Report for a proposed truck trailer parking located at 13291 Airport Road in the Town of Caledon. The purpose of this report is to assess the existing tree population on-site and adjacent areas, evaluate potential impacts from the proposed development, and provide recommendations for tree preservation, removal, and compensation in accordance with the Town of Caledon's guidelines.

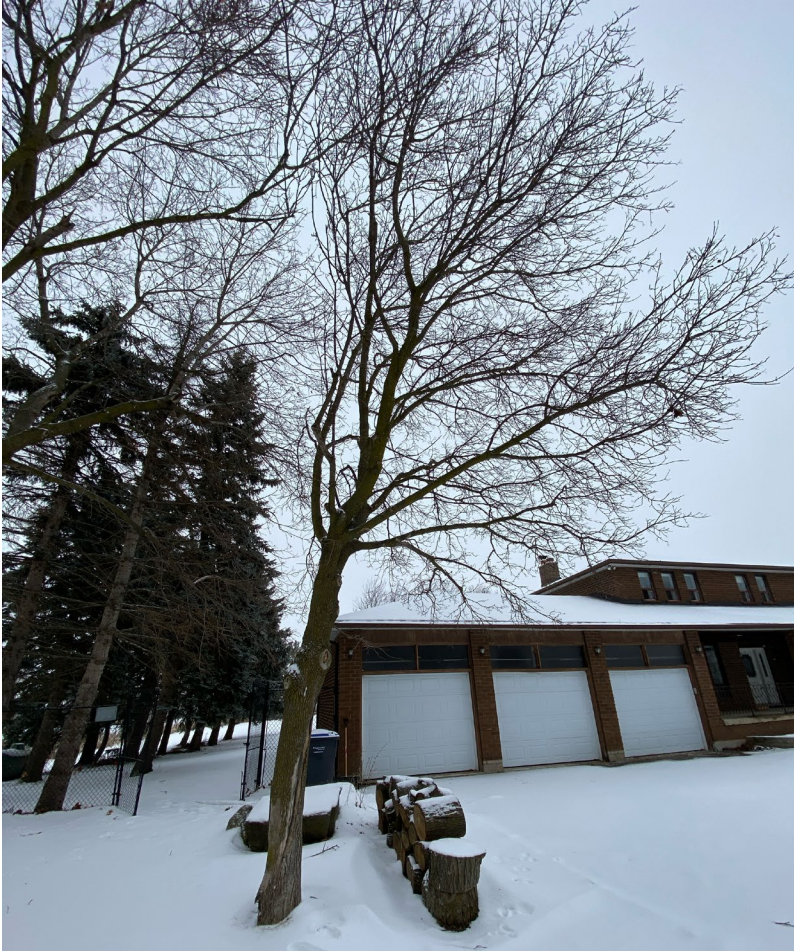
Tree with Tag # 16

ZONE 1 ALONG THE ENTRY ROAD									
TAG #	SPECIES	DBH	Canopy	TPZ	COND.	OWN.	Remarks	Recommendation	compensation
16	<i>Acer platanoides</i> (Norway Maple)	29	7	1.8	Fair	1	A vertical scar on the lower trunk. In conflict with the proposed development	Remove	2
17	<i>Acer platanoides</i> (Norway Maple)	49	12	3.0	Good	1	In conflict with proposed construction	Remove	3
18	<i>Acer platanoides</i> (Norway Maple)	34	8	2.4	Good	1		Preserve	
19	<i>Acer platanoides</i> (Norway Maple)	58	15	3.6	Poor	1	Truck injured.	Preserve	
20	<i>Picea pungens</i> (Colorado Spruce)	35	8	2.4	Poor	1	many yellowing needles.	Preserve	
21	<i>Picea pungens</i> (Colorado Spruce)	28	7	1.8	Good	1		Preserve	
22	<i>Picea pungens</i> (Colorado Spruce)	29	7	1.8	Fair	1		Preserve	
23	<i>Picea pungens</i> (Colorado Spruce)	19	5	1.8	Good	1		Preserve	
24	<i>Picea pungens</i> (Colorado Spruce)	30	9	2.4	Poor	1	many yellowing needles.	Preserve	
25	<i>Picea pungens</i> (Colorado Spruce)	45	12	3.0	Good	1		Preserve

- Norway Maple (Tag #16, 17, 403, 404, 416-417)
- Colorado Spruce (Tag # 101-115, 174, 176, 432-433)
- Willow (Tag #175, 409, 410)
- Linden (Tag #405, 408)
- Austrian Pine (Tag #198-200, 406-407)
- Red Maple (Tag #415, 418)
- Manitoba Maple (Tag #163, 168)
- Hawthorn (Tag #164, 166, 169)

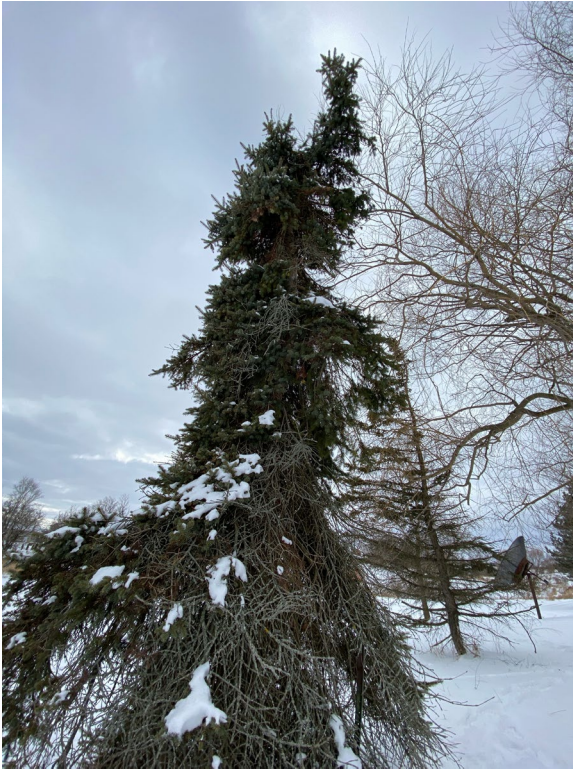
Tree with Tag #174

174	<i>Picea pungens</i> (Colorado Spruce)	20	4	1.8	Good	1		Remove	1
175	<i>Salix</i> sp. (Willow species)	40/40/50/60	NA	3.6	Good	1	Multistem. In conflict with proposed construction	Remove	4
176	<i>Picea pungens</i> (Colorado Spruce)	20	3	1.8	Fair	1	In conflict with proposed construction	Remove	1
177	<i>Picea pungens</i> (Colorado Spruce)	25	4	1.8	Fair	1		Preserve	
178	<i>Picea pungens</i> (Colorado Spruce)	38	8	2.4	Good	1		Preserve	
179	<i>Picea pungens</i> (Colorado Spruce)	39	9	2.4	Fair	1		Preserve	
180	<i>Picea pungens</i> (Colorado Spruce)	11	2	1.8	Fair	1		Preserve	
181	<i>Picea pungens</i> (Colorado Spruce)	22	4	1.8	Fair	1		Preserve	
182	<i>Acer platanoides</i> (Norway Maple)	19	5	1.8	Good	1		Preserve	
183	<i>Acer platanoides</i> (Norway Maple)	28	4	1.8	Good	1		Preserve	
184	<i>Picea pungens</i> (Colorado Spruce)	20	2	1.8	Poor	1		Preserve	
185	<i>Salix</i> sp. (Willow species)	60	10	3.6	Fair	1	Preserve with injury.	Preserve

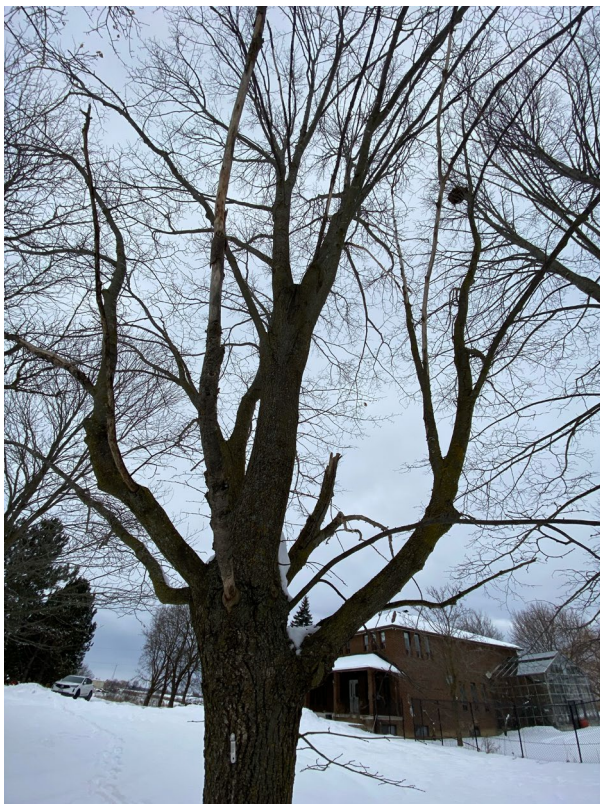
Tree with Tag #409

TAG #	SPECIES	DBH	Canopy	TPZ	COND.	OWN.	Remarks	Recommendation	compensation
408	<i>Tilia</i> sp. (Linden species)	59	9	3.6	Good	1	In conflict with proposed construction	Remove	4
409	<i>Salix</i> sp. (<i>Willow species</i>)	65	10	4.2	Poor	1	Dead branches. In conflict with proposed construction	Remove	4
410	<i>Salix</i> sp. (<i>Willow species</i>)	99	15	6.0	Fair	1	In conflict with proposed construction	Remove	5
411	<i>Salix</i> sp. (<i>Willow species</i>)	92	14	6.0	Fair	1	Preserve with injury.	Preserve	
412	<i>Pinus nigra</i> (Austian Pine)	30	4	2.4	Good	1		Preserve	
413	<i>Pinus nigra</i> (Austian Pine)	30	4	2.4	Good	1		Preserve	
414	<i>Pinus nigra</i> (Austian Pine)	28	4	1.8	Good	1		Preserve	
415	<i>Acer rubrum</i> (Red Maple)	39	6	2.4	Good	1	In conflict with proposed construction	Remove	3
416	<i>Acer platanoides</i> (Norway Maple)	50	8	3.0	Good	1	In conflict with proposed construction	Remove	3
417	<i>Acer platanoides</i> (Norway Maple)	38	7	2.4	Good	1	In conflict with proposed construction	Remove	3

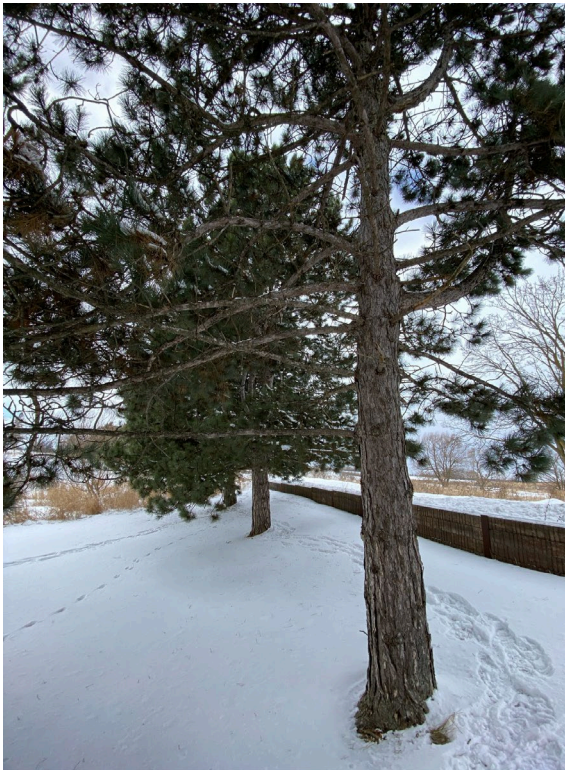
Tree with Tag # 200

200	<i>Pinus nigra</i> (Austrian Pine)	42	6	3.0	Fair	1	In conflict with proposed construction	Remove	3
246	<i>Pinus nigra</i> (Austrian Pine)	37	6	2.4	Good	1		Preserve	
ZONE 3 BACKYARD									
404	<i>Acer platanoides</i> (Norway Maple)	22	4	1.8	Good	1	In conflict with proposed construction	Remove	2
405	<i>Tilia</i> sp. (Linden species)	53	8	3.6	Good	1	In conflict with proposed construction	Remove	4
406	<i>Pinus nigra</i> (Austrian Pine)	30	4	2.4	Fair	1	In conflict with proposed construction	Remove	2
407	<i>Pinus nigra</i> (Austrian Pine)	18	2	1.8	Fair	1	In conflict with proposed construction	Remove	1

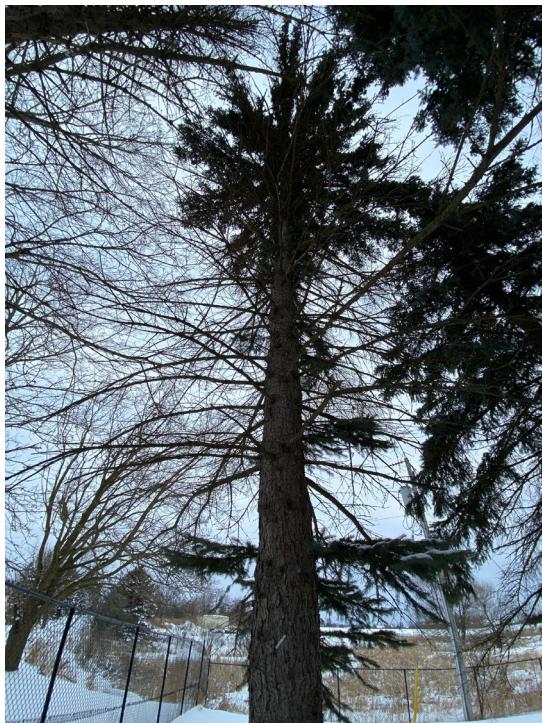
Tree with Tag # 432

418	<i>Acer rubrum</i> (Red Maple)	45	9	3.0	Good	1	In conflict with proposed construction	Remove	3
432	<i>Picea pungens</i> (<i>Colorado Spruce</i>)	48	9	3.0	Good	1	In conflict with proposed construction	Remove	3
433	<i>Picea pungens</i> (<i>Colorado Spruce</i>)	35	6	2.4	Good	1	In conflict with proposed construction	Remove	2
434	<i>Picea pungens</i> (<i>Colorado Spruce</i>)	40	8	2.4	Good	1	Preserve with injury.	Preserve	
435	<i>Picea pungens</i> (<i>Colorado Spruce</i>)	34	6	2.4	Good	1	Preserve with injury.	Preserve	
436	<i>Picea pungens</i> (<i>Colorado Spruce</i>)	41	7	3.0	Good	1		Preserve	
437	<i>Picea pungens</i> (<i>Colorado Spruce</i>)	34	6	2.4	Good	1	Preserve with injury.	Preserve	
438	<i>Picea pungens</i> (<i>Colorado Spruce</i>)	35	6	2.4	Good	1		Preserve	
439	<i>Picea pungens</i> (<i>Colorado Spruce</i>)	20	4	1.8	Good	1		Preserve	
440	<i>Picea pungens</i> (<i>Colorado Spruce</i>)	42	8	3.0	Good	1		Preserve

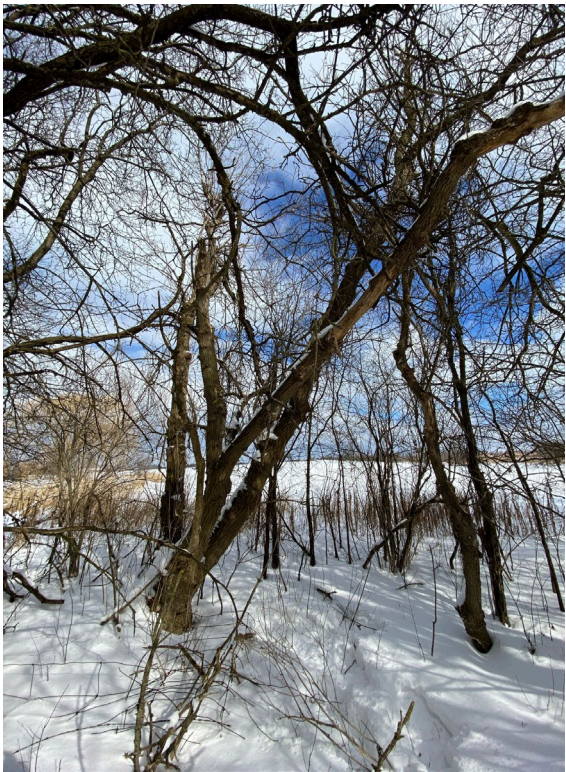
Tree with Tag # 163

163	<i>Acer negundo</i> (Manitoba Maple)	22	4	1.8	Poor	1	In conflict with proposed construction	Remove	2
164	<i>Crataegus</i> sp. (Hawthorn)	20/16/18	4	2.4	Fair	1	Multistem. In conflict with proposed construction	Remove	1
165	<i>Crataegus</i> sp. (Hawthorn)	10/13/10	4	1.8	Good	1	Multistem.	Preserve	
166	<i>Crataegus</i> sp. (Hawthorn)	12/15/18/1 0	2	1.8	Good	1	Multistem. In conflict with proposed construction	Remove	1
167	<i>Crataegus</i> sp. (Hawthorn)	19	4	1.8	Fair	1		Preserve	
168	<i>Acer negundo</i> (Manitoba Maple)	20	4	1.8	Good	1	In conflict with proposed construction	Remove	1
169	<i>Malus</i> sp.(Apple species)	30/20/25/2 2/10	6	2.4	Good	1	Multistem. In conflict with proposed construction	Remove	2
170	<i>Ulmus americana</i> (American Elm)	12/11/10	2	1.8	Good	1	Multistem	Preserve	
171	<i>Ulmus americana</i> (American Elm)	20	3	1.8	Good	1		Preserve	
172	<i>Ulmus americana</i> (American Elm)	39	5	2.4	Good	1	Preserve with injury.	Preserve
