Geotechnical Investigations And Slope Stability Analysis Final Report

6600 Mayfield Rd,
Brampton, ON

Khalsa Gurmat Academy Toronto

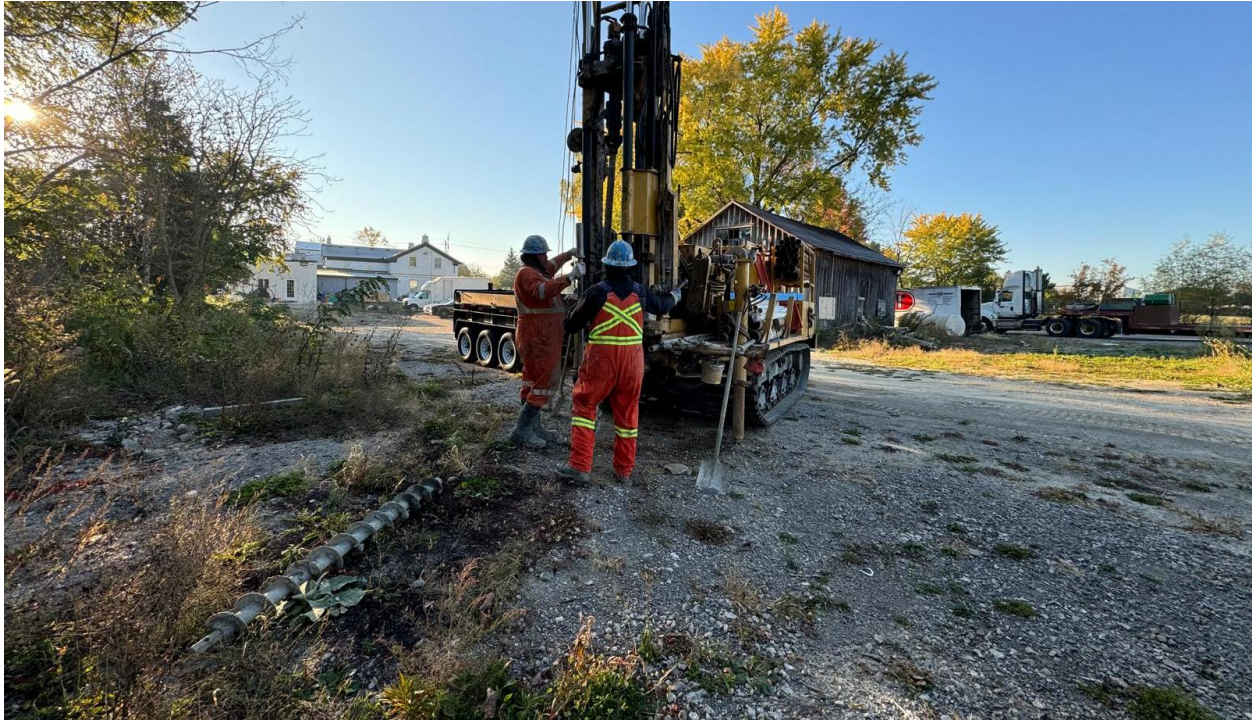
Figure 1-1: Site condition (borehole BH1) – Facing southeast.

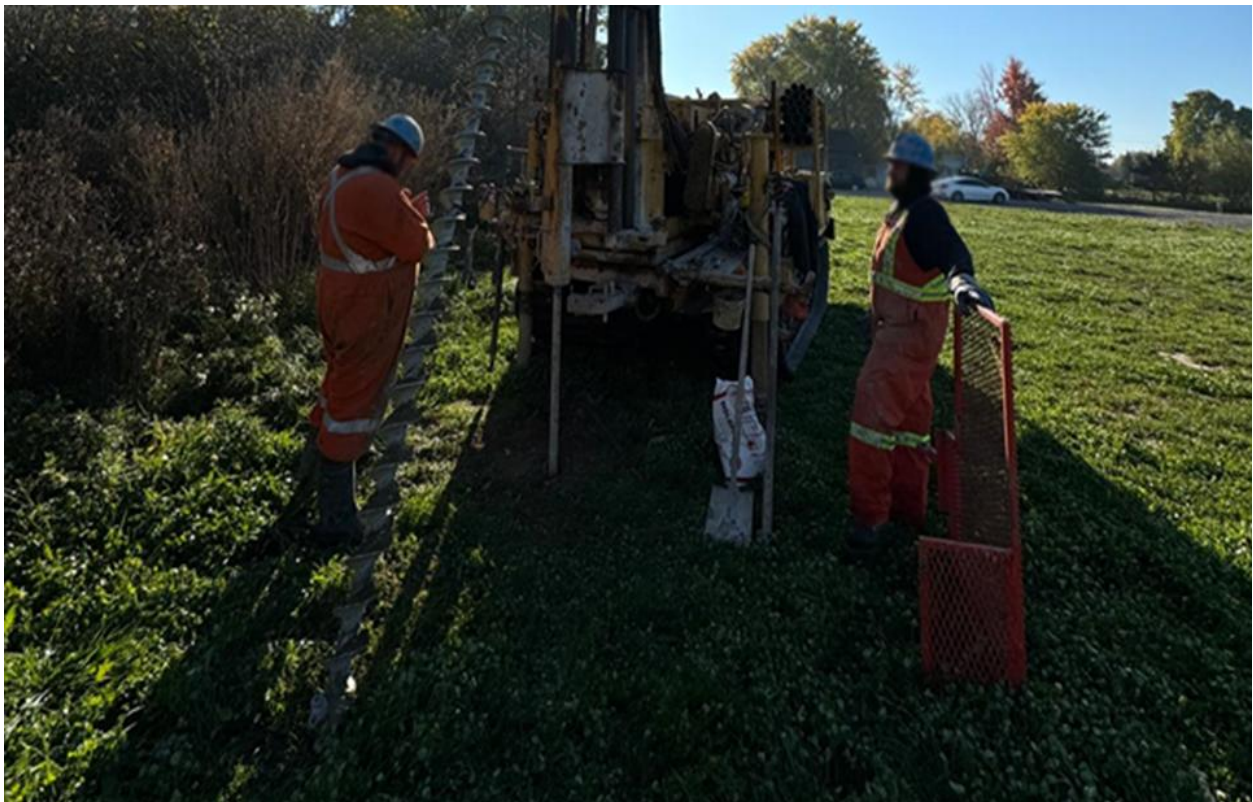
Figure 1-2: Drilling Area (borehole BH2) – Facing southeast.

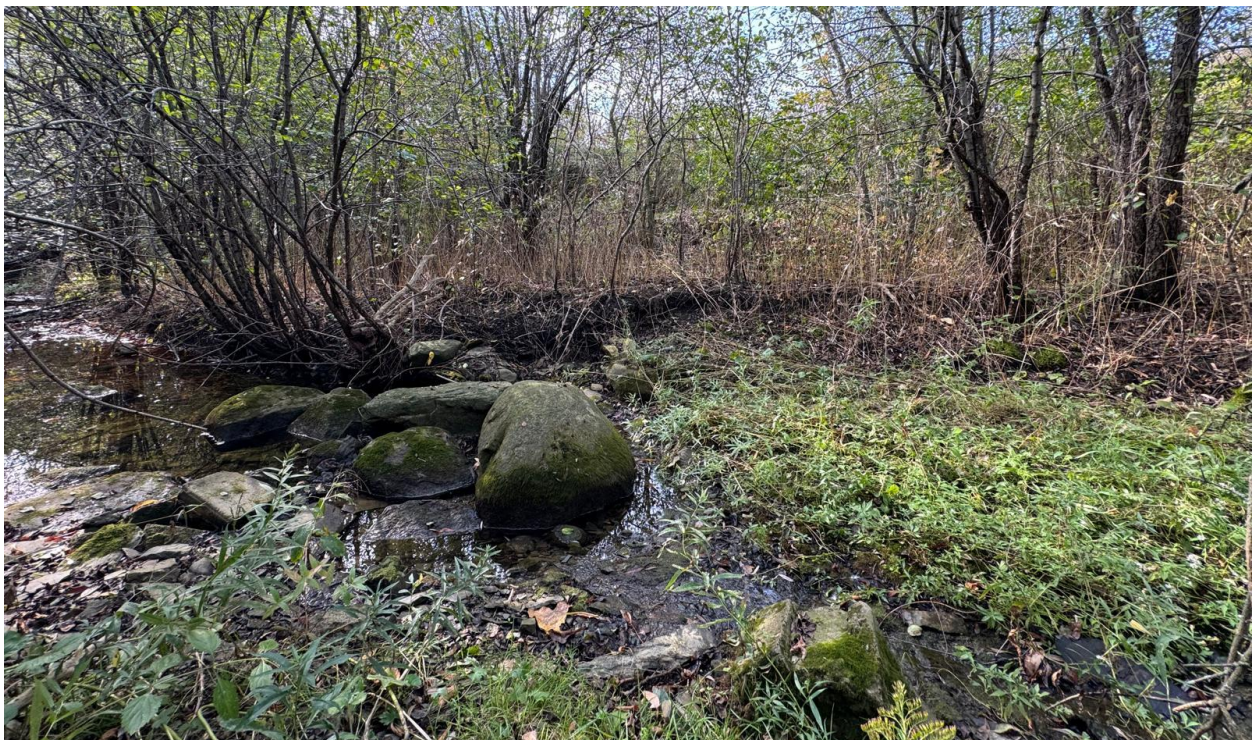
The visual examination of the slope's *toe and face* did not reveal evidence of active erosion, nor signs of slope instabilities or failures, such as tension cracks, slope movements, soil creep, bulging, heave, or subsidence. However, signs of failure were visible at the top of the slope at all cross-sections, where the fill material had slightly bulged and started creeping downward.

During the inspection, the slope area was dry with no visible water seepage or previous seepage paths.

Figure 8-1: Creek at cross-section A-A` - Facing southeast.

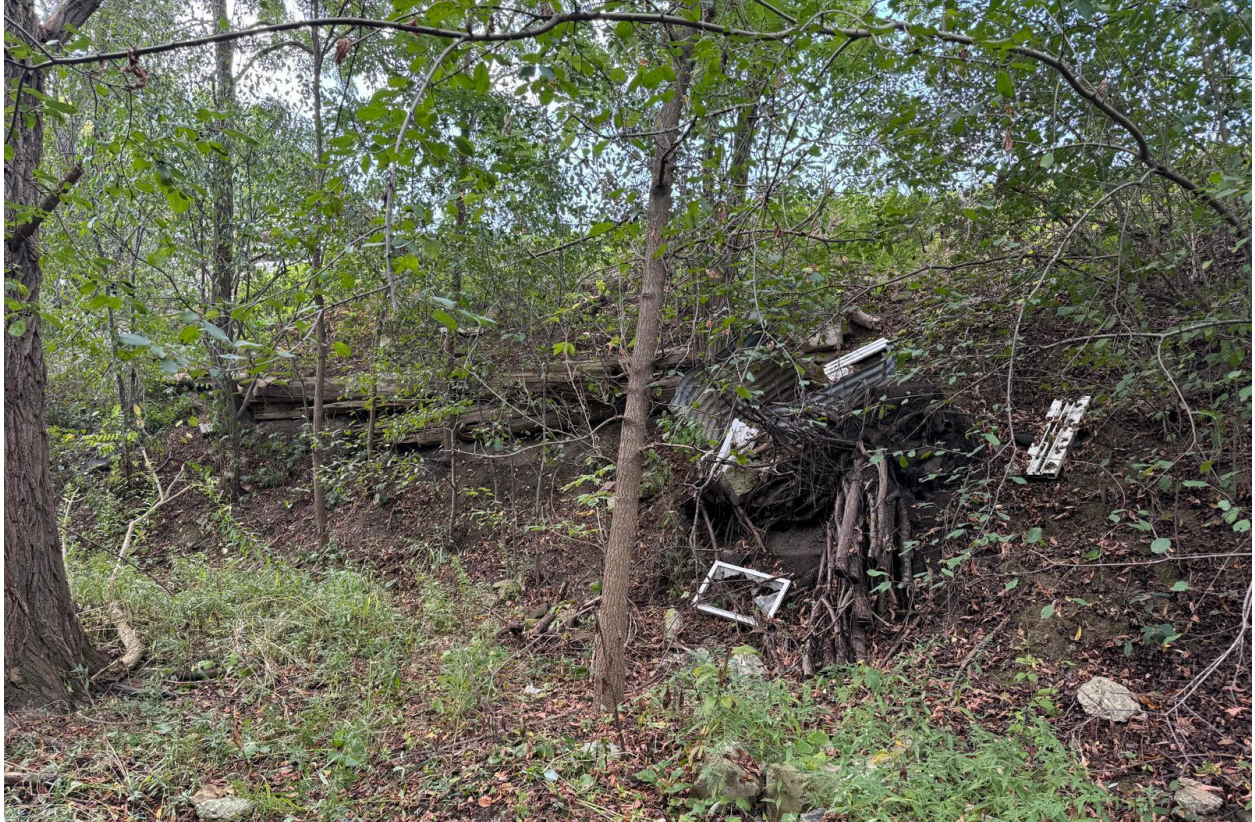
Figure 8-2: At cross-section B-B` - Facing southeast.

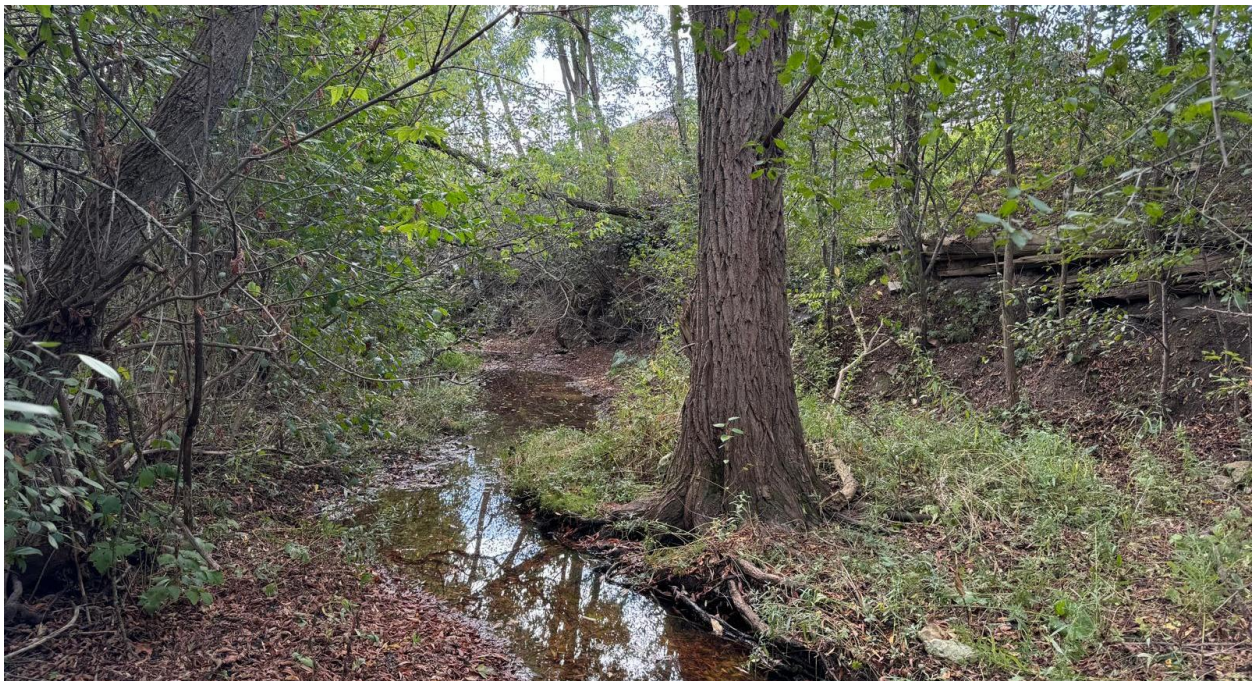
Figure 8-3: Creek at cross-section B-B` - Facing southeast.

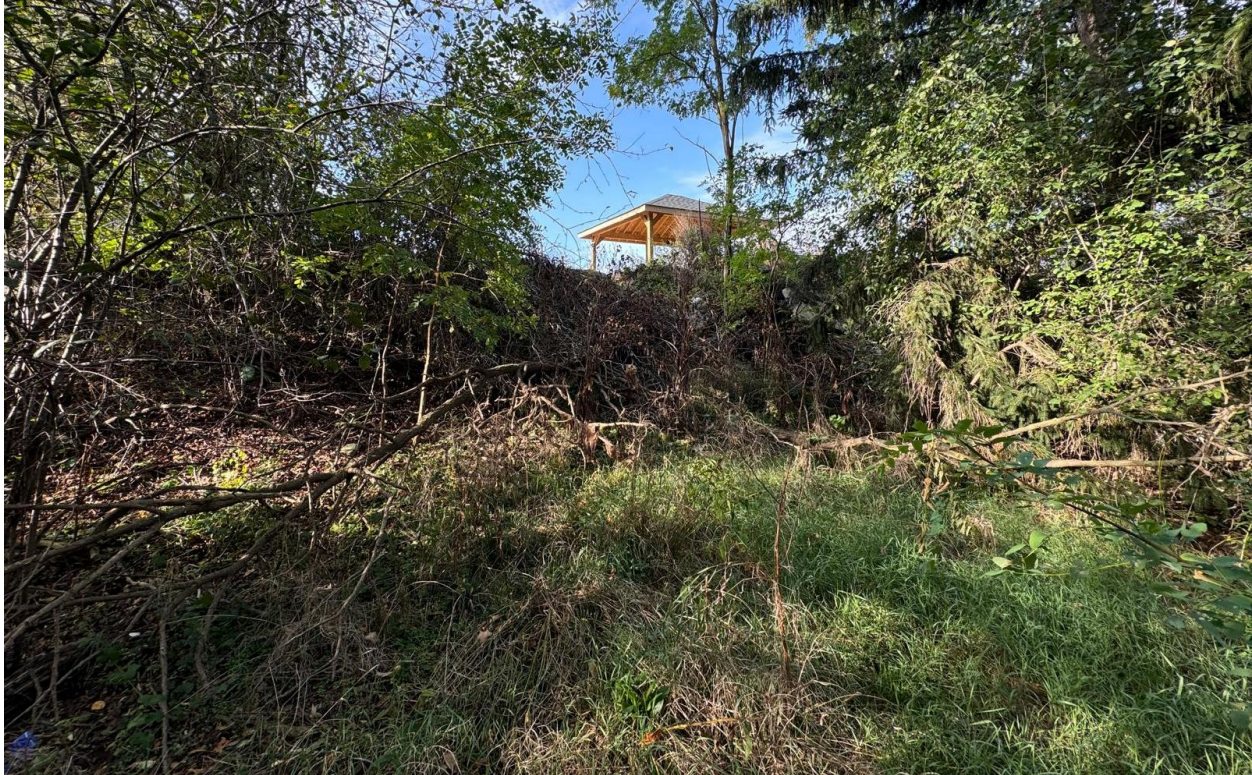
Figure 8-4: At cross-section C-C` - Facing southwest.

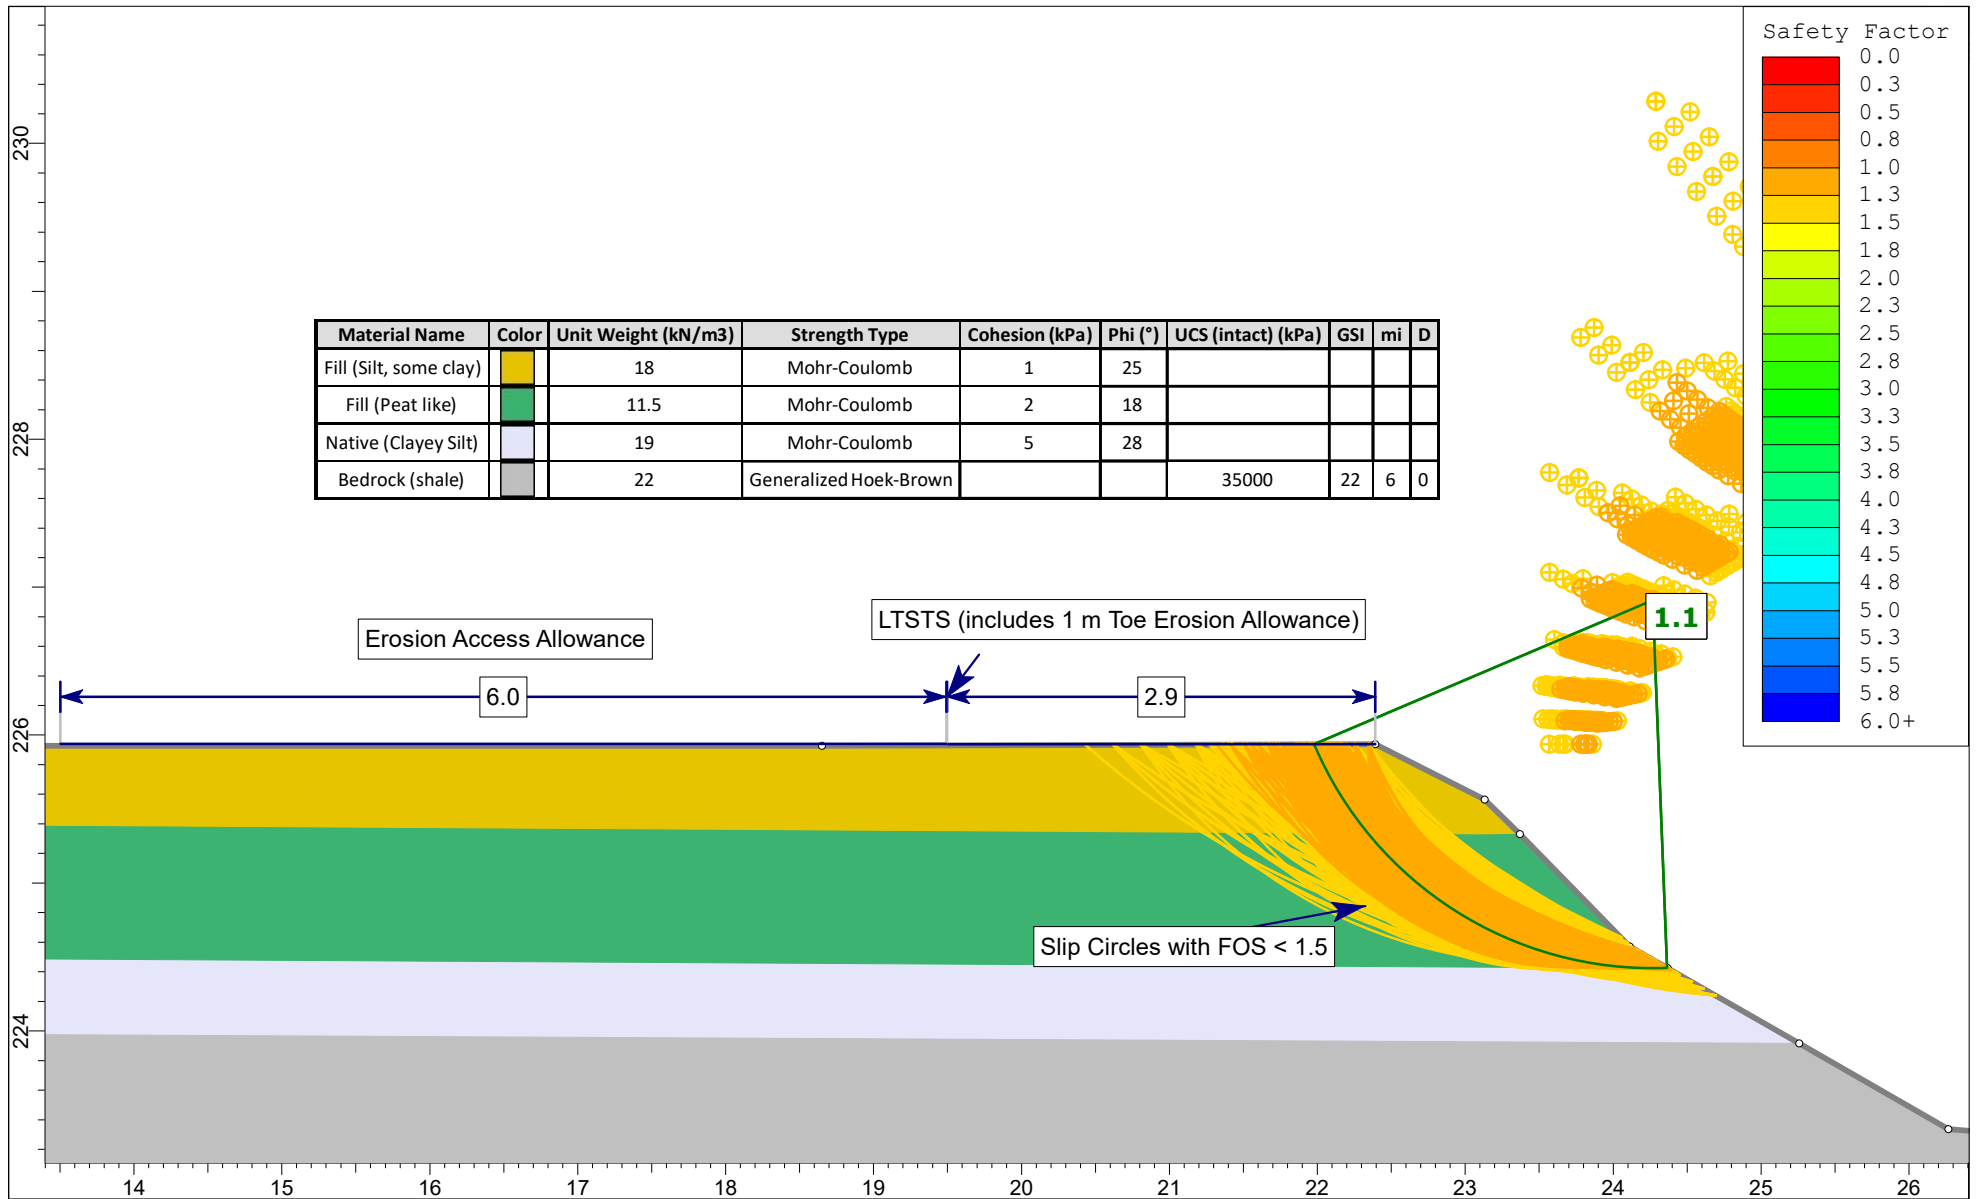
PNJ ENGINEERING INC. Pavement • Materials • Geo-Environmental • Engineering	Project			600 Mayfield Rd, Brampton, ON - Slope Stability Analysis		
	Project Engineer			Client		
	AS			Khalsa Gurmat Academy Toronto		
	Date			Title:		
2025-02-20			Cross-section C-C' - Master Scenario

The graphical outputs of the slope stability analyses are presented in **Appendix G** of this report. A review of the results shows that, given the assumed engineering parameters of the subsurface conditions are representative of the site, a Factor of Safety (FOS) of less than 1.5 was computed for cross-sections A-A' and C-C', while cross-section B-B' has a FOS greater than the recommended FOS of 1.5. Therefore, the slope in its existing condition, particularly at cross-sections A-A and C-C', did not achieve the minimum recommended FOS of 1.5 as discussed in **Section 9.3**.

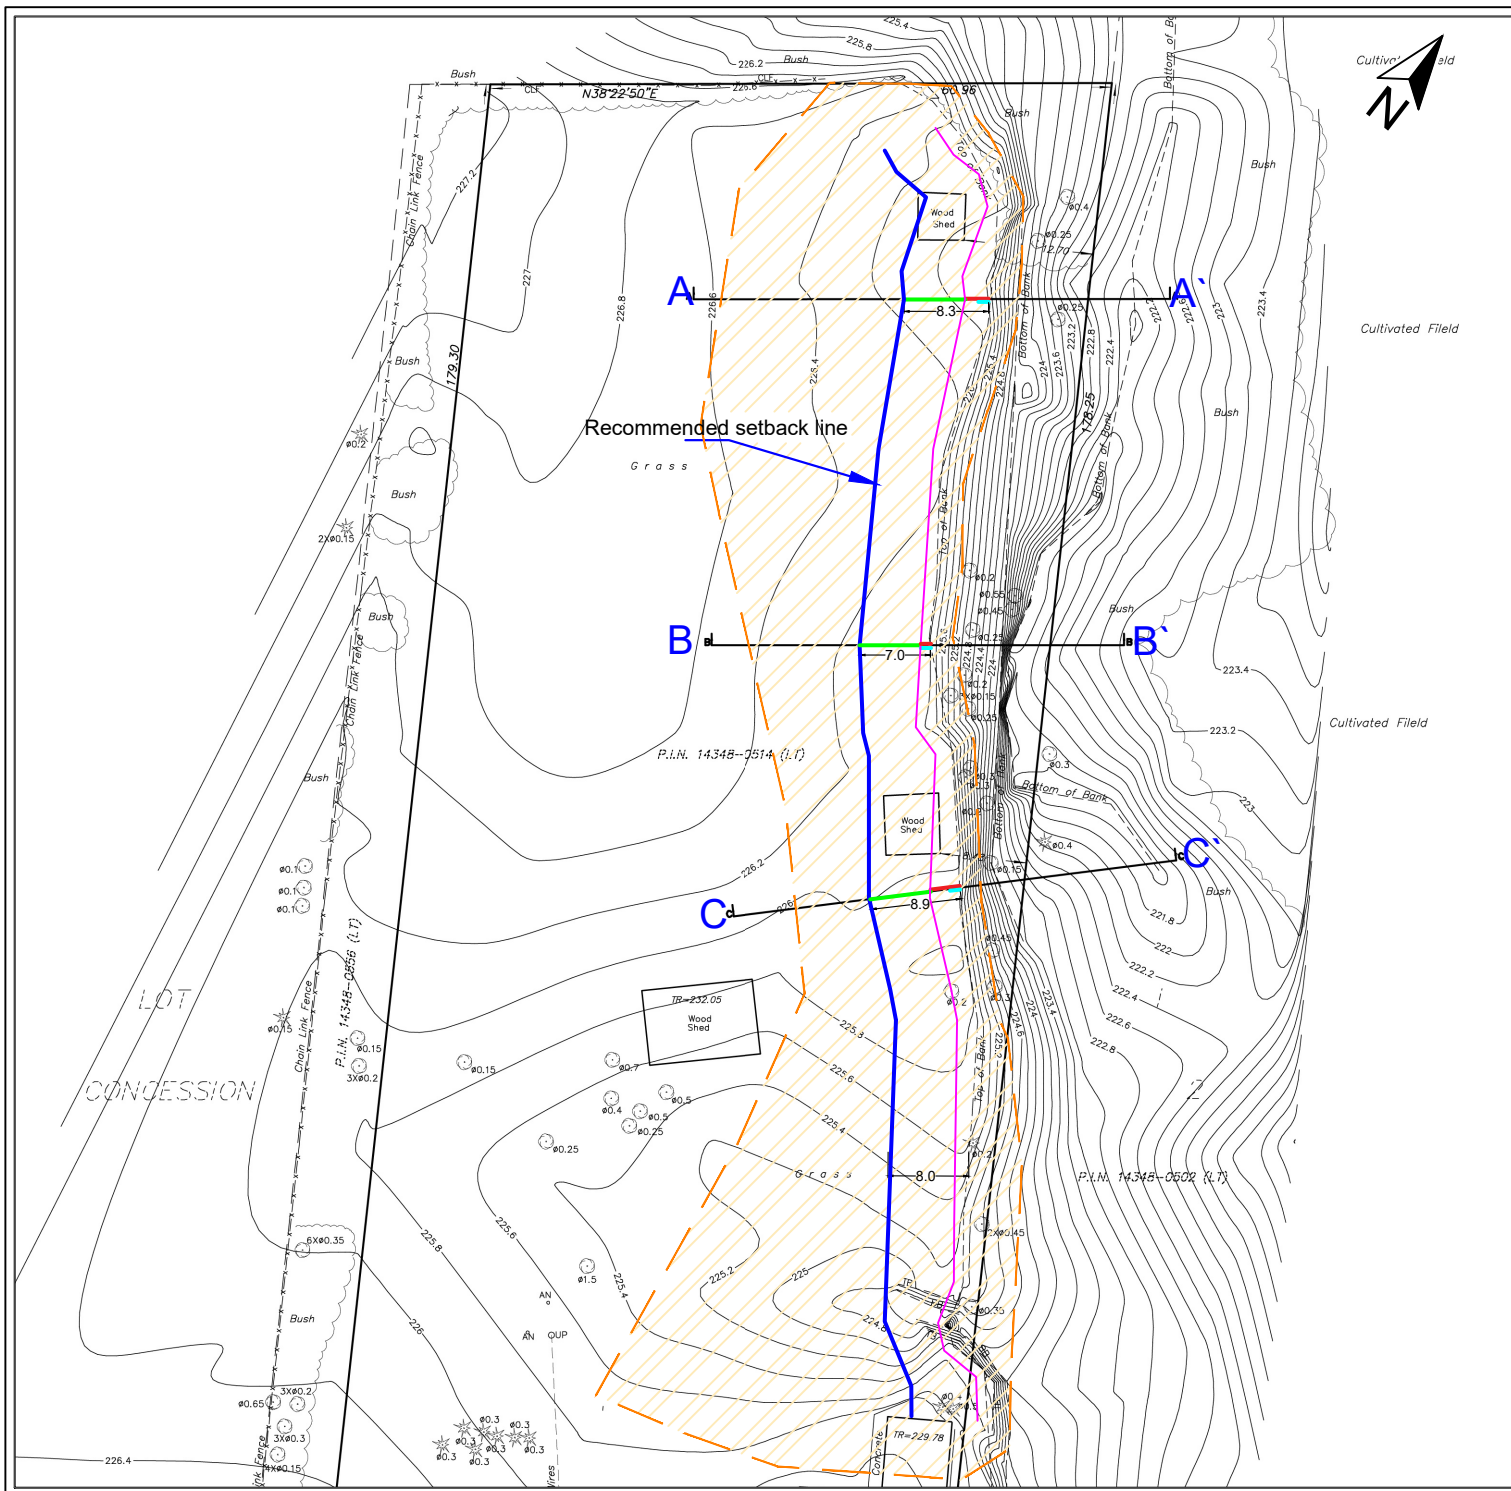
DRAWING NO. LTSTOS DATE FEB 19, 2025 PREPARED BY MA REVIEWED BY AS

The total recommended setback line, toe erosion allowance, the distance from the existing top of slope to LTSTS, and the erosion access allowance are depicted on the topographic map included in **Appendix H**.
