# HERITAGE IMPACT ASSESSMENT

18667 MISSISSAUGA ROAD, TOWN OF CALEDON,  
REGIONAL MUNICIPALITY OF PEEL, ONTARIO

CBM AGGREGATES

PROJECT NO.: OCUL2216  
DATE: JULY 28, 2023

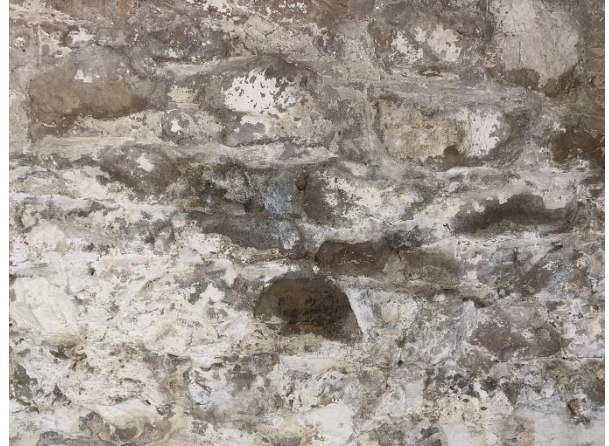
**Plate 33: Parged stone foundation**

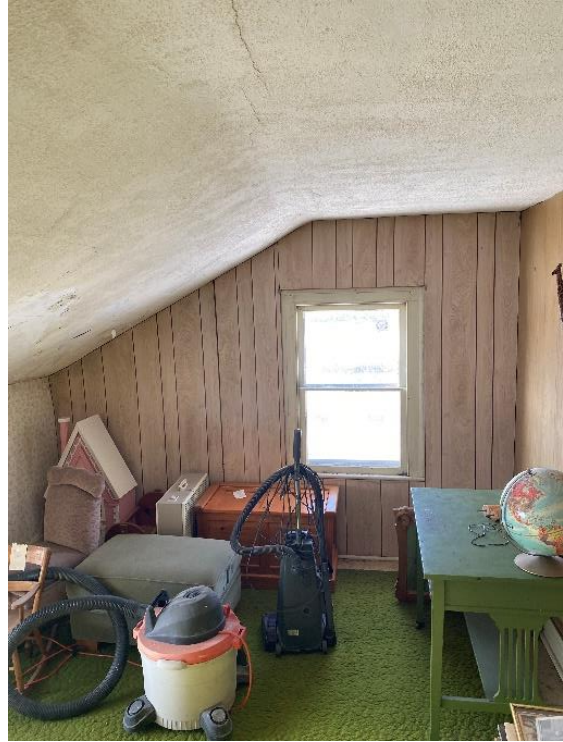
The southeast room is decorated with faux wood panelling and wallpaper on the walls and carpet over linoleum flooring (Plate 48). Both windows (of the north and west elevations) appear to be original and in good condition (Plate 49 and Plate 50). Cracks and subsequent repairs are evident in the plaster of the ceiling (Plate 53).

**Plate 48: Southeast room of second floor**

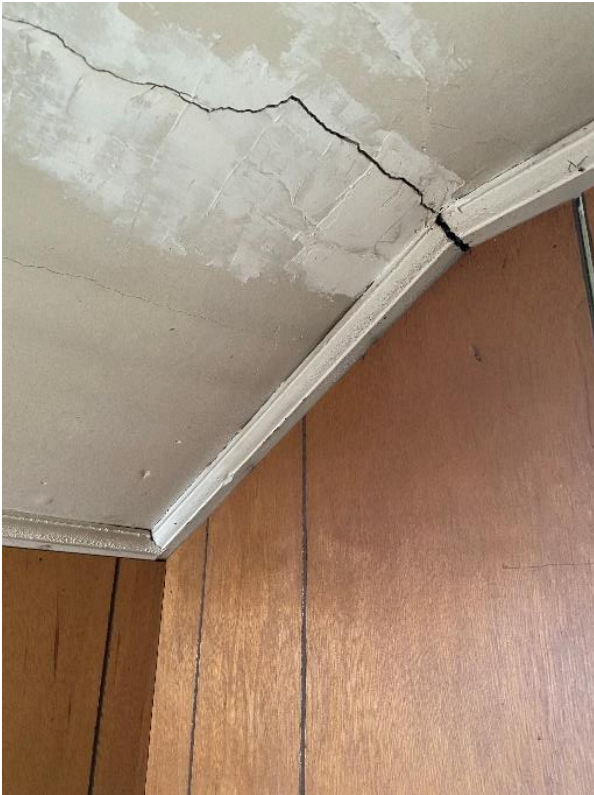
**Plate 53: Cracks and repairs of southeast room**
