August 31, 2020

Reference No. 1801-S032

**Re: A Supplementary Slope Stability Assessment for  
Proposed Residential Development  
Chickadee Lane and Glasgow Road  
Town of Caledon**

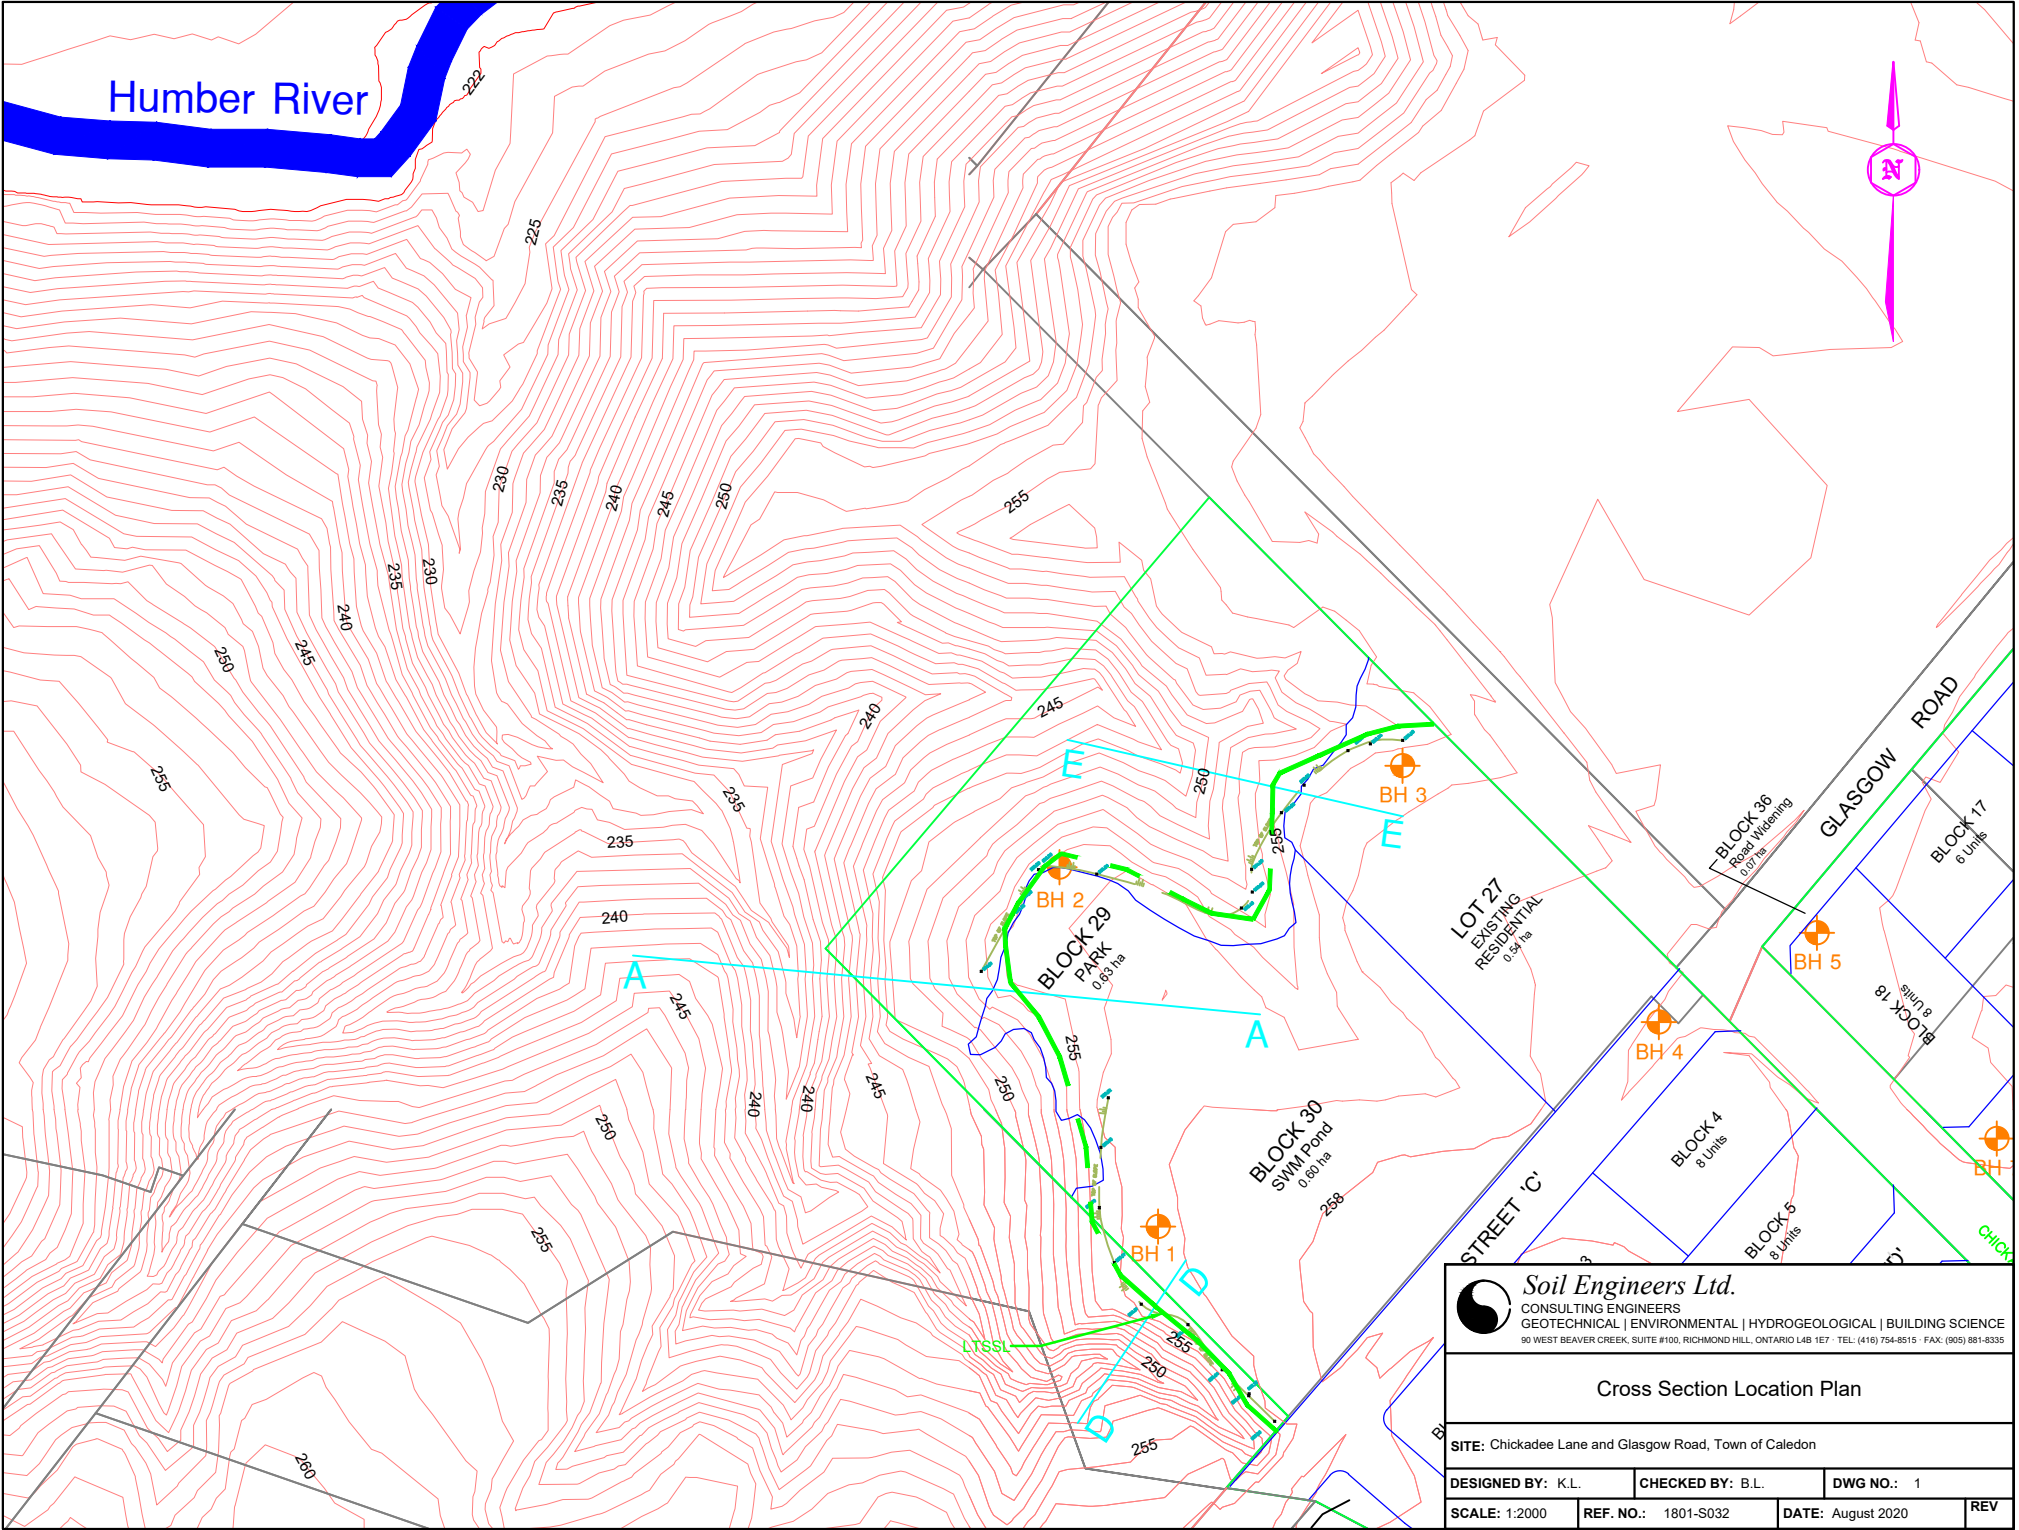
**Cross Section Location Plan**

Based on the analytical results, the LTSSL, incorporating the stable slope gradient, is established and is illustrated in Drawing No. 1.

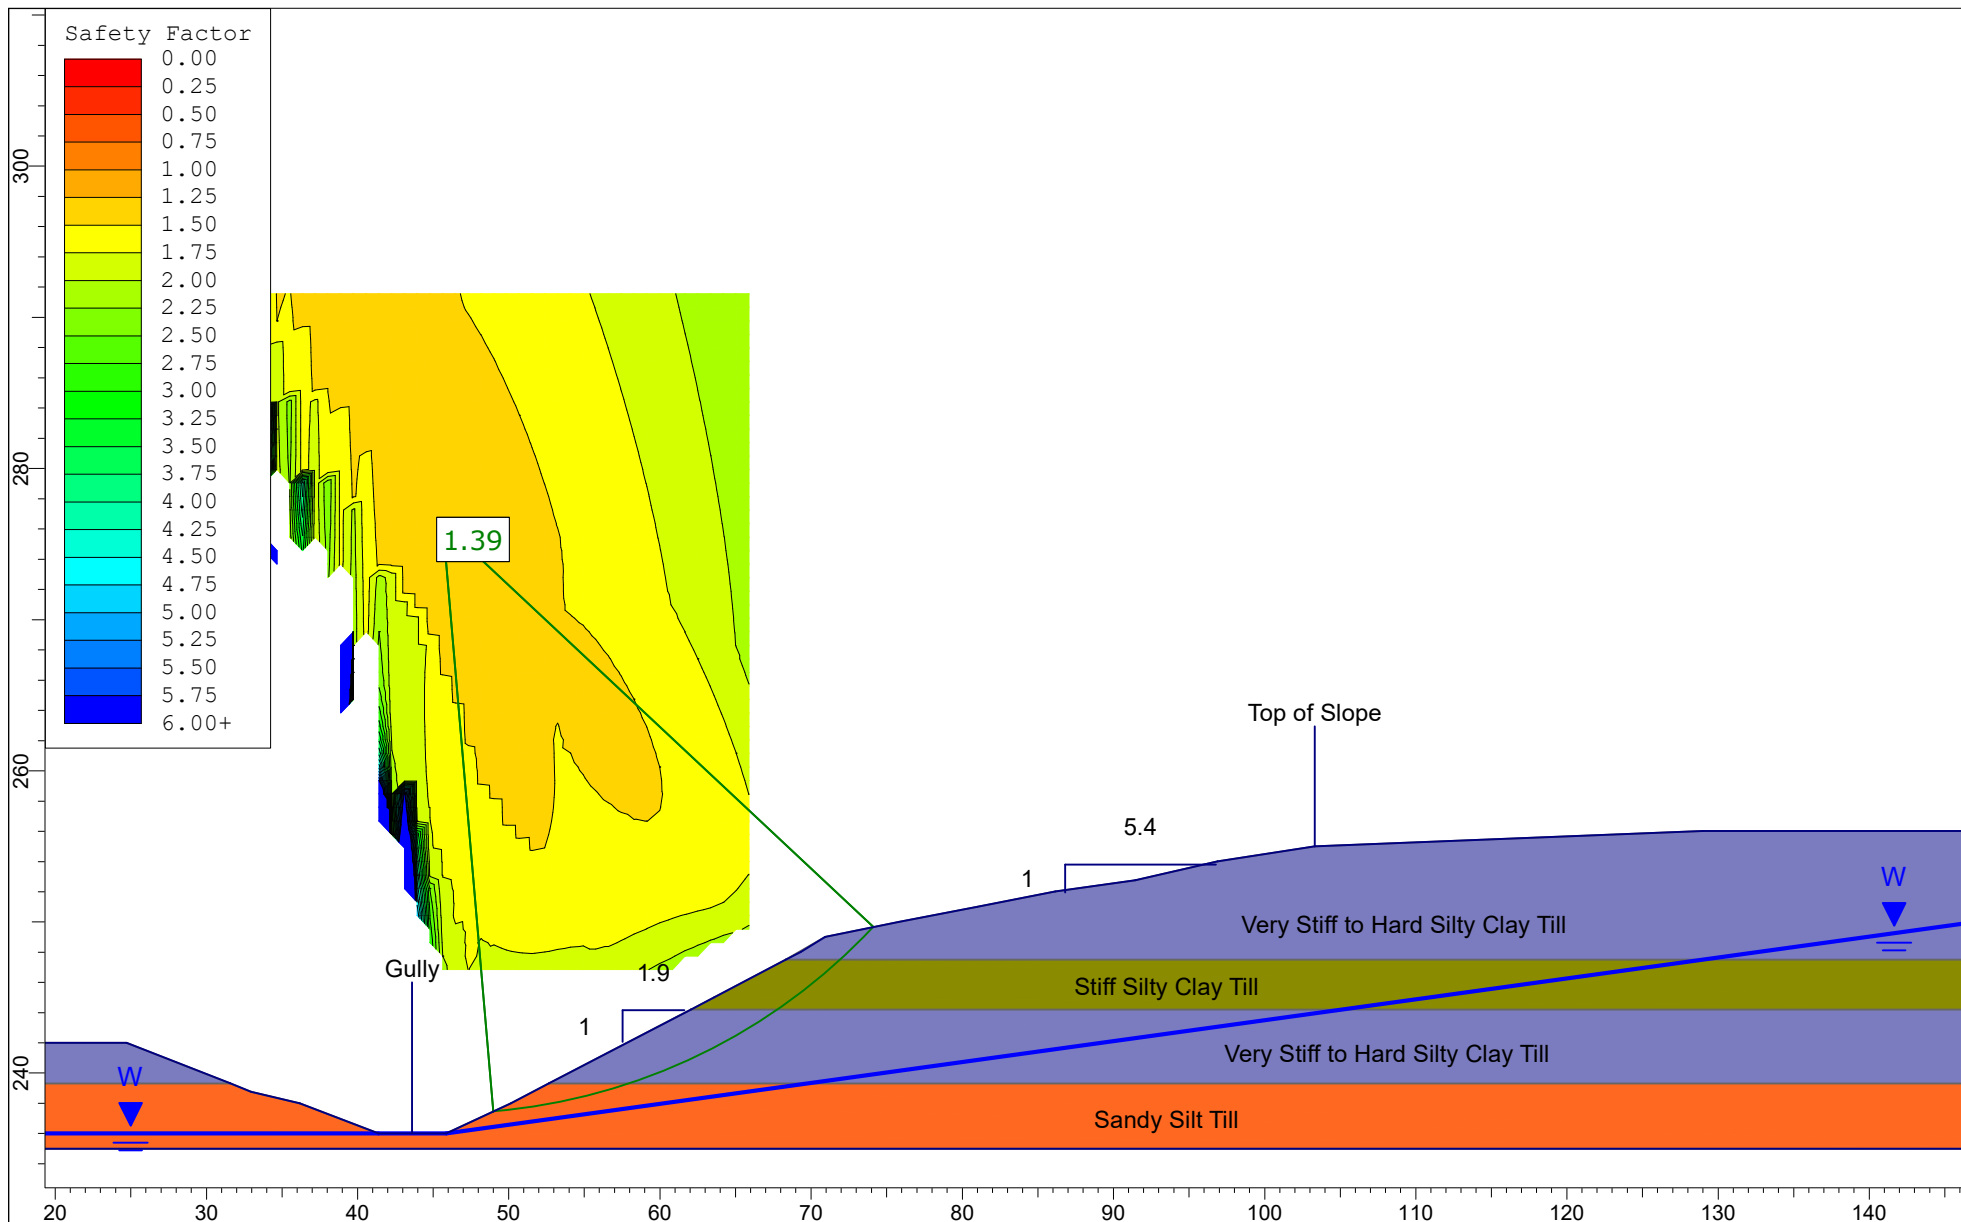
Project Title			Load Case
Slope Stability Assessment - Cross Section A-A			Existing Condition
Location			
Chickadee Lane and Glasgow Road, Town of Caledon			
Drawn By	K.L.	Checked By	B.L.
Scale	1:500		
Revision	-		
Date	August 2020		Reference No.
			1801-S032
Drawing No.	2

Cross Section	Height (m)	Existing Slope Gradient	Factor of Safety (FOS)	Remodeled Slope Gradient	Resulting FOS
A-A	19.0	1.9 to 5.4H:1V	1.39	2.5H:1V	1.61
D-D	8.5	1.6H:1	1.31	2H:1V	1.51
E-E	7.0	3.1 to 4.7H:1V	2.40	-	-

The resulting FOS at the Cross-Section E-E meet the Ontario Ministry of Natural Resources and Forestry (OMNRF) guideline requirement for 'Active' land use (FOS of 1.5), while the FOS for Cross-Sections A-A and D-D is below the OMNRF guideline requirement. A stable slope allowance will be required for Cross-Sections A-A and D-D.

After incorporating the stable slope gradient of 2.5 to 2.0H:1V at Cross- Sections A-A and D-D, the resulting FOS for the remodeled slope meets the OMNRF guideline of FOS 1.5. The results are presented on Drawing No. 5 and 6.
