**REPORT ON**  
Slope Stability Assessment  
Proposed Innis Lake Secondary Plan Area  
Caledon, Ontario

**PREPARED FOR:**  
Innis Lake Secondary Plan Area Landowners  
c/o Mattamy (Innis Lake) Limited

**Project No.** 22-030-100/101 (Slope)  
**Date:** February 27, 2026

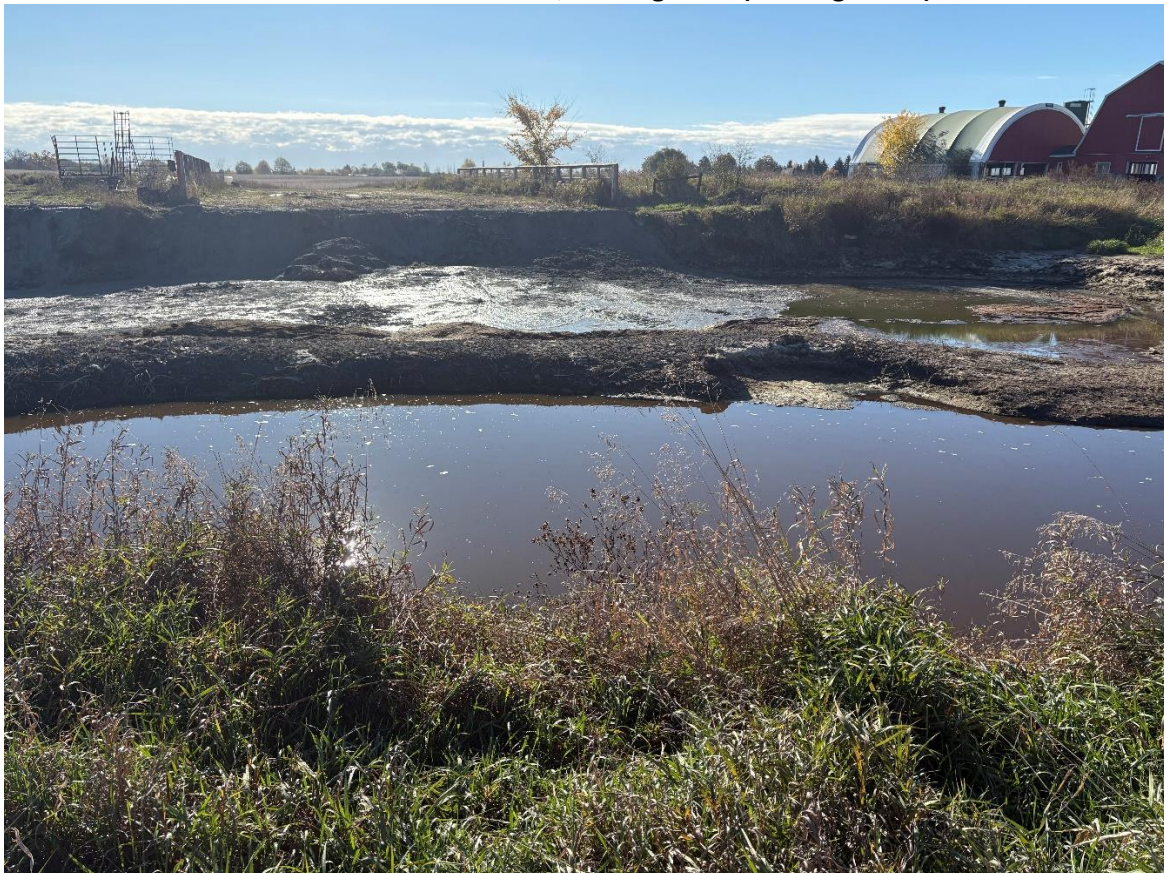
**Photo 2: Near Section A-A, Existing Pond (Looking South)**

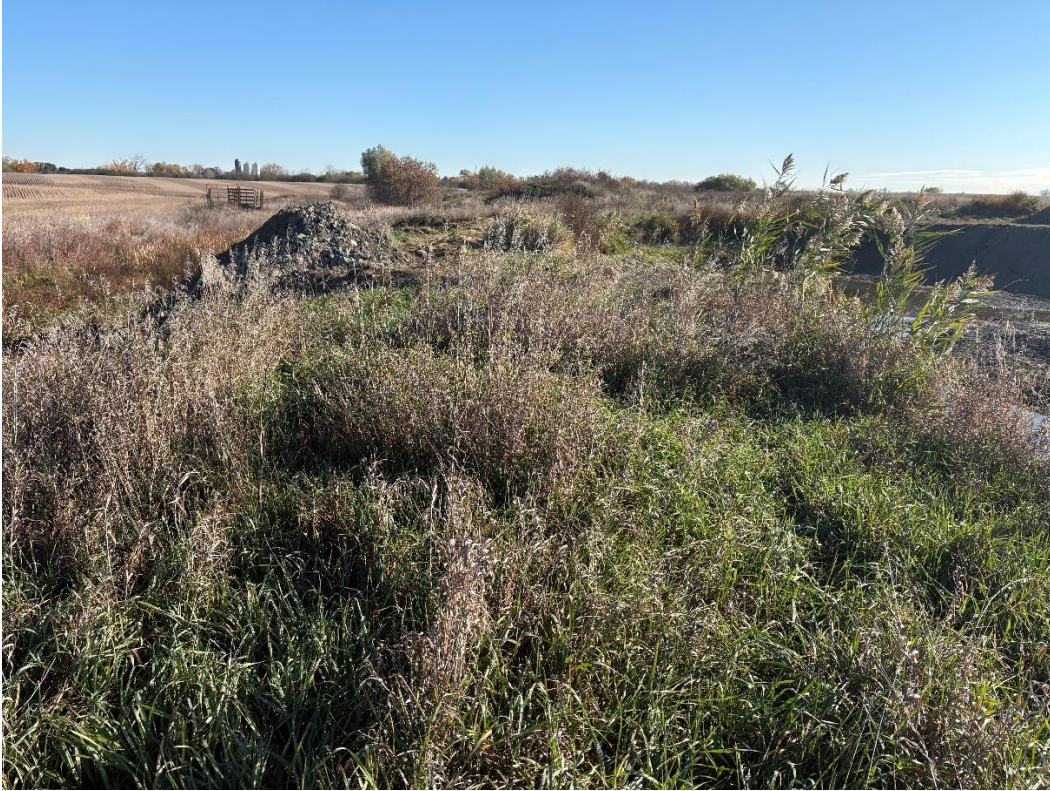
**Photo 3: Near Section A-A (Looking East)**

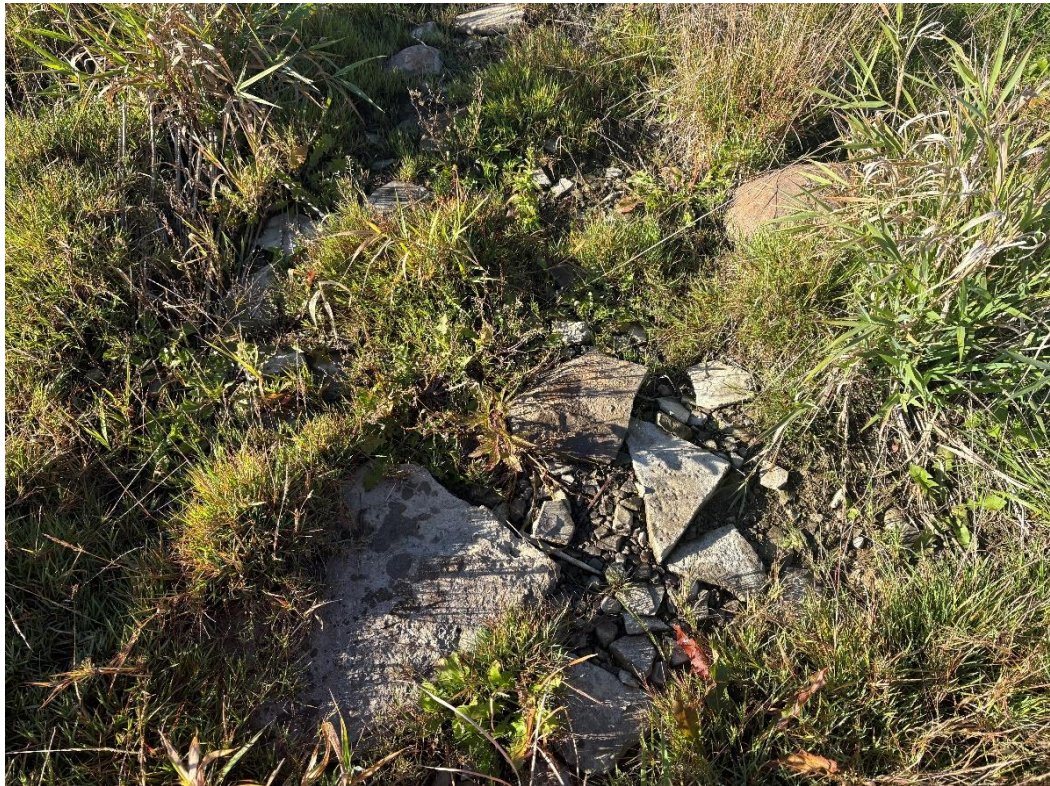
**Photo 4: Near Section A-A, Bedrock was Observed at Creek Bed**

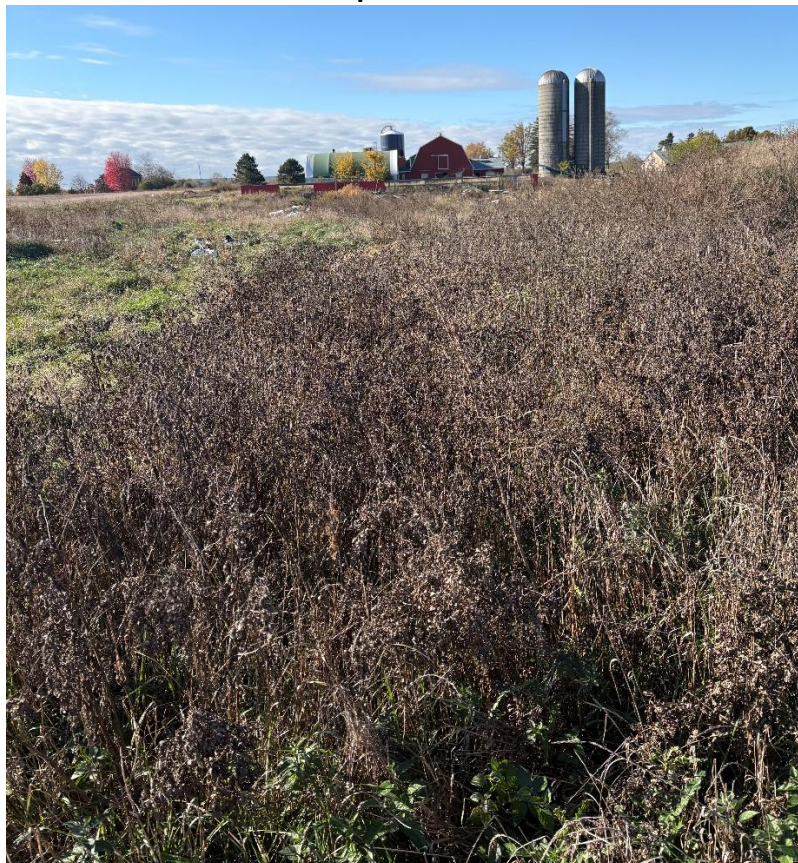
**Photo 6: Slope Near Section C-C**

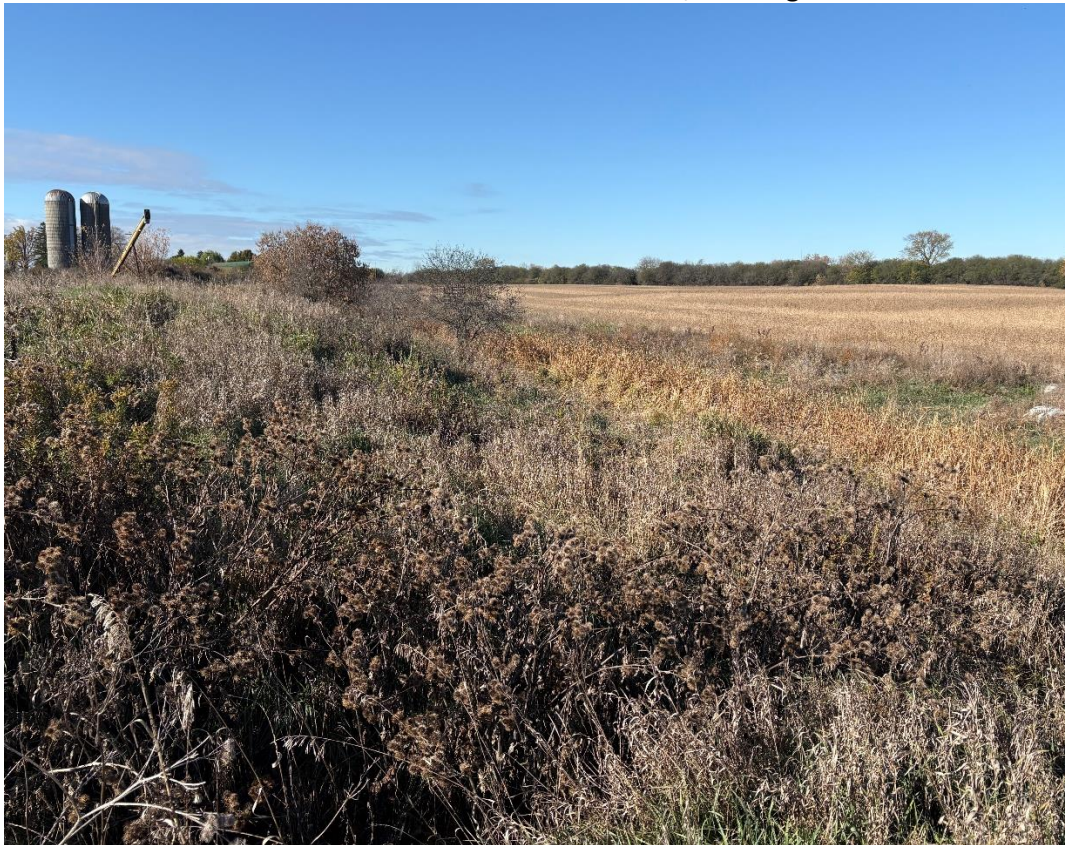
**Photo 8: Between Sections C-C and D-D, Looking West**

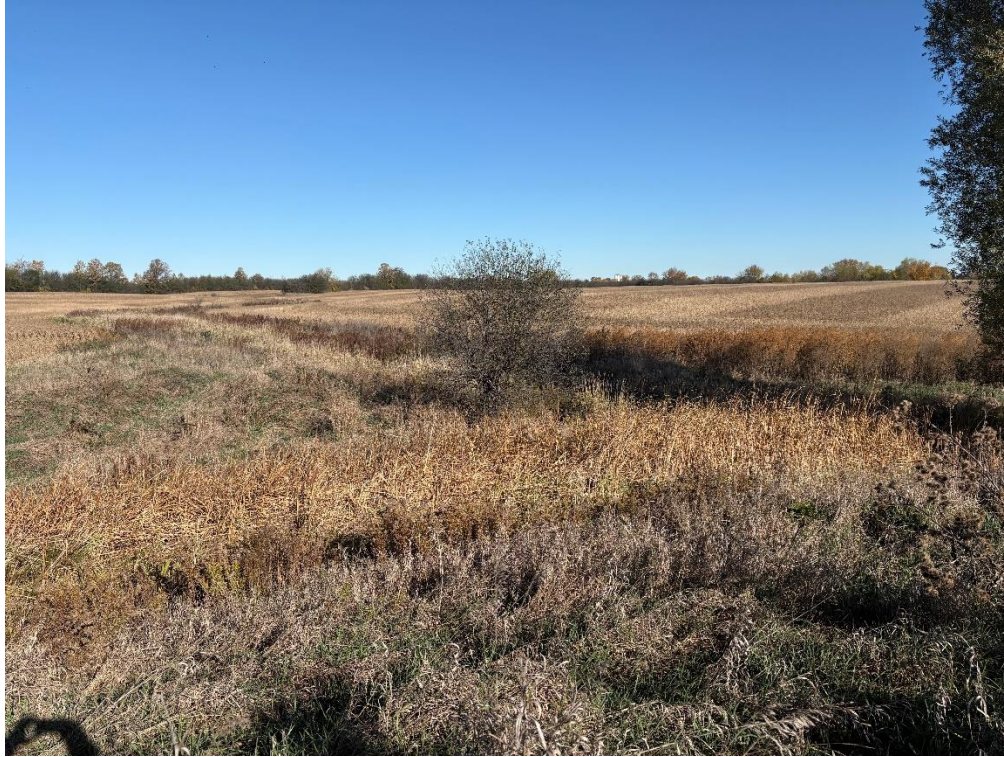
**Photo 9: Between Sections C-C and D-D, Looking North (no Obvious Slope)**

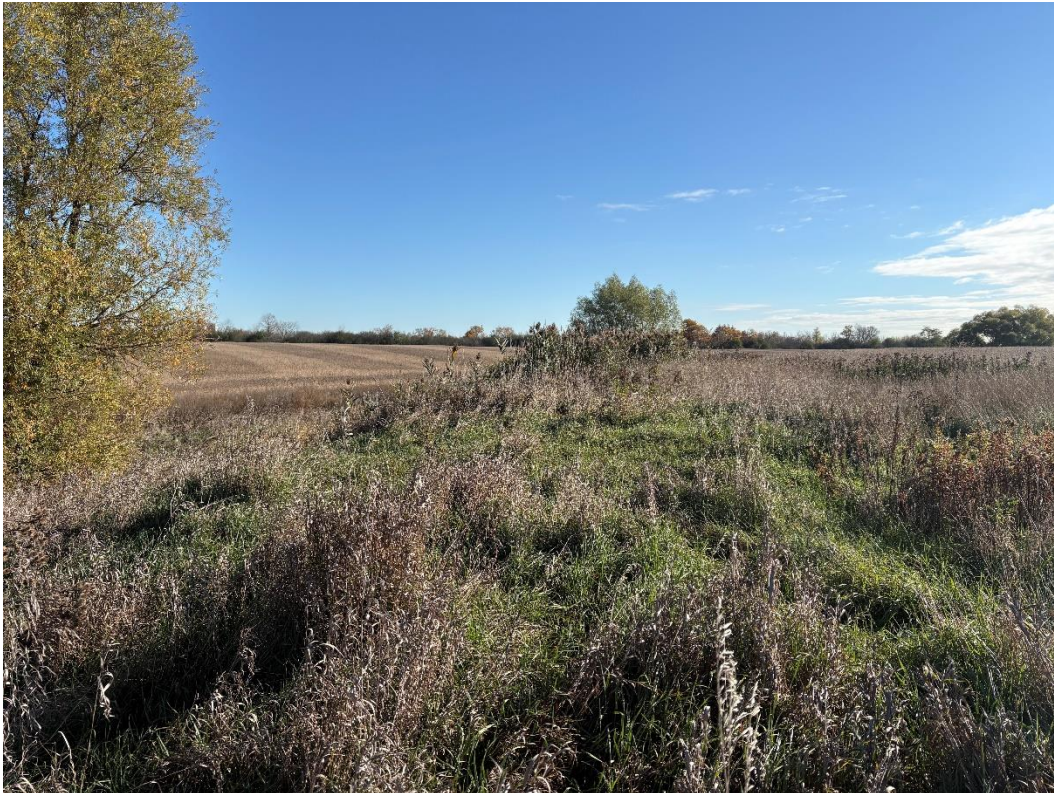
**Photo 10: Near Section C-C, Looking East**

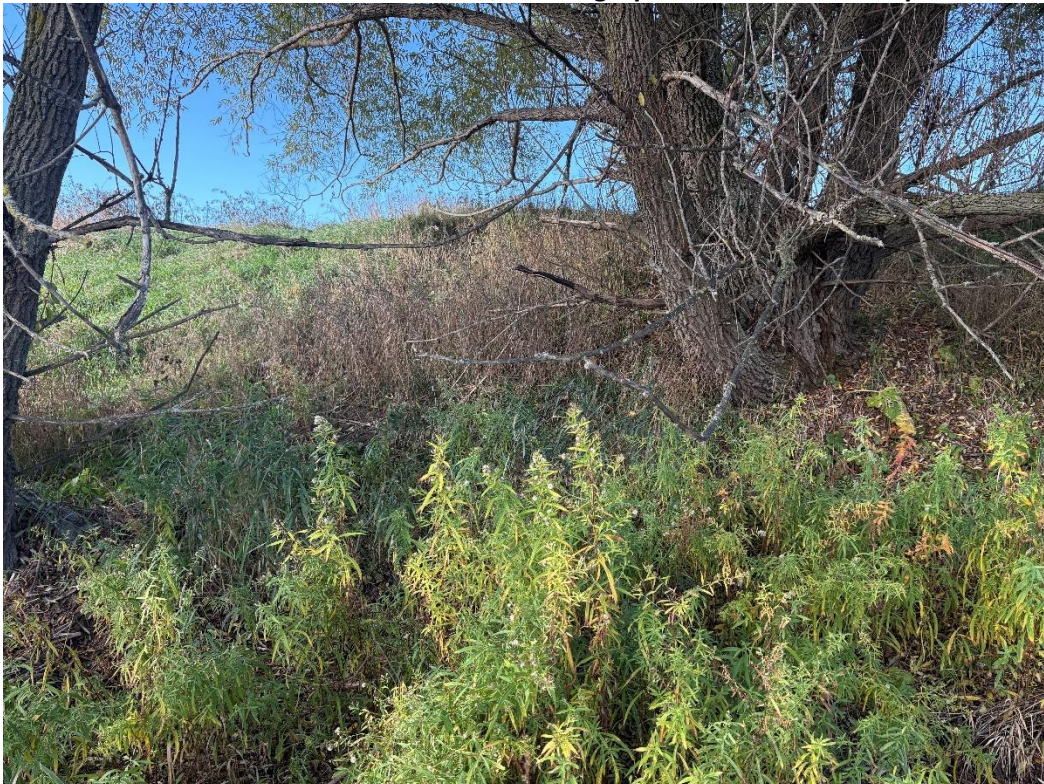
Photo 12: Near Section F-F, Looking Upward from Toe of Slope

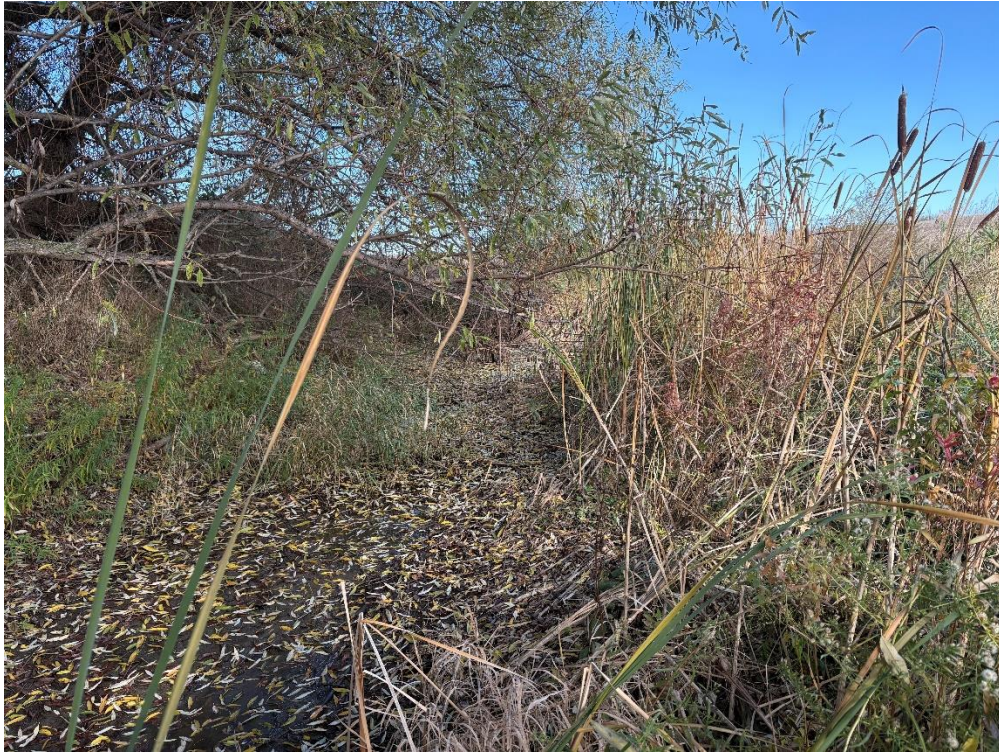
**Photo 13: Near Section F-F, Looking North**

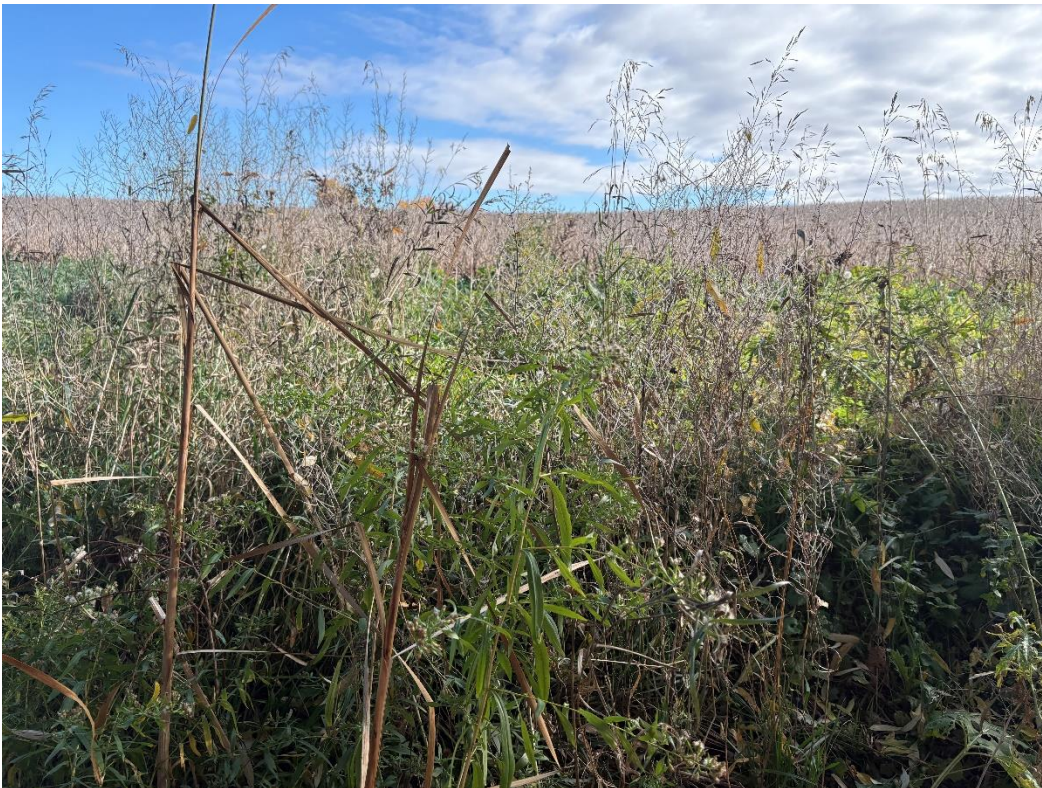
**Photo 14: Near Section F-F, Looking East (no Obvious Slope)**

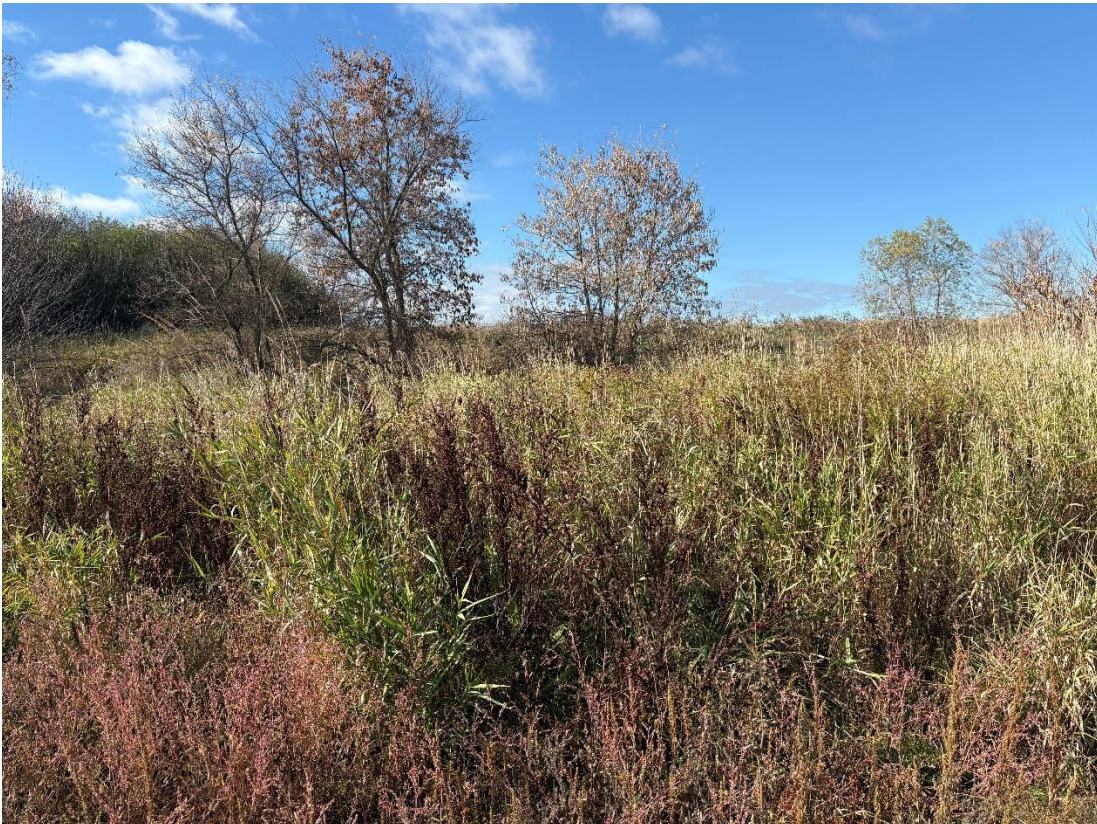
**Photo 16: Near Section H-H, Looking West**

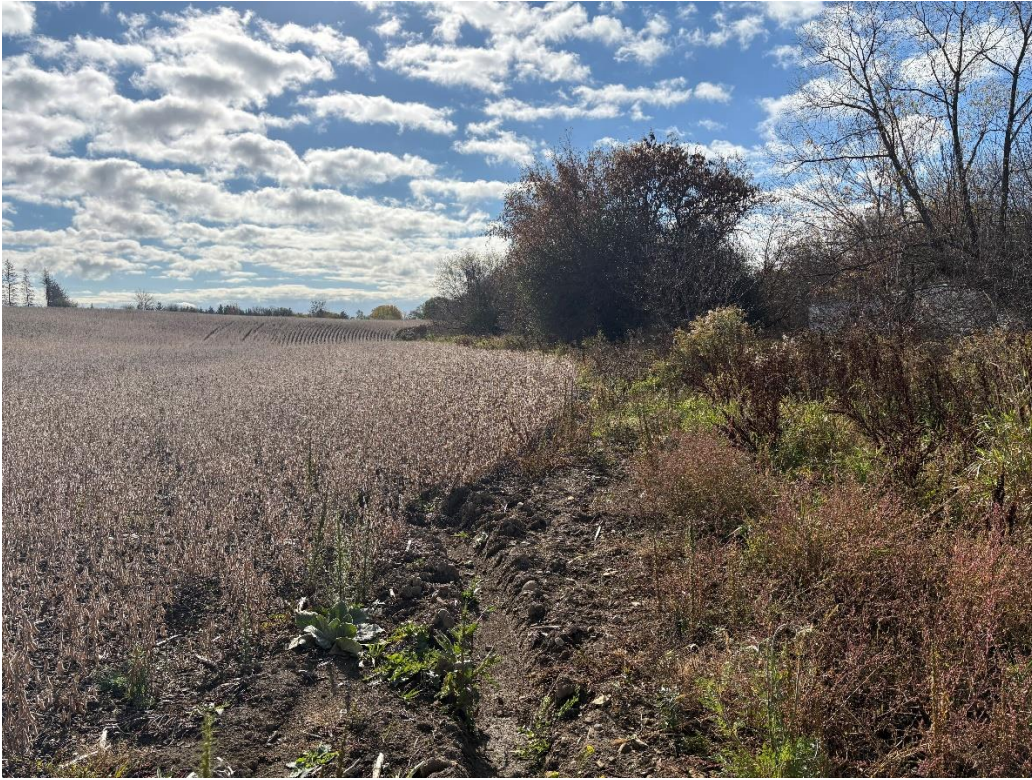
**Photo 17: Near Section H-H, Looking South**

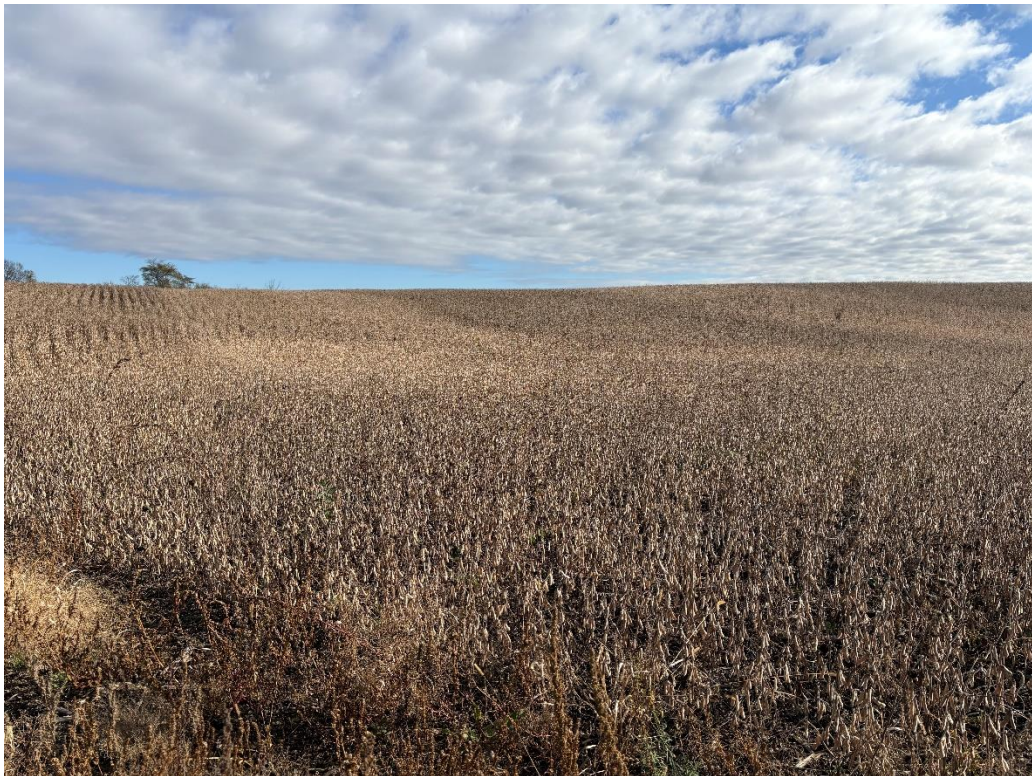
**Photo 18: Near Section H-H, Looking East (no Obvious Slope)**

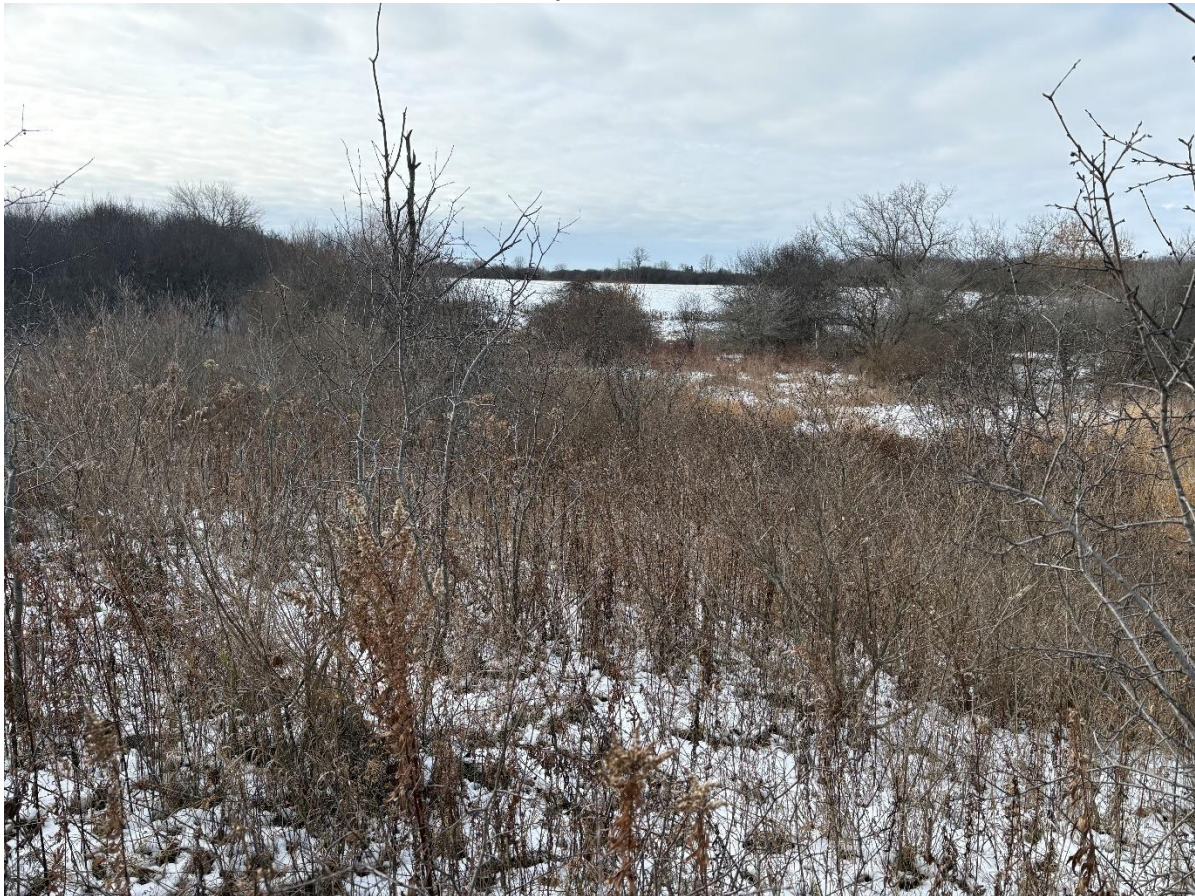
**Photo 2: Slope Near Section 3-3**

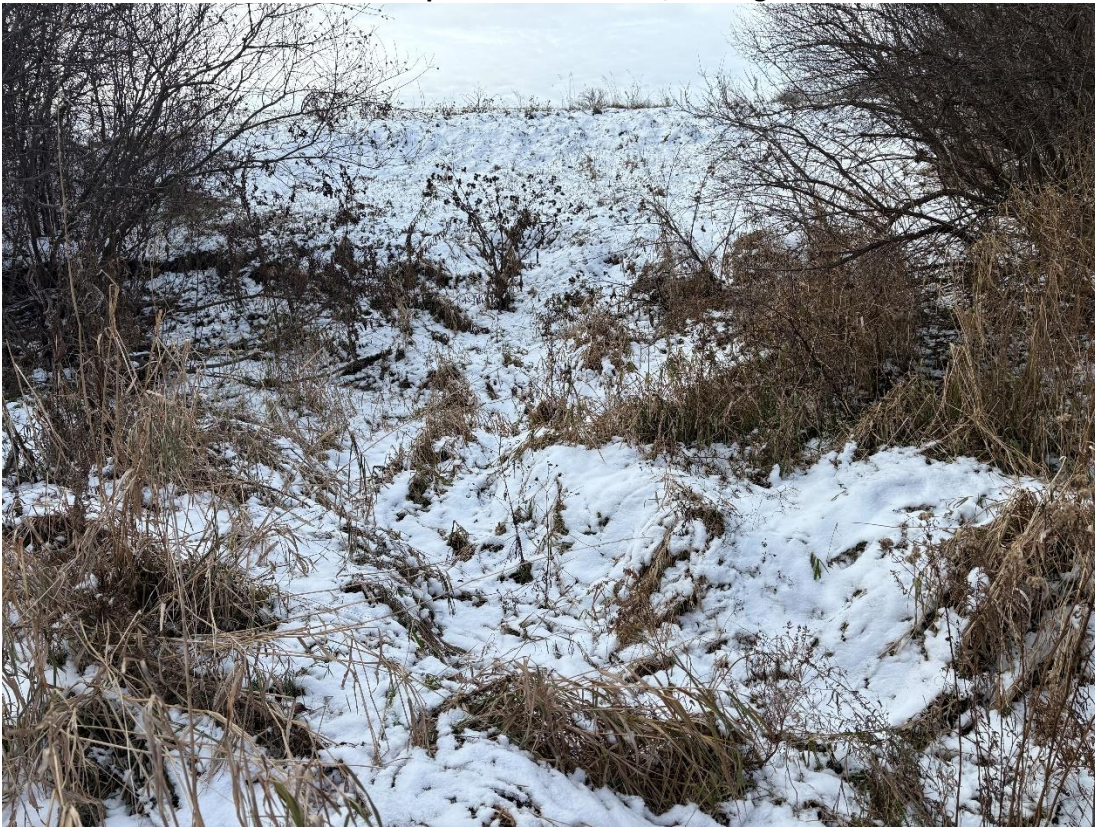
**Photo 4: Slope Near Section 4-4, looking East**

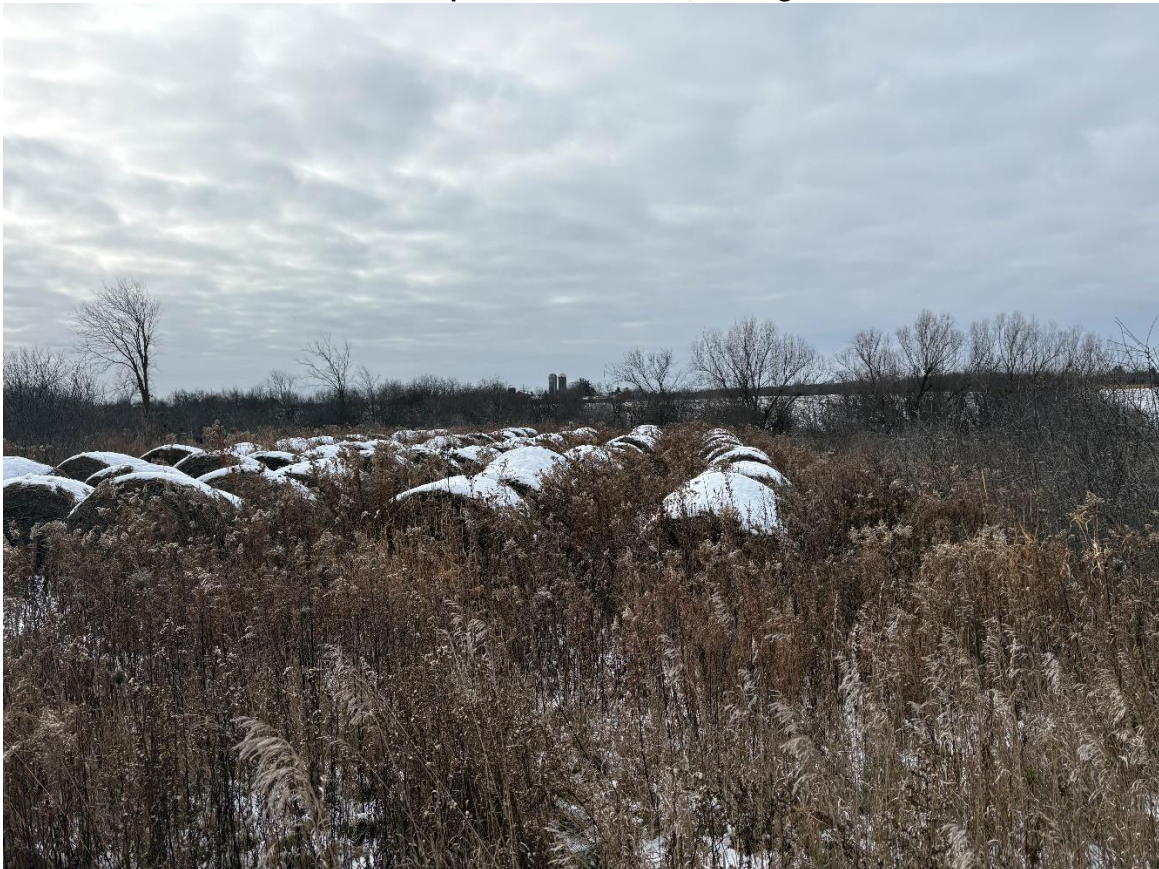
**Photo 6: Slope Near Section 6-6, looking West**

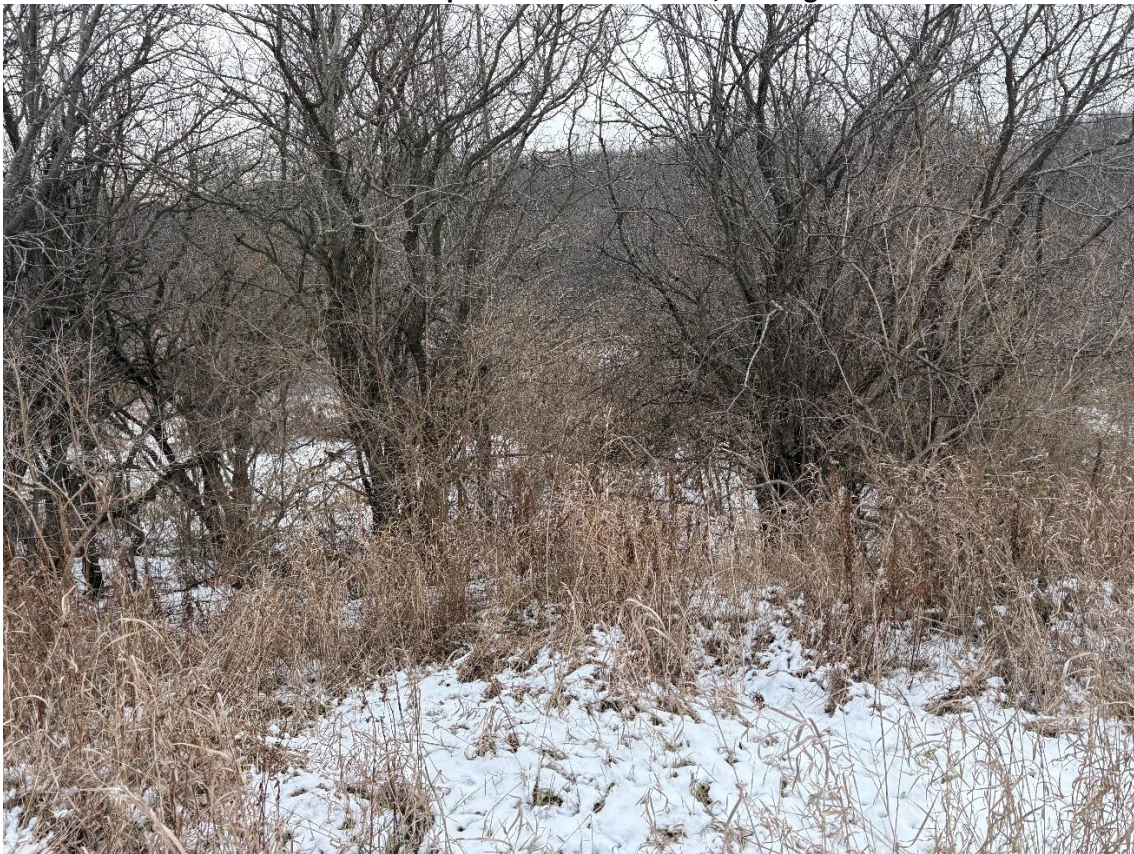
**Photo 8: Slope Near Section 10-10, looking West**

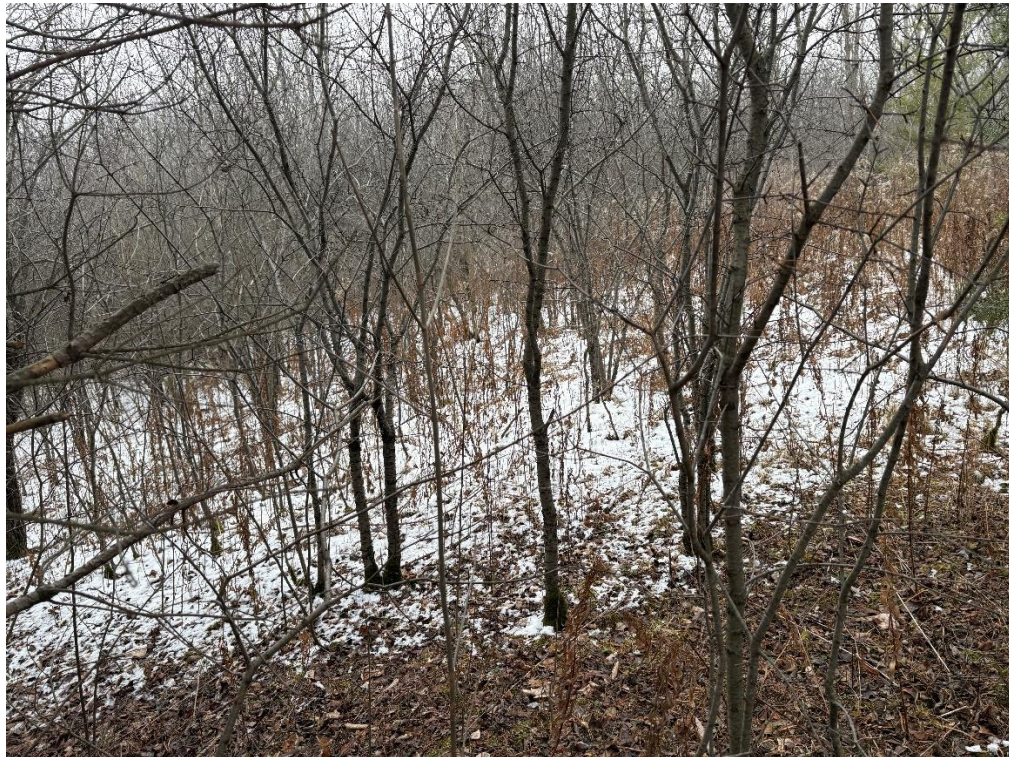
**Photo 10: Slope Near Section 17-17, looking North**

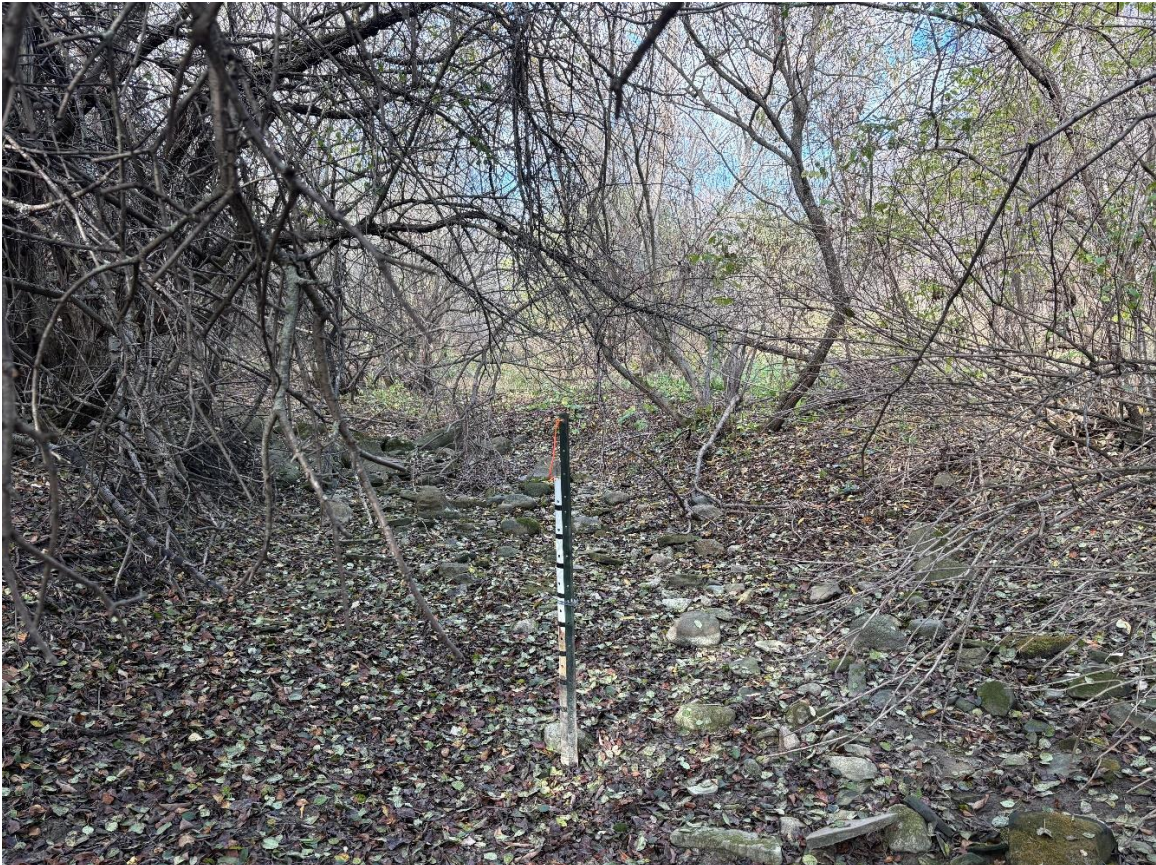
Photo 12: Near Section 20-20, Looking East

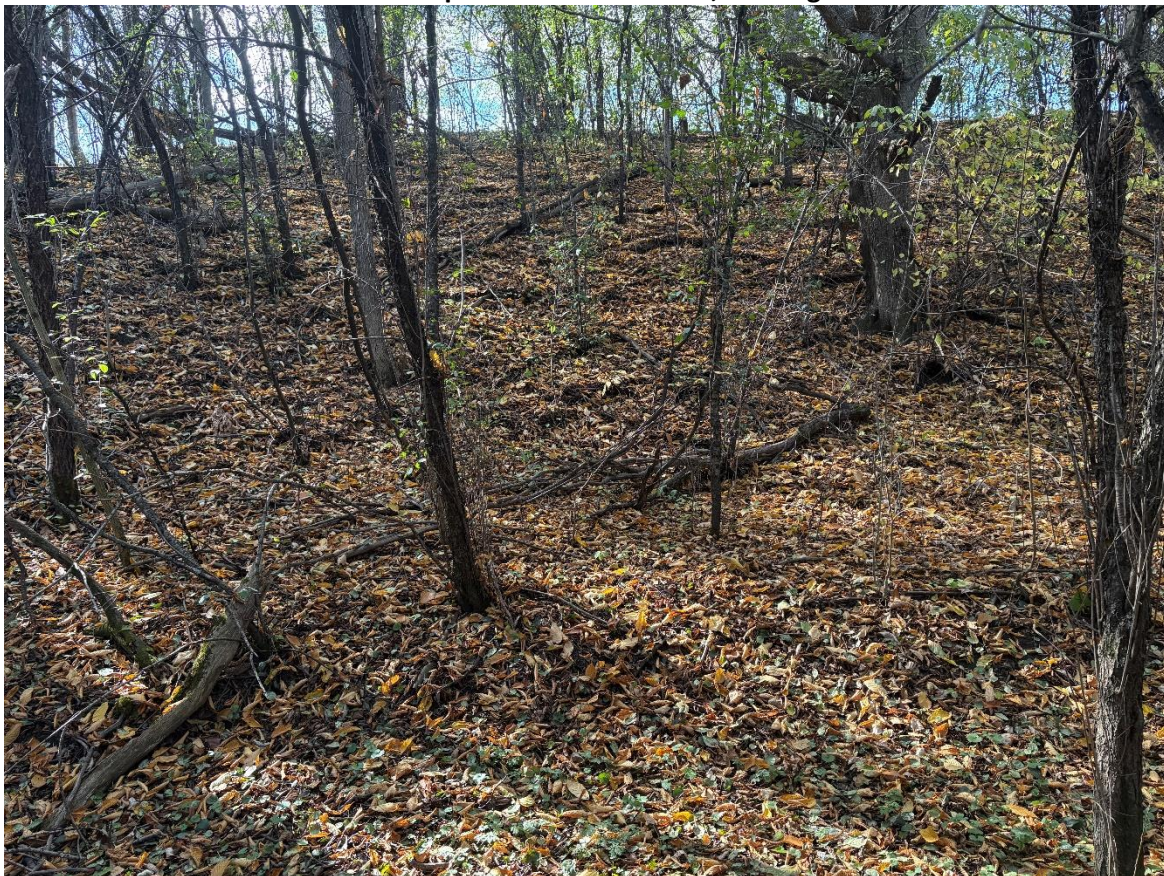
**Photo 14: Slope Near Section 18-18, Looking West**

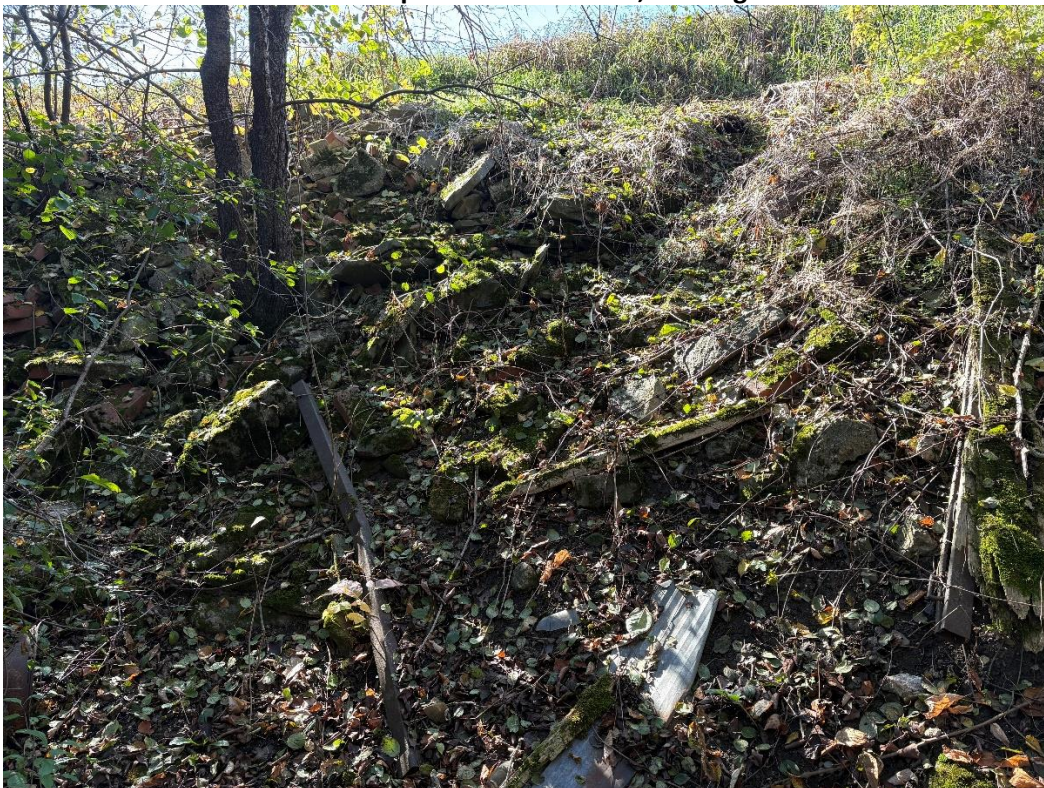
**Photo 18: Slope Near Section 7-7, Looking West**

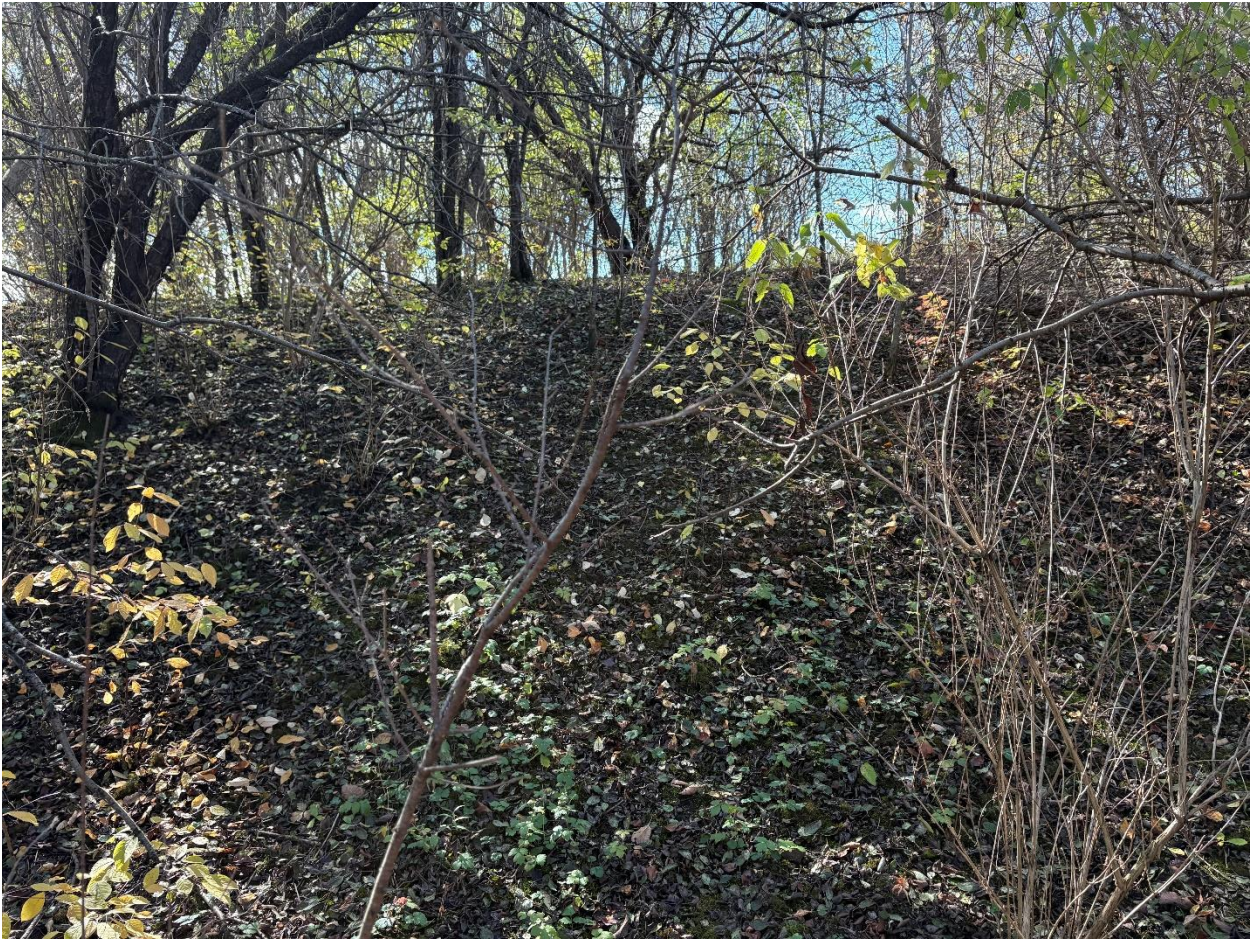
**Photo 20: Slope Near Section 3-3, Looking West**
