PROJECT:  
**PROPOSED RESIDENTIAL DEVELOPMENT  
11 TOWNHOUSE UNITS**  
336 KING STREET EAST, BOLTON, ONTARIO

DRAWING TITLE:  
**EXISTING TREE INVENTORY &  
PRESERVATION PLAN AND  
ARBORIST REPORT**

SCALE: 1 : 200	PROJECT No. 18-5186
DATE: MAY 04, 2018	DRAWING No. V100
DRAWN BY: SS	
CHECKED BY: BB

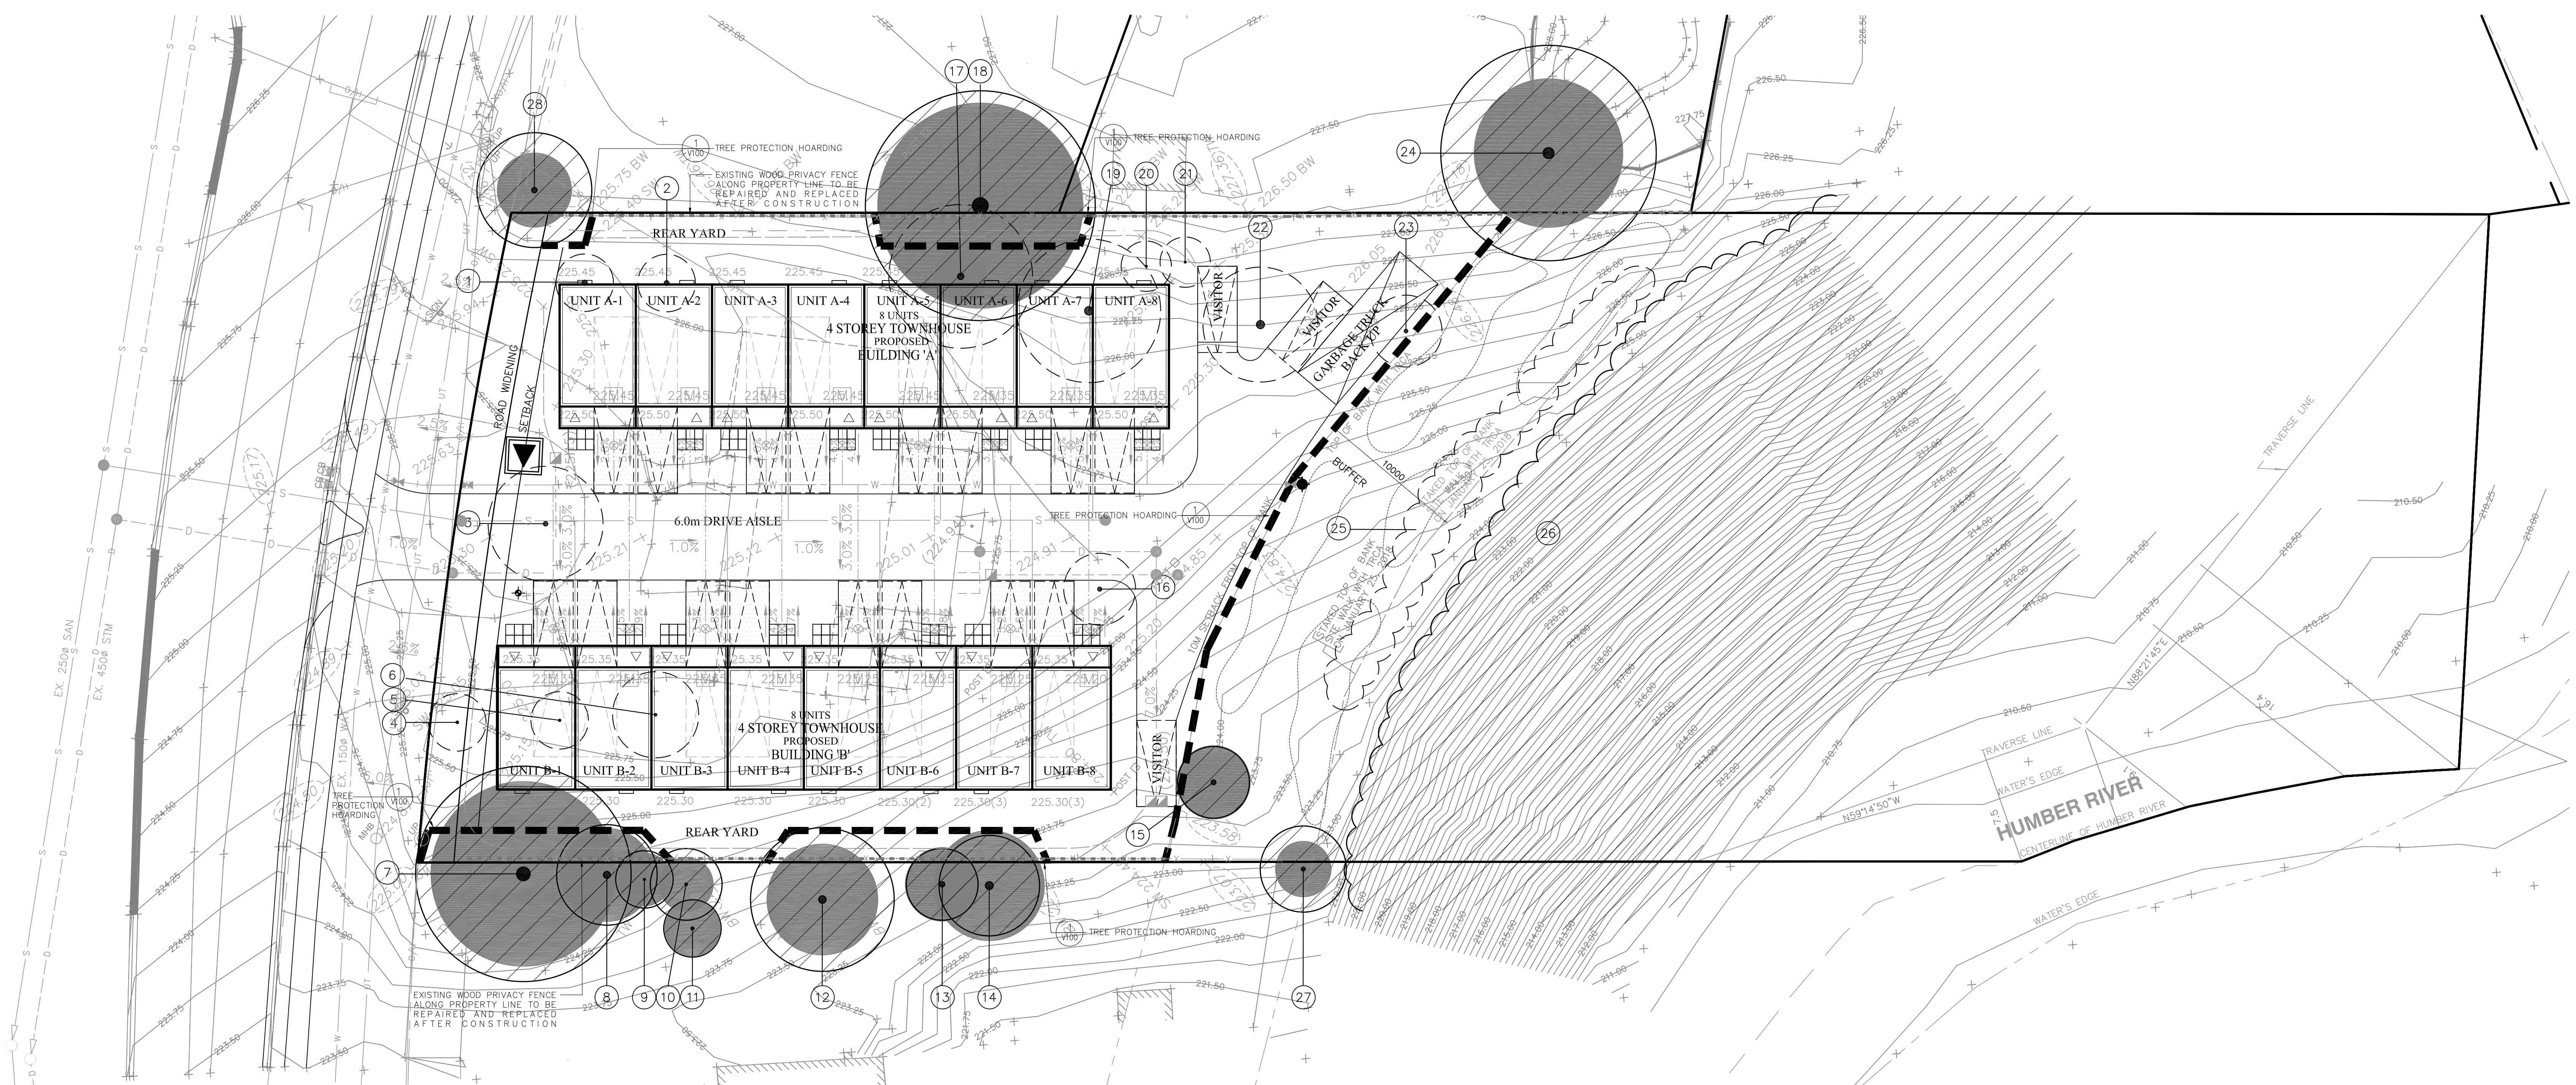
Tree No.	Common Name	Botanical Name	Diameter (cm)	Crown Dia. (m)	Health G:R:P	Structure	Comments	TPZ	Action	Tree No.
1	Colorado Blue Spruce	<i>Picea pungens</i>	37	4	P	Poor Form	Tree uprooted in recent wind storm, fallen over, root system exposed damage to fence.	2.4	Remove	1
2	Colorado Blue Spruce	<i>Picea pungens</i>	34	4	P	Poor Form	Tree uprooted in recent wind storm, fallen over, root system exposed damage to fence.	2.4	Remove	2
3	Norway Maple	<i>Acer platanoides</i>	32	8	G	Broad Form	Good health, minor broken branching in canopy.	2.4	Remove	3
4	Ivory Silk Lilac	<i>Syringa reticulata</i>	19	4	G	Good Form	Codominant stems with crossing branching, callus on trunk near base of the tree.	1.8	Remove	4
5	Ivory Silk Lilac	<i>Syringa reticulata</i>	17	4	G	One Sided Form	Crowded/uneven canopy, lack of sunlight, crossing branching, minor dieback on shaded side.	1.8	Remove	5
6	Apple Sp.	<i>Malus</i>	18	6	G	Broad Form	Pruned for structure, elevated canopy, good form.	1.8	Remove	6

7	Manitoba Maple	<i>Acer negundo</i>	94	15	F	Broad Form	Located on adjacent property, leaning, multiple leaders, suckering from trunk, base, and structural branches, broken branches and minor damage throughout.	6	Preserve	7
8	Manitoba Maple	<i>Acer negundo</i>	48	7	F	Narrow Form	Located on adjacent property, leaning, multiple leaders, suckering from trunk, base, and structural branches, broken branches and minor damage throughout.	3	Preserve	8
9	Manitoba Maple	<i>Acer negundo</i>	14.9, 10	4	P	Multi Stemmed	Located on adjacent property, multiple stems from base, poor health, dead branching throughout, weak structure at stem unions.	1.8	Preserve	9
10	Manitoba Maple	<i>Acer negundo</i>	14.11, 17, 10	5	P	Multi Stemmed	Located on adjacent property, multiple stems growing from decaying stump, one stem broken and leaning on fence, weak structure at stem unions.	1.8	Preserve	10
11	Red Cedar	<i>Juniperus Virginiana</i>	21, 15	4	F	Pyramidal Form	Located on adjacent property, crowded and shaded by adjacent trees, dieback on the east side due to crowding, minor needle discoloration in some areas of the canopy.	1.8	Preserve	11

12	Larch	<i>Larix decidua</i>	51	10	G	Good Form	Located on adjacent property, lower branches pruned to elevate canopy, minor dieback.	3.6	Preserve	12
13	White Spruce	<i>Picea glauca</i>	36	5	F	One Sided Form	Located on adjacent property, crowded by adjacent pine, dieback on south side due to adjacent tree growth, minor needle dieback on other areas of the tree.	2.4	Preserve	13
14	White Pine	<i>Pinus strobus</i>	55	7	G	Broad Form	Located on adjacent property, broken branching, dieback on lower branches on the north due to crowding from adjacent tree, broken branches present.	3.6	Preserve	14
15	Colorado Spruce	<i>Picea pungens</i>	33	5	F	Upright Form	Good form, minor dieback on lower branching. Branching starts at grade, minor needle discoloration present.	2.4	Preserve	15
16	Colorado Spruce	<i>Picea pungens</i>	29	5	F	Upright Form	Good form, minor dieback on lower branching. Branching starts at grade, minor needle discoloration present.	2.4	Remove	16

17	Norway Spruce	<i>Acer platanoides</i>	45	10	F	Upright Form	Mature tree, lower branches pruned to elevate canopy 2m +/-, minor dieback throughout.	3	Remove	17
18	Manitoba Maple	<i>Acer negundo</i>	110	16	F	Broad Form	Located on adjacent property, Multiple leaders, structural branches pruned, crowded by adjacent tree, dieback where shaded from evergreens, suckers present on trunk and structural branches.	6.6	Preserve	18
19	White Spruce	<i>Picea glauca</i>	60	10	F	Pyramidal Form	Located on adjacent property, Multiple leaders, structural branches pruned, crowded by adjacent tree, dieback where shaded from evergreens, suckers present on trunk and structural branches.	3.6	Remove	19
20	Colorado Spruce	<i>Picea pungens</i>	15	3.5	P	One Sided Form	Declining due to crowding/shade from adjacent trees, major dieback and sparse needles throughout.	1.8	Remove	20
21	Colorado Spruce	<i>Picea pungens</i>	14	3.5	P	One Sided Form	Declining due to crowding/shade from adjacent trees, major dieback and sparse needles throughout.	1.8	Remove	21

22	Colorado Spruce	<i>Picea pungens</i>	57	8	F	Pyramidal Form	Mature tree, lower branches pruned to elevate canopy 2m +/-, minor dieback throughout.	3.6	Remove	22
23	Ivory Silk Lilac	<i>Syringa reticulata</i>	26	5	F	Asymmetrical Form	Leaning, contorted trunk, small canopy, mechanical damage present.	1.8	Remove	23
24	Manitoba Maple	<i>Acer negundo</i>	76	15	F	Broad Form	Located on adjacent property, Multiple leaders, structural branches pruned, leaning, suckers present on trunk and structural branches.	4.8	Preserve	24
25	False Spirea	<i>Sorbaria sorbifolia</i>	1.5	G	Shrub Form/Hedge	Deciduous hedge along the top of bank limit.	N/A	Remove	25	
26	Mixed Vegetation			F	Woodlot/Valley	Wood lot along steep slope consisting mainly of Manitoba maple. Some white spruce present at east limits near adjacent properties and flowering dogwood and buckthorn as understorey plant material.	Top of Bank	Preserve	26

27	Cherry Sp.	<i>Prunus sp.</i>	27	6	P	Broad Form	Located on adjacent property, declining, 80% dead, one-sided canopy, crowded by wood lot on bank.	1.8	Preserve	27
28	Norway Maple	<i>Acer platanoides</i>	37	8	F	Asymmetrical Form	Located on adjacent property to the East, canopy pruned due to utility conflicts, additional trees of the same species continue in a headgrowth along property, damage due to fallen spruce.	2.4	Preserve	28
