REPORT ON
SLOPE STABILITY INVESTIGATION
PROPOSED RESIDENTIAL SUBDIVISION
336 KING STREET EAST, CALEDON, ONTARIO

PREPARED FOR:
336 KINGS RIDGE INC.

PREPARED BY:
DS CONSULTANTS LTD.

DS Project No : 18-566-30
Date : August 9, 2018

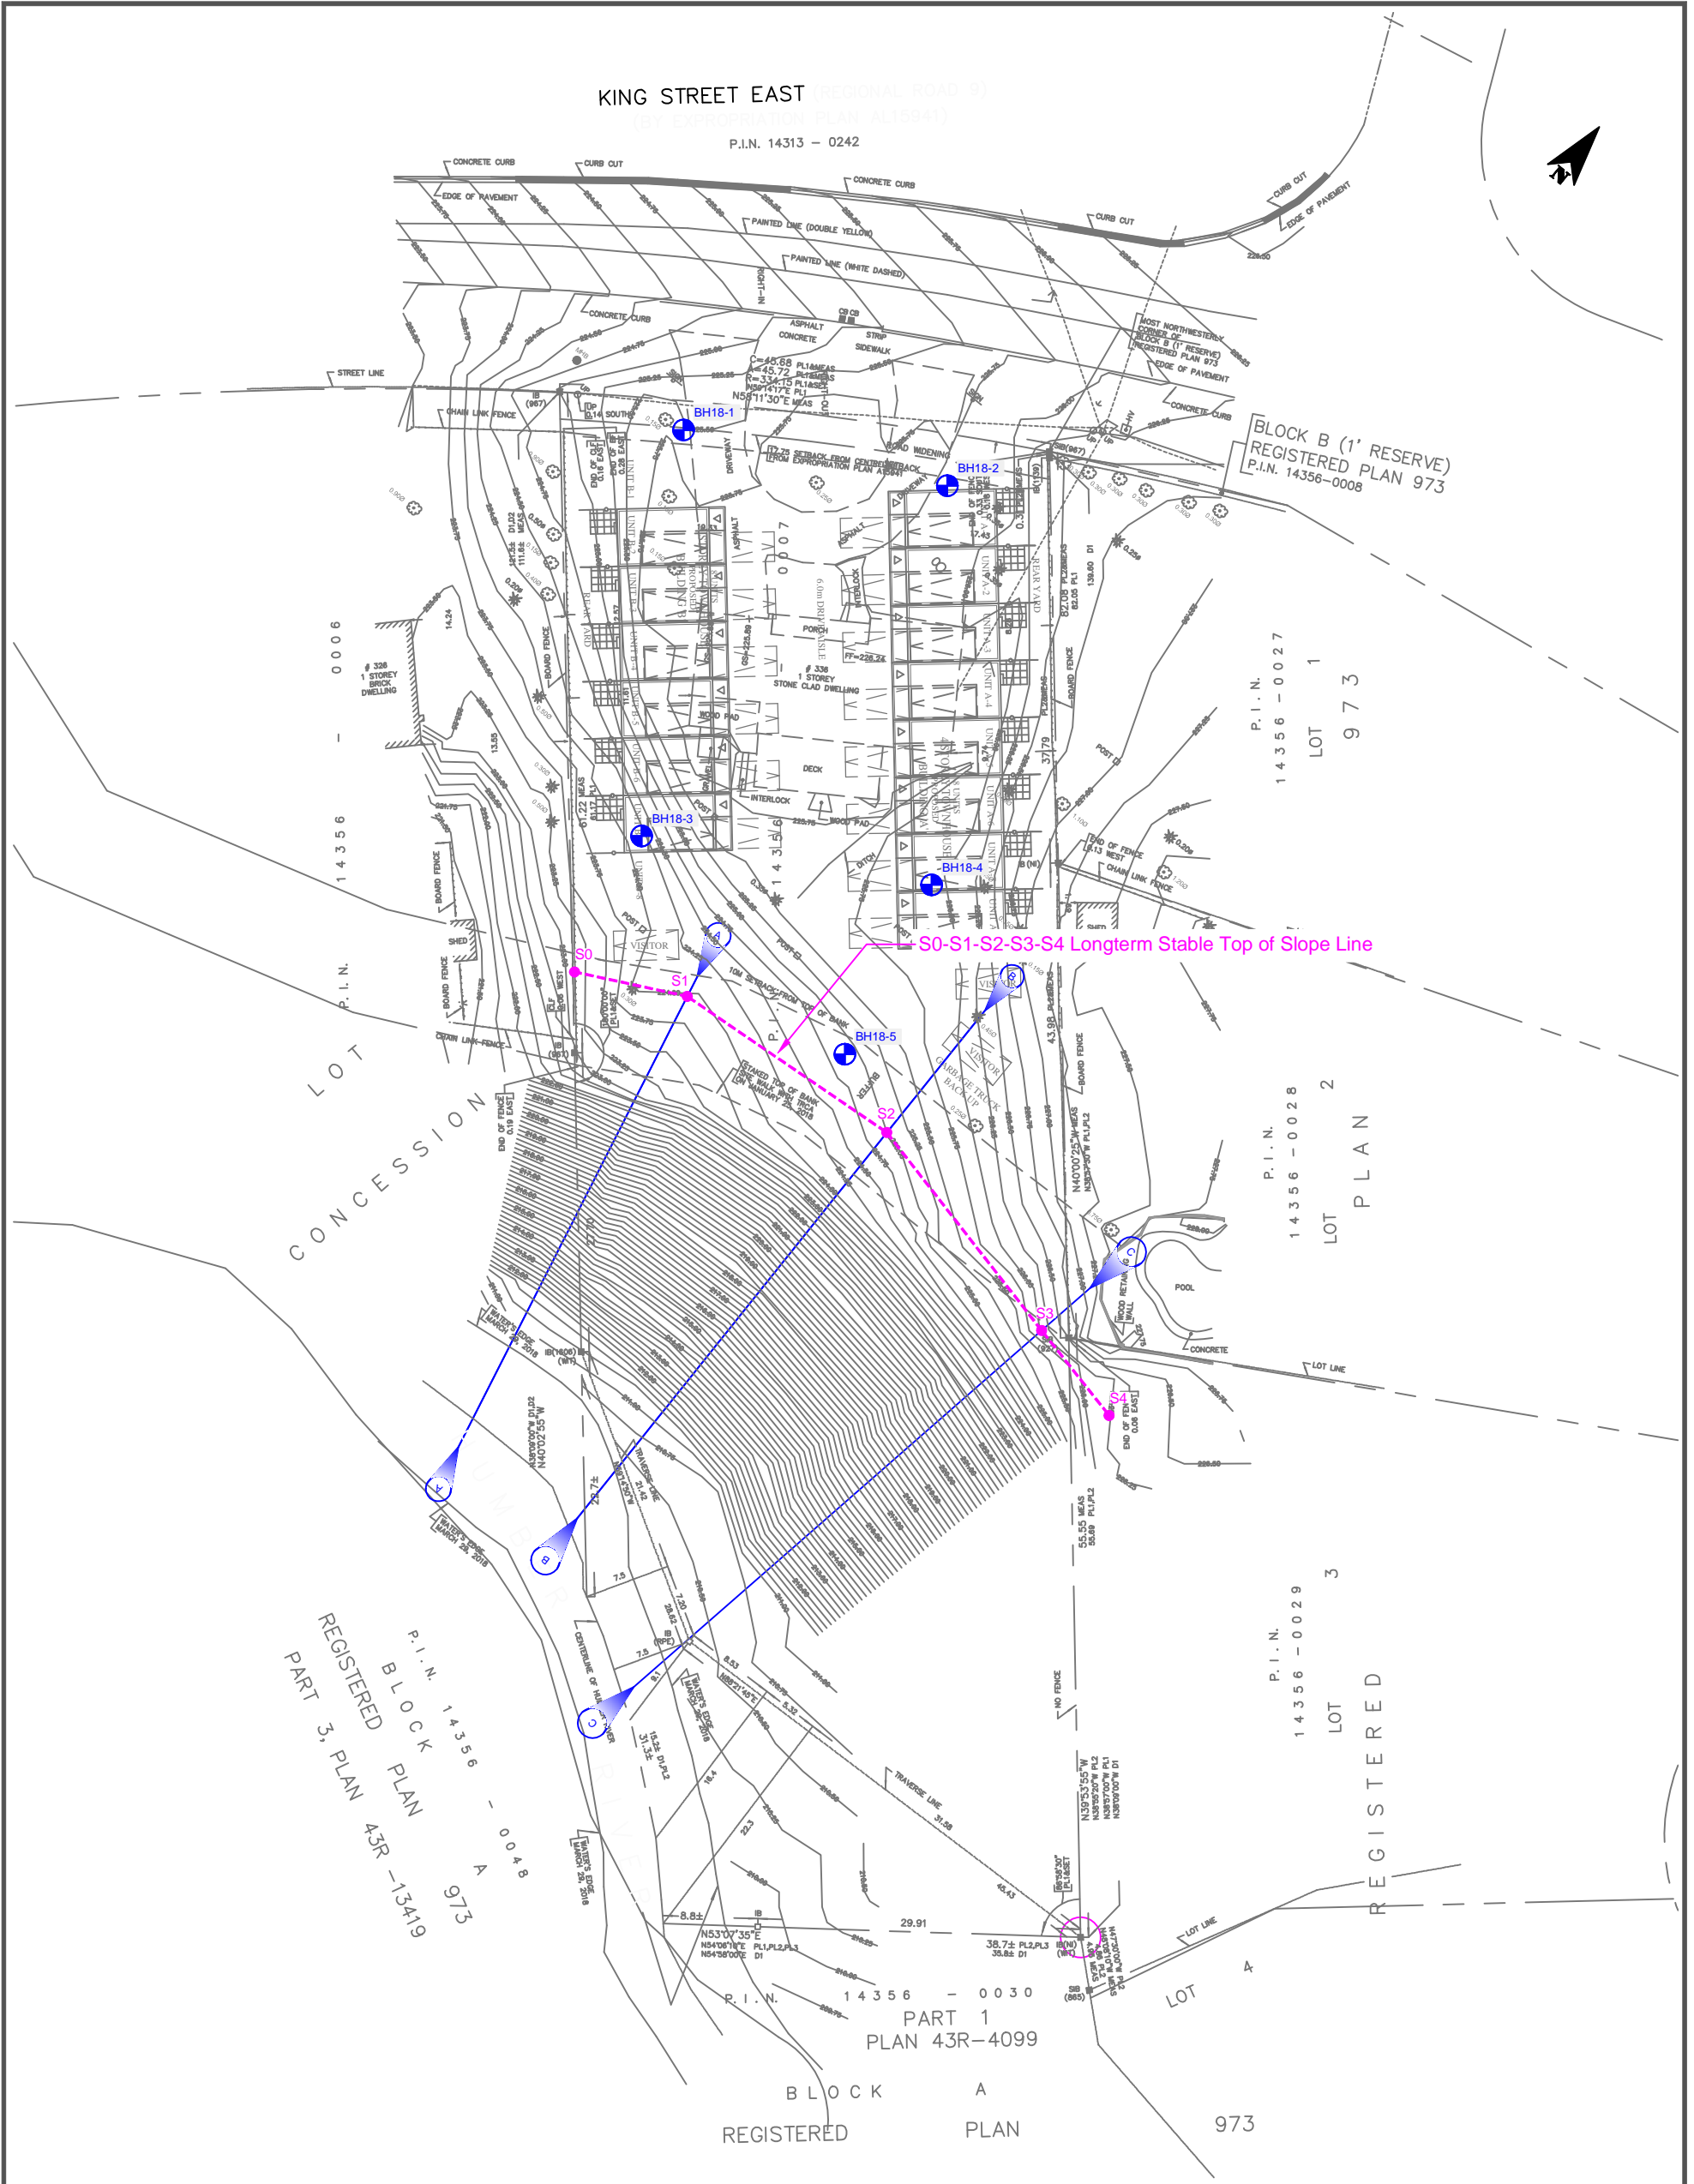
Based on the long-term stable top of slope at Sections A-A to C-C, and our field observations, the recommended long-term stable top of slope lines (Line S0-S1-S2-S3-S4) is shown on Drawing 1.

This long-term stable top of slope line must be reviewed by the Toronto & Region Conservation Authority (TRCA) for their approval, staked on site and then surveyed to verify the lines on design drawings.

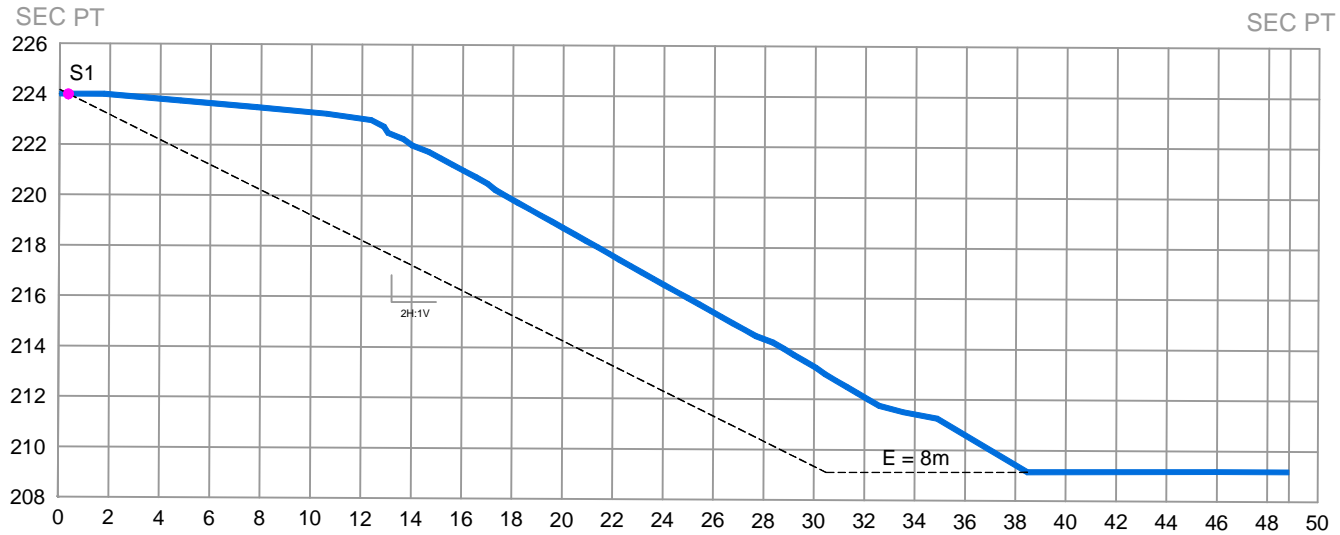
- The height of the ravine slope, from ravine to top of bank, typically ranges from about 13m to 17 m. The steepness of the slope varies from about 1.7H:1V to 2.2H:1V, as shown on Drawings 9 to 11.

- Points "S1" on Drawings 9 and 13 represents the long-term stable top of slope at Section A-A
- Point "S2" on Drawing 10 represents the long-term stable top of slope at Section B-B
- Point "S3" on Drawings 11 and 14 represents the long-term stable top of slope at Section C-C

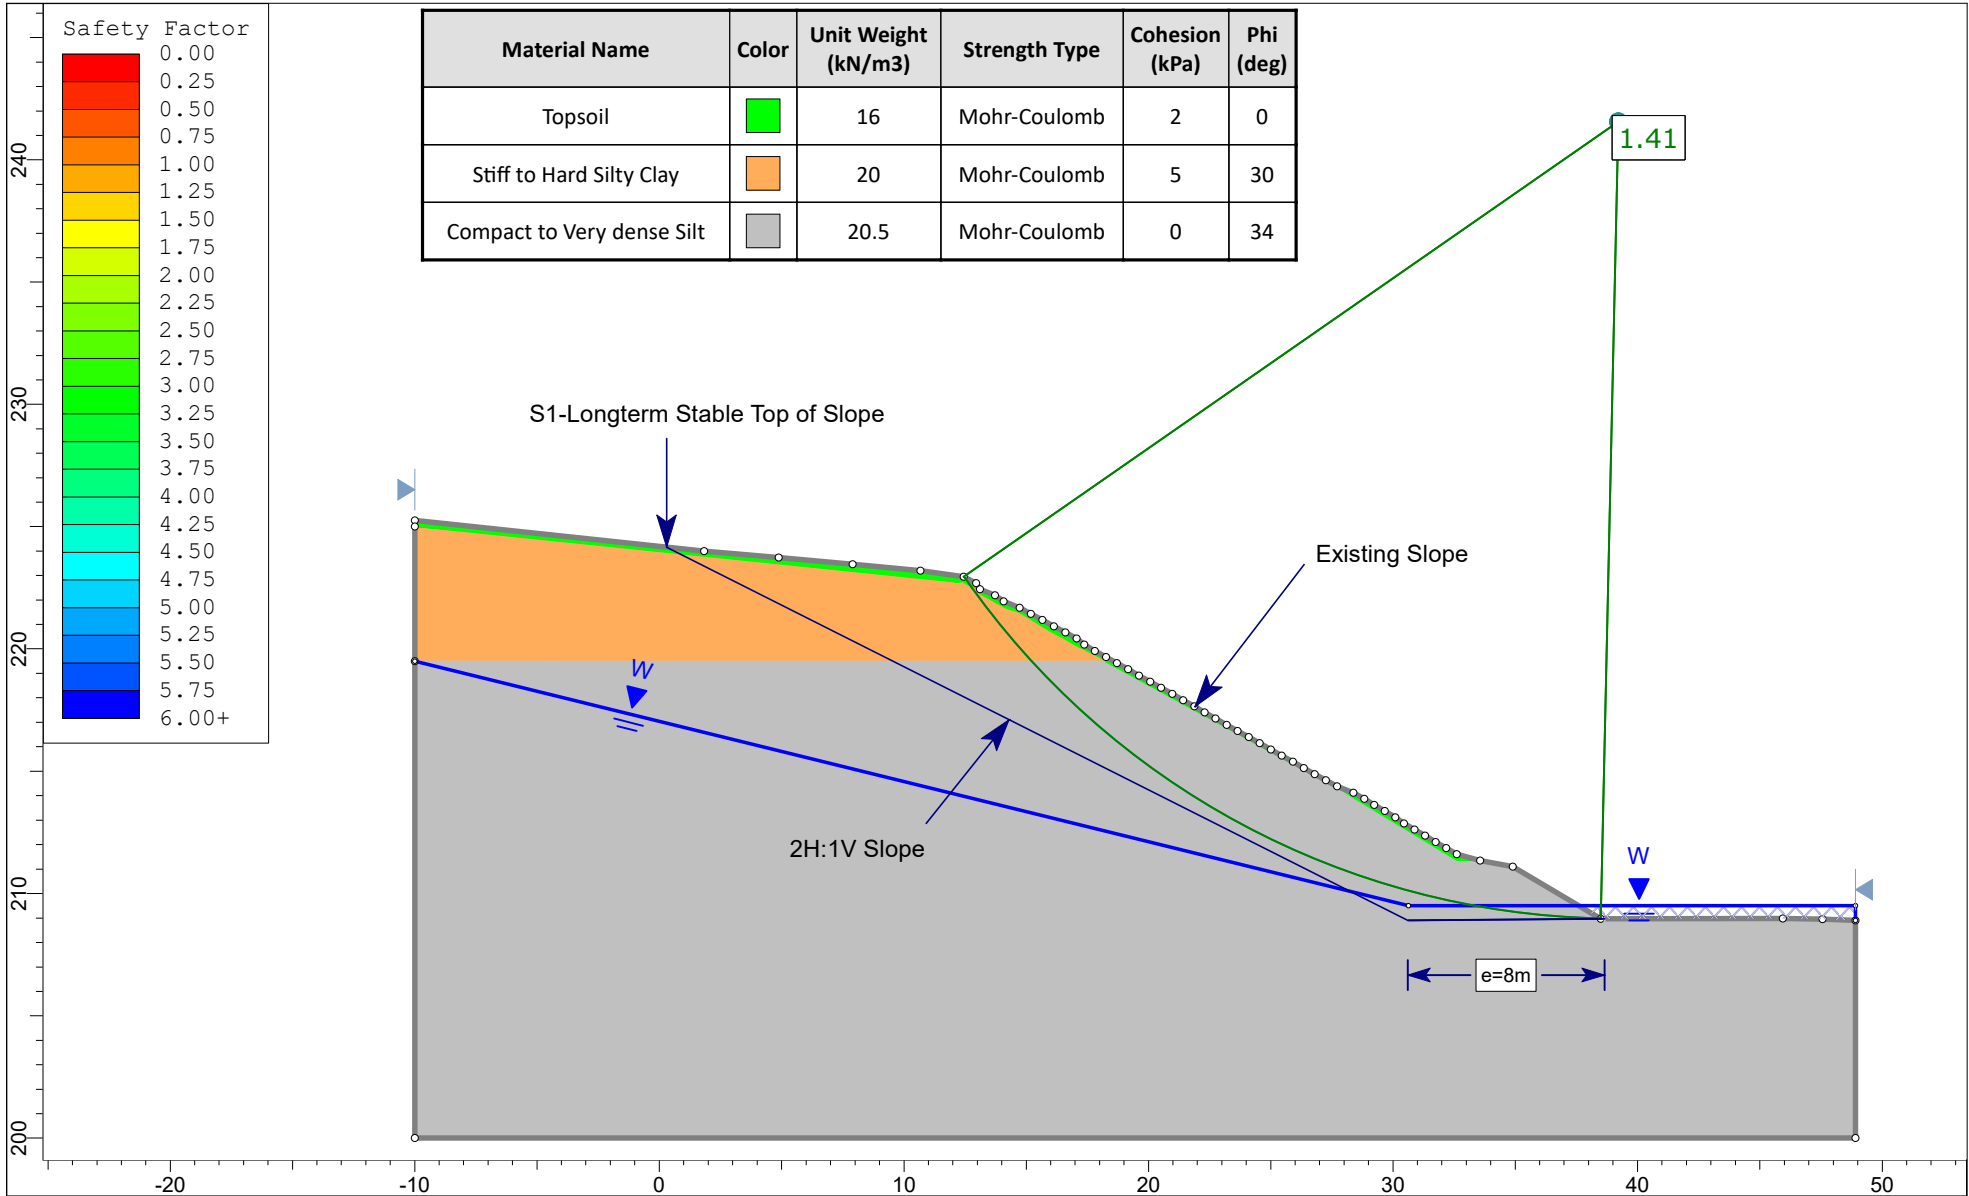
Project				Project No.-18-566-30-Slope Stability Analyses-336 King Street E., Caledon, ON	
Analysis Description				Existing Slope at Section A-A	
Drawn By	AS	Scale	1:309	Company	DS Consultants Ltd
Date	2018-08-09, 1:38:57 PM			File Name	Drawing 12.slim

Slope Location	Calculated Factor of Safety (FS)	Long-Term Stability
Section A-A (See Drawing 12)	1.41	Unstable (FS < 1.5)
Section C-C (See Drawing 13)	1.62	stable (FS > 1.5)

The calculated factor of safety of the existing slope at A-A is 1.41, which is less than the minimum acceptable value of 1.5. Therefore, the existing slope at Section A-A is considered unstable in terms of long term stability based on the TRCA requirements.

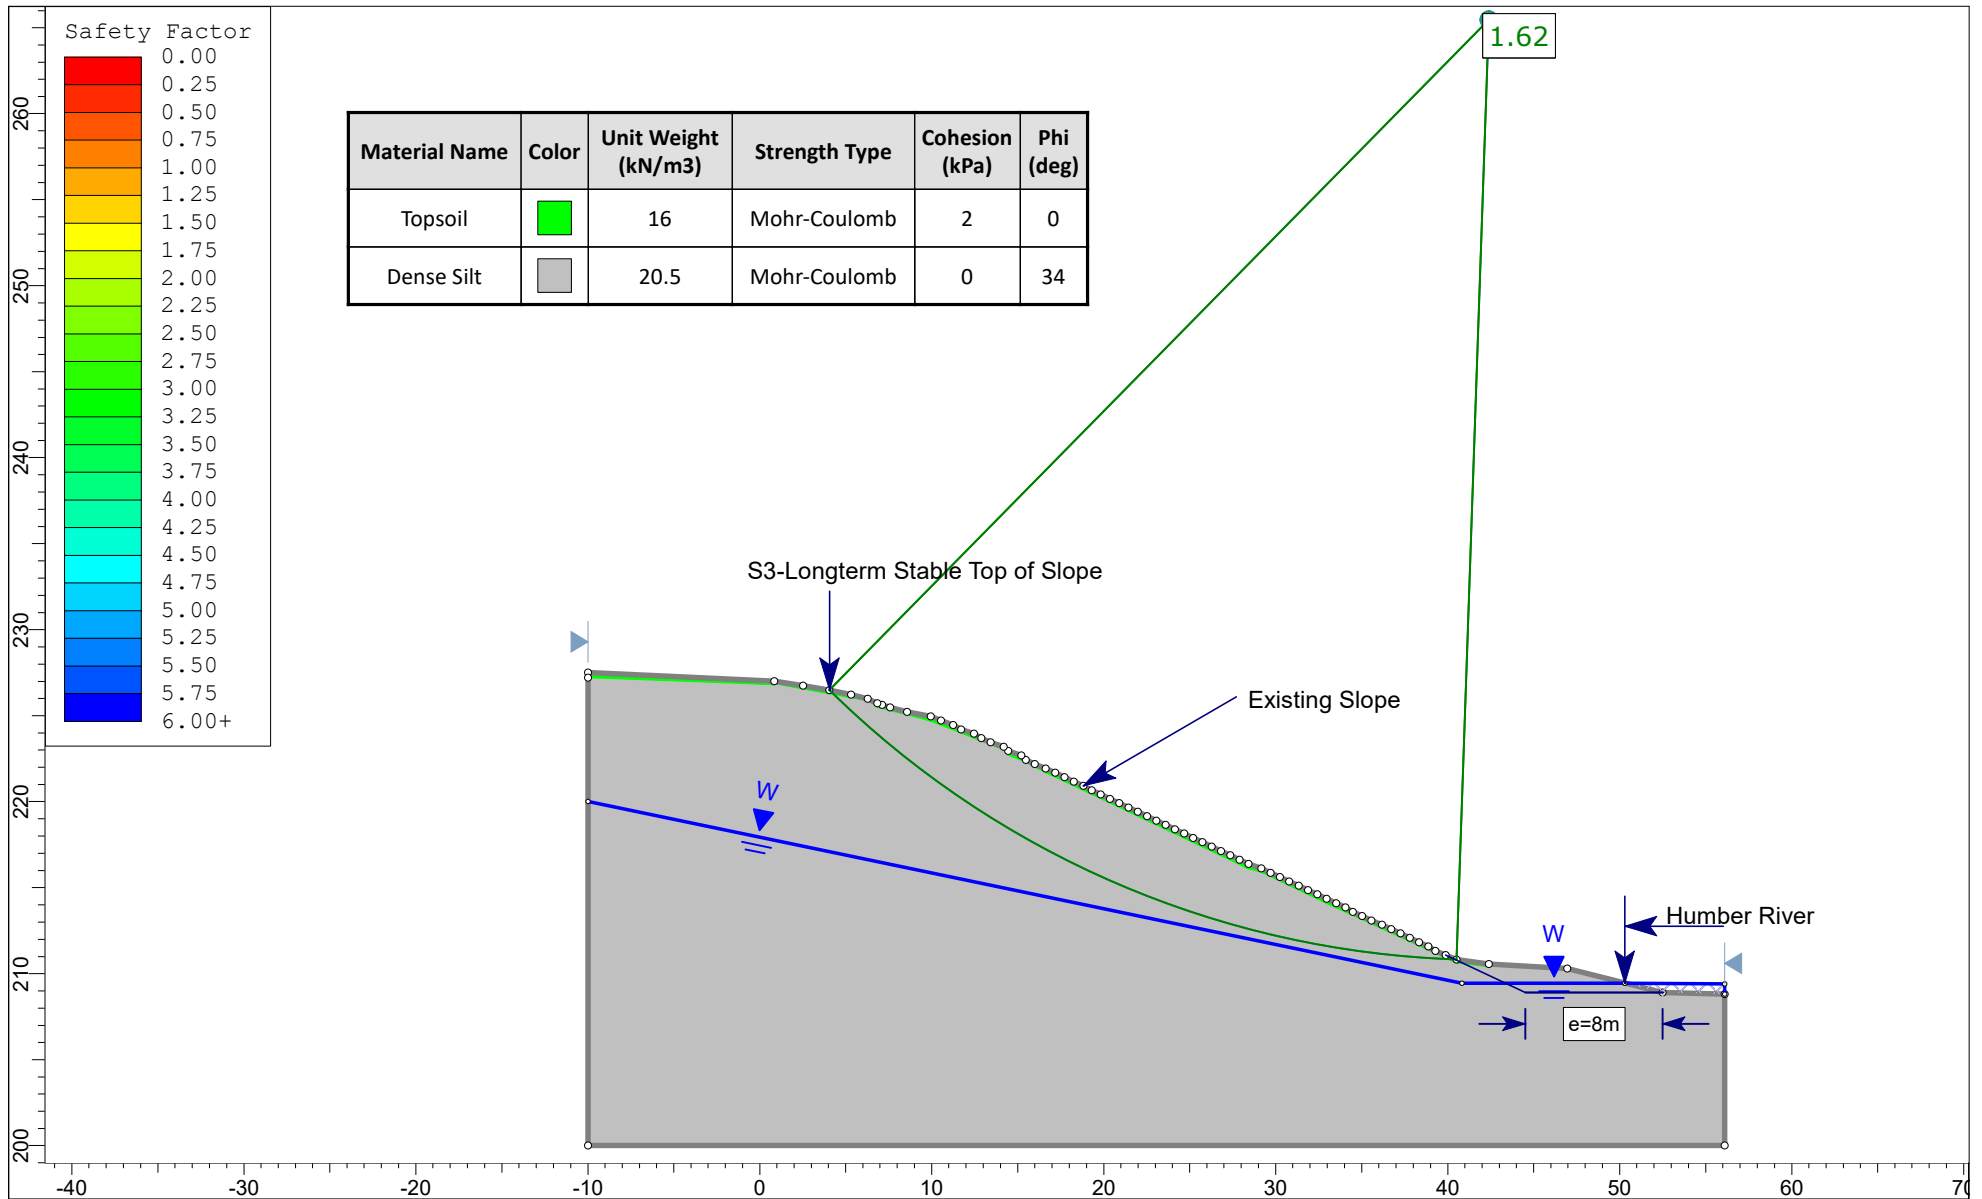
Project				Project No. 18-566-30 - Slope Stability Assessment-336 King St. E, Caledon, ON	
Analysis Description				Existing Slope at Section C-C	
Drawn By	AS	Scale	1:439	Company	DS Consultants Ltd
Date	2018-08-09, 1:14:40 PM			File Name	Drawing 13.slim

The calculated factor of safety of the existing slope at C-C is 1.62, which is greater than the minimum acceptable value of 1.5. The existing slope at Section C-C is considered stable in terms of long term stability based on TRCA requirements.

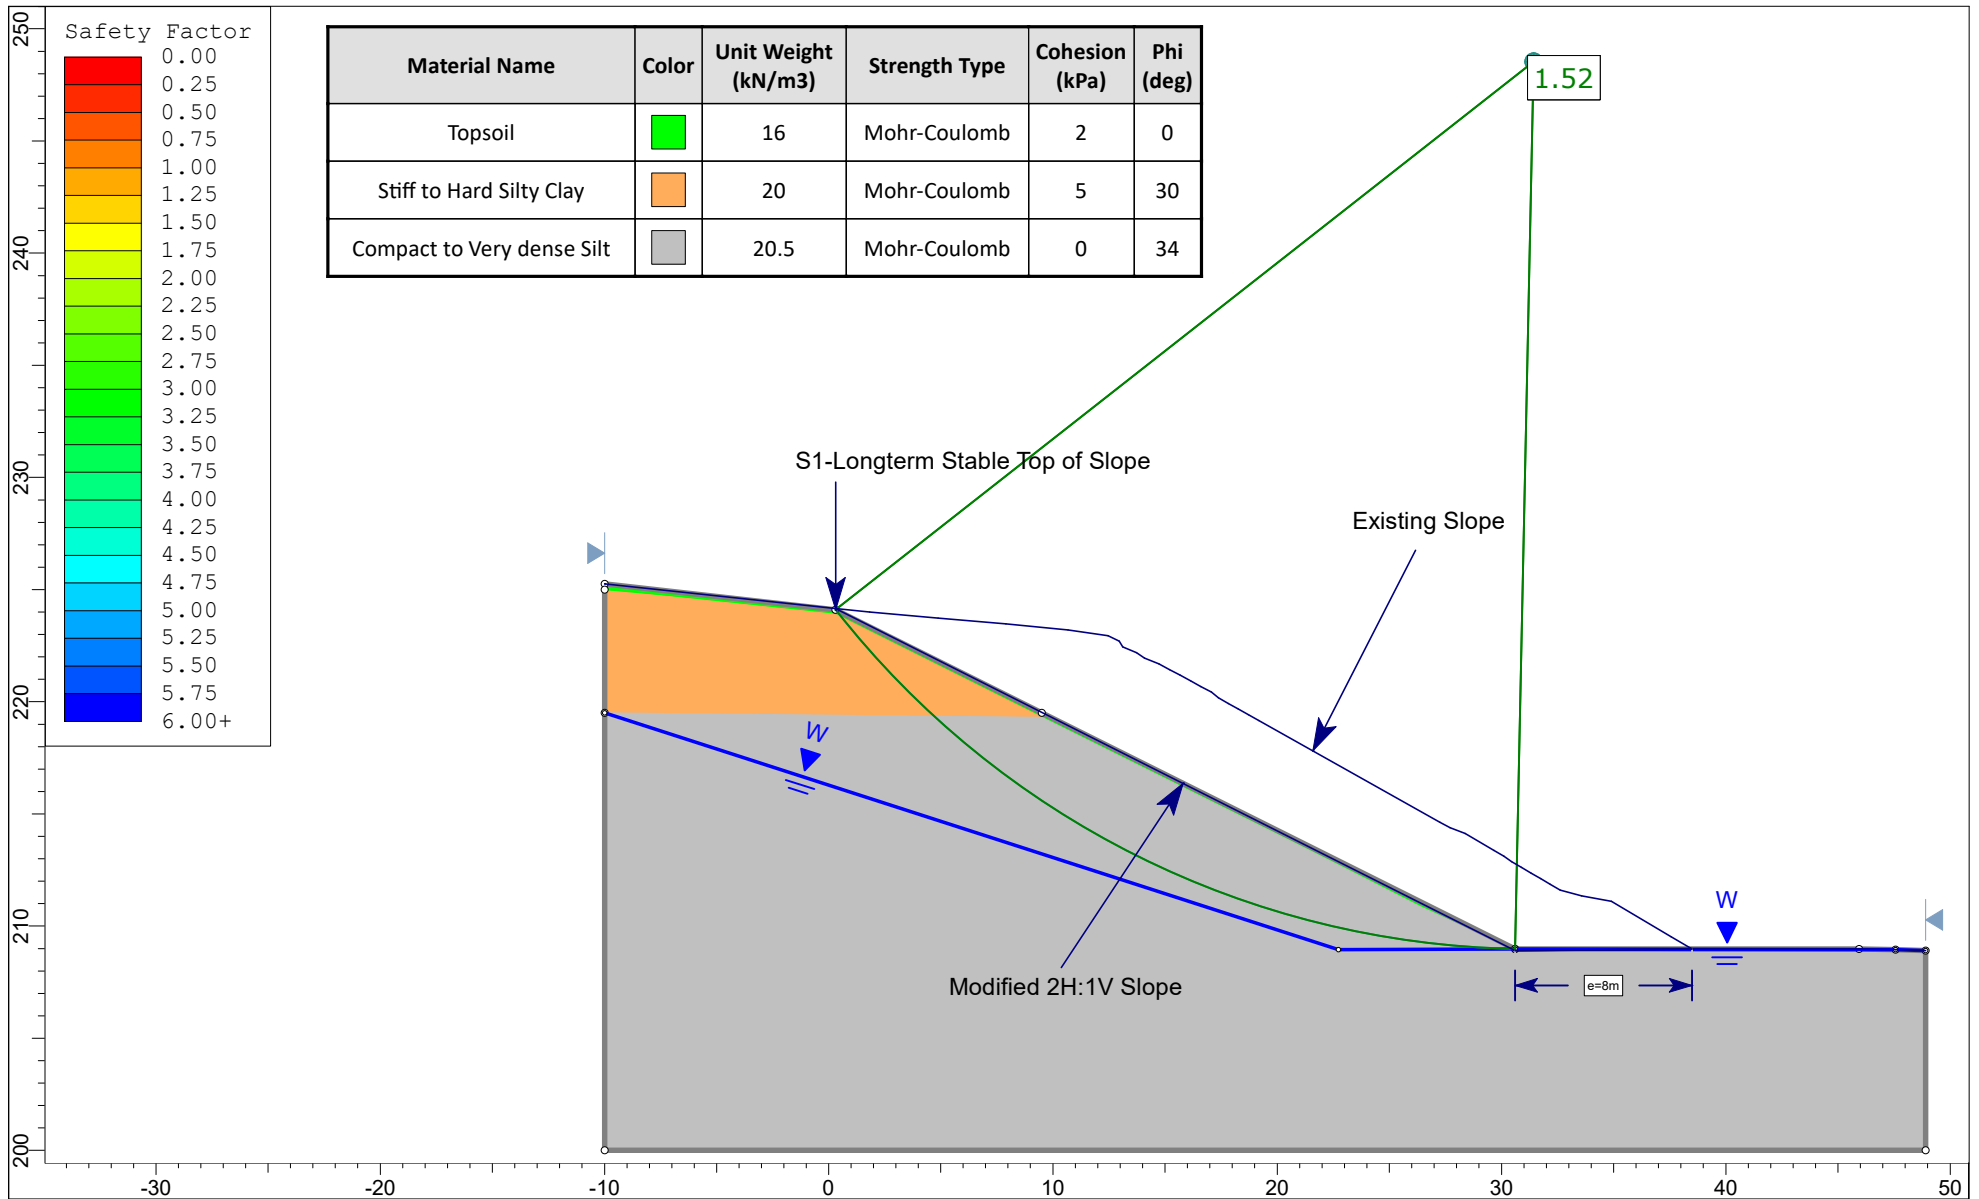
In order to determine the long-term stable slope at site, analysis of the imaginary 2H:1V slope together with erosion allowance of 8m at Section A-A (modified slope) has been carried out, and the results are

presented on Drawing 14. The calculated factor of safety of the 2H:1V slope at Section A-A is 1.52, which is greater than the minimum acceptable value of 1.5. The 2H:1V slope as shown on Drawing 14 is considered stable in terms of long-term stability.

An erosion allowance of 8m together with 2H:1V slope will be applied to determine the long-term stable top of slope.

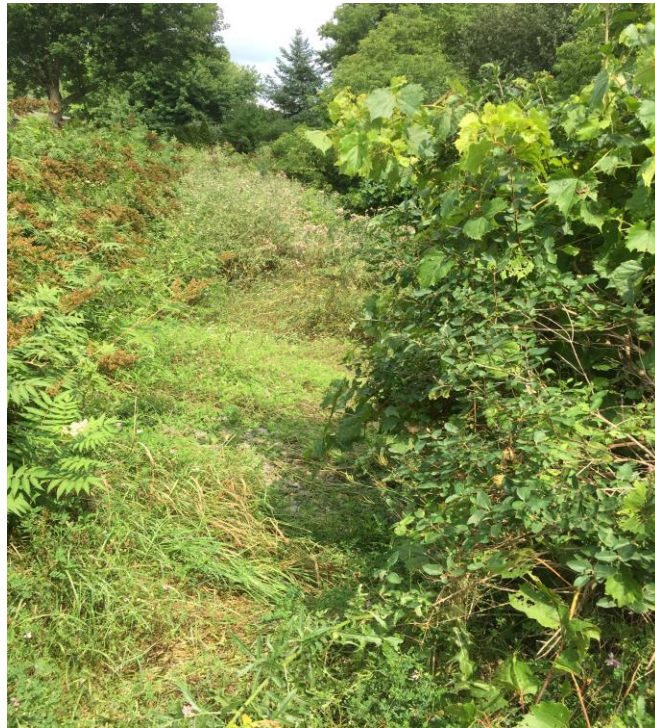
Photo 4: Vegetation on Slope Surface near the top of slope (looking East)

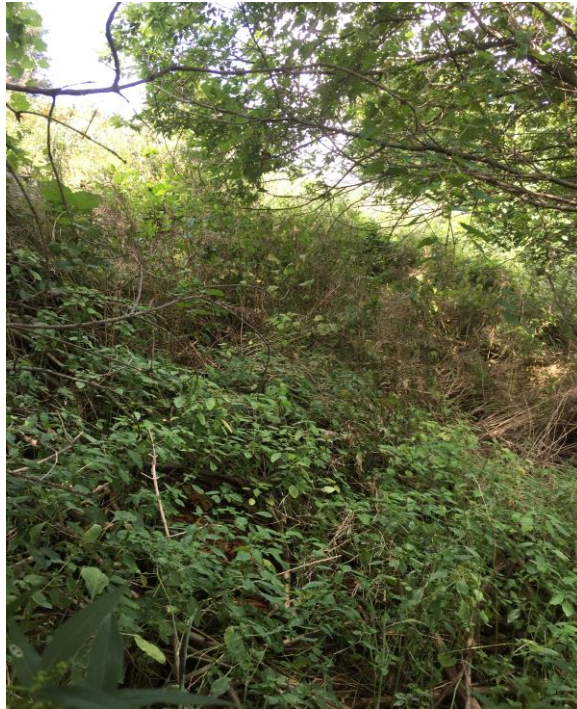
Photo 5: Vegetation on Slope Surface (looking southeast-downslope)

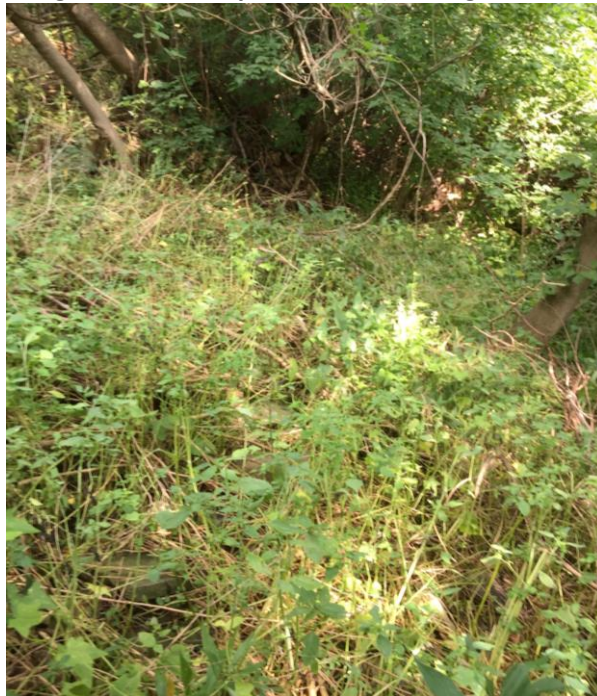
Photo 8: Vegetation on Slope Surface (looking southwest-downslope)

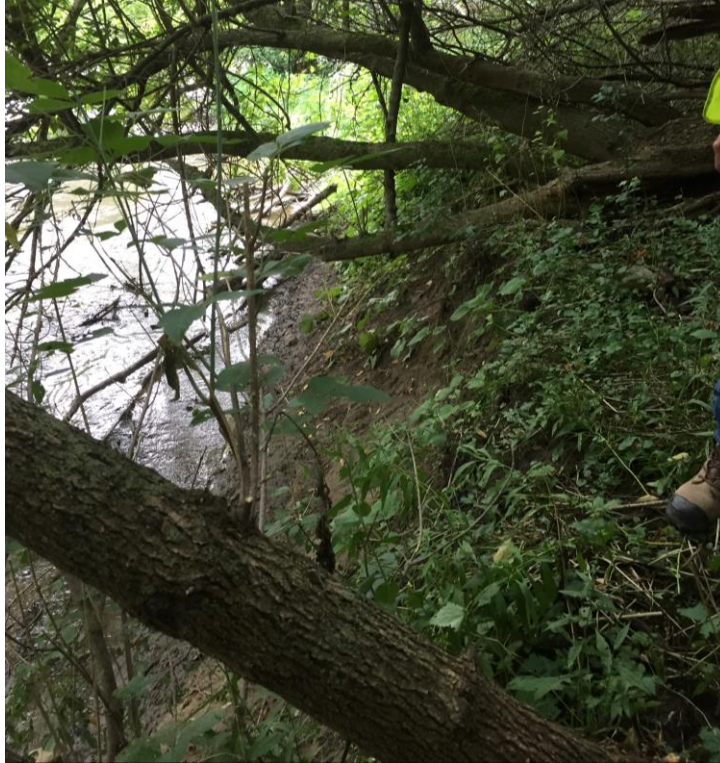
Photo 9: Watercourse Conditions Near Section B-B (looking west)

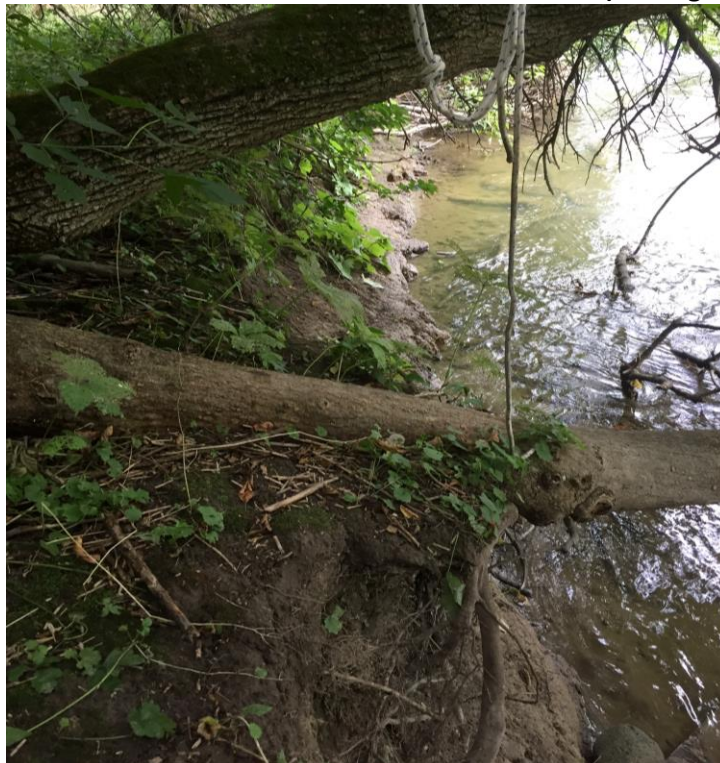
Photo 10: Watercourse Conditions Near Section B-B (looking east)

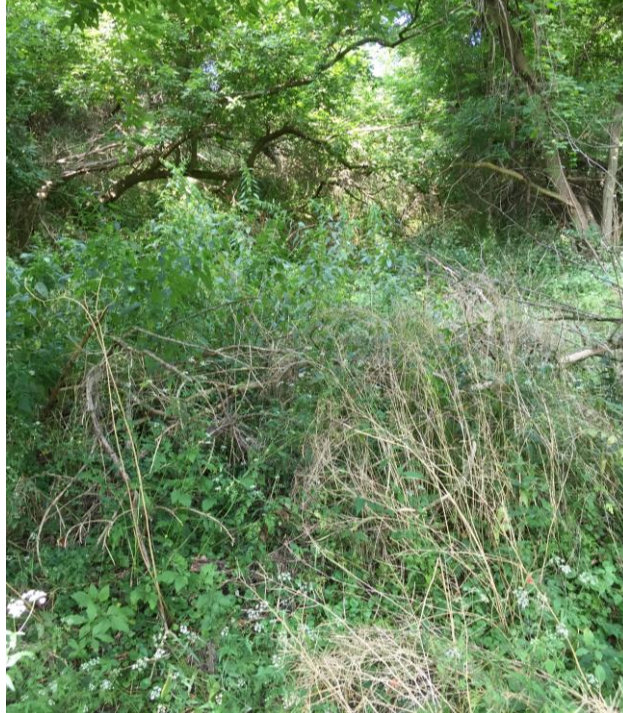
Photo 11: Vegetation Conditions near the toe of slope (looking north, upslope)

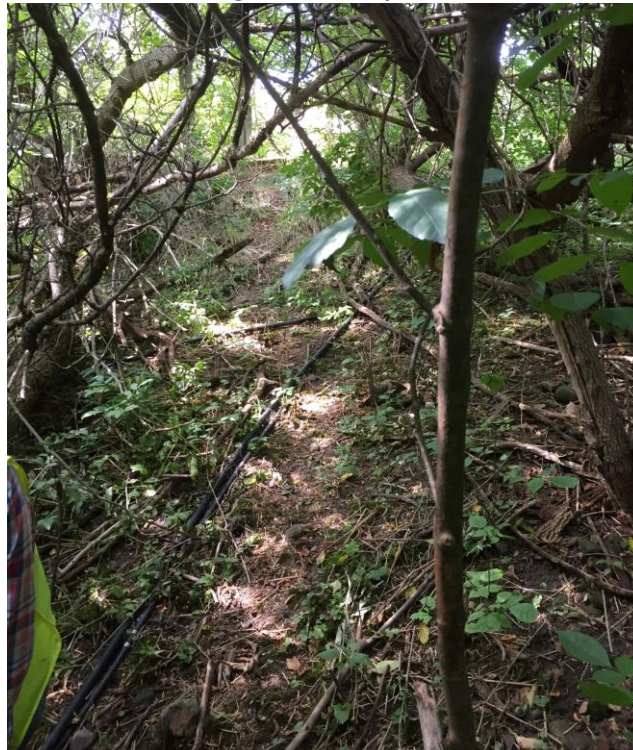
Photo 12: Photo 11: A Walking trail on Slope between Section A-A and B-B

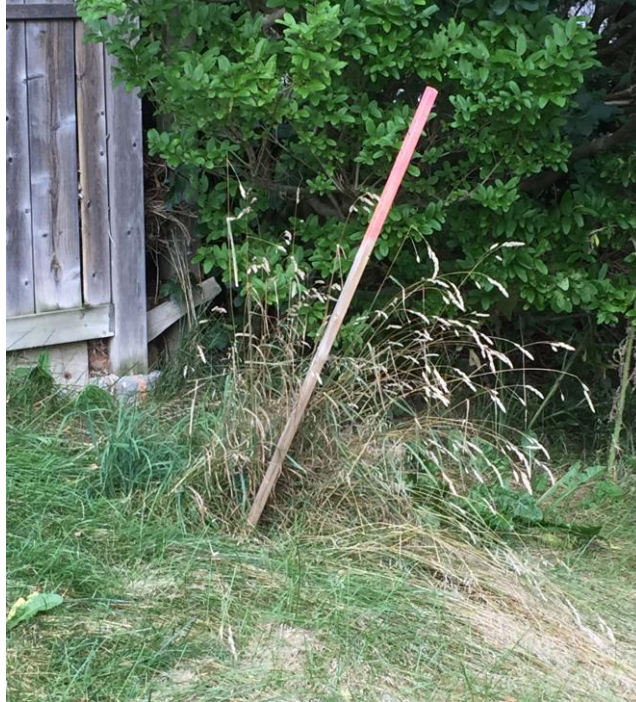
Photo 13: TRCA Staked Top of Slope at East Property Boundary (near Section C-C, looking south)
