Tree Inventory and Assessment Report
Laurelpark Subdivision
Part Lot 19, Concession 6, Town of Caledon (Albion)
Town of Caledon, Region of Peel

May 2017

AEC 08-019

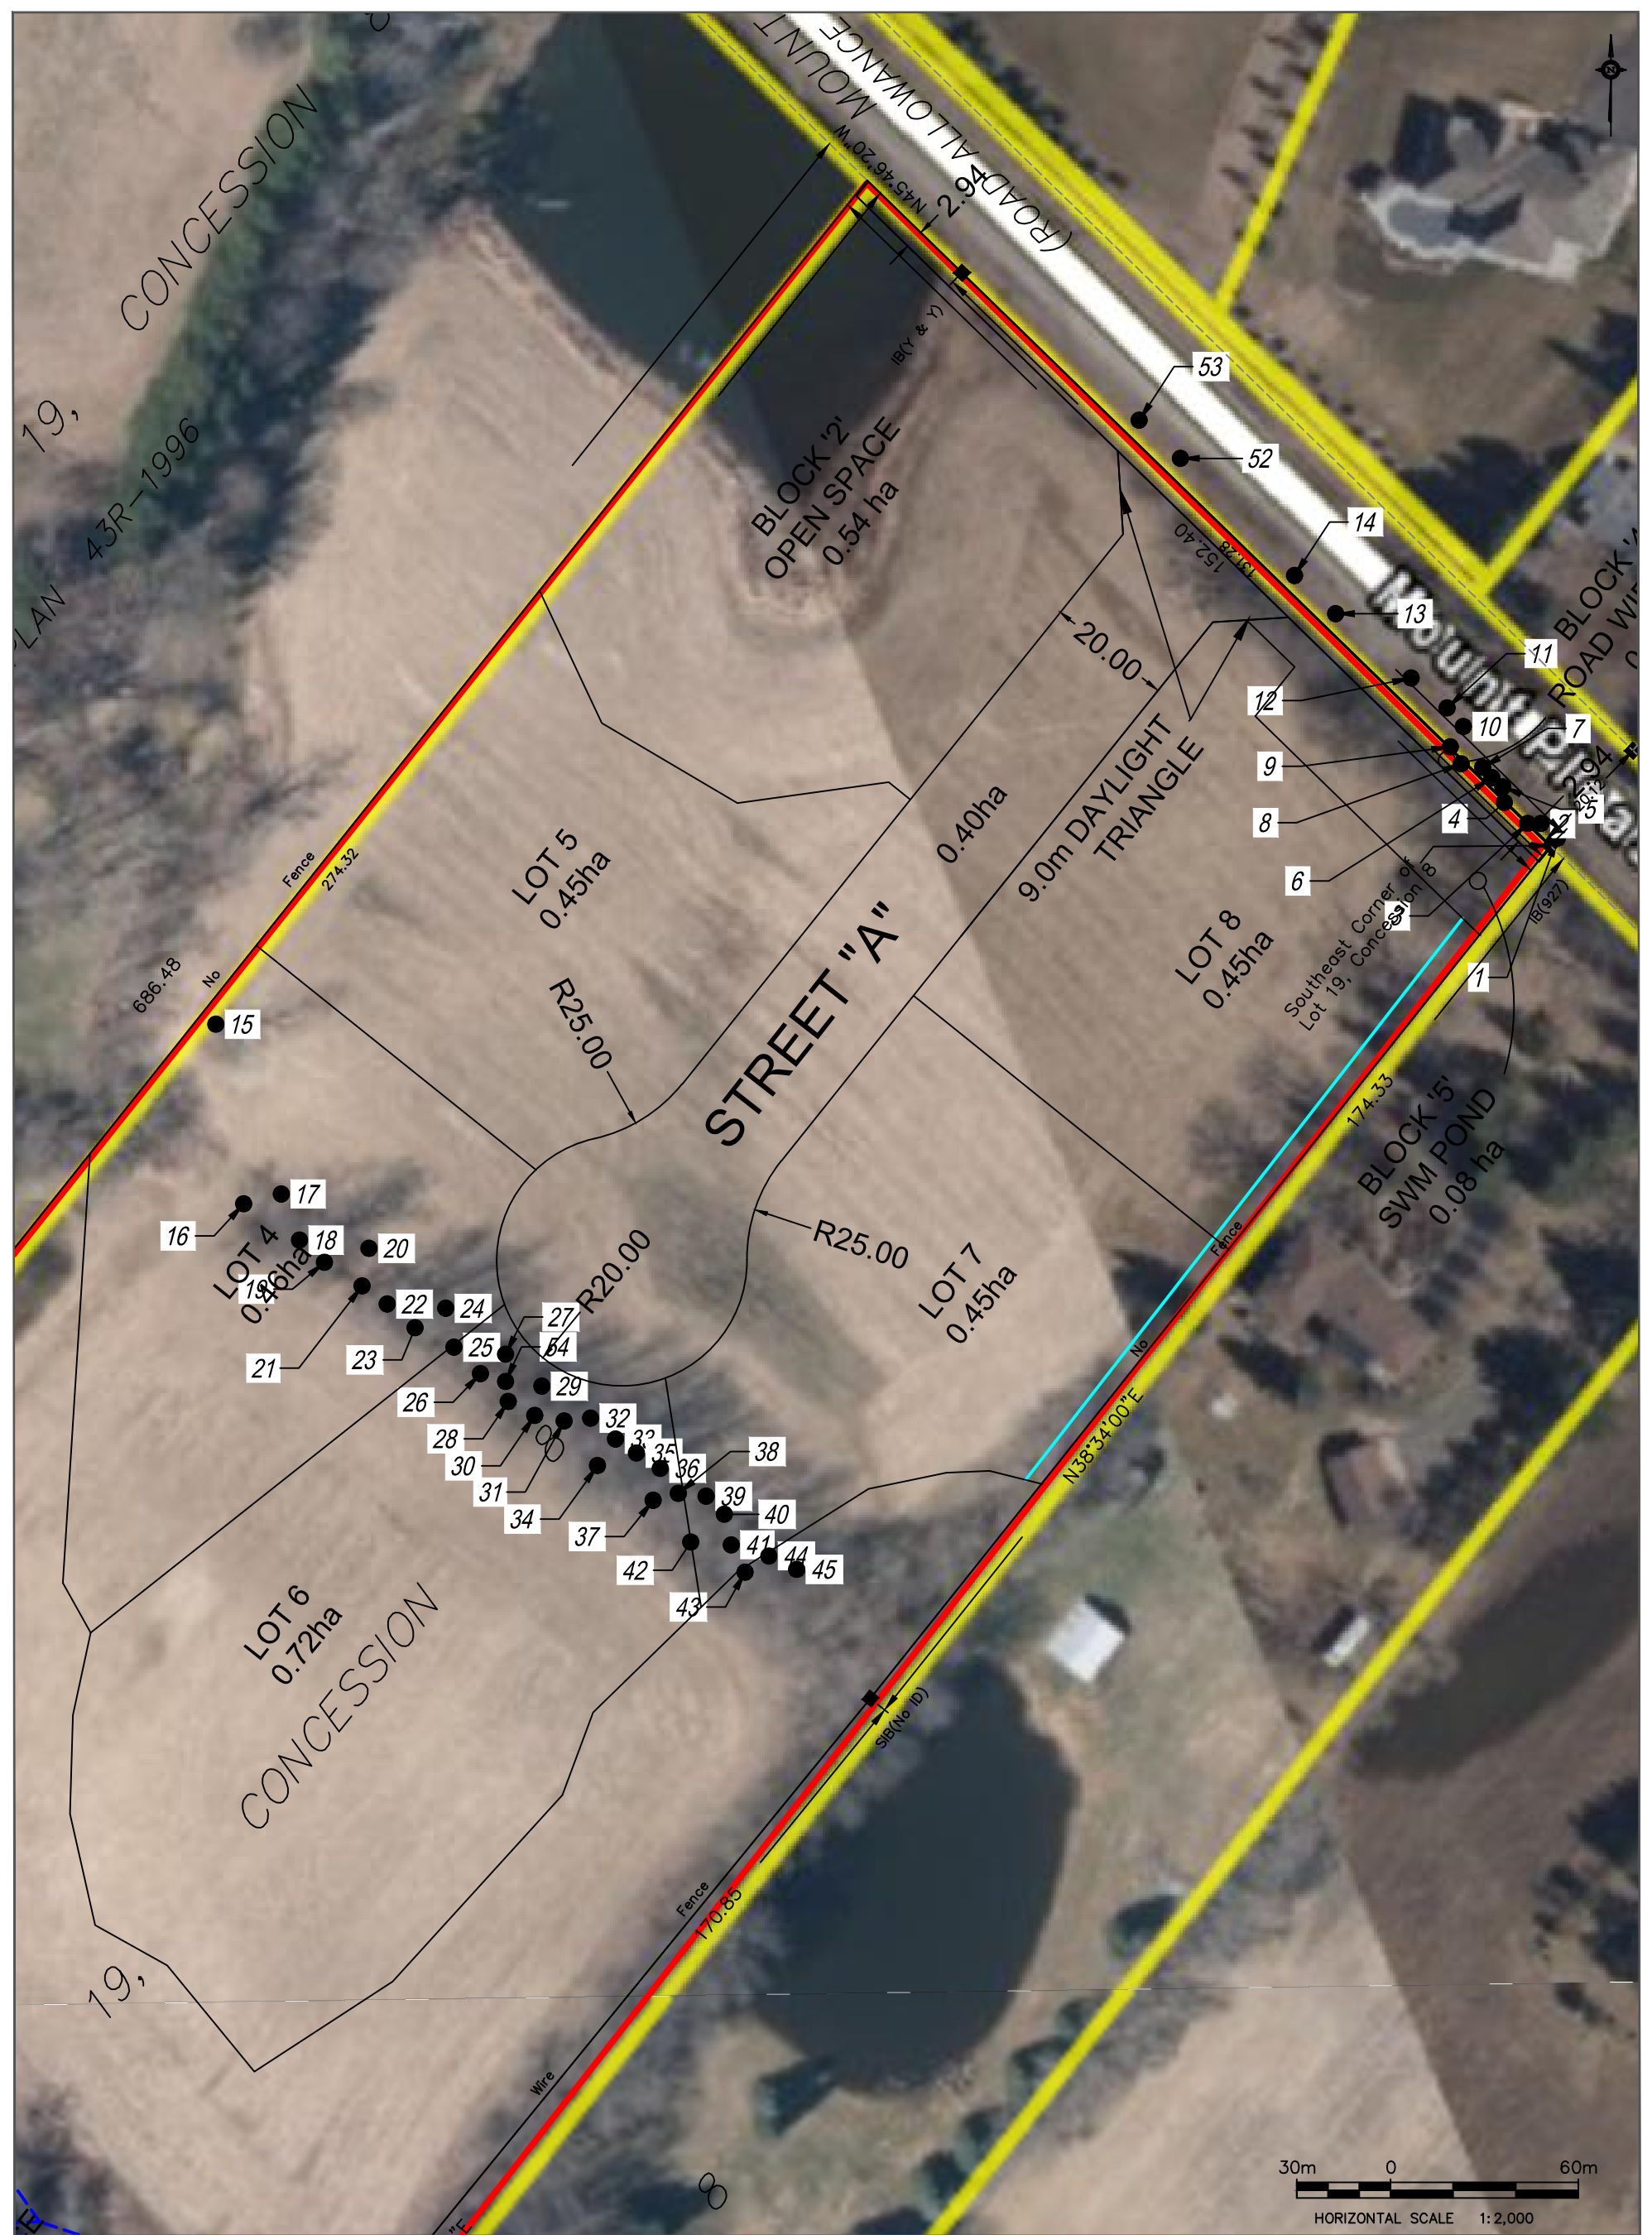
Northern Tree Locations

Trees #1, #2 and #15 (see Figure 2) have been identified as hazard trees within 10 metres of residential lands and should be removed from the property prior to any construction activities. Theoretically, all 22 inventoried trees in a state of decline should be considered a safety hazard, although the trees listed above in proximity to residential lands should be considered as top priority for removal.

The neighbouring residential property to the southeast also has several mature trees growing in the front yard, with portions their root zones likely extending into the subject site. It is recommended that tree protection fencing be installed 3 metres offset from the southeastern property boundary (see Figure 2) adjacent to these trees to ensure minimal impact to their respective root zones. No construction activities such as paving, building construction, excavating, filling or equipment storage would be permitted within this root protection area.
