## **Triple Crown Line Development Inc.**

**Revised Slope Stability Analysis  
Triple Crown Line Residential  
Development  
Airport Road and Cranston Drive  
City of Caledon East, Ontario**

**Project Number**  
BRM-00235186-G0

**Date Submitted**  
September 11, 2018

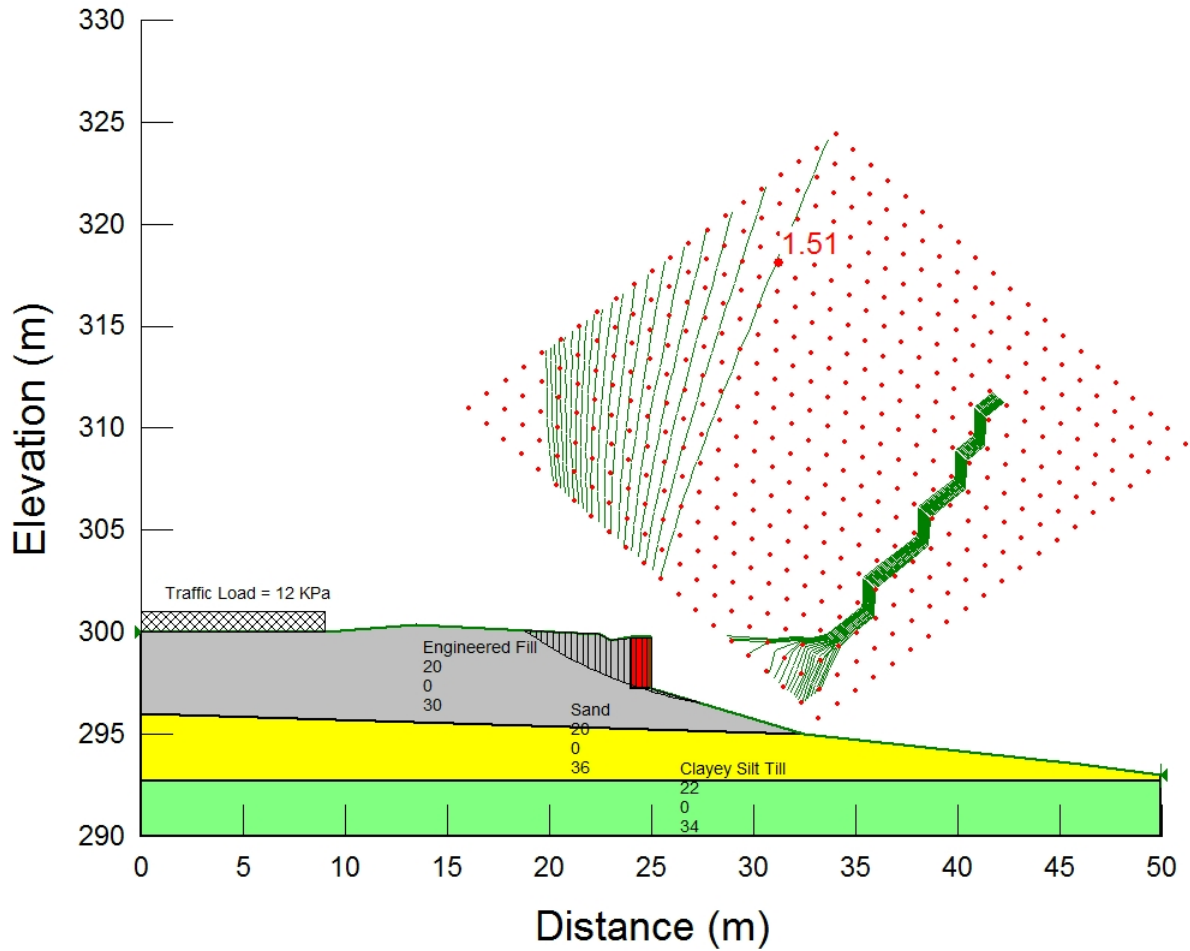
Figure 1  
Section 2 After Construction (Static)

The existing slope at this section is about 4.5 m high, and the slope gradient is very gentle at about 8H:1V at the toe and 22H:1V in the upper slope. The proposed slope is 5.0 m high, with a maximum retaining wall height of 2.5 m, gradient of 3H:1V at the toe of the slope and 20H:1V at the upper slope. The minimum calculated values of F.S. for this proposed section are 1.51 and 1.17 under static and seismic conditions, respectively. The results indicate that the physical top of slope will be the long term stable top of slope.

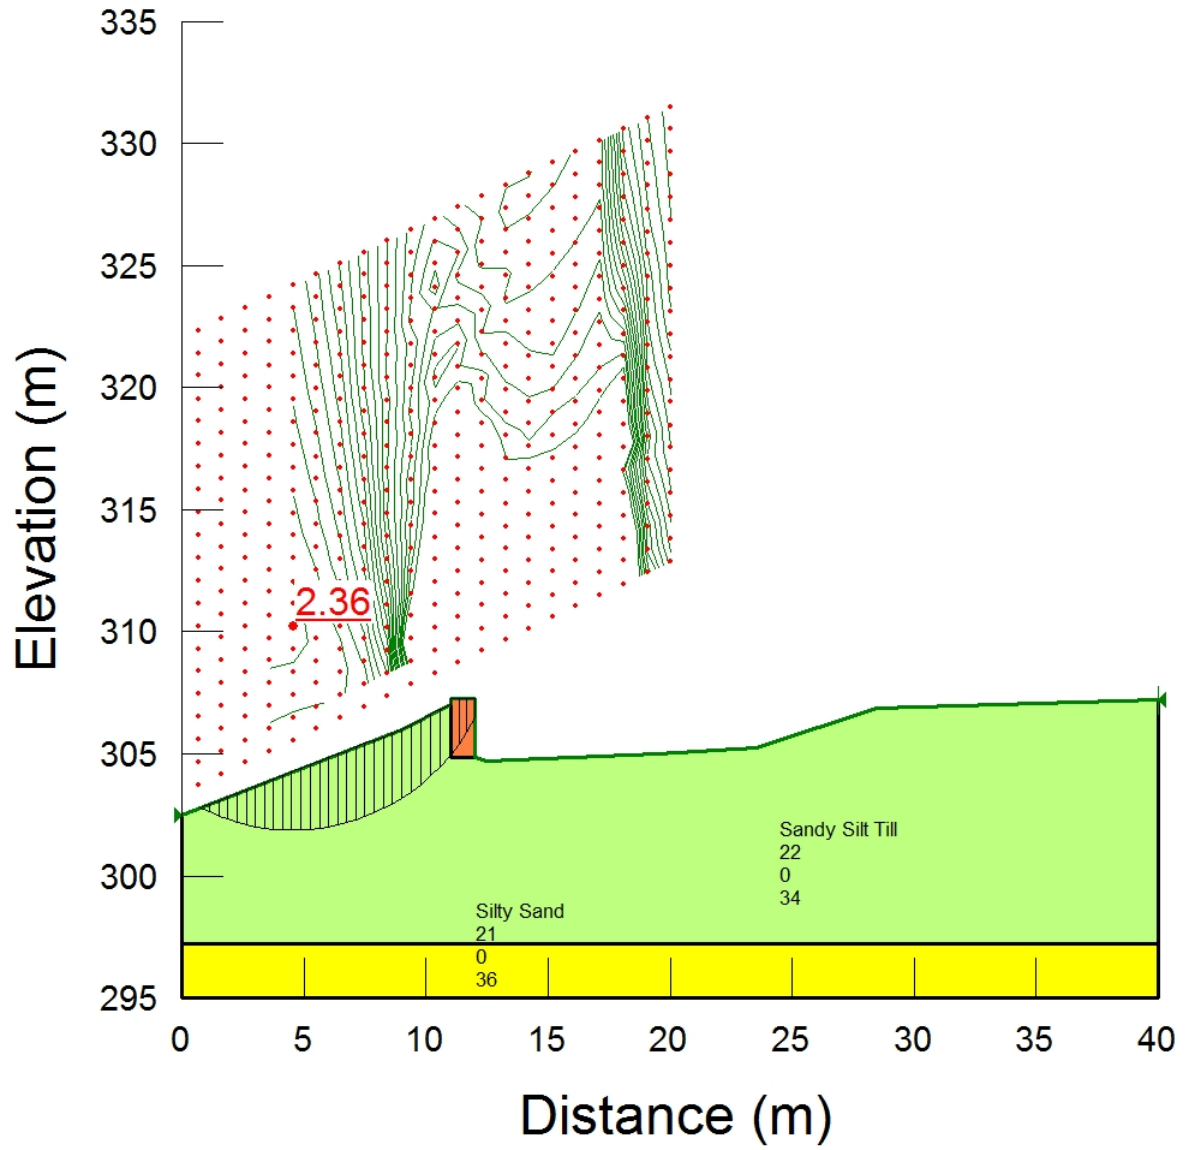
Figure 3  
Section 9 After Construction (Static)

The existing slope at this section is about 4.5 m high, and the slope gradient is very gentle at about 25H:1V with 3H:1V at the toe. The proposed slope at this section is the same as the existing, except for some trimming at the top of the slope and proposed retaining wall with a maximum height of 2.4 m. The minimum calculated values of F.S. for this proposed section are 2.36 and 1.93 under static and seismic conditions, respectively. The results indicate that the physical top of slope will be the long term stable top of slope.

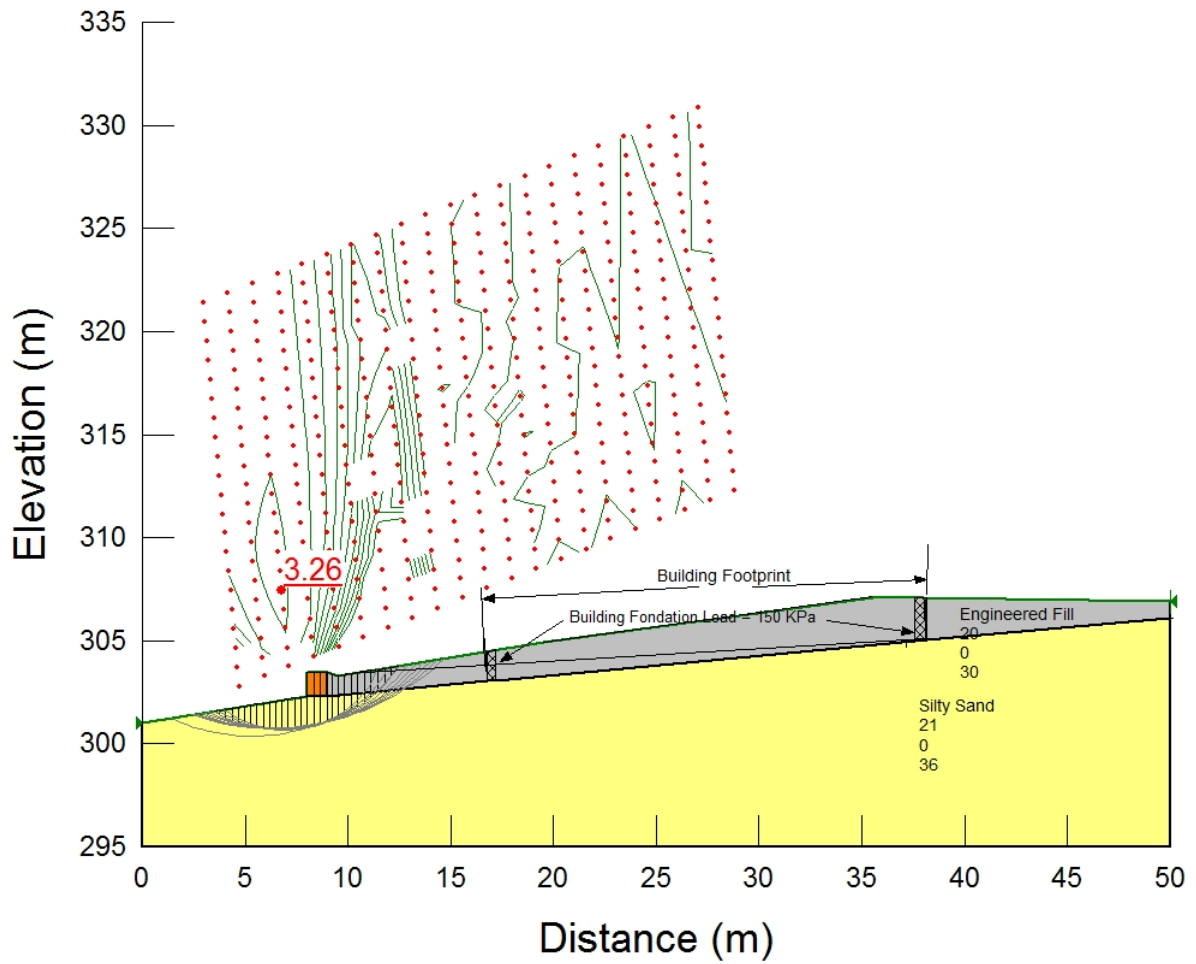
Figure 5  
Section 10 After Construction Condition (Static)

The proposed slope at this section is about 6.0 m high with about 1.1 m height wall, and the slope gradient is very gentle at about 5H:1V at the toe and 15H:1V in the upper slope. The minimum calculated values of F.S. for this section are 3.26 and 2.46 under static and seismic conditions, respectively. The results indicate that the physical top of slope will be the long term stable top of slope.

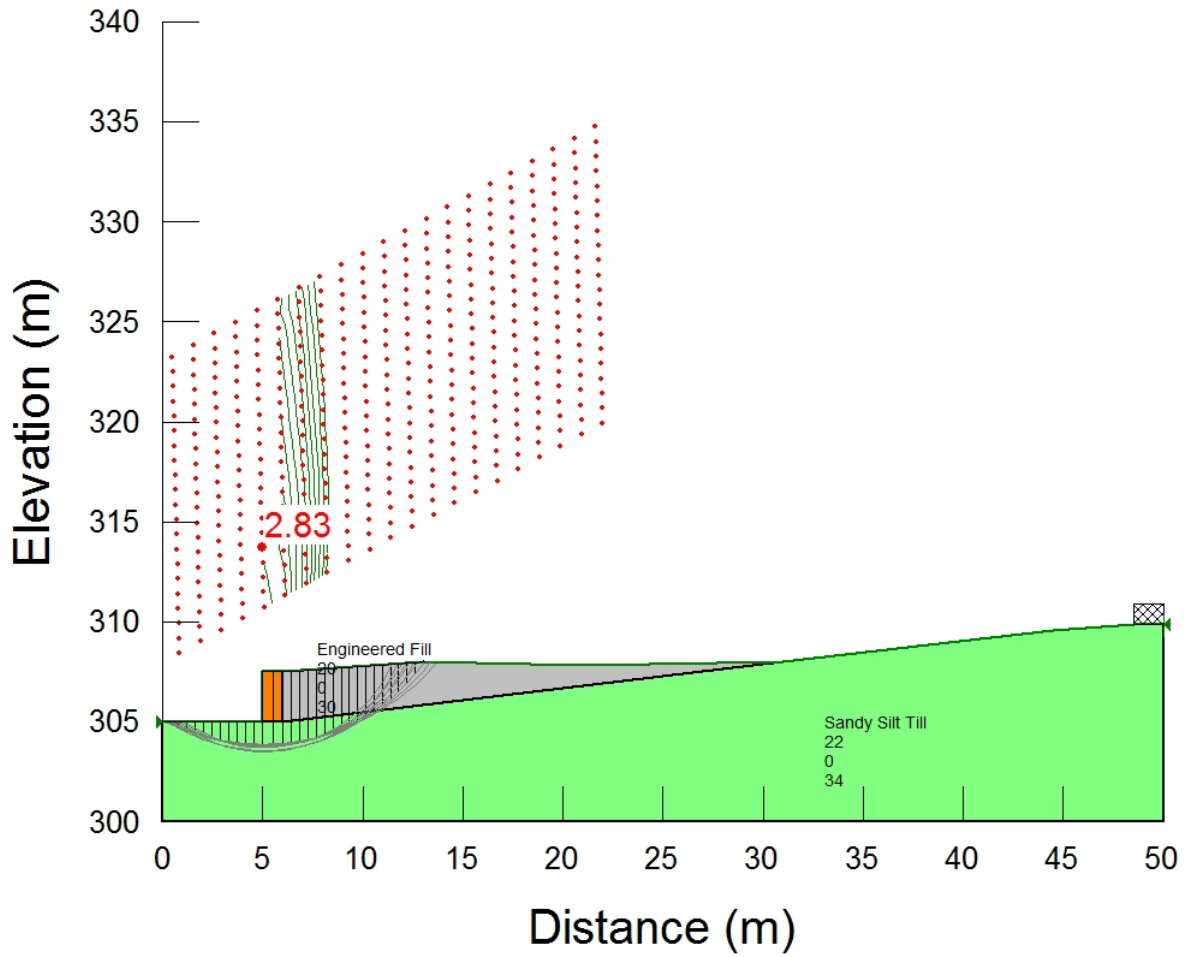
Figure 7  
Section 12 After Construction (Static)

The existing slope at this section is about 7.0 m high, and the slope gradient is very gentle at about 16H:1V to 13H:1V. The proposed slope at this section is about 5.0 m high with a 2.5 m high retaining wall, and the slope gradient is very gentle at about 14H:1V in the middle and 3H:1V at the top and toe. The minimum calculated values of F.S. for this section are 2.83 and 2.23 under static and seismic conditions, respectively. The results indicate that the physical top of slope will be the long term stable top of slope.

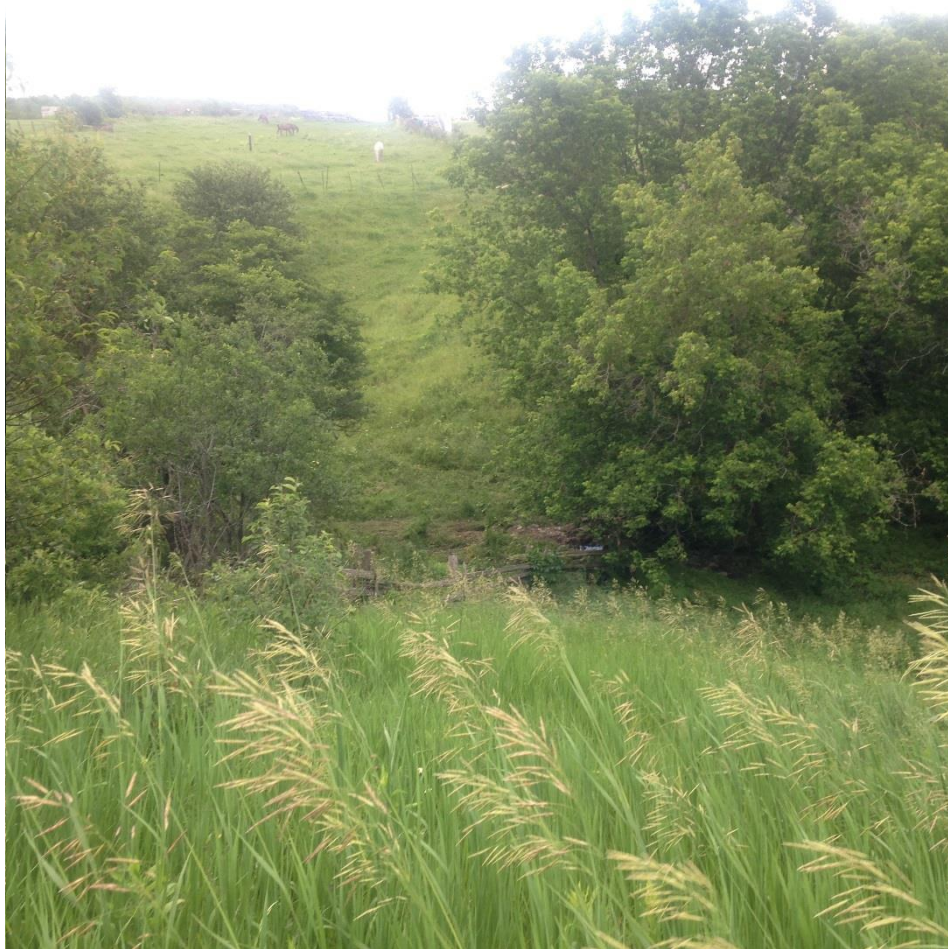
During the site visits on June 25, 2017 and January 19, 2018, no visible signs of instability (e.g., surface failure, leaning trees, tension cracks, etc.) were noted. No stream flow was observed during our site visit.

Photo 1. General View of Section Existing Slope

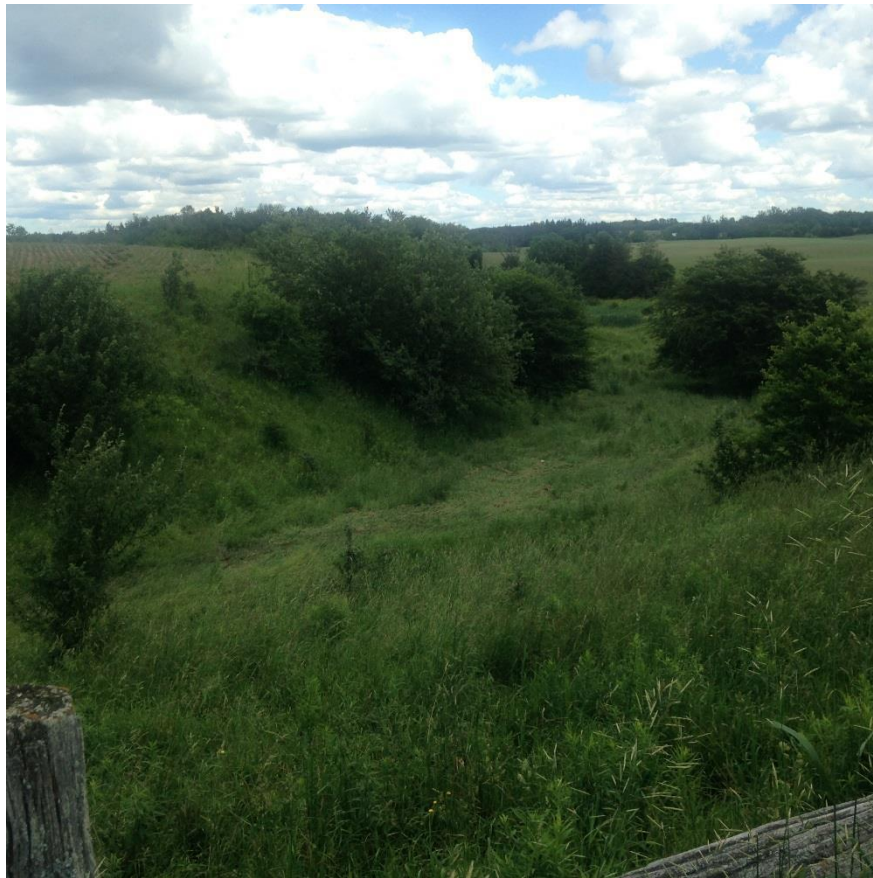
Photo 2. General View of Existing Slope

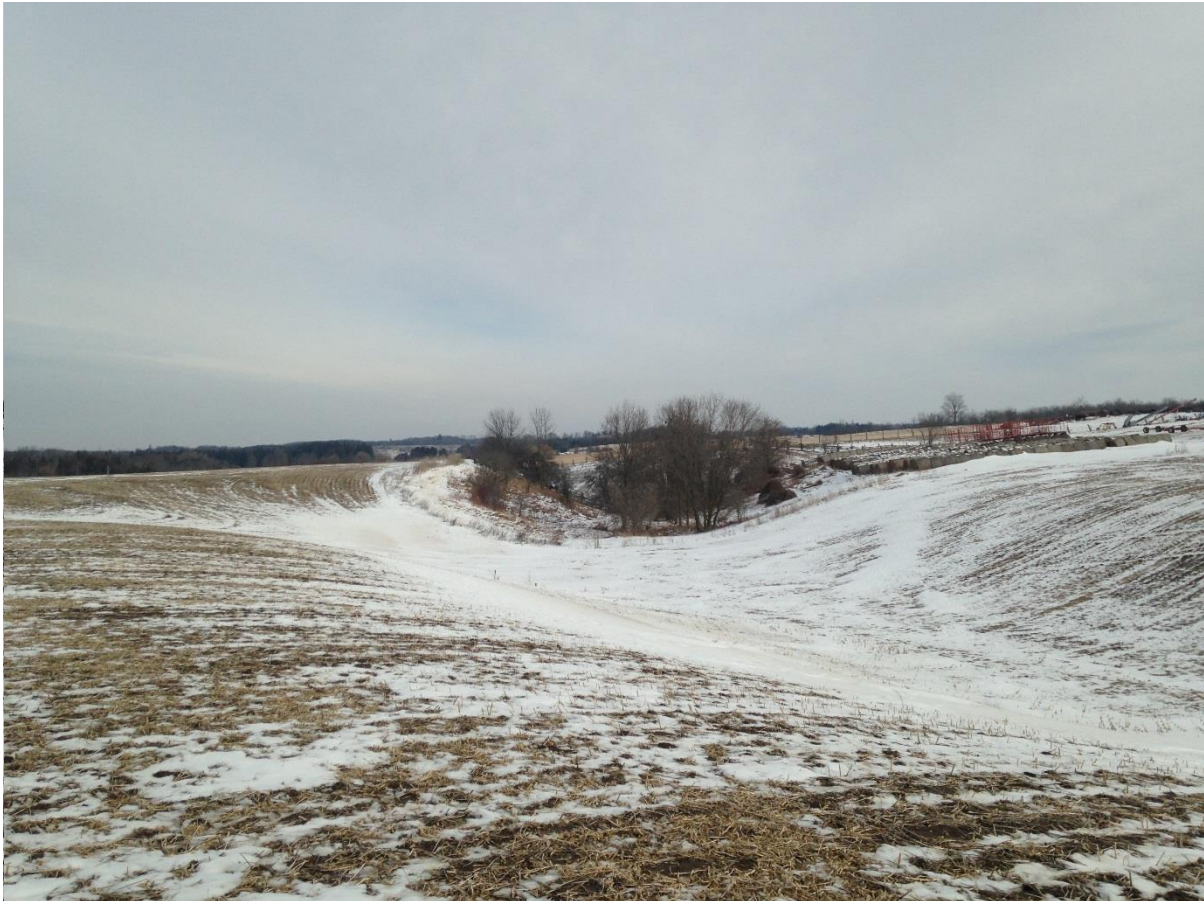
Photo 3. General View of Existing Southside Slope

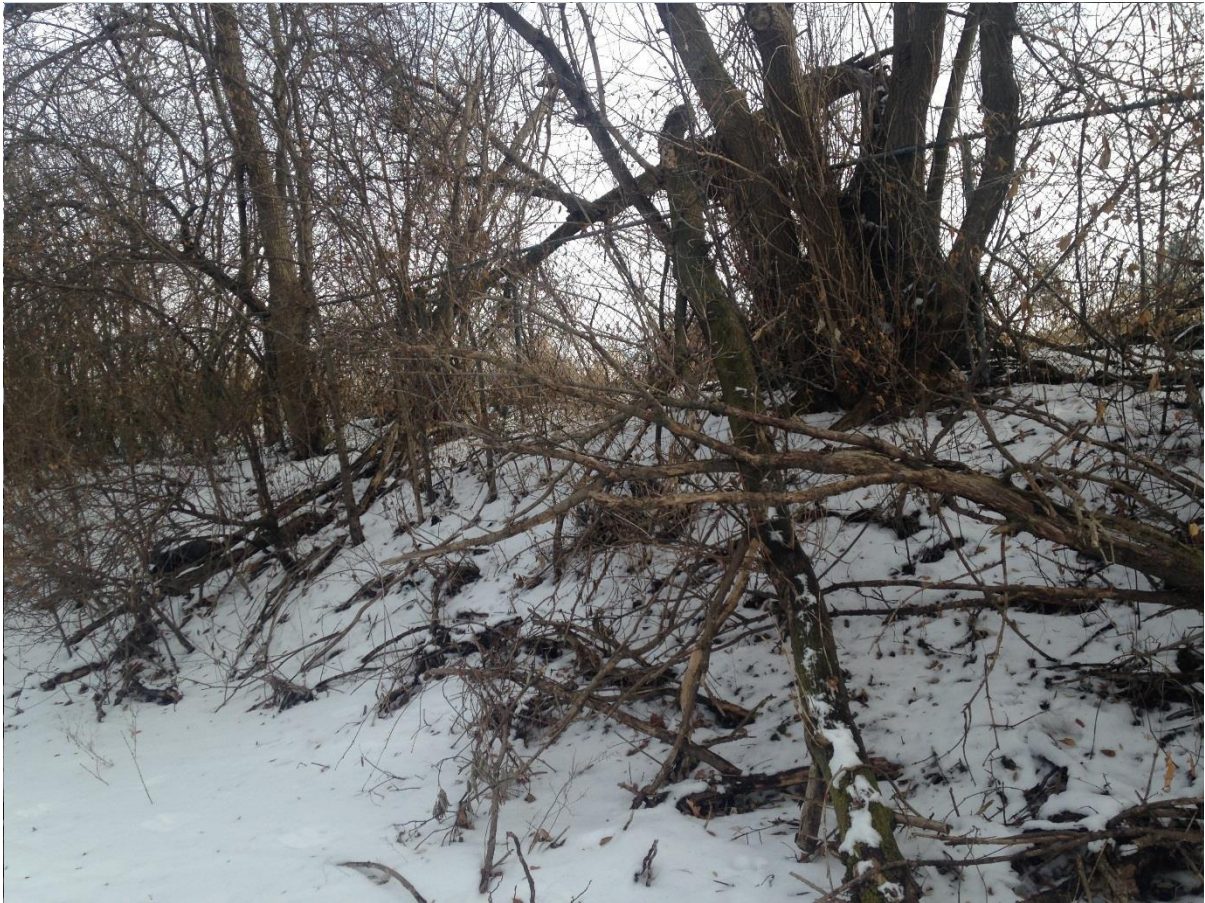
Photo 4. General View of Existing Slope along the Valewood Drive

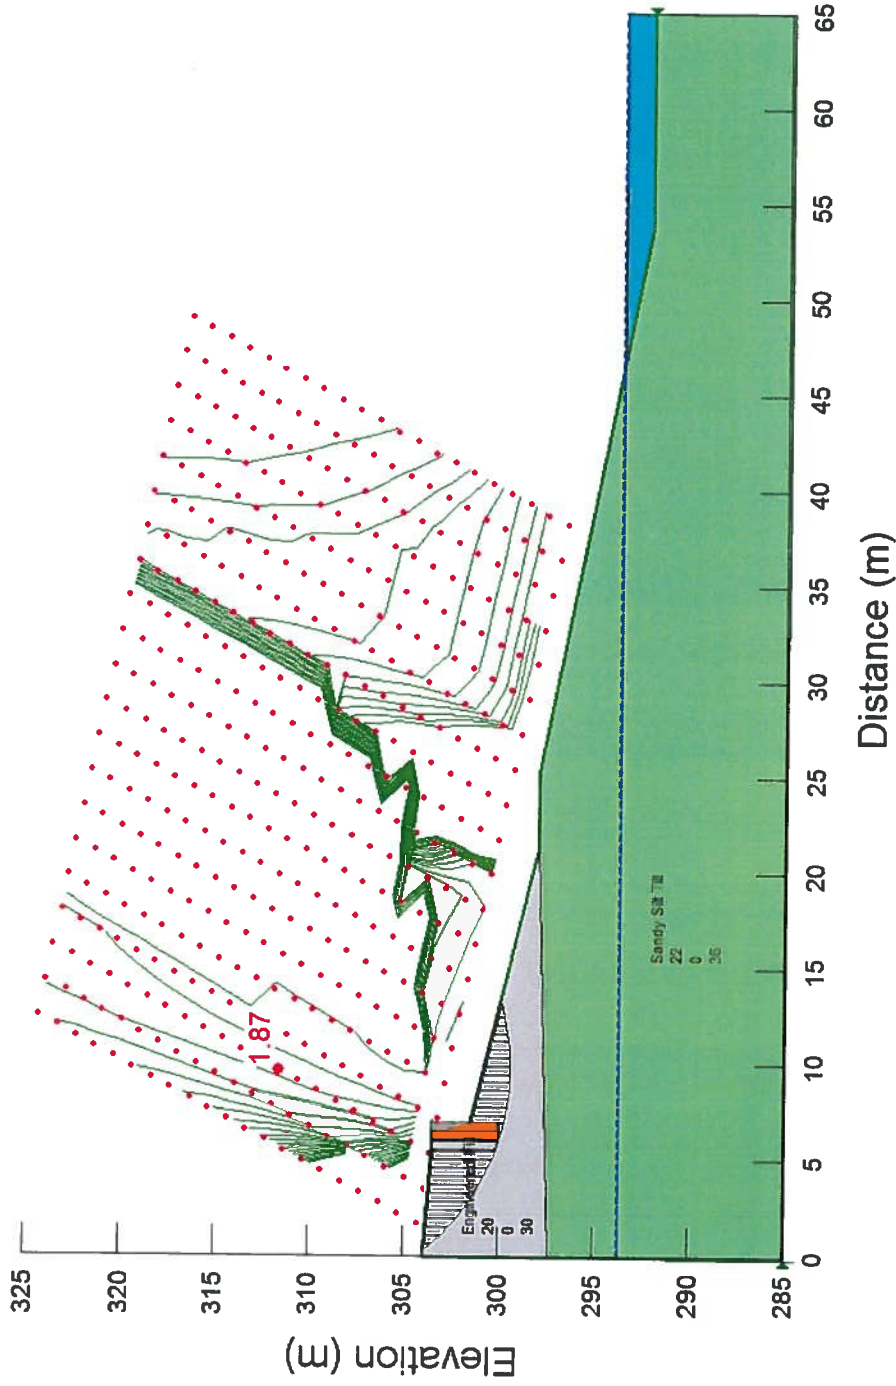
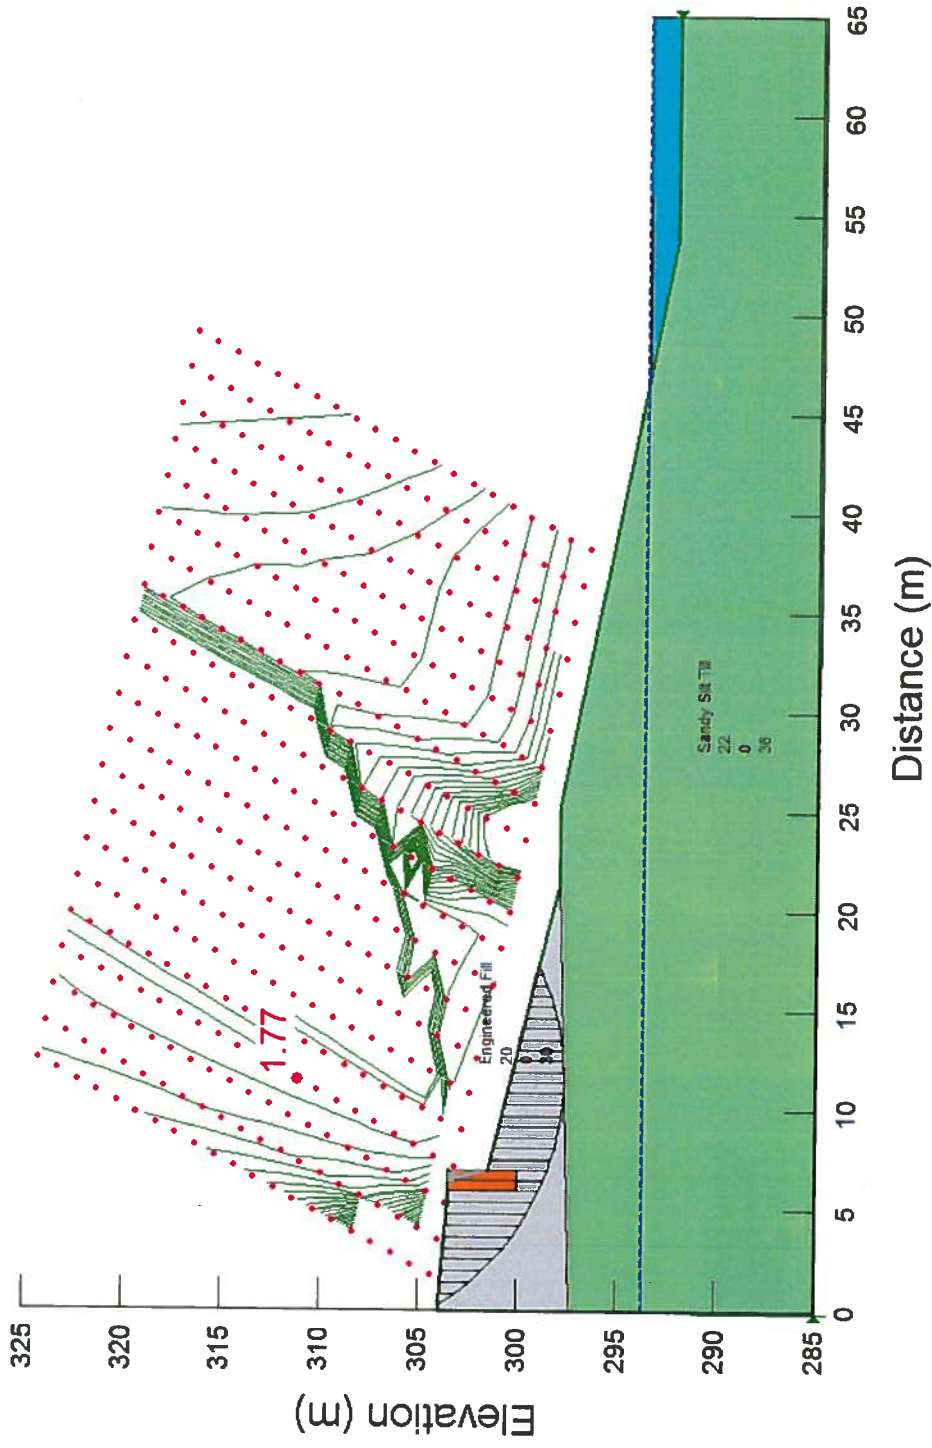
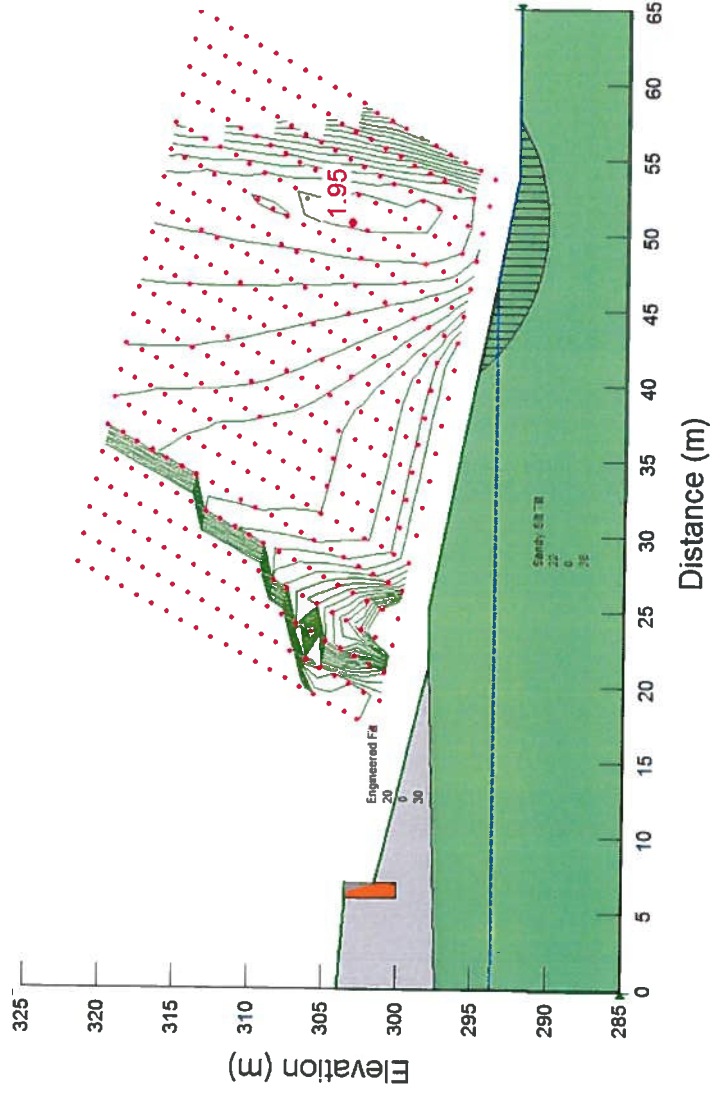
Figures D-1 to D-3 in Appendix D. The soil parameters adopted in the stability analyses are also shown on the Figures. The results indicate that both the embankments have adequate factors of safety under static, seismic and rapid drawdown conditions.
