# Arborist Report Villalago Residences Town of Caledon

**Treasure Hill Homes**

**Beacon Environmental**

**May 31, 2016      216177**

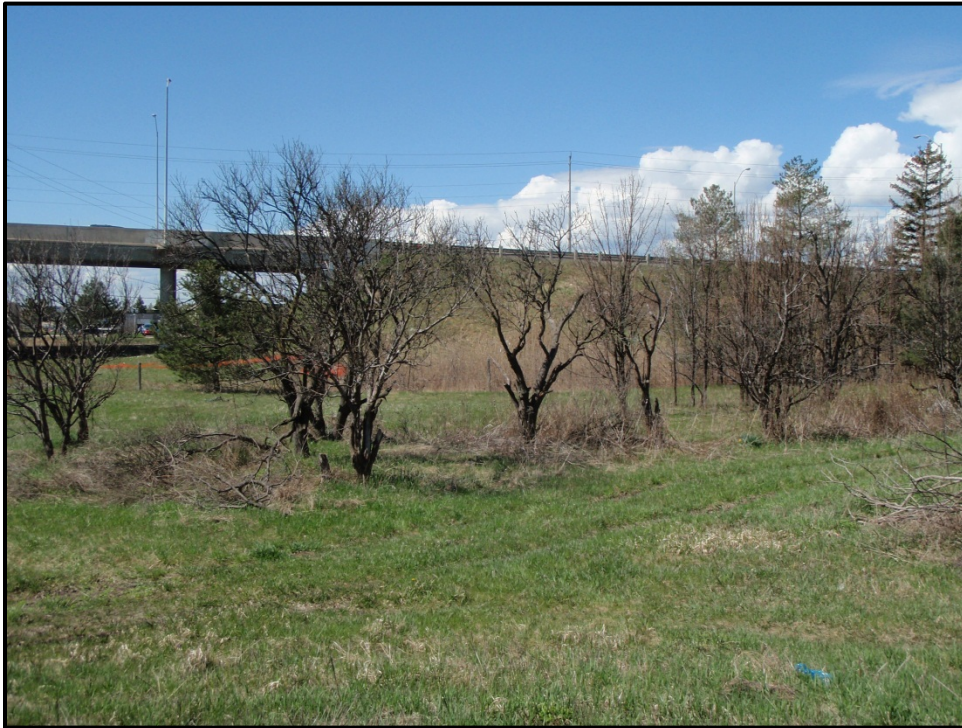
This grouping is a row of cherry trees (*Prunus sp.*) that are generally in fair to poor condition with a few dead trees. Their sizes range from approximately 6 cm to 20 cm dbh, with an average of approximately 10 cm dbh (**Photograph 1**).

**Photograph 1. View of Group A, a row of planted cherry trees in poor condition (May 3, 2016).**

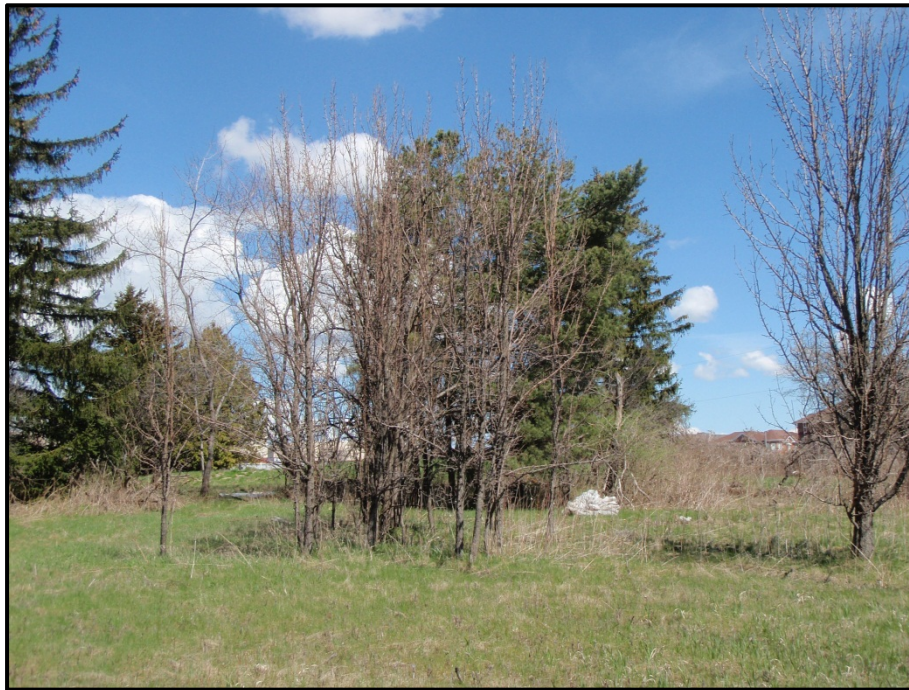
This group is a clump of ornamental or fruit trees that consist of approximately 19 stems, most of which are adventitious sprouts from a planted tree. The trees range in size between 3 and 22 cm dbh and are in good to fair condition (**Photograph 2**).

This group is a row of planted Scotch Pine that are in good to fair condition, with five trees measuring over 15 cm dbh (23, 21, 19, 18 and 18 cm dbh) with another 6 trees measuring less than 15 cm dbh.

**Photograph 2. View of Group B, naturalized ornamental trees, with Group C, a row of young Scotch Pine in the background (May 3, 2016).**

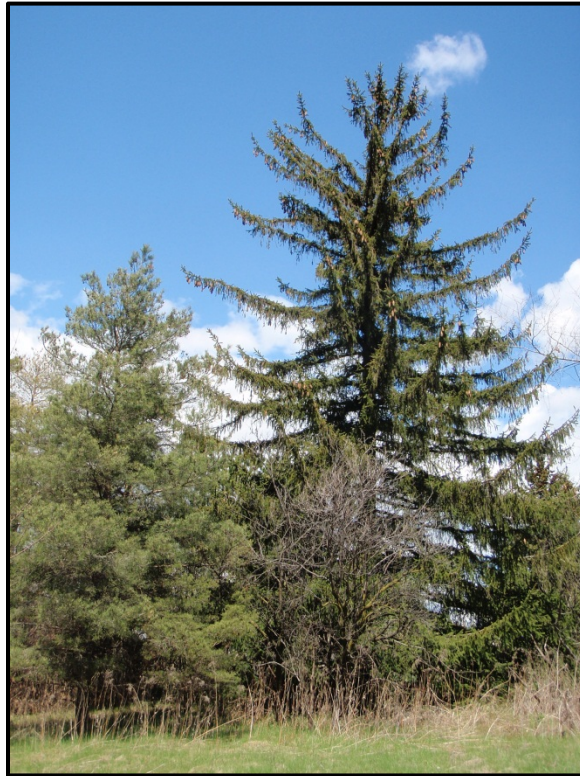
Not including nine individually numbered and tagged trees (#428 to 437), this group consists of approximately 44 stems of an ornamental apple (*Malus sp.*) or pear (*Pyrus sp.*) variety, measuring from 2 to 20 cm dbh with an average size of approximately 7 cm. Many of these are naturalized regeneration (sprouts from spreading rhizomes) of the original planted trees. There is also one 8 cm dbh Freeman's Maple and one 7 cm dbh Trembling Aspen (*Populus tremuloides*) in this grouping (**Photograph 3**).

**Photograph 3. Partial view of Group D, and trees #428 (right) and #429 (left) (May 3, 2016).**

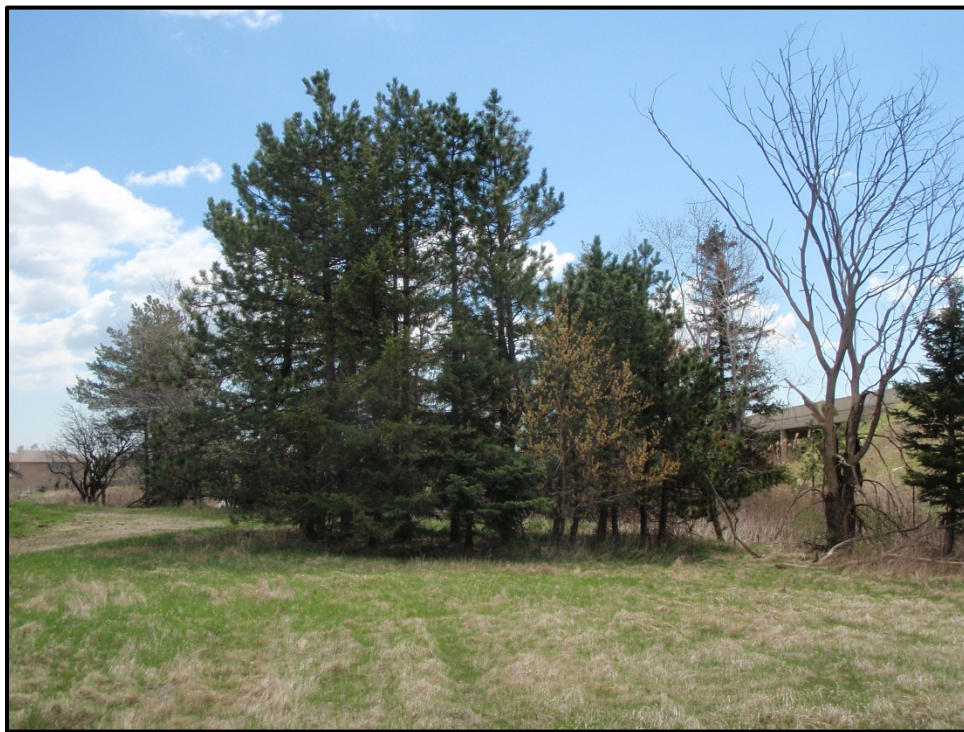
This group is made up of 14 planted Austrian Pine, ranging from 9 to 31 cm dbh with an average of approximately 12 cm, two planted White Spruce (18 and 13 cm dbh) and two Manitoba Maple (*Acer negundo*) measuring 8 and 7 cm dbh (**Photograph 4**). All the trees in this group are in good or good to fair condition.

**Photograph 4. View of Group E, mostly Austrian Pine (May 3, 2016).**

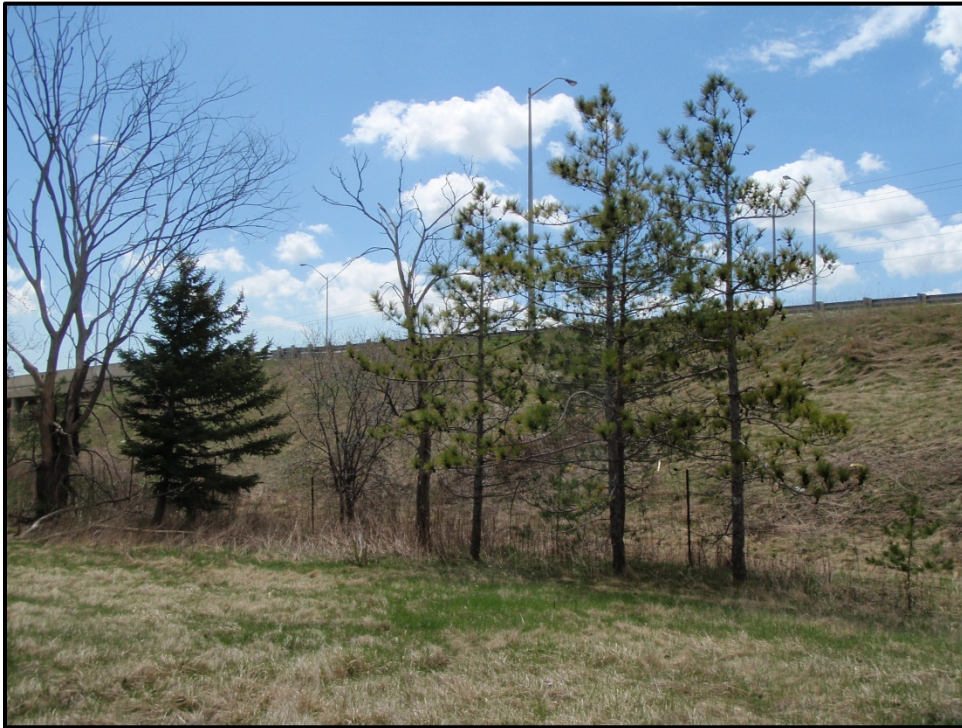
This short row of four planted Austrian Pine are located along the southwest property boundary. They measure between 10 and 13 cm and are in good condition (**Photograph 5**).

**Photograph 5. View of Group F, four Austrian Pine in poor condition (May 3, 2016).**

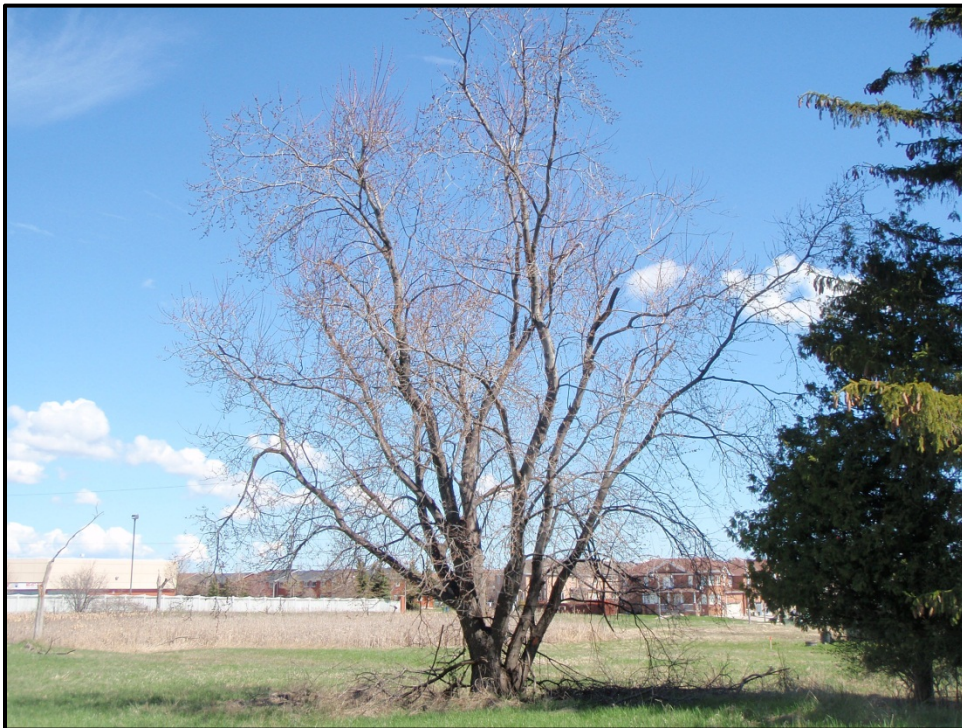
**Photograph 6. View of tree #420 (May 3, 2016).**

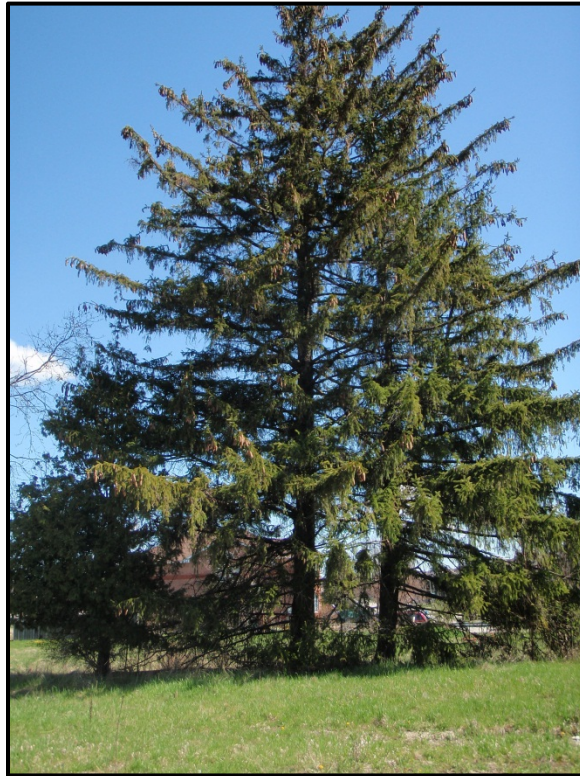
**Photograph 7. View of tree #421 to 423 (left to right) (May 3, 2016).**

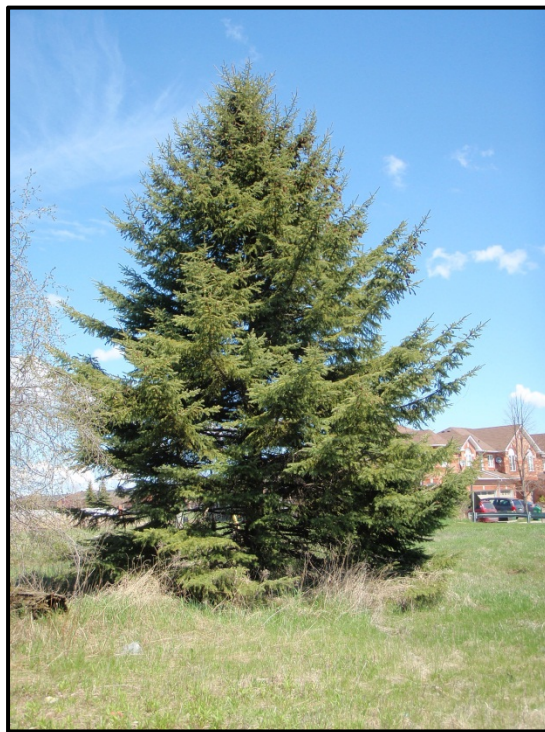
**Photograph 8. View of tree #424 (May 3, 2016).**

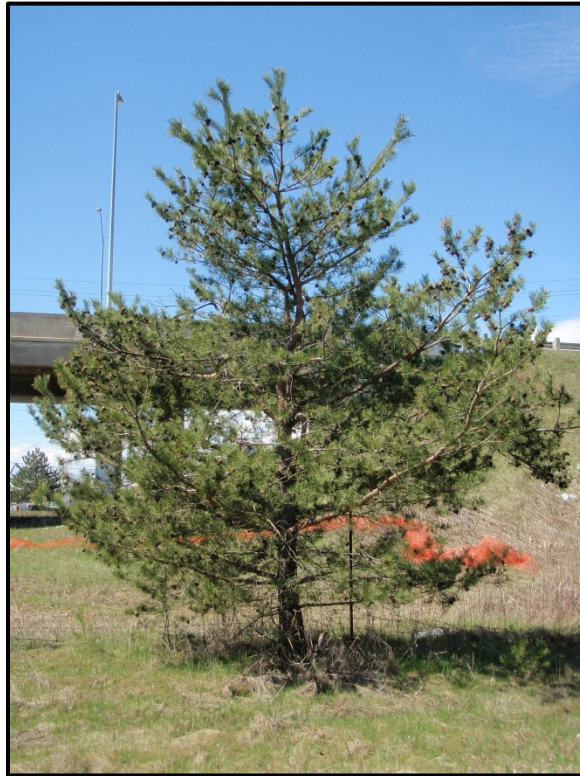
**Photograph 9. View of tree #425 (May 3, 2016).**

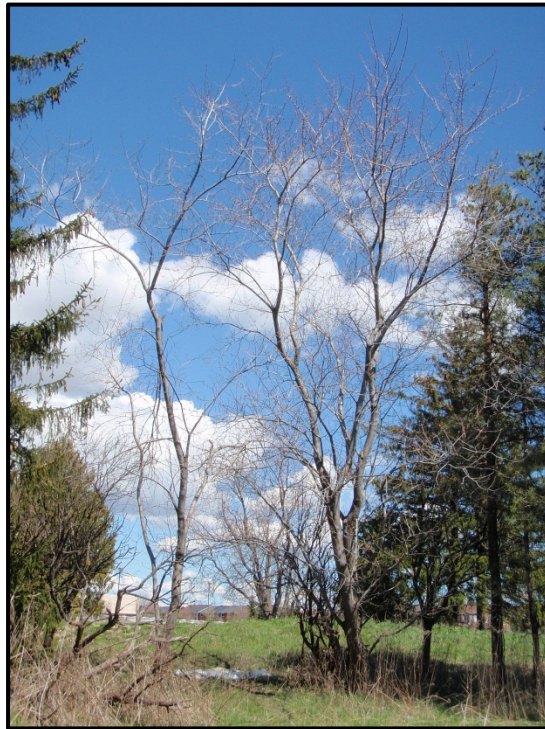
**Photograph 10. View of tree #426 & #427 (May 3, 2016).**

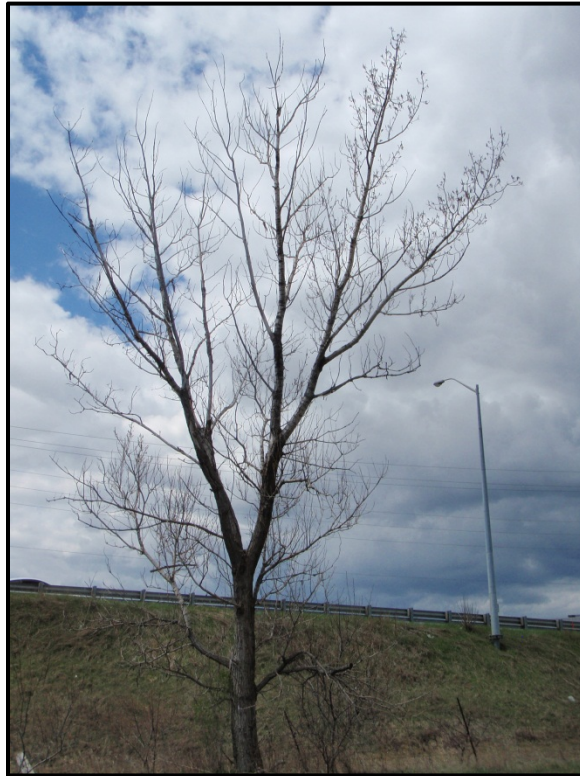
**Photograph 11. View of tree #440 (May 3, 2016).**

The proposed development plan for the subject property will consist of 110 townhome condominiums, with private streets, and future park block. All of the 87 trees included in this inventory are proposed for removal to accommodate construction as they conflict with the proposed site plan's building footprints, roads or grading and servicing requirements. One tree, #440, is not in conflict with the proposed site plan, however, this is a 45 cm dbh Eastern Cottonwood that is in poor condition with only approximately 30% live crown and in an advanced state of decline (**Photograph 11**). This tree will likely be completely dead within a few years and eventually constitute a hazard.

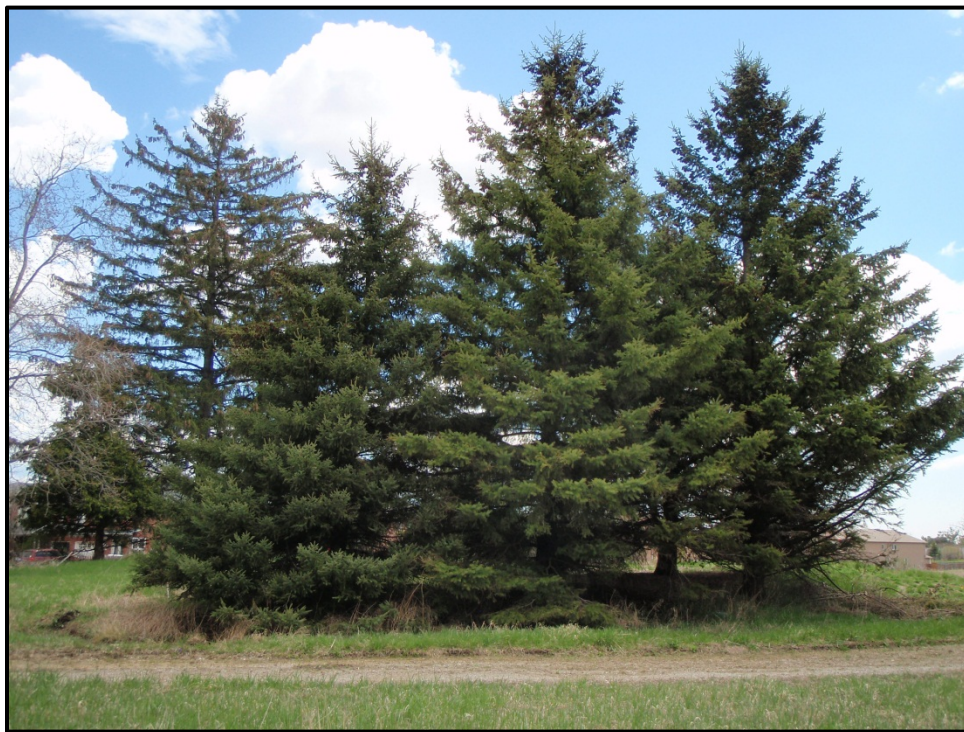
**Photograph 12. View of tree #441 to #444 (left to right) (May 3, 2016).**
