# Arborist Report Villalago Residences Town of Caledon

**Treasure Hill Homes**

**Beacon Environmental Limited**

**Revised February 2017 216177**

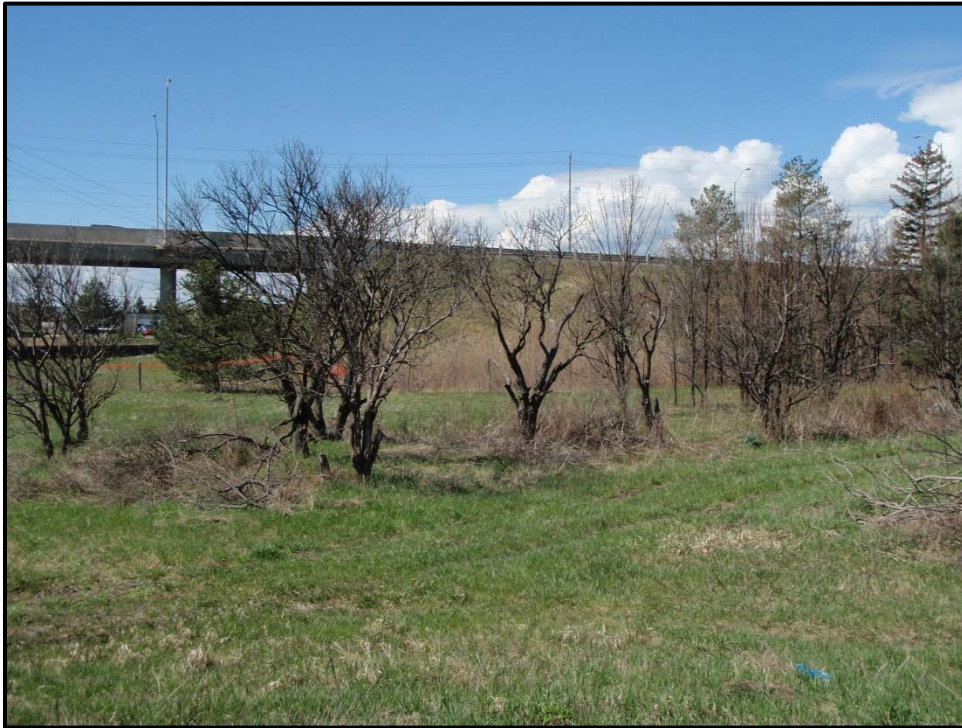
This grouping is a row of cherry trees (*Prunus sp.*) that are generally in fair to poor condition with a few dead trees. Their sizes range from approximately 6 cm to 20 cm dbh, with an average of approximately 10 cm dbh (**Photograph 1**).

**Photograph 1. View of Group A, a row of planted cherry trees in poor condition (May 3, 2016).**

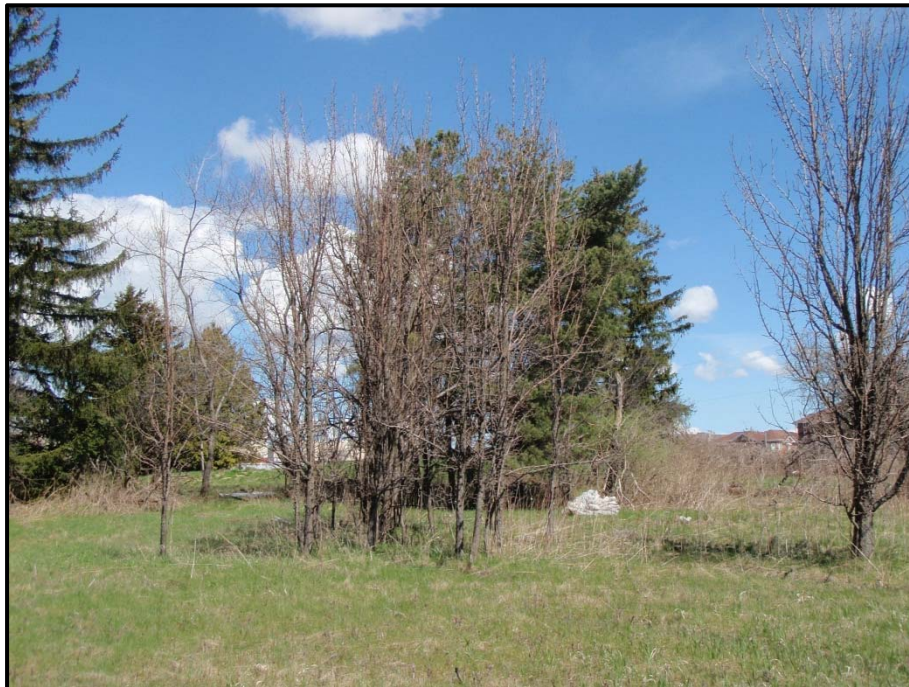
This group is a clump of ornamental or fruit trees that consist of approximately 19 stems, most of which are adventitious sprouts from a planted tree. The trees range in size between 3 and 22 cm dbh and are in good to fair condition (**Photograph 2**).

This group is a row of planted Scotch Pine that are in good to fair condition, with five trees measuring over 15 cm dbh (23, 21, 19, 18 and 18 cm dbh) with another 6 trees measuring less than 15 cm dbh.

**Photograph 2. View of Group B, naturalized ornamental trees, with Group C, a row of young Scotch Pine in the background (May 3, 2016).**

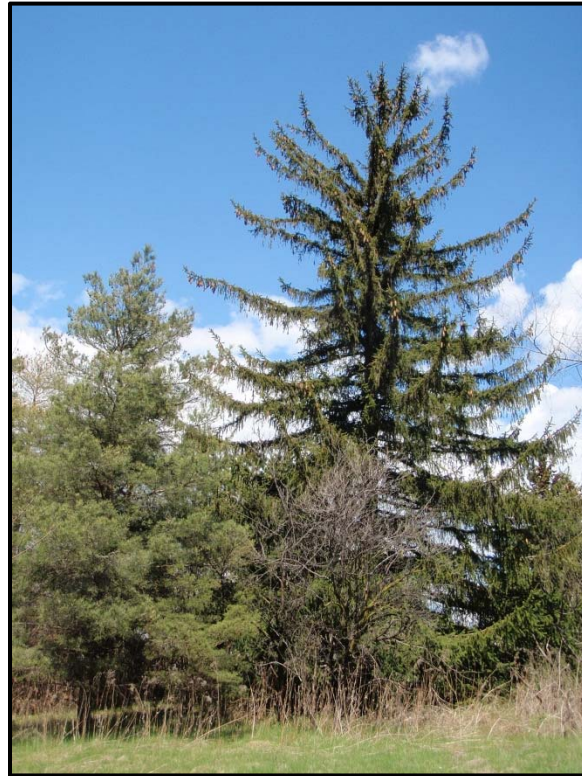
Not including nine individually numbered and tagged trees (#428 to 437), this group consists of approximately 44 stems of an ornamental apple (*Malus sp.*) or pear (*Pyrus sp.*) variety, measuring from 2 to 20 cm dbh with an average size of approximately 7 cm. Many of these are naturalized regeneration (sprouts from spreading rhizomes) of the original planted trees. There is also one 8 cm dbh Freeman's Maple and one 7 cm dbh Trembling Aspen (*Populus tremuloides*) in this grouping (**Photograph 3**).

**Photograph 3. Partial view of Group D, and trees #428 (right) and #429 (left) (May 3, 2016).**

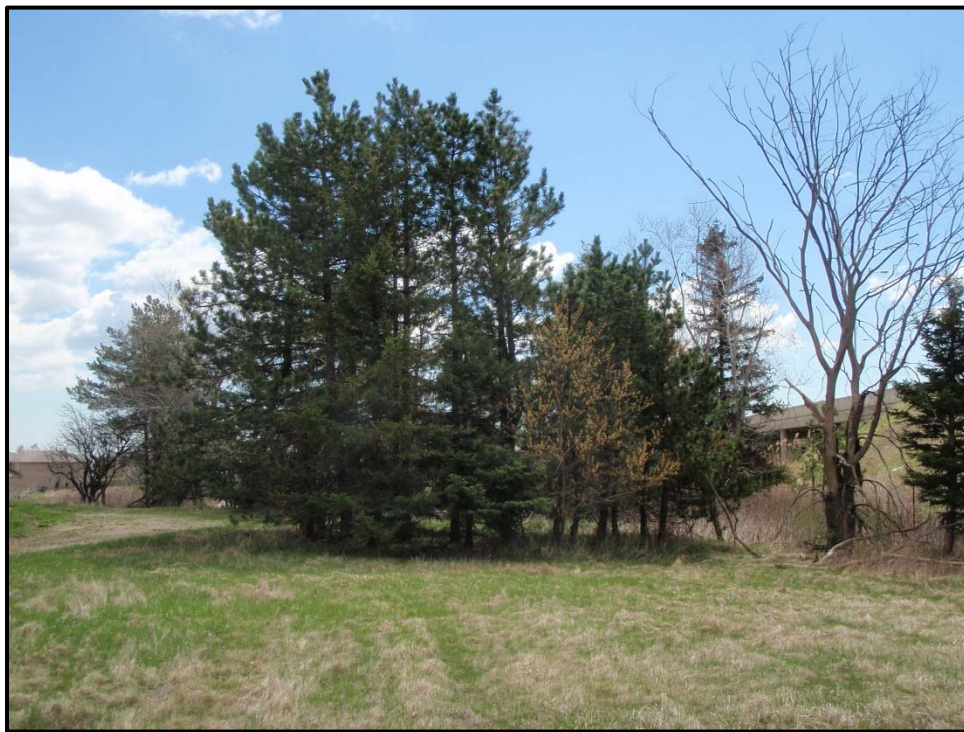
This group is made up of 14 planted Austrian Pine, ranging from 9 to 31 cm dbh with an average of approximately 12 cm, two planted White Spruce (18 and 13 cm dbh) and two Manitoba Maple (*Acer negundo*) measuring 8 and 7 cm dbh (**Photograph 4**). All the trees in this group are in good or good to fair condition.

**Photograph 4. View of Group E, mostly Austrian Pine (May 3, 2016).**

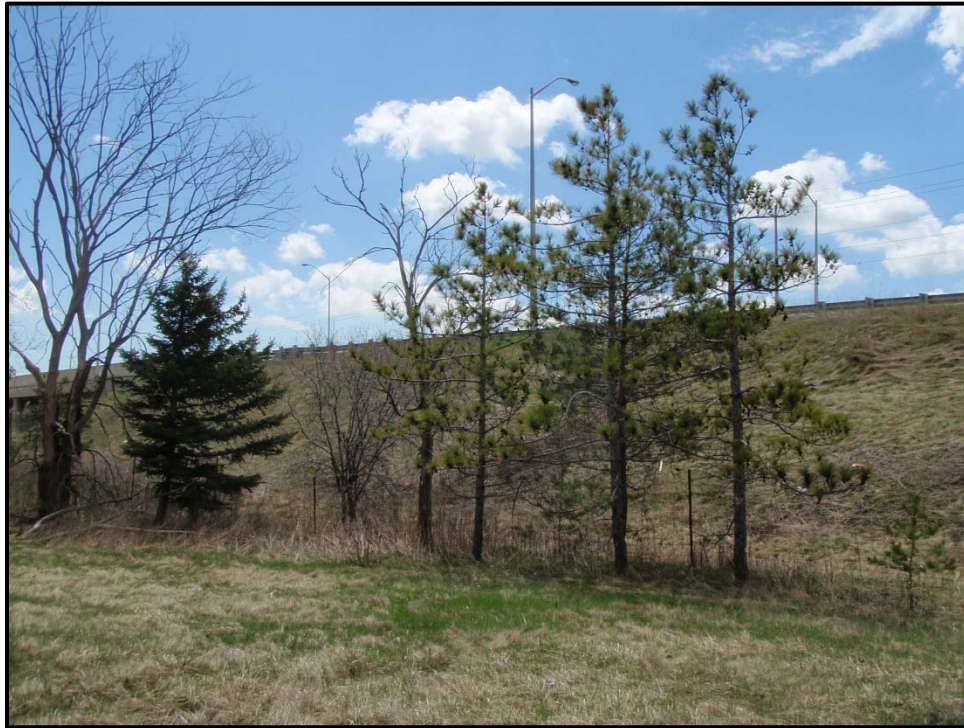
This short row of four planted Austrian Pine are located along the southwest property boundary. They measure between 10 and 13 cm and are in good condition (**Photograph 5**).

**Photograph 5. View of Group F, four Austrian Pine in poor condition (May 3, 2016).**

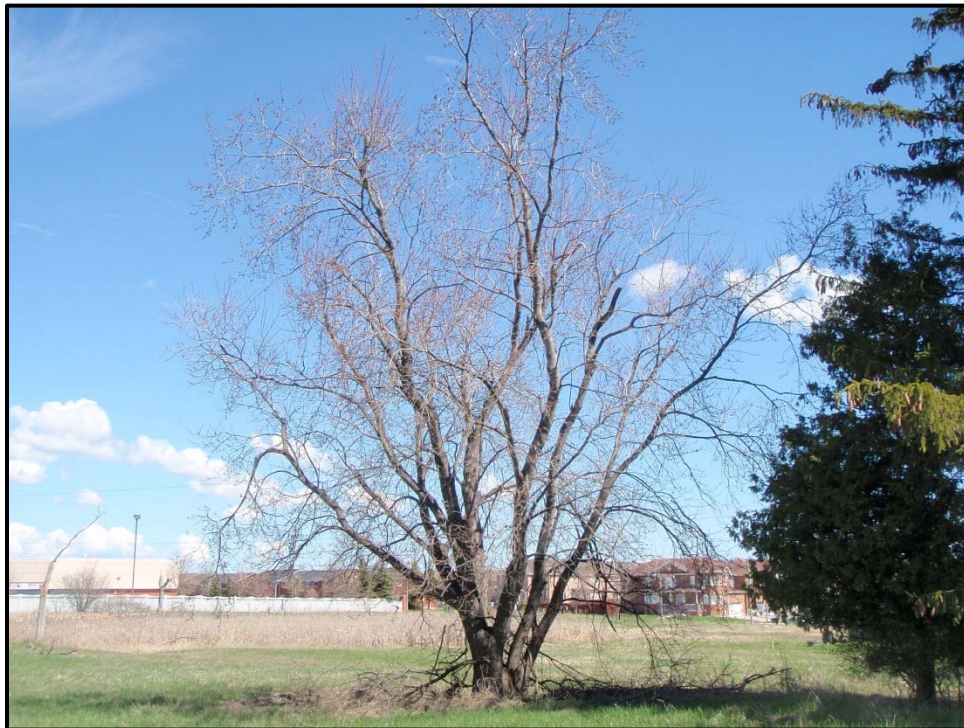
| Tag/Tree No. | Scientific Name | Common Name | DBH (cm) | Condition | Crown radius (m) | Comments |
|---|---|---|---|---|---|---|
| 420 | Acer X freemanii | Freeman's Maple | 55/46/27/26 | Good-Fair | 4 | Forked x4 at base |

**Photograph 6. View of tree #420 (May 3, 2016).**

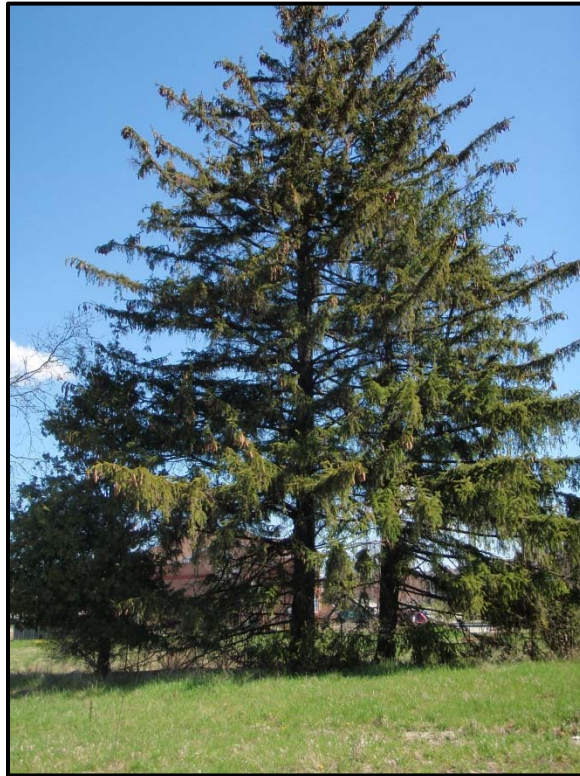
| Tag/Tree No. | Scientific Name | Common Name | DBH (cm) | Condition | Crown radius (m) | Comments |
|---|---|---|---|---|---|---|
| 421 | Thuja occidentalis | Northern White Cedar | 28 | Good-Fair | 2 | Leader dieback due to competition |
| 422 | Picea abies | Norway Spruce | 61 | Good | 4 | Asymmetrical crown |
| 423 | Picea abies | Norway Spruce | 44 | Good | 4 | Asymmetrical crown |

**Photograph 7. View of tree #421 to 423 (left to right) (May 3, 2016).**

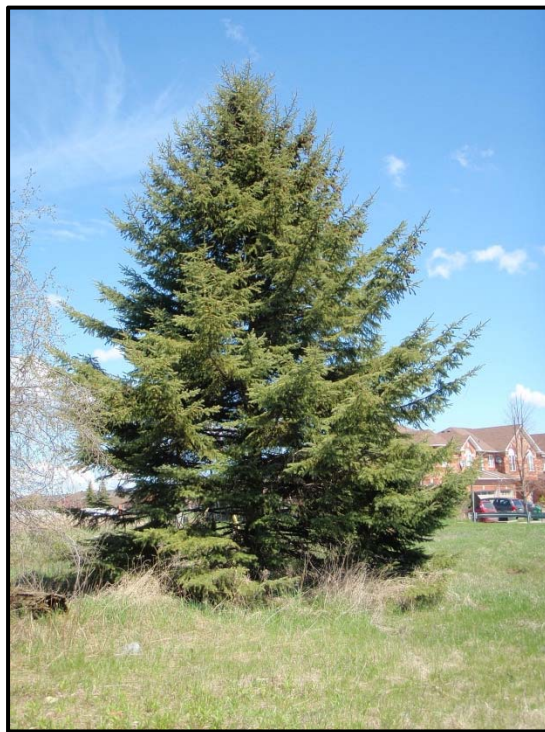
| Tag/Tree No. | Scientific Name | Common Name | DBH (cm) | Condition | Crown radius (m) | Comments |
|---|---|---|---|---|---|---|
| 424 | Picea glauca | White Spruce | 33/27 | Good | 3 | Forked at base; good health & vigour |

**Photograph 8. View of tree #424 (May 3, 2016).**

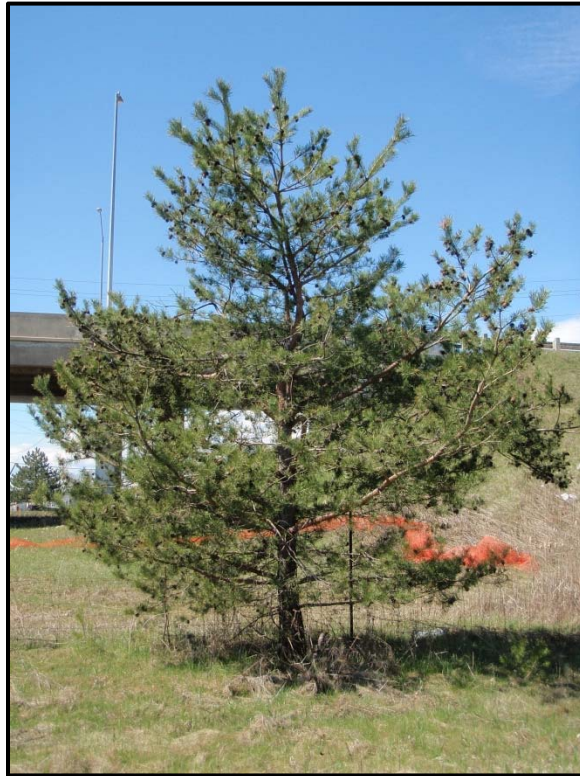
| Tag/Tree No. | Scientific Name | Common Name | DBH (cm) | Condition | Crown radius (m) | Comments |
|---|---|---|---|---|---|---|
| 425 | Pinus sylvestris | Scotch Pine | 20 | Good | 2.5 | |

**Photograph 9. View of tree #425 (May 3, 2016).**

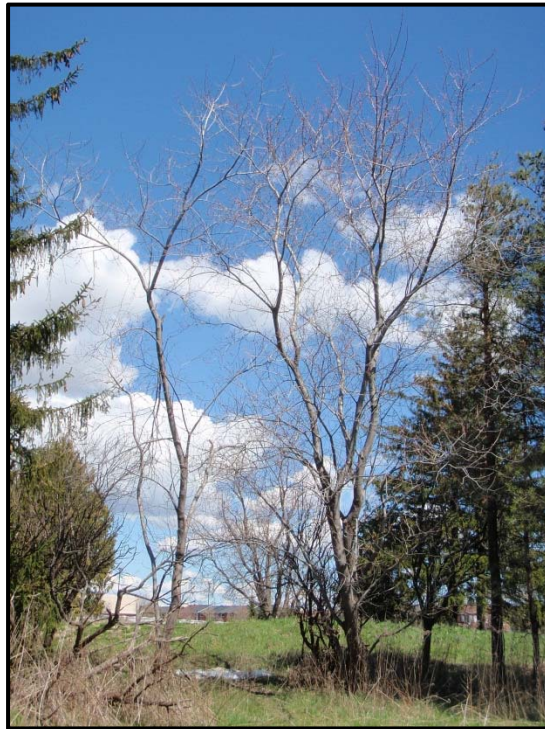
| Tag/Tree No. | Scientific Name | Common Name | DBH (cm) | Condition | Crown radius (m) | Comments |
|---|---|---|---|---|---|---|
| 426 | Acer X freemanii | Freeman's Maple | 24/23 | Good | 3 | Forked at base; good health & vigour |
| 427 | Acer X freemanii | Freeman's Maple | 20/9 | Good | 2.5 | Forked at base; broken branch |

**Photograph 10. View of tree #426 & #427 (May 3, 2016).**

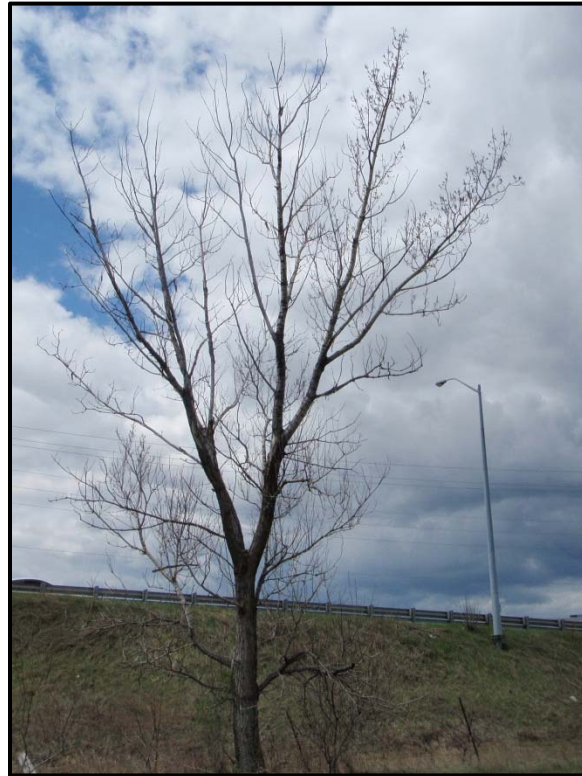
| Tag/Tree No. | Scientific Name | Common Name | DBH (cm) | Condition | Crown radius (m) | Comments |
|---|---|---|---|---|---|---|
| 440 | Populus deltoides ssp. monilifera | Eastern Cottonwood | 45 | Poor | 3 | 40% live crown |

**Photograph 11. View of tree #440 (May 3, 2016).**

The proposed development plan for the subject property will consist of 110 townhome condominiums, with private streets, and future park block. All of the 87 trees included in this inventory are proposed for removal to accommodate construction as they conflict with the proposed site plan's building footprints, roads or grading and servicing requirements. One tree, #440, is not in conflict with the proposed site plan, however, this is a 45 cm dbh Eastern Cottonwood that is in poor condition with only approximately 30% live crown and in an advanced state of decline (**Photograph 11**). This tree will likely be completely dead within a few years and eventually constitute a hazard.

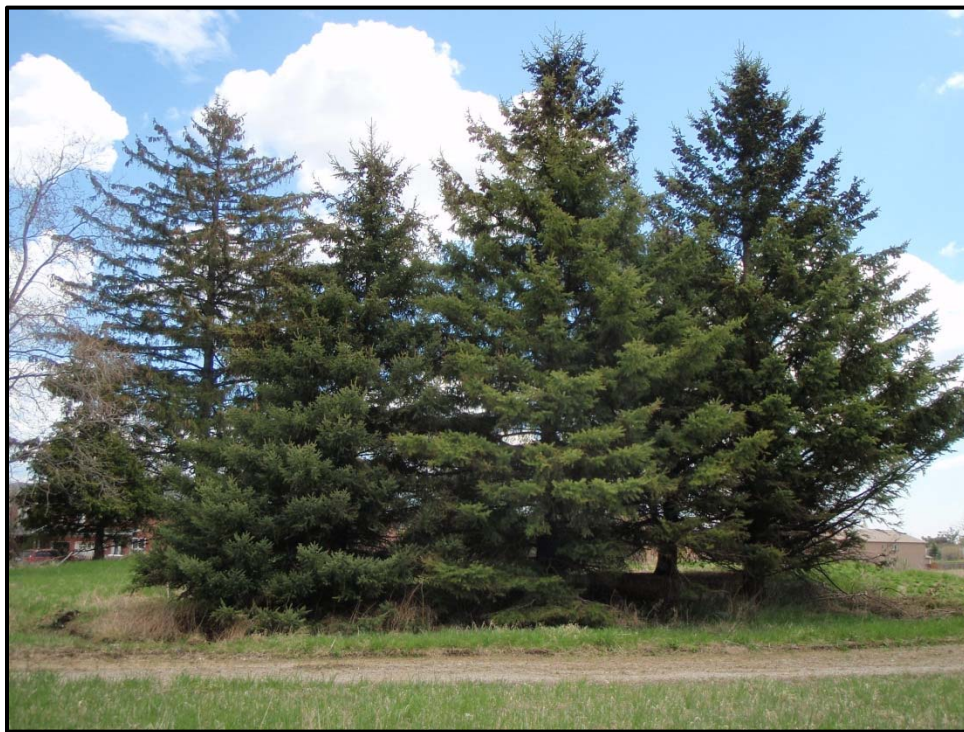
| Tag/Tree No. | Scientific Name | Common Name | DBH (cm) | Condition | Crown radius (m) | Comments |
|---|---|---|---|---|---|---|
| 441 | Picea glauca | White Spruce | 26 | Good | 3 | Good health & vigour |
| 442 | Picea glauca | White Spruce | 33 | Good | 3.5 | Good health & vigour |
| 443 | Picea glauca | White Spruce | 37 | Good | 3 | Good health & vigour |
| 444 | Thuja occidentalis | Northern White Cedar | 36/17/10 | Good | 3 | Forked at 1.1m |

**Photograph 12. View of tree #441 to #444 (left to right) (May 3, 2016).**
