# Village of Alton

## Main Street North and Queen Street West Class Environmental Assessment

Transportation Study Report

November 13, 2020

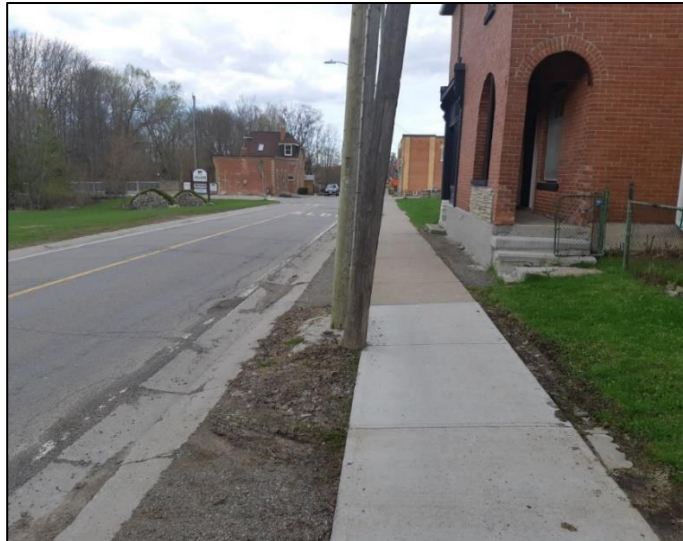
Within the village core near the intersection of Queen Street West at Main Street North, there are several instances of wooden hydro poles encroaching into sidewalks on Queen Street West, as shown in **Figure 2**. This encroachment into the pedestrian zone can pose an accessibility concern and generally does not confirm to good urban design principles.

*Figure 2: Hydro pole encroaching sidewalk*

Relocating hydro poles so they do not encroach into adjacent sidewalks will help promote pedestrian usage.

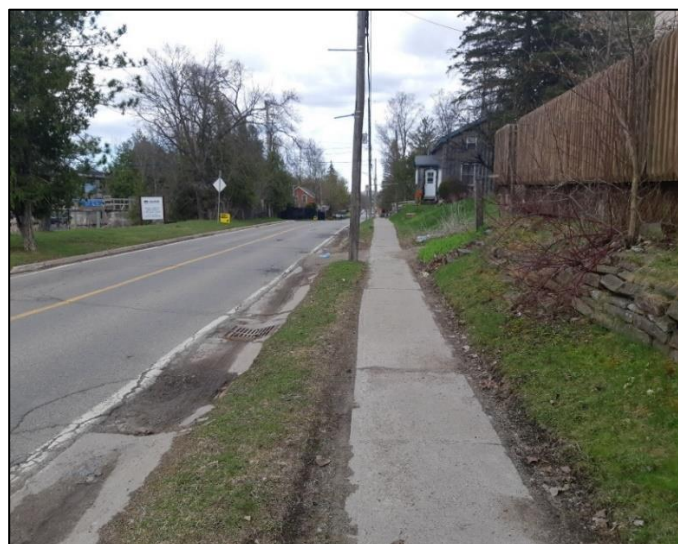
Due to significant grade differentiation between the sidewalk and adjacent properties along the south side of Queen Street West, it is evident that runoff has resulted in undesirable sidewalk conditions along several sections. As shown in **Figure 3**, mud, natural debris, and fine gravel are observed to be flowing across the sidewalk. Reducing the grade differentiations adjacent to the sidewalk where possible, and improving overall drainage of runoff, is expected to mitigate the issue.

*Figure 3: Poor sidewalk conditions*

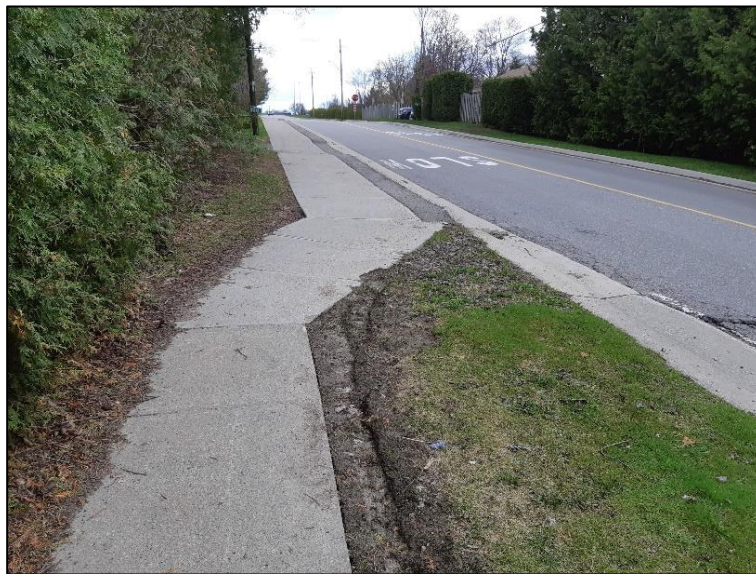
There is an abrupt change in the sidewalk alignment on the south side of Queen Street West approximately 80 metres east of James Street North, as shown in **Figure 4**. East of this location the sidewalk generally has a grassy boulevard separation from the road, which is eliminated at this location and replaced with a narrow asphalt strip which continues west for approximately 150 metres before the grassy boulevard is re-introduced. The abrupt change in alignment is not ideal for pedestrian flow and given the lack of on-street bicycle facilities, could pose a safety concern for recreational cyclists utilizing the sidewalk travelling eastbound on the downward gradient. Re-configuring the alignment change to a more gradual re-alignment is expected to mitigate the issue.

*Figure 4: Abrupt change in sidewalk alignment*

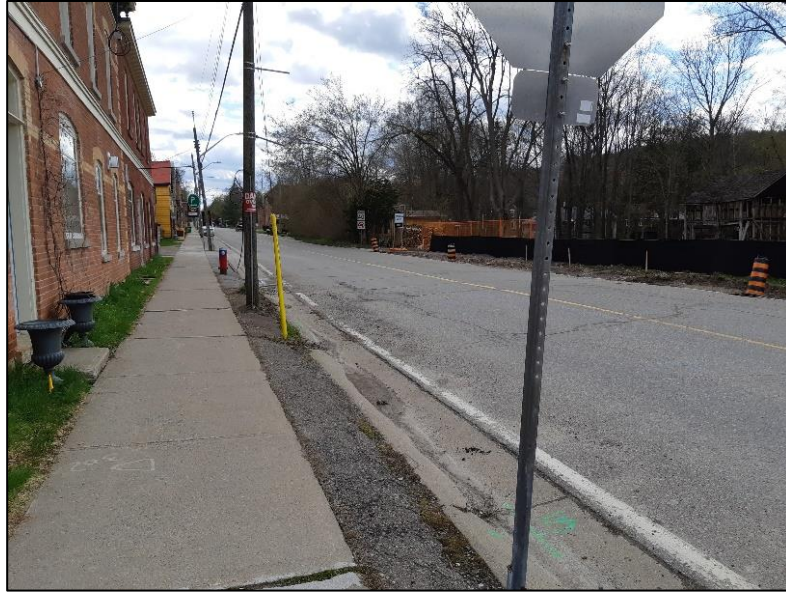
Within the village core near the intersection of Queen Street West at Main Street North the sidewalk is elevated noticeably above the roadway, with a narrow asphalt strip separating the two facilities comprised of hydro poles, fire hydrants, and traffic signage poles, as shown in **Figure 5**. This layout generally does not confirm to good urban design principles and also poses a safety concern to pedestrians. There is opportunity to improve the pedestrian realm by cross-section enhancements.

*Figure 5: Pedestrian realm*

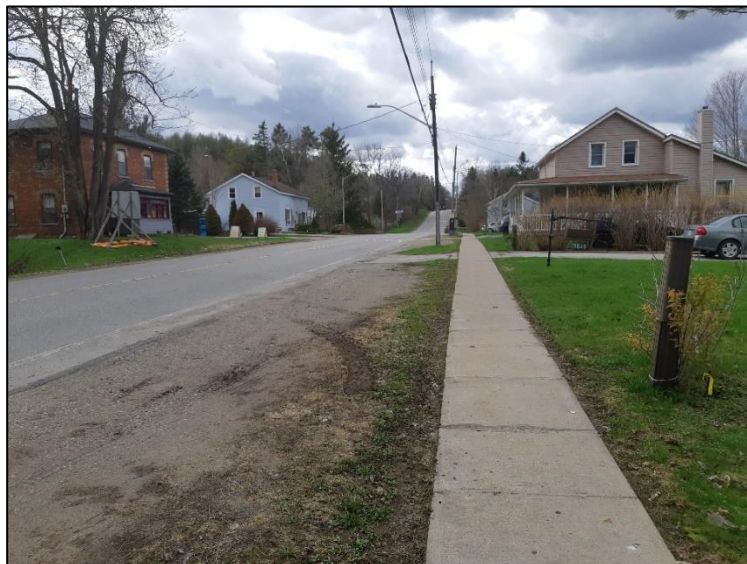
On the east side of Main Street North, north of the bridge, the sidewalk is separated from the pavement by a wide shoulder (gravel and asphalt sections) approximately 4-5 metres wide. As shown in **Figure 6** and **Figure 7**, the shoulder is under-utilized and consists of hydro poles. There are no on-street parking restrictions, and the shoulder is currently utilized as on-street parking where possible. From an urban design and functionality standpoint, there is opportunity to improve the cross-section of Main Street North to provide designated parking facilities.

*Figure 6: Under-utilized shoulder*

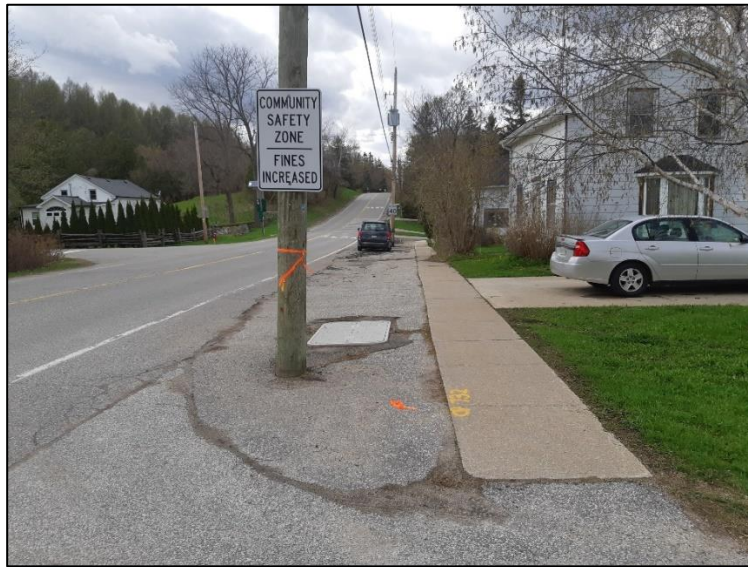
*Figure 7: Paved shoulder*

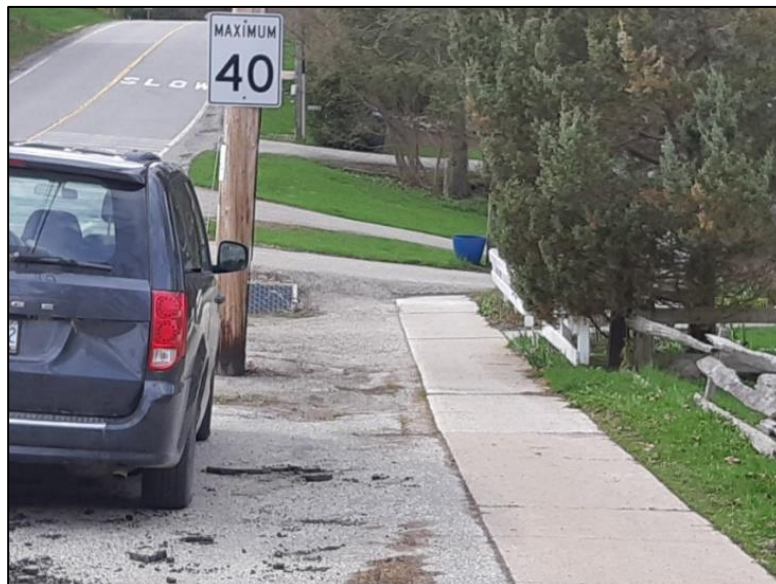
The sidewalk on the east side of Main Street North terminates approximately 50 metres north of Margaret Street, and approximately 100 metres south of Mary Street, as shown in **Figure 8**. Generally, sidewalk terminations should occur at key destination points or at a cross-street, but typically not mid-block as is the case here.

*Figure 8: Sidewalk termination*

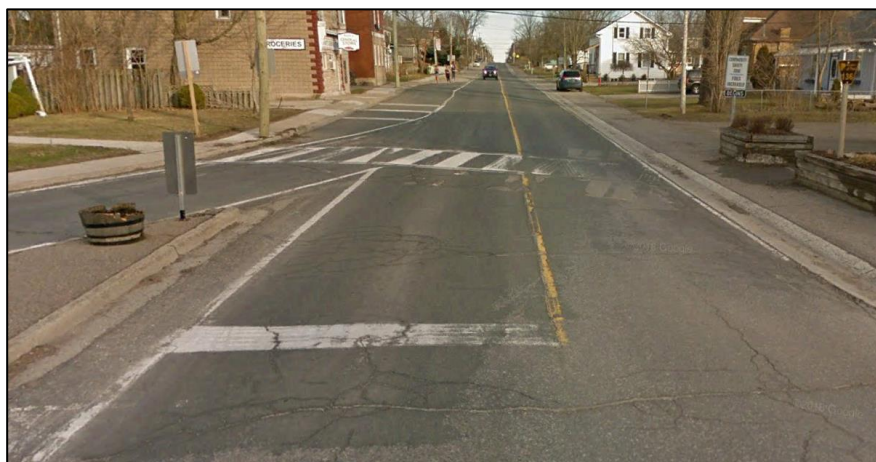
The pedestrian crosswalk on the south leg of the intersection of Main Street North at Queen Street is situated approximately 10 metres upstream of the approach stop bar, as shown in **Figure 9**. This is generally a unique configuration as it does not provide the same level of pedestrian safety as traditional configurations where the stop bar is situated upstream of the crosswalk. It requires pedestrians cross two directions of free flow traffic in one crossing movement, and potentially cross within a queue of vehicles stopped at the stop bar which can result in visibility issues, reducing pedestrian safety. Since the crosswalk is technically not situated at the intersection, it is generally operating as a midblock crossing. There is opportunity to improve pedestrian safety by re-configuring the crosswalk to be consistent with typical intersection intersections, improving road user expectations, improving visibility during crossing movements, and consequently overall improving pedestrian safety.

*Figure 9: Crosswalk behind stop bar*

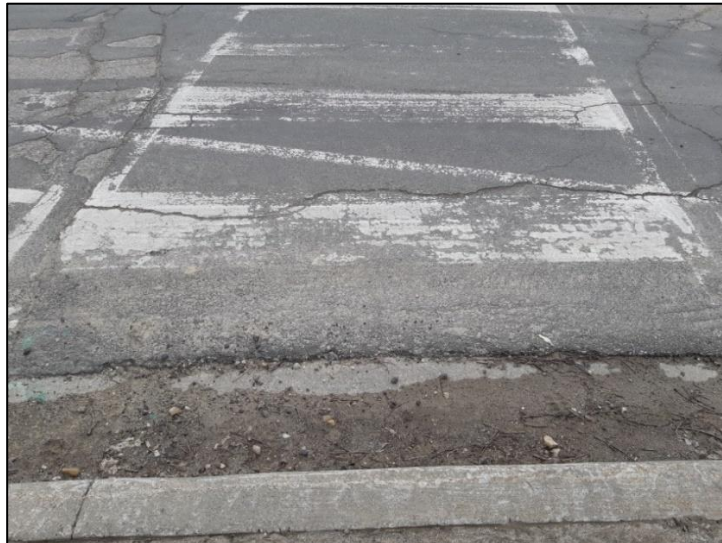
Furthermore, the crosswalk currently does not meet Accessibility for Ontarians with Disability (AODA) standards as it does not provide a pedestrian let-down, as shown in **Figure 10**. For example, the crosswalk currently does not permit access by wheelchairs due to the barrier curb. Given this is the only designated pedestrian crossing facility in the study area, this significantly restricts the accessibility of the pedestrian network. There is opportunity to improve accessibility by ensuring all designated crossing locations have pedestrian letdowns per AODA.

*Figure 10: No pedestrian let-down*

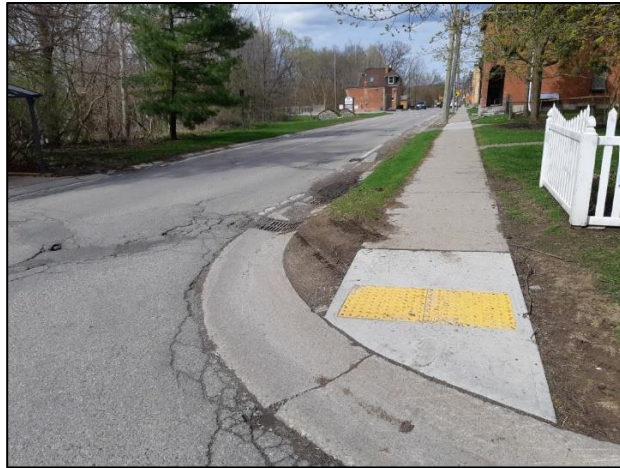
As shown in **Figure 11**, the sidewalk approaching the east side of Agnes Street is equipped with a tactile walking surface indicator. These indicators are used to alert people with visual impairments of potential hazards, such as moving vehicular traffic, as they are detectable underfoot when walking and provide a high tonal contrast with the surrounding surface. It is expected the indicator was installed during previous sidewalk replacement work. The application of tactile plates should be used consistently at all

*Figure 11: Tactile Walking Surface Indicator*

crossing locations along with curb depression treatments that adhere to the AODA requirements.

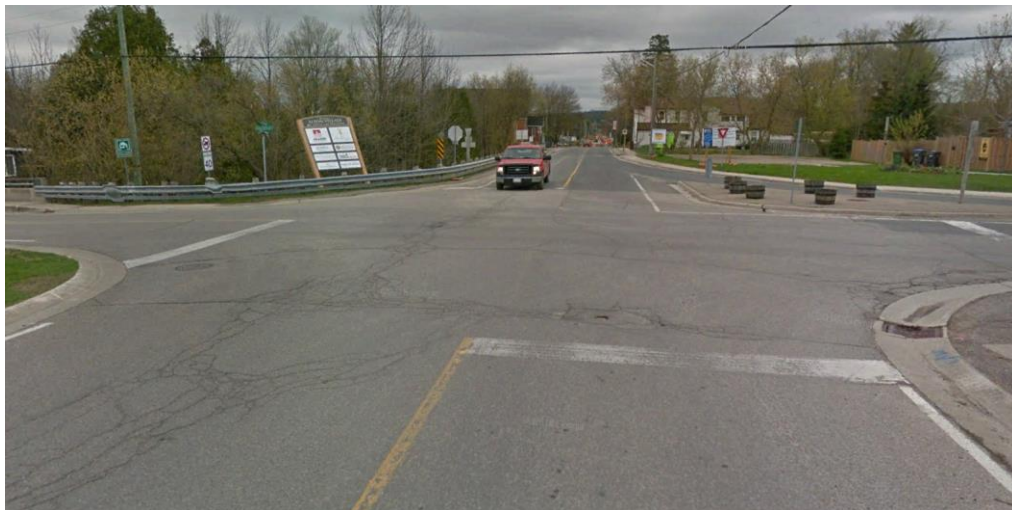
Overall, the study area has limited designated pedestrian crossing facilities. Specifically, the all-way stop controlled intersection of Main Street North at Queen Street does not have any crosswalks, as shown in **Figure 12**, except for the unique midblock crosswalk configuration immediately south of the intersection on Main Street North. The Region of Peel is currently rebuilding this intersection along with improvements along Main Street South and Queen Street East, which will improve the network's overall pedestrian connectivity and accessibility through the introduction of additional crossing facilities.

*Figure 12: Lack of intersection crossing facilities*

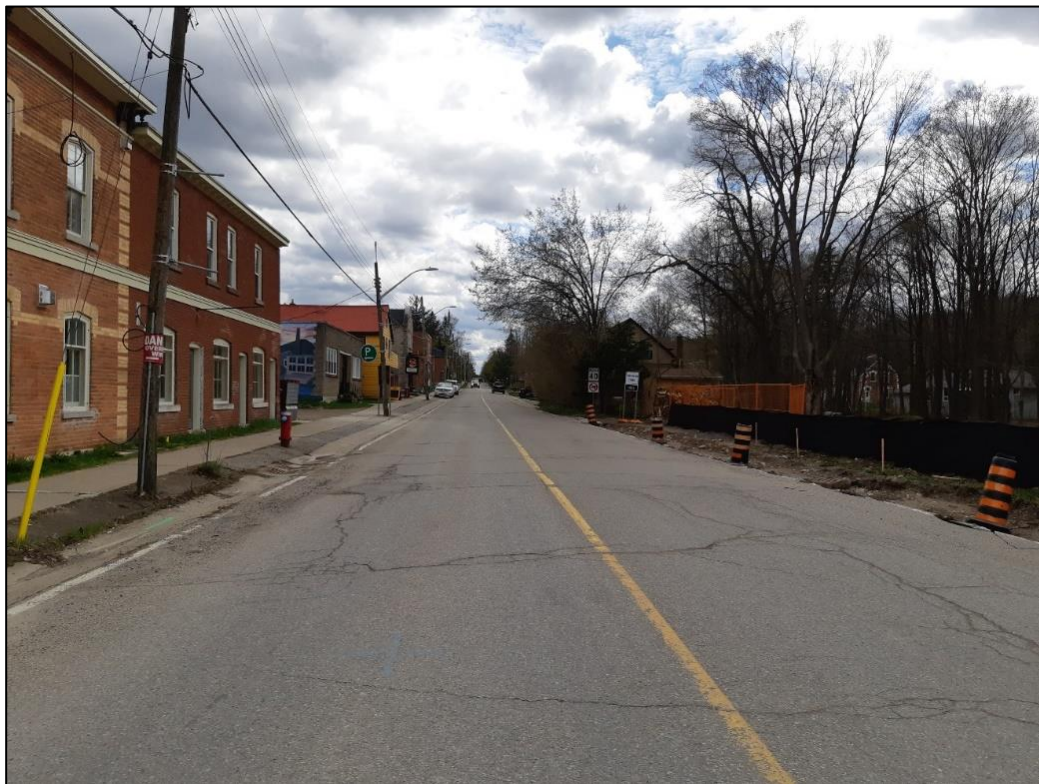
The study area currently has no bicycle facilities. Although cyclists are required to utilize the existing general-purpose travel lanes, there are no traffic control measures (i.e. signage and/or pavement markings) indicating to road users that the roadway is a shared facility, as shown in the Queen Street cross-section in **Figure 13**.

*Figure 13: No bicycle facilities*

Given the desired recreational, community, and visitor-friendly character of the Village, there is expected to be demand for cycling as a mode of local transportation, especially during weekends and the summer season. Consequently, there is opportunity to accommodate this demand and improve overall road user safety by the introduction of on- and/or off-street bicycle facilities. This could include signage, pavement markings, and bike racks at strategic locations (i.e. Alton Millpond and/or Village core).

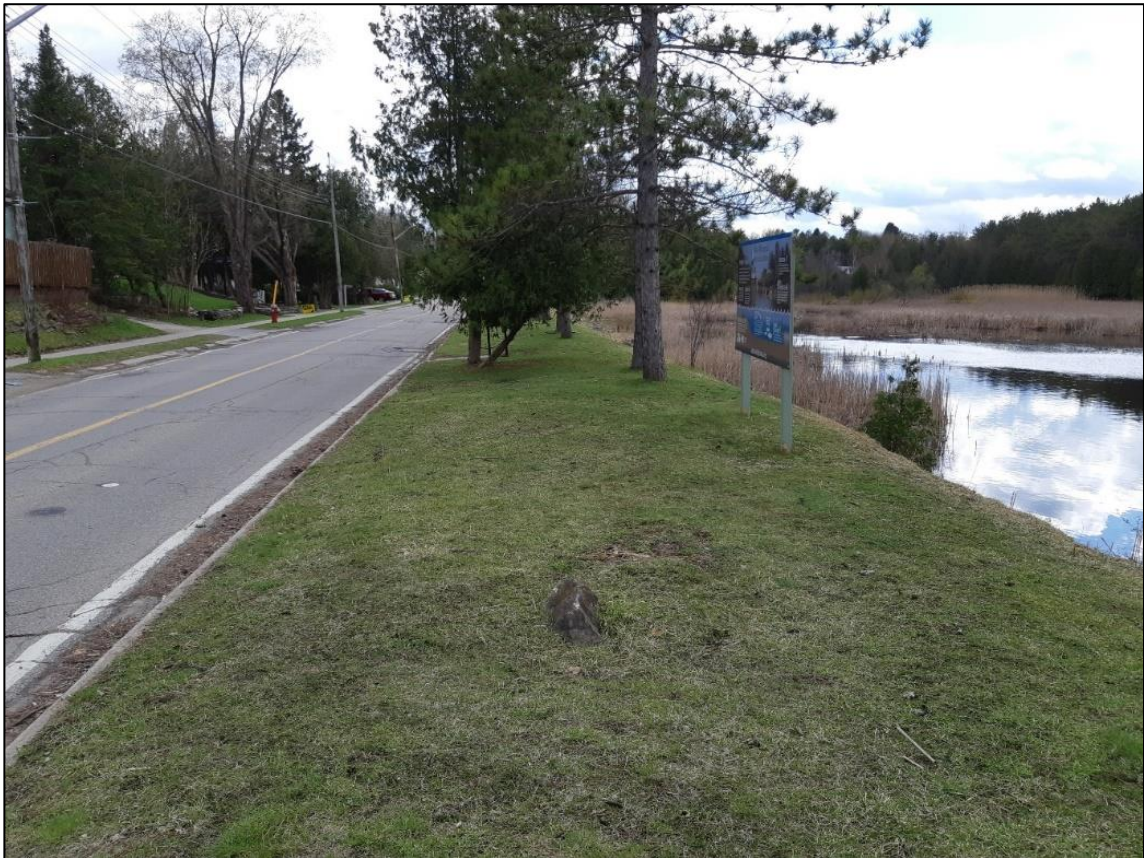
As shown in **Figure 14**, the grassy boulevard on the south side of Alton Millpond, on the north side of Queen Street West, does not have any active transportation facilities, such as a viewing area. The pond acts as an active transportation attractor, especially during the summer season, in which the pond can provide a meeting area and key destination for residents and/or visitors to the village. A viewing area could also include active transportation amenities, such as benches and/or bike racks, further improving the pedestrian and cyclist experience and enhancing the pond's role as a desirable destination in the village.

*Figure 14: No pedestrian amenities at pondside*

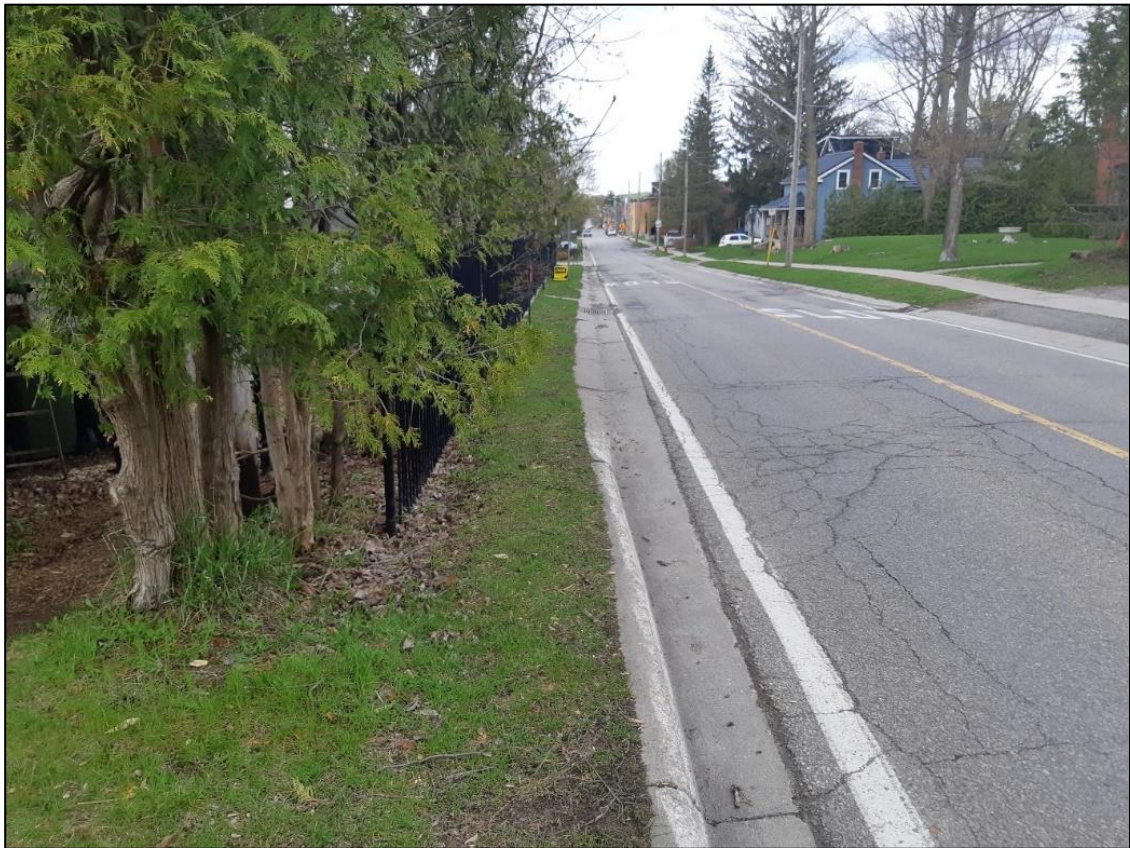
Furthermore, there is currently no pedestrian access to the pond. As shown in **Figure 15**, the available public right-of-way is too limited to provide a sidewalk connection, and with no sidewalks on the north side of Queen Street West, there is no existing sidewalk network to accommodate a connection. It is expected pedestrians are currently crossing Queen Street West from the sidewalk on the south side and viewing the pond from the grassy boulevard. There is opportunity to improve pedestrian connectivity to the pond; a potential option would be the introduction of a designated mid-block pedestrian crossing on Queen Street West.

*Figure 15: No pedestrian access to pond*

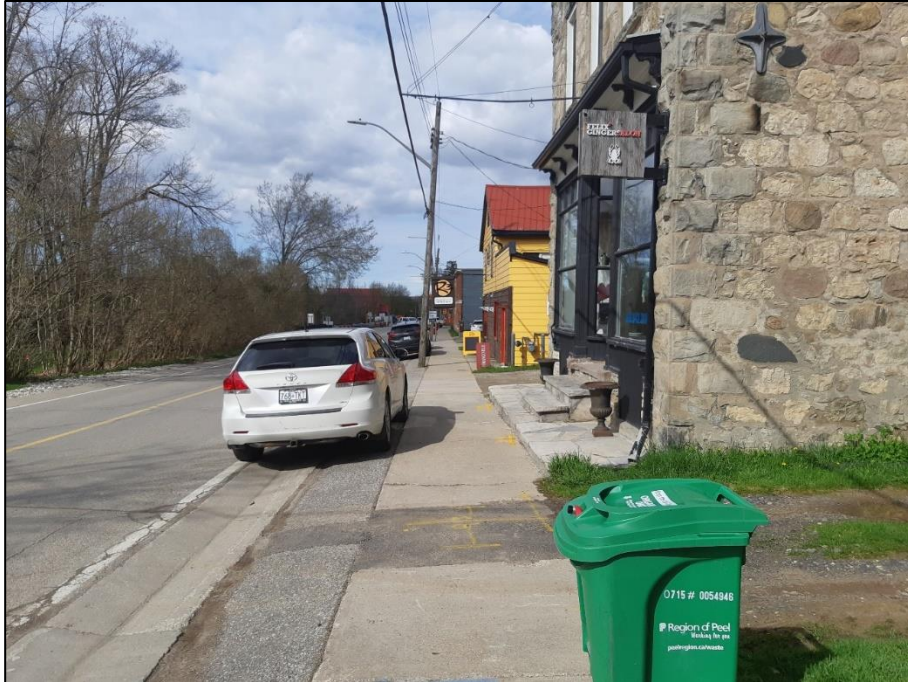
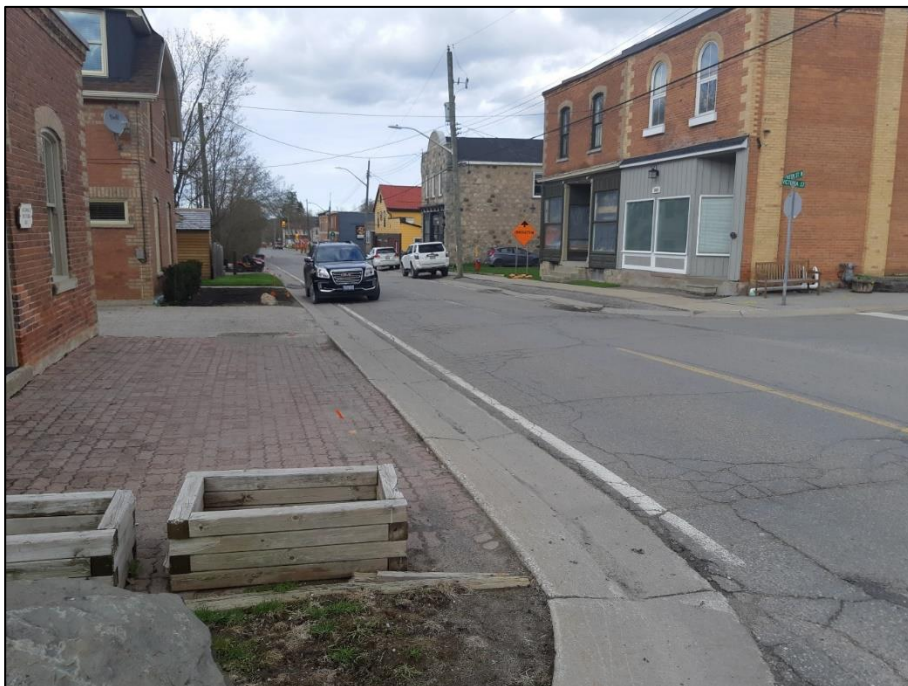
As shown in **Figure 16** and **Figure 17**, on-street parking is currently occurring roadside near the Village core. This is likely a result of the existing commercial establishments and no on-street parking restrictions. Public parking is also permitted on-street on the local roads in the community, and access to a public parking lot does exist on the south side of Queen Street West approximately 40 metres west of Main Street North.

The current arrangement has parked vehicles encroaching into the travel lanes. Although this is generally not a serious concern on local roads, this is not a desirable situation on an arterial road from an operational and safety standpoint. There is opportunity to improve the public parking arrangement in the Village through the provision of designated on-street parking facilities, and/or the implementation of on-street parking restrictions where required with more demand diverted to local streets and/or the public lot. Under a current construction contract, the Region of Peel is incorporating additional parking facilities on Main Street South to add additional parking capacity.

*Figure 16: No designated on-street parking*

*Figure 17: No designated on-street parking*

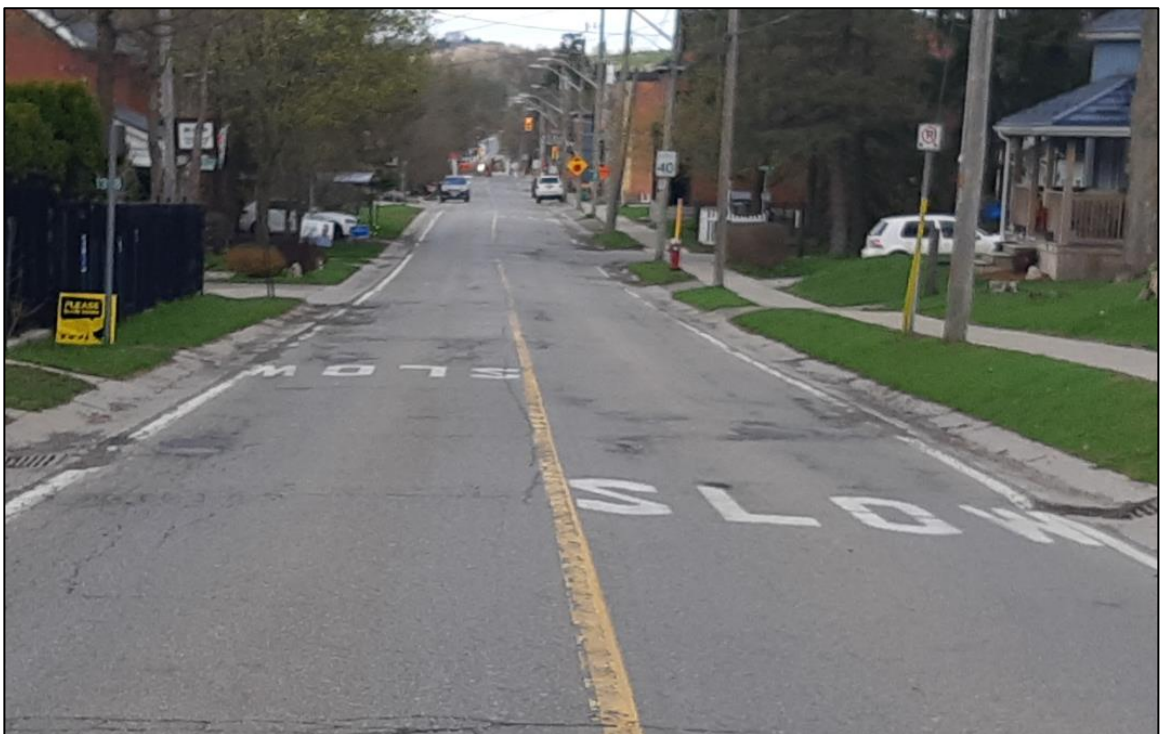
The alignment of Queen Street West is generally on a tangent with minimal slope on the profile. A tangent, approximately 800 metres in length, is located between the s-curve to the west and the all-way stop controlled intersection at Main Street North to the east, both of which have speed-reducing effects. As shown in **Figure 18**, this tangent section already has the following traffic calming measures:

- A reduced posted maximum speed limit of 40 km/h;
- On-street parking in the Village core; and
- “SLOW” pavement marking messaging.

*Figure 18: Traffic calming on Queen Street West*

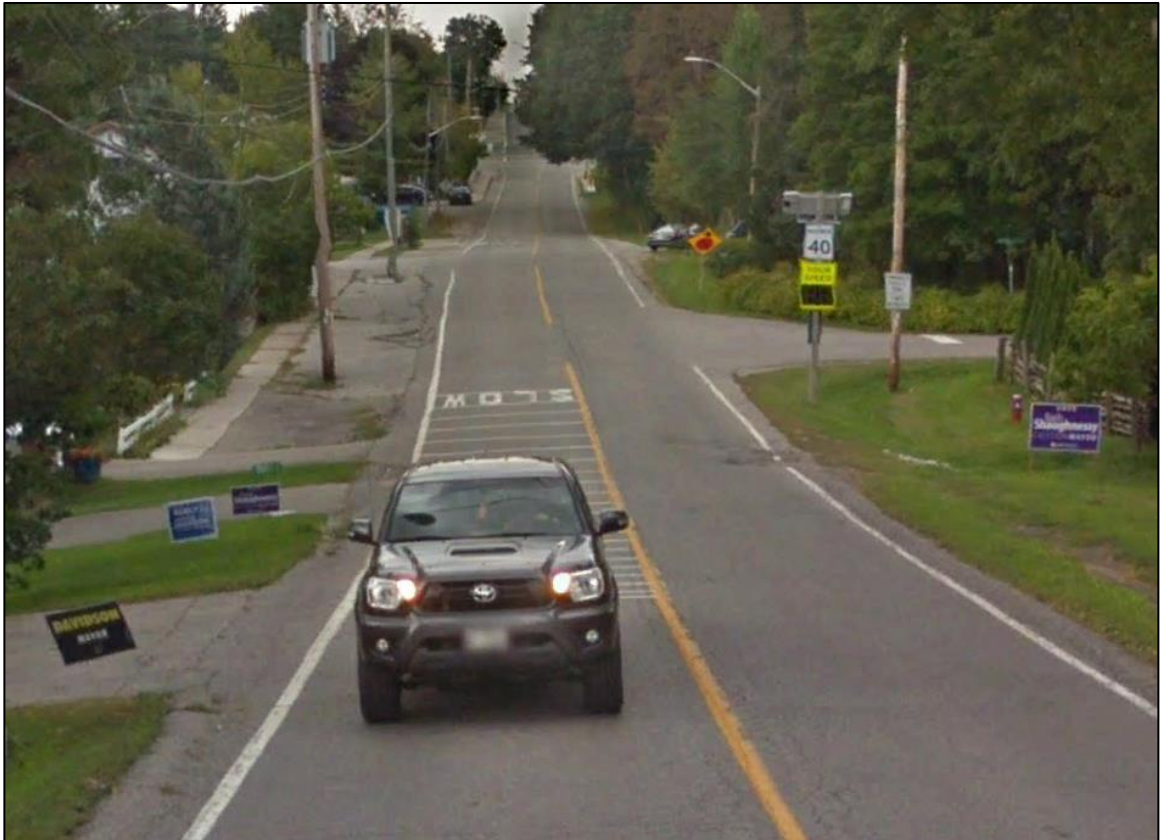
The alignment of Main Street North is generally on a tangent with rolling hills. A tangent, approximately 1 kilometre in length, is located between the s-curve to the north and the all-way stop controlled intersection at Queen Street West to the south, both of which have speed-reducing effects. As shown in **Figure 19**, this section of straight tangent road already has the following traffic calming measures:

- A reduced posted maximum speed limit of 40 km/h;
- Radar speed signs; and
- “SLOW” pavement marking messaging.

*Figure 19: Traffic calming on Main Street*
