DETAILED CONDITION SURVEY REPORT

Site No. B26030042, Main Street, Alton
Caledon, ON

Prepared for: GHD Limited

BCC Project No.: BCC19012
Report Date: May 31, 2019

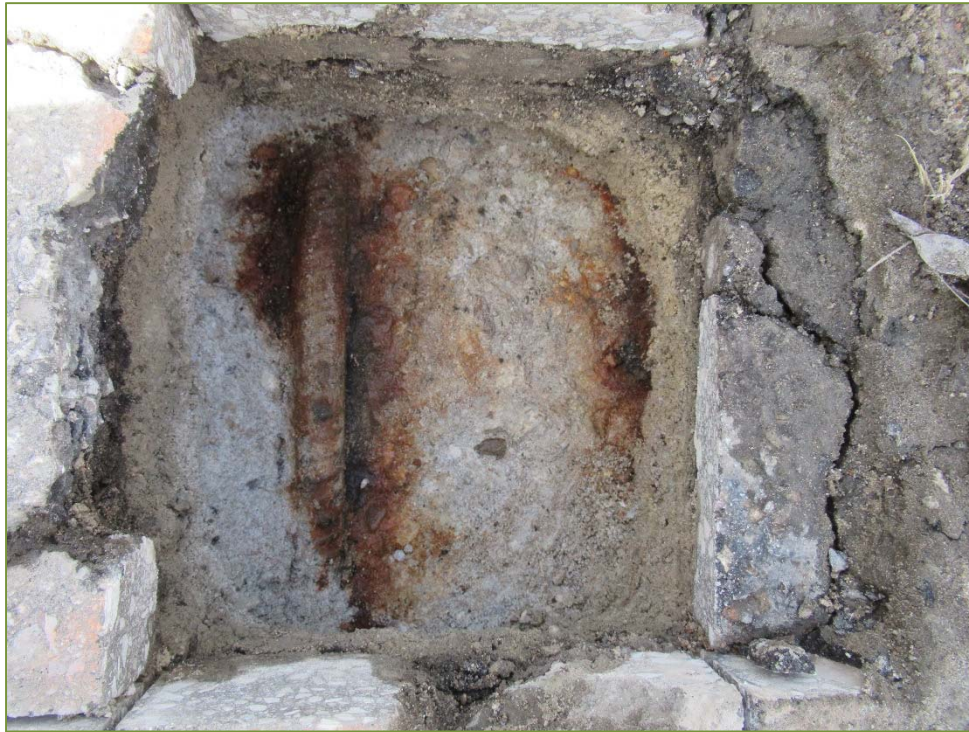
asphalt samples revealed disintegration, exposed and corroded reinforcement in SS5. Refer to the core and sawn asphalt sample logs and photos.

Photo S5 – Sawn Sample SS5 (disintegration) note exposed and corroded rebar

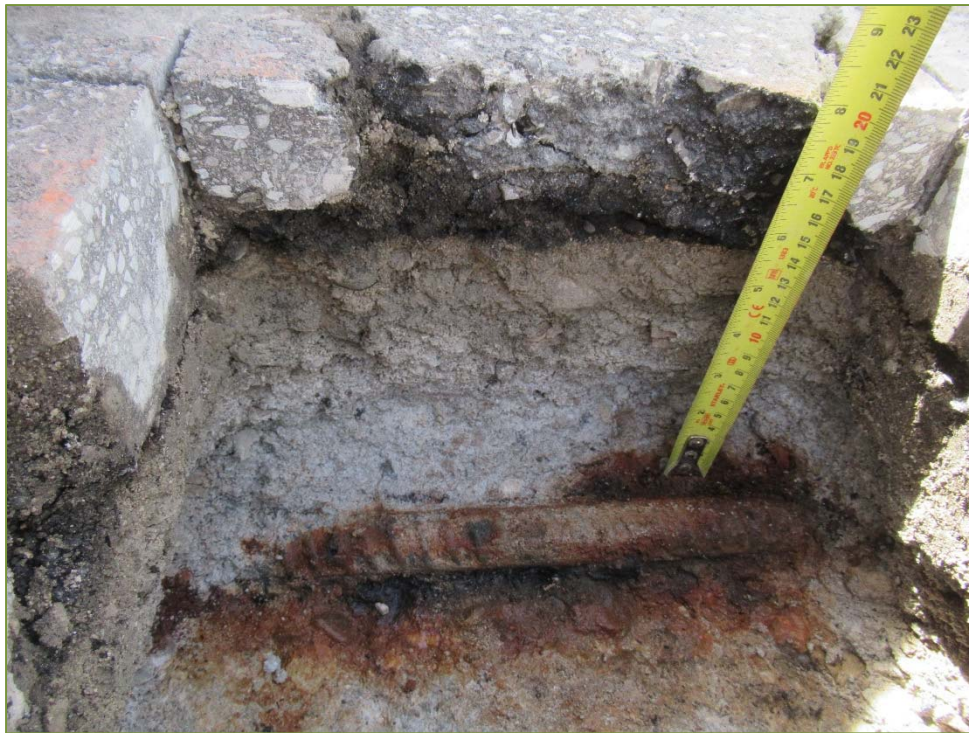
Photo S6 – Sawn Sample SS5 (disintegration) note exposed and corroded rebar

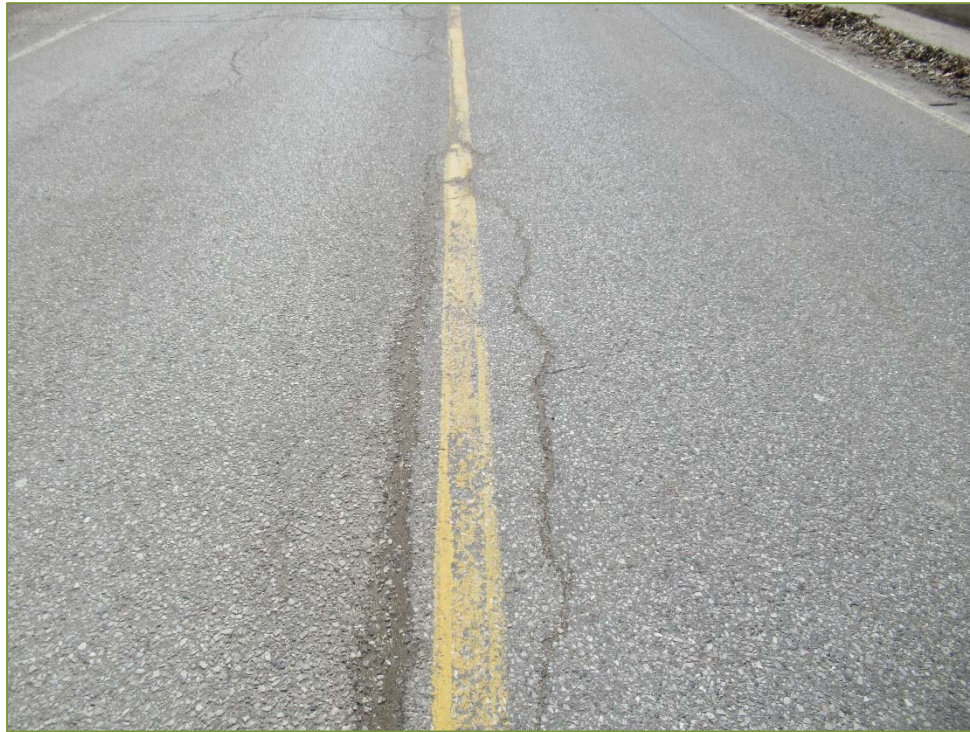
Photo P5 – Deck Wearing Surface (fair condition – unsealed cracks)

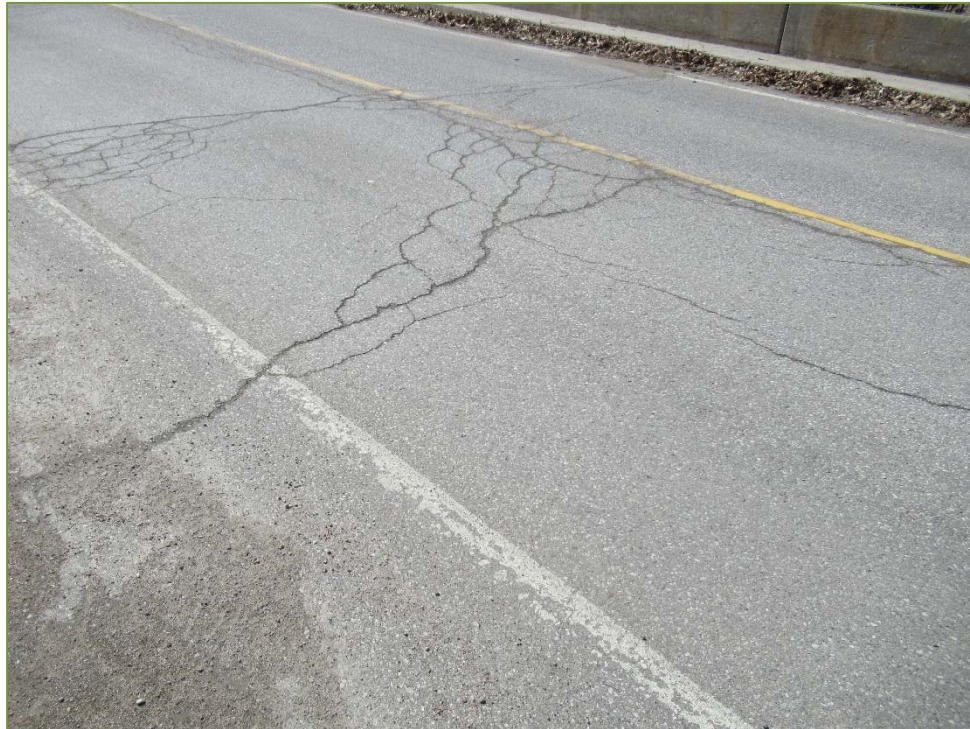
Photo P6 – Deck Wearing Surface (unsealed cracks)

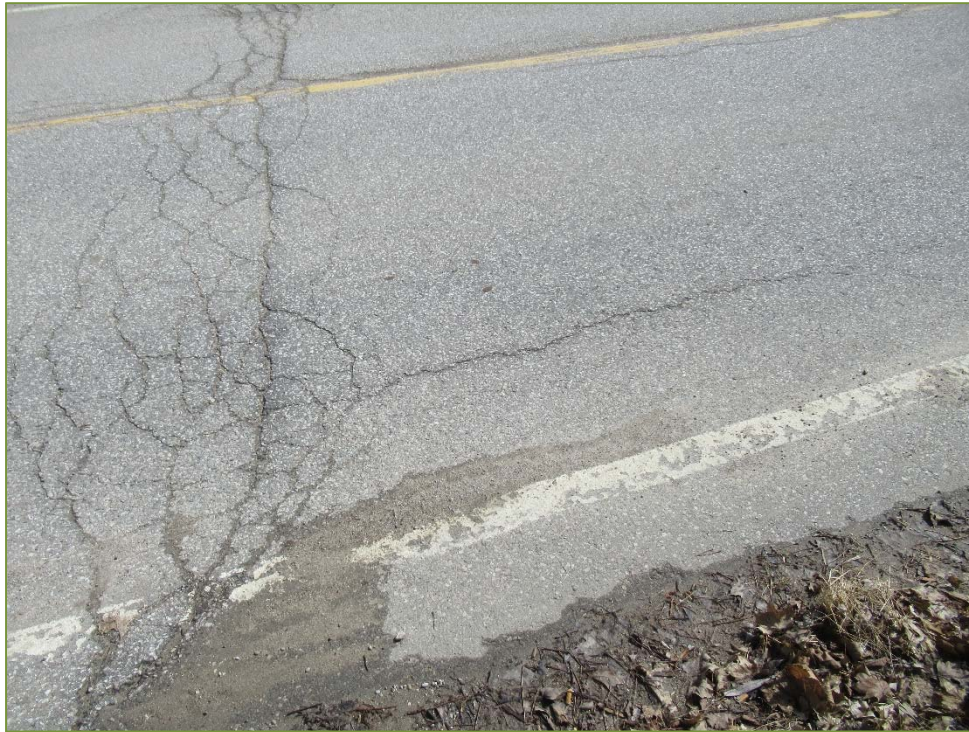
Photo P7 – Deck Wearing Surface (unsealed cracks)

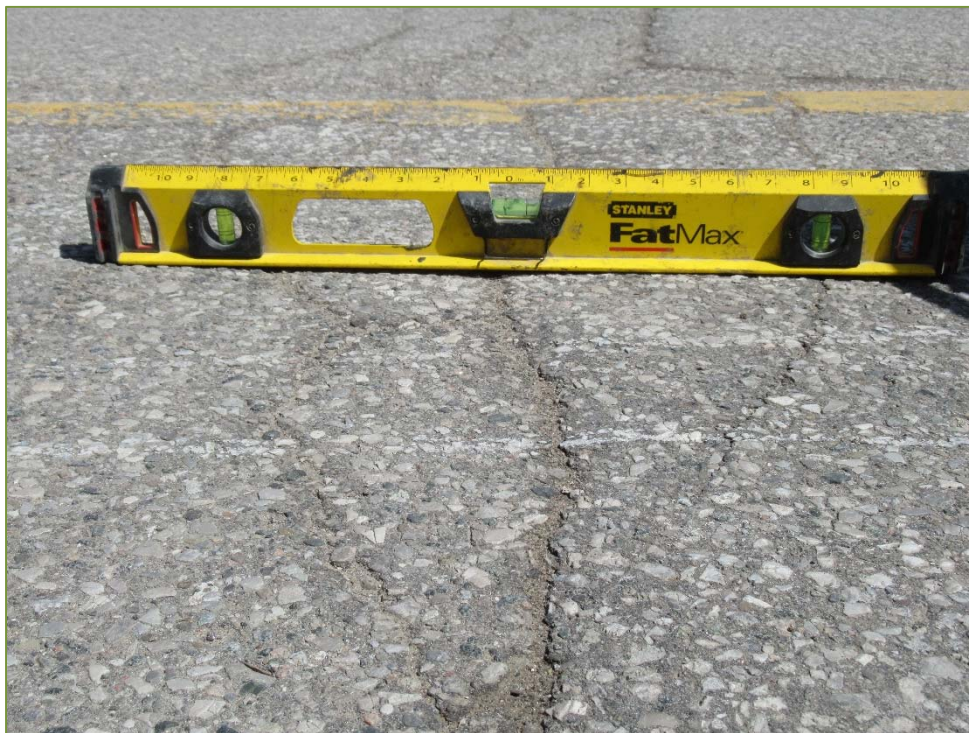
Photo P8 – Deck Wearing Surface (unsealed cracks) note minor settlement

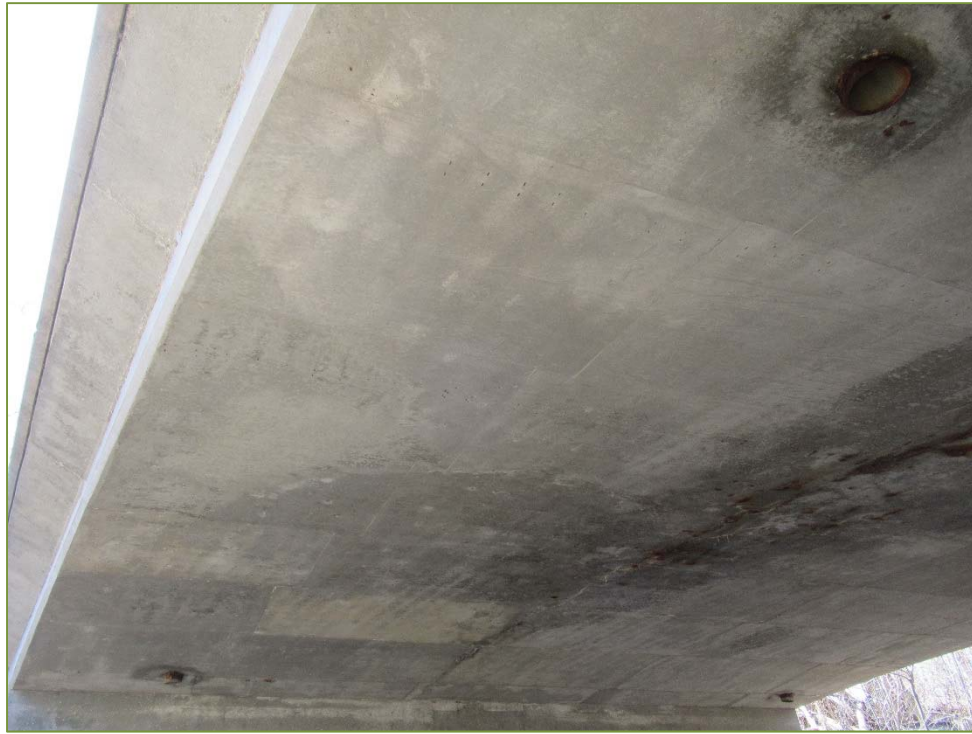
The bridge deck soffit and fascia, with a total surveyed area of 110.00 m², was in fair condition with clean/stained medium width cracks (26.0 m), delaminations (9.40 m²), and wet areas (19.60 m²). Medium corrosion was observed on the deck drain pipes.

Photo P9 – Soffit (fair condition – cracks, delamination and wet area)

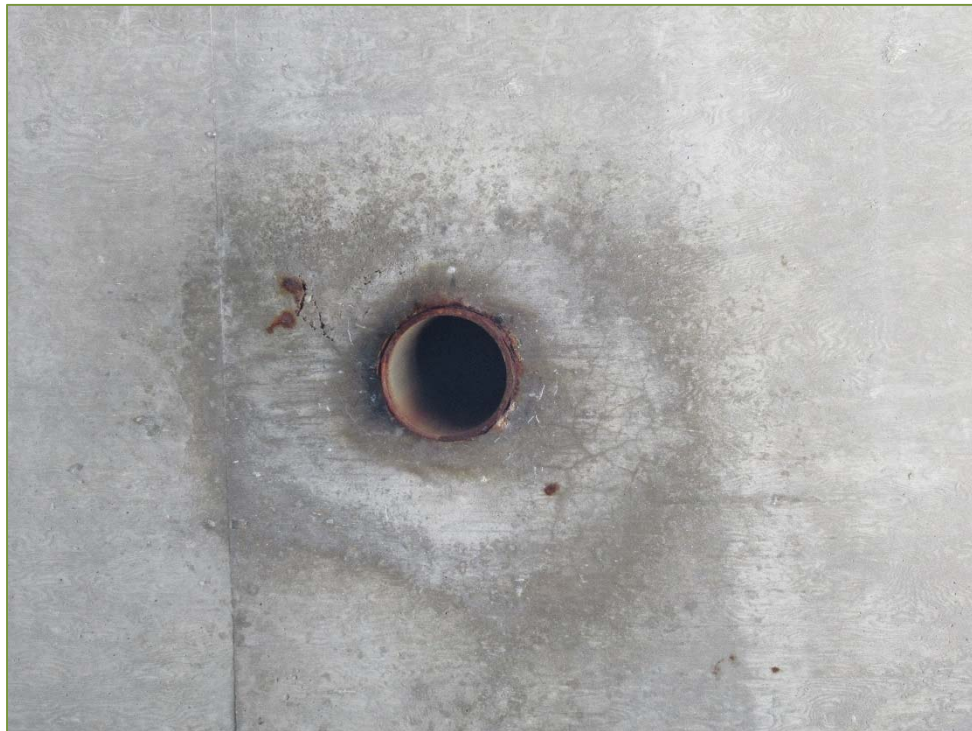
Four steel drain pipes were located on deck, each having a 150 mm diameter and a 720 mm length (Photos P17 to P20). Medium corrosion was observed on the deck drain pipes, as shown in Photo P10. Deck drains were partially covered with dirt and debris. Catch basins were detected all four quadrants outside structure limits (Photos P21 to P23).

Photo P10 – Soffit at North Abutment, east edge (cracks, delamination and wet area) note medium corrosion on deck drain

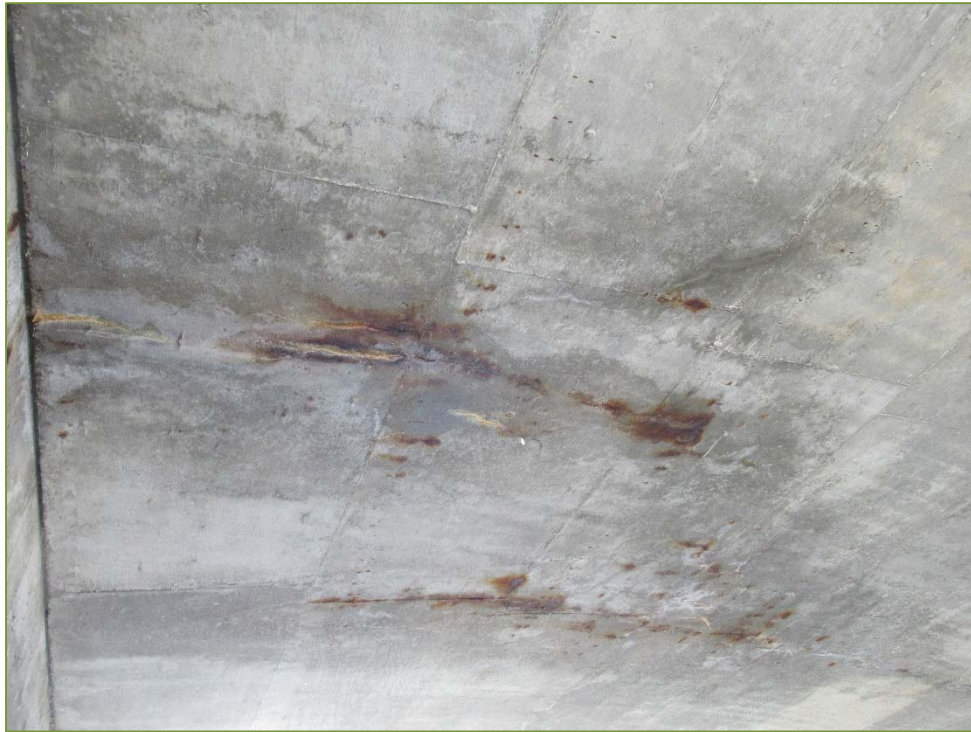
Photo P11 – Soffit at North Abutment (cracks, delamination and wet area)

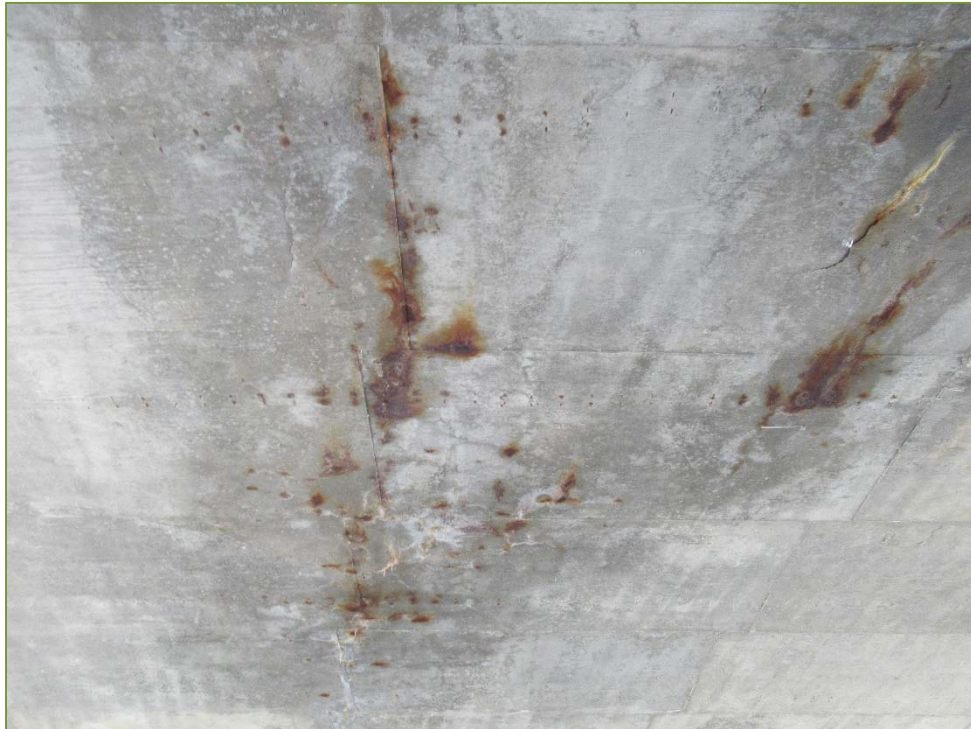
Photo P12 – Soffit (cracks, delamination and wet area)

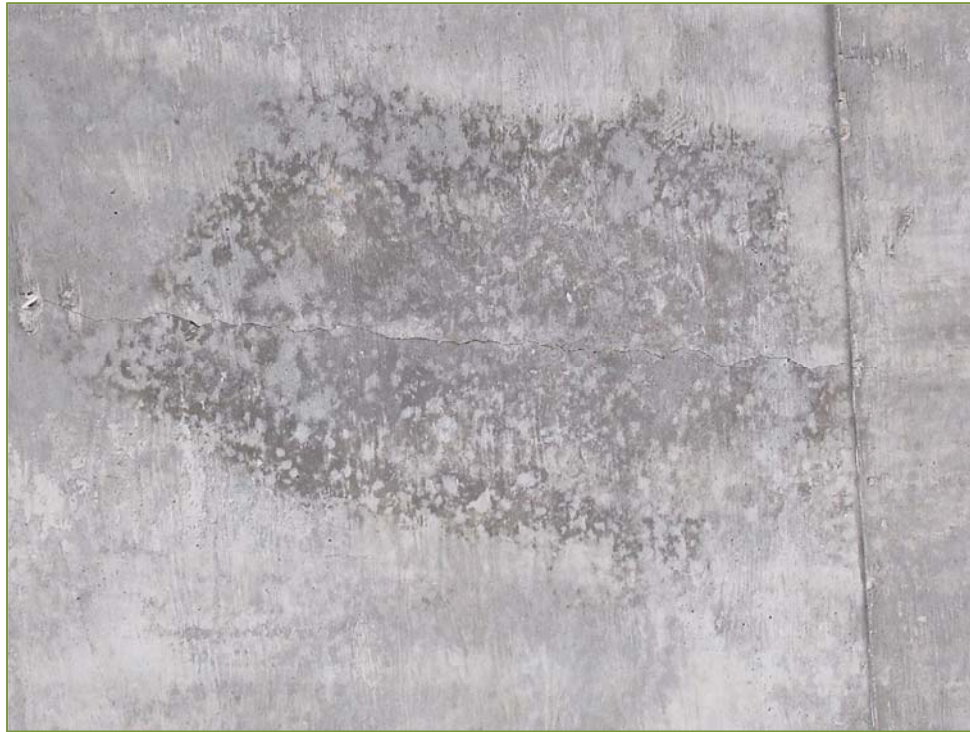
Photo P13 – Soffit (crack and wet area)

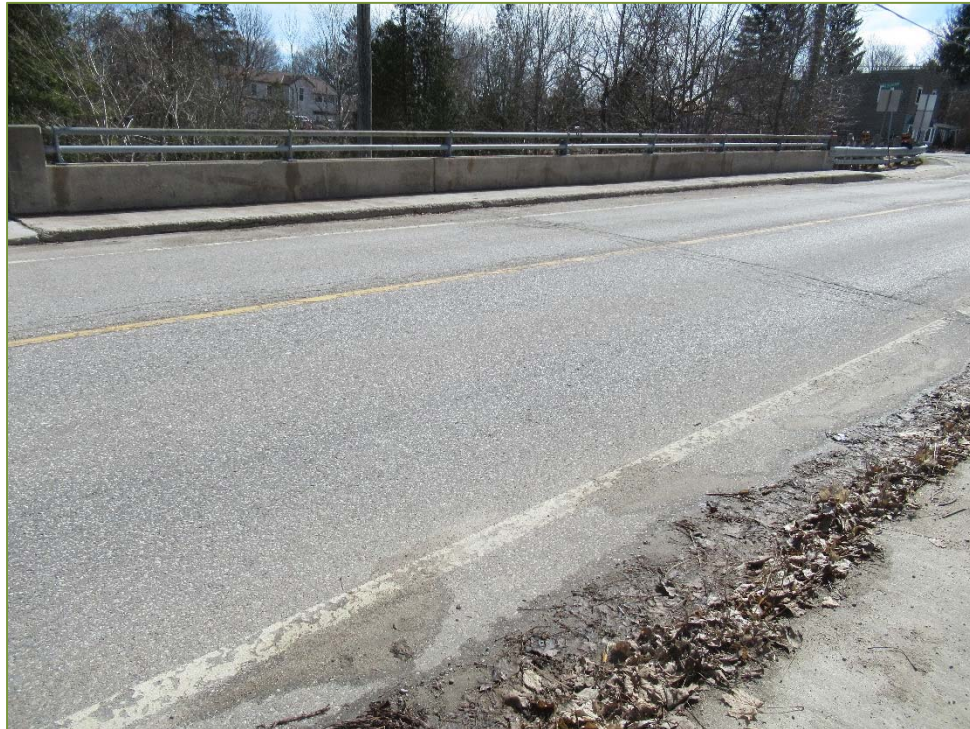
The asphalt wearing surface on the bridge approaches was generally in fair-to-good condition with unsealed cracks and settlements. Photos P14 to P16 show the general pavement condition on the approaches. Core C1 was taken from the north approach, where granular materials were encountered beneath 55 mm of asphalt.

Photo P14 – North Approach Wearing Surface (fair condition – unsealed cracks) note settlement

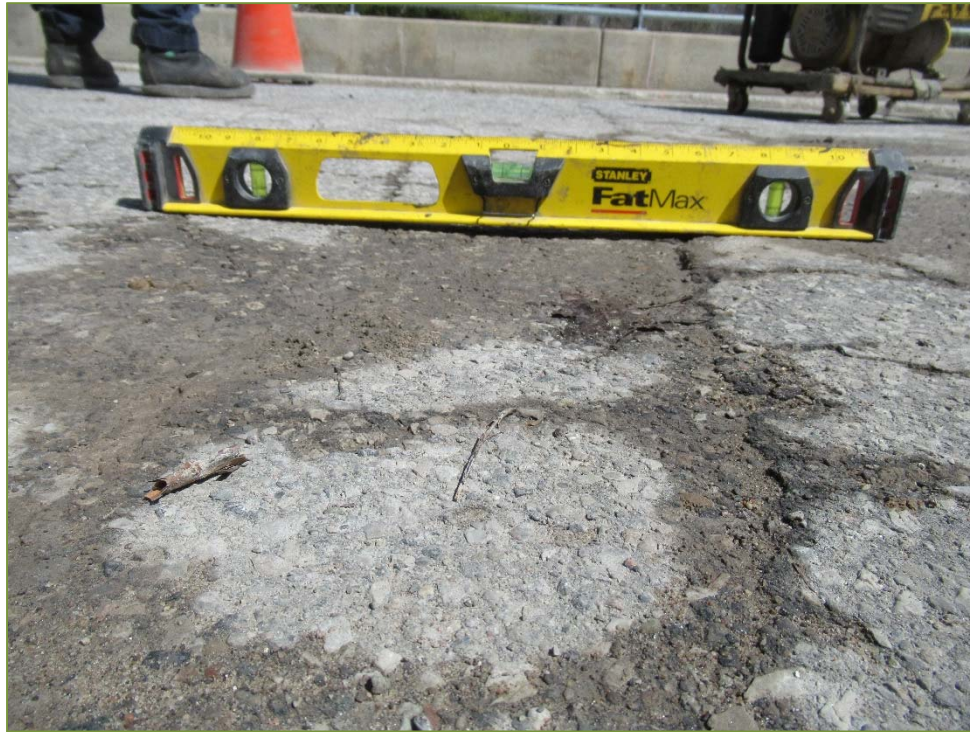
Photo P15 – North Approach Wearing Surface (unsealed cracks) note settlement

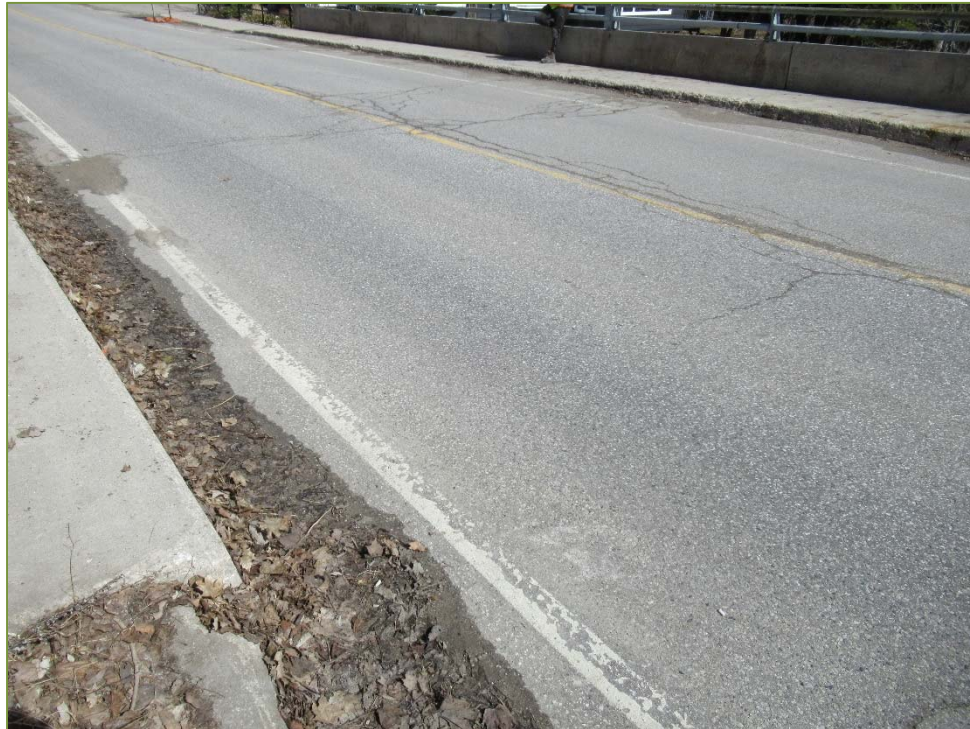
Photo P16 – South Approach Wearing Surface (fair to good condition – unsealed cracks)

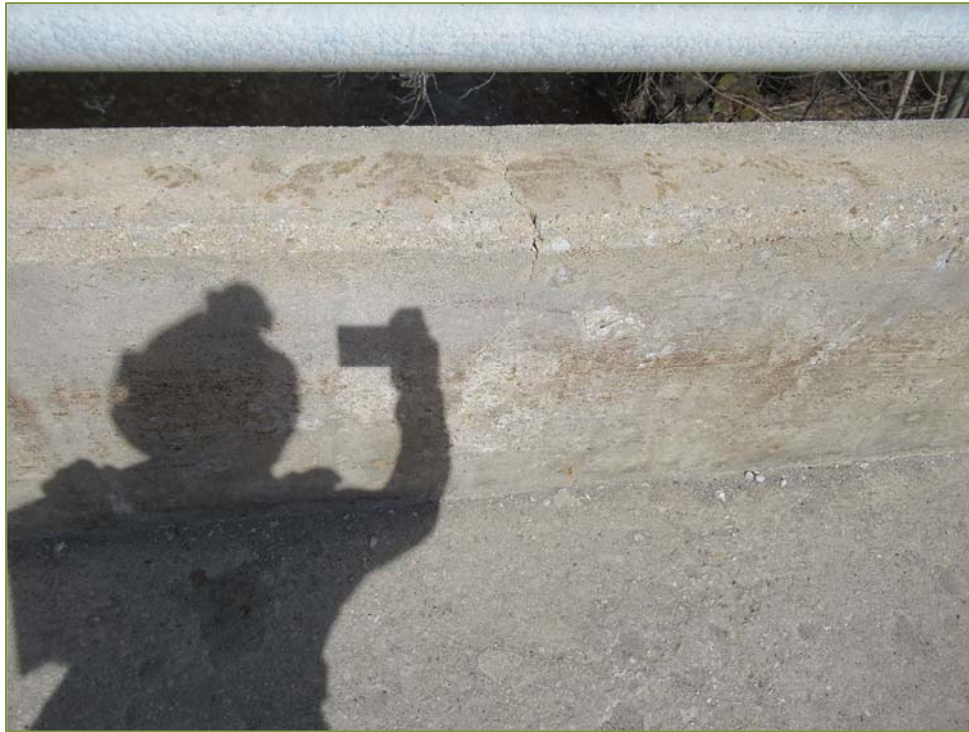
Photo P25 – East Parapet Wall (crack and light scaling)

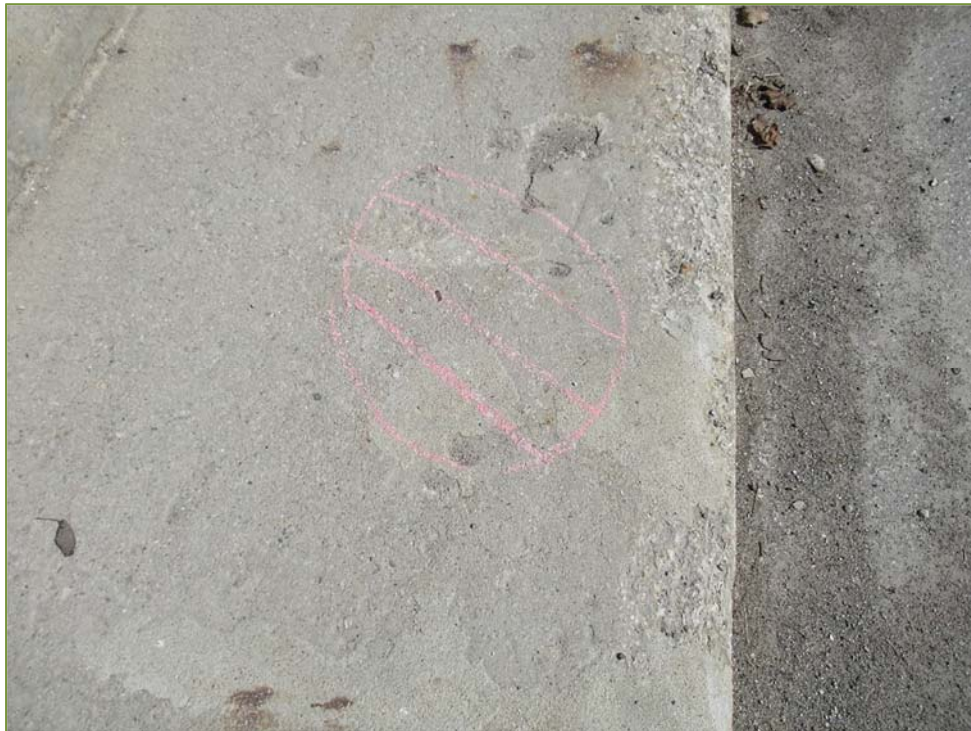
Photo P28 – East Sidewalk @ South Approach (spall, delamination and light/medium scaling)

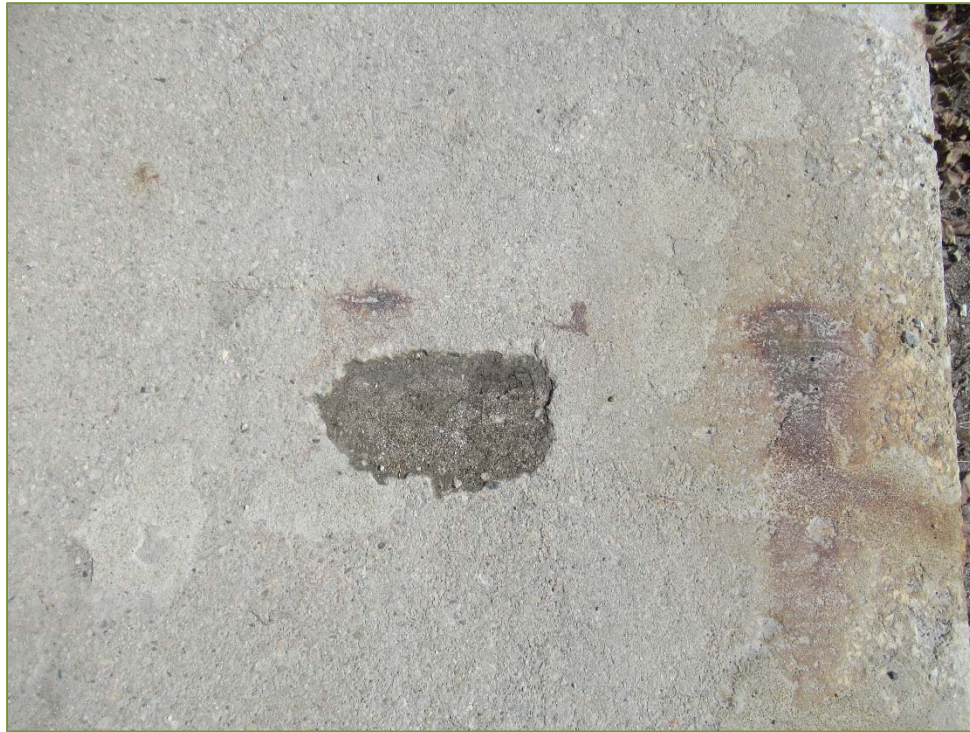
Photo P29 – East Sidewalk @ South Approach (spall and light scaling)

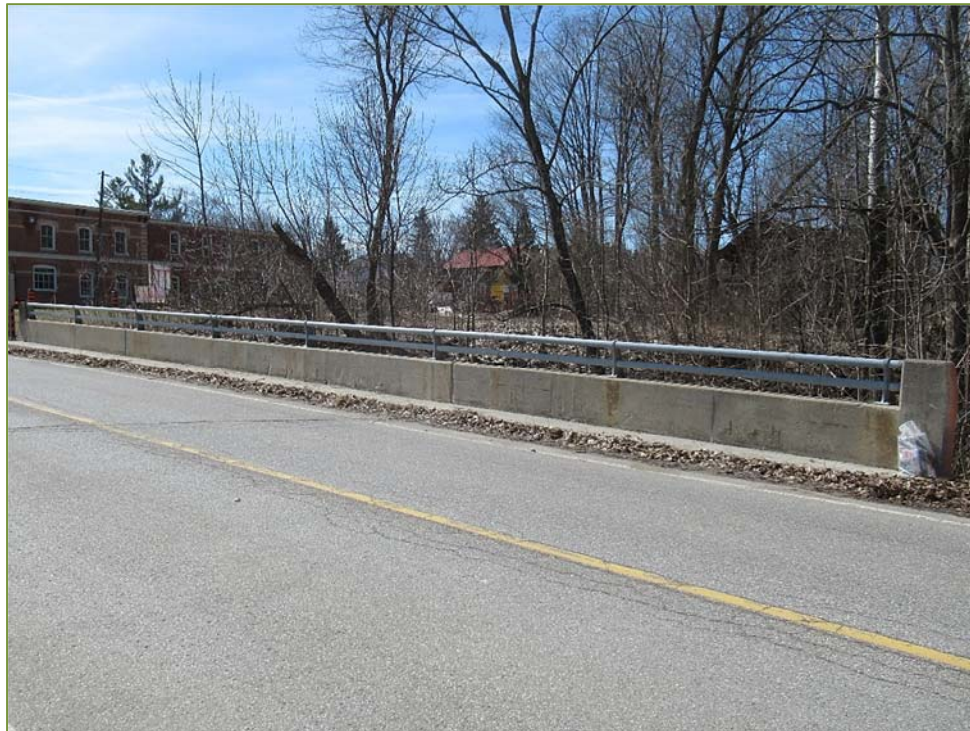
Photo P30 – West Curb (fair to good condition – cracks and medium scaling) **and Parapet Wall** (fair condition – cracks, spall and delamination)

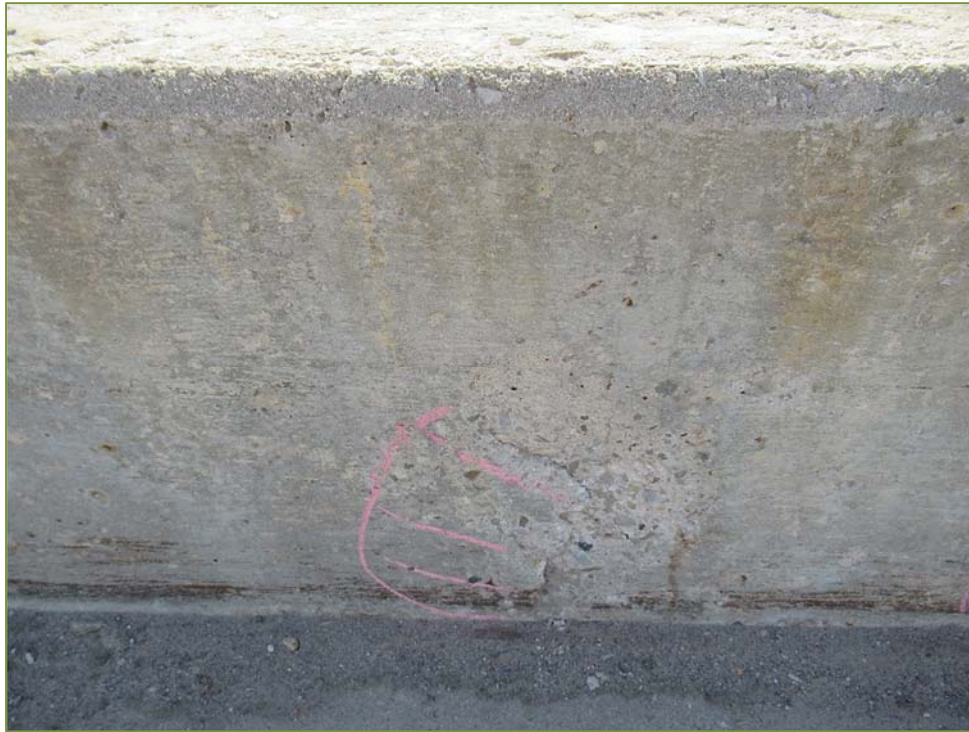
Photo P31 – West Parapet Wall (spall and delamination)

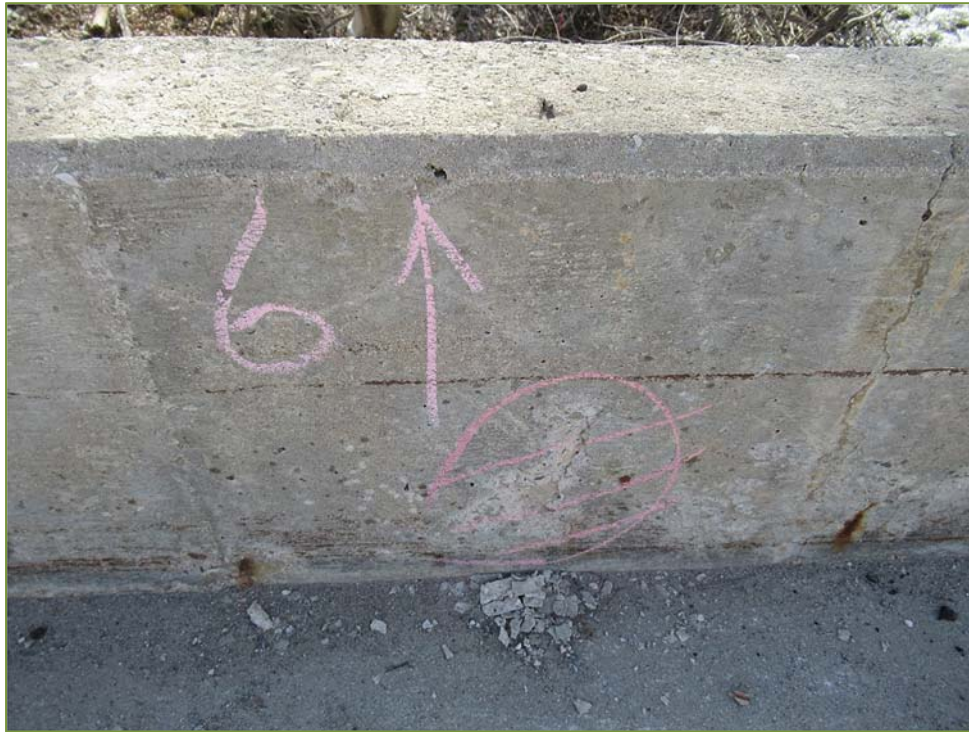
Photo P33 – West Parapet Wall (crack, spall and delamination)

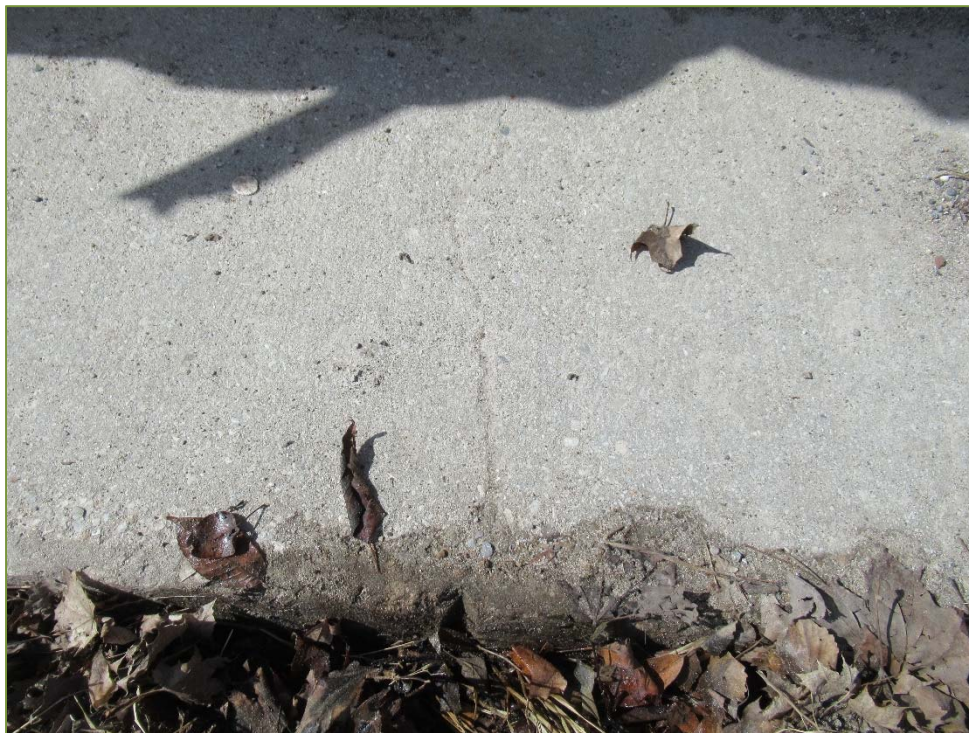
Photo P34 – West Curb (crack and medium scaling)

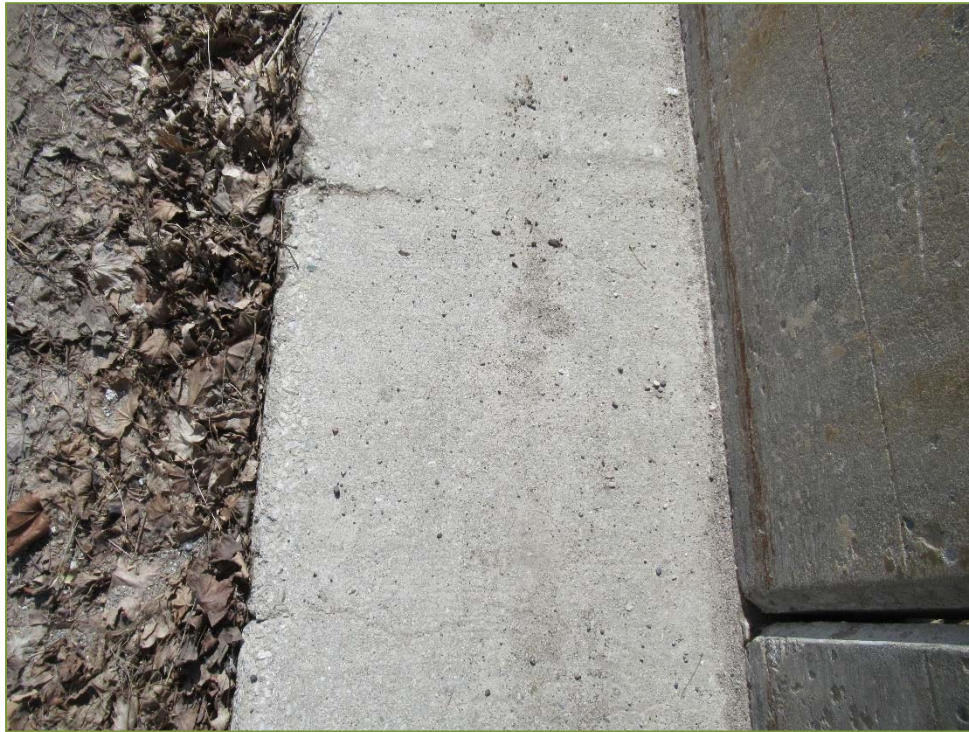
Photo P35 – West Curb (crack and medium scaling)

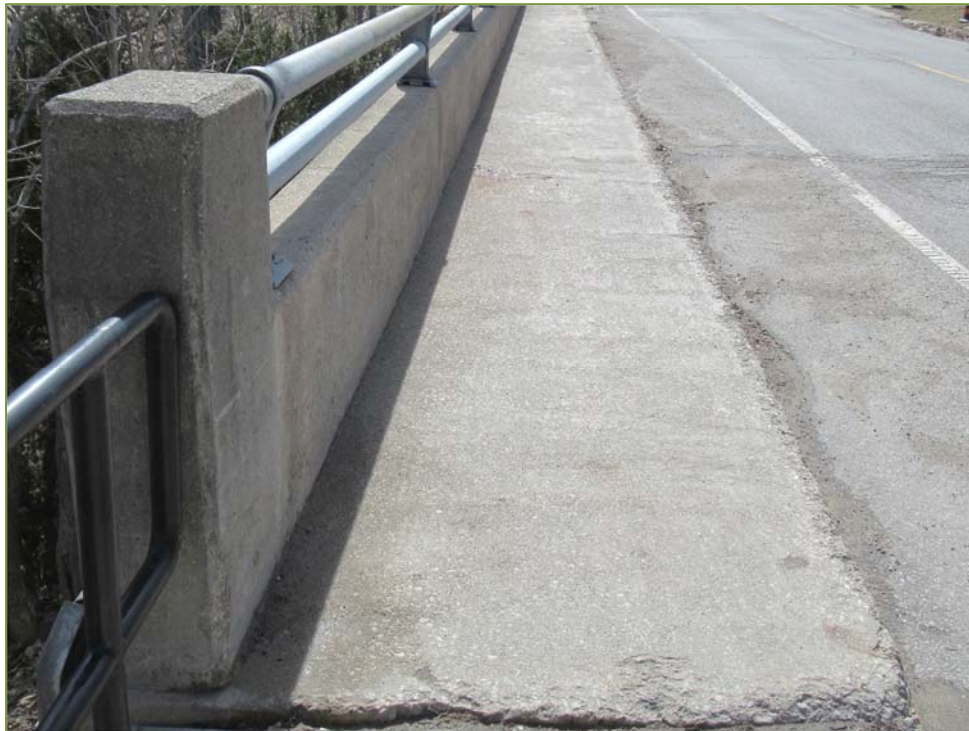
Photo P36 – Northeast End Post (fair to good condition – light scaling)

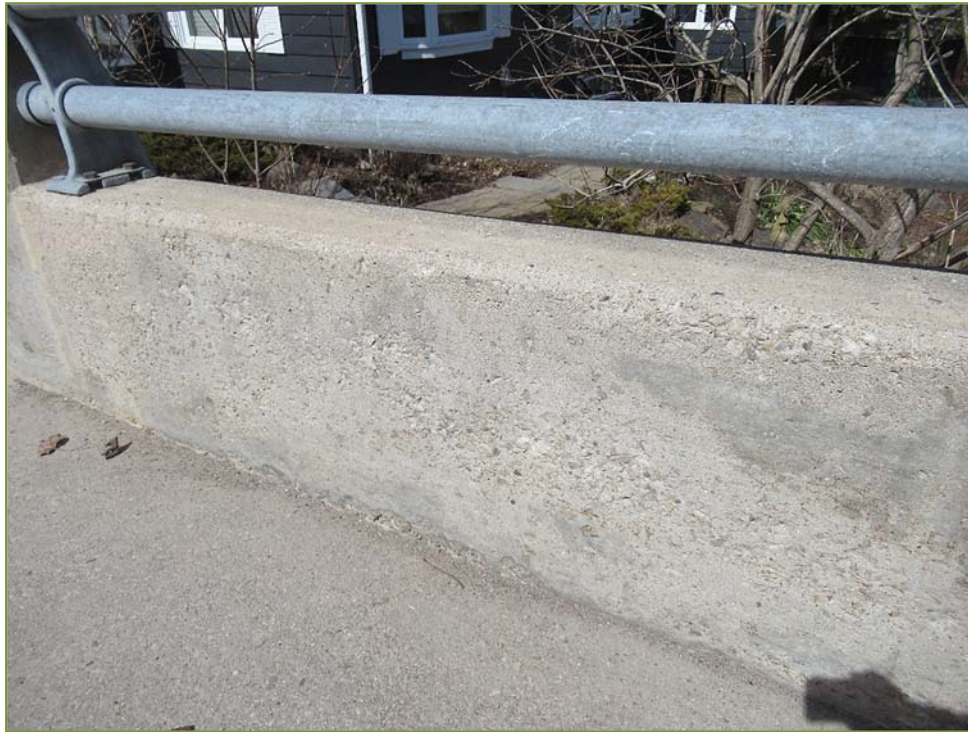
Photo P37 – Northeast End Post (light scaling)

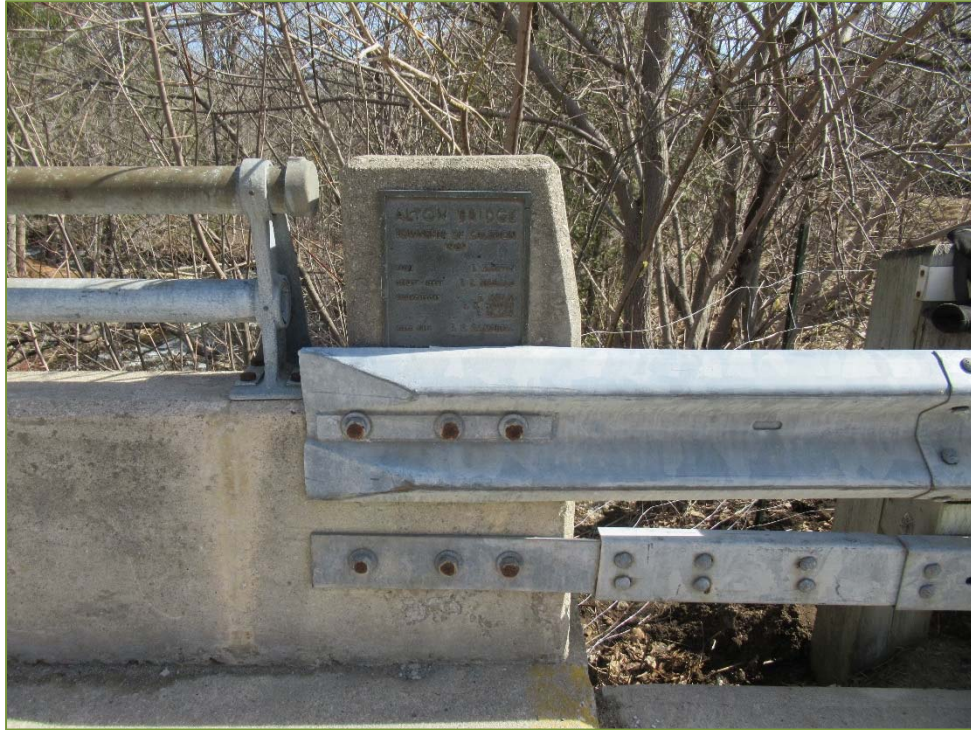
The steel handrails were generally in good condition with missing end caps at southeast and southwest corner and localized light surface rusting.

Photo P39 – Southeast End Post note missing handrail end cap

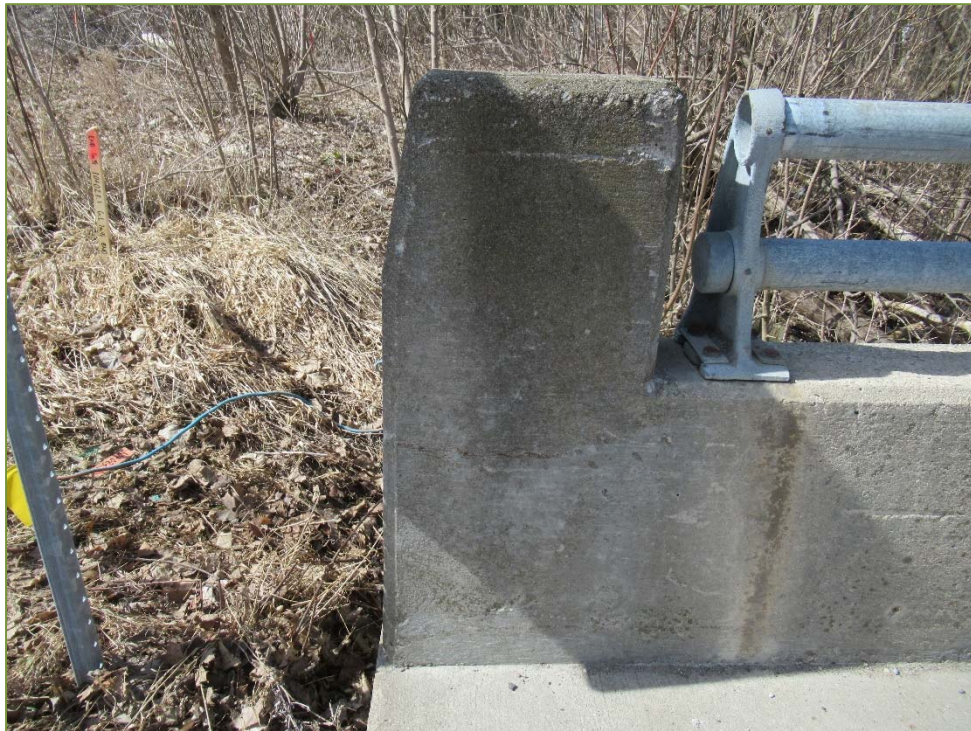
Photo P40 – Southwest End Post note missing handrail end cap

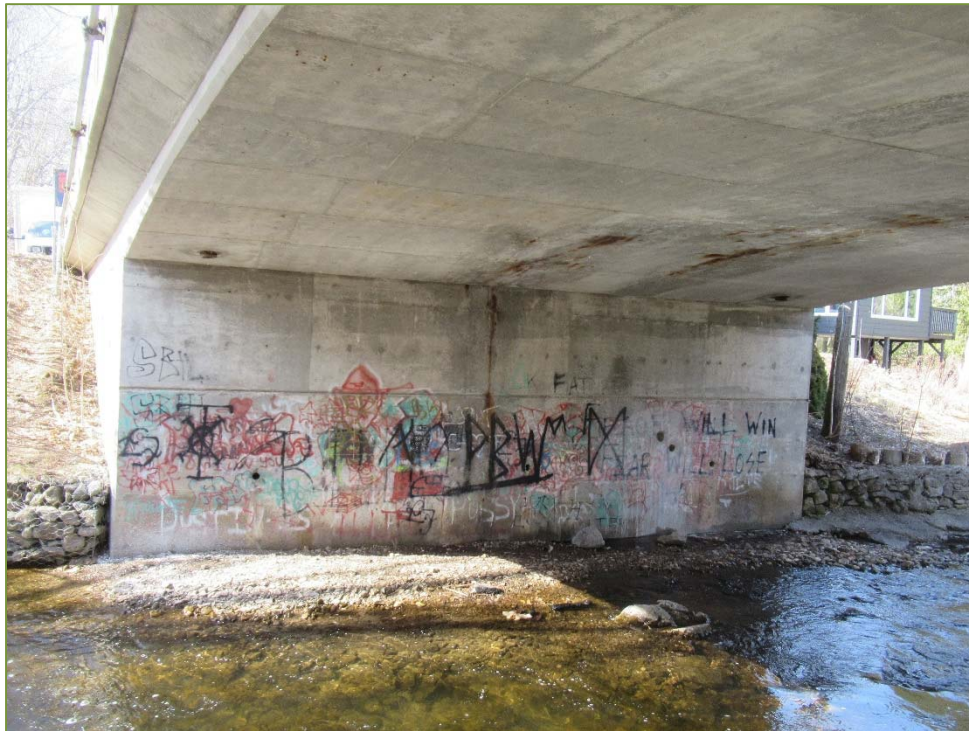
Photo P42 – North Abutment (fair to good condition – wide crack and wet area)

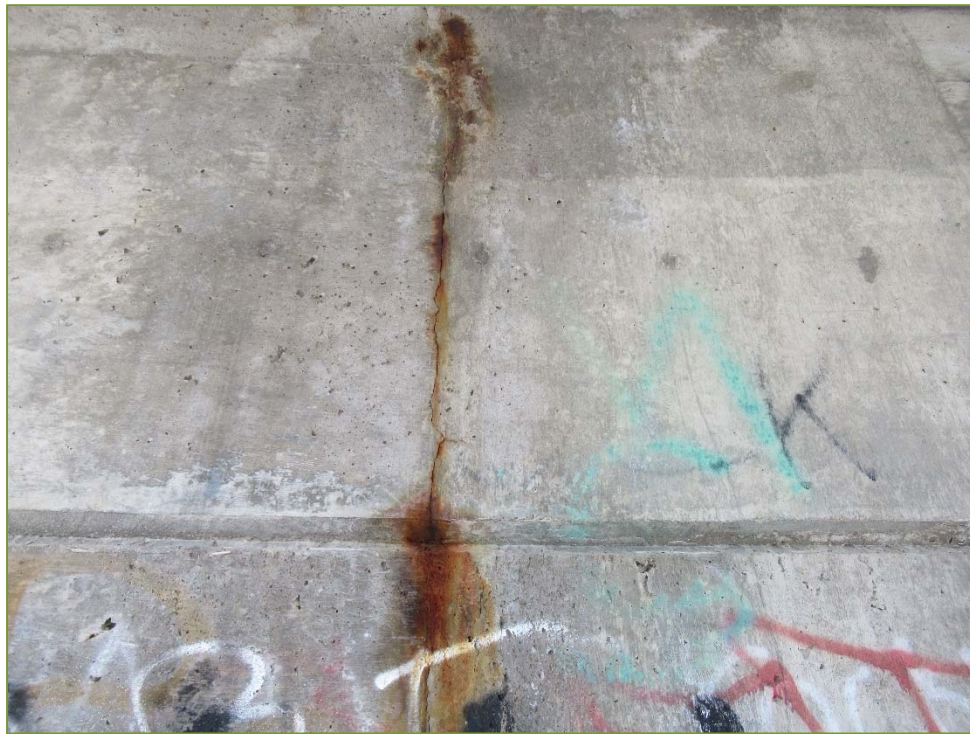
Photo P43 – North Abutment (wide crack and wet area)

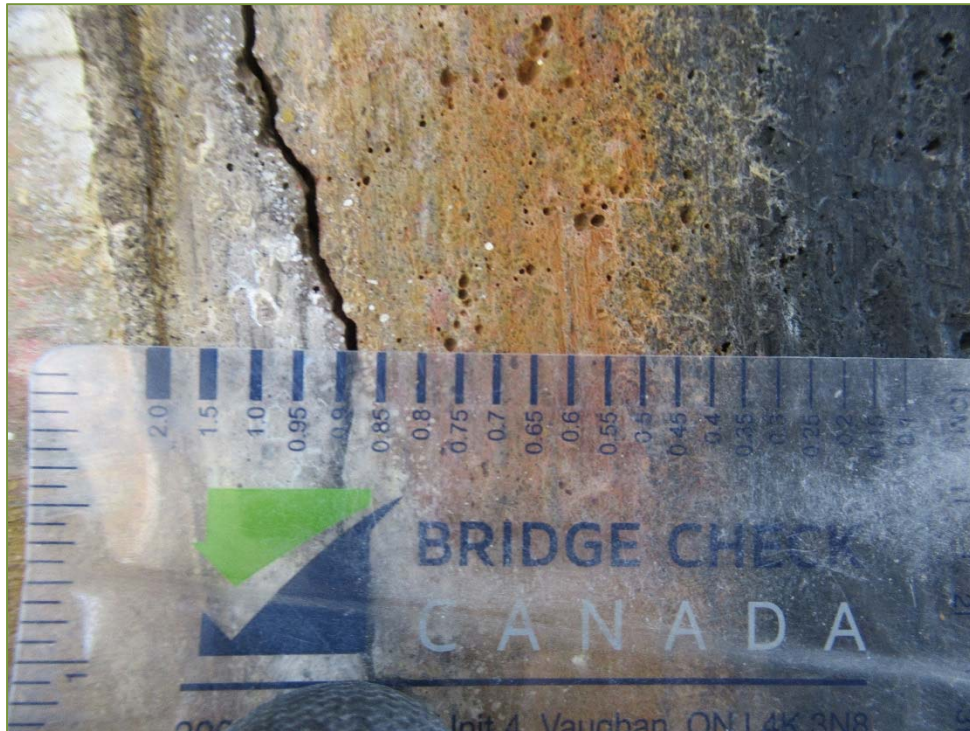
Photo P44 – North Abutment (wide crack and wet area)

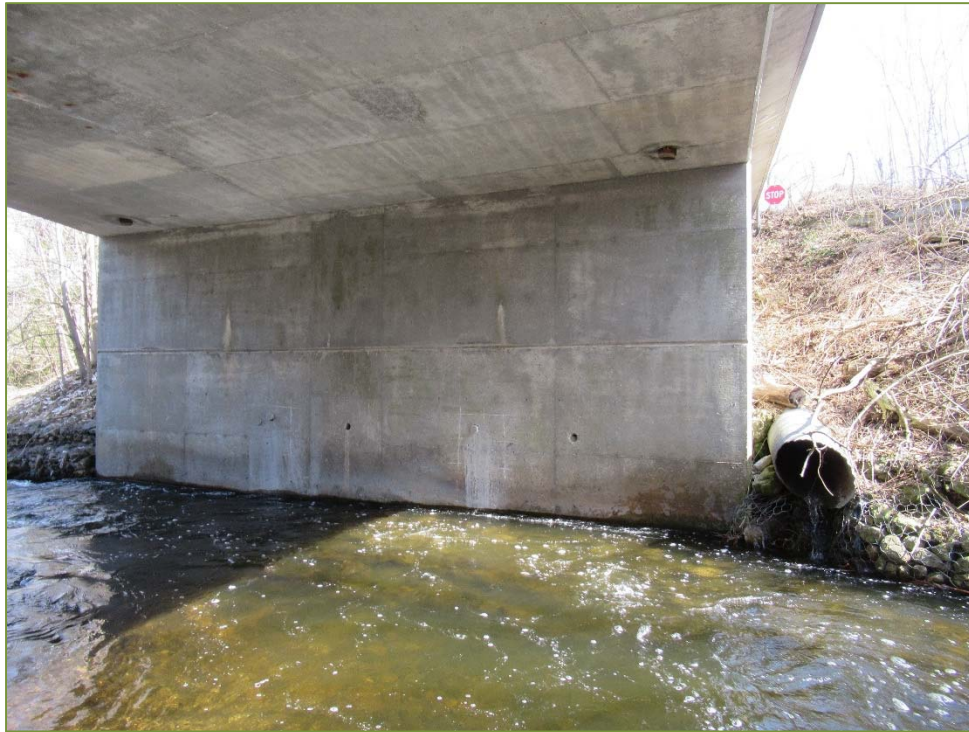
Photo P45 – South Abutment (good condition – cracks)

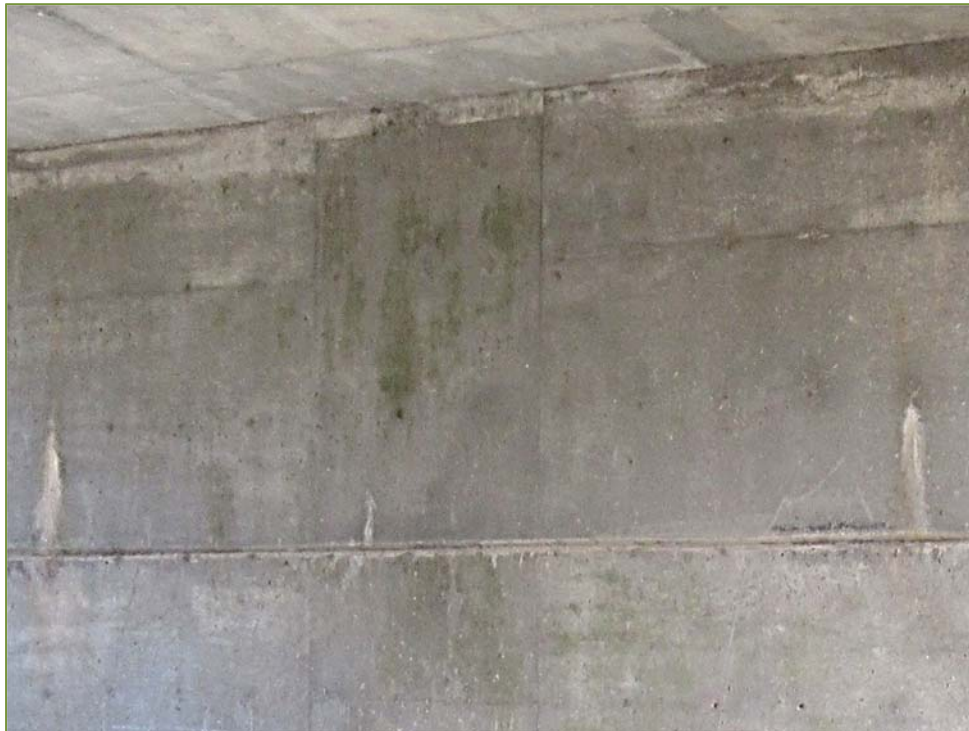
Photo P46 – South Abutment (cracks)
