DETAILED CONDITION SURVEY REPORT

Site No. B26030042, Main Street, Alton
Caledon, ON

Prepared for: GHD Limited

BCC Project No.: BCC19012
Report Date: May 31, 2019

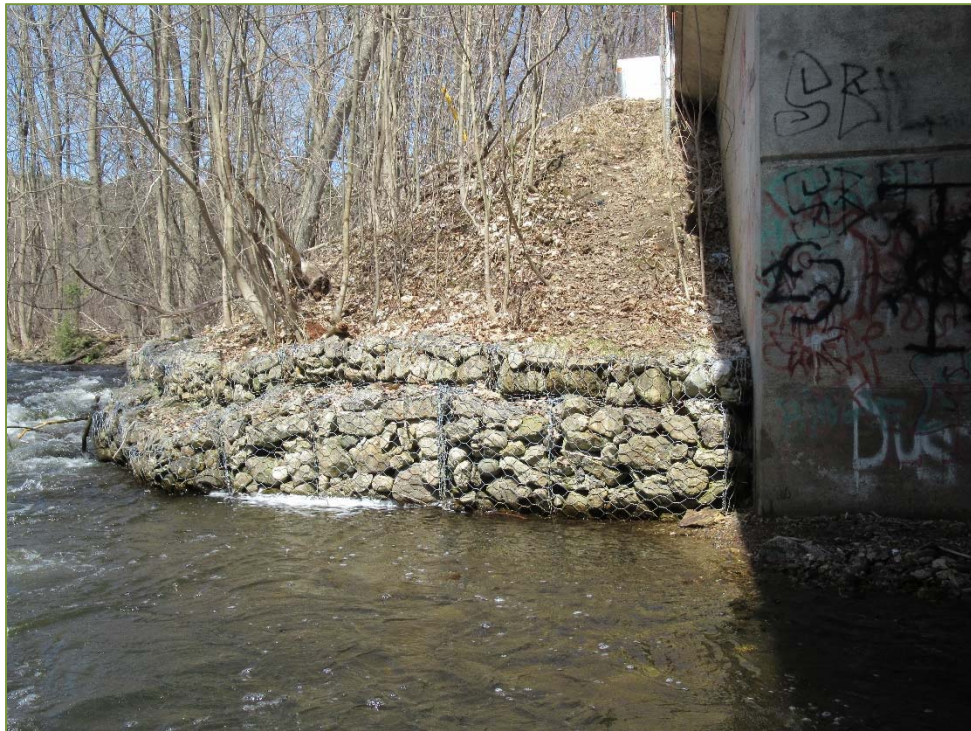
Photo P52 – Northwest Gabion Wall (fair to good condition – bulging)

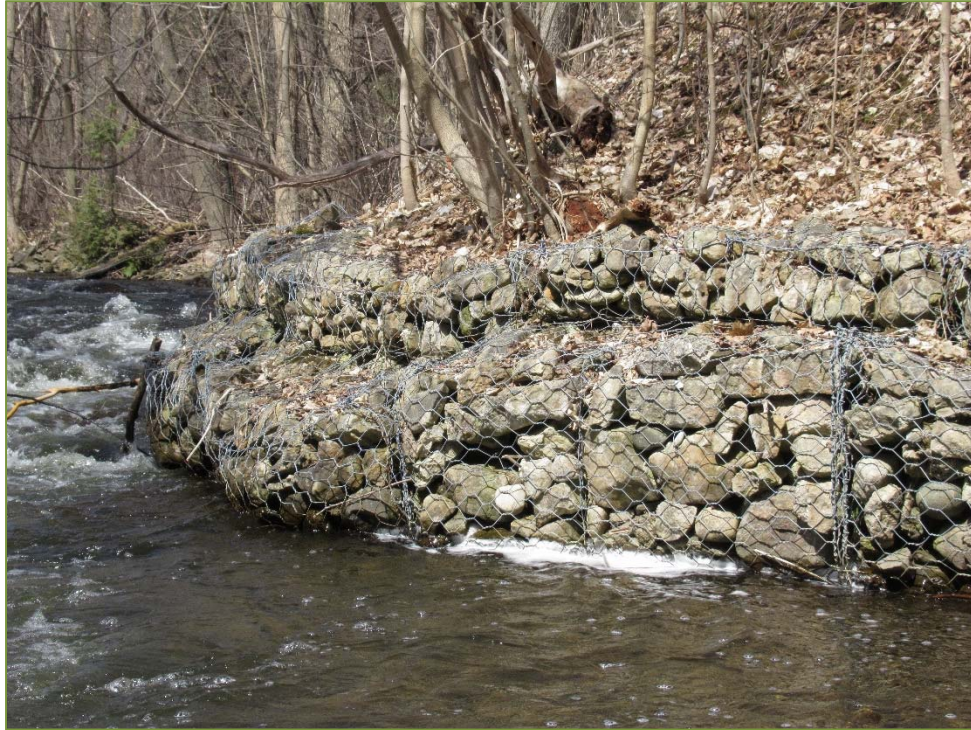
Photo P53 – Northwest Gabion Wall (bulging)

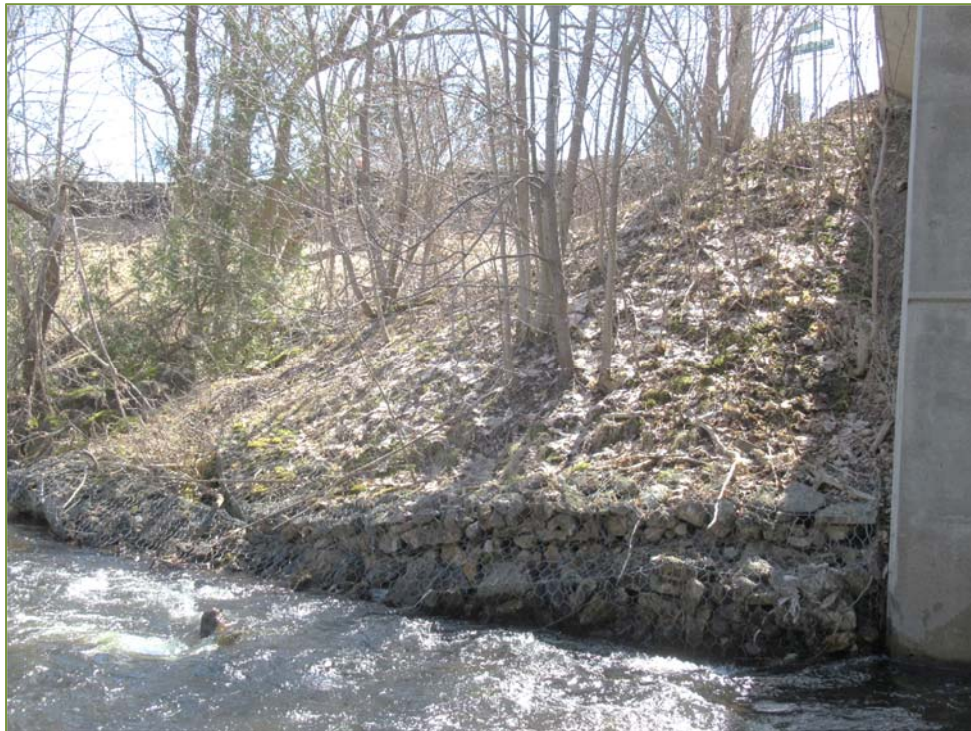
The gabion walls were found to be in fair-to-good condition with bulging, tilting, and damaged baskets (Photos P51 to P56). A section of southeast gabion has collapsed/overtaken, as shown in Photo P54. The embankment slopes were in fair-to-good condition with evidence of minor soil erosion at bases, as shown in Photos P57 to P60.

Photo P54 – Southeast Gabion Wall (fair condition – overturning)

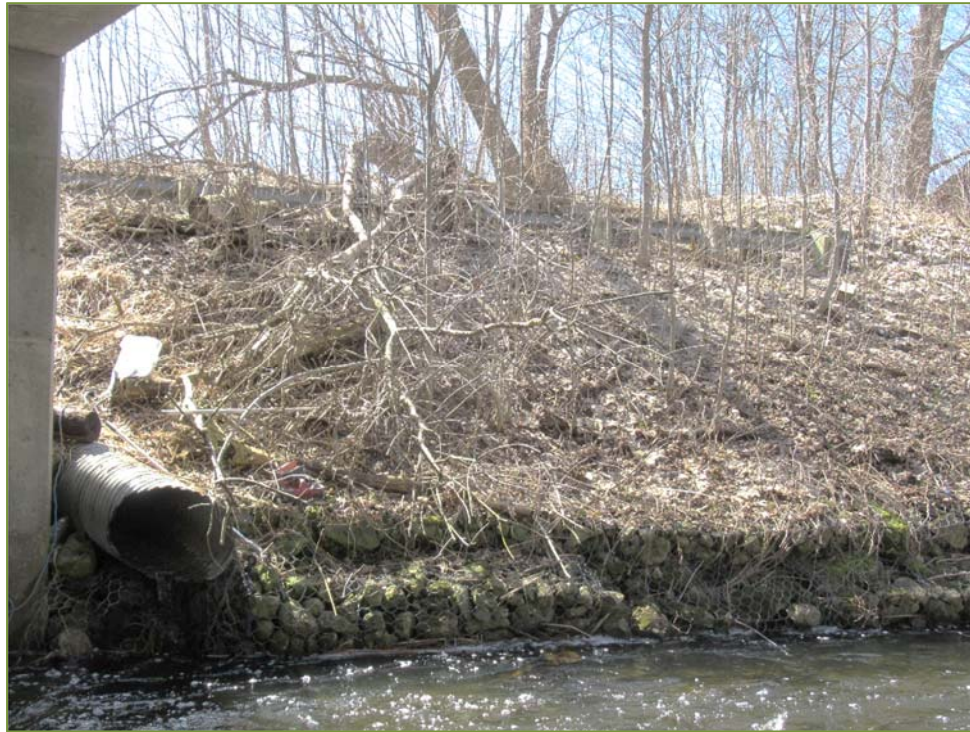
Photo P55 – Southwest Gabion Wall (fair condition – overturning and damaged gabion basket)

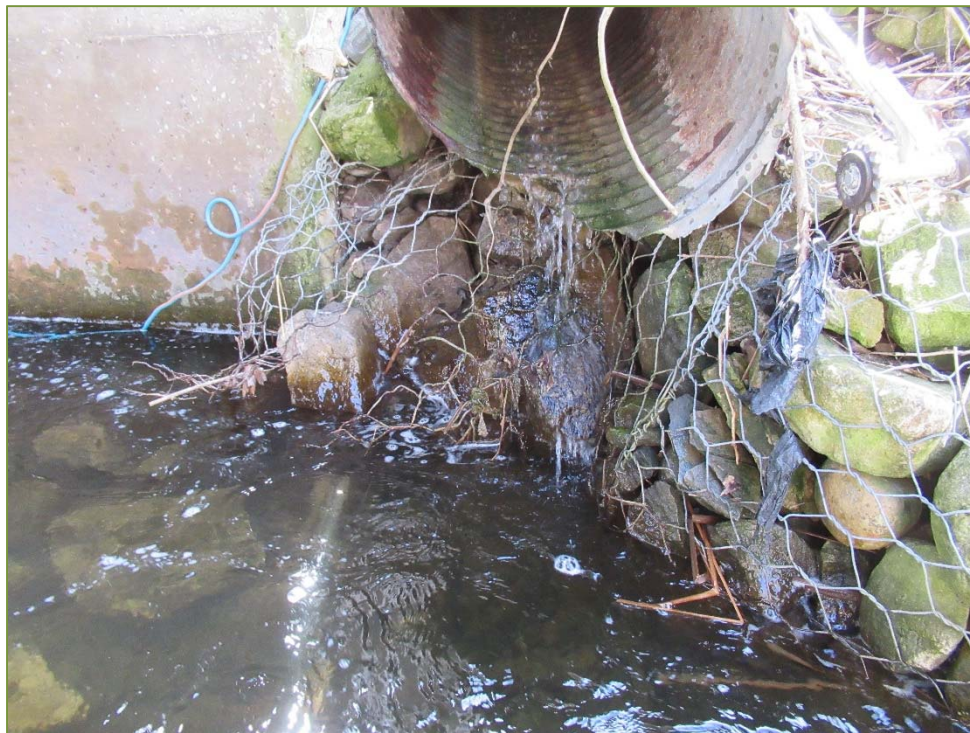
Photo P56 – Southwest Gabion Wall (overturning and damaged gabion basket)

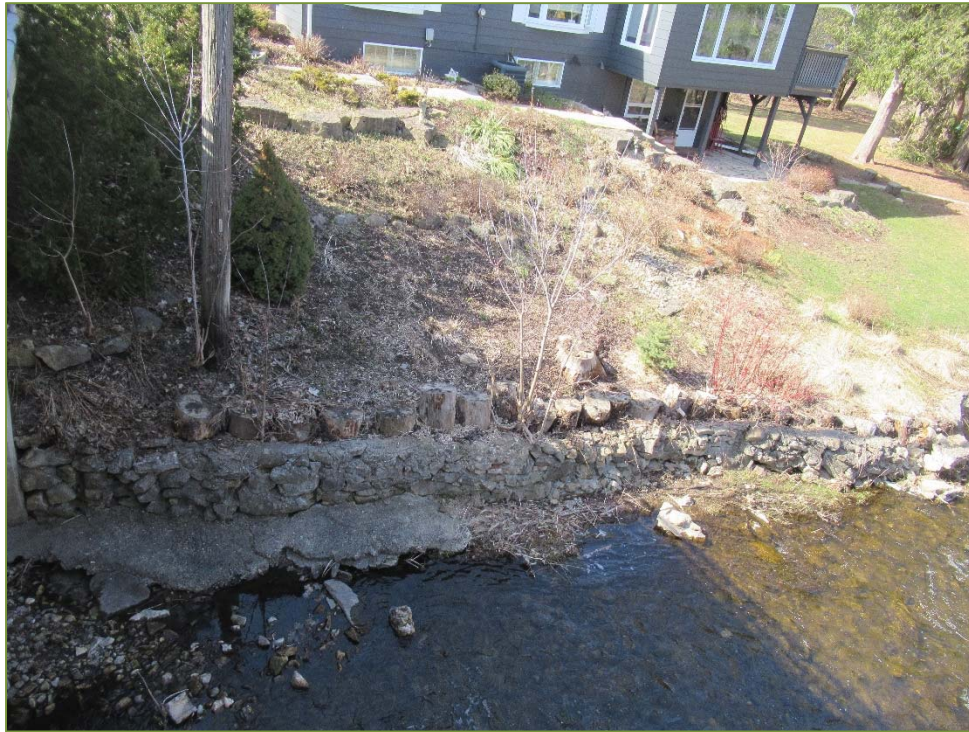
Photo P57 – Northeast Embankment (fair to good condition – soil erosion)

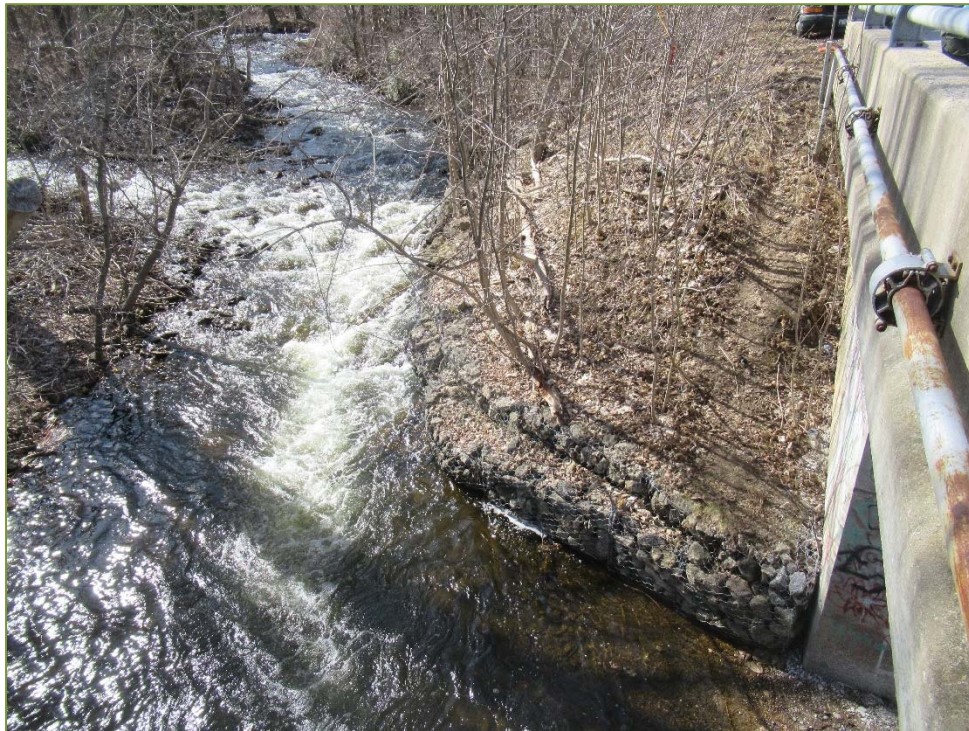
Photo P58 – Northwest Embankment (fair to good condition – soil erosion)

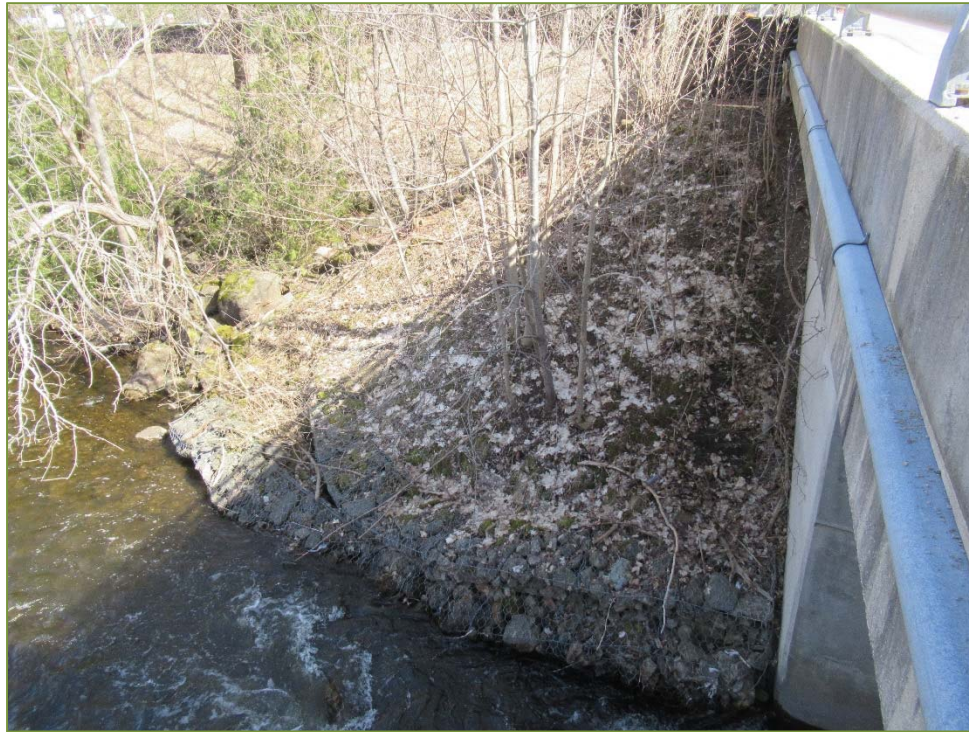
Photo P59 – Southeast Embankment (fair to good condition – soil erosion)

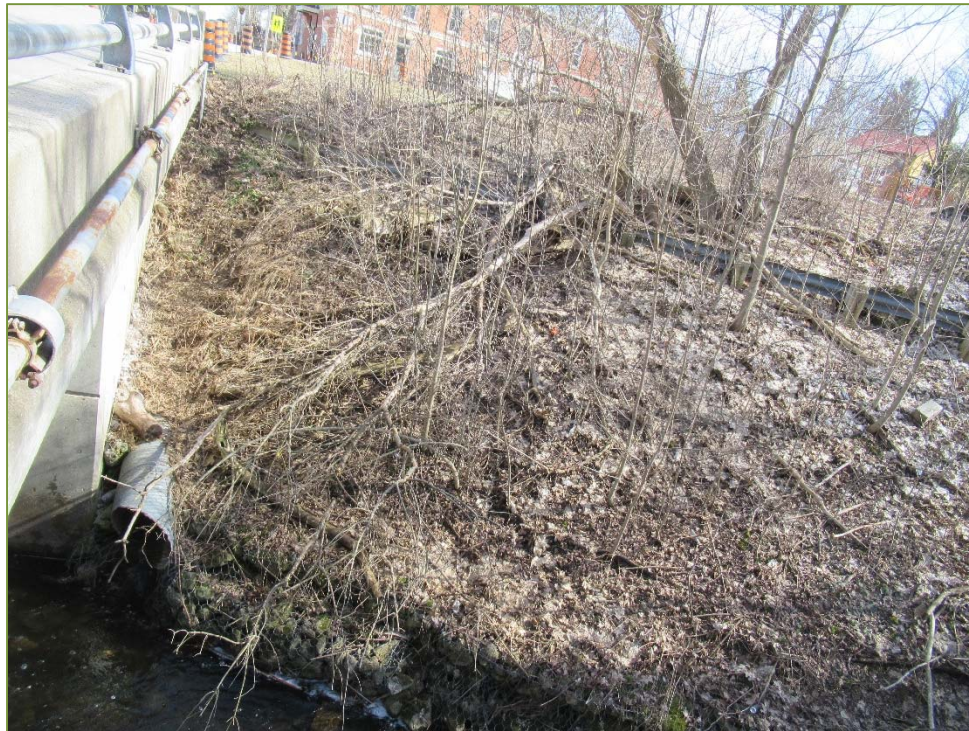
Photo P60 – Southwest Embankment (fair to good condition – soil erosion)

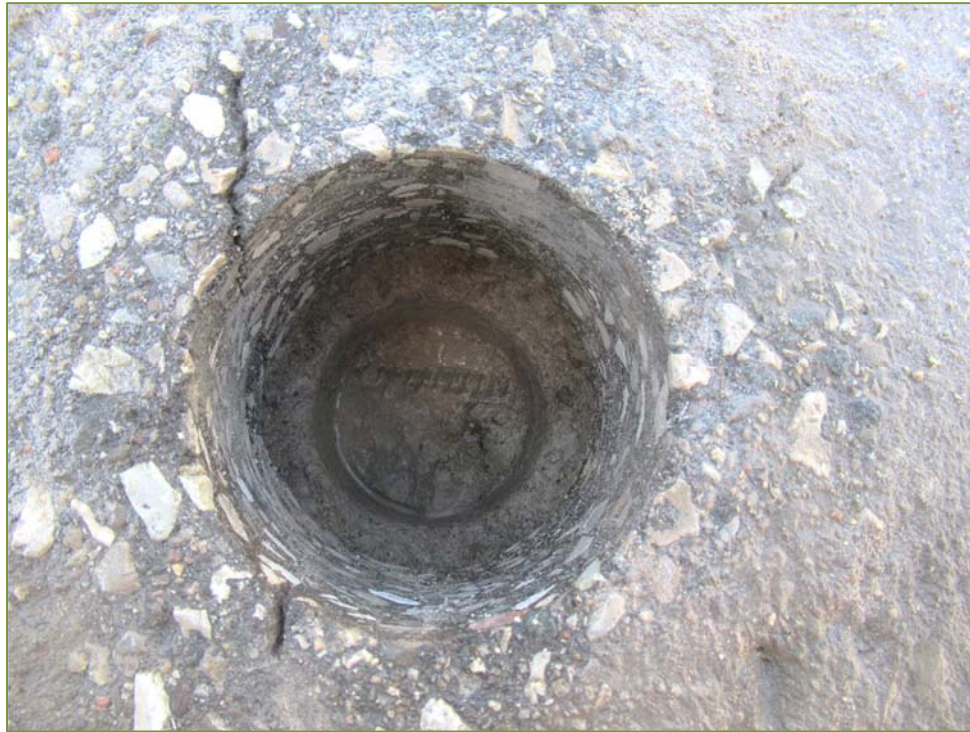
Photo P63 – Typical Condition of Inside Core – C6 (disintegration)

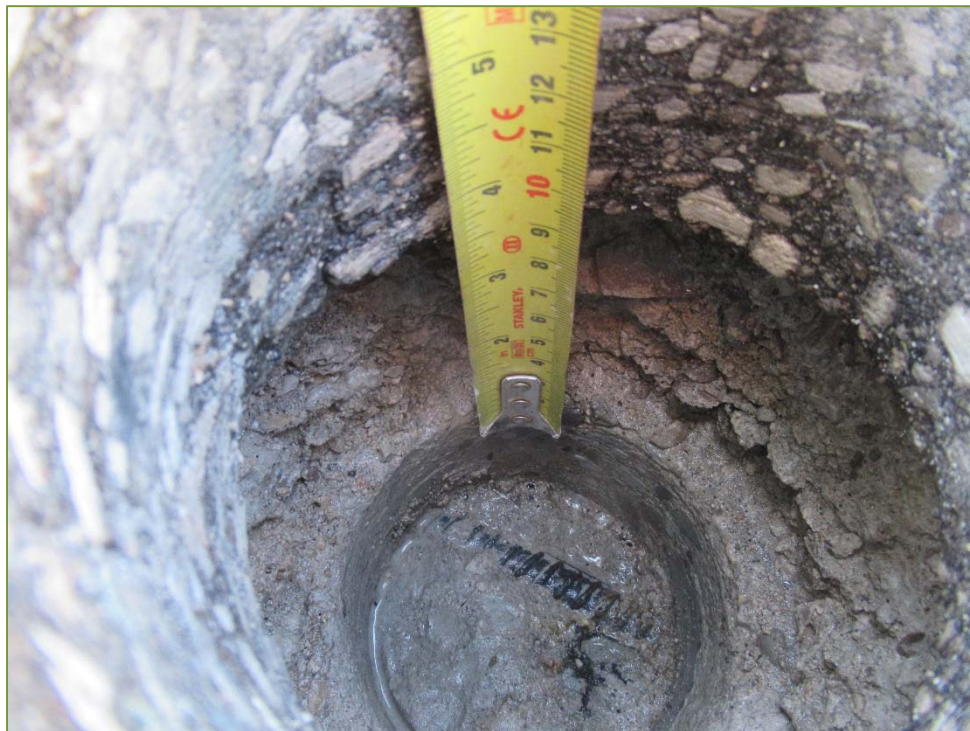
Photo P64 – Typical Condition of Inside Core – C6 (disintegration)

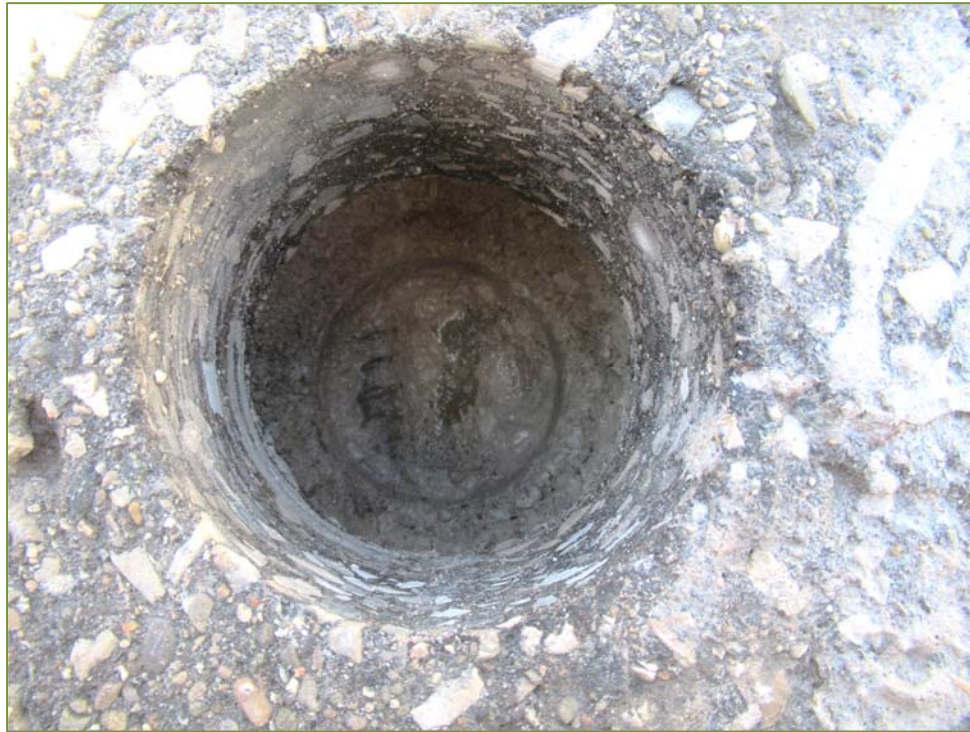
Photo P65 – Typical Condition of Inside Core – C8 (disintegration)

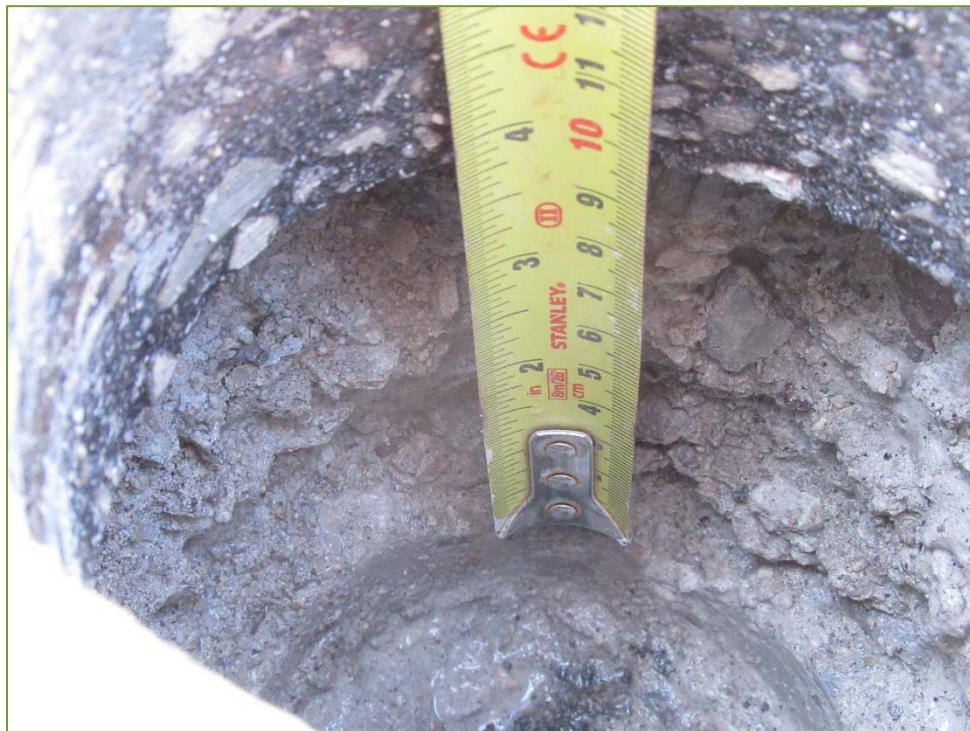
Photo P66 – Typical Condition of Inside Core – C8 (disintegration)

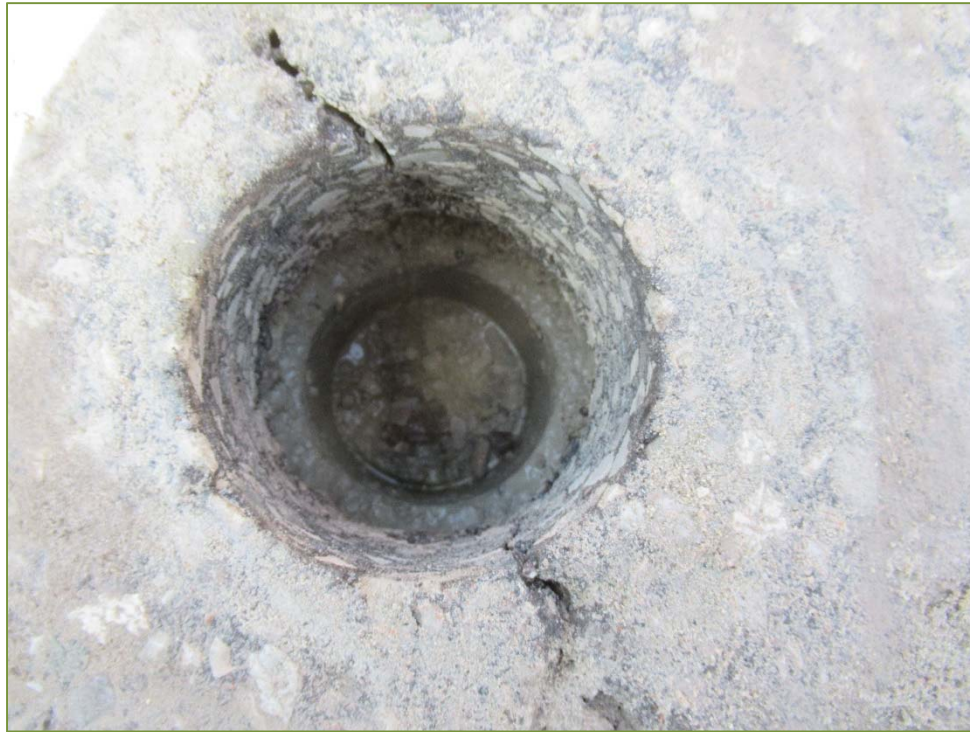
Photo P67 – Typical Condition of Inside Core – C9 (disintegration)

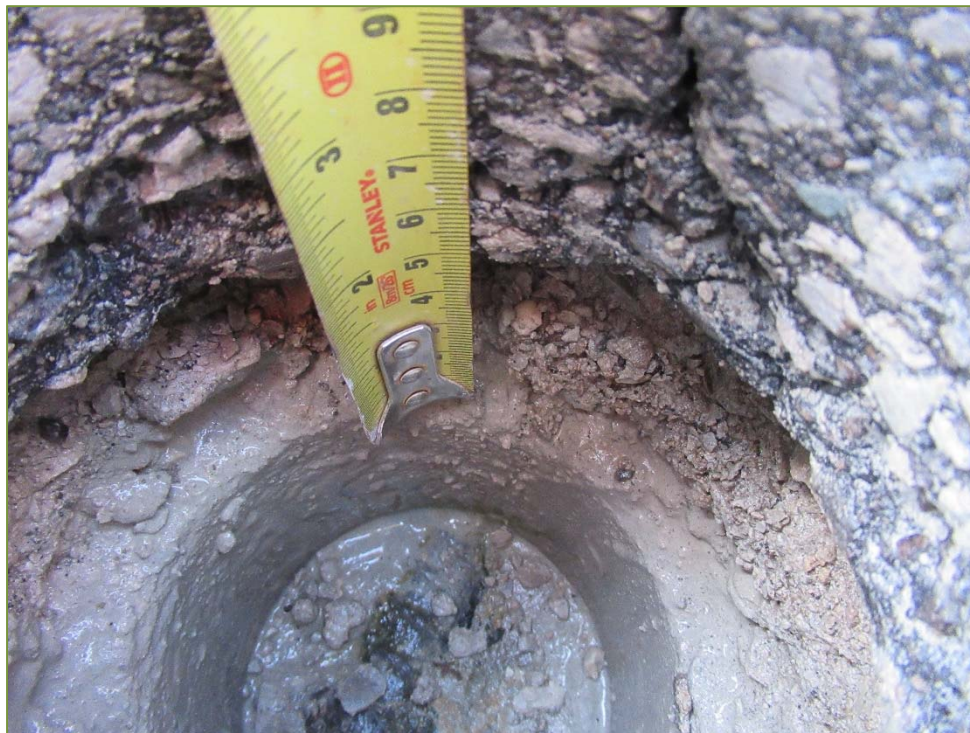
Photo P68 – Typical Condition of Inside Core – C9 (disintegration)

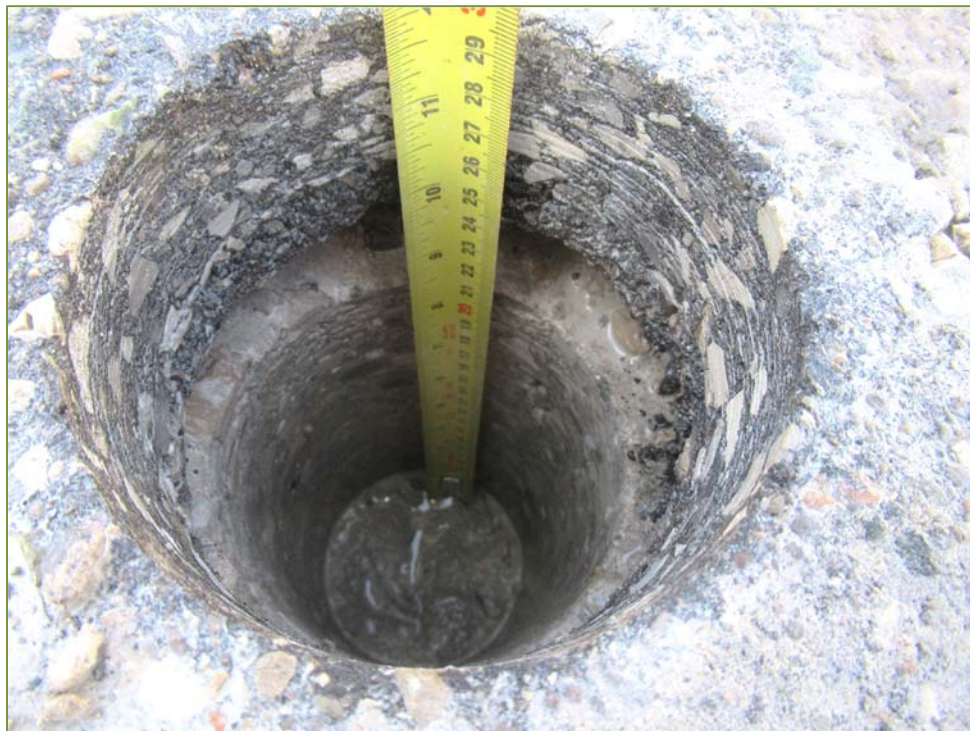
Photo P70 – Typical Condition of Inside Core – C12 (disintegration)

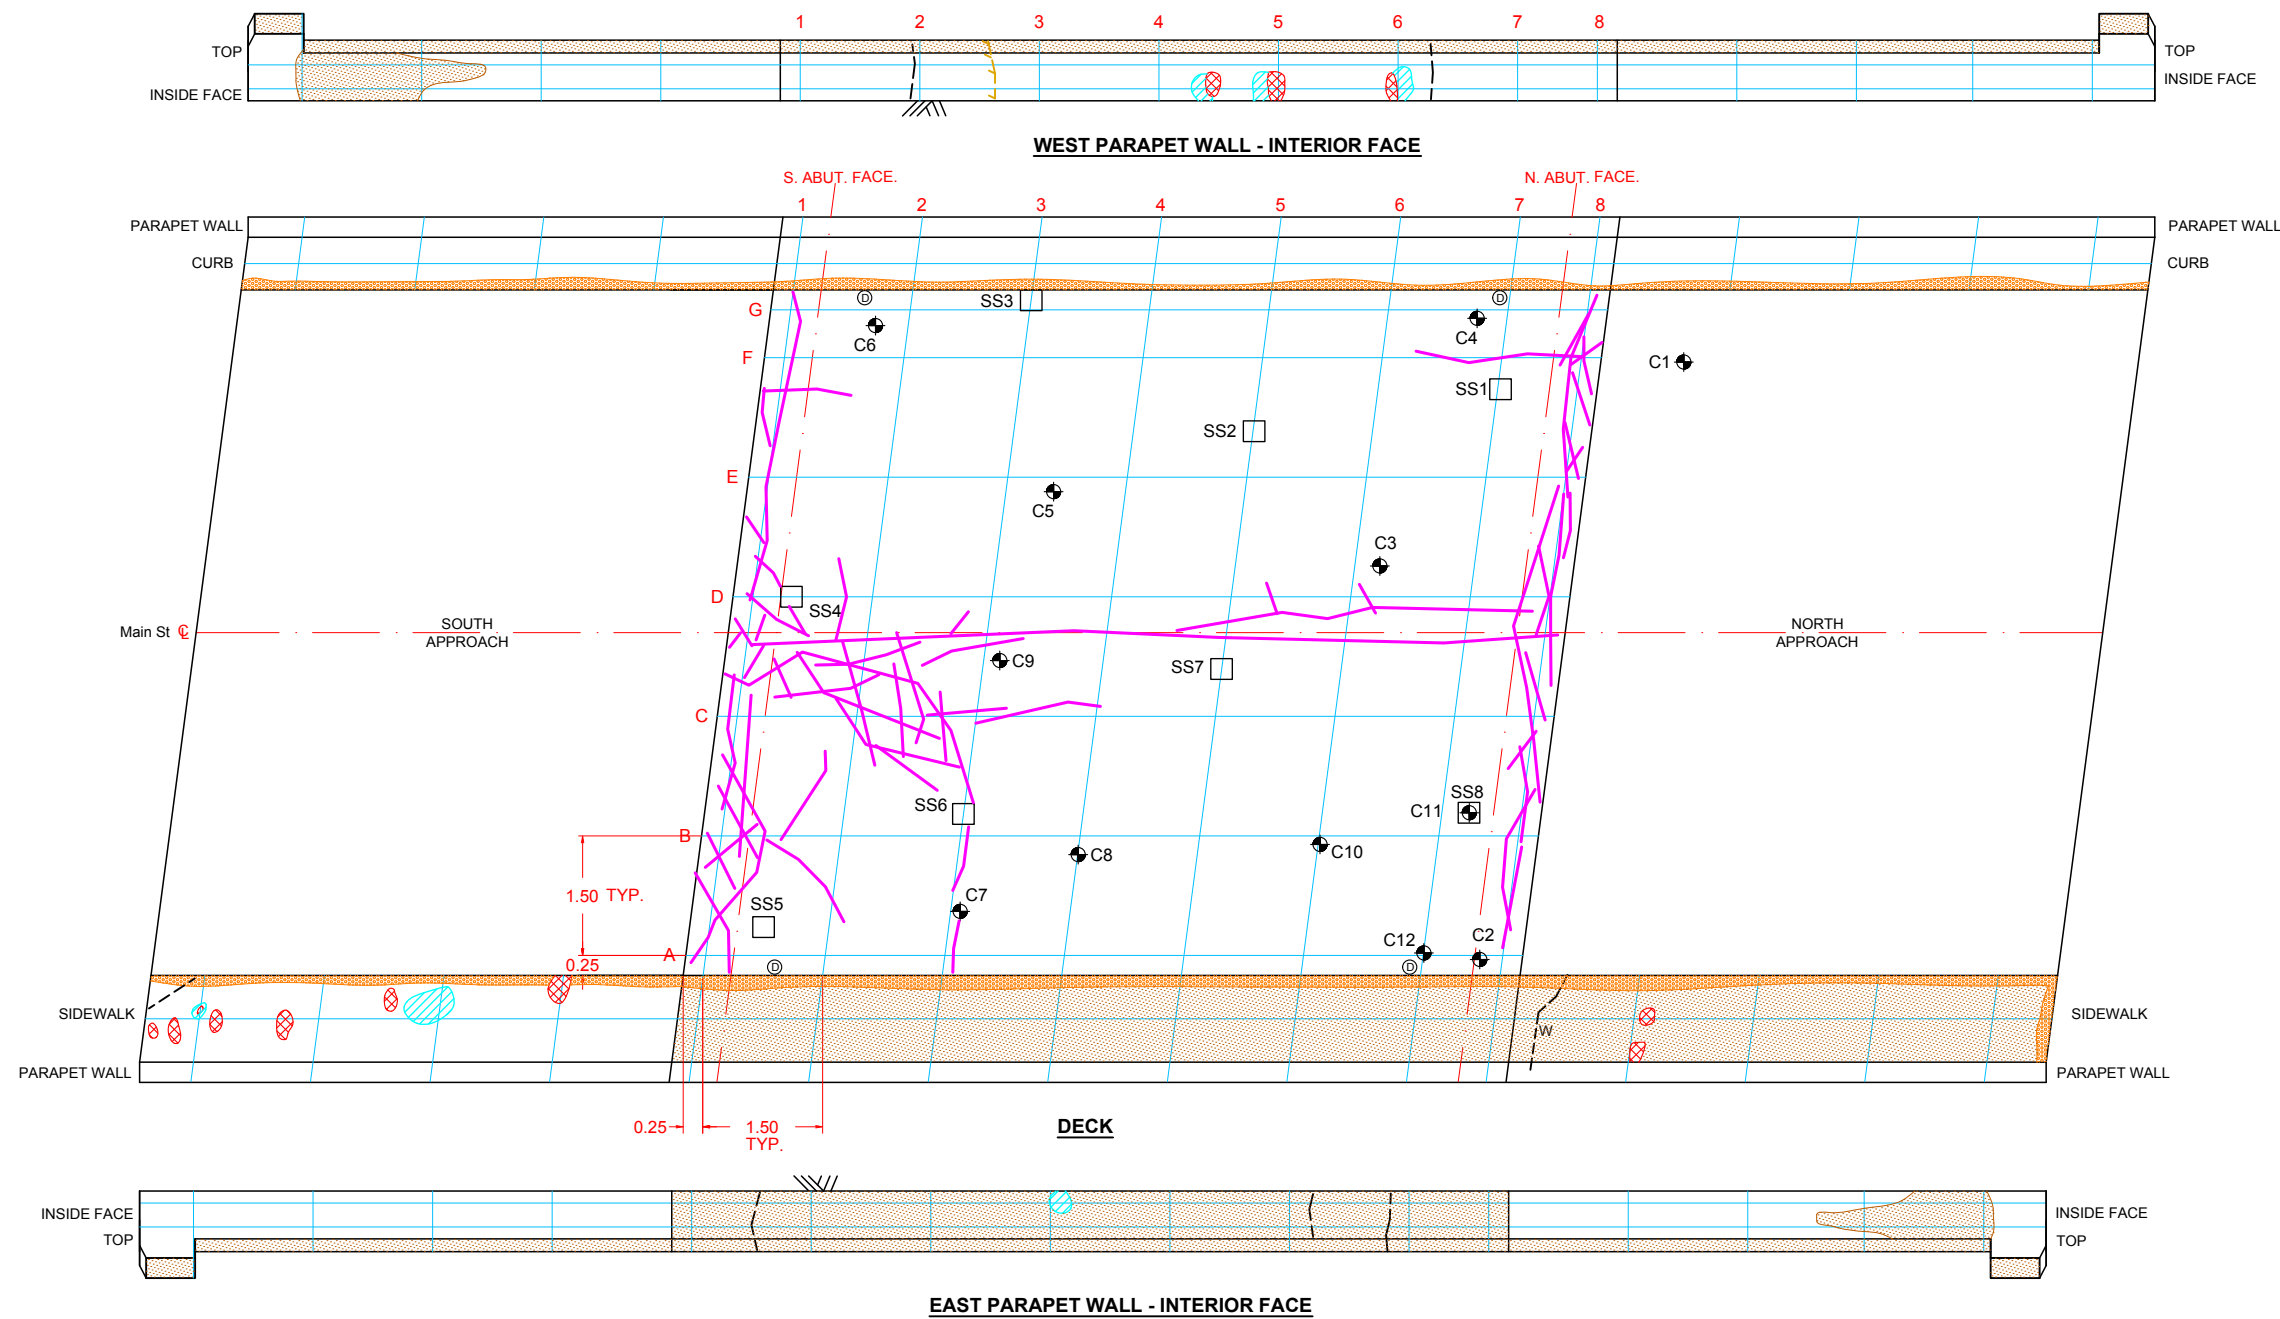
TITLE:
SURFACE DETERIORATION OF
ASPHALT ON DECK, CONCRETE
SIDEWALK, CURB AND
PARAPET WALLS

The width and length of the asphalt is 8.60 m and 10.50 m respectively, with a total surveyed area of 90.30 m². The condition of the asphalt wearing surface on the bridge deck was identified through visual field observations and review of cores and sawn asphalt samples. Drawing 1 shows the defects on the asphalt wearing surface as well as the location of the cores and sawn asphalt samples. The general pavement surface condition is shown in Photos P3 to P8. The asphalt wearing surface on the concrete deck is generally in fair condition with unsealed transverse cracks (16.0 m), longitudinal cracks (27.0 m), and random cracks (42.0 m). The asphalt depth, measured in the drilled holes, coreholes, and sawn asphalt samples, varied from 60 mm to 110 mm with an average depth of 88 mm (refer to Drawing 2).

The concrete parapet walls, with a total surveyed area of 41.14 m², were in fair-to-good condition with clean/stained medium width cracks (4.0 m), delaminations (0.31 m²), spalls (0.22 m²), light scaling (16.20 m²). The surface deterioration is shown on Drawing 1 and in Photos P24 to P35. The cracks were mainly vertical. The concrete cover ranged from 69 mm to 99 mm, with average cover of 84 mm, as shown on Drawing 2.

The west concrete curb, with a total surveyed area of 21.77 m², was in fair-to-good condition medium scaling (2.50 m²). The surface deterioration is shown on Drawing 1 and in Photos P30 to P35. The concrete cover ranged from 96 mm to 119 mm, with average cover of 106 mm, as shown on Drawing 2.

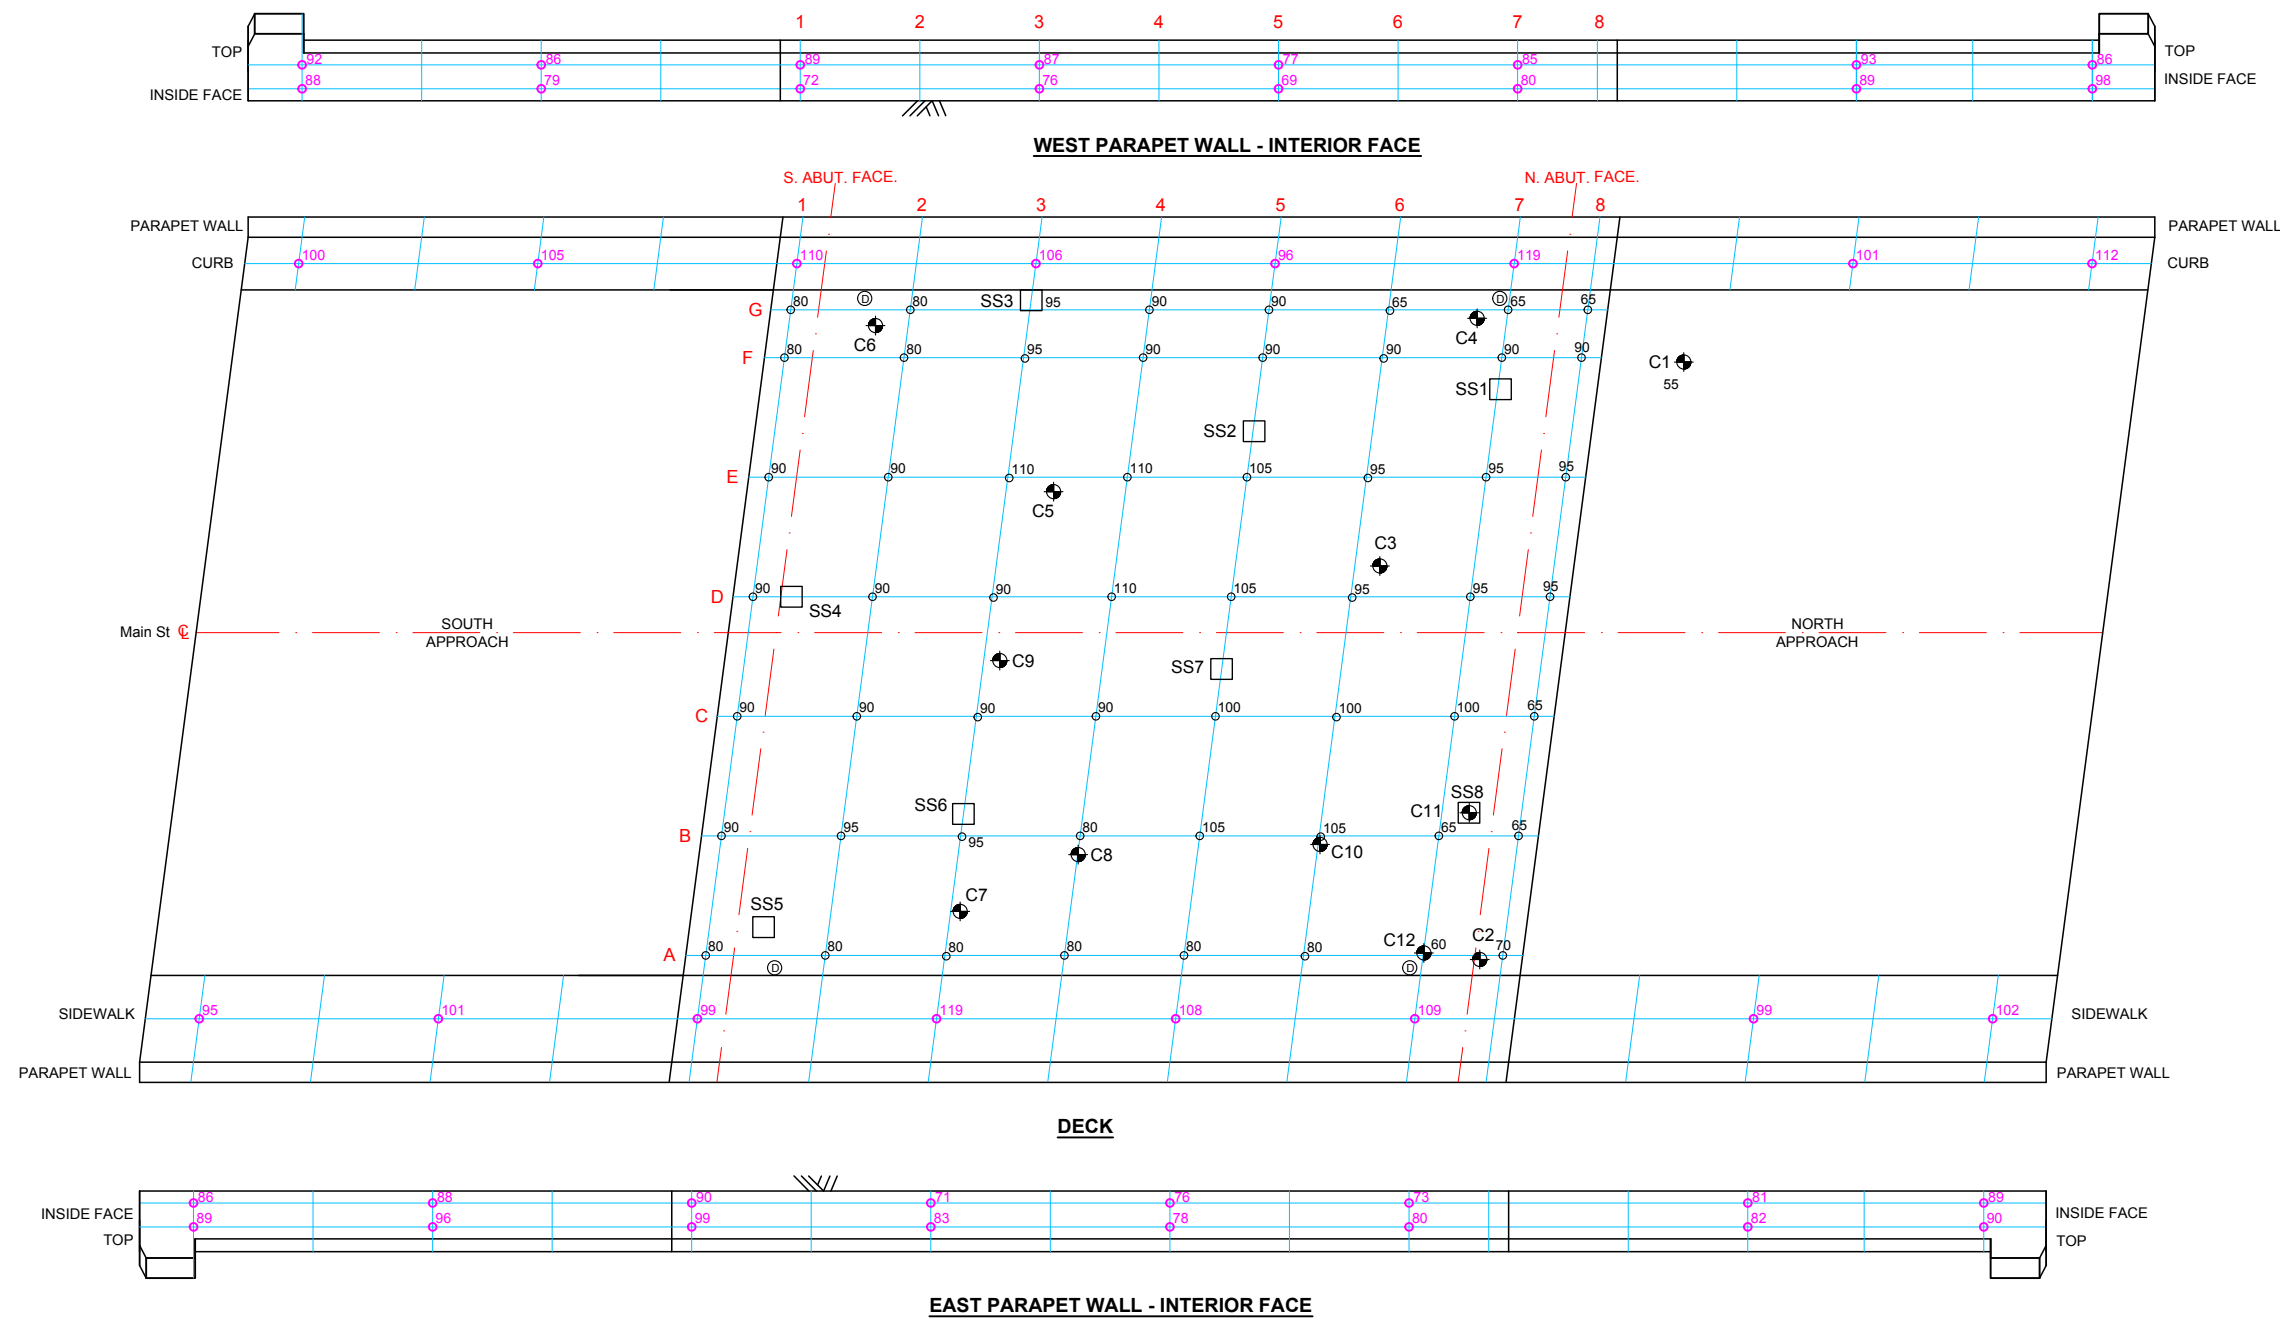
TITLE:
 CORROSION POTENTIAL OF DECK, SIDEWALK, CURB AND PARAPET WALLS

Corrosion potential values obtained from the half-cell test carried out in the asphalt covered deck ranged from -0.207 V to -0.468 V with an average value of -0.382 V . The half-cell survey indicated uncertain low corrosion activity for 35.7% (12.5%+23.2%) of the deck area, with values ranging from -0.200 V to -0.349 V . Probable active corrosion was detected for 64.3% (35.7%+28.6%) of the deck area with corrosion potential values more negative than -0.350 V . Drawing 3 shows the corrosion potential readings in deck.

A corrosion potential survey was conducted for the parapet walls. The survey was not performed on the end posts as there is no continuity in the approach sides. Corrosion potential values obtained from the half-cell test carried out in the parapet walls ranged from -0.224 V to -0.440 V with an average value of -0.339 V. The half-cell survey indicated uncertain low corrosion activity for 50.0% (25.0%+25.0%) of the parapet wall area, with values ranging from -0.200 V to -0.349 V. Probable active corrosion was detected for 50.0% (50.0%+0.0%) of the parapet wall area with corrosion potential values more negative than -0.350 V. Drawing 3 shows the corrosion potential readings in the parapet walls.

Corrosion potential values obtained from the half-cell test carried out in the sidewalk ranged from -0.413 V to -0.461 V with an average value of -0.438 V. The half-cell survey indicated probable active corrosion for 100.0% (62.5%+37.5%) of the sidewalk area with corrosion potential values more negative than -0.350 V. Drawing 3 shows the corrosion potential readings in the east sidewalk.

Corrosion potential values obtained from the half-cell test carried out in the curb ranged from -0.220 V to -0.373 V with an average value of -0.305 V. The half-cell survey indicated uncertain low corrosion activity for 87.5% (50.0%+37.5%) of the curb area, with values ranging from -0.200 V to -0.349 V. Probable active corrosion was detected for 12.5% (12.5%+0.0%) of the curb area with corrosion potential values more negative than -0.350 V. Drawing 3 shows the corrosion potential readings in the west curb.

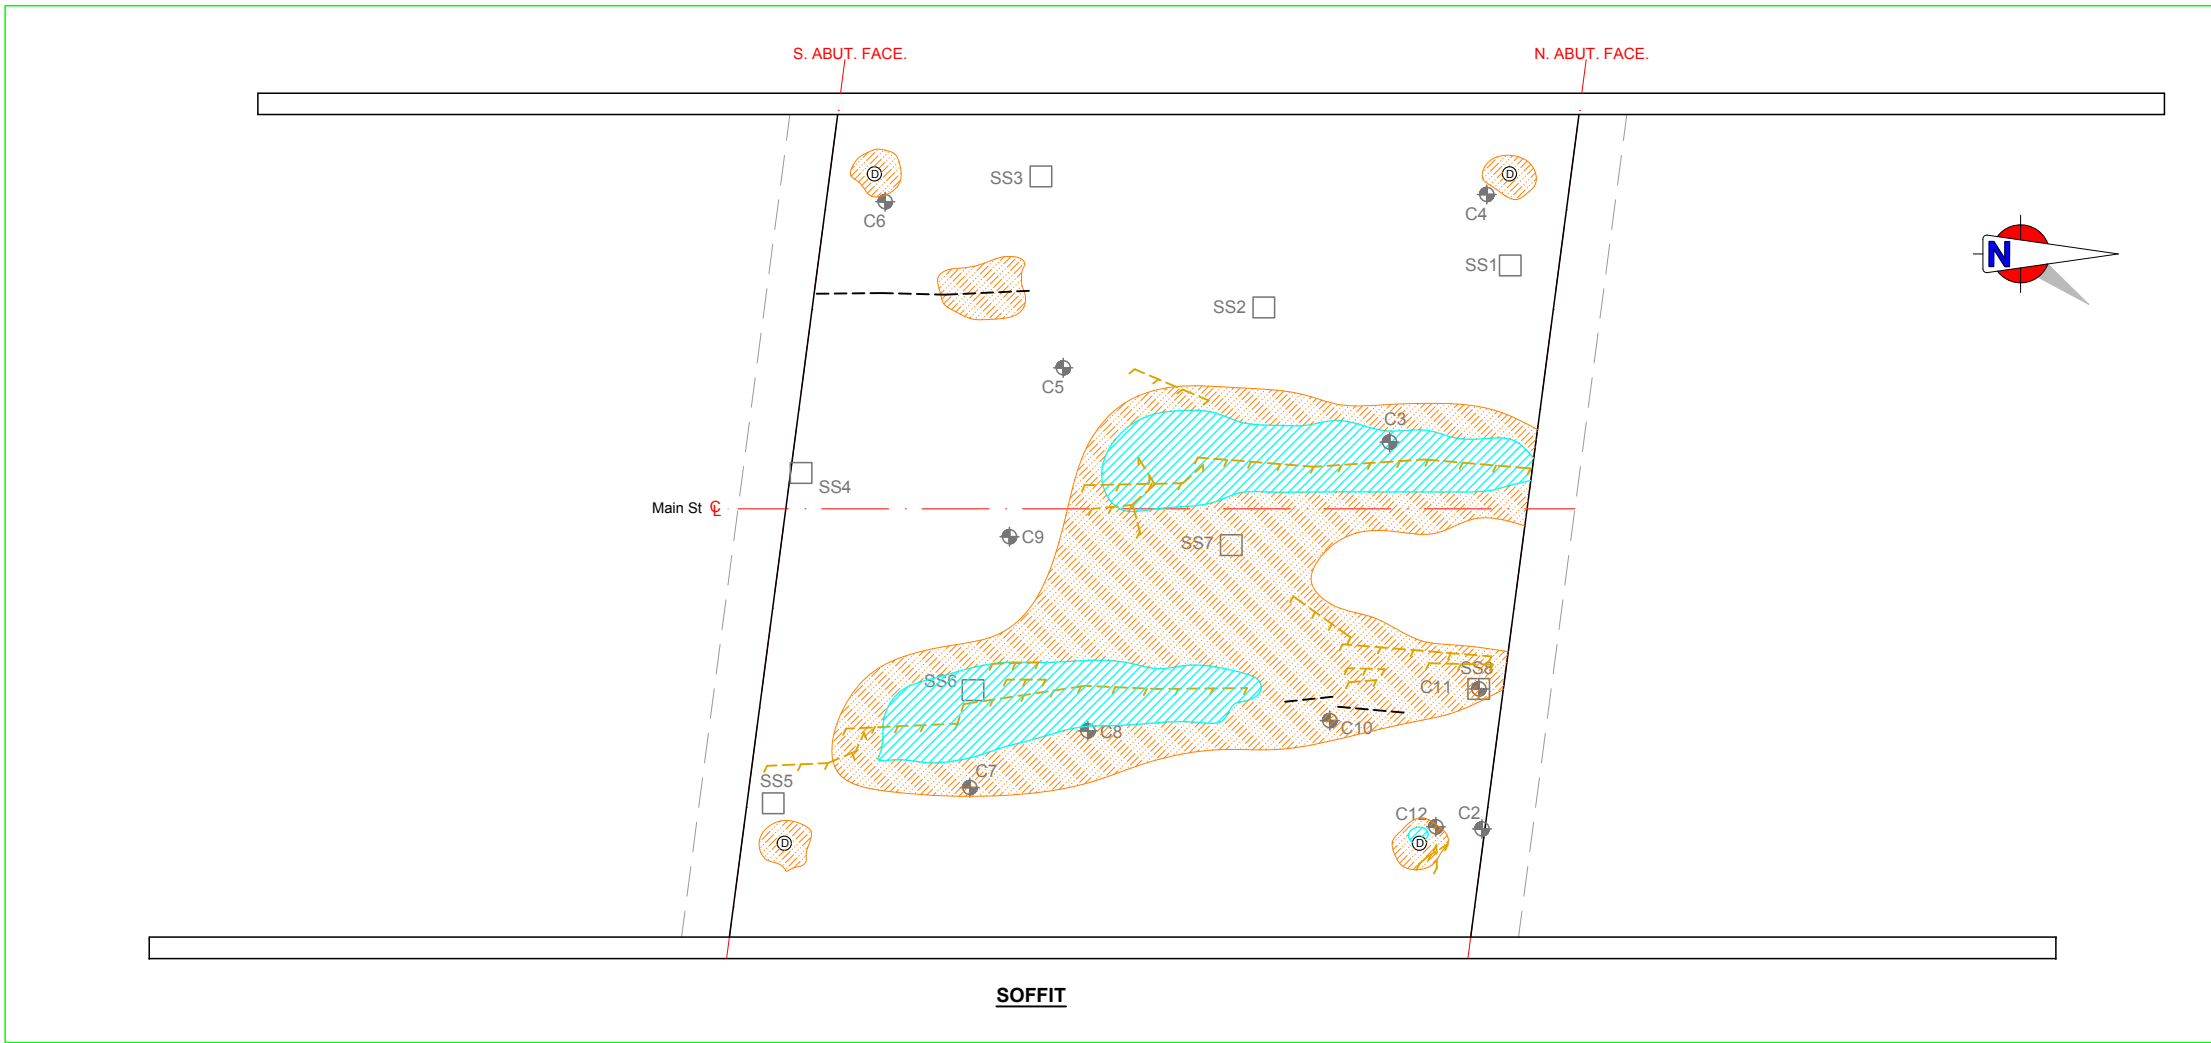
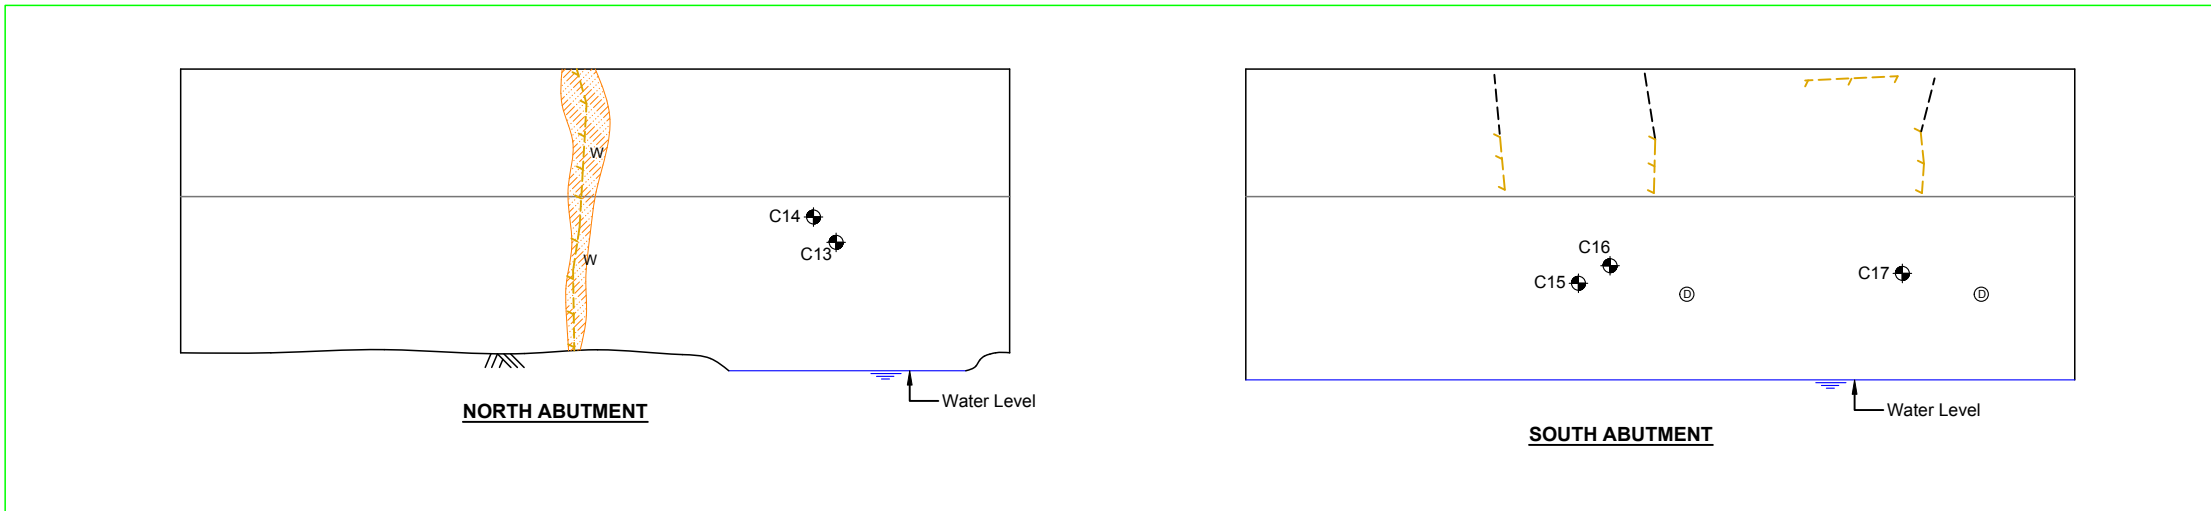
TITLE:
 SURFACE DETERIORATION OF
 SOFFIT AND ABUTMENTS

A detailed visual inspection and hammer sounding of deck soffit and fascia were carried out. The deterioration is shown on Drawing 4 and in Photos P9 to P13. Access to the soffit was provided by means of small ladder, chest waders and delam 2000.

The bridge deck soffit and fascia, with a total surveyed area of 110.00 m², was in fair condition with clean/stained medium width cracks (26.0 m), delaminations (9.40 m²), and wet areas (19.60 m²). Medium corrosion was observed on the deck drain pipes.

The exposed surfaces of the abutment walls were inspected and sounded to check for delaminations. The total surveyed area for the north and south abutments were 37.41 m² and 40.56 m², respectively. The deterioration is shown on Drawing 4. General views of the abutment walls are shown in Photos P42 to P46. The abutment walls were generally in fair-to-good condition. The field investigation of the north abutment wall revealed stained wide width cracks (4.0 m) and wet areas (1.21 m²). The field investigation of the south abutment wall revealed clean/stained medium width cracks (5.0 m). The cracks were mainly vertical.
