1361605 ONTARIO LIMITED
LOTS 1 TO 7
RESIDENTIAL DEVELOPMENT
JACK KENNY COURT
CALEDON, ON
L7E 2M5

Title **TREE INVENTORY/
ASSESSMENT**

TREE ASSESSMENT - JACK KENNY COURT

DATE: 31 MAY + 10 JULY 2013

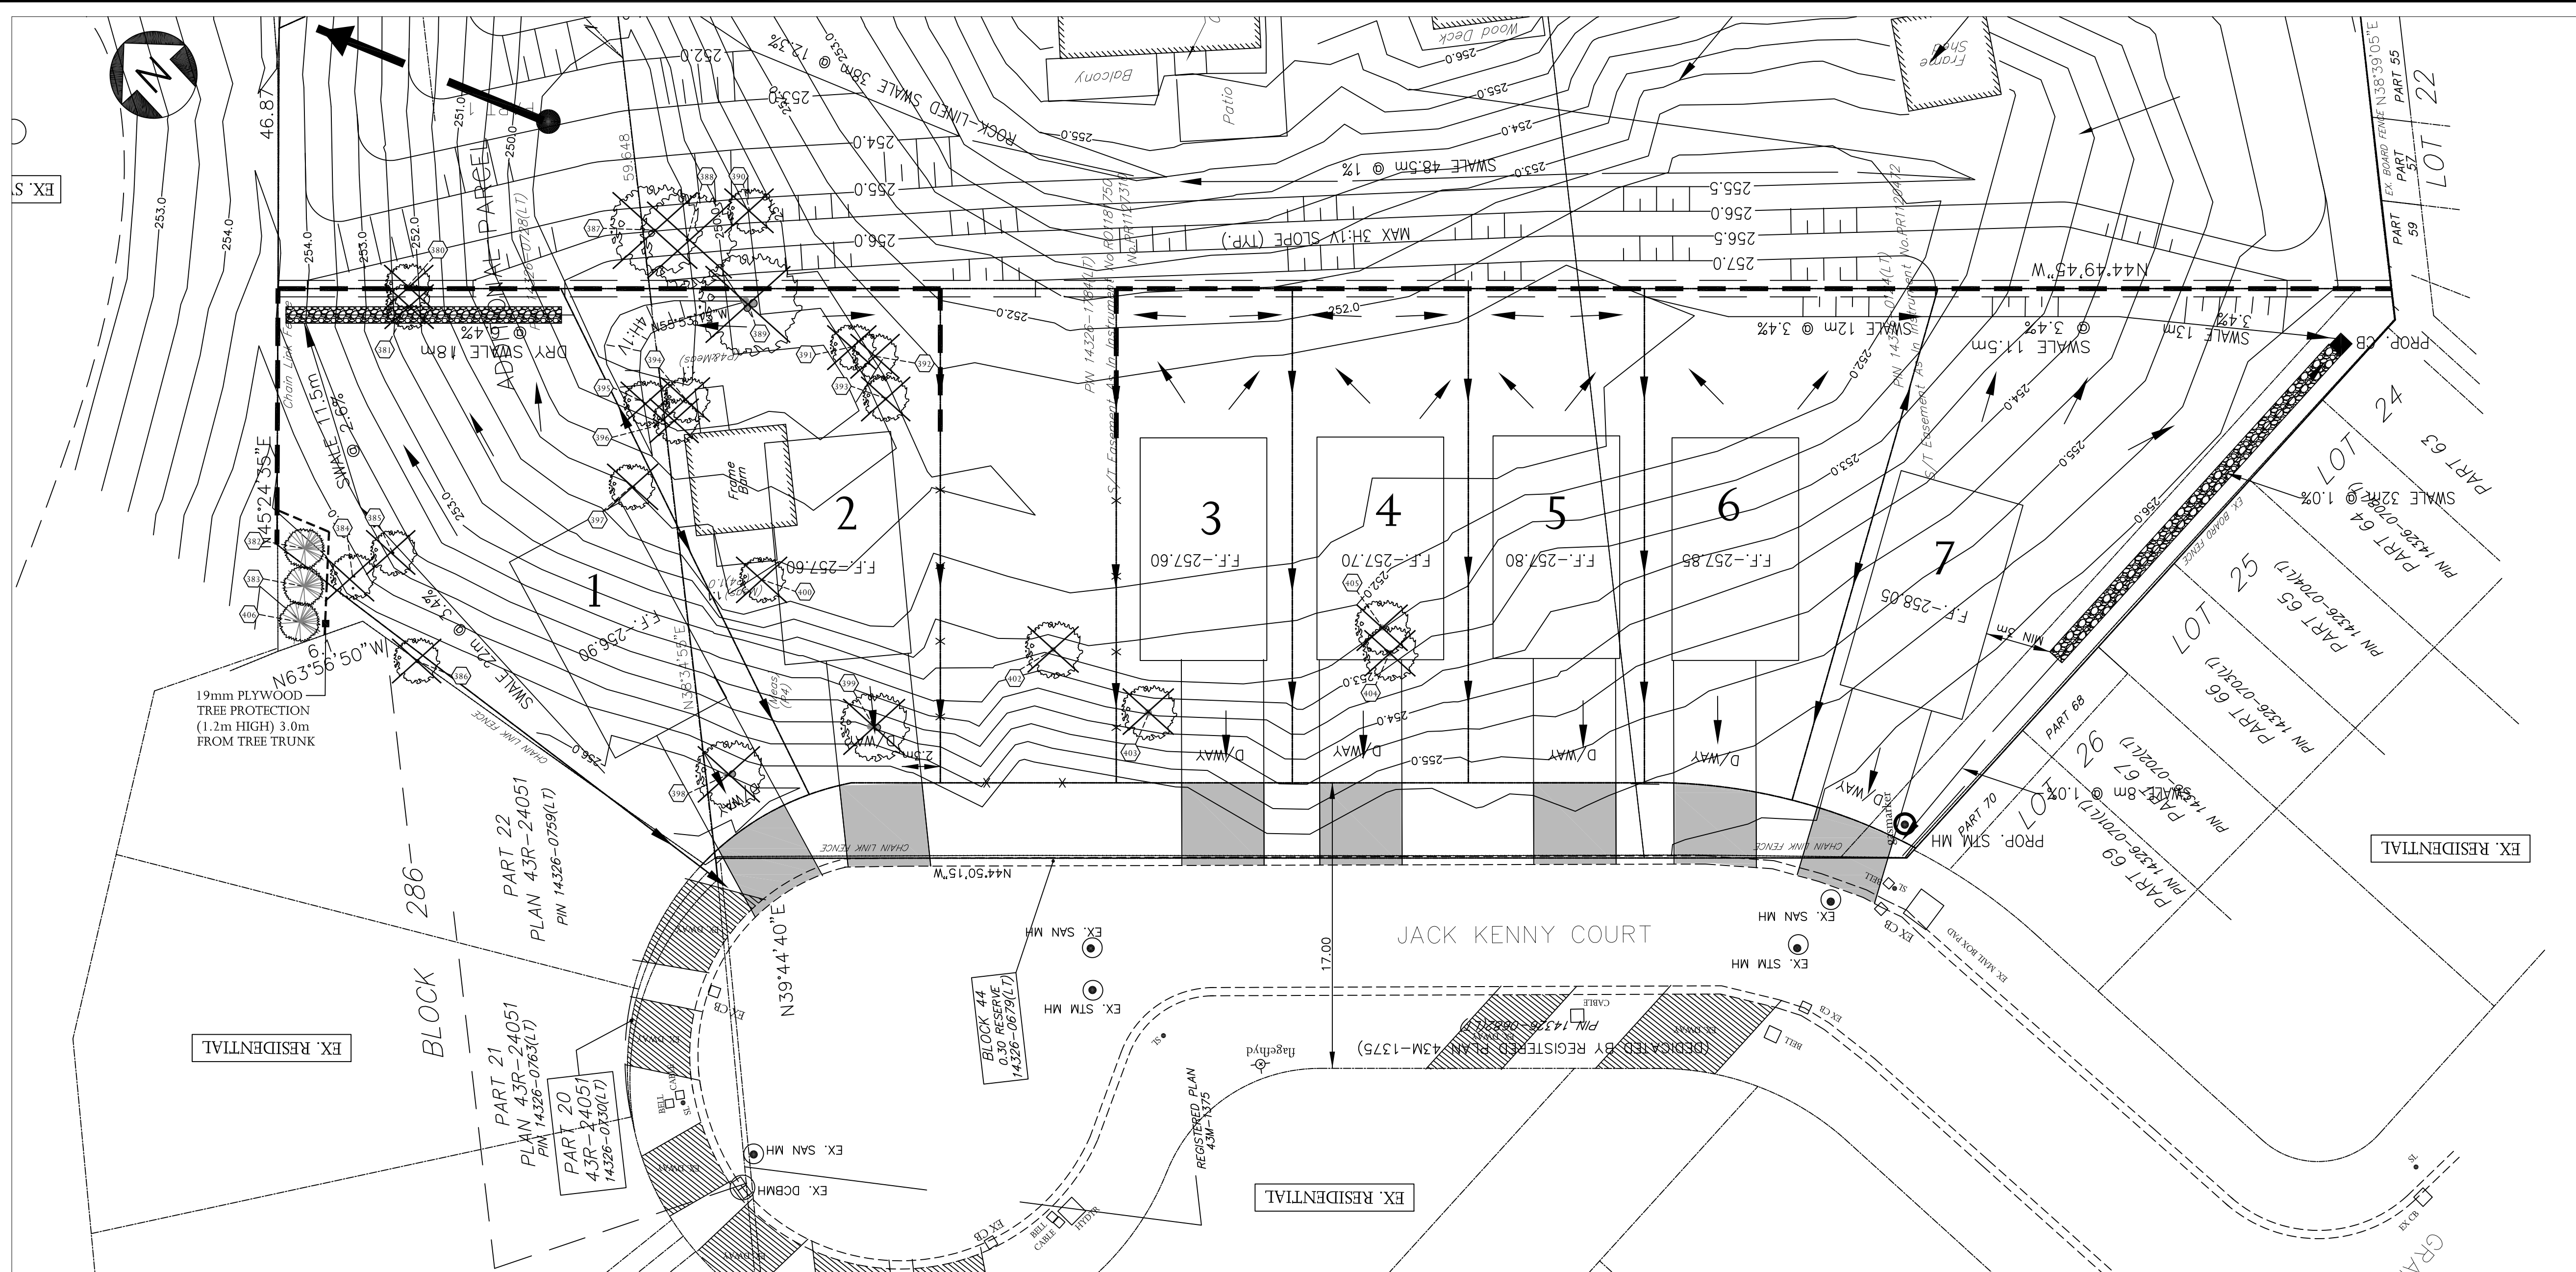
MANAGEMENT NOTES FOR DIPLODIA TIP BLIGHT

| Tree # | Common Name | Botanical Name | DIA. (cm) | R.E | T.I. | C.S. | C.V. | TPZ Required | Comments | Site Plan Results |
|---|---|---|---|---|---|---|---|---|--|---|
| 382 | Austrian Pine | <i>Pinus nigra</i> | 17 | G | G | G | G | 3.0 | presence of Diplodia tip blight (see management note) | preserve |
| 383 | Austrian Pine | <i>Pinus nigra</i> | 15 | F | G | G | G | 3.0 | presence of Diplodia tip blight (see management note) | preserve |
| 406 | Austrian Pine | <i>Pinus nigra</i> | 15 | G | G | G | F | 3.0 | presence of Diplodia tip blight (see management note) | preserve |

Stressed and weakened trees are more susceptible to Diplodia. Maintain tree vigour through adequate watering and fertilization. Improve soil environment by removing competing turf and mulching around trees. Improve soil conditions by aerating the soil.

A tree exhibiting a few symptoms may be pruned to help reduce the spread of the disease. However, in most cases, pruning will only improve the appearance of the plant rather than control the disease. Fungus will develop on second year cones as well as on stressed mature tissue. Pruning during dry weather, raking blighted needles, twigs, and cones, and discarding them may help to reduce disease pressure. Disinfect tools between pruning cuts. Improving air circulation around the trees will help in a faster drying of needles and reducing the chance of infection

Maintain tree health, since infection is difficult to manage. Apply fungicides (Copper Spray - 4 kg per 1,000 L water) at bud break, using a maximum of 3 applications per year at 2-week intervals to help protect new shoots. Removing infected branches does not reduce infection, since spores are also produced on seed cones. Do not crowd plants. Maintain adequate sunlight and good air circulation.
