Memorandum

Date: December 8, 2022 Project #: 17056012

- To: Nimit Mittal, M.Eng., P.Eng.
- From: Alex Scott, M.Sc. & Robin McKillop, M.Sc., P.Geo., CAN-CISEC
 - cc: Mike Brierley, M.Sc.
 - Re: Fluvial Geomorphic Crossing Assessment for the Town of Caledon Growth Roads Program Chinguacousy Road

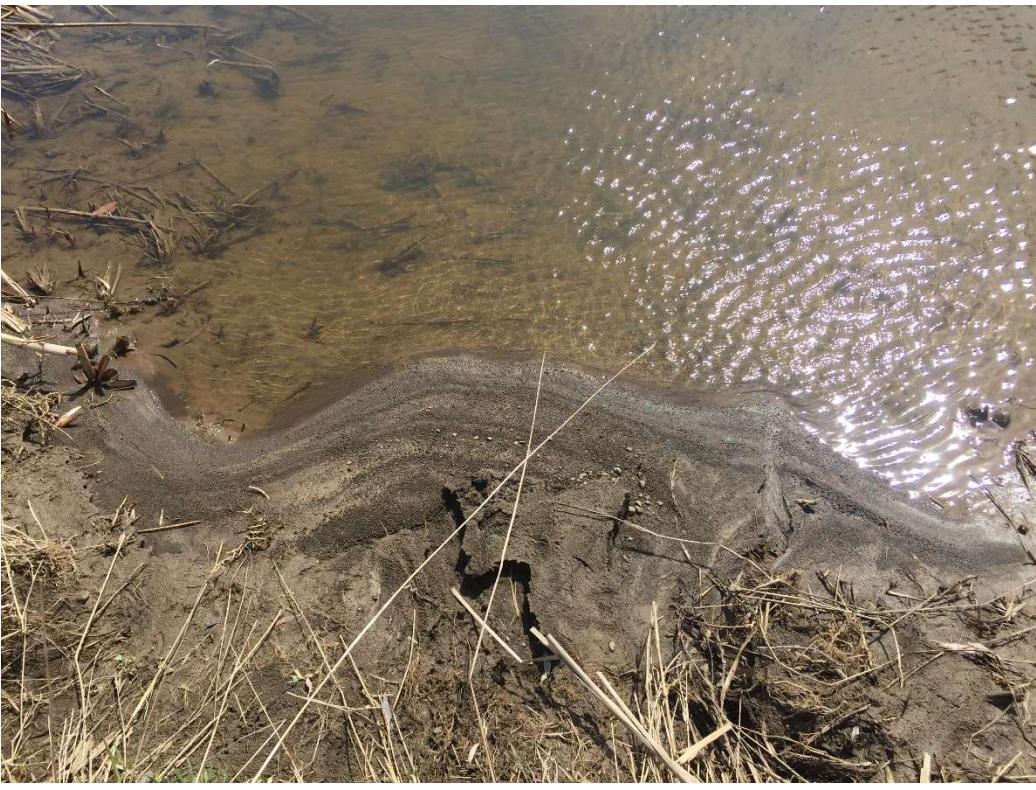
CH1 is a 6.5 m-wide concrete box culvert installed in 2020 that conveys a watercourse across Chinguacousy Road (**Figure 1; Table 1**). The watercourse is unconfined and has a low gradient. Historically the channel has been realigned with a straight planform and has a locally over-widened cross-section in the vicinity of the culvert (**Appendix A CH1 US**). Just upstream of the culvert, the channel bends abruptly (90°) along its approach to the box culvert. The channel is anomalously wide immediately upstream and downstream of the culvert before returning to a narrower, more typical dimension 5 m downstream (**Appendix A CH1 DS**). Both upstream and downstream of the culvert, there is no bank stabilization and restorative plantings were in poor condition at the time of the visit. There is also evidence of rill formation and sediment mobilization into the channel from the banks. Sediment has accumulated where the channel is locally over-widened (**Photo 1**). The average bankfull width and depth of the channel measured downstream of the culvert are 4.2 m and 0.4 m, respectively (**Table 1**). Dense in-stream vegetation just beyond the culvert inlet/outlet local impedes flow of water and sediment (**Appendix A CH1 US & DS**). This site will need fluvial consideration for crossing replacement as outlined in Section 6.

Photo 1. Evidence of sediment accumulation in a locally over-widened section of channel near the culvert (CH1).

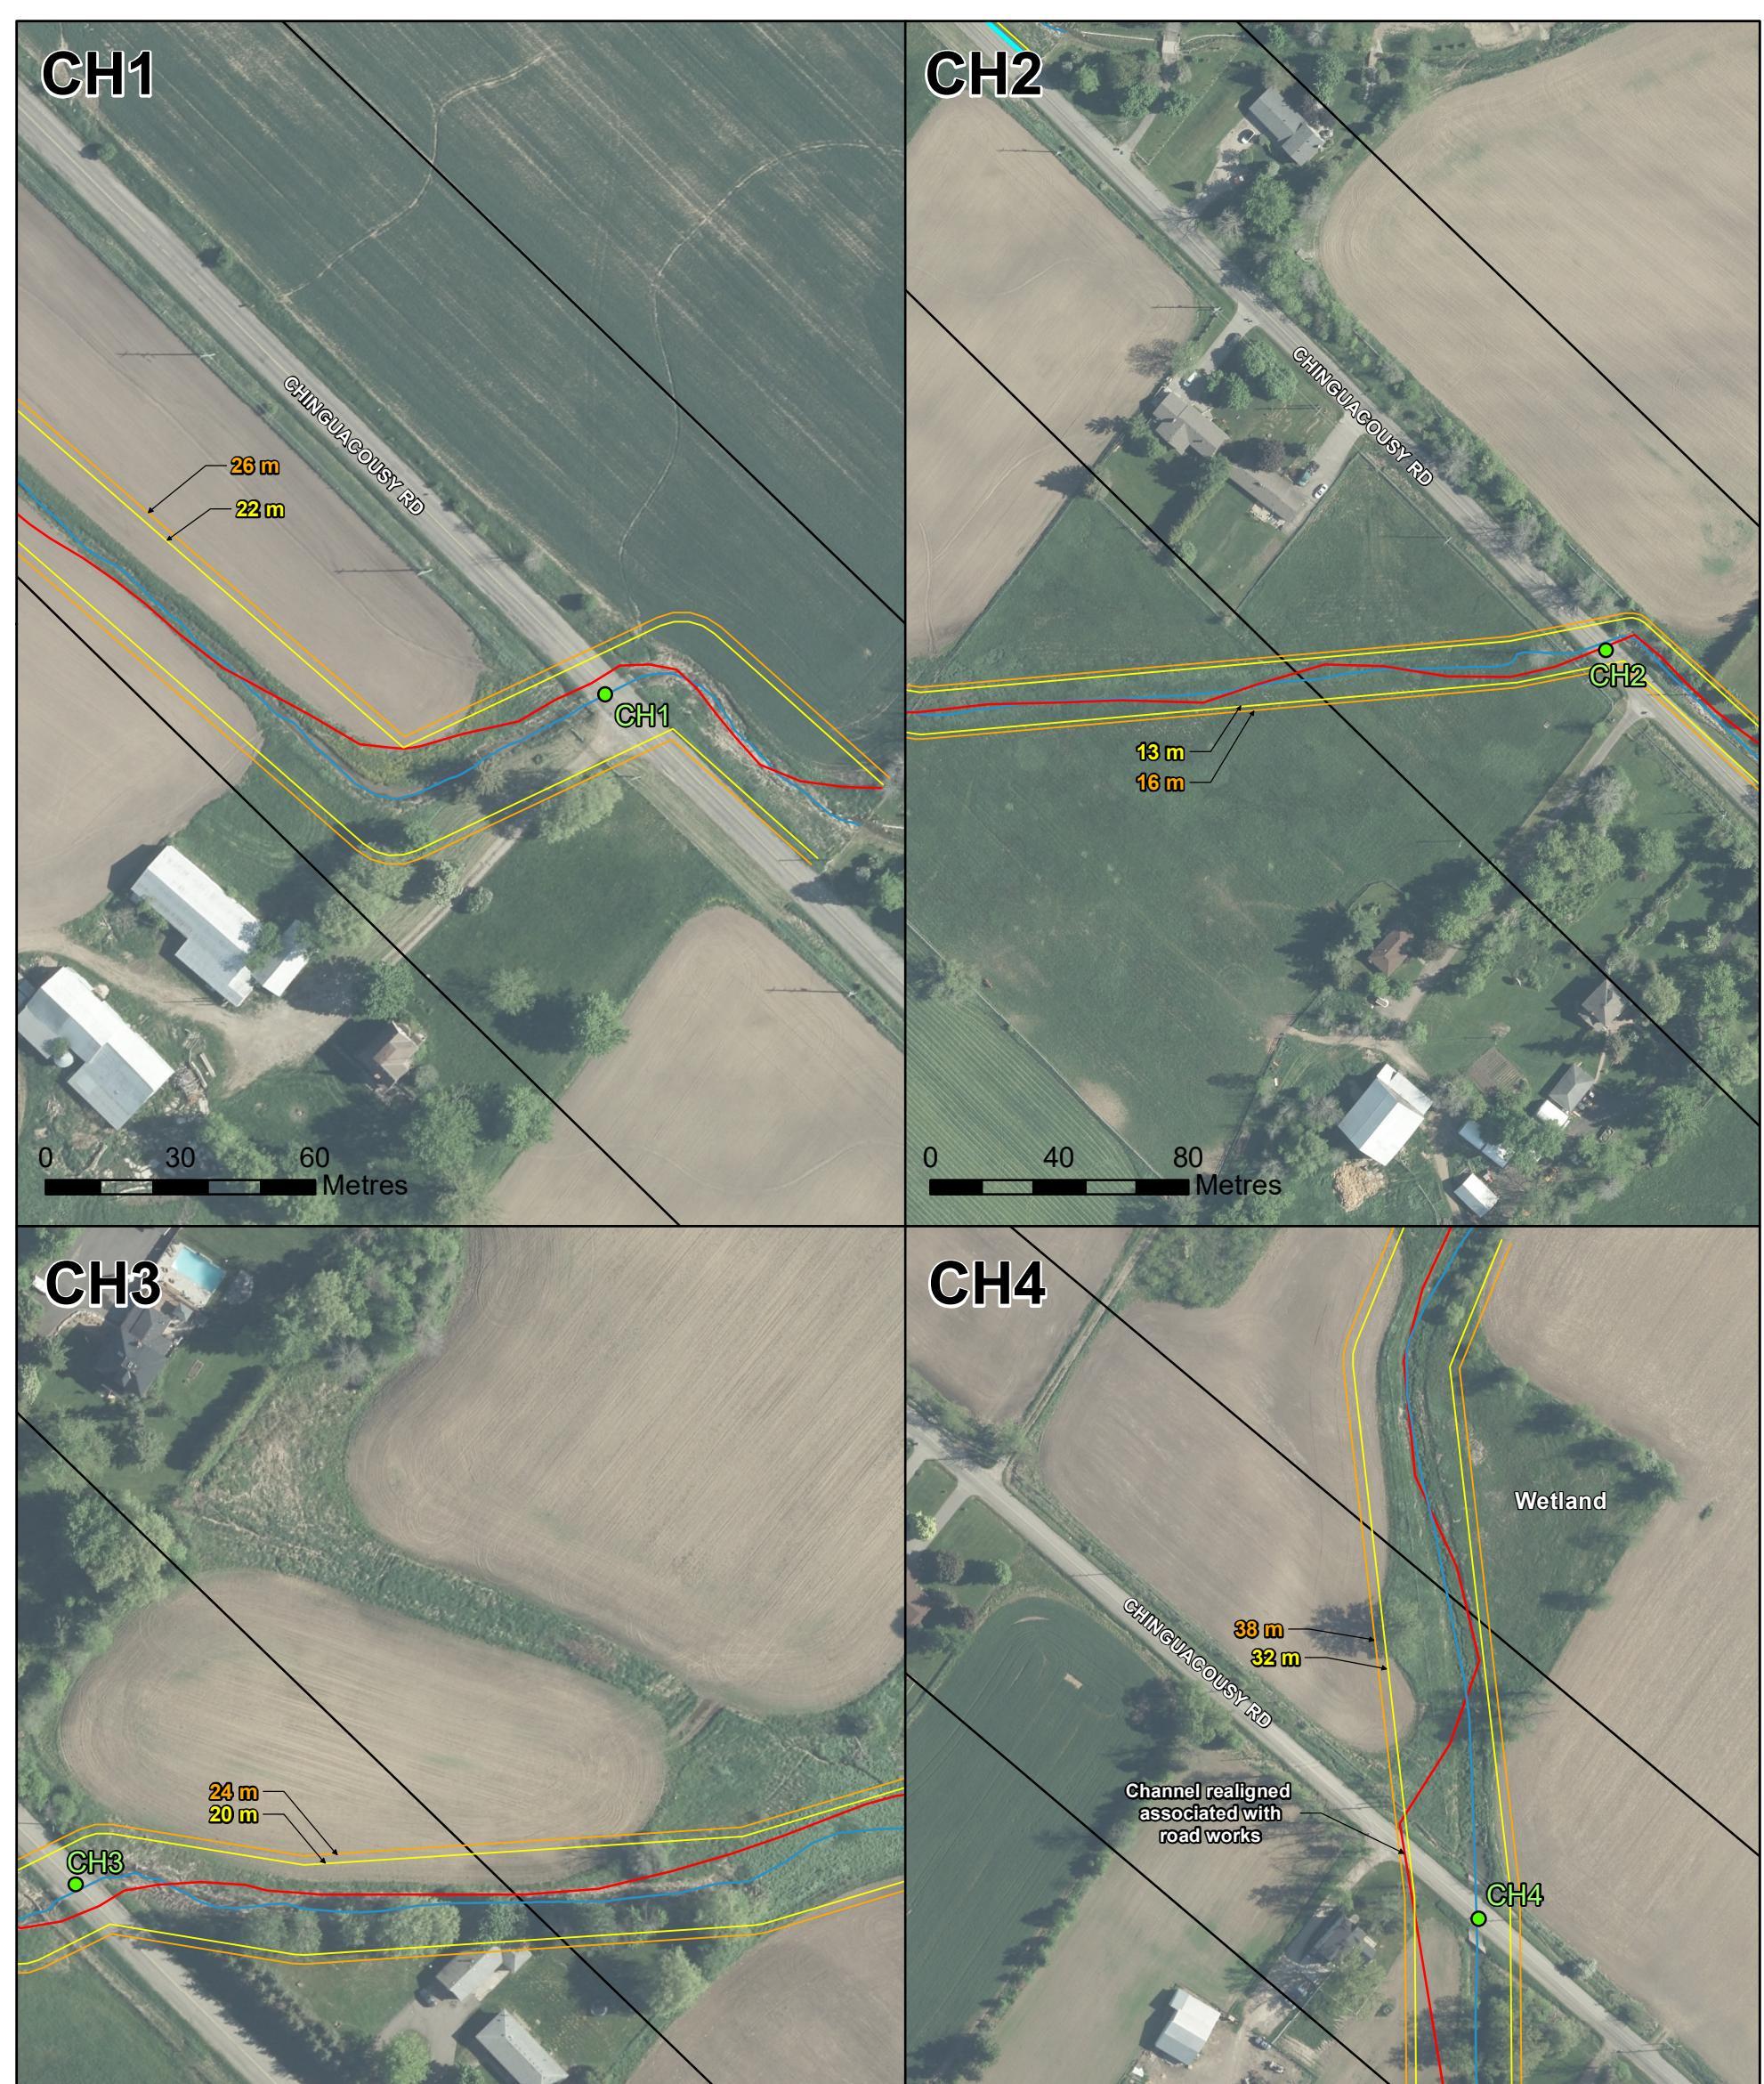
An existing meander belt width was delineated for the four watercourses located along Chinguacousy Road (CH1, CH2, CH3, and CH4) (**Table 2; Figure 2**). The final belt widths include a 20% factor of safety (**Table 2**). **2**).

The existing CH1 and CH4 culverts are aligned perpendicular to their respective roads as opposed to the natural trends, or axes, of their respective watercourses (**Figure 2**). The watercourse just downstream of the CH2 culvert has an abrupt bend, likely a result of historic channel modification (**Figure 2**). The CH3 culvert is aligned perpendicular to the road but exists within a natural channel bend (**Figure 2**). The existing skew of the CH1, CH2 and CH4 culverts effectively reduces what may be the intended (designed) hydraulic capacity during flood conditions and locally alters sediment transport patterns.

Palmer recommends consideration be given to reorienting the CH4 culvert along the natural axis of the channel corridor. It is also recommended that the CH2 culvert be reoriented to reduce the abruptness of the downstream channel bend and mitigate potential erosion at the culvert outlet. Reorientation would add little to the required culvert length. Reorienting the CH1 culvert would realign the culvert with the natural watercourse axis, but it would necessitate substantial channel realignment both upstream and downstream that is likely cost-prohibitive and of only modest benefit to channel function. A slight reorientation of the CH3 culvert to reduce the abruptness of the channel bend would be beneficial, but this is not recommended unless completed in conjunction with other works (e.g., culvert resizing) due to the modest benefit. Any reorientation of the CH3 culvert should not impact the upstream confluence.
