# Tributary of West Humber River Fluvial Geomorphological Assessment

12506 & 12698 Heart Lake Road, Caledon, ON

GEO Morphix Project No. 25023

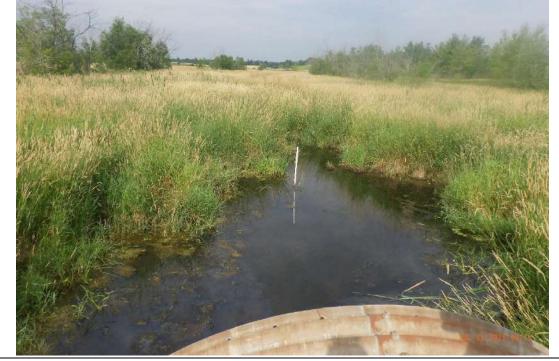
Photo 1

Photograph looking upstream at Reach 9 from Heart Lake Road. Channel situated within a wide grassy floodplain/corridor.

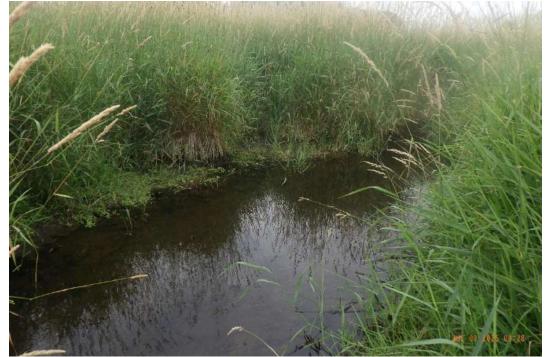
Photo 2

Photograph taken facing upstream near downstream extent of Reach 9 on subject property. Single, defined channel with sand/silt/clay banks.

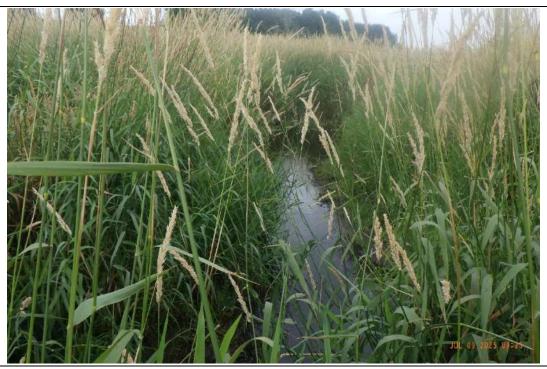
Photo 3

Photograph taken facing upstream in middle portion of Reach 9 on subject property. Limited channel definition with several flow paths observed across floodplain.

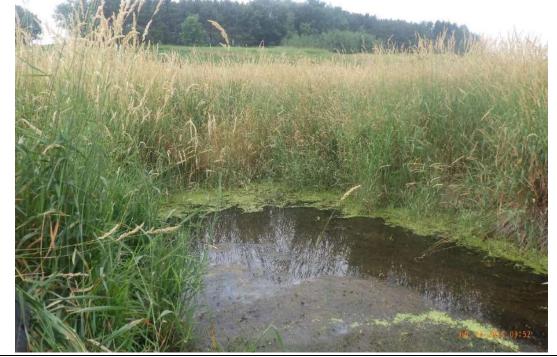
Photo 4

Photograph taken along the upstream extent of Reach 9 through the subject property. Pool of water was noted along the south side of the floodplain.

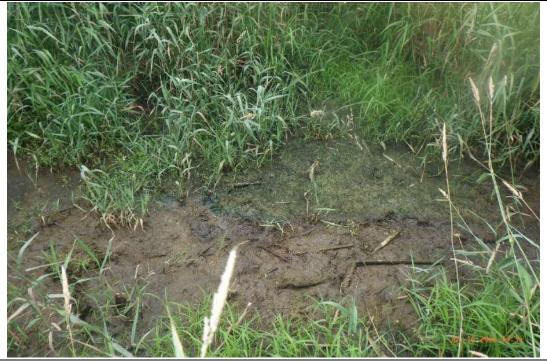
Photo 5

Photograph taken of substrate along the upstream extent of Reach 9 on the subject property. Materials consist of silt with some clay and sand.

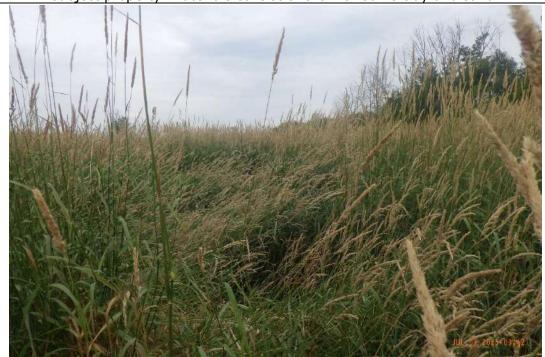
Photo 6

Photograph demonstrates typical condition across corridor through majority of Reach 9 on the subject property. Vegetation encroachment is extensive with multiple flow paths across the floodplain area.

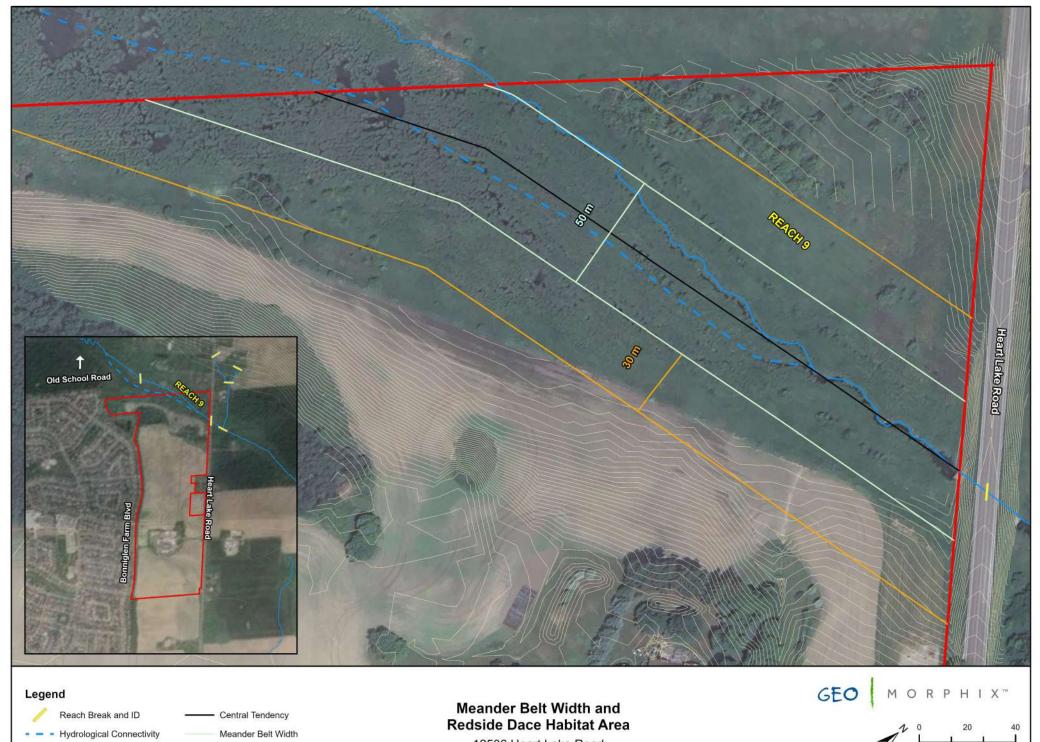
Appendix E: Meander Belt Width and Reside Dace Habitat Area

The recommended 50 m meander belt width is graphically displayed in **Appendix E**. As noted in **Section 3.1**, the OHN stream layer does not appropriately reflect the extent of flow paths across the valley. As such, the meander belt width was not plotted along the central tendency of the OHN stream layer. Instead, a central valley tendency was delineated – denoted as "hydrologic connectivity" – in **Appendix E**. The meander belt width was plotted along this central tendency to better reflect and capture the extent of flow activity across the floodplain.

A 30 m Redside Dace habitat area line was offset from the meander belt width, and is graphically displayed in **Appendix E**.
