Arborist Report 12363 Dixie Road Town of Caledon

Prepared By:
Beacon Environmental Limited

Date:
2023-05-31

Project:
222071

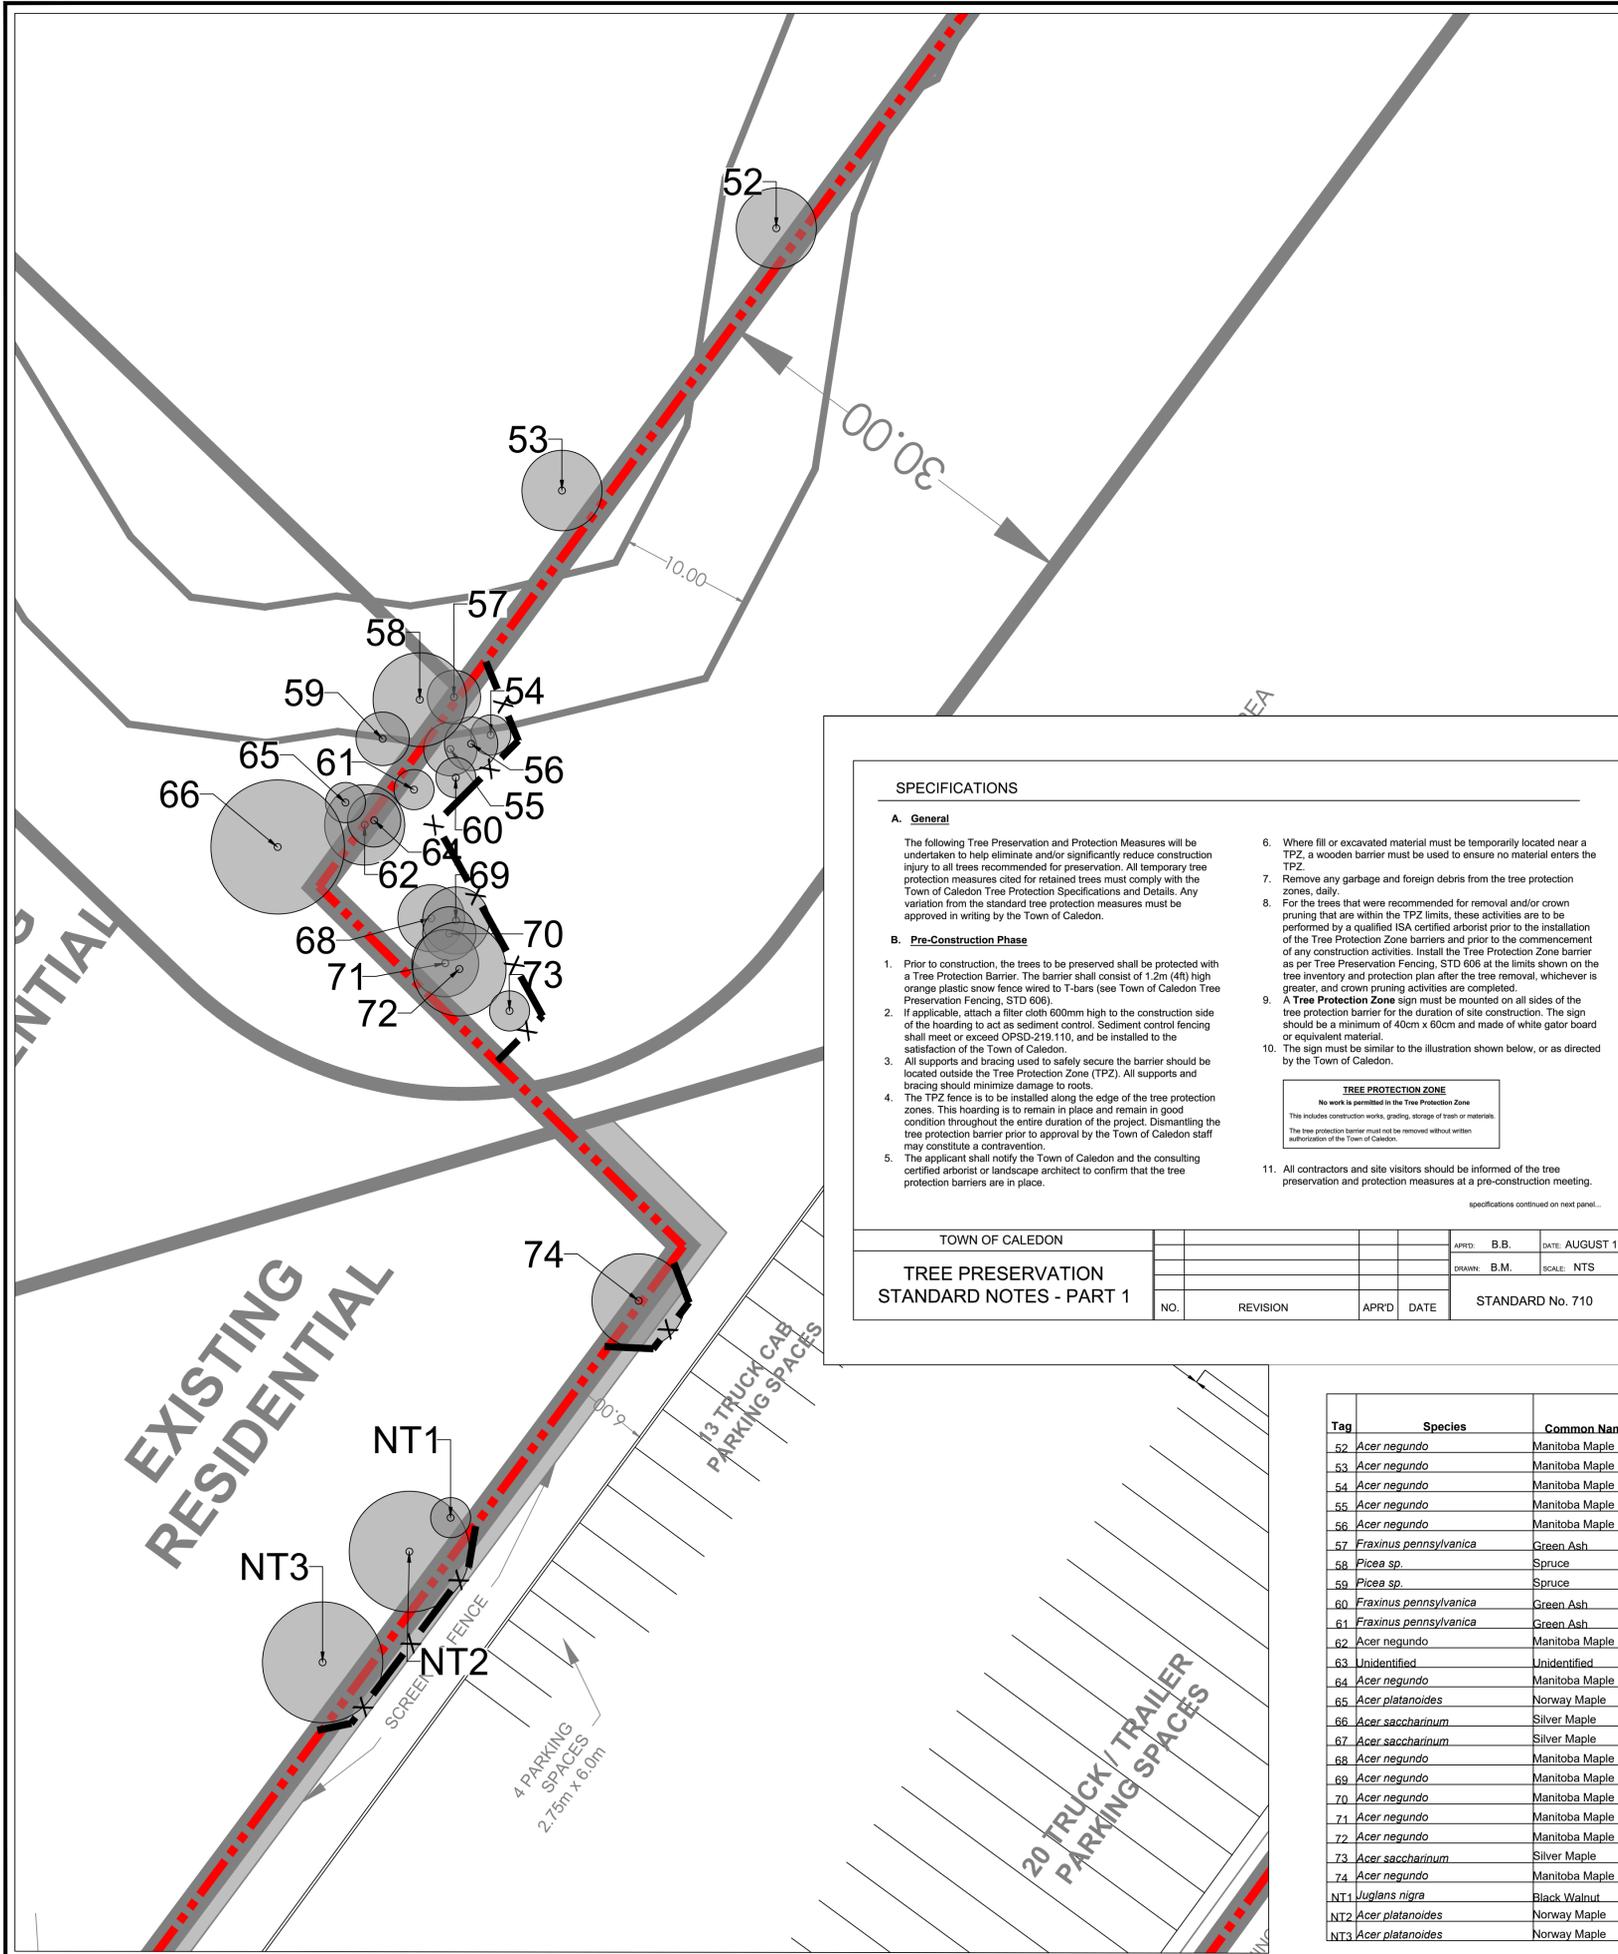
SHEET TITLE
**TREE INVENTORY AND
PRESERVATION PLAN**

A total of 26 trees were documented and assessed on or adjacent to the subject property. All trees are located along the northern property limit. The tree inventory is presented in **Drawing TP-1 (Appendix B)**.

| Tag | Species | Common Name | DBH (cm) | Crown Diameter | Location | Health | Root flare | Trunk | Branch/Crown | Comments | Recommendation |
| 54 | Acer negundo | Manitoba Maple | 12 | 3 | On-site | Good | Fair | Fair | Poor | significant lean | Preserve |
| 55 | Acer negundo | Manitoba Maple | 15 | 4 | On-site | Fair | Fair | Fair | Poor | significant lean | Preserve |
| 56 | Acer negundo | Manitoba Maple | 16 | 4 | On-site | Fair | Fair | Poor | Poor | severe lean | Preserve |
| 57 | Fraxinus pennsylvanica | Green Ash | 15 | 4 | Property line | Poor | Por | Poor | Poor | EAB, lean | Preserve |
| 60 | Fraxinus pennsylvanica | Green Ash | 11 | 3 | On-site | Poor | Por | Good | Poor | EAB, severely bent | Preserve |
| 62 | Acer negundo | Manitoba Maple | 31.15 | 6 | Property line | Fair | Fair | Fair | Poor | severe lean | Preserve |
| 64 | Acer negundo | Manitoba Maple | 17 | 4 | On-site | Fair | Fair | Poor | Poor | significant lean | Preserve |
| 66 | Acer saccharinum | Silver Maple | 40.30 | 10 | Off-site | Good | Good | Poor | Fair | massive wound in trunk | Preserve |
| 69 | Acer negundo | Manitoba Maple | 20 | 5 | On-site | Fair | Fair | Fair | Poor | severe lean | Preserve |
| 72 | Acer negundo | Manitoba Maple | 31 | 7 | On-site | Good | Fair | Fair | Poor | severe lean | Preserve |

All trees identified on or adjacent to the subject property have been identified for preservation as illustrated in **Drawing TP-1**.

Prior to site alteration, tree protection fencing should be established at the limit of the TPZs. The location of tree protection fencing is illustrated in **Drawing TP-1**.
