**Arborist Report and Tree Preservation Plan**  
**Stellar Homes Phase 2**  
**Part of Lot 18, Concession 8**  
**Town of Caledon**

January 2025 Update  
February 2024

AEC 23-056

Re: January 2025 Update **Arborist Report and Tree Preservation Plan**  
**Stellar Estate Homes Phase 2**  
**Part of Lot 18, Concession 8, Town of Caledon, Regional Municipality of Peel**

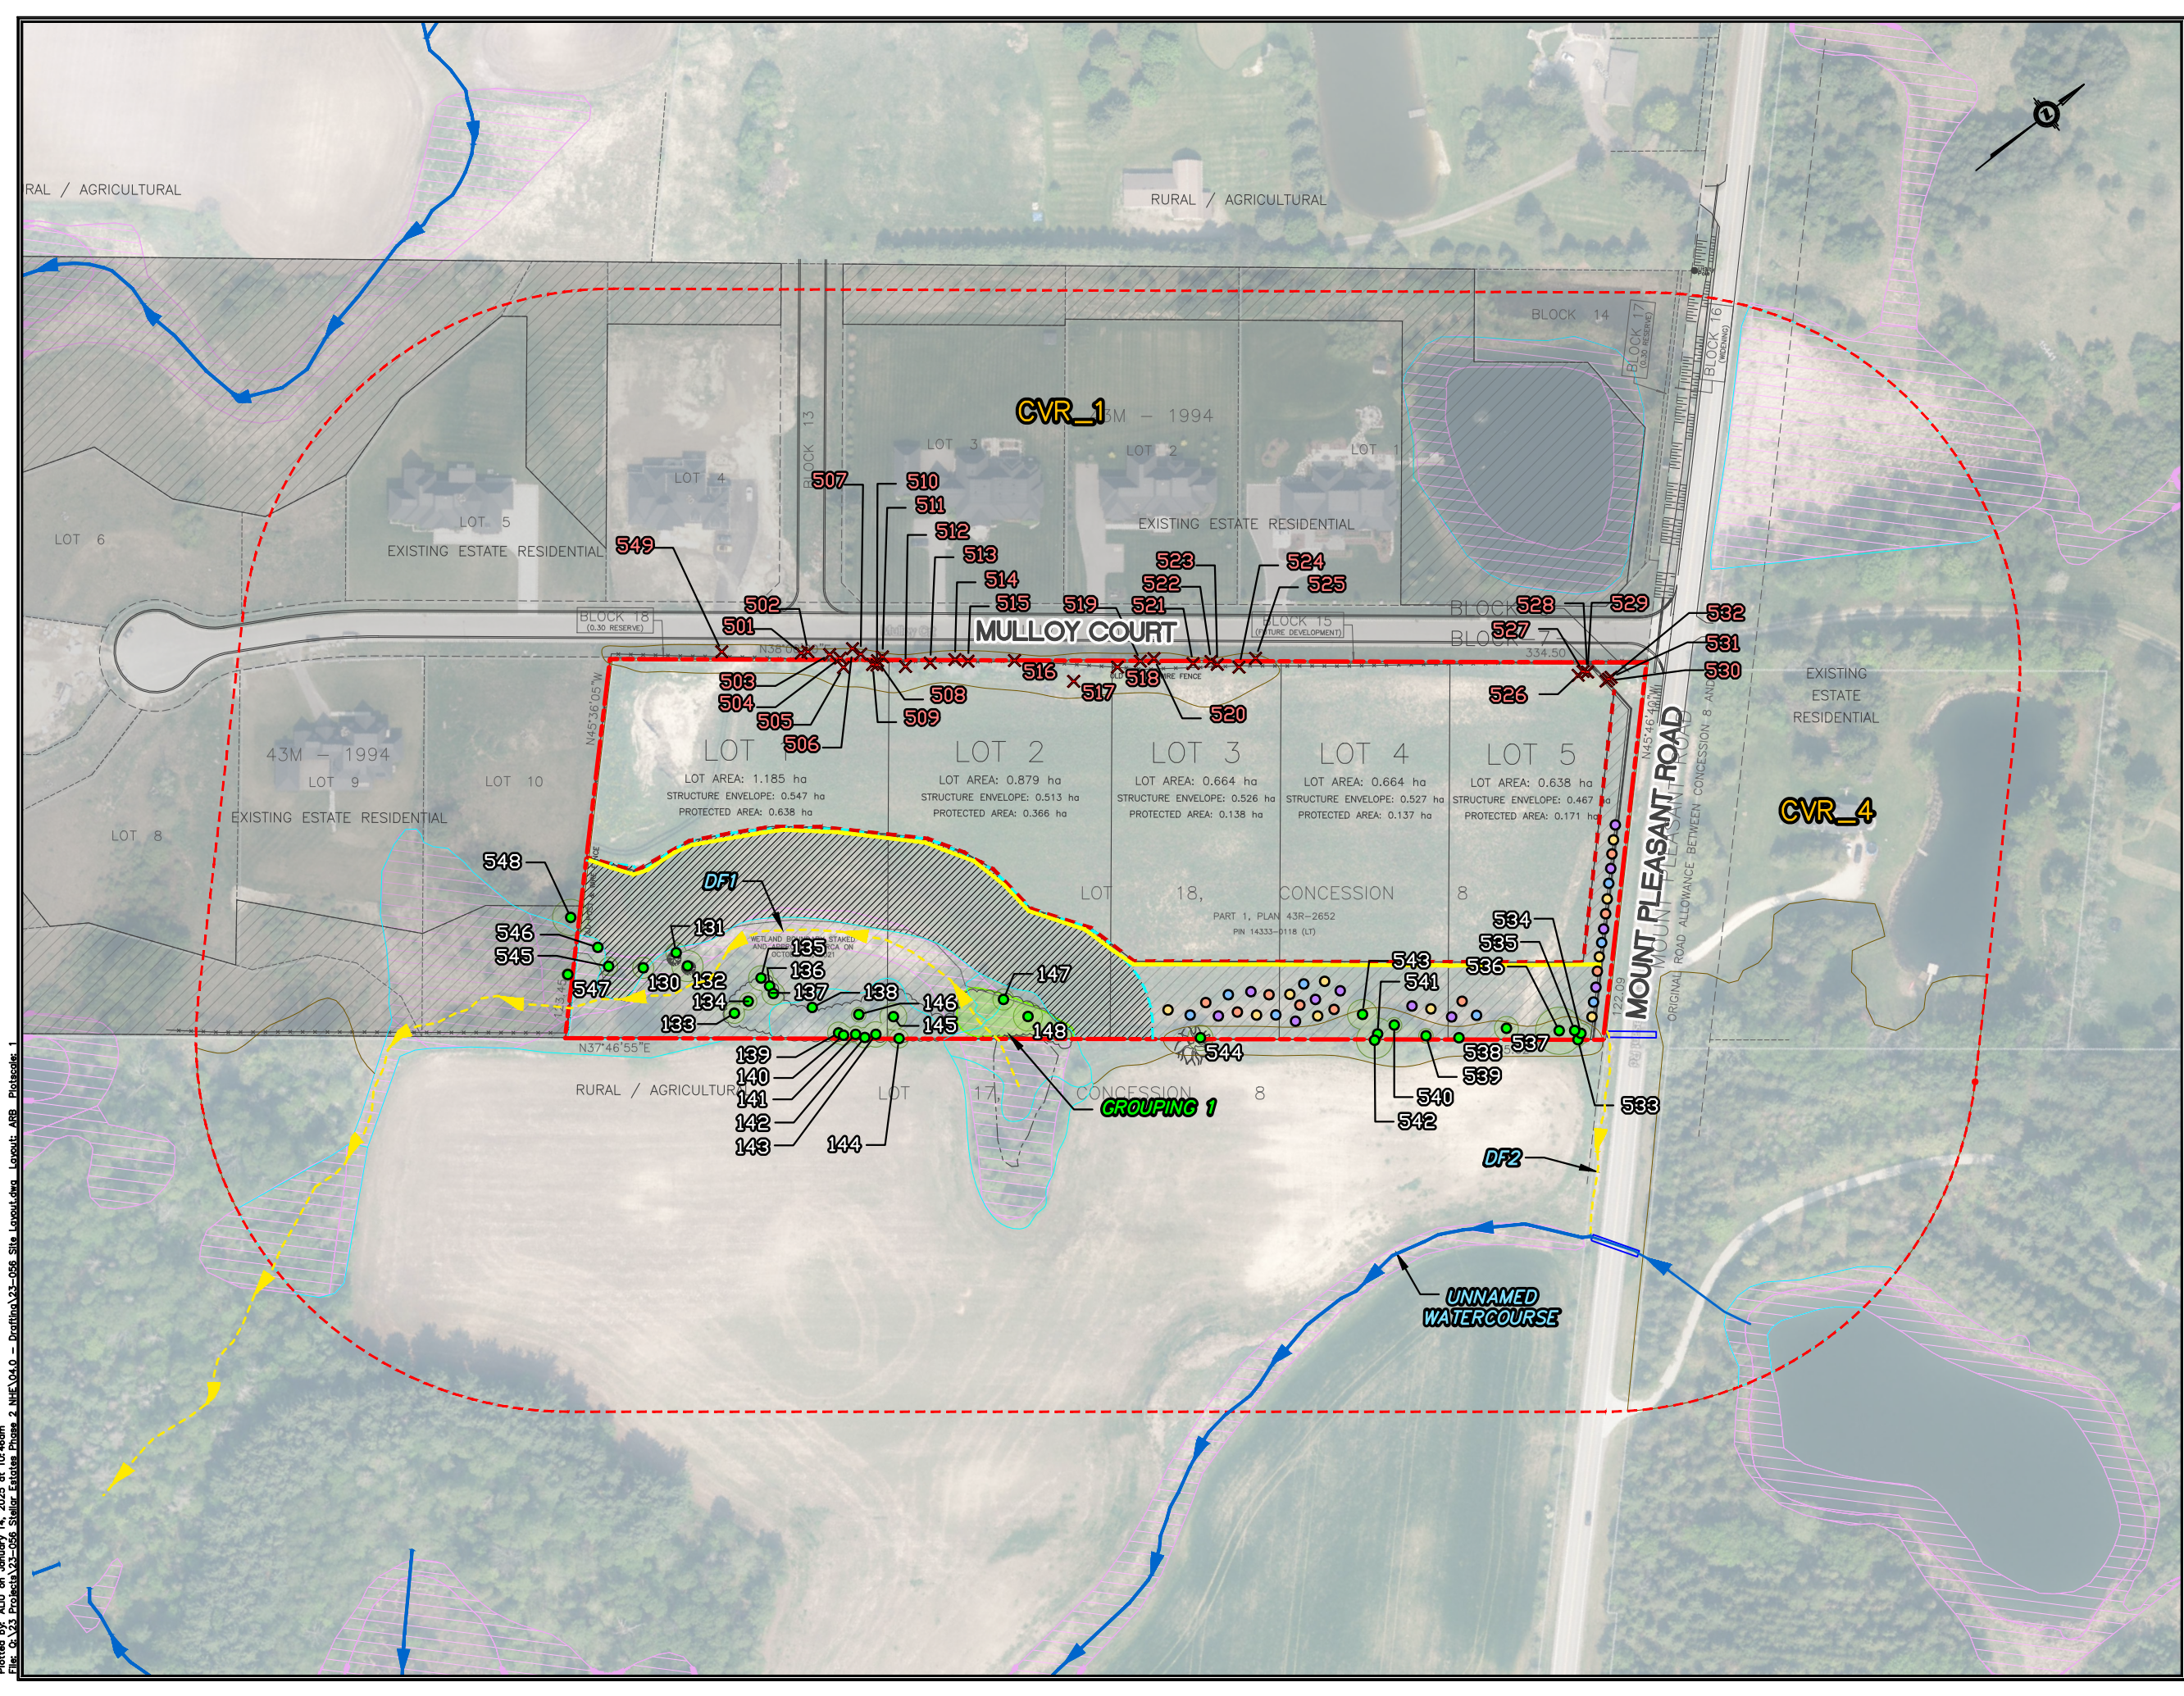
| TREE PRESERVATION PLAN | | |

In total, 78 trees were included in the inventory and assessed for this report, which included a grouping of 10 willow trees (see Figure 2). Of the 78 trees assessed, 45 trees are located within the on-site wetland or designated 30 metre (m) vegetation protection zone (VPZ) along the southern property boundary.

to the TPZ. TPZ radius measurements for all trees to be retained are listed in Appendix A, with the resulting TPZ areas around retained trees shown in Figure 2.

Tree protection fencing (hoarding) should be installed along the northern edge of the MVPZ and Open Space Block (see Figure 2) to ensure construction machinery does not enter this preservation zone. As per the Town of Caledon Tree Preservation Standard No. 606, siltation control fencing may be used as a tree preservation fencing substitute if required by engineering at the discretion of the Town. Therefore, if erosion and sediment control (ESC) fencing is already proposed for the MVPZ and Open Space Block, then duplication in fencing alignments should not be necessary. Any tree protection fencing must comply with the standard shown in the Town of Caledon Standard Drawing 606 and the Tree Preservation Standard Notes – Part 1 and 2 (Standard Drawings 710 and 711; Appendix B).

Figure 2 shows where the proposed tree compensation plantings could occur. High value native species such as Sugar Maple (*Acer saccharum*), Silver Maple (*Acer saccharinum*) Red Oak (*Quercus rubra*), Eastern White Pine (*Pinus strobus*) and White Spruce (*Picea glauca*) are recommended for the plantings.

A total of 45 trees are recommended for preservation, while a total of 33 trees are recommended for removal due to the proposed development. To compensate for the loss of 33 trees, it is recommended that the developer provide compensation at at the ratios prescribed by the Town (2020) for a total of 38 compensation trees at the general locations shown in Figure 2.
