Fluvial Geomorphological Assessment, Erosion Hazard Delineation, and Channel Realignment

12035 Dixie Road, Caledon, ON

March 16, 2021 PN20109

GEO MORPHIX Earth Science

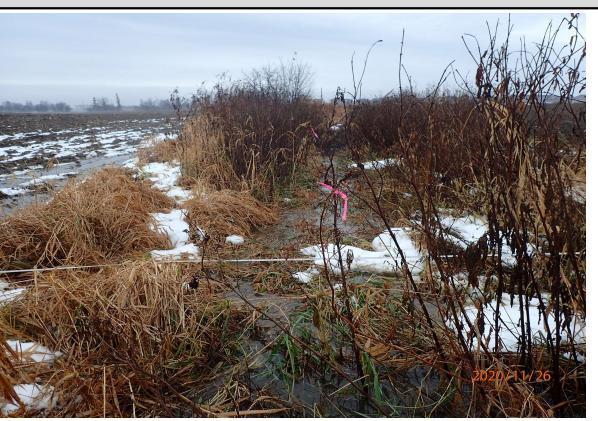
Photograph at Cross-Section 6 (looking downstream)

Average feature width and depth were approximately 6.36 m and 0.13 m, respectively. It is important to note that banks were poorly defined and bankfull indicators were absent on the day of assessment. Additionally, the reach was heavily modified and there was extreme encroachment of vegetation. Bank angles ranged from 0° to 60° and consisted of entirely clay/silt. Evidence of erosion was observed through less than 5% of the channel.

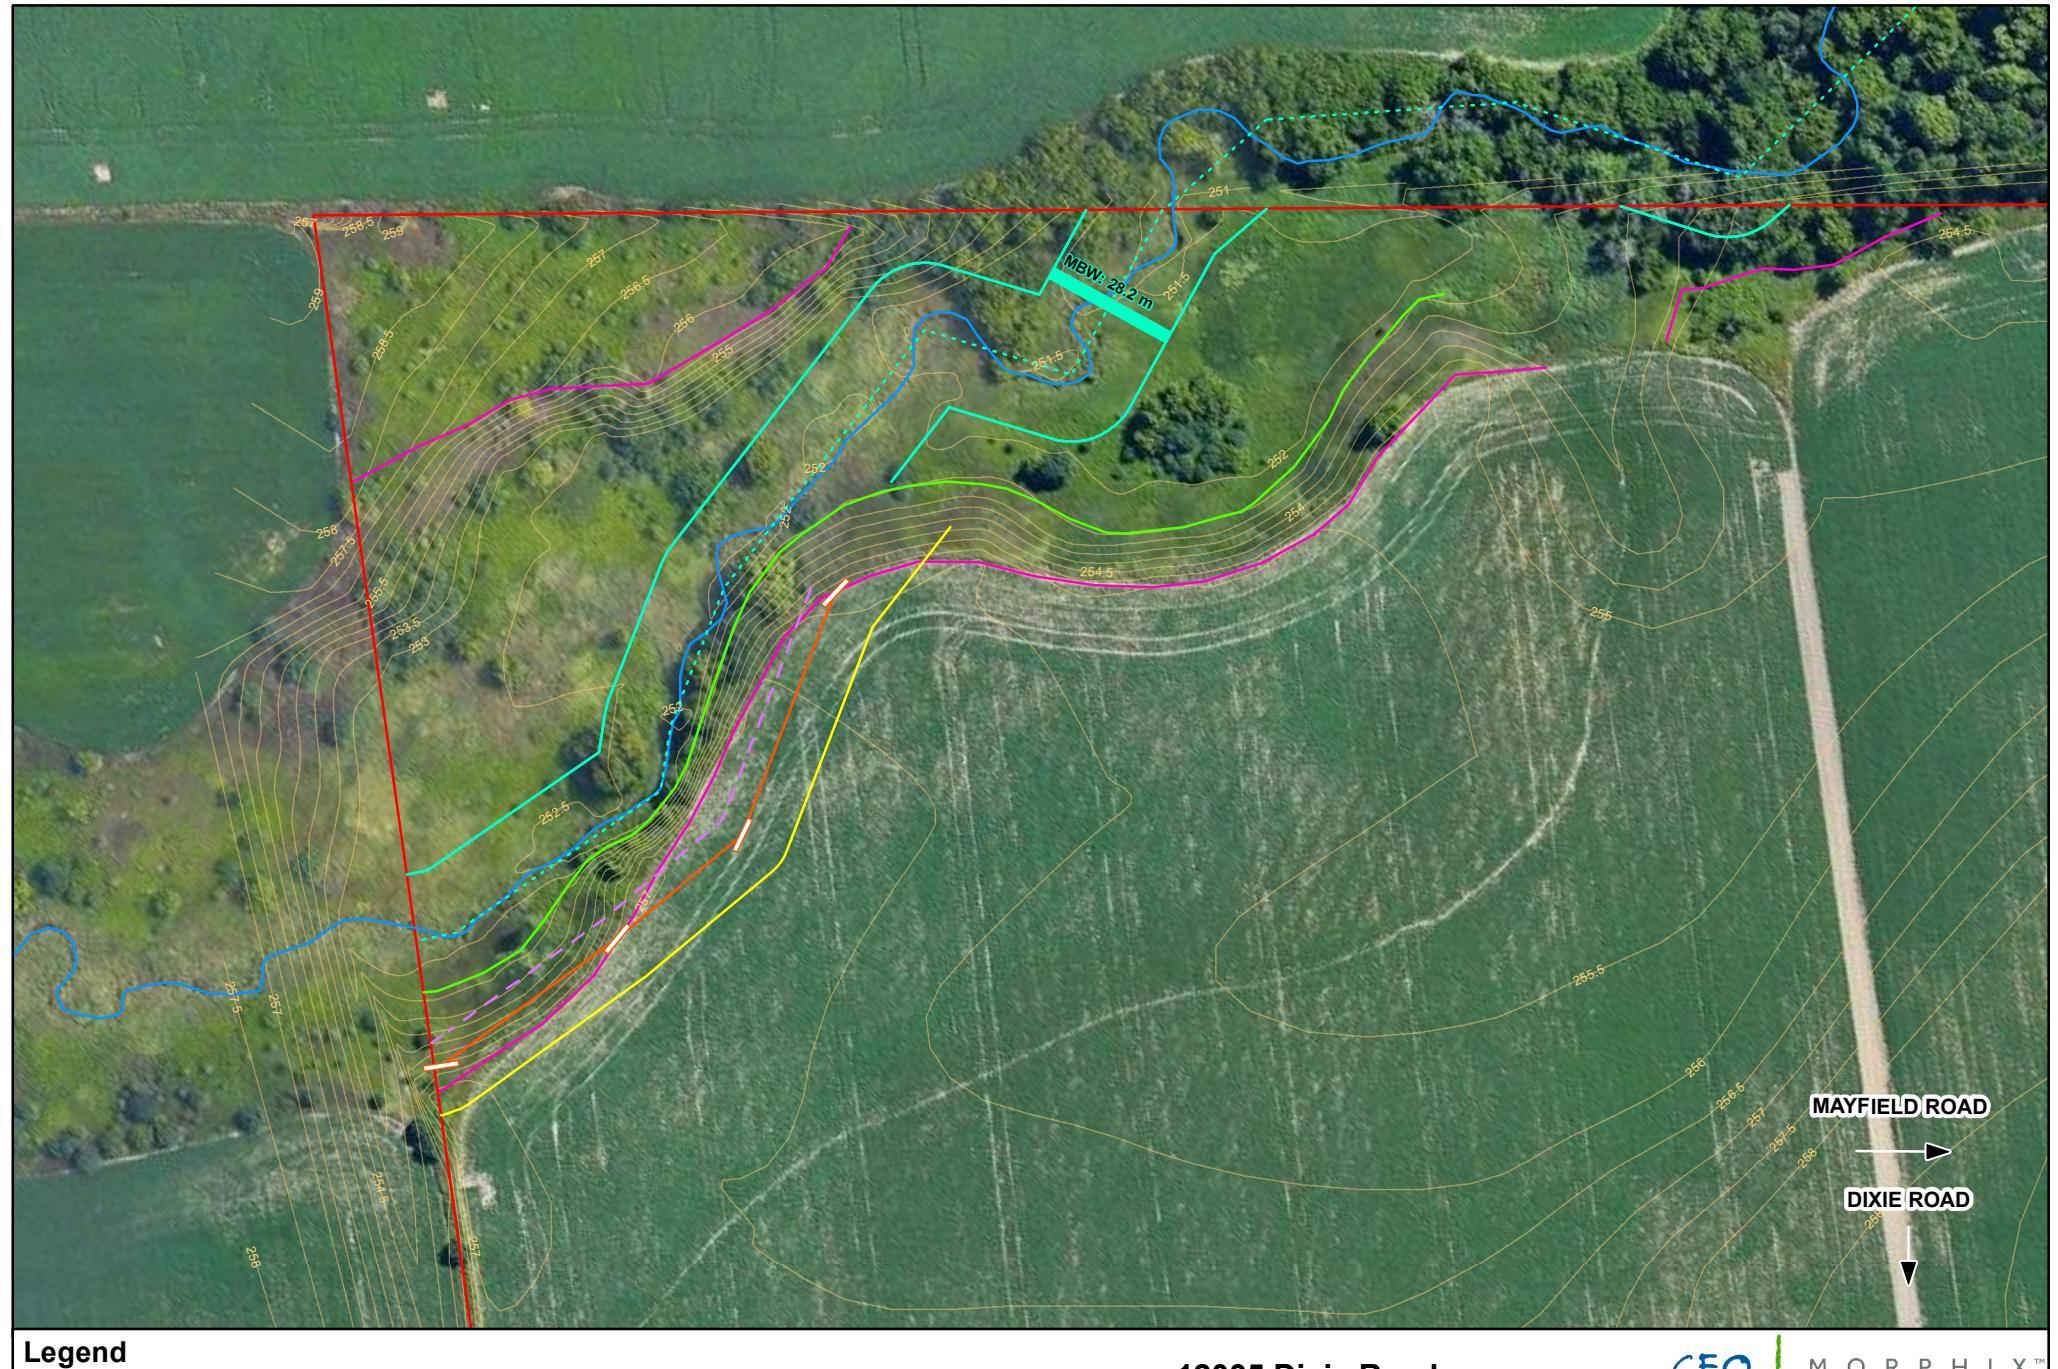
12035 Dixie Road Preliminary Erosion Setback and Meander Belt Width Caledon, Ontario

Where **Reach 3** was within a confined valley system or flowed within 15 m of the toe of slope (based on the topographic break in slope) through the subject property, a toe erosion allowance was determined to address the erosion hazard. Based on the type of bed and bank material (i.e., clay/silt, tills) and evidence of active erosion, a 5 m toe erosion was deemed appropriate using MNRF (2002) guidelines.

It is important to note that the total erosion hazard for confined valley systems is based on a combined influence of the toe erosion allowance and the stable slope. For confined systems, a stable slope is identified as 3:1 (H:V) or as determined by a study using accepted geotechnical principles (MNRF, 2002). A geotechnical investigation and slope stability analysis was completed for **Reach 3** by MTE Consultants (2021) to identify the stable top of slope. The geotechnical study confirmed that the slope is relatively stable under current conditions. The stable top of slope documented by MTE (2021) includes the 5 m toe erosion allowance, and as such, adequately characterizes the erosion hazard associated with **Reach 3**. The erosion setback delineation is provided in **Appendix E**.

Where **Reach 3** was within an unconfined valley system or flowed beyond 15 m from the toe of slope (based on the topographic break in slope), meander amplitude was applied to delineate the erosion hazard. Using recent aerial photographs from Google Earth Pro, the amplitude of three meander bends was measured. This measurement was used to inform the meander belt width delineation and address natural erosion hazard. Meander amplitudes were measured using an aerial photograph from 2005 (GEP) where the channel planform was discernable and unobstructed by vegetation. Meander amplitudes ranged from 11.8 m to 23.5 m. Further, a 20% factor of safety was applied to the largest meander amplitude (23.5 m) to account for changes in creek morphology over time. With a 20% factor of safety, the hazard limit is approximately 28.2 m. The meander belt width delineation is provided in **Appendix E.** The meander belt width associated with **Reach 3** was also applied to **Reach 2** within the subject property. Although **Reach 2** was located beyond the subject property, the meander belt width (28.2 m) extends into the subject property in one location. This is illustrated in **Appendix E**.
