November 10, 2023

RE: Fluvial Geomorphic Site Visit – Drainage Feature, Tributary of Beeton Creek, 10249 Hunsden Sideroad (GEI PN2101948)

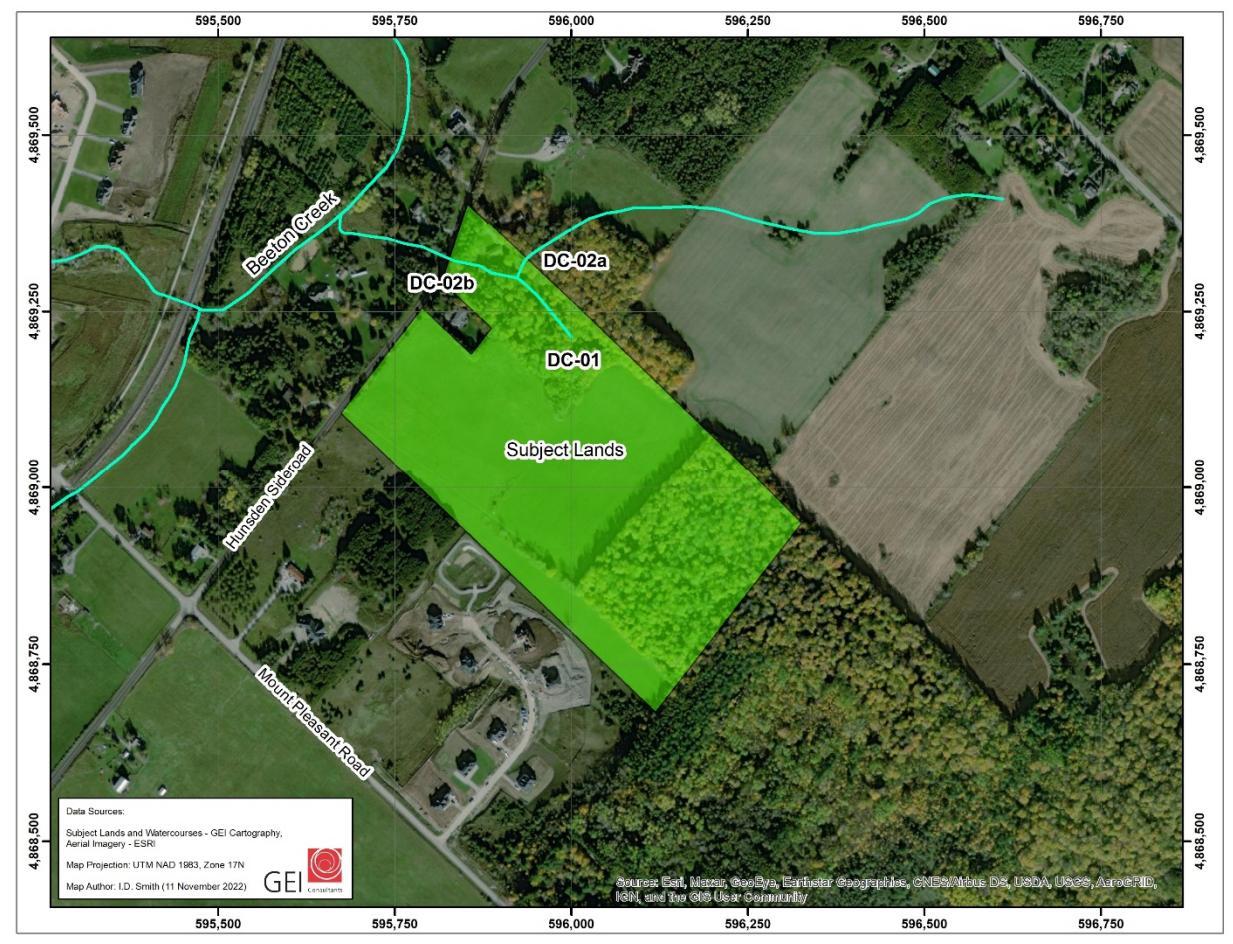
Figure 2: Reaches within the Subject Lands.

Reach DC-01: Begins within the northeast woodlot of the Subject Lands, flowing northwest from the woodlot area towards an existing residence. This short drainage feature consists of less than 120 metres of poorly defined channel. Reach DC-01 terminates at the confluence with Reach DC-02a.

Reach DC-02a: Begins some 720 metres east of the approximate property line for the Subject Lands. It flows across mostly agricultural lands (with photogrammetric evidence of being tilled or ploughed through) and into the woodlot of the Subject Lands. The channel is slightly defined in the woodlot area but exits to a manicured lawn that shows little definition beyond that of a shallow swale. Reach DC-02a flows for approximately 30 metres from the Subject Lands' property line to the confluence with Reach DC-01.

Reach DC-02b: Begins at the confluence of Reaches DC-01 and DC-02a, flowing northwestward to the Hunsden Sideroad culvert crossing at the edge of the Subject Lands. This poorly defined channel flows next to manicured lawn areas but is situated at the edge of the Subject Lands' woodlot area.
