Preliminary Fluvial Geomorphological Assessment and Erosion Hazard Delineation

12892 Dixie Road, Caledon, ON

February 24, 2021
PN20109

Report Title: Preliminary Fluvial Geomorphological Assessment
and Erosion Hazard Delineation
12892 Dixie Road, Caledon, ON

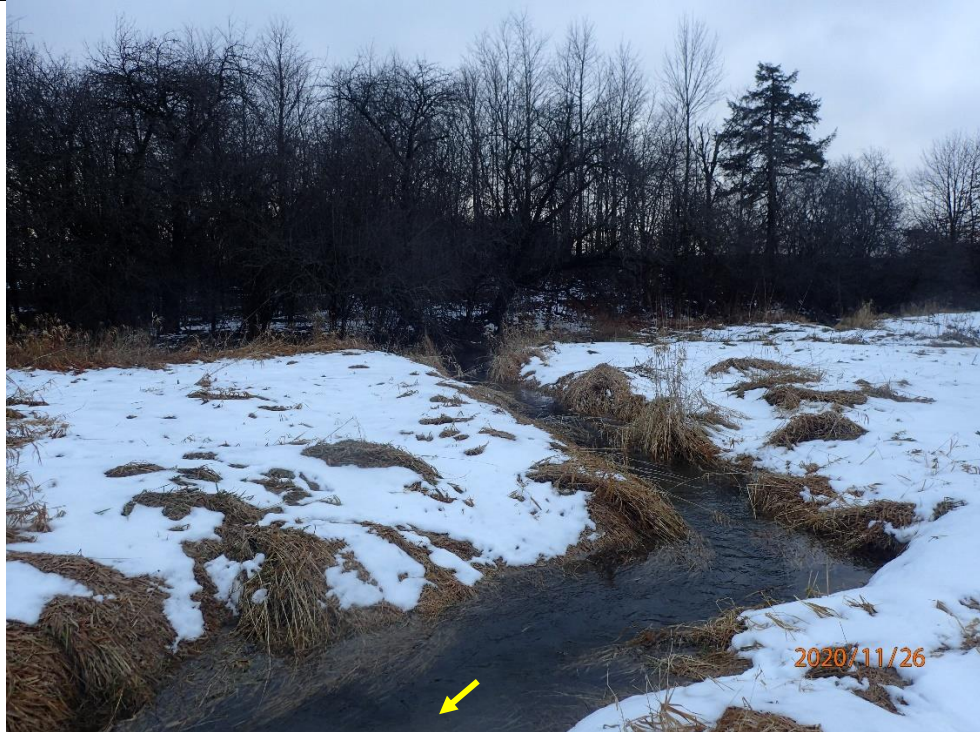
Photo 1
Reach 6 – West Humber River

Photograph at the furthest upstream extent of Reach 6 within the subject lands. The channel was single-thread, meandering, with tortuous meanders.

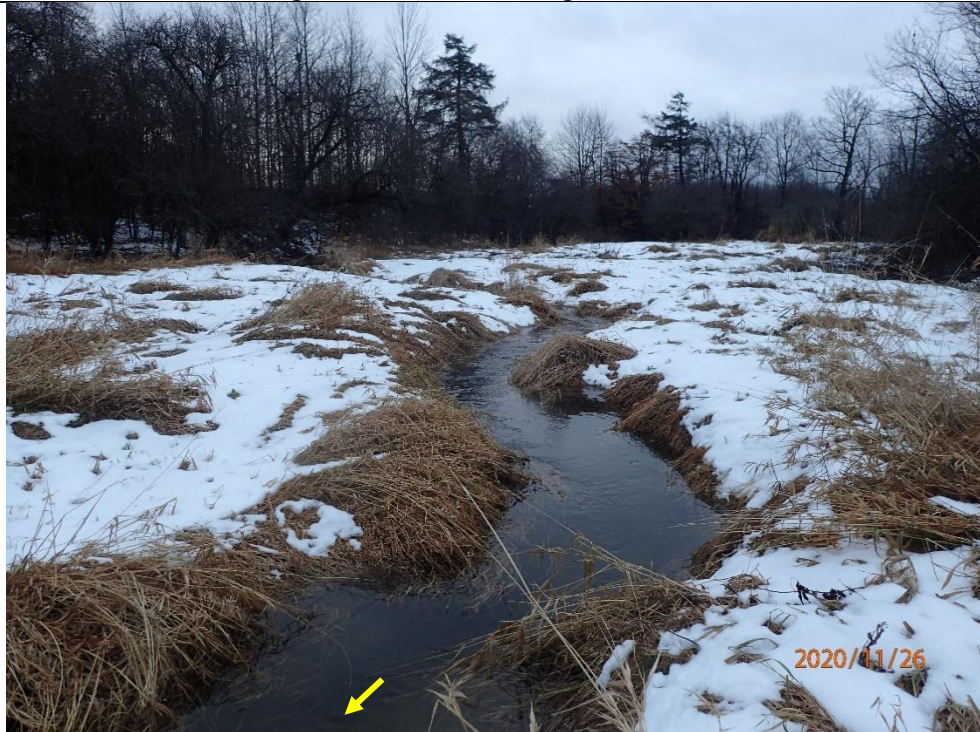
Photo 2
Reach 6 – West Humber River

Photograph taken looking upstream. The estimated average bankfull width and depth was 1.83 m and 0.78 m, respectively. The riparian zone was 1 to 4 channel widths and dominated by grasses.

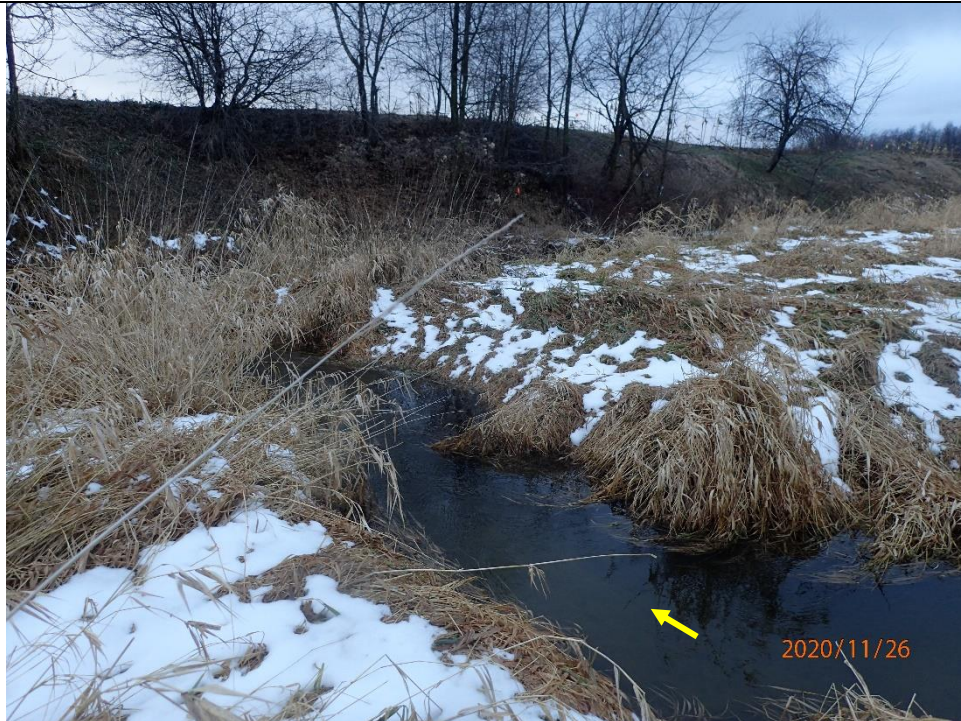
Photo 3
Reach 6 – West Humber River

Photograph taken looking downstream. Reach 6 flowed through a confined valley system with the valley wall contact observed. Riparian habitat conditions were limited with < 50% canopy coverage.

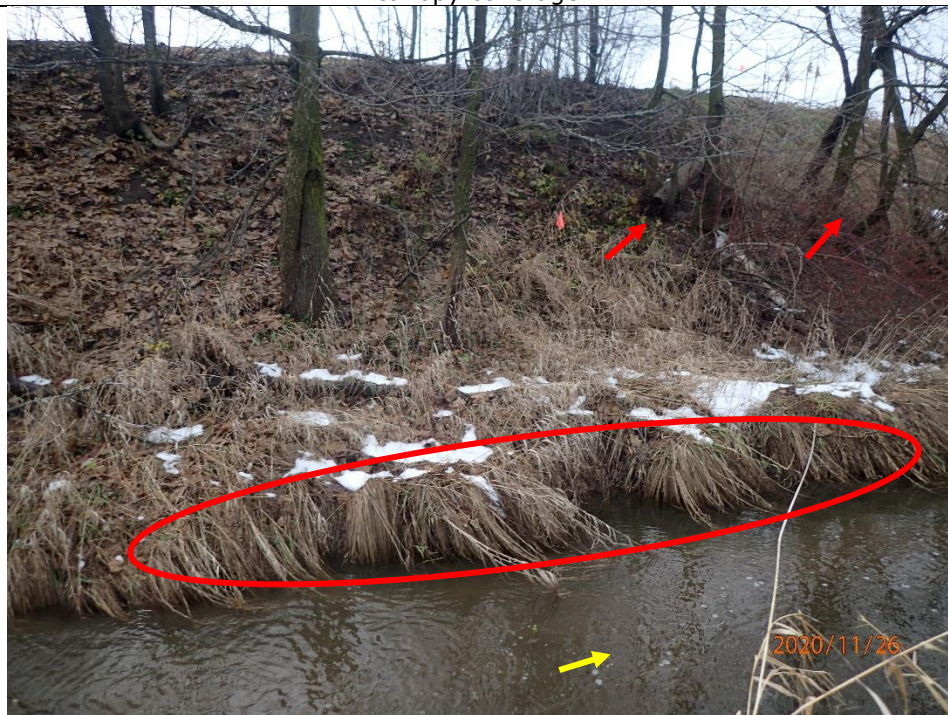
Photo 4
Reach 6 – West Humber River

Photograph taken looking towards the left bank (facing downstream). Leaning and fallen trees were observed along the valley wall (arrows) and undercuts measured to 0.15 m in depth (circled). These observations indicated evidence of widening.

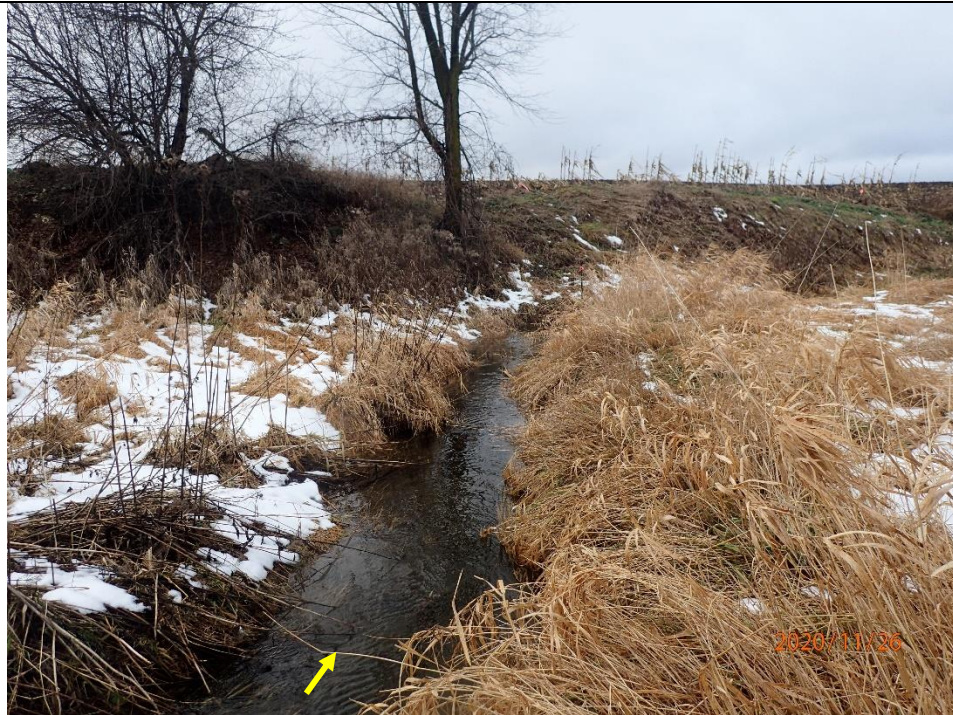
Photo 5
Reach 6 – West Humber River

Photograph taken looking downstream. There was limited development of geomorphic units, rather, the reach was dominated by riffles and runs with few pools present.

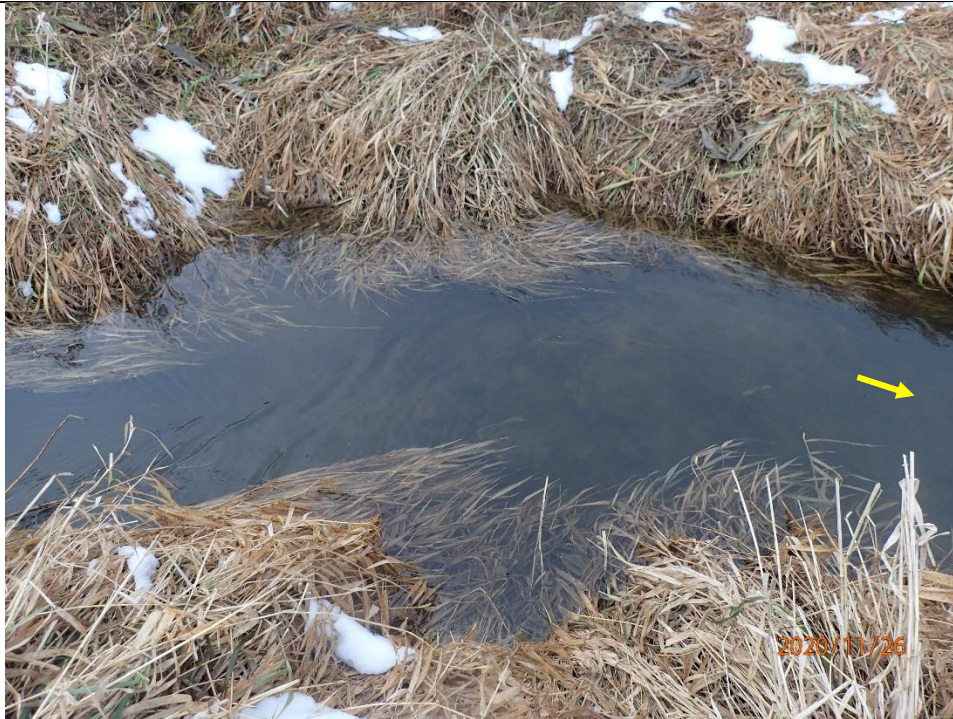
Photo 6
Reach 6 – West Humber River

Riffle substrate consisted of sand, gravel, and cobble, whereas bank material consisted of clay/silt, sand, and gravel. Basal scour was observed along inside meander bends and on both sides of the channel through riffles.

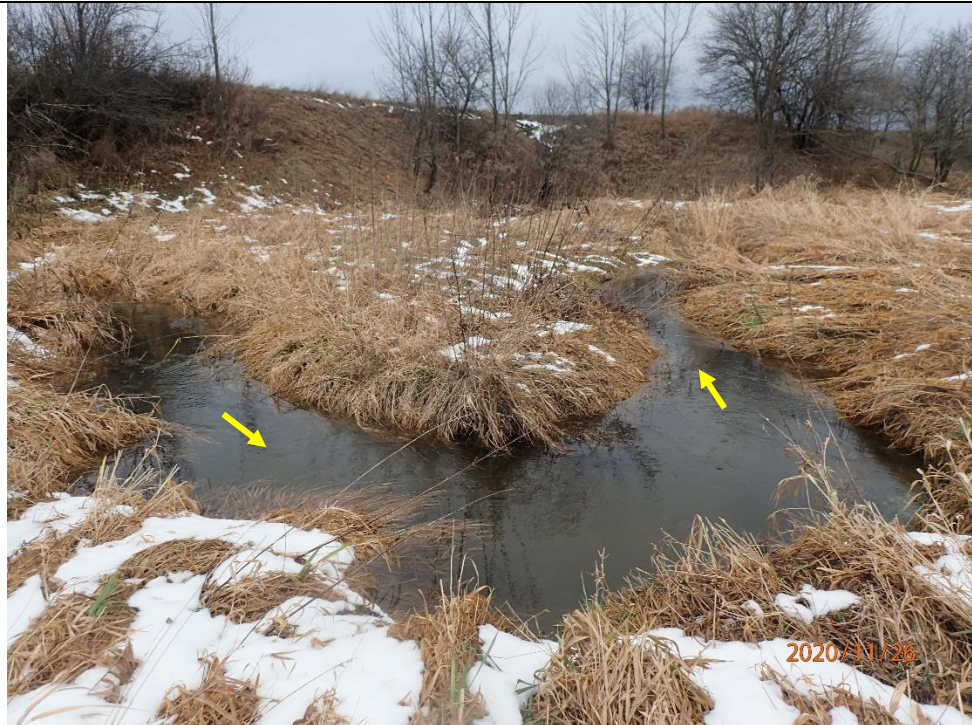
Photo 7
Reach 6 – West Humber River

Photograph taken on the outside of a meander bend, facing downstream. Meander amplitude was measured as approximately 15 m to 25 m throughout the system.

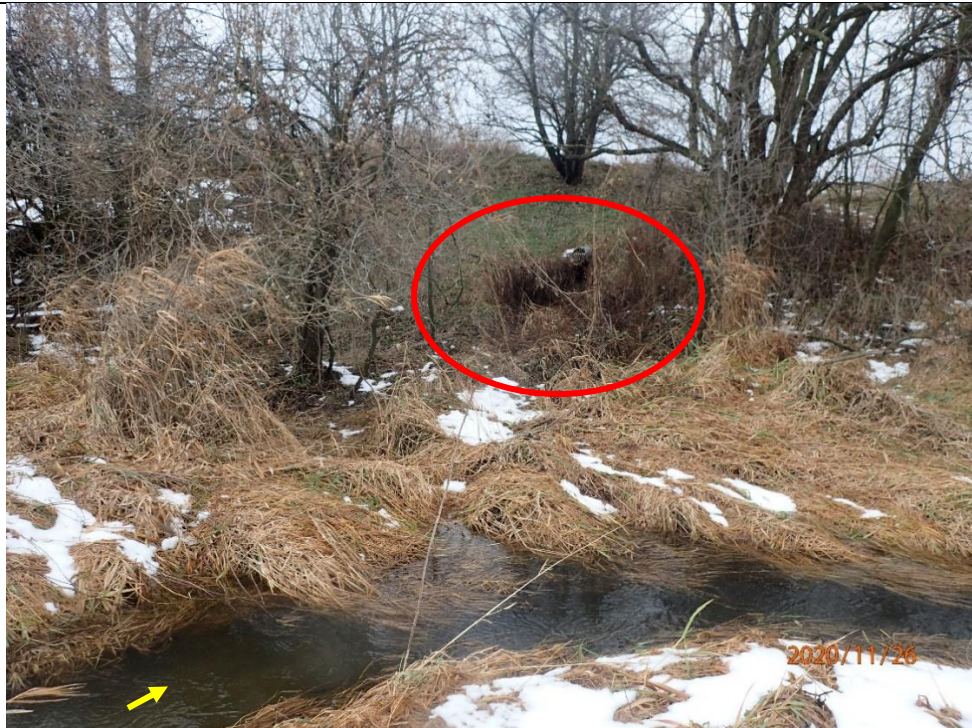
Photo 8
Reach 6 – West Humber River

Photograph taken facing valley wall. Approximately 71 – 80% of the bank network was considered stable with infrequent signs of bank slumping or failure (circled).

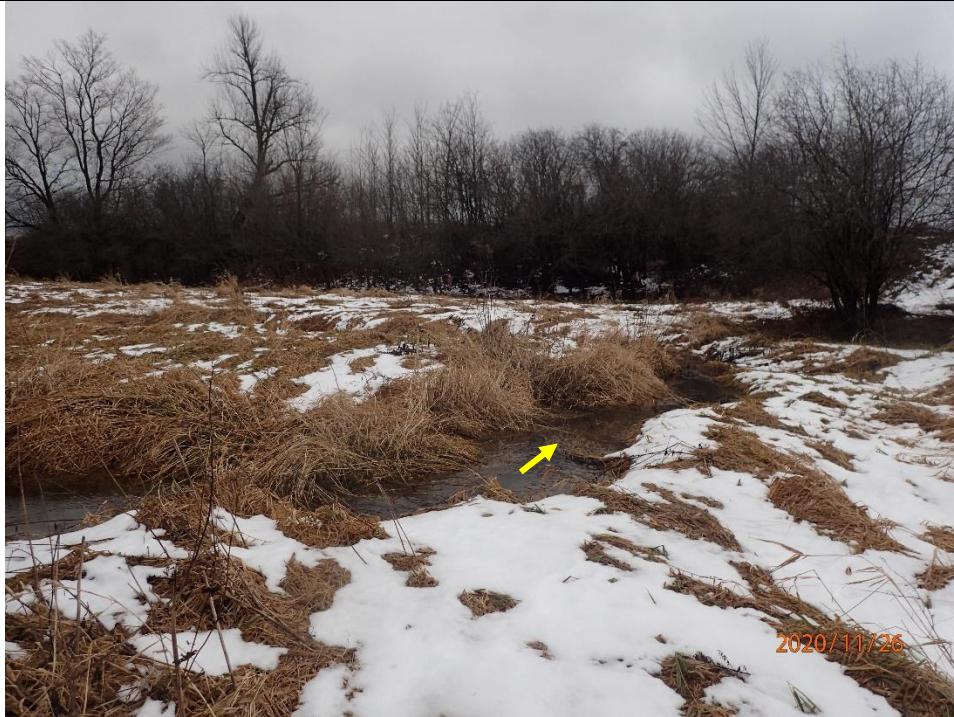
Photo 9
Reach 6 – West Humber River

Photograph taken towards the left bank, facing generally downstream. Instream vegetation occupied 10% of the channel and consisted of submergent aquatic species.

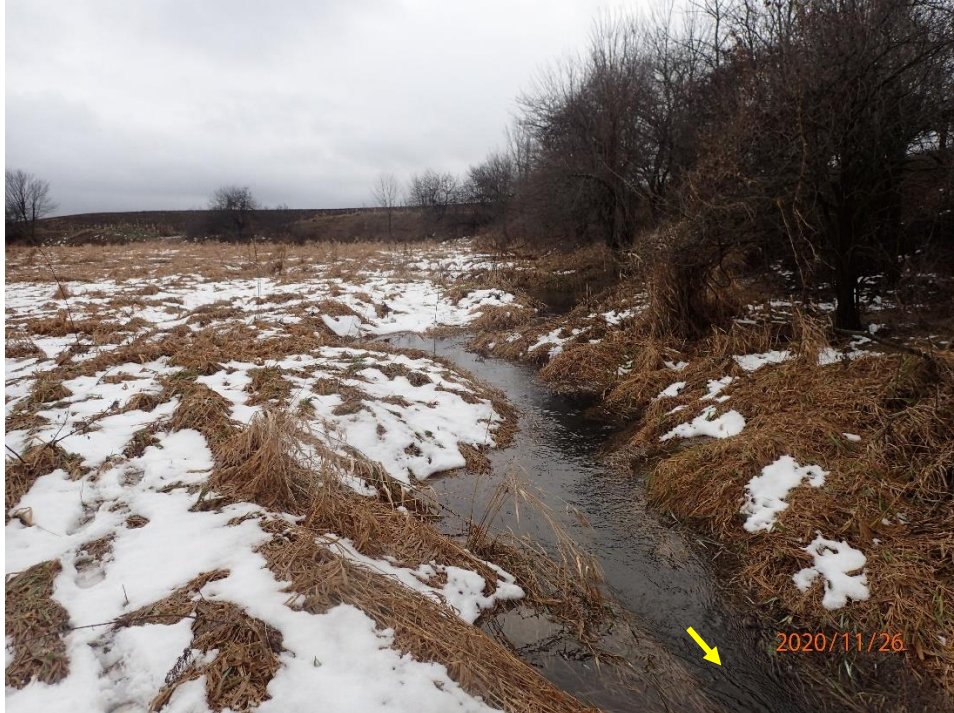
Photo 10
Reach 6 – West Humber River

Photograph taken looking upstream. Given the watercourse was confined within the subject property, a toe erosion allowance was determined to delineate the erosion hazard limit. Additionally, a 30 m setback was recommended to account for Redside Dace habitat.

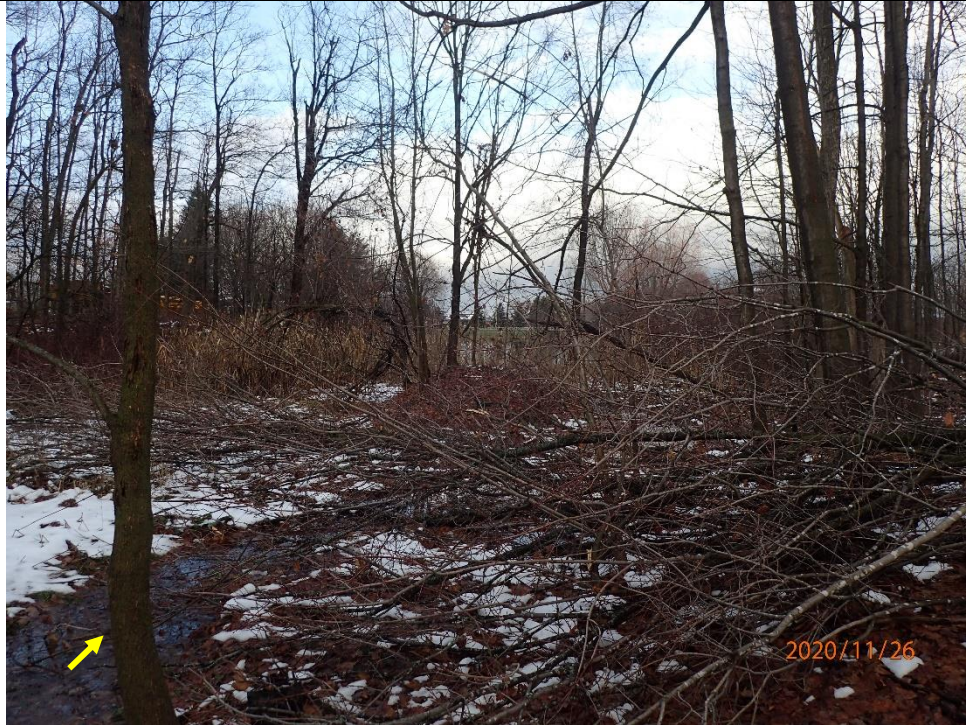
Photo 11
Reach 10 – Tributary of West Humber River

Photograph taken looking towards the furthest downstream extent of the reach. The watercourse was within a partially confined valley and traversed through a woodlot.

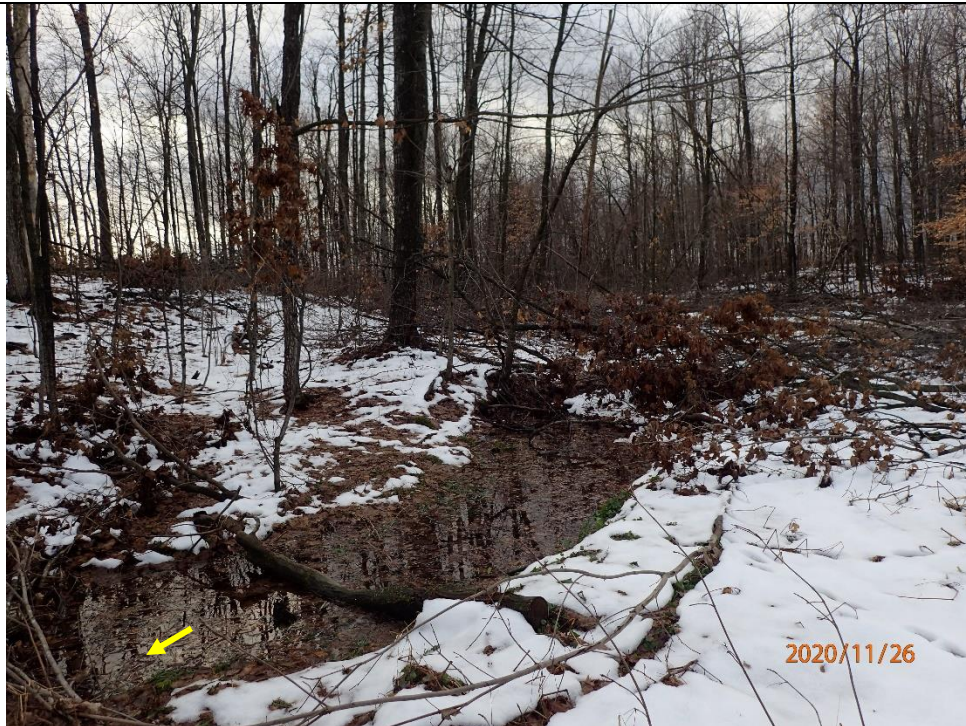
Photo 12
Reach 10 – Tributary of West Humber River

Photograph taken looking upstream. Leaning and fallen trees, exposed tree roots, and occurrences of large organic debris were observed through the reach. This indicated evidence of widening.

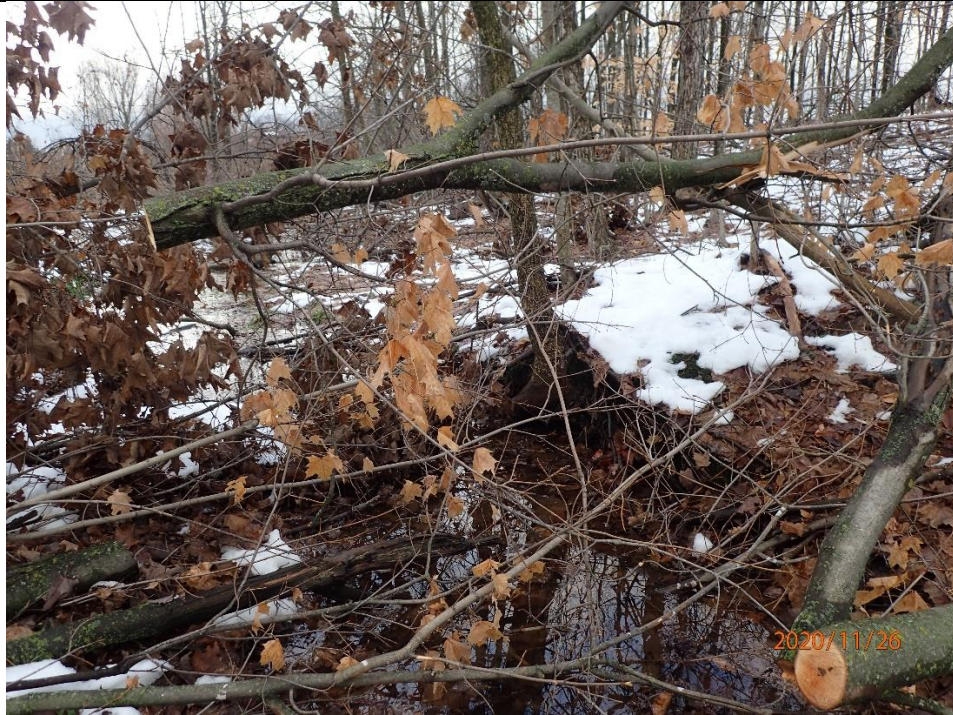
Photo 13
Reach 10 – Tributary of West Humber River

A high density of woody debris was observed within the channel and cutbank, with approximately 1 woody debris jam every 50 m.

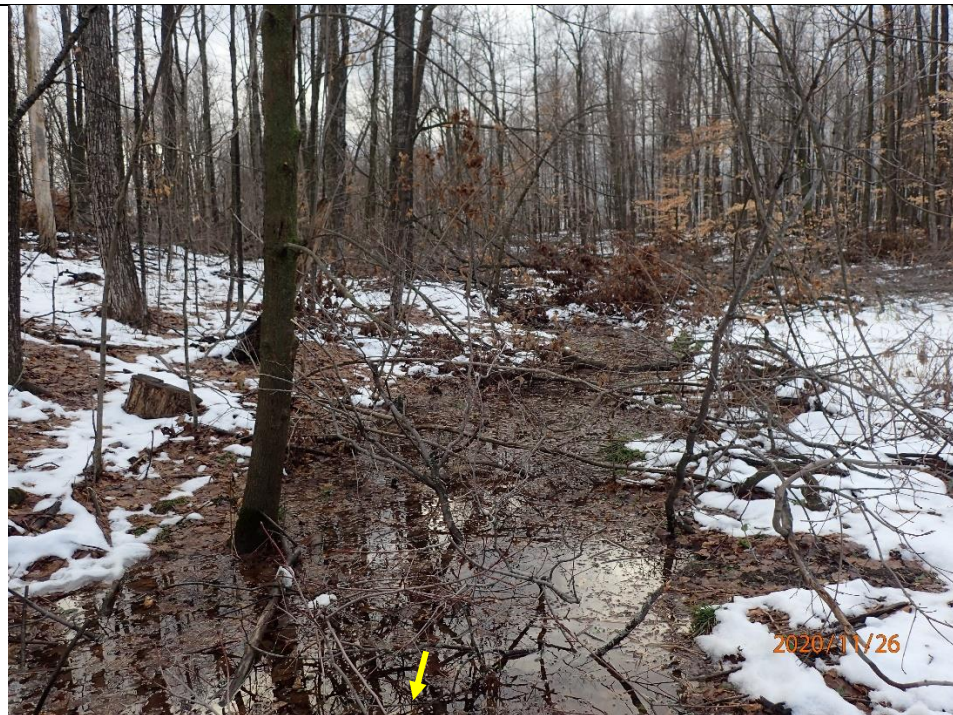
Photo 14
Reach 10 – Tributary of West Humber River

Photograph taken facing upstream. The channel exhibited a generally straight planform with a low sinuosity which ranged from 1.06 to 1.30. The dominant riparian vegetation was characterized as established and mature tree species.

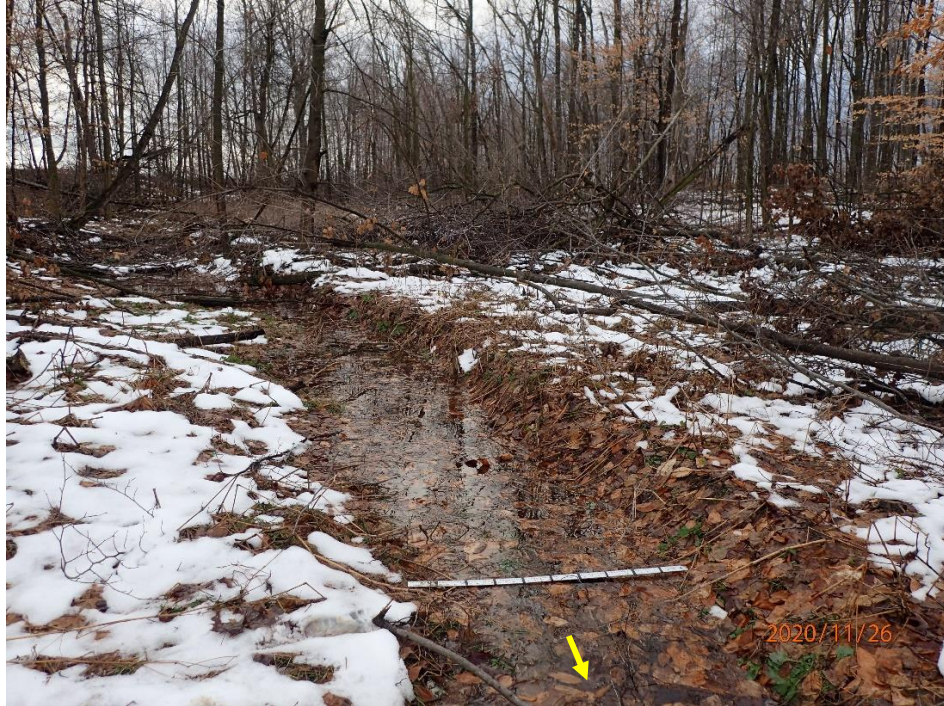
Photo 15
Reach 10 – Tributary of West Humber River

Photograph taken looking upstream. Average bankfull width and depth were approximately 2.84 m and 0.44 m, respectively. Bank angles ranged from 30° to 90° and consisted of clay/silt.

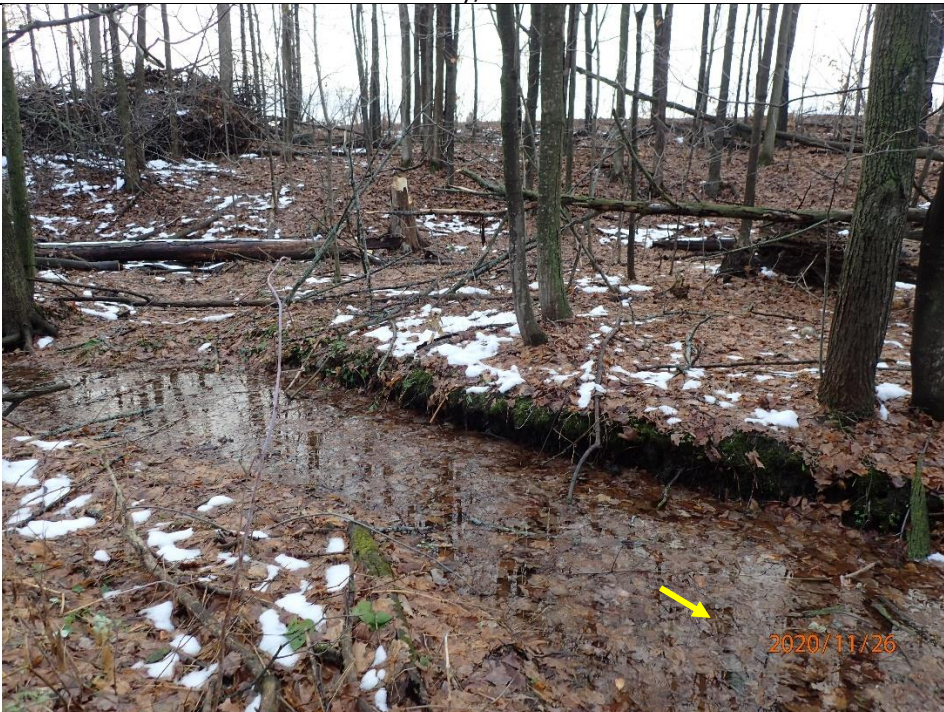
Photo 16
Reach 10 – Tributary of West Humber River

Photograph taken looking upstream. Bank erosion was observed through 30 to 60% of the channel, with undercuts measuring approximately 0.08 m in depth. Basal scour was also observed through over 50% of the reach.

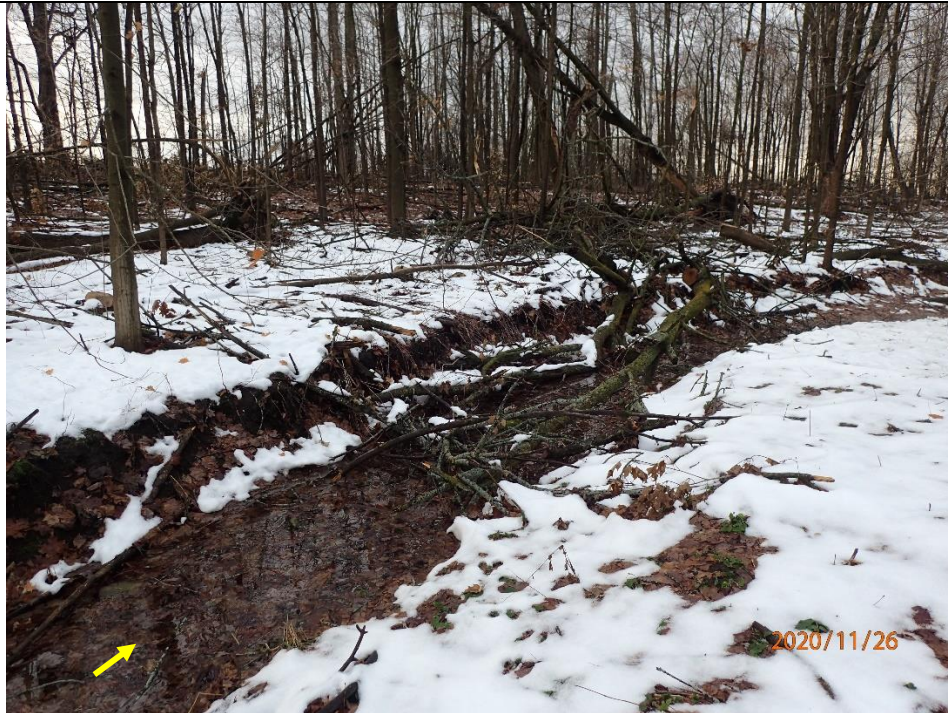
Photo 17
Reach 10 – Tributary of West Humber River

Photograph taken facing downstream. Approximately 50 to 70% of the bank network was considered stable, with recent signs of bank sloughing, slumping, and failure quite common. Further, stream bend areas were considered unstable.

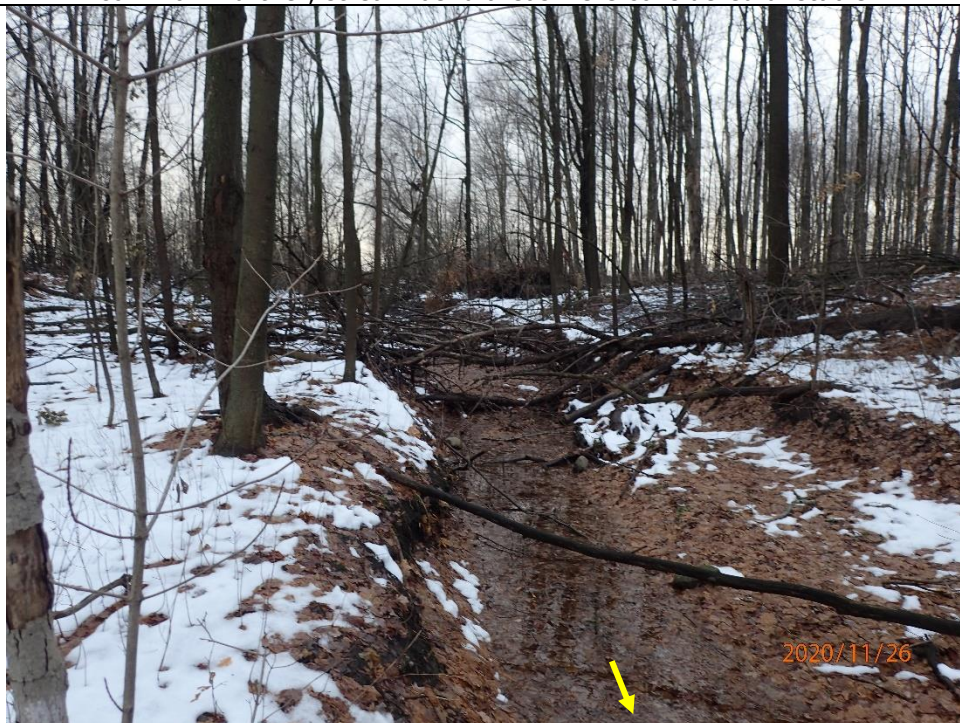
Photo 18
Reach 10 – Tributary of West Humber River

Photograph taken facing upstream. The reach was dominated by one habitat type (runs) with no riffles and few large pools. There was also limited diversity in channel depth and velocity.

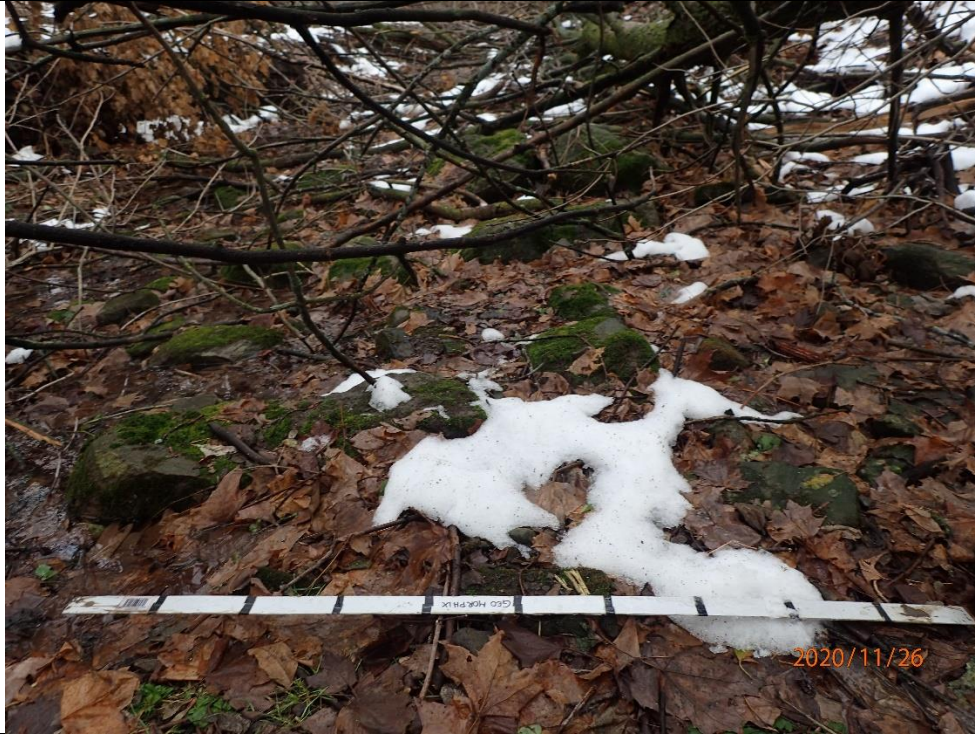
Photo 19
Reach 10 – Tributary of West Humber River

Bed and bank materials were characterized by clay/silt. Large cobbles were also observed in some locations immediately downstream from woody debris jams.

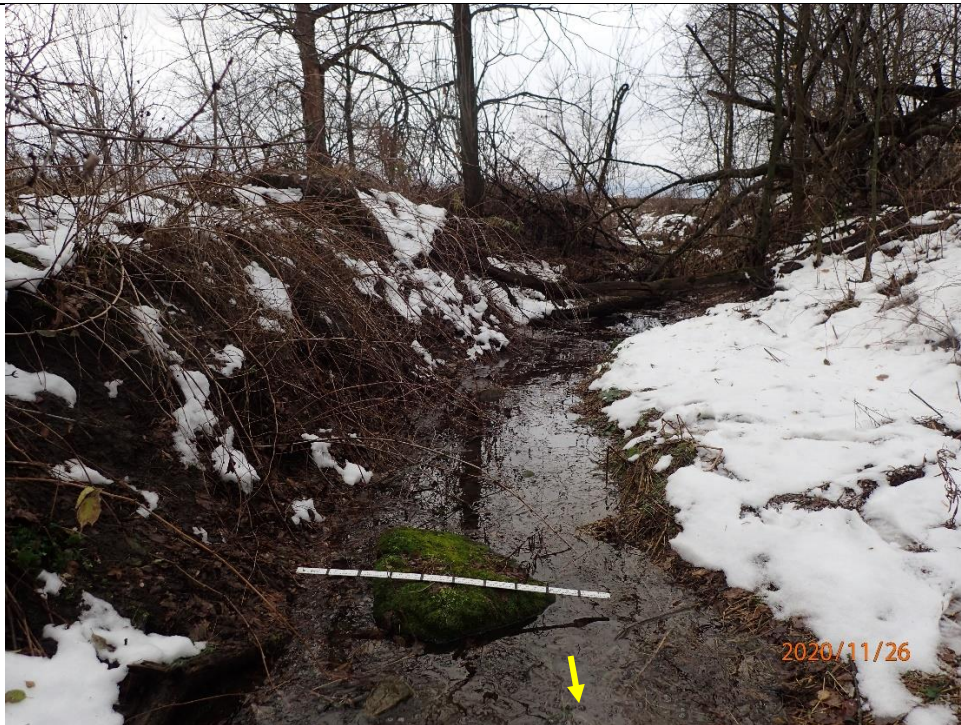
Photo 20
Reach 10 – Tributary of West Humber River

Moving upstream, the system became more confined with bank heights approaching 2 m. Leaning and fallen trees contributing to woody debris jams, as well as exposed tree roots, were indicative of channel widening.

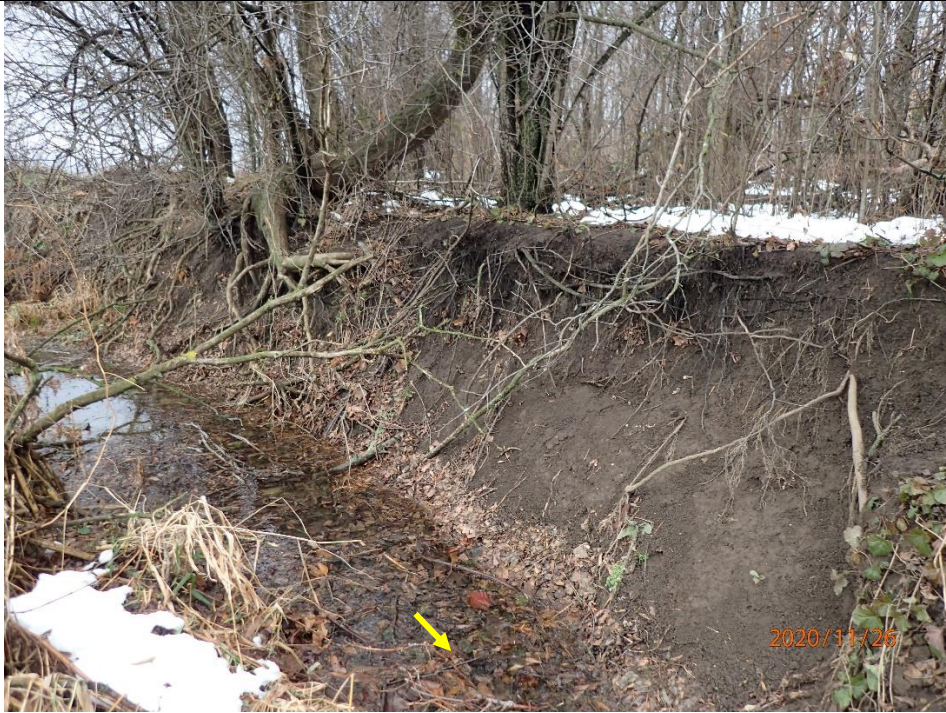
Photo 21
Reach 10 – Tributary of West Humber River

Photograph looking towards left bank (facing downstream). Valley wall contact was observed in this location, in addition to erosion scarring and exposed tree roots.

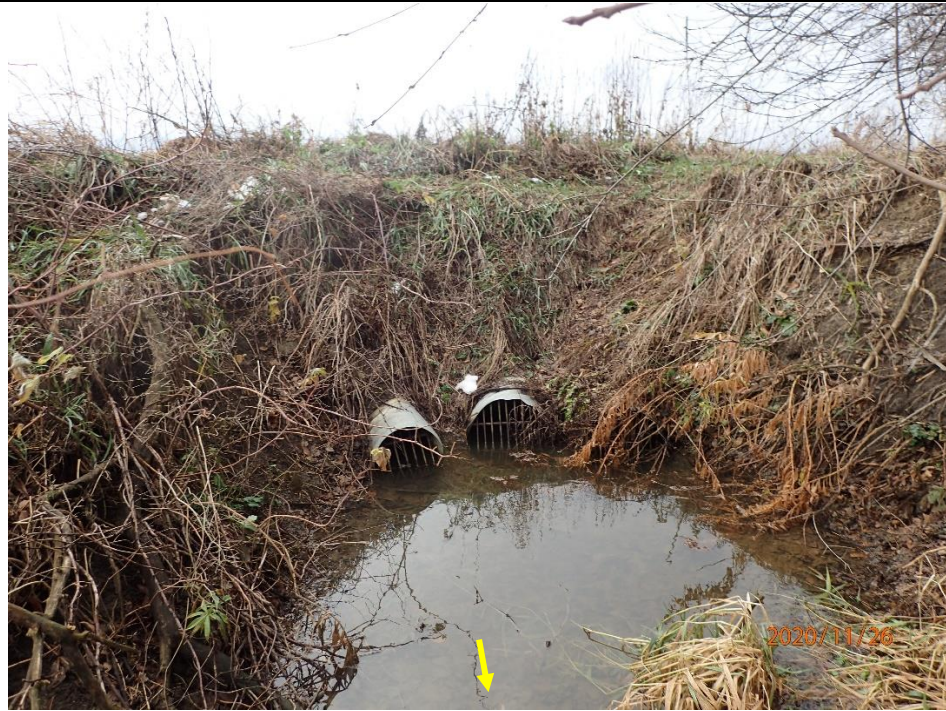
Photo 22
Reach 10 – Tributary of West Humber River

At the furthest upstream extent of the reach, tile drains were observed conveying flows beneath the agricultural field and into the watercourse. An enlarged scour pool was present immediately downstream from the tile drain outlets.

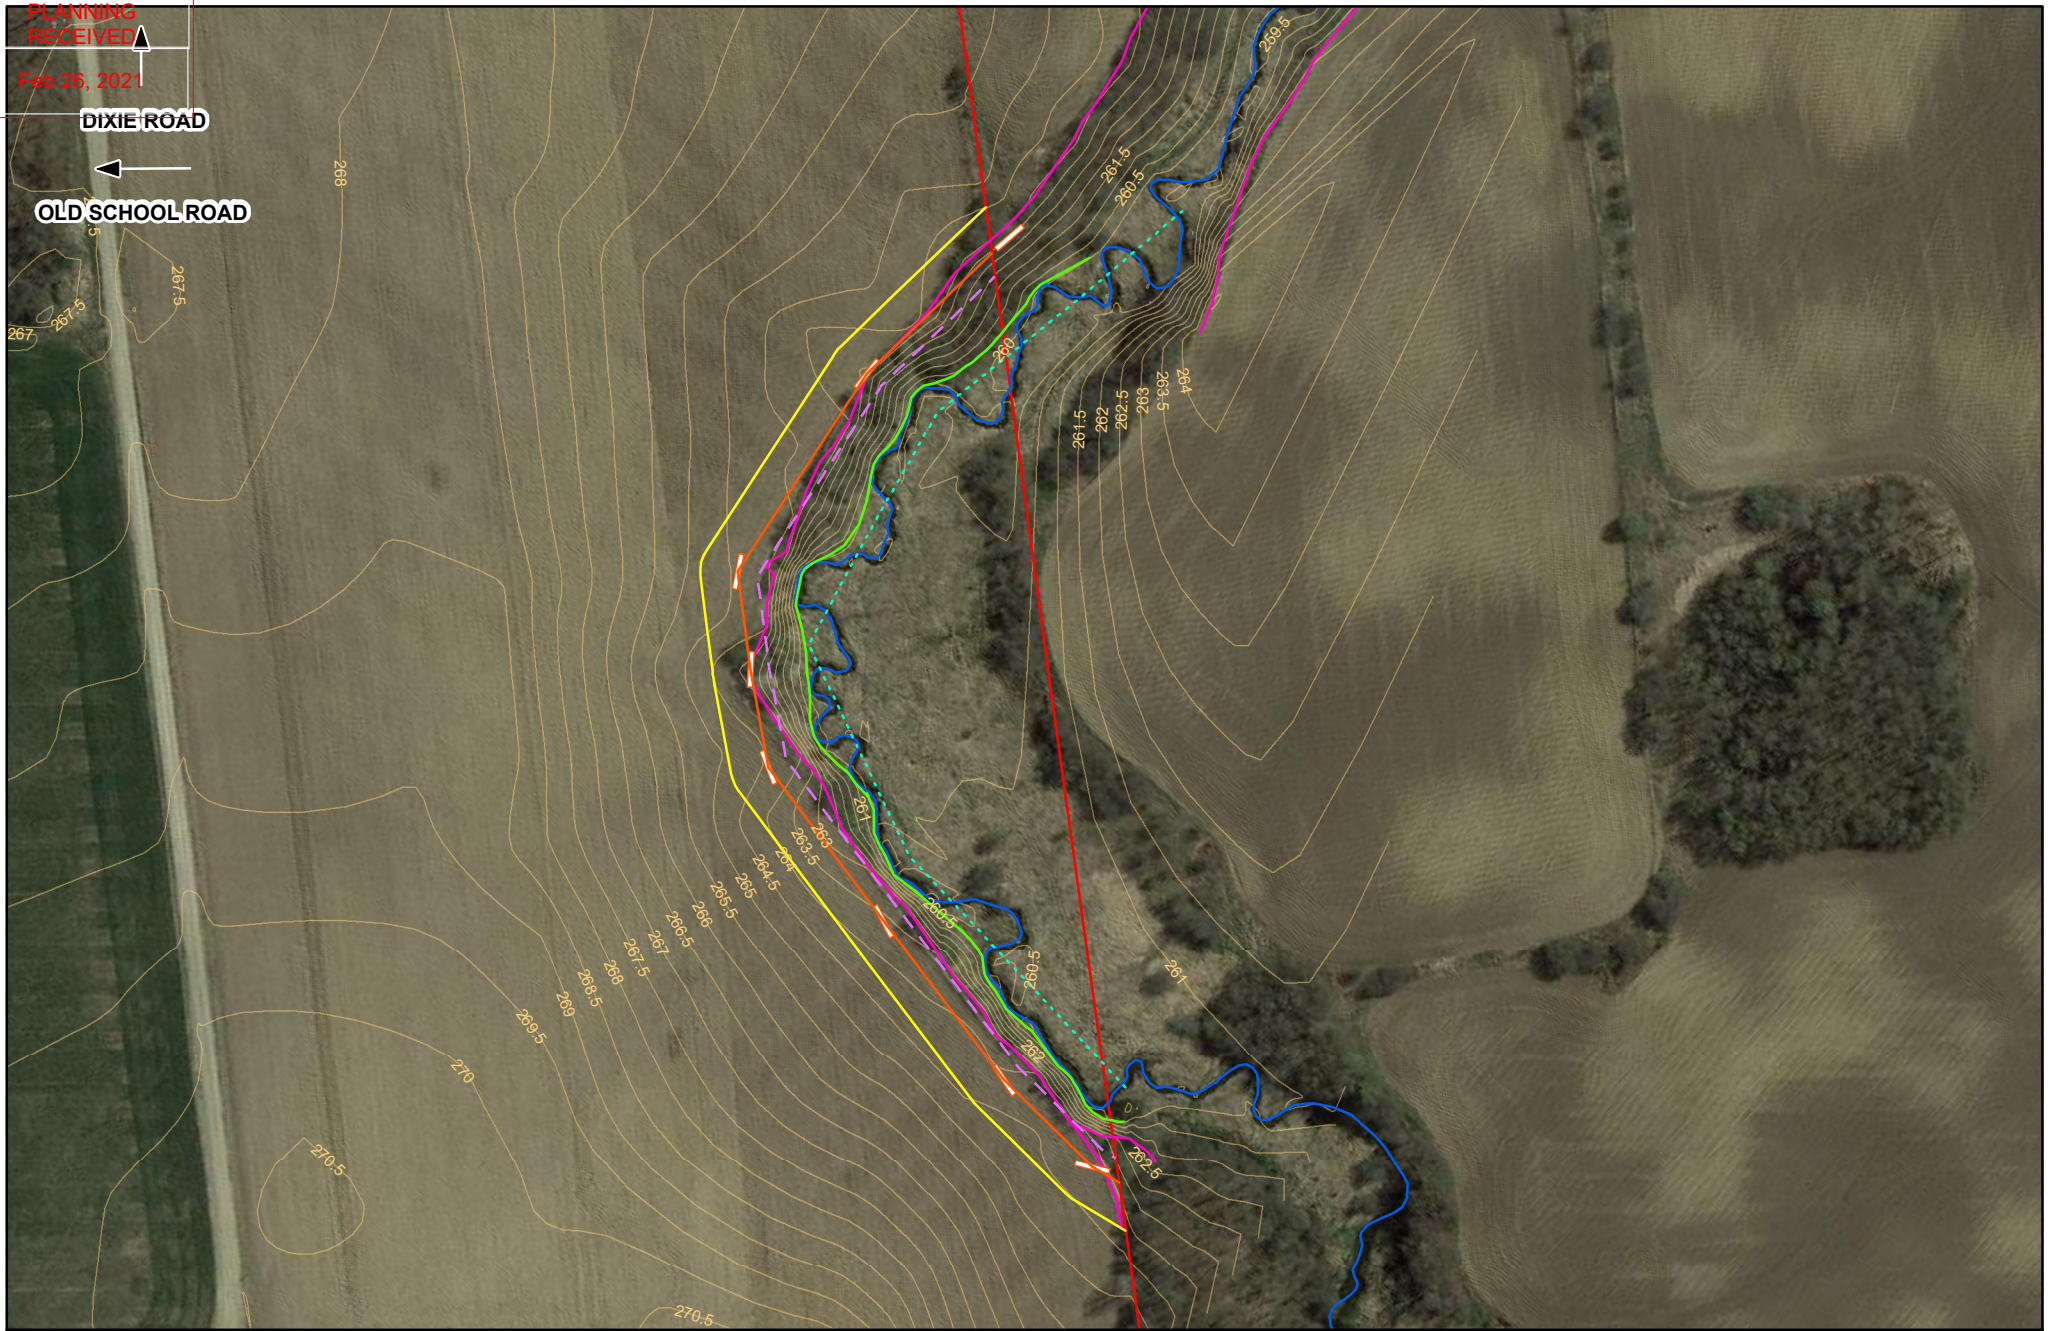
12892 Dixie Road
 Preliminary Erosion Setback
 Caledon, Ontario

Given the scale of the channel and limited migration, erosion rates could not be measured from historical aerial photographs. Since **Reach 6** was within 15 m of the toe of slope (based on the topographic break in slope) through the subject property, a toe erosion allowance was determined to address the erosion hazard. Based on the type of bed and bank material (i.e., clay/silt, tills) and evidence of active erosion, a 5 m toe erosion was deemed appropriate using MNRF (2002) guidelines.

It is important to note that the total erosion hazard for confined valley systems is based on a combined influence of the toe erosion allowance and the stable slope. For confined systems, a stable slope is identified as 3:1 (H:V) or as determined by a study using accepted geotechnical principles (MNRF, 2002). A geotechnical investigation and slope stability analysis was completed for **Reach 6** by MTE Consultants (2021) to identify the stable top of slope. The geotechnical study confirmed that the slope is relatively stable under current conditions. The stable top of slope documented by MTE (2021) includes the 5 m toe erosion allowance, and as such, adequately characterizes the erosion hazard associated with **Reach 6**. The erosion setback delineation is provided in **Appendix E**.

Reach 6 was identified as a confined system with several observations of valley wall contact. As such, the MNR (2002) approach for confined systems was implemented for delineating the erosion hazard. Given that **Reach 6** was within 15 m from the toe of slope within the subject property, a toe erosion allowance was determined. Based on the type of bed and bank material (i.e., clay/silt, tills) and evidence of active erosion, a 5 m toe erosion was deemed appropriate. The 5 m toe erosion allowance was also applied to the stable top of slope (MTE, 2021) to delineate the total erosion hazard.
