**Tree Inventory and Preservation Plan Report
13286 Nunnville Road
Bolton, Ontario**

09 December 2025

KUNTZ FORESTRY CONSULTING Inc. Project P4871

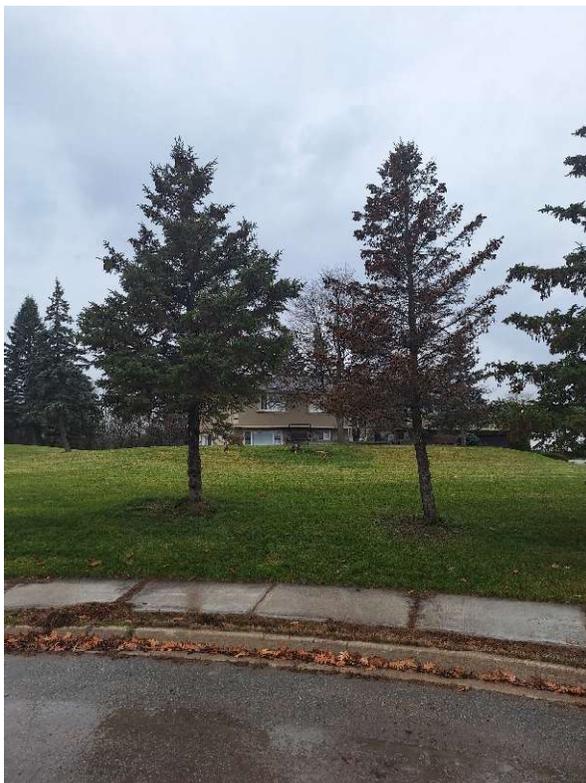
Image 3. Trees 525 and 526 (right to left)

The removal of 40 trees is proposed to accommodate the proposed site plan. The overall health condition of Tree 525 is poor and not applicable to compensation requirements. As such, a total of 63 replacement plantings is required on the subject property. Refer to Landscape Plan for the planting plan.

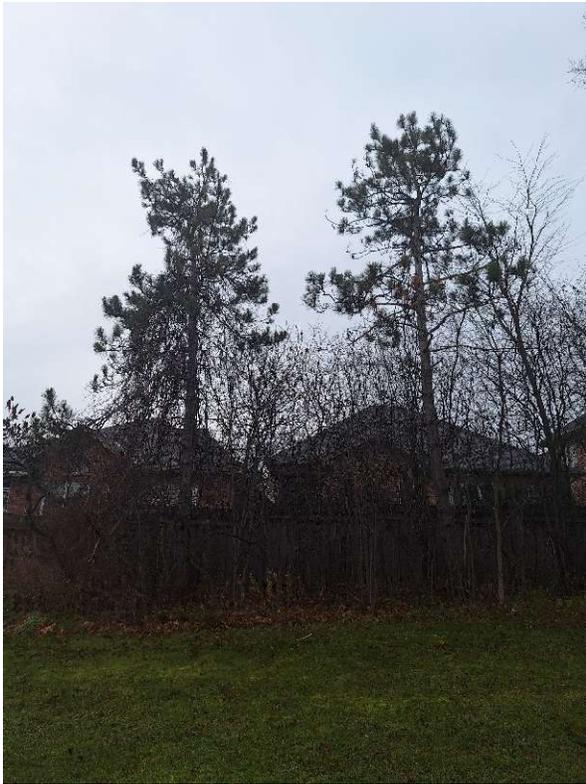
Image 9. Trees 530, 531 (left to right)

530	Red Pine	<i>Pinus resinosa</i>	27.5	F-G	F	F	4.0		Vine competition (H), Deadwood (M), Recommend remove vines	Remove	Private	2
531	Red Pine	<i>Pinus resinosa</i>	25.5	F-G	F-G	F-G	4.0		Lean (L), Sweep (L), Deadwood (L)	Remove	Private	2
532	White Elm	<i>Ulmus americana</i>	14.5	F-G	F-G	F-G	4.0		Crooked stem (L), Lean (L)	Remove	Private	1
533	White Elm	<i>Ulmus americana</i>	9, 10.5	F-G	F-G	F-G	4.0		Co-dominant at base, Crooked stems (L)	Remove	Private	1
534	White Elm	<i>Ulmus americana</i>	45.0	G	G	G	9.0		Co-dominant at approximately 5.0m, Deadwood (L)	Remove	Private	3
535	White Elm	<i>Ulmus americana</i>	32.0	F-G	F-G	F-G	5.0		Co-dominant at approximately 4.5m, Deadwood (L)	Remove	Private	2
536	White Elm	<i>Ulmus americana</i>	21.5	F-G	F	F-G	5.0		Bow (L), Asymmetric crown (M)	Remove	Private	2
537	Apple Species	<i>Malus spp.</i>	~17	F-G	F-G	F-G	4.0		Lean (M), Sweep (M), Deadwood (L), Vine competition (M)	Remove	Private	1

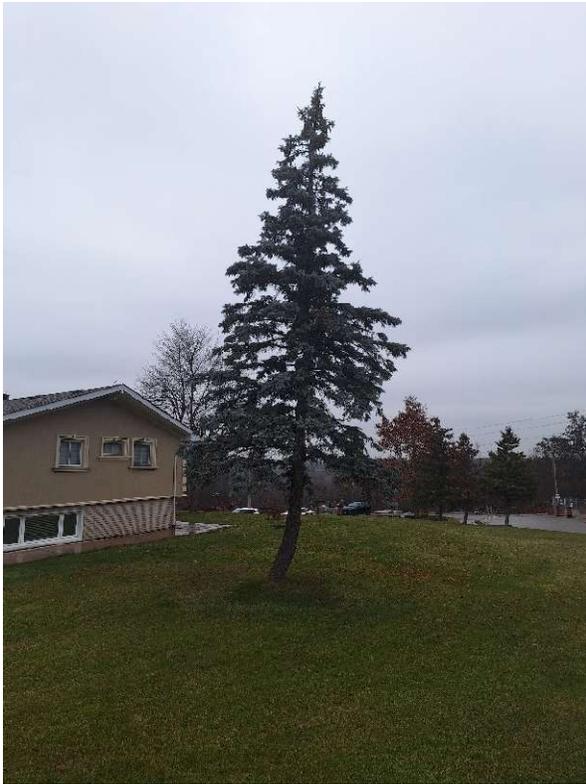
Image 13. Tree 538

538	Blue Spruce	<i>Picea pungens</i>	32.0	F-G	F-G	F-G	2.5	10	Lean (M), Sweep (M), Deadwood (L)	Remove	Private	2
539	Blue Spruce	<i>Picea pungens</i>	49.0	F-G	F-G	F-G	4.0		Lean (L), Sweep (VL), Deadwood (L)	Remove	Private	3
540	Blue Spruce	<i>Picea pungens</i>	44.0	F-G	F	F-G	4.0		Lean (L), Lost leader	Remove	Private	3

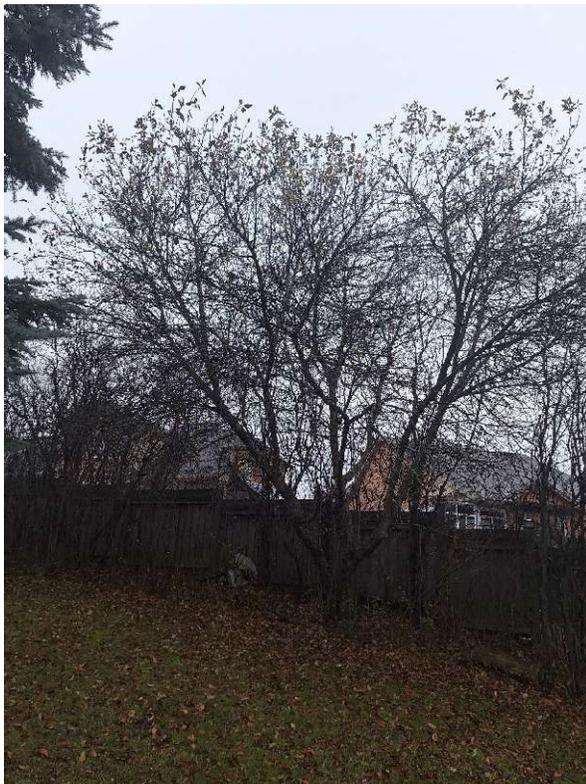
Image 15. Tree 541

541	Apple Species	<i>Malus spp.</i>	21, 21, 21	F	F	F-G	6.0		Co-dominant at ground, Lean (M), Crooked stems (H), Bow (M), Deadwood (L)	Remove	Private	3
542	Red Maple	<i>Acer rubrum</i>	24.0	F-G	F-G	F-G	5.0		Stem wounds (L), Pruning wounds (L), Crooked stems (L)	Remove	Private	2
543	Sugar Maple	<i>Acer saccharum</i>	23.5	F-G	G	G	4.0		Stem wound at base	Retain	Private	
544	Black Walnut	<i>Juglans nigra</i>	20.5	G	G	G	5.0		Co-dominant at approximately 3.0m	Remove	Private	2
545	Sugar Maple	<i>Acer saccharum</i>	9, 10	F-G	G	G	3.0		Co-dominant at approximately 0.6m	Remove	Private	1
546	Blue Spruce	<i>Picea pungens</i>	44.0	G	G	F-G	4.0		Deadwood (L)	Remove	Private	3
547	Blue Spruce	<i>Picea pungens</i>	39.0	F-G	F-G	F-G	4.5	10	Lean (L), Deadwood (L)	Remove	Private	3
548	Norway Maple	<i>Acer platanoides</i>	23.0	F-G	P-F	F-G	3.0		Girdling root (L), Pollarded	Remove	Private	2
549	Blue Spruce	<i>Picea pungens</i>	18.0	G	G	G	2.5		Pruning wounds (L)	Remove	Private	1

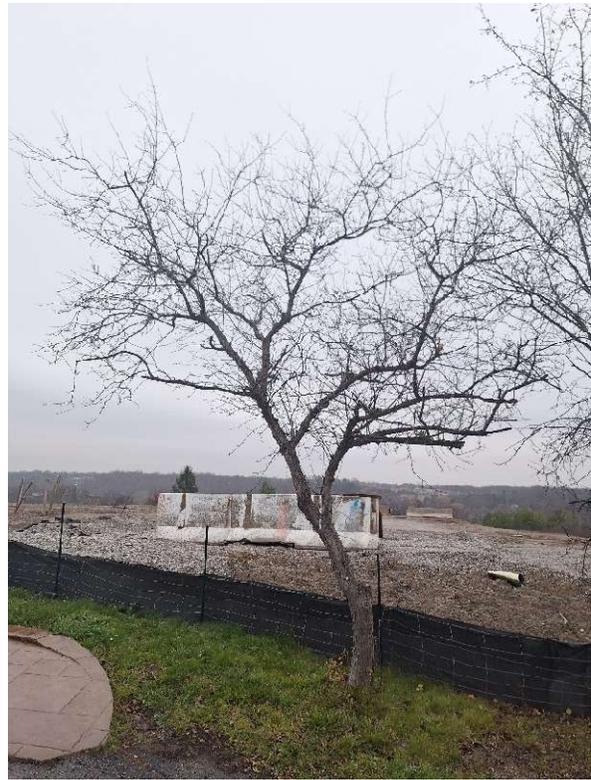
Image 24. Tree 550

550	Crabapple	<i>Malus spp.</i>	14.5	F	F	F-G	3.0		Pruning wounds (M), Crooked stem (H), Epicormic branching (H), Deadwood (L)	Remove	Private	1
551	Crabapple	<i>Malus spp.</i>	25.0	F-G	F-G	F-G	5.0		Co-dominant at approximately 1.5m, Epicormic branching (H), Pruning wounds (M), Deadwood (L)	Remove	Private	2
552	Japanese Maple	<i>Acer palmatum</i>	12.5	F	F-G	F-G	4.5		Crooked stem (H), Pruning wounds (L), Co-dominant at approximately 1.8m, Lean (M)	Remove	Private	1
553	Blue Spruce	<i>Picea pungens</i>	24.0	F-G	G	G	2.5		Pruning wounds (L), Crooked stem (L)	Remove	Private	2
554	Norway Maple	<i>Acer platanoides</i>	36.0	F-G	F-G	F-G	6.0		Pruning wounds (L), Co-dominant at approximately 2.5m, Deadwood (L), Growth deficit (L), Broken branches (L)	Remove	Private	3
A	Callery Pear	<i>Pyrus calleryana</i>	18.5	G	G	G	2.5		Co-dominant at approximately 1.5m	Retain	Municipality	
B	Red Oak	<i>Quercus rubra</i>	~12	F-G	G	G	3.0		Lean (L)	Retain	Neighbour
