Tree Inventory and Preservation Plan Report 13290 Nunnville Road Caledon, Ontario

6 April 2022

KUNTZ FORESTRY CONSULTING Inc. Project P3110

# Appendix A. Photographs of Trees and Property

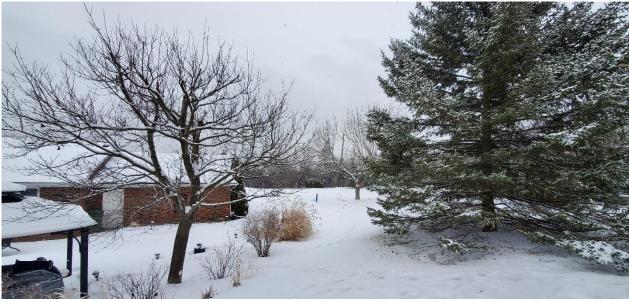
Image 14. Trees 454-455

The removal of 26 trees on the subject property is proposed to accommodate the proposed site plan. Trees 455 and 457 are in poor condition and not applicable to compensation requirements. As such, a total of 39 replacement plantings is required on the subject property. Refer to Landscape Plan for the planting plan.

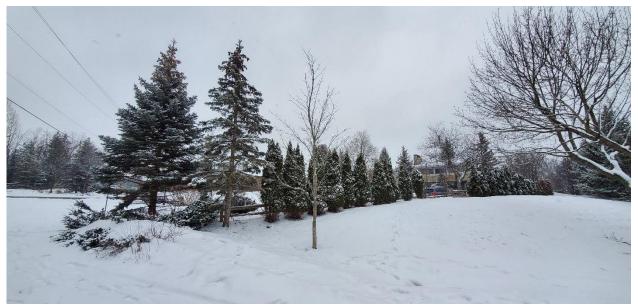
Image 17. Trees 458-459 and B

Encroachment into the dripline of Trees B and C, a Blue Spruce with 18cm DBH and a Red Oak with approximately 30cm DBH, respectively, is required to accommodate the proposed walkway. Excavation for the proposed walkway is required at 1.2m and 2.3m from the base of Trees B and

C, respectively. Excavation for the proposed walkway within the dripline of Trees B and C must be completed by a low-pressure hydro vac or air spade excavation methods and supervised by a Certified Arborist. Once excavation is completed, exposed roots must be pruned by a Certified Arborist in accordance with Good Arboricultural Standards.
