# ARBORIST REPORT

Location: 13291 Airport Road, Caledon

Project: Truck Trailer Parking

Project No: GPI037

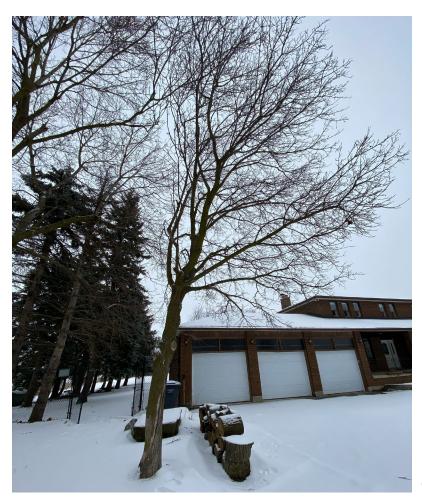
Tree with Tag # 16

ZONE 1 ALONG THE ENTRY ROAD								
TAG#	SPECIES	DBH	Canopy	TPZ	COND.	OWN.	Remarks	Recommendation	compensation
16	Acer platanoides (Norway Maple)	29	7	1.8	Fair	1	A vertical scar on the lower trunk. In conflict with the proposed development	Remove	2
17	Acer platanoides (Norway Maple)	49	12	3.0	Good	1	In conflict with proposed construction	Remove	3
18	Acer platanoides (Norway Maple)	34	8	2.4	Good	1		Preserve	
19	Acer platanoides (Norway Maple)	58	15	3.6	Poor	1	Truck injured.	Preserve	
20	Picea pungens (Colorado Spruce)	35	8	2.4	Poor	1	manyyellowing needles.	Preserve	
21	Picea pungens (Colorado Spruce)	28	7	1.8	Good	1		Preserve	
22	Picea pungens (Colorado Spruce)	29	7	1.8	Fair	1		Preserve	
23	Picea pungens (Colorado Spruce)	19	5	1.8	Good	1		Preserve	
24	Picea pungens (Colorado Spruce)	30	9	2.4	Poor	1	many yellowing needles.	Preserve	
25	Picea pungens (Colorado Spruce)	45	12	3.0	Good	1		Preserve	
26	Picea pungens (Colorado Spruce)	35	9	2.4	Fair	1	yellowing needles	Preserve

- Norway Maple (Tag #16, 17, 403, 404, 416-417)
- Colorado Spruce (Tag # 101-115, 176, 432-433)
- Willow (Tag #175, 409, 410)
- Linden (Tag #405, 408)
- Austrian Pine (Tag #198-200, 406-407)
- Red Maple (Tag #415, 418)
- Manitoba Maple (Tag #163)

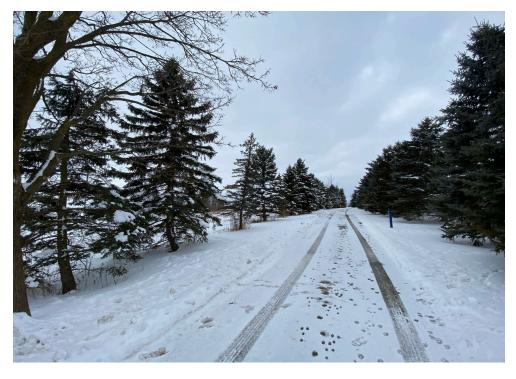
Tree with Tag # From 101 to 107

42	Salix sp. (Willow species)	140	18	8.4	Good	1		Preserve	
43	Picea pungens (Colorado Spruce)	15	3	1.8	Good	1		Preserve	
44	Picea pungens (Colorado Spruce)	20	3	1.8	Poor	1		Preserve	
45	Picea pungens (Colorado Spruce)	31	6	2.4	Fair	1	yellowing needles	Preserve	
46	Picea pungens (Colorado Spruce)	21	4	1.8	Fair	1	yellowing needles	Preserve	
47	Picea pungens (Colorado Spruce)	31	6	2.4	Fair	1	yellowing needles	Preserve	
48	Picea pungens (Colorado Spruce)	35	7	2.4	Good	1	Jonething Hoodings	Preserve	
49	Picea pungens (Colorado Spruce)	35	7	2.4	Good	1		Preserve	
50	Picea pungens (Colorado Spruce)	38	8	2.4	Good	1		Preserve	
297	Picea pungens (Colorado Spruce)	30	6	2.4	Fair	1	yellowing needles	Preserve	
52	Picea pungens (Colorado Spruce)	36	7	2.4	Good	1	yenowing needles	Preserve	
300	Picea pungens (Colorado Spruce)	25	4	1.8	Fair	1	yellowing needles	Preserve	
101	Picea pungens (Colorado Spruce)	18	3	1.8	Good	1	In conflict with proposed construction	Remove	1

102	Picea pungens (Colorado Spruce)	25	5	1.8	Good	1	In conflict with proposed construction	Remove	2
103	Picea pungens (Colorado Spruce)	13	2	1.8	Fair	1	yellowing needles. In conflict with proposed construction	Remove	1
104	Picea pungens (Colorado Spruce)	24	4	1.8	Fair	1	yellowing needles. In conflict with proposed construction	Remove	2
105	Picea pungens (Colorado Spruce)	14	2	1.8	Fair	1	yellowing needles. In conflict with proposed construction	Remove	1
106	Picea pungens (Colorado Spruce)	19/20	4	1.8	Fair	1	yellowing needles. In conflict with proposed construction	Remove	1

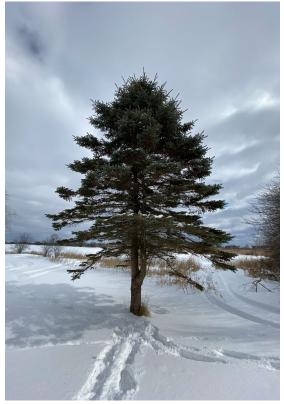
Tree with Tag #176

Picea pungens (Colorado Spruce)   38   8   2.4   Good   1   Preserve	176	Picea pungens (Colorado Spruce)	20	3	1.8	Fair	1	In conflict with proposed construction	Remove	1
179   Picea pungens (Colorado Spruce)   39   9   2.4   Fair   1   Preserve	177	Picea pungens (Colorado Spruce)	25	4	1.8	Fair	1		Preserve	
180   Picea pungens (Colorado Spruce)   11   2   1.8   Fair   1   Preserve	178	Picea pungens (Colorado Spruce)	38	8	2.4	Good	1		Preserve	
180   Picea pungens (Colorado Spruce)   11   2   1.8   Fair   1   Preserve	179	Picea pungens (Colorado Spruce)	39	9	2.4	Fair	1		Preserve	
181   Picea pungens (Colorado Spruce)   22   4   1.8   Fair   1   Preserve	180	, , ,			1.8		1			
182   Acer platanoides(Norway Maple)   19   5   1.8   Good   1   Preserve     183   Acer platanoides(Norway Maple)   28   4   1.8   Good   1   Preserve     184   Picea pungens (Colorado Spruce)   20   2   1.8   Poor   1   Preserve with injury.   Preserve     185   Salix sp. (Willow species)   60   10   3.6   Fair   1   Preserve with injury.   Preserve     186   Salix sp. (Willow species)   55   9   3.6   Fair   1   Preserve with injury.   Preserve     187   Tilia sp. (Linden species)   36   5   2.4   Fair   1   Preserve     188   Tilia sp. (Linden species)   29   4   1.8   Fair   1   Preserve     189   Acer platanoides(Norway Maple)   21   5   1.8   Good   1   Preserve     190   Gleditista triacanthos(Horvey Locust)   40   8   2.4   Good   1   Preserve     191   Acer saccharum(Sugar Maple)   36   7   2.4   Good   1   Preserve     192   Pinus nigra(Austian Pine)   59   8   3.6   Good   1   Preserve     193   Pinus nigra(Austian Pine)   50   8   3.0   Good   1   Preserve     194   Pinus nigra(Austian Pine)   55   8   3.6   Fair   1   Preserve     195   Pinus nigra(Austian Pine)   55   8   3.6   Good   1   Preserve     196   Pinus nigra(Austian Pine)   51   7   3.6   Good   1   Preserve     197   Pinus nigra(Austian Pine)   50   7   3.0   Good   1   Preserve     198   Pinus nigra(Austian Pine)   50   8   3.6   Poor   1   In conflict with proposed construction   Remove   4     199   Pinus nigra(Austian Pine)   55   8   3.6   Fair   1   In conflict with proposed construction   Remove   4     200   Pinus nigra(Austian Pine)   37   6   2.4   Good   1   In conflict with proposed construction   Remove   4     404   Acer platanoides(Norway Maple)   22   4   1.8   Good   1   In conflict with proposed construction   Remove   4     404   Acer platanoides(Norway Maple)   22   4   1.8   Good   1   In conflict with proposed construction   Remove   4     406   Pinus nigra(Austian Pine)   30   4   2.4   Fair   1   In conflict with proposed construction   Remove   2		, , , , , , , ,	_

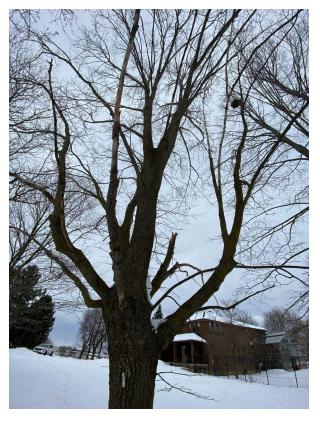
Tree with Tag #409

TAG#	SPECIES	DBH	Canopy	TPZ	COND.	OWN.	Remarks	Recommendation	compensation
408	Tilia sp. ( Linden species)	59	9	3.6	Good	1	In conflict with proposed construction	Remove	4
409	Salix sp. (Willow species)	65	10	4.2	Poor	1	Dead branches. In conflict with proposed construction	Remove	4
410	Salix sp. (Willow species)	99	15	6.0	Fair	1	In conflict with proposed construction	Remove	5
411	Salix sp. (Willow species)	92	14	6.0	Fair	1	Preserve with injury.	Preserve	
412	Pinus nigra(Austian Pine)	30	4	2.4	Good	1		Preserve	
413	Pinus nigra(Austian Pine)	30	4	2.4	Good	1		Preserve	
414	Pinus nigra(Austian Pine)	28	4	1.8	Good	1		Preserve	
415	Acer rubrum (Red Maple)	39	6	2.4	Good	1	In conflict with proposed construction	Remove	3
416	Acer platanoides(Norway Maple)	50	8	3.0	Good	1	In conflict with proposed construction	Remove	3
417	Acer platanoides(Norway Maple)	38	7	2.4	Good	1	In conflict with proposed construction	Remove	3

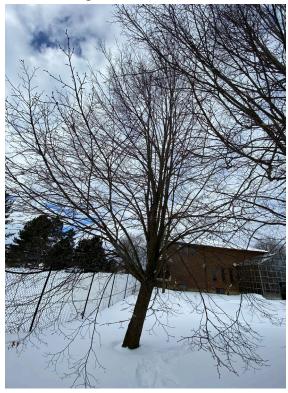
Tree with Tag #404

ZONE 3 BACKYARD  404		- , , ,						In commot with proposed construction		
404     Acer platanoides(Norway Maple)     22     4     1.8     Good     1     In conflict with proposed construction     Remove     2       405     Tilia sp. (Linden species)     53     8     3.6     Good     1     In conflict with proposed construction     Remove     4       406     Pinus nigra(Austian Pine)     30     4     2.4     Fair     1     In conflict with proposed construction     Remove     2	240	,	31	0	2.4	G000			1-1626146	
405 Tilia sp. (Linden species) 53 8 3.6 Good 1 In conflict with proposed construction Remove 4 406 Pinus nigra(Austian Pine) 30 4 2.4 Fair 1 In conflict with proposed construction Remove 2	10:							1. 6		
406 Pinus nigra(Austian Pine) 30 4 2.4 Fair 1 In conflict with proposed construction Remove 2		, , , ,								
						Good		In conflict with proposed construction	Remove	
407   Pinus nigra(Austian Pine)   18   2   1.8   Fair   1   In conflict with proposed construction   Remove   1	406	Pinus nigra(Austian Pine)	30	4	2.4	Fair	1	In conflict with proposed construction	Remove	2

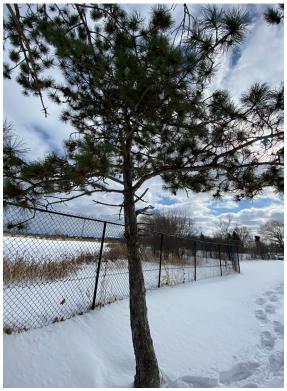
Tree with Tag #407

407	Pinus nigra(Austian Pine)	18	2	1.8	Fair	1	In conflict with proposed construction	Remove	1

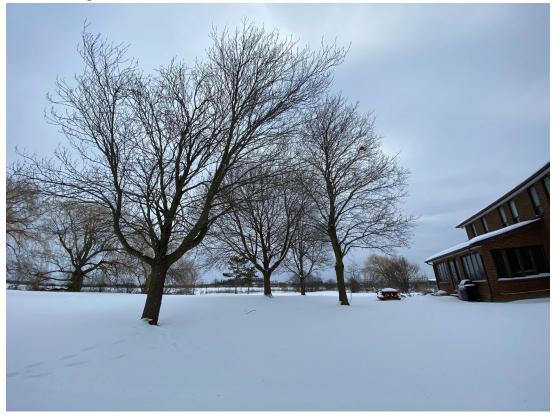
Tree with Tag # 418-417-416-415

418	Acer rubrum (Red Maple)	45	9	3.0	Good	1	In conflict with proposed construction	Remove	3
432	Picea pungens (Colorado Spruce)	48	9	3.0	Good	1	In conflict with proposed construction	Remove	3
433	Picea pungens (Colorado Spruce)	35	6	2.4	Good	1	In conflict with proposed construction	Remove	2
434	Picea pungens (Colorado Spruce)	40	8	2.4	Good	1	Preserve with injury.	Preserve	
435	Picea pungens (Colorado Spruce)	34	6	2.4	Good	1	Preserve with injury.	Preserve	
436	Picea pungens (Colorado Spruce)	41	7	3.0	Good	1		Preserve	
437	Picea pungens (Colorado Spruce)	34	6	2.4	Good	1	Preserve with injury.	Preserve	
438	Picea pungens (Colorado Spruce)	35	6	2.4	Good	1		Preserve	
439	Picea pungens (Colorado Spruce)	20	4	1.8	Good	1		Preserve	
440	Picea pungens (Colorado Spruce)	42	8	3.0	Good	1		Preserve	
441	Picea pungens (Colorado Spruce)	41	8	3.0	Good	1	Preserve with injury.	Preserve	
442	Picea pungens (Colorado Spruce)	37	6	2.4	Good	1		Preserve
