**Arborist Report and Tree Preservation Plan
Station Road**

14 Station Road, Bolton, Ontario L7E 1T8

February 11, 2026
Project 2300763

Development Application Number: DART RZ 2024-0003

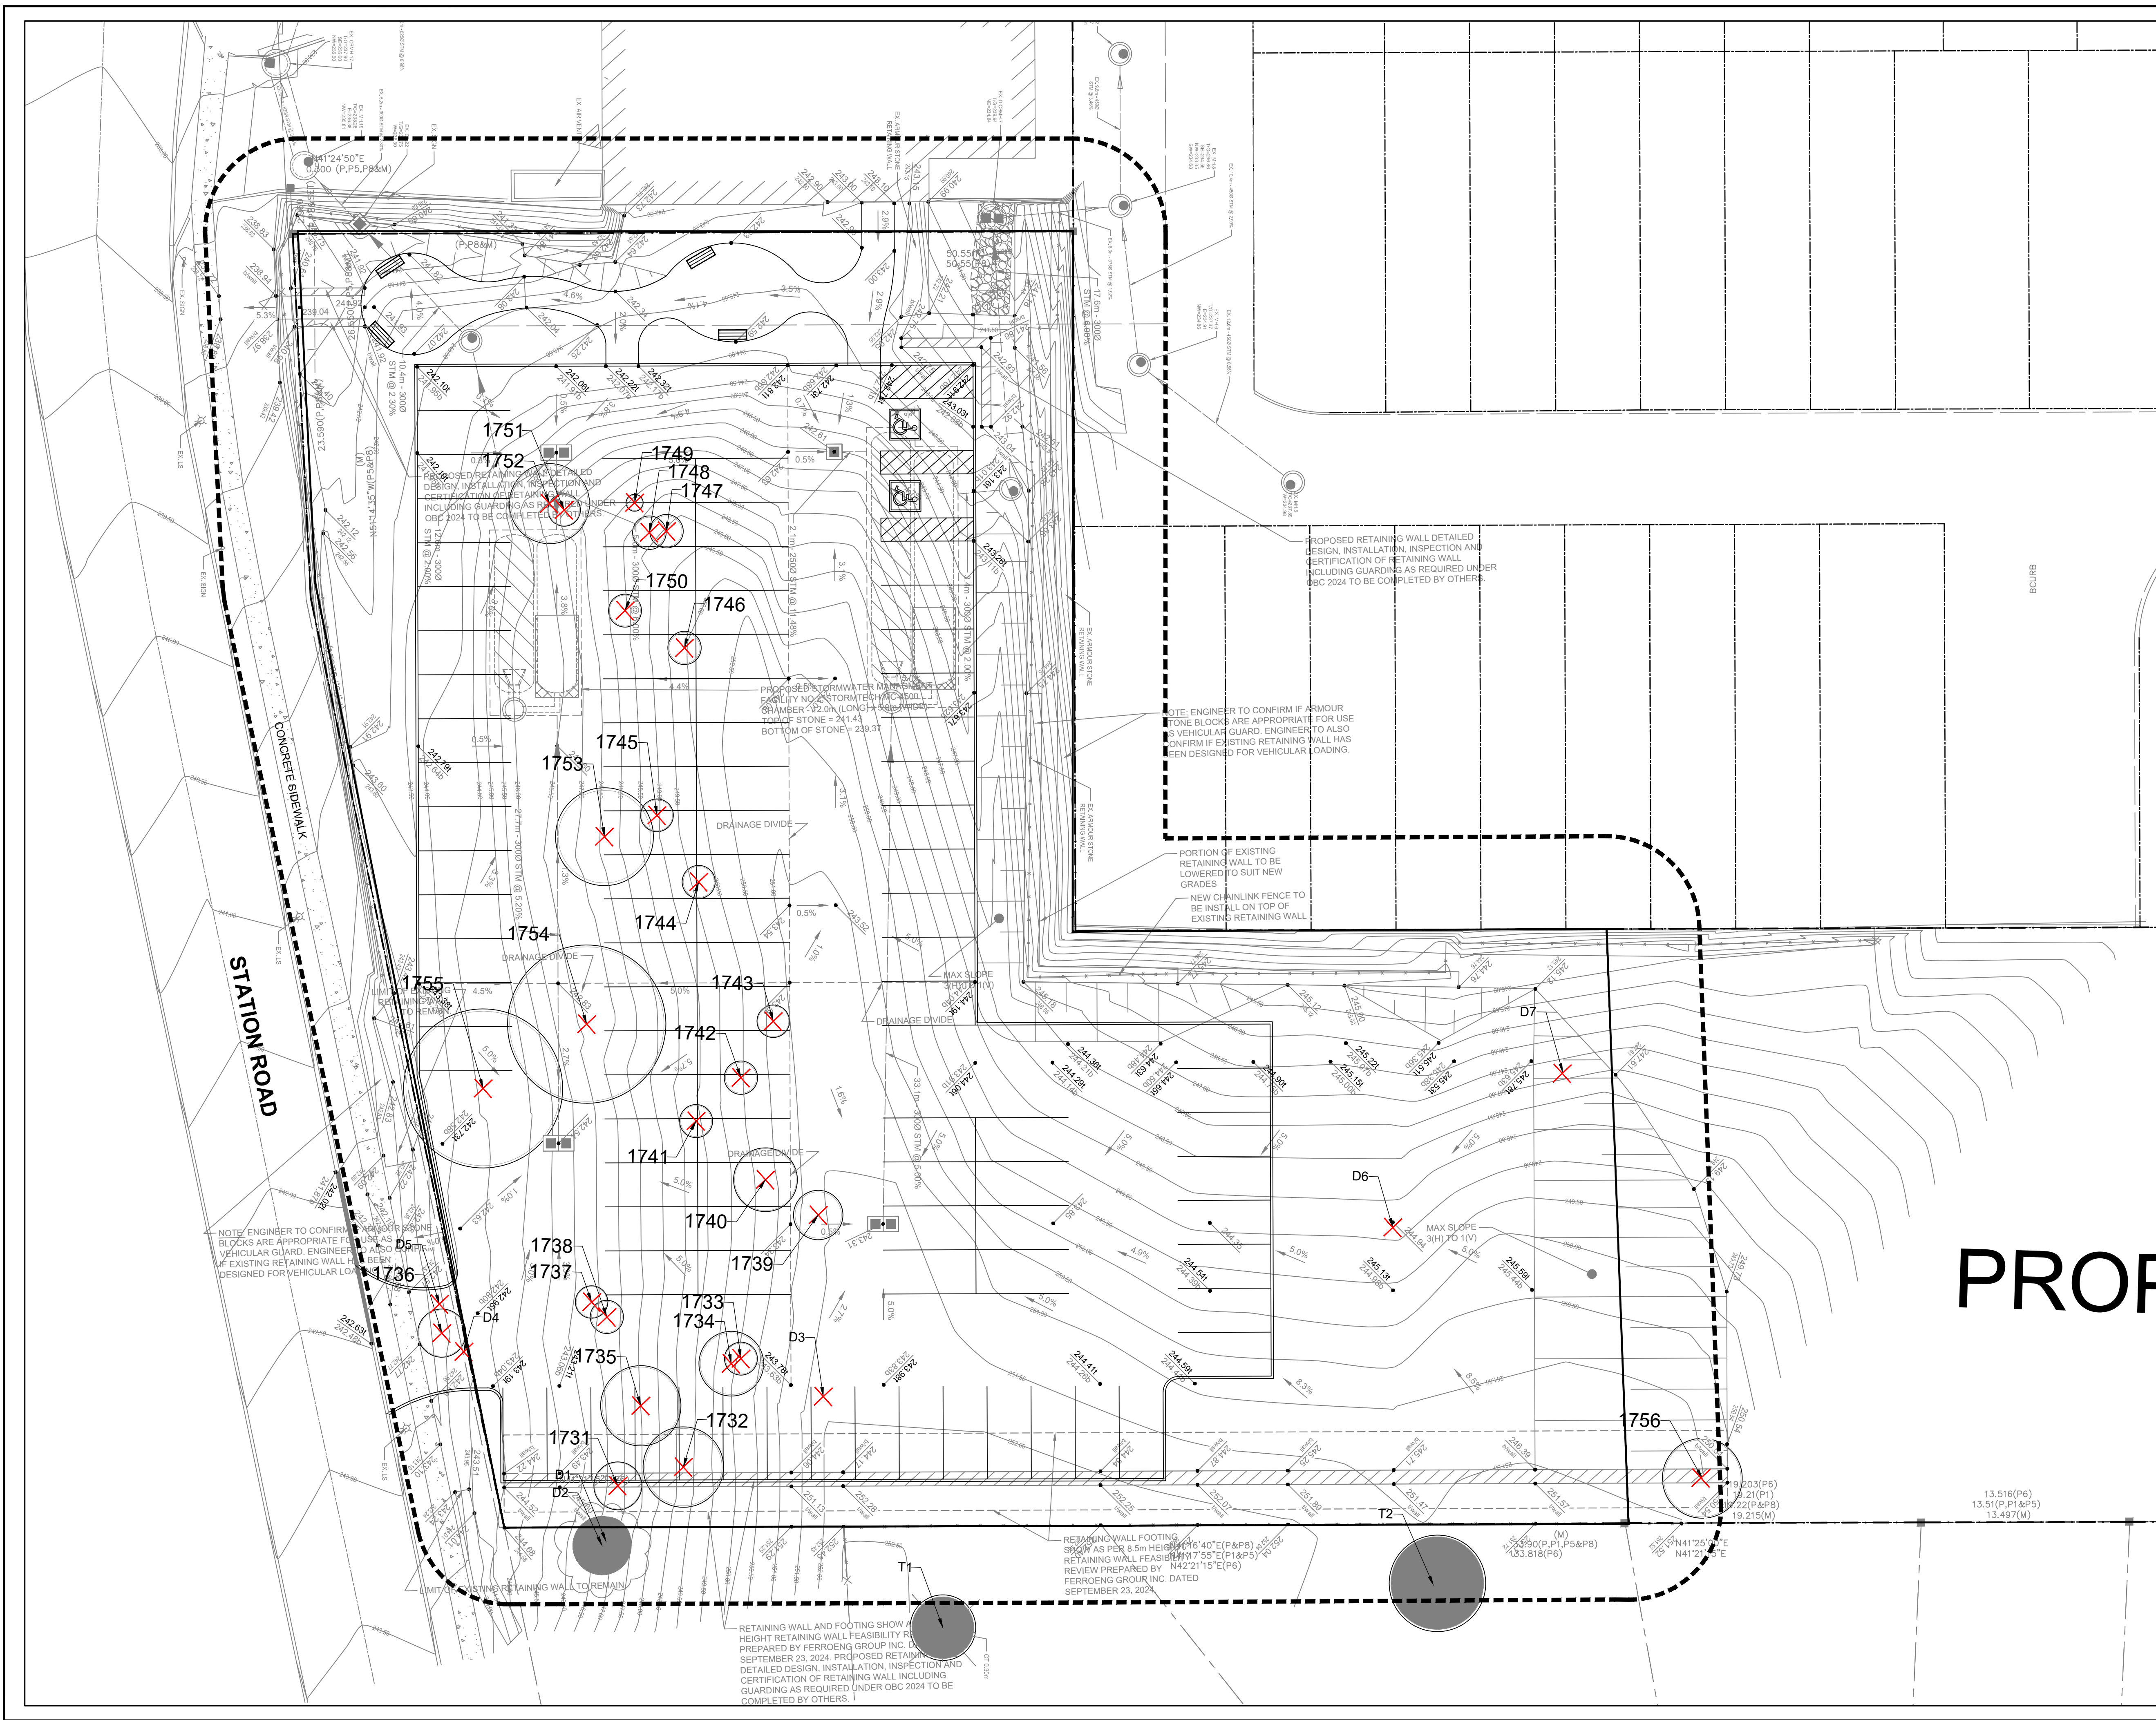
TREE INVENTORY AND PRESERVATION PLAN

GEI inventoried a total of 35 trees for the Project, including 27 trees within the Subject Lands and eight trees within the adjacent 6 m buffer area. (**TIPP.1, Appendix A**). **Appendix B** outlines the results of the tree inventory, including the tree identification number, species, DBH, health category (biological, structural, and overall), ownership and notes regarding the assigned health category. (**Appendix B**) also provides the Tree Protection Zone (TPZ), and recommendations for preservation or removal, and the rate of compensation tree plantings.

Tree preservation will be achieved through avoidance and the use of appropriate tree protection measures. GEI inventoried 35 trees for the Project, of which four are recommended for preservation as seen in **TIPP.1 (Appendix A)**. Proposed tree protection measures for these preservation trees is described in the following subsections.

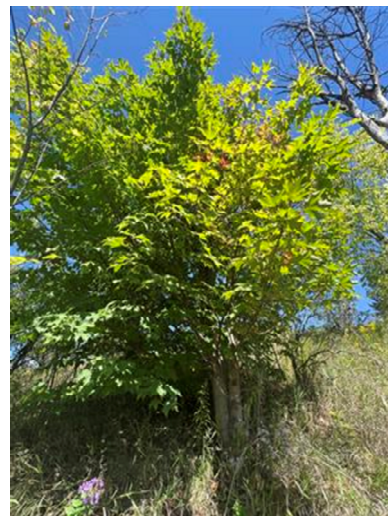
Photo 4 – Tree 1735

1735	Sugar Maple	<i>Acer saccharum</i>	18	14	20	2.5	2.5	Good	Fair	Fair	Private - Client	Remove	Parking Lot	1	Growing on slope, codominant stems; included bark; healed wound along stem; large wound at base
1736	White Elm	<i>Ulmus americana</i>	12	-	12	1.5	1.5	Good	Fair	Fair	Town of Caledon	Remove	Parking Lot	1	Growing on slope, overgrown with vines
1737	White Elm	<i>Ulmus americana</i>	10	-	10	1	1.0	Good	Fair	Fair	Private - Client	Remove	Parking Lot	1	Growing on slope, lower branch dieback
1738	White Elm	<i>Ulmus americana</i>	15	-	15	1	1.0	Good	Fair	Fair	Private - Client	Remove	Parking Lot	1	Growing on slope, lower branch dieback
1739	White Elm	<i>Ulmus americana</i>	20	-	20	1.5	1.5	Good	Good	Good	Private - Client	Remove	Parking Lot	1	Growing on slope
1740	Common Apple	<i>Malus domestica</i>	13	-	13	2	2.0	Good	Fair	Fair	Private - Client	Remove	Parking Lot	1	Rubbing and twisting branches; lower branch dieback

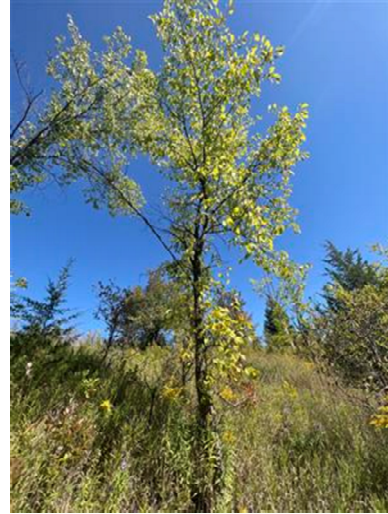
Photo 10 – Tree 1741

1741	White Elm	<i>Ulmus americana</i>	14	-	14	1	1.0	Good	Fair	Fair	Private - Client	Remove	Parking Lot	1	Growing on slope, lower branch dieback
1742	White Elm	<i>Ulmus americana</i>	16	-	16	1	1.0	Fair	Fair	Fair	Private - Client	Remove	Parking Lot	1	Growing on slope, crown dieback
1743	Red Cedar	<i>Juniperus virginiana</i>	10	-	10	1	1.0	Fair	Good	Fair	Private - Client	Remove	Parking Lot	1	Crown dieback
1744	White Elm	<i>Ulmus americana</i>	14	-	14	1	1.0	Poor	Poor	Poor	Private - Client	Remove	Parking Lot	1	Growing on slope, severe crown dieback
1745	Green Ash	<i>Fraxinus pennsylvanica</i>	12	-	12	1	1.0	Poor	Poor	Poor	Private - Client	Remove	Parking Lot	1	Growing on slope, severe crown dieback; peeling bark and EAB evidence
1746	White Elm	<i>Ulmus americana</i>	16	-	16	1	1.0	Poor	Poor	Poor	Private - Client	Remove	Parking Lot	1	Growing on slope, severe crown dieback
1747	White Elm	<i>Ulmus americana</i>	17	-	17	1	1.0	Fair	Fair	Fair	Private - Client	Remove	Parking Lot	1	Growing on slope, crown dieback

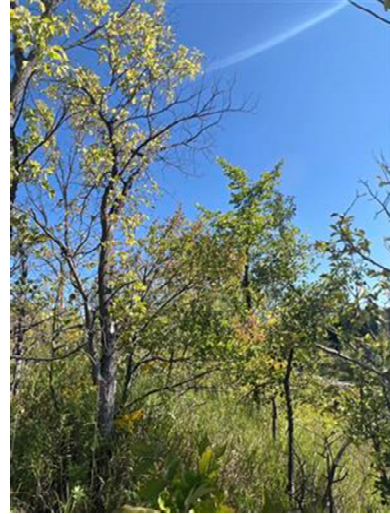
Photo 18 – Tree 1748

1748	White Elm	<i>Ulmus americana</i>	17	-	17	1	1.0	Fair	Fair	Fair	Private - Client	Remove	Parking Lot	1	Growing on slope, crown dieback
1749	White Elm	<i>Ulmus americana</i>	10	-	10	0.5	0.5	Fair	Fair	Fair	Private - Client	Remove	Parking Lot	1	Growing on slope, crown dieback
1750	White Elm	<i>Ulmus americana</i>	13	-	13	1	1.0	Good	Good	Good	Private - Client	Remove	Parking Lot	1	Growing on slope
1751	White Elm	<i>Ulmus americana</i>	10	-	10	1	1.0	Good	Fair	Fair	Private - Client	Remove	Parking Lot	1	Growing on slope, some lower branch dieback
1752	White Elm	<i>Ulmus americana</i>	19	-	19	2.5	2.5	Good	Fair	Good	Private - Client	Remove	Parking Lot	1	Growing on slope, exposed roots due to erosion; some lower branch dieback
1753	White Elm	<i>Ulmus americana</i>	34	-	34	3	3.0	Poor	Fair	Poor	Private - Client	Remove	Parking Lot	2	Growing on slope, severe crown dieback
1754	White Elm	<i>Ulmus americana</i>	25	-	25	5	5.0	Good	Good	Good	Private - Client	Remove	Parking Lot	2

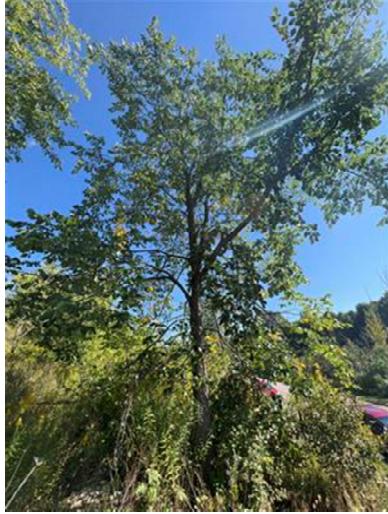
Photo 25 – Tree 1755

1755	White Elm	<i>Ulmus americana</i>	30	-	30	5	5.0	Good	Good	Good	Private - Client	Remove	Parking Lot	2	
1756	Black Walnut	<i>Juglans nigra</i>	17	-	17	2.5	2.5	Good	Good	Good	Private - Client	Remove	Grading	1	Within grading area
T1	Blue Spruce	<i>Picea pungens</i>	25	-	25	2	2.0	Good	Good	Good	Private - Neighbour	Preserve	-	-	
T2	Norway Maple	<i>Acer platanoides</i>	25	-	25	3	3.0	Good	Good	Good	Private - Neighbour	Preserve	-	-	
D1	Dead	N/A	13	-	13	-	-	-	-	-	Private - Neighbour	Preserve	-	-	South of Subject Lands
D2	Dead	N/A	16	-	16	-	-	-	-	-	Private - Neighbour	Preserve	-	-	South of Subject Lands
D3	Dead	N/A	21	-	21	-	-	-	-	-	Private - Client	Remove	Parking Lot	-	Within Subject Lands, outside of grading area
D4	Dead	N/A	13	-	13	-	-	-	-	-	Town of Caledon	Remove	Grading	-	Near Station Road
D5	Dead	N/A	17	-	17	-	-	-	-	-	Town of Caledon	Remove	Grading	-	Near Station Road
D7	Dead	N/A	21	-	21	-	-	-	-	-	Private - Client	Remove	Grading	-	Within grading area
