Fluvial Geomorphology Assessment and Conceptual Natural Corridor Design

Mount Hope West Secondary Plan Area Local Subwatershed Study Town of Caledon, Ontario

GEO Morphix Project No. 25026

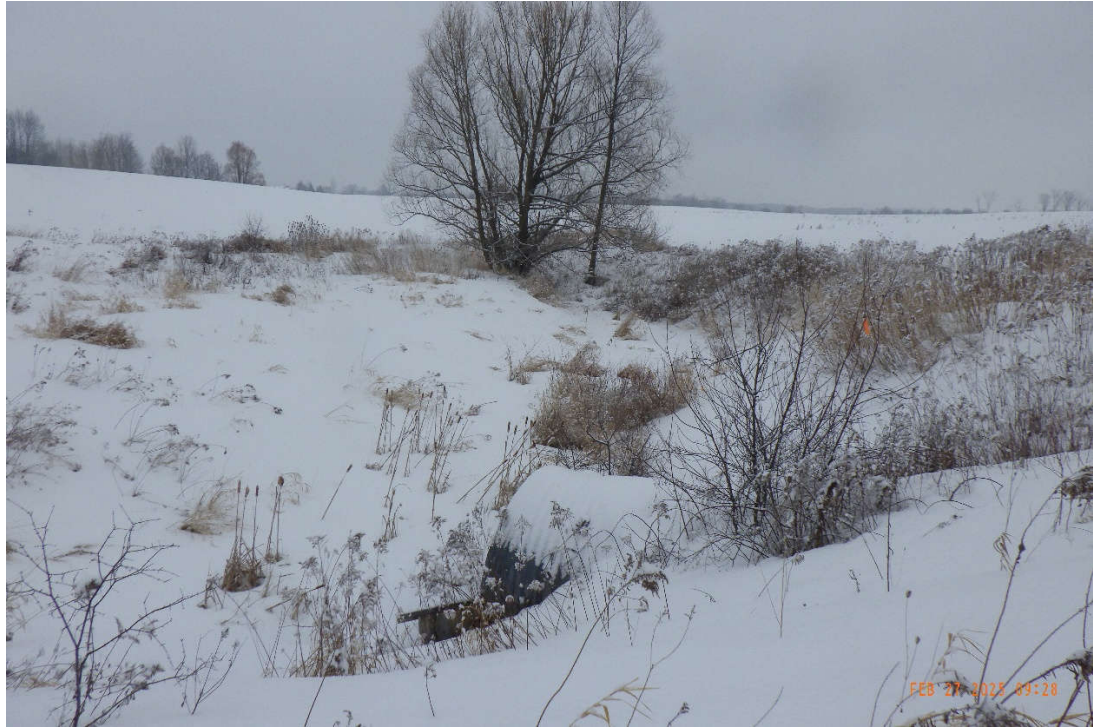
Photo 1
Tributary of Humber River– Reach THRE-1-1-1
Caledon, Ontario

Photo of Reach **THRE-1-1** facing upstream from the culvert at Columbia Way. Note the limited valley form and riparian vegetation.

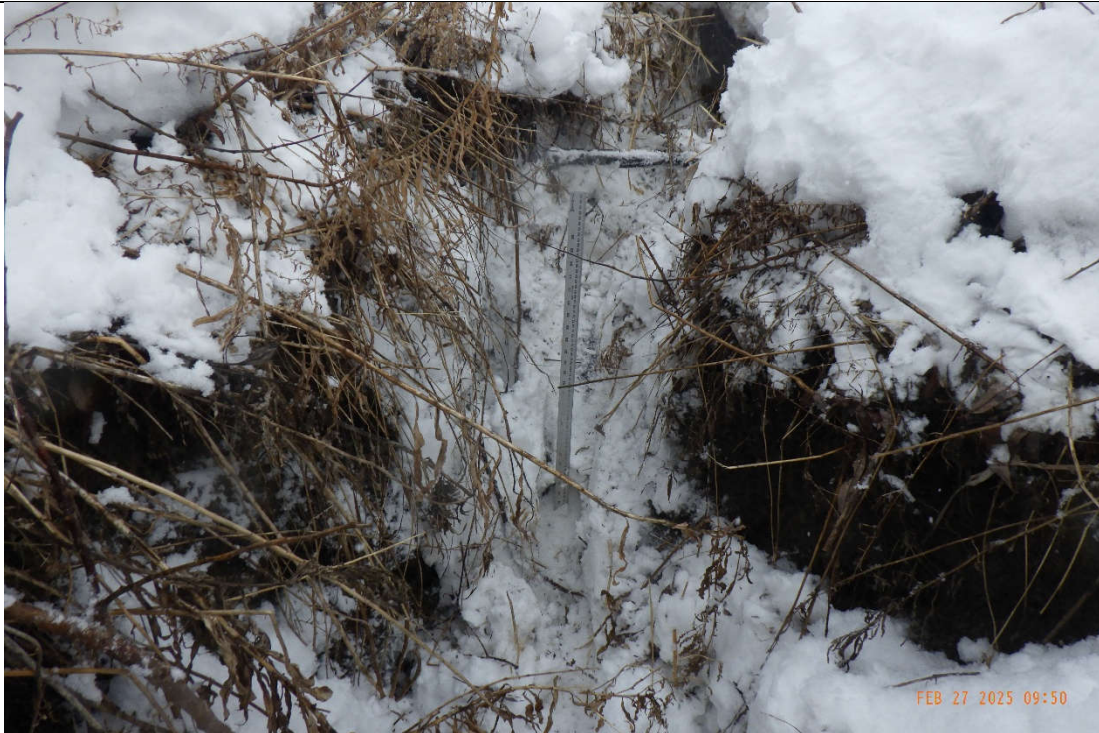
Photo 2
Tributary of Humber River– Reach THRE-1-1-1
Caledon, Ontario

Photo of Reach **THRE-1-1** taken facing upstream at an approximately 0.8 m knickpoint. Channel was eroded on both banks.

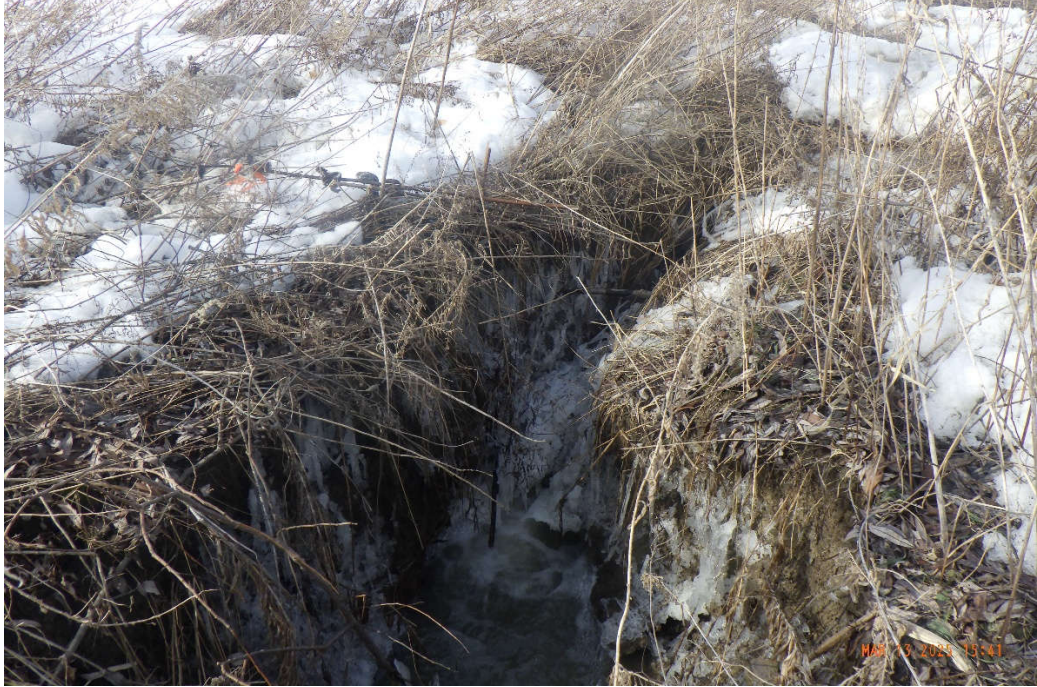
Photo 3

Photo of Reach **THRE-1-1** taken facing upstream at the knickpoint from **Photo 2**.

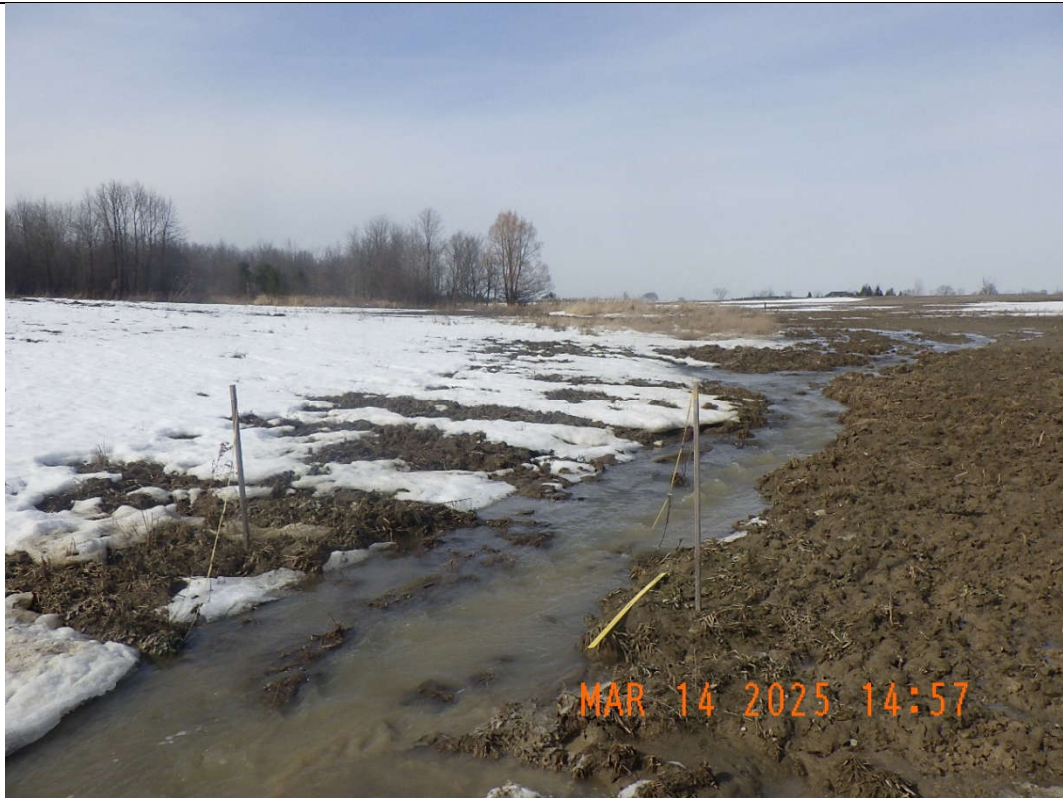
Photo 4

Photo of Reach **THRE-1-1** taken facing upstream. The edge of the treeline to the left represents the reach break between **THRE-1-1** and **THRE-1-2**. The reach appeared to be regularly ploughed to the edge of channel, which was poorly defined.

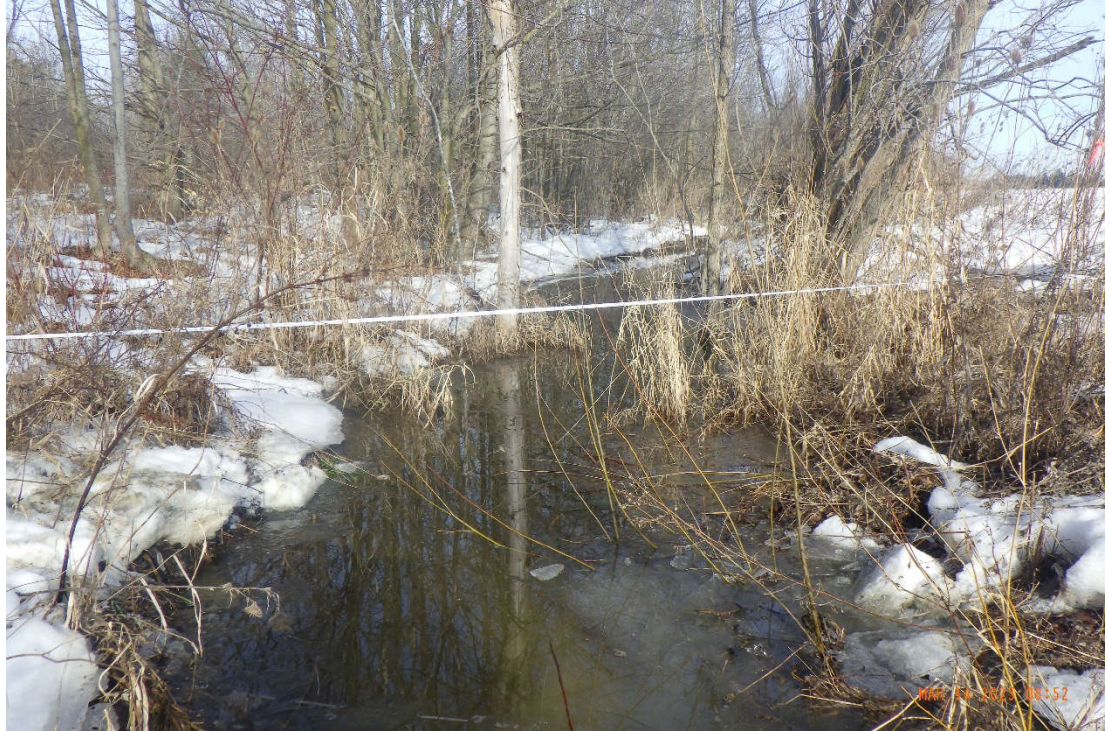
Photo 5

Photo of Reach **THRE-1-2** taken facing upstream at the first detailed assessment cross-section. Water was approximately 0.4 m deep and the wetted width was 1.66 m.

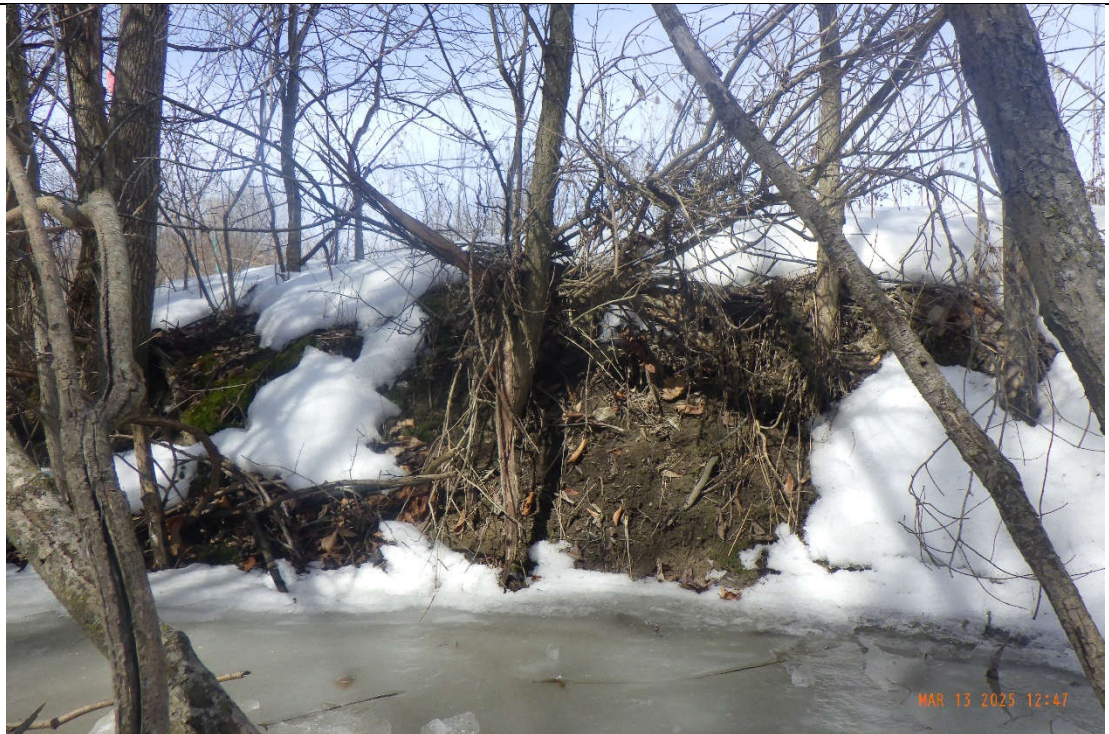
Photo 6

Photo of the left bank of Reach **THRE-1-2** taken upstream of **Photo 5**. Trees appeared to be leaning due to erosion of the bank. The channel widened at this location.

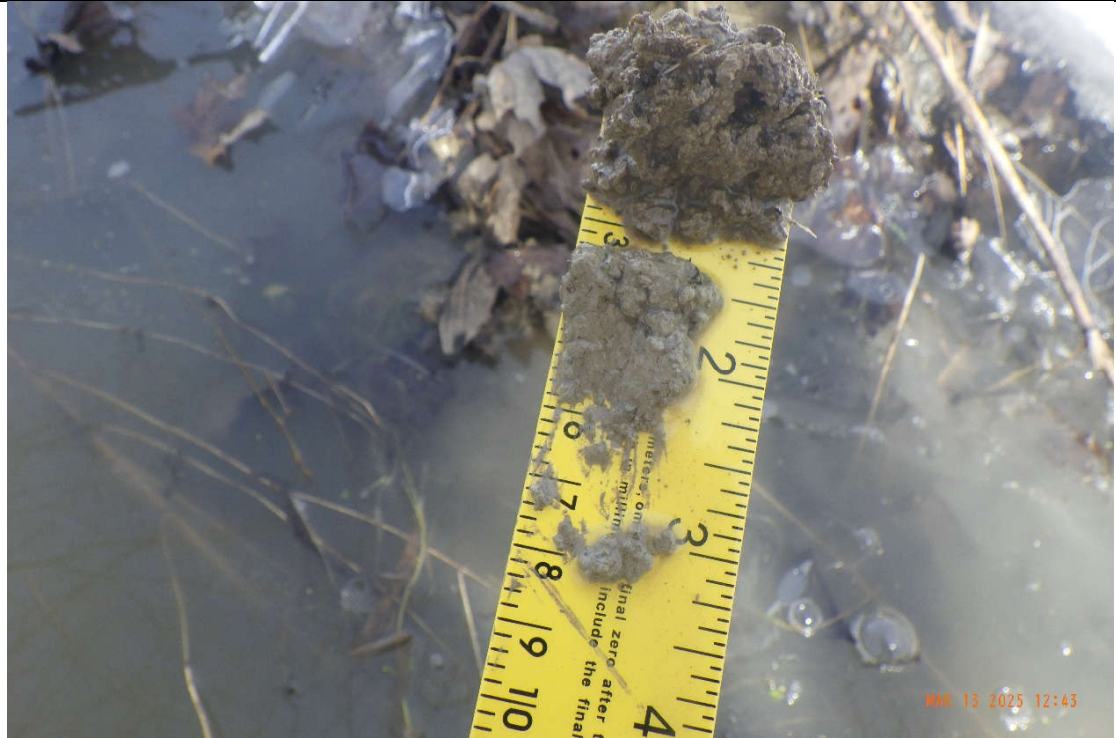
Photo 7

No riffle morphology was identified and channel substrate consisted of silt, clay, and some organics.

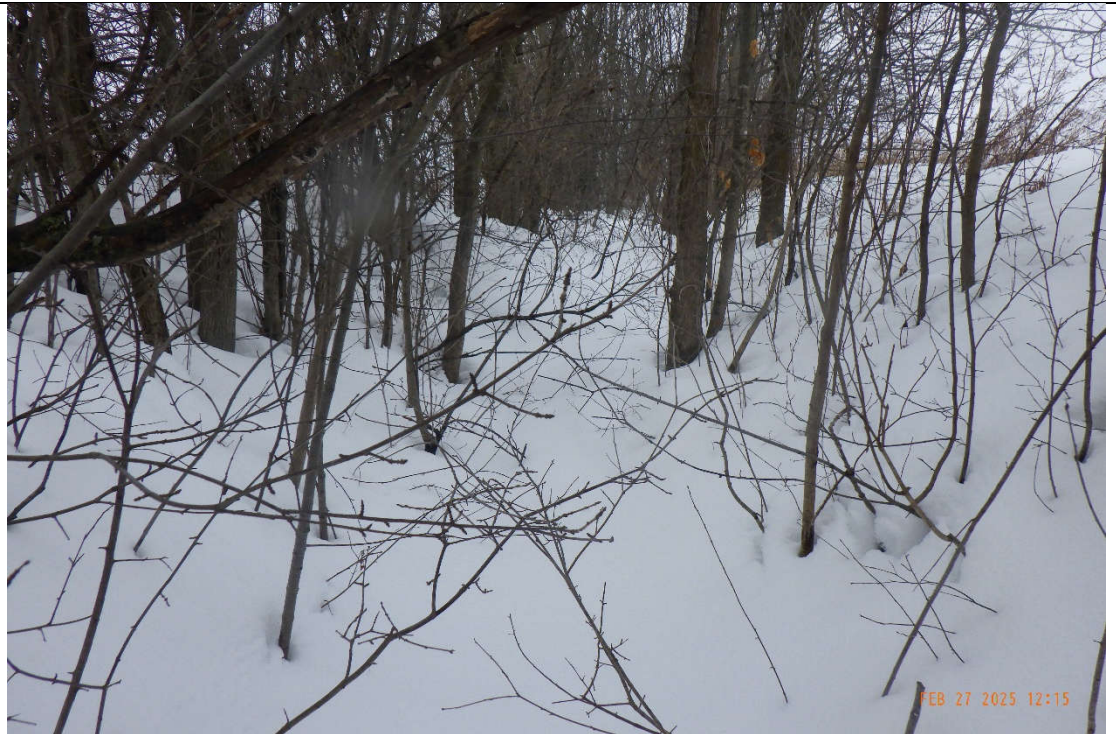
Photo 8

Photo of Reach **THRE-1-2** taken facing upstream just before the reach break, where the trees were denser and encroached the channel.

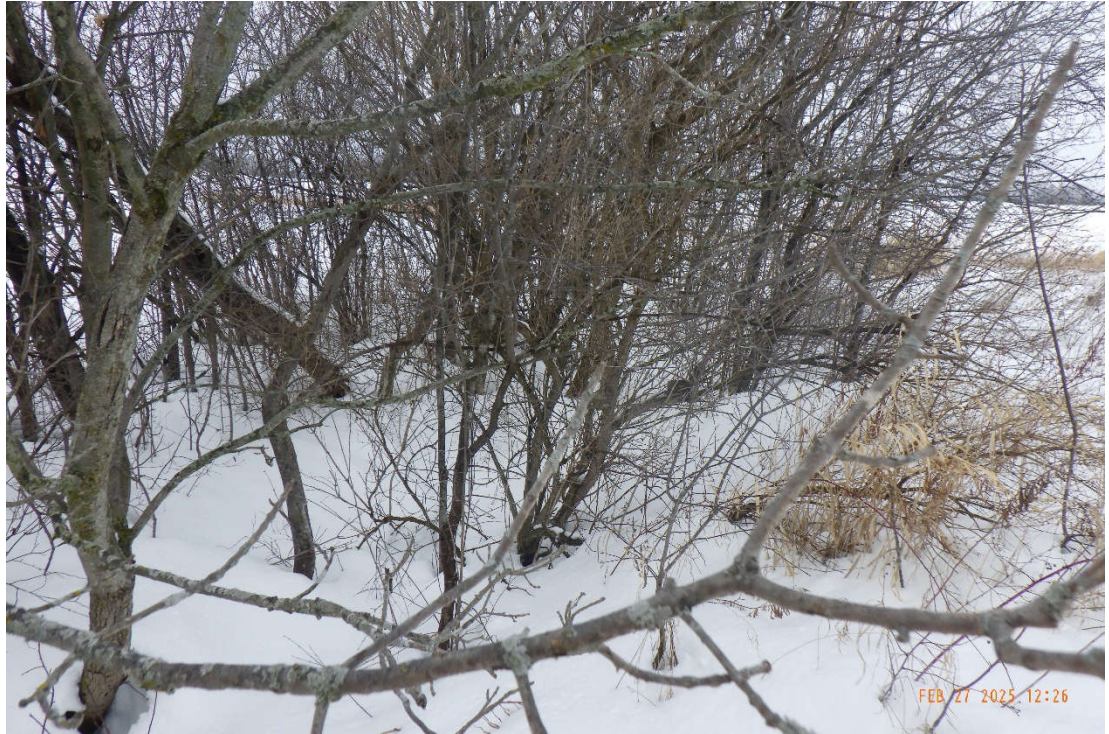
Photo 9
Tributary of Humber River– Reach THRE-1-3
Caledon, Ontario

Photo of Reach **THRE-1-3** taken facing upstream from the downstream extent of the reach, where trees heavily encroached the channel.

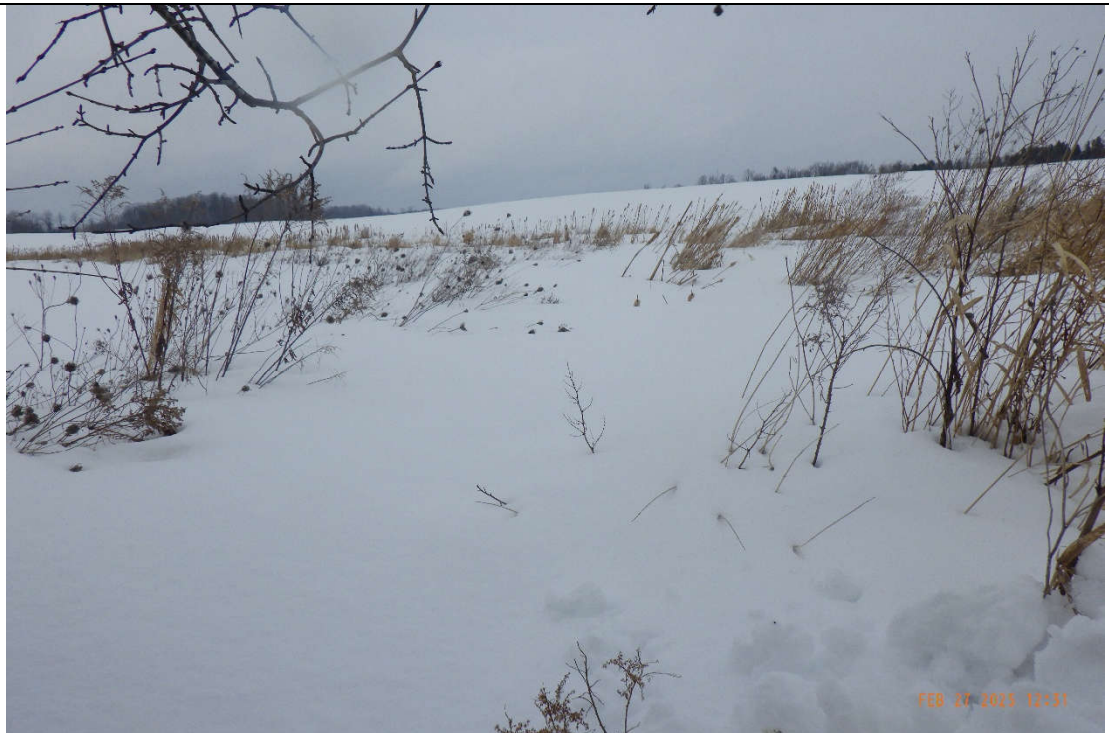
Photo 10
Tributary of Humber River– Reach THRE-1-3
Caledon, Ontario

Photo of Reach **THRE-1-3** taken facing upstream near the northern extent of the reach, where the watercourse originated in an agricultural field.

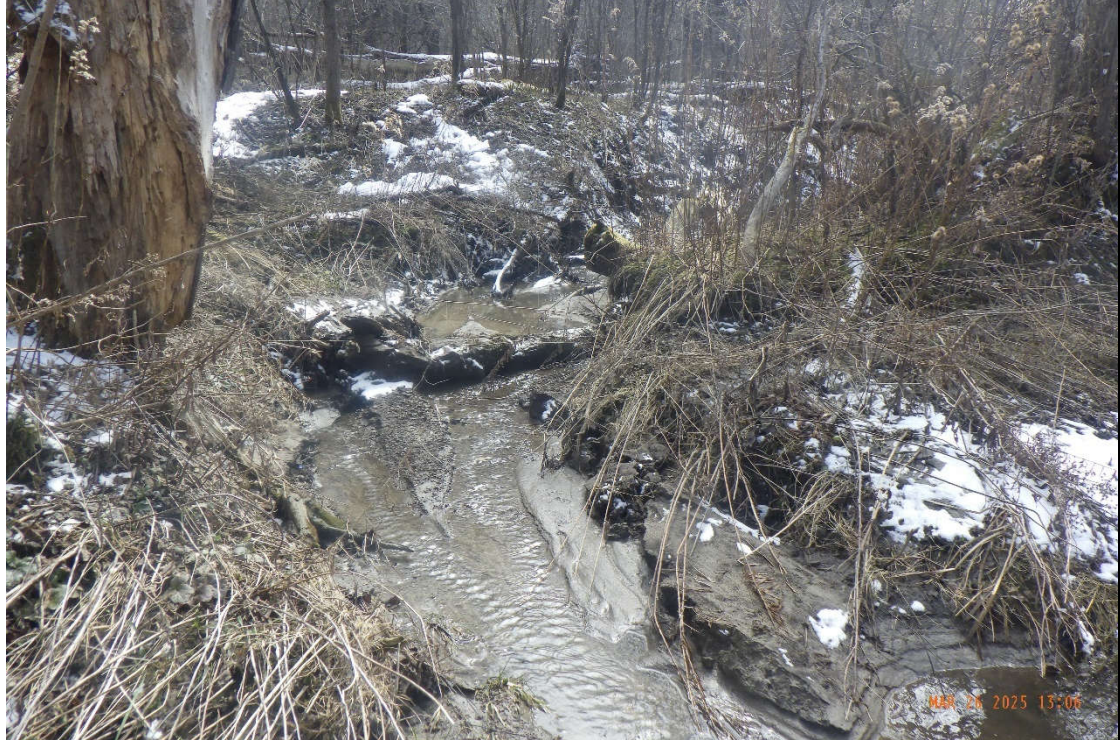
Photo 11

Photograph taken facing upstream at the downstream extent of **Reach THRF-1**. The channel flowed through a continuous, mature forest. Sand and gravel deposits were noted on the channel bed at the downstream extent of the reach.

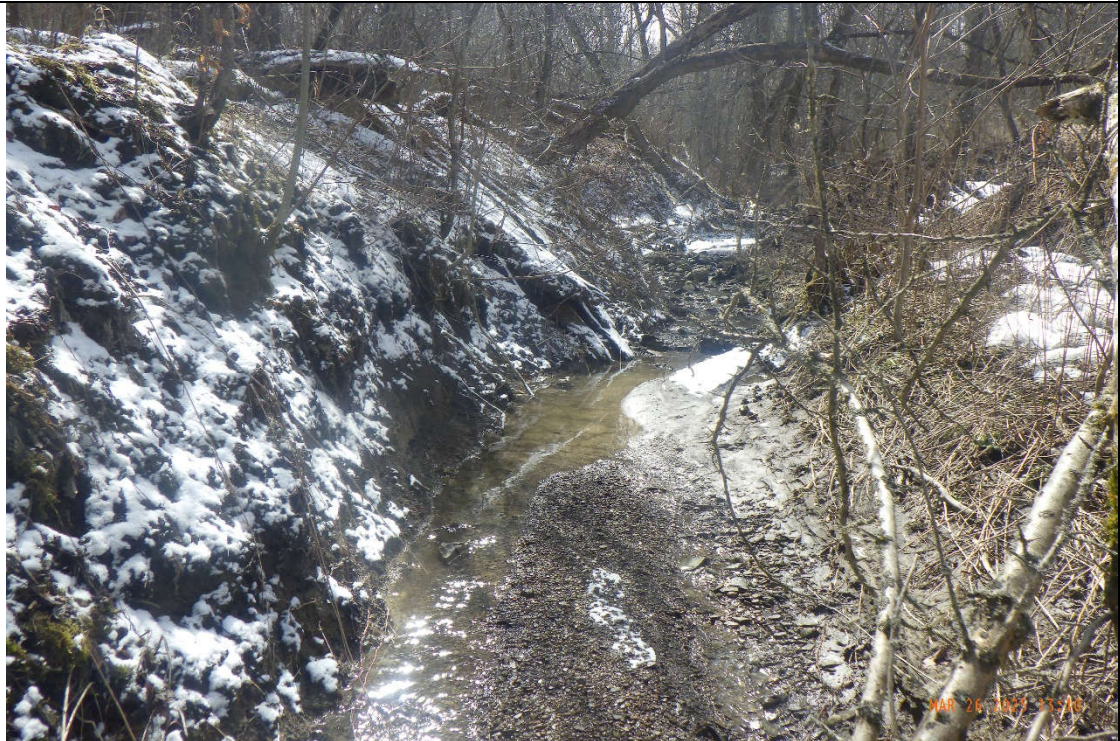
Photo 12

Banks were generally high and steep, and erosion was common. At this location banks were measured to be 1.8 m.

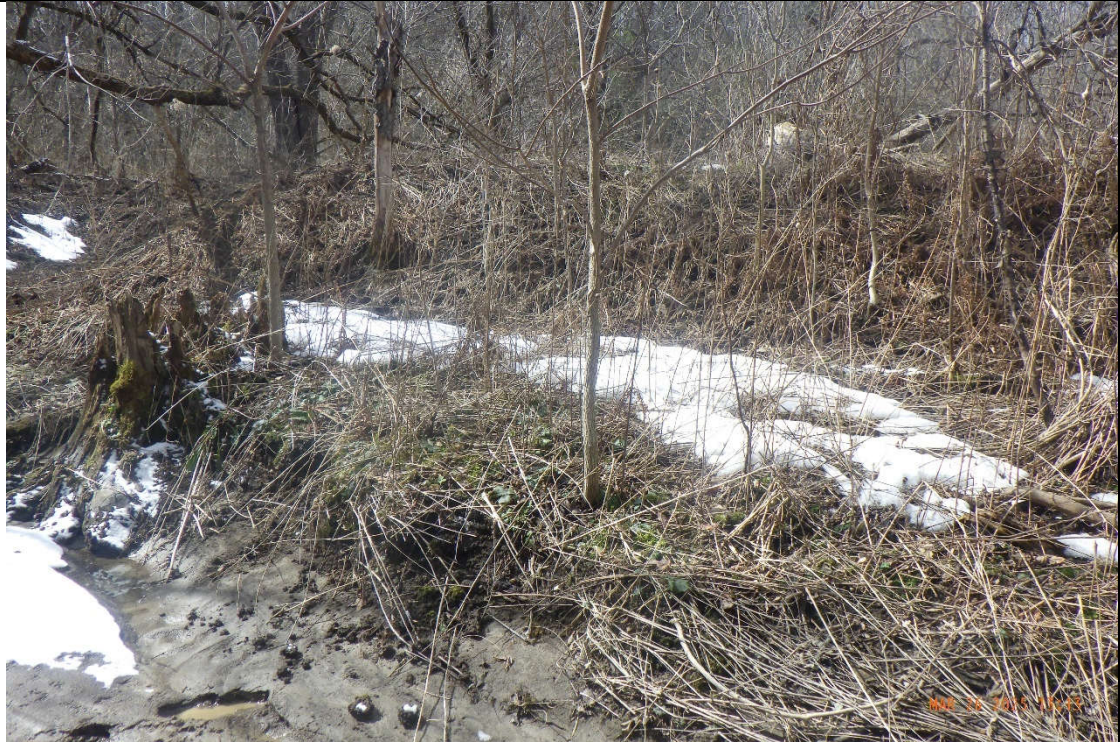
Photo 13

Photograph taken facing the left bank (facing downstream) of a terrace cut through older bar material.

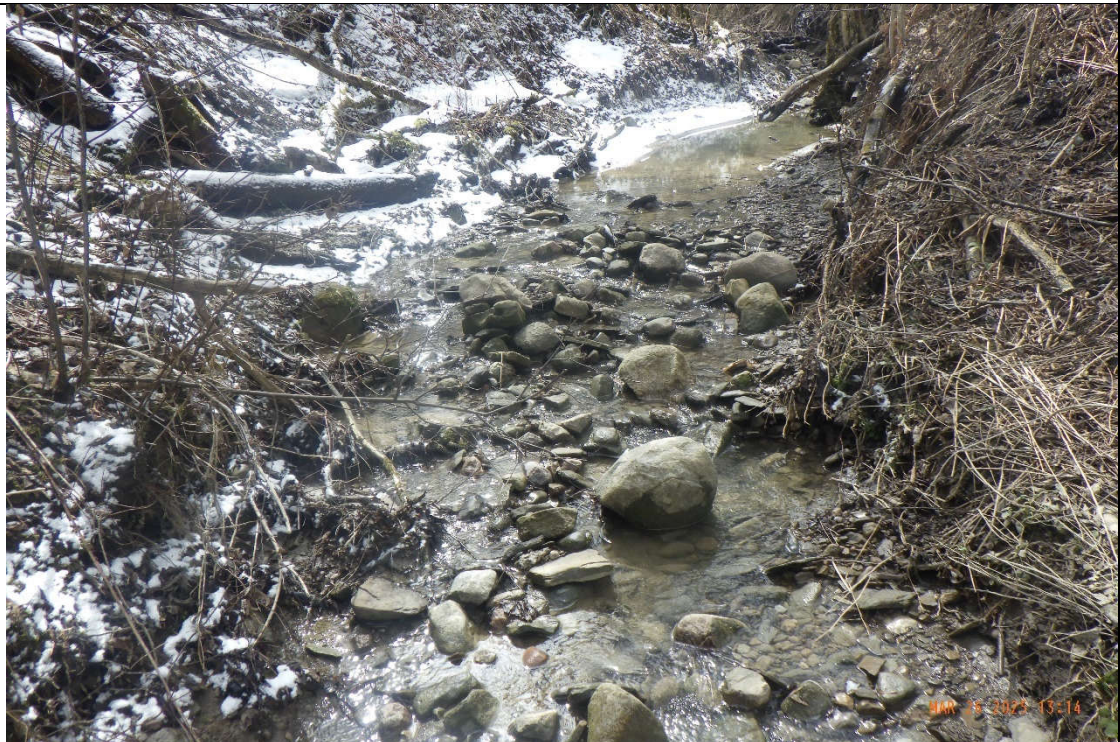
Photo 14

Bed substrate ranged from silt to large boulders. Riffles were composed primarily of cobbles, with a low level of embeddedness. Substrate fowling was not observed.

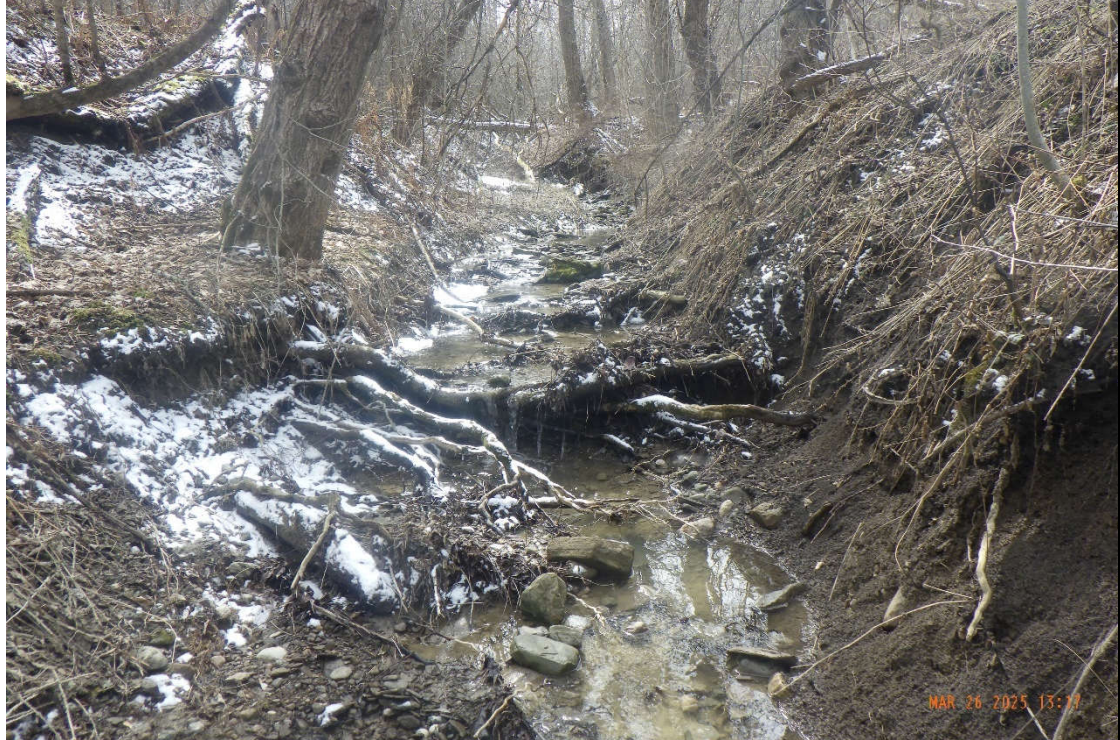
Photo 15

Photograph taken facing upstream of the first rooted knickpoint observed. The height was 0.30 m.

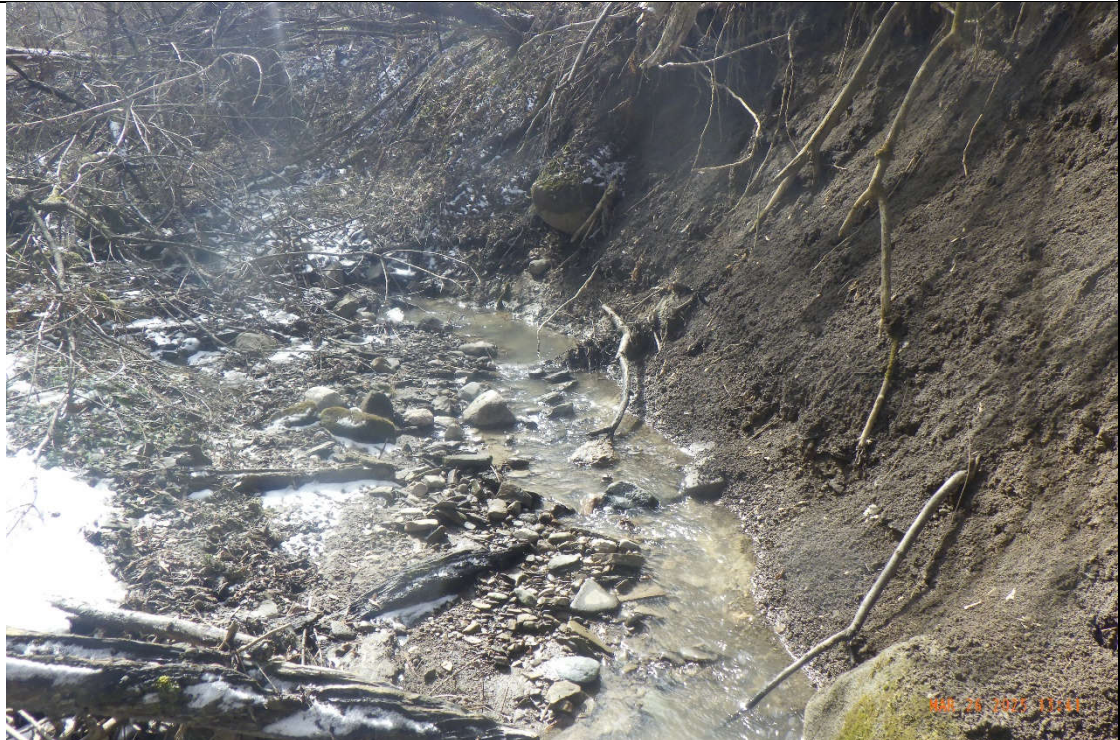
Photo 16

Exposed clay was noted throughout the channel, increasing in frequency upstream. Channel bed morphology was primarily comprised of riffles, with few deep pools. Measured riffle lengths were between 8.40 and 11.20 m.

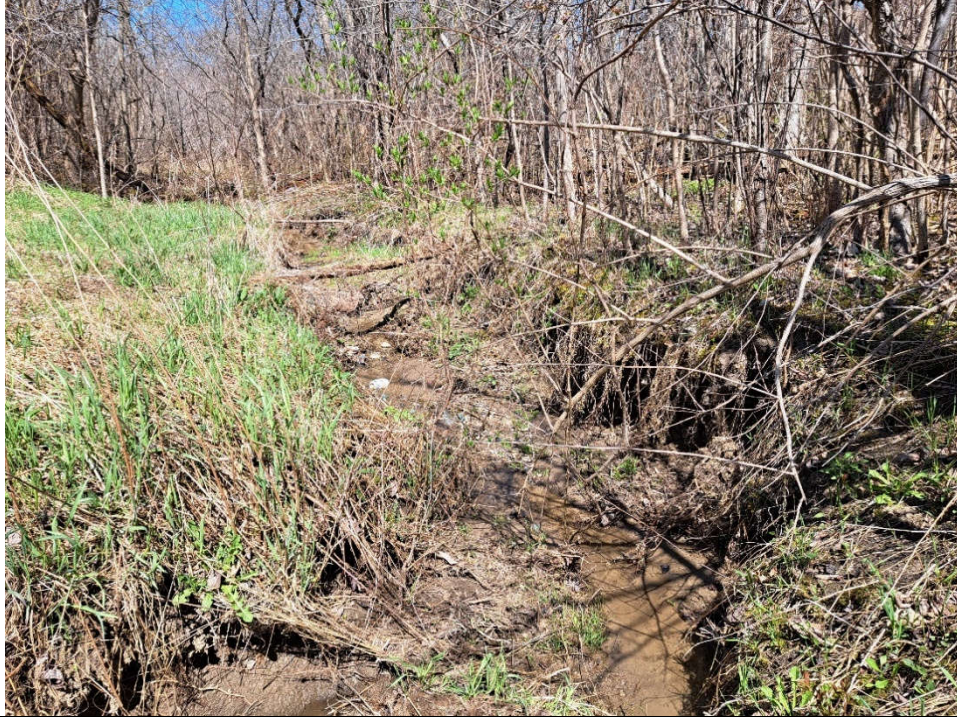
Photo 17

Photograph taken facing downstream. In the upstream portion of the reach erosion and undercutting was commonly observed. Undercuts were measured up to 0.48 m.

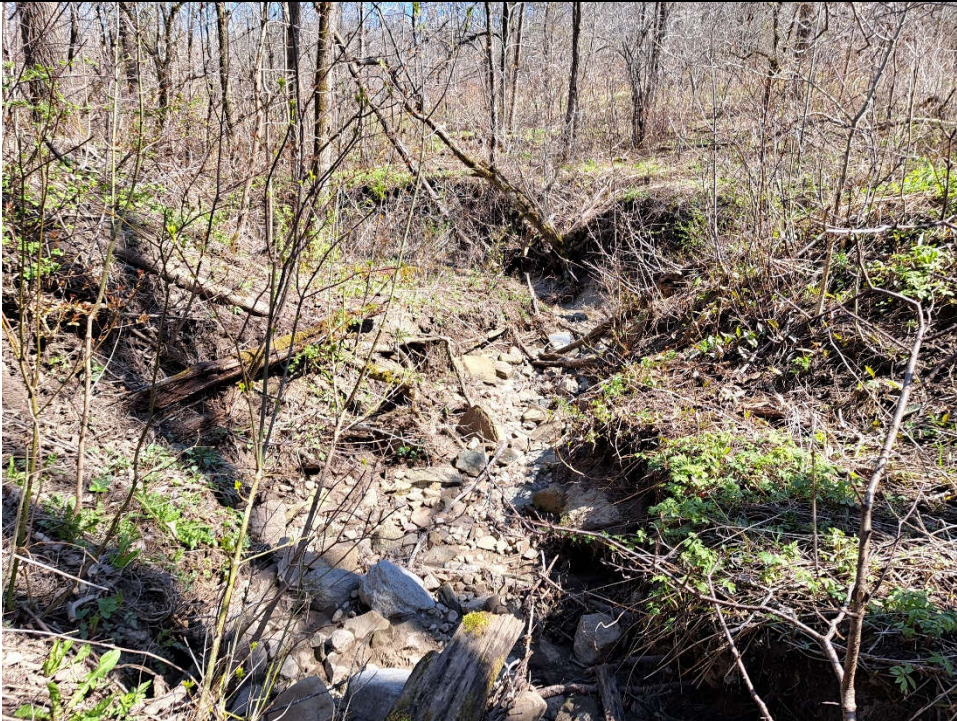
Photo 18

Photograph taken facing downstream. The bed substrate consisted of gravel and cobbles and the bank substrate consisted of clay, silt, and gravel primarily.

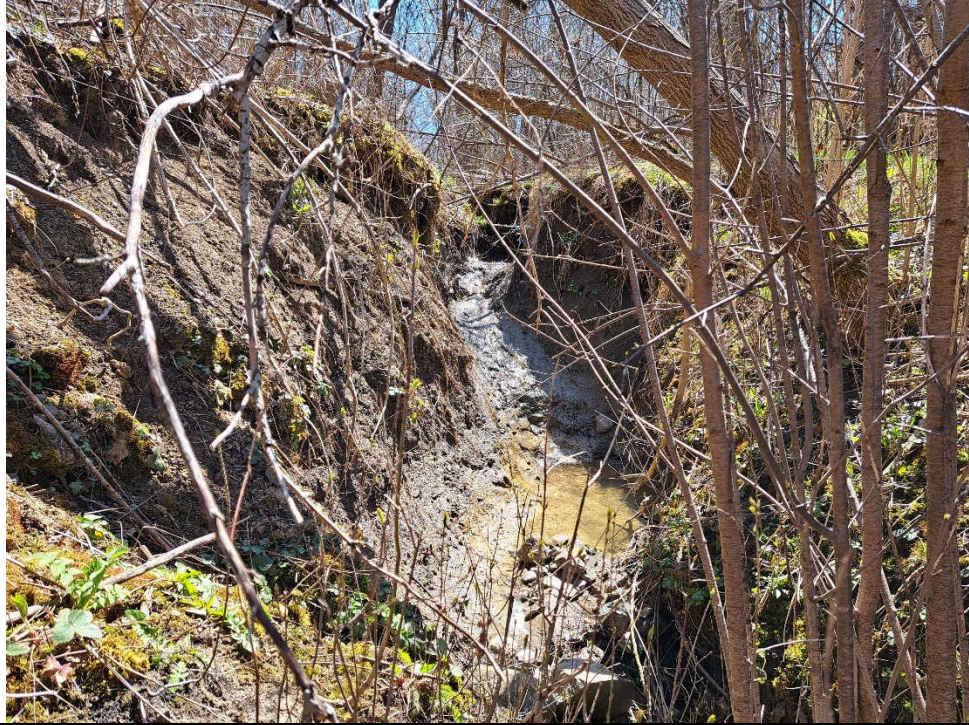
Photo 19

Photograph taken facing upstream. The gradient along the reach was high and entrenchment increased at localized sections where knickpoints were present.

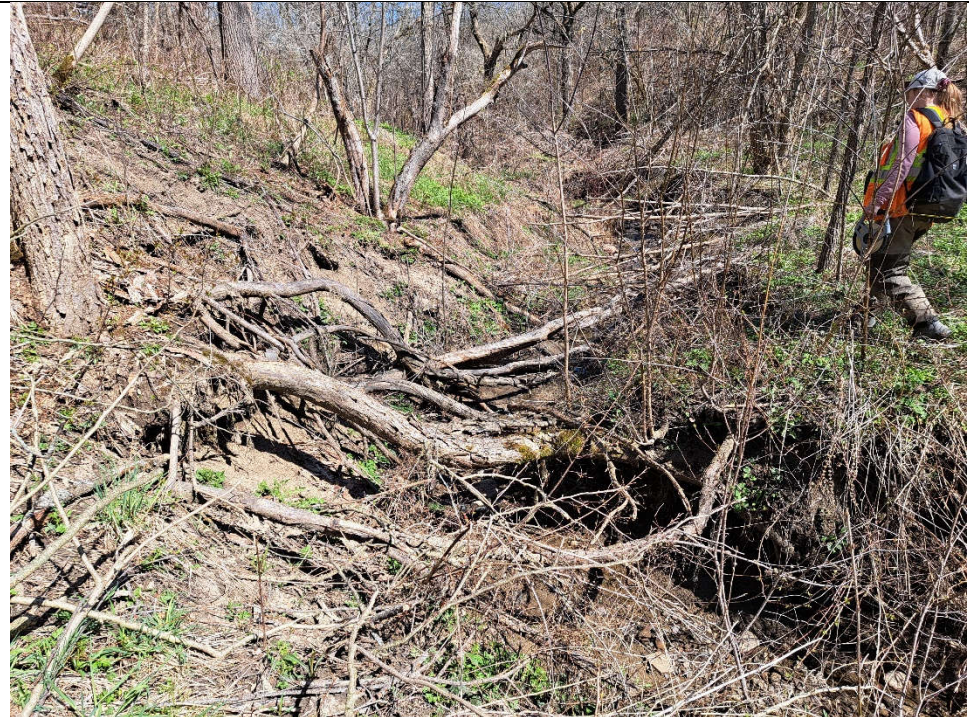
Photo 20

Photograph taken facing downstream. Woody debris, leaning and fallen trees, and exposed roots were common, with the highest concentration in the upstream section of the reach.

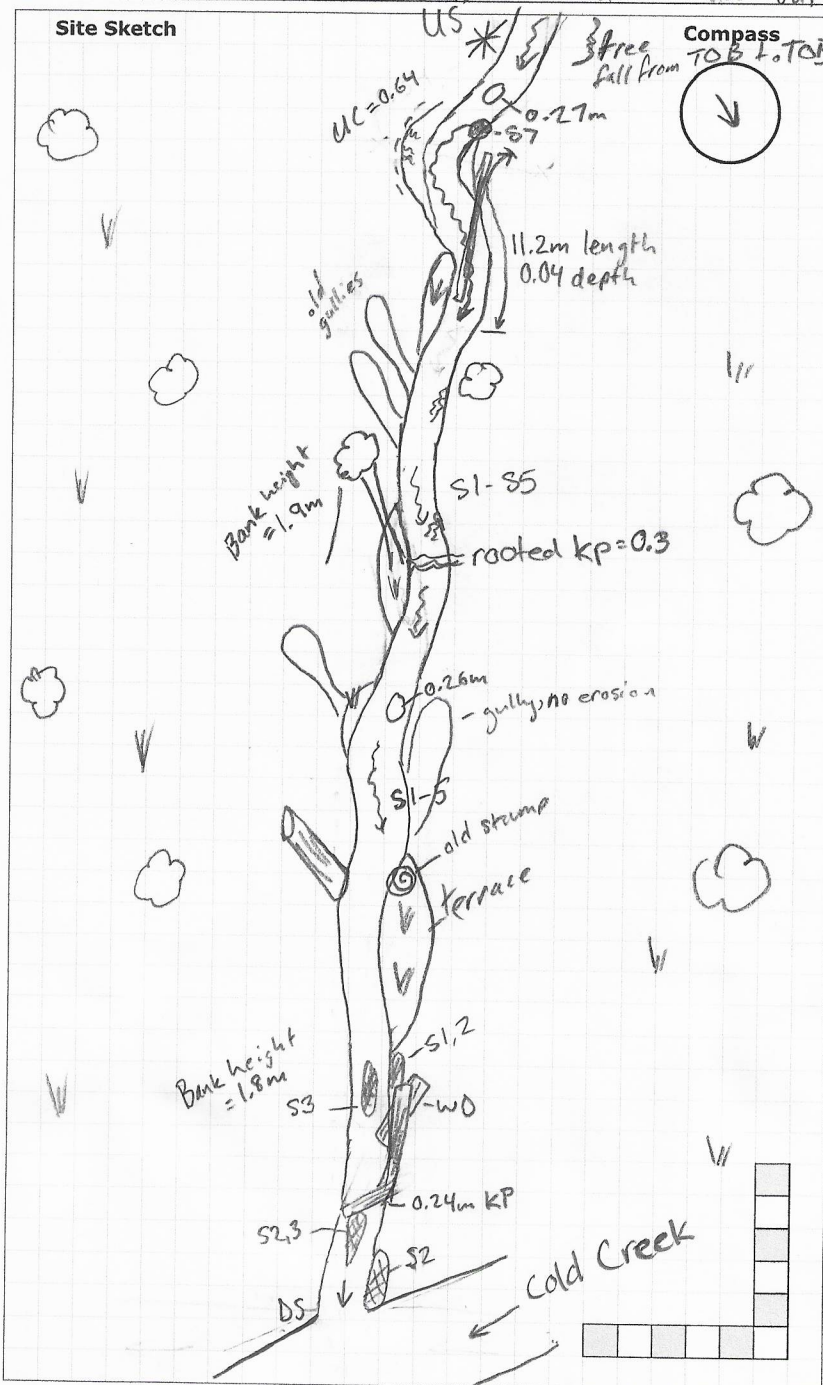
Notes: Exposed soil, highly entrenched, erosion on most banks for all of the reach. Grain size ranged silt to large boulders. US portion of reach became very exposed hard clay bed with less unconsolidated material.
