Preliminary Arborist Report Palgrave Estates 17791 Mount Hope Road Town of Caledon

Beacon Environmental Limited

January 2020 218250.1

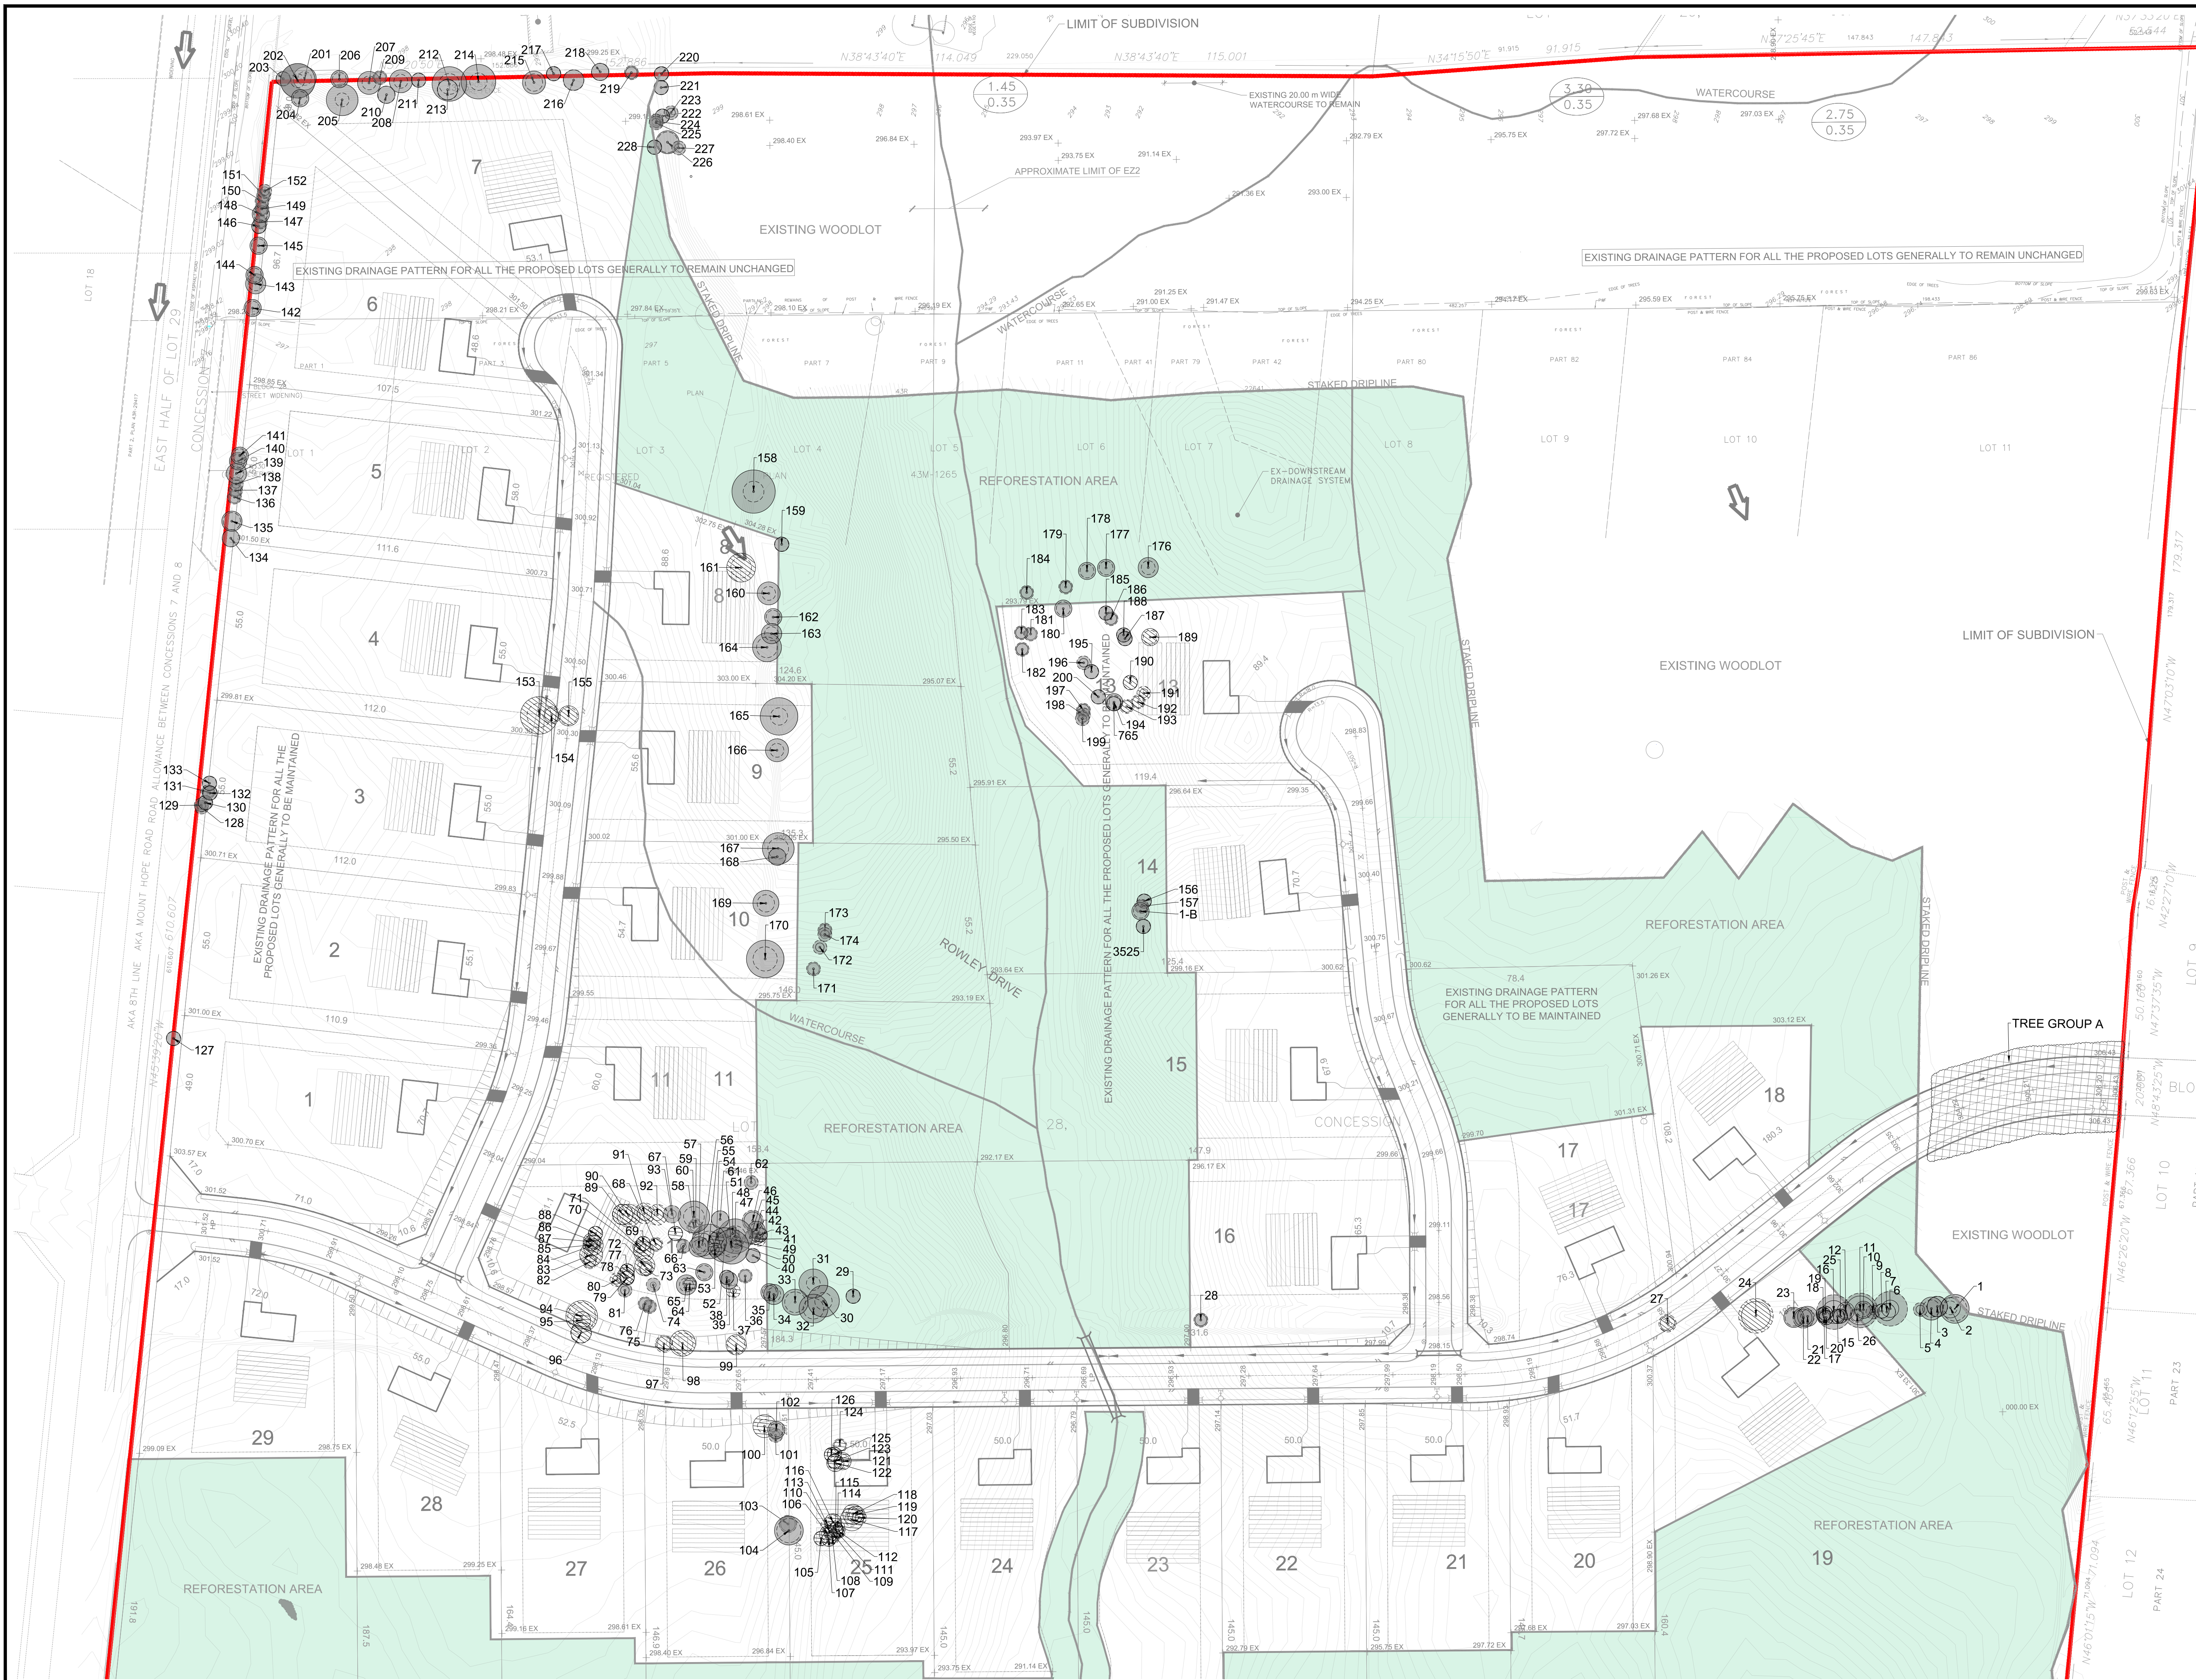
SHEET TITLE
TREE INVENTORY
AND
PRESERVATION PLAN

Currently the grading design for this property is in a preliminary phase. Septic and dwelling locations shown on **Figure 2** are conceptual. Minimal changes to the existing drainage patterns are proposed currently and therefore it is expected that some trees within the development area are candidates for preservation. All trees within the reforestation area will be preserved. Within Tree Group A, it is estimated that due to the width of the proposed road as well as the swales which flank both sides of it that 80-90% (183-206 trees) of trees tallied will require removal. Updated recommendations, as well as

Of the 228 trees individually tagged and assessed, a total of 159 are recommended for preservation. This includes 40 trees located within the reforestation zone along the edges of the proposed development. The remaining 119 trees recommended for preservation are located within the proposed development but along the edges of the lots and/or outside of the proposed septic and dwelling footprints. It is expected that once the detailed grading and servicing plans have been provided the number of trees recommended for removal and preservation will require adjustment.

A total of 69 individually tagged and assessed trees are recommended for removal. 62 of these are in direct conflict with the proposed grading, septic, or dwelling locations. The remaining 7 trees are recommended for removal due to their poor condition and potential locations in residential backyards. Invasive species including Manitoba maple (86%) and Scots Pine (7%) dominate trees for removal. Generally, trees for removal were mature with an average DBH of 33 cm and a DBH range of 15 cm - 115 cm. 54% of trees for removal were in good or fair-good condition, and 35% were in poor or fair-poor condition. **Table 3** provides a summary of trees for removal.

with erosion/silt control measures is required to be installed around the tree located a minimum distance as shown in the “TPZ” column of the tree inventory table in **Appendix B**, as measured from the base of the tree, or to the edge of a paved surface. The TPZ should be demarcated with tree protection fence consistent with silt fencing, comprised of wire fence secured to t-bar stakes spaced a maximum of 1.8 m apart with siltation fabric toed into ground surface. No materials shall be stored inside or up against this fencing, and a sign should be hung on the most visible side designating the TPZ. The location of the tree protection barrier in relation to the proposed development is shown on **Figure 2**.
