## Mount Pleasant, Caledon Tree Preservation Plan

Prepared for:  
David Goodman  
Tropical Land Developments Ltd.  
1500-439 University Ave.  
Toronto, ON M5G 1Y8

Project No. 1930 | October 2019

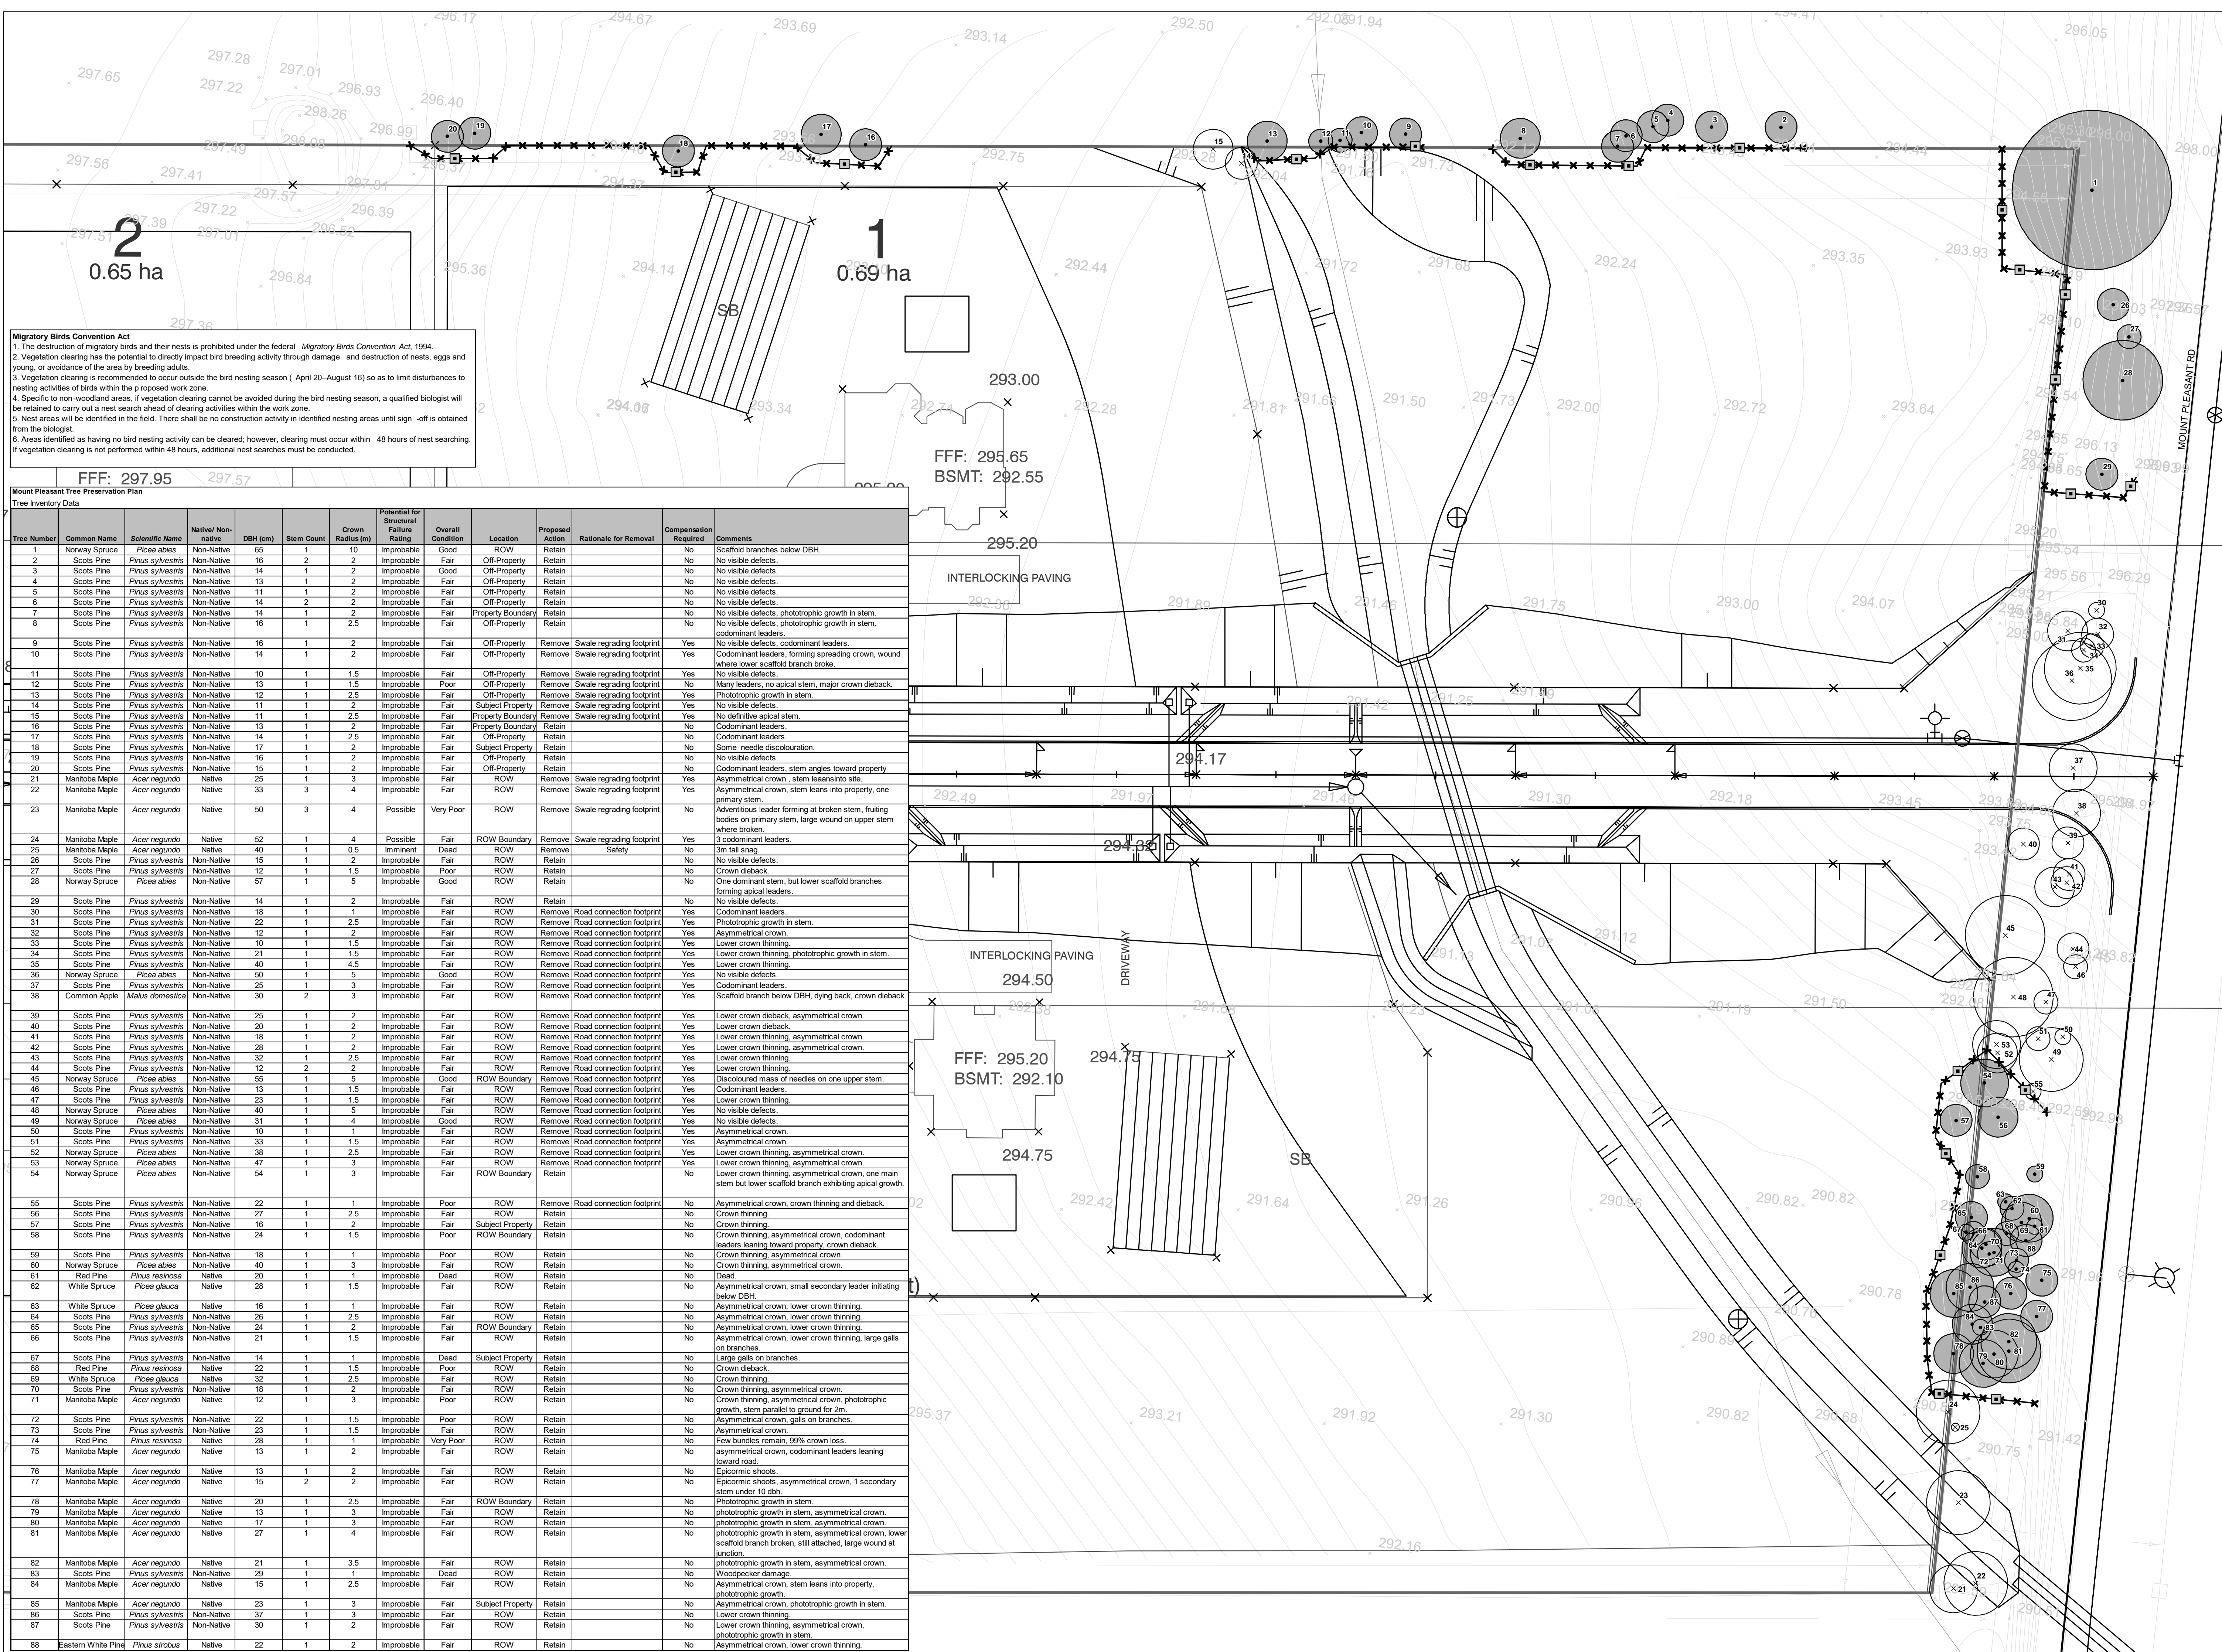
Tree Number	Common Name	Scientific Name	Native/Non-native	DBH (cm)	Stem Count	Crown Radius (m)	Potential for Structural Failure Rating	Overall Condition	Location	Proposed Action	Rationale for Removal	Compensation Required	Comments
1	Norway Spruce	<i>Picea abies</i>	Non-Native	65	1	10	Improbable	Good	ROW	Retain	No	No	Scaffold branches below DBH.
2	Scots Pine	<i>Pinus sylvestris</i>	Non-Native	16	2	2	Improbable	Fair	Off-Property	Retain	No	No	No visible defects.
3	Scots Pine	<i>Pinus sylvestris</i>	Non-Native	14	1	2	Improbable	Good	Off-Property	Retain	No	No	No visible defects.
4	Scots Pine	<i>Pinus sylvestris</i>	Non-Native	13	1	2	Improbable	Fair	Off-Property	Retain	No	No	No visible defects.
5	Scots Pine	<i>Pinus sylvestris</i>	Non-Native	11	1	2	Improbable	Fair	Off-Property	Retain	No	No	No visible defects.
6	Scots Pine	<i>Pinus sylvestris</i>	Non-Native	14	2	2	Improbable	Fair	Off-Property	Retain	No	No	No visible defects.

7	Scots Pine	<i>Pinus sylvestris</i>	Non-Native	14	1	2	Improbable	Fair	Property Boundary	Retain	No	No	No visible defects, phototropic growth in stem.
8	Scots Pine	<i>Pinus sylvestris</i>	Non-Native	16	1	2.5	Improbable	Fair	Off-Property	Retain	No	No	No visible defects, phototropic growth in stem, codominant leaders.
9	Scots Pine	<i>Pinus sylvestris</i>	Non-Native	16	1	2	Improbable	Fair	Off-Property	Remove	Swale regrading footprint	Yes	No visible defects, codominant leaders.
10	Scots Pine	<i>Pinus sylvestris</i>	Non-Native	14	1	2	Improbable	Fair	Off-Property	Remove	Swale regrading footprint	Yes	Codominant leaders, forming spreading crown, wound where lower scaffold branch broke.
11	Scots Pine	<i>Pinus sylvestris</i>	Non-Native	10	1	1.5	Improbable	Fair	Off-Property	Remove	Swale regrading footprint	Yes	No visible defects.
12	Scots Pine	<i>Pinus sylvestris</i>	Non-Native	13	1	1.5	Improbable	Poor	Off-Property	Remove	Swale regrading footprint	No	Many leaders, no apical stem, major crown dieback.

13	Scots Pine	<i>Pinus sylvestris</i>	Non-Native	12	1	2.5	Improbable	Fair	Off-Property	Remove	Swale regrading footprint	Yes	Phototropic growth in stem.
14	Scots Pine	<i>Pinus sylvestris</i>	Non-Native	11	1	2	Improbable	Fair	Subject Property	Remove	Swale regrading footprint	Yes	No visible defects.
15	Scots Pine	<i>Pinus sylvestris</i>	Non-Native	11	1	2.5	Improbable	Fair	Property Boundary	Remove	Swale regrading footprint	Yes	No definitive apical stem.
16	Scots Pine	<i>Pinus sylvestris</i>	Non-Native	13	1	2	Improbable	Fair	Property Boundary	Retain	No	No	Codominant leaders.
17	Scots Pine	<i>Pinus sylvestris</i>	Non-Native	14	1	2.5	Improbable	Fair	Off-Property	Retain	No	No	Codominant leaders.
18	Scots Pine	<i>Pinus sylvestris</i>	Non-Native	17	1	2	Improbable	Fair	Subject Property	Retain	No	No	Some needle discoloration.
19	Scots Pine	<i>Pinus sylvestris</i>	Non-Native	16	1	2	Improbable	Fair	Off-Property	Retain	No	No	No visible defects.

26	Scots Pine	<i>Pinus sylvestris</i>	Non-Native	2	1	2	Improbable	Fair	ROW	Retain	No	No	No visible defects.
27	Scots Pine	<i>Pinus sylvestris</i>	Non-Native	12	1	1.5	Improbable	Poor	ROW	Retain	No	No	Crown dieback.
28	Norway Spruce	<i>Picea abies</i>	Non-Native	57	1	5	Improbable	Good	ROW	Retain	No	No	One dominant stem, but lower scaffold branches forming apical leaders.
29	Scots Pine	<i>Pinus sylvestris</i>	Non-Native	14	1	2	Improbable	Fair	ROW	Retain	No	No	No visible defects.
30	Scots Pine	<i>Pinus sylvestris</i>	Non-Native	18	1	1	Improbable	Fair	ROW	Remove	Road connection footprint	Yes	Codominant leaders.
31	Scots Pine	<i>Pinus sylvestris</i>	Non-Native	22	1	2.5	Improbable	Fair	ROW	Remove	Road connection footprint	Yes	Phototropic growth in stem.
32	Scots Pine	<i>Pinus sylvestris</i>	Non-Native	12	1	2	Improbable	Fair	ROW	Remove	Road connection footprint	Yes	Asymmetrical crown.
33	Scots Pine	<i>Pinus sylvestris</i>	Non-Native	10	1	1.5	Improbable	Fair	ROW	Remove	Road connection footprint	Yes	Lower crown thinning.

34	Scots Pine	<i>Pinus sylvestris</i>	Non-Native	21	1	1.5	Improbable	Fair	ROW	Remove	Road connection footprint	Yes	Lower crown thinning, phototropic growth in stem.
35	Scots Pine	<i>Pinus sylvestris</i>	Non-Native	40	1	4.5	Improbable	Fair	ROW	Remove	Road connection footprint	Yes	Lower crown thinning.
36	Norway Spruce	<i>Picea abies</i>	Non-Native	50	1	5	Improbable	Good	ROW	Remove	Road connection footprint	Yes	No visible defects.
37	Scots Pine	<i>Pinus sylvestris</i>	Non-Native	25	1	3	Improbable	Fair	ROW	Remove	Road connection footprint	Yes	Codominant leaders.
38	Common Apple	<i>Malus domestica</i>	Non-Native	30	2	3	Improbable	Fair	ROW	Remove	Road connection footprint	Yes	Scaffold branch below DBH, dying back, crown dieback.
39	Scots Pine	<i>Pinus sylvestris</i>	Non-Native	25	1	2	Improbable	Fair	ROW	Remove	Road connection footprint	Yes	Lower crown dieback, asymmetrical crown.
40	Scots Pine	<i>Pinus sylvestris</i>	Non-Native	20	1	2	Improbable	Fair	ROW	Remove	Road connection footprint	Yes	Lower crown dieback.

48	Norway Spruce	<i>Picea abies</i>	Non-Native	40	1	5	Improbable	Fair	ROW	Remove	Road connection footprint	Yes	No visible defects.
49	Norway Spruce	<i>Picea abies</i>	Non-Native	31	1	4	Improbable	Good	ROW	Remove	Road connection footprint	Yes	No visible defects.
50	Scots Pine	<i>Pinus sylvestris</i>	Non-Native	10	1	1	Improbable	Fair	ROW	Remove	Road connection footprint	Yes	Asymmetrical crown.
51	Scots Pine	<i>Pinus sylvestris</i>	Non-Native	33	1	1.5	Improbable	Fair	ROW	Remove	Road connection footprint	Yes	Asymmetrical crown.
52	Norway Spruce	<i>Picea abies</i>	Non-Native	48	1	2.5	Improbable	Fair	ROW	Remove	Road connection footprint	Yes	Lower crown thinning, asymmetrical crown.
53	Norway Spruce	<i>Picea abies</i>	Non-Native	47	1	3	Improbable	Fair	ROW	Remove	Road connection footprint	Yes	Lower crown thinning, asymmetrical crown.
54	Norway Spruce	<i>Picea abies</i>	Non-Native	54	1	3	Improbable	Fair	ROW Boundary	Retain	No	No	Lower crown thinning, asymmetrical crown, one main stem but lower scaffold branch exhibiting apical growth.

- The destruction of migratory birds and their nests is prohibited under the federal *Migratory Birds Convention Act, 1994*.
- Vegetation clearing has the potential to directly impact bird breeding activity through damage and destruction of nests, eggs and young, or avoidance of the area by breeding adults.

- Vegetation clearing is recommended to occur outside the bird nesting season (April 20–August 16) so as to limit disturbances to nesting activities of birds within the proposed work zone.
