## **ARBORIST REPORT**

**ARGO MAYFIELD WEST V  
PROPOSED RESIDENTIAL SUBDIVISION  
12192 CHINGUACOUSY ROAD  
TOWN OF CALEDON, ONTARIO**

**February 7, 2025**

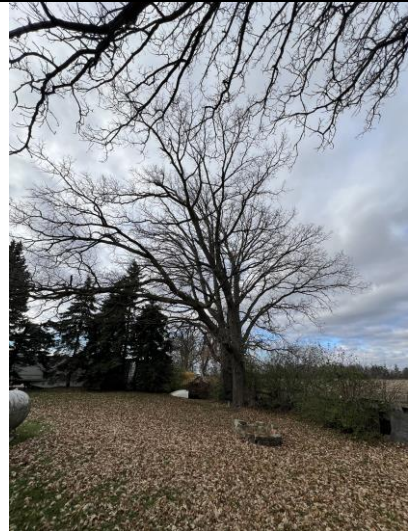
Trees #873-875

873	Bur Oak	88	22	Fair	Mature	Crowded by adjacent tree, dieback in lower branches, broken branches	Subject Site	Remove	5.4	873
874	Bur Oak	80	24	Fair	Mature	Crowded by adjacent tree, dieback in lower branches, broken branches	Subject Site	Remove	5.4	874
875	Bur Oak	99	20	Fair	Mature	Crowded by adjacent tree, dieback in lower branches, broken branches	Subject Site	Remove	6.0	875
