Humber River Tributaries Fluvial Geomorphological Assessment

**Bolton North Hill Secondary Plan Area
Local Subwatershed Study - Stage 1**
Town of Caledon, Ontario

GEO Morphix Project No. PN24084

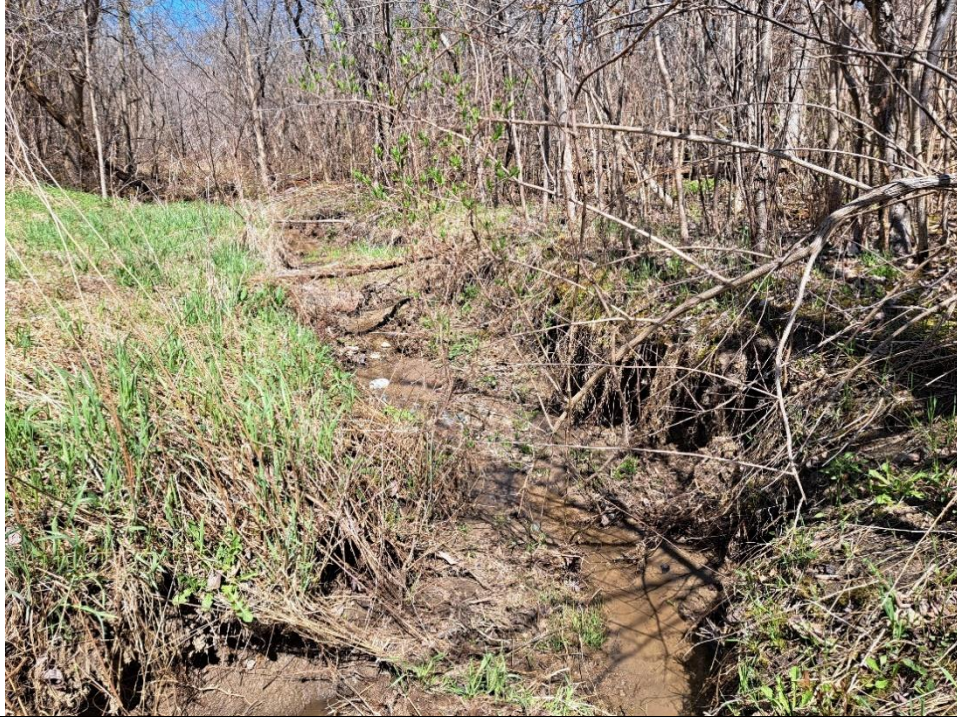
Photo 1
Tributary of the Humber River - Reach THRF-2, Caledon,
Ontario

In the upstream portion of the reach erosion and undercutting was commonly observed. Undercuts were measured up to 0.48 m.

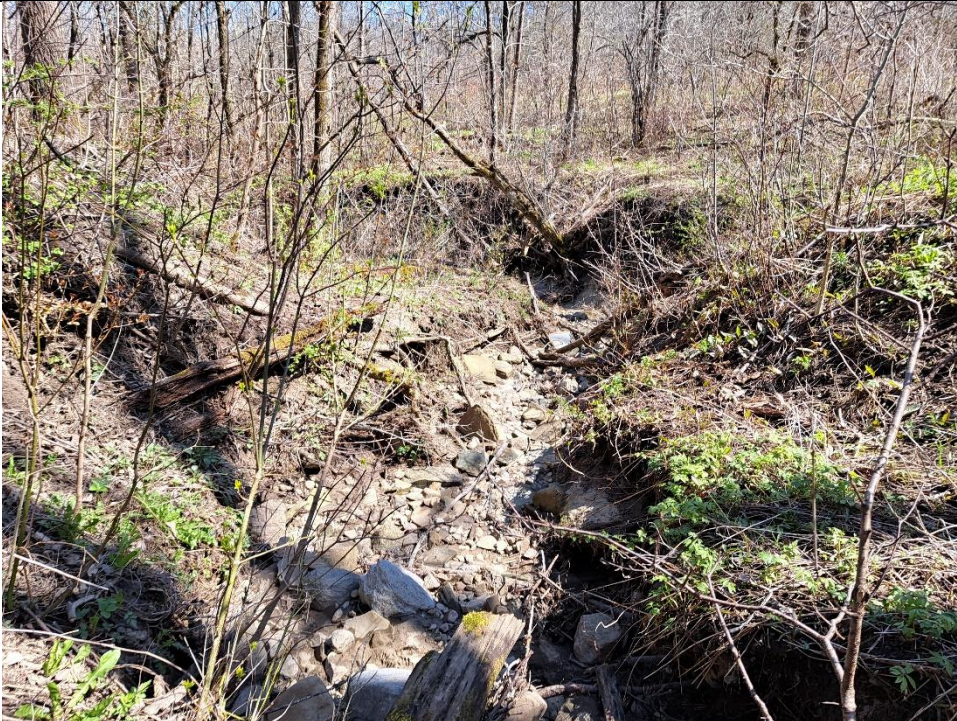
Photo 2
Tributary of the Humber River - Reach THRF-2, Caledon,
Ontario

The bed substrate consisted of gravel and cobbles and the bank substrate consisted of clay, silt, and gravel primarily.

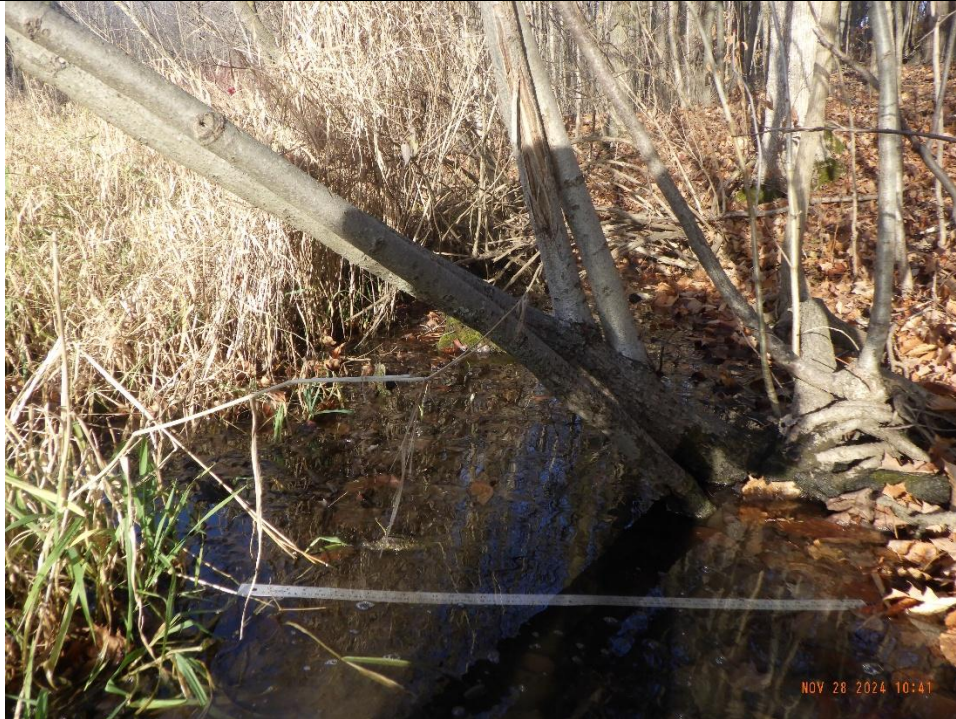
Photo 5
Tributary of the Humber River - Reach THRE-1, Caledon,
Ontario

A few leaning trees and exposed roots were observed throughout the reach.

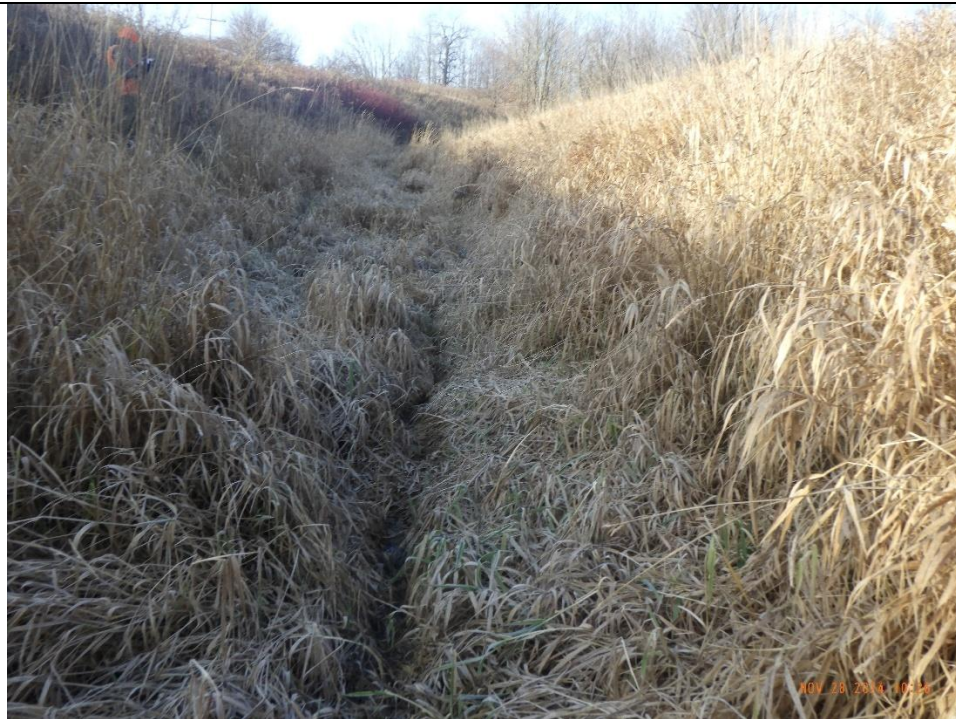
Photo 5
Tributary of the Humber River - Reach THRE-1, Caledon,
Ontario

The downstream portion of the reach was characterized by a straight, defined channel with a steep gradient.

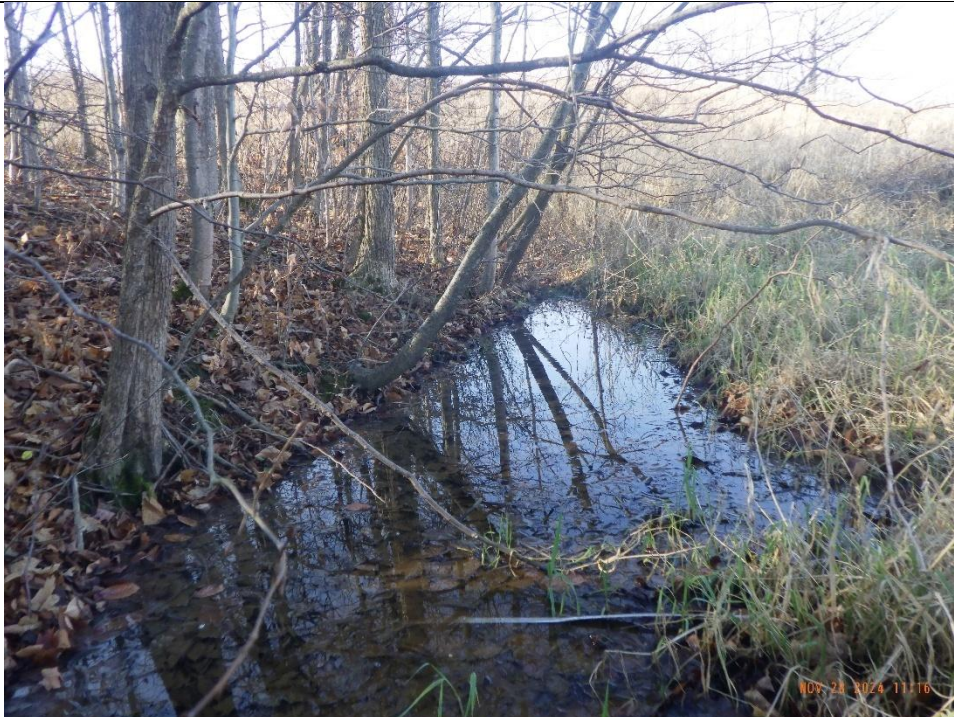
Photo 6
Tributary of the Humber River - Reach THRE-1, Caledon,
Ontario

Localized areas of definition and pooling were observed throughout the reach.

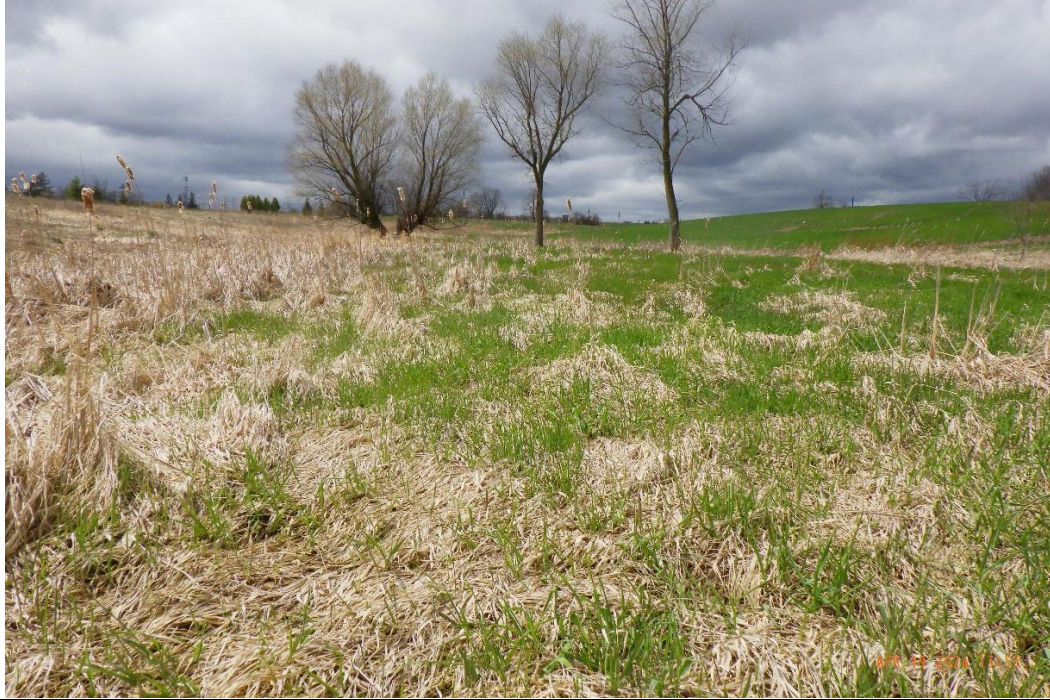
Photo 7
Tributary of the Humber River - Reach THRE-2, Caledon,
Ontario

Reach consisted of a poorly defined wetland with multiple flow paths. Grasses heavily encroached the channel.

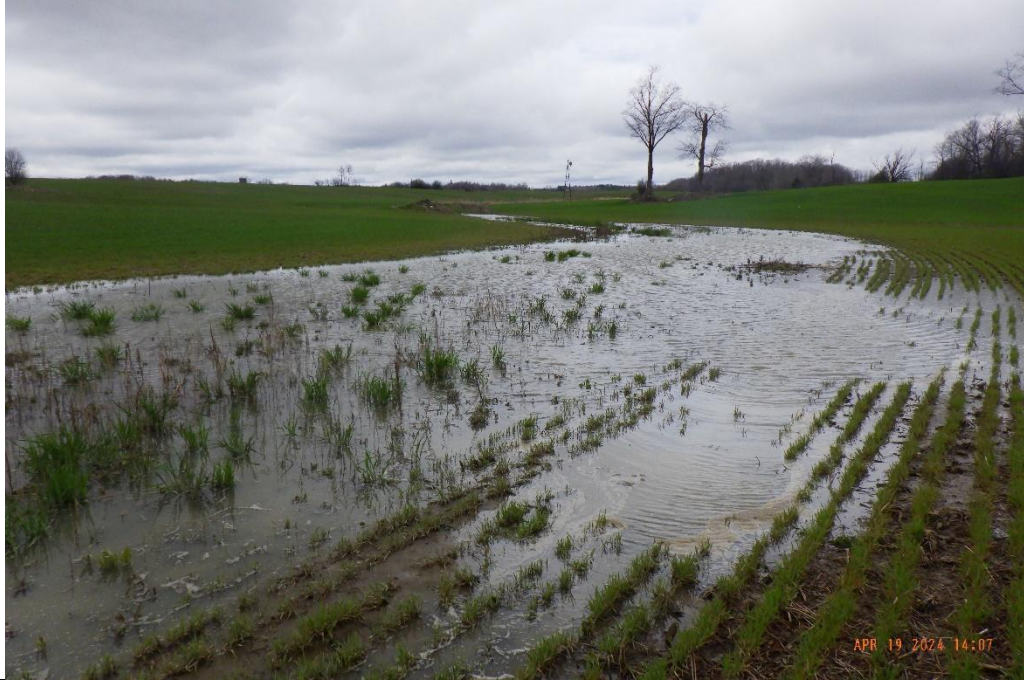
Photo 9
Tributary of the Humber River - Reach THRE-2, Caledon,
Ontario

Pooling and flooding were observed along the poorly defined section of reach between two agricultural fields.

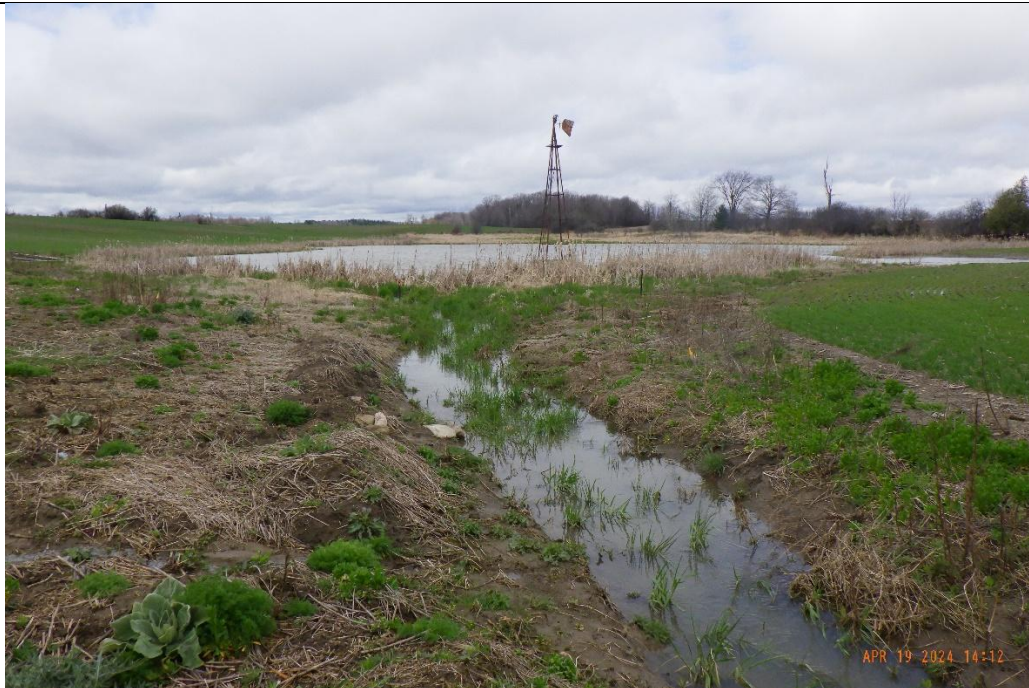
Photo 10
Tributary of the Humber River - Reach THRE-2, Caledon,
Ontario

The pond outlet showed evidence of widening. Cattails and wetland vegetation were present at the outlet.

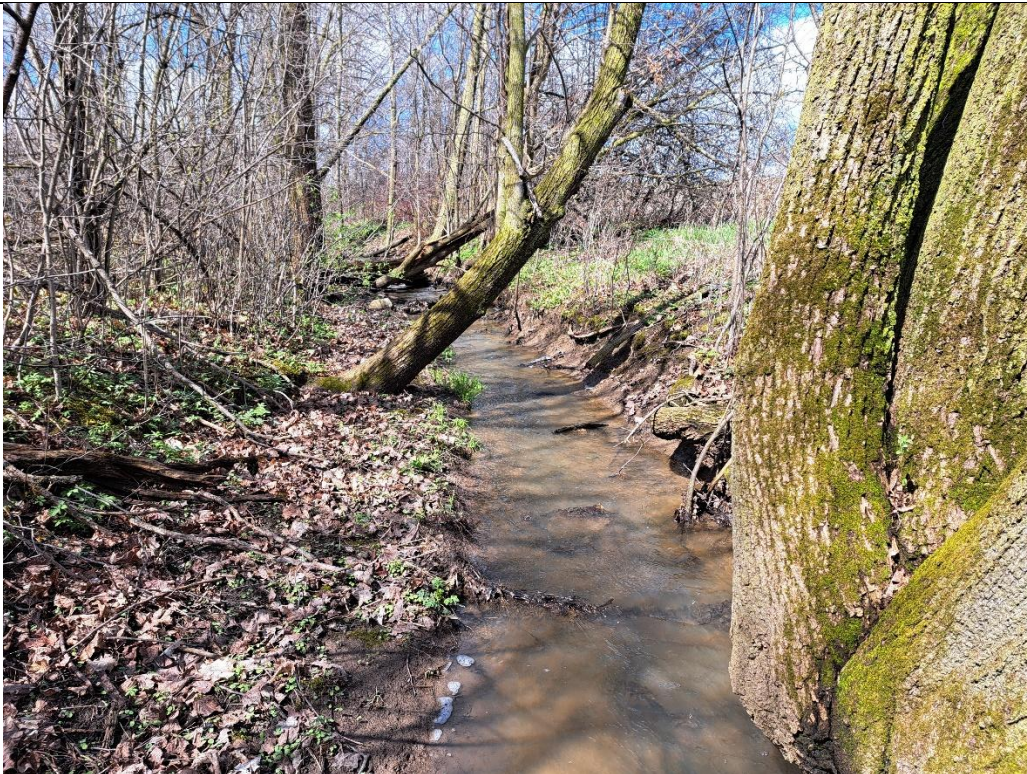
Photo 14
Tributary of the Humber River - Reach THRE-5, Caledon, Ontario

Fallen and leaning trees, exposed roots, and organic debris were observed throughout the reach.

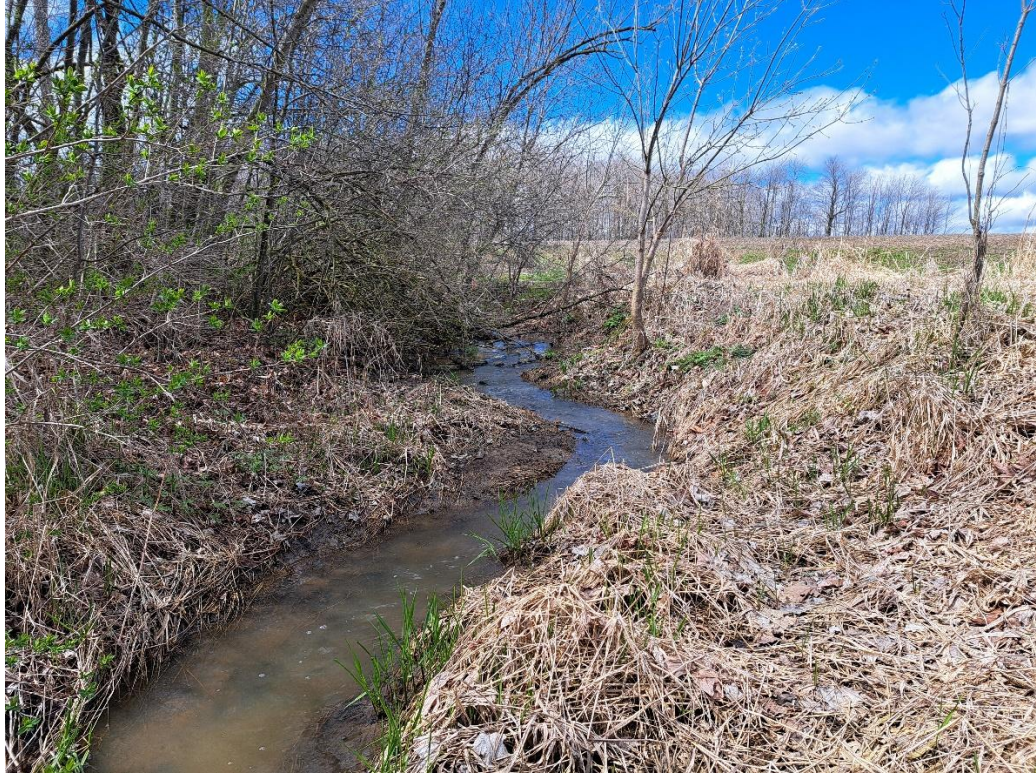
Photo 15
Tributary of the Humber River - Reach THRE-5, Caledon, Ontario

The riparian buffer consisted of forest but was fragmented by adjacent agricultural fields.

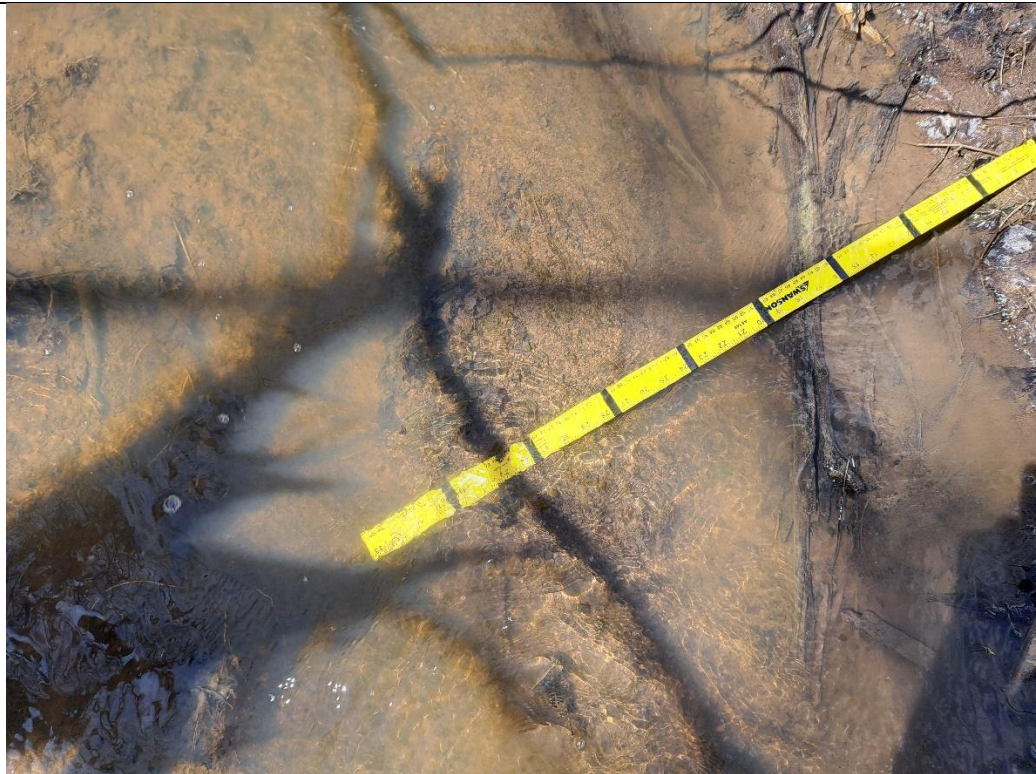
Photo 16
Tributary of the Humber River - Reach THRE-5, Caledon, Ontario

Bed substrate consisted of clay, silt, sand and some gravel. The gravel was very embedded. The bank substrate generally consisted of clay, silt and sand.

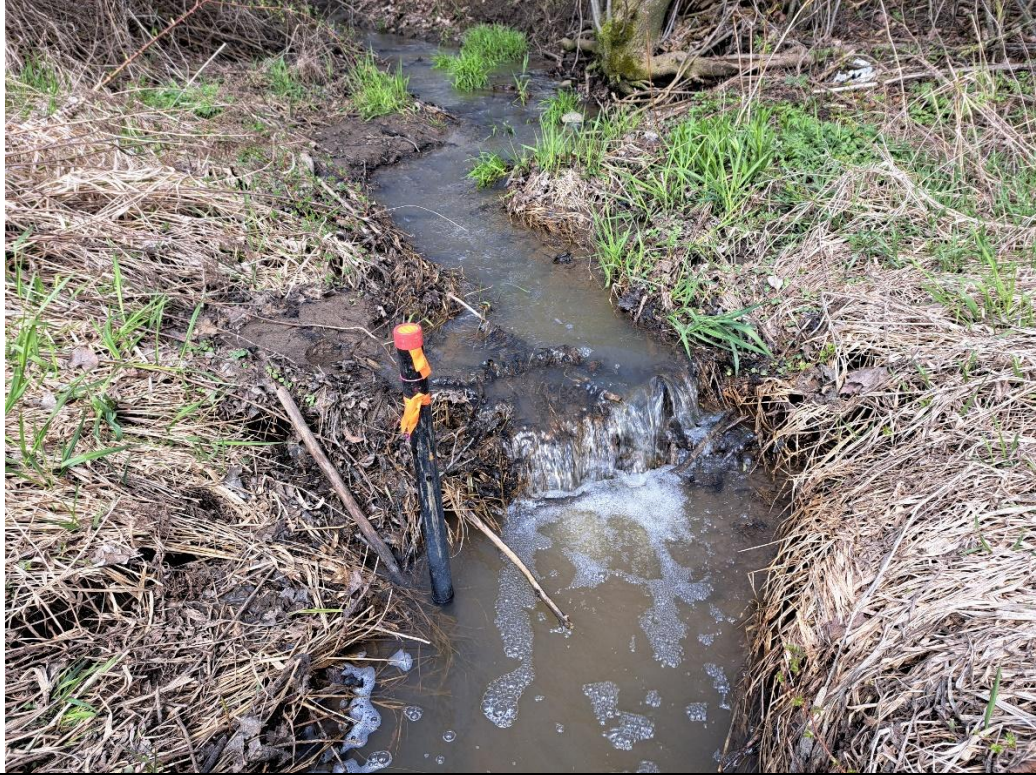
Photo 17
Tributary of the Humber River - Reach THRE-5, Caledon, Ontario

A knickpoint measuring 0.26 m was observed in the downstream portion of the reach. A small pool had formed downstream of the knickpoint.

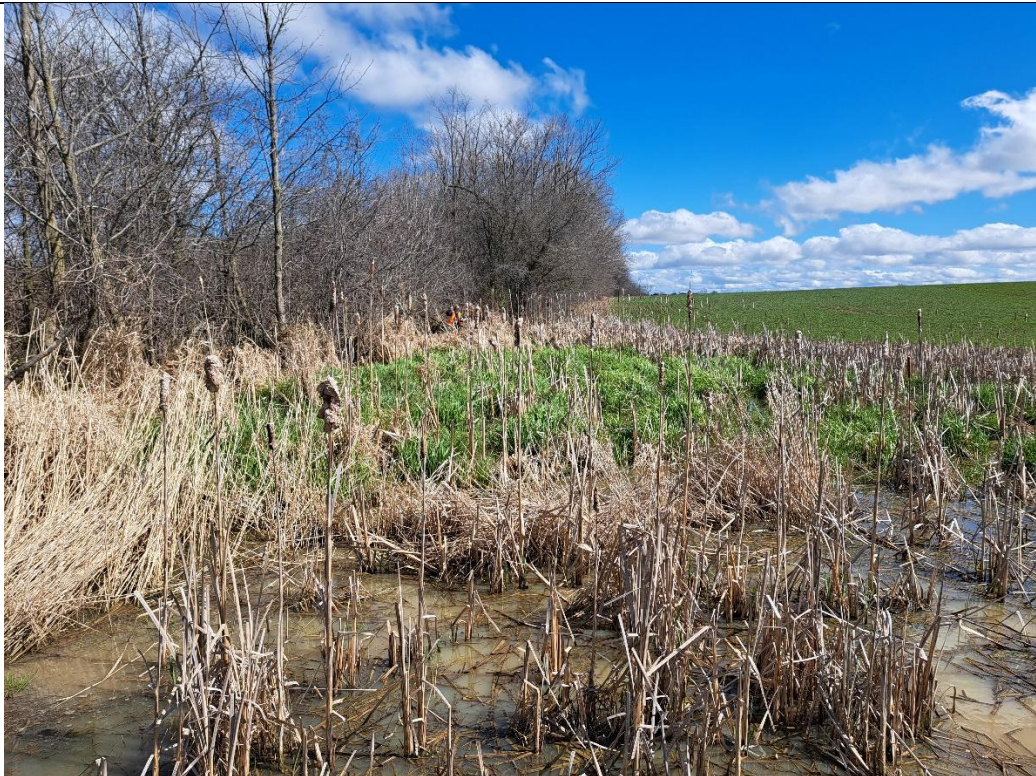
Photo 18
Tributary of the Humber River - Reach THRE-6, Caledon, Ontario

Rooted emergent instream vegetation, including cattails and wetland vegetation, was present in patches throughout the reach; however, the patches were concentrated in the furthest upstream and downstream portions at connections to waterbodies.

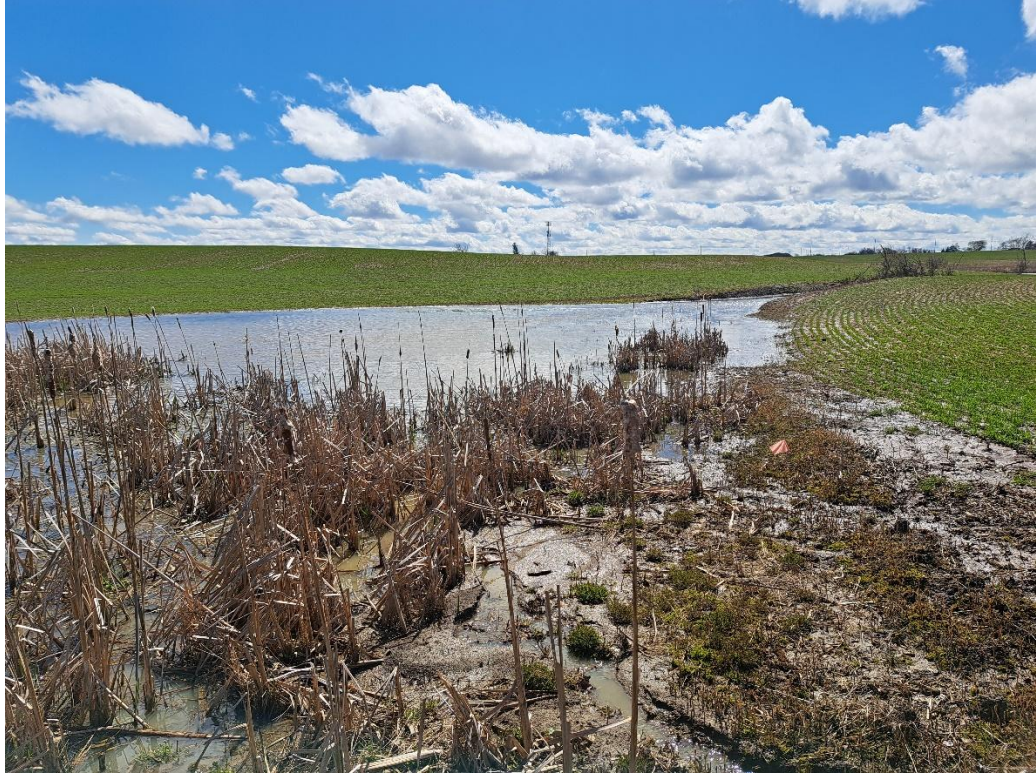
Photo 19
Tributary of the Humber River - Reach THRE-6, Caledon, Ontario

A pond was present at the downstream portion of the reach. Agricultural fields directly abut both sides of the reach.

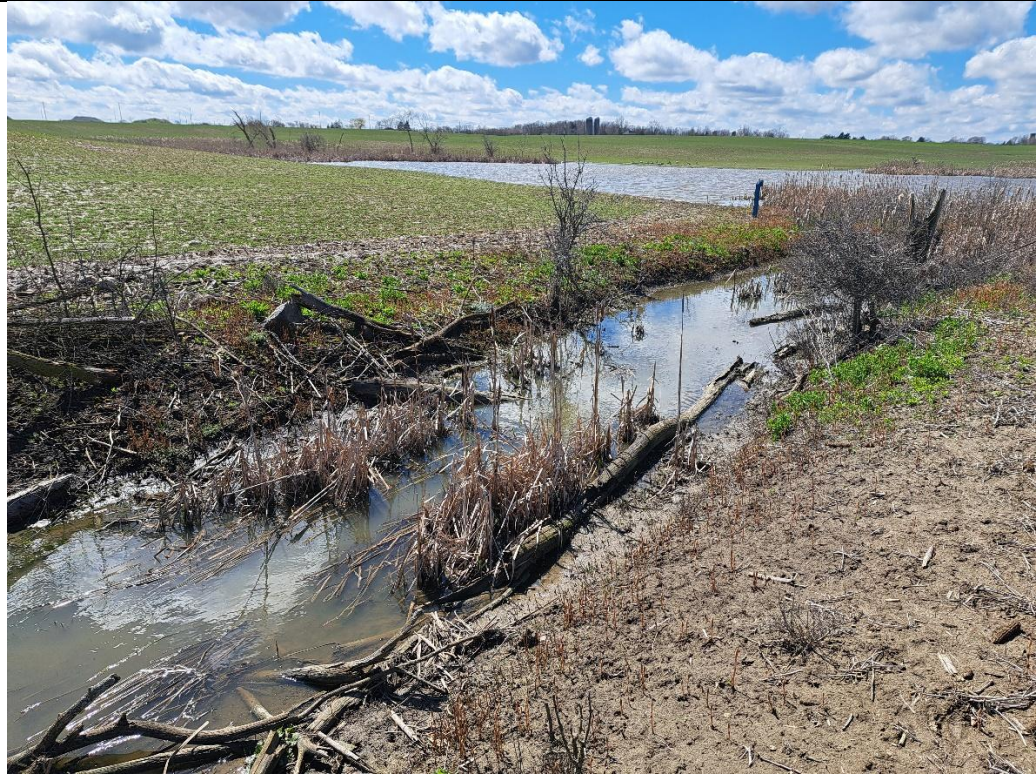
Photo 20
Tributary of the Humber River - Reach THRE-6, Caledon, Ontario

Old woody debris was observed in the channel in the connection between the two waterbodies.

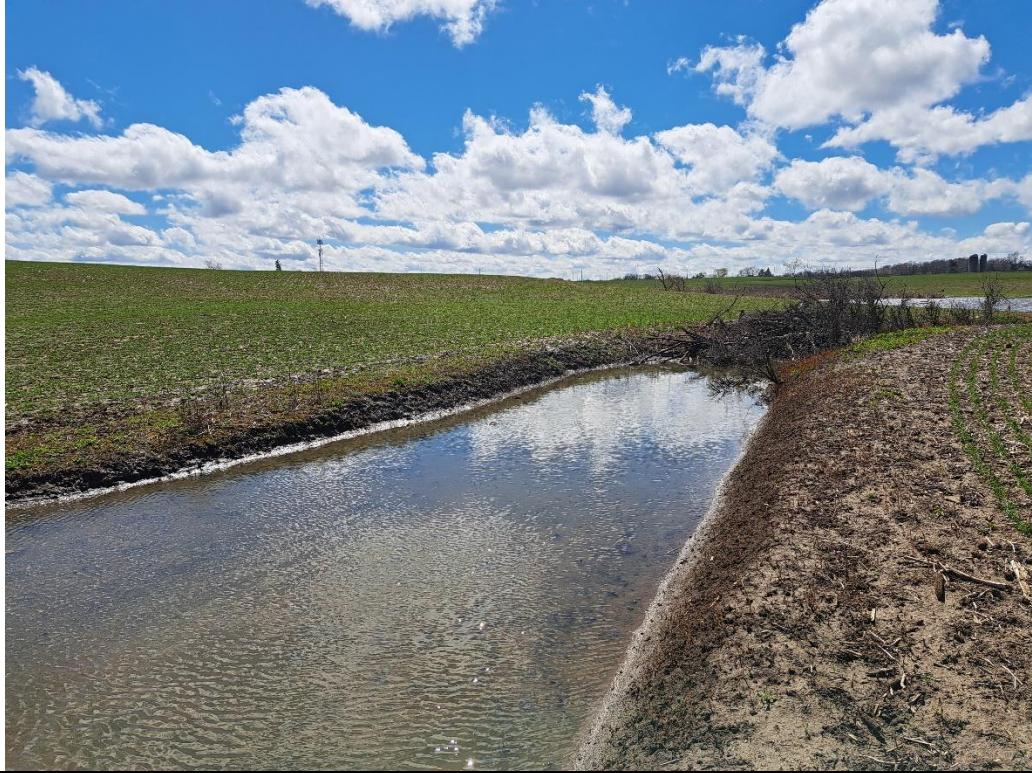
Photo 21
Tributary of the Humber River - Reach THREE-6, Caledon, Ontario

The bed and bank substrate were generally uniformly clay, silt, and sand.

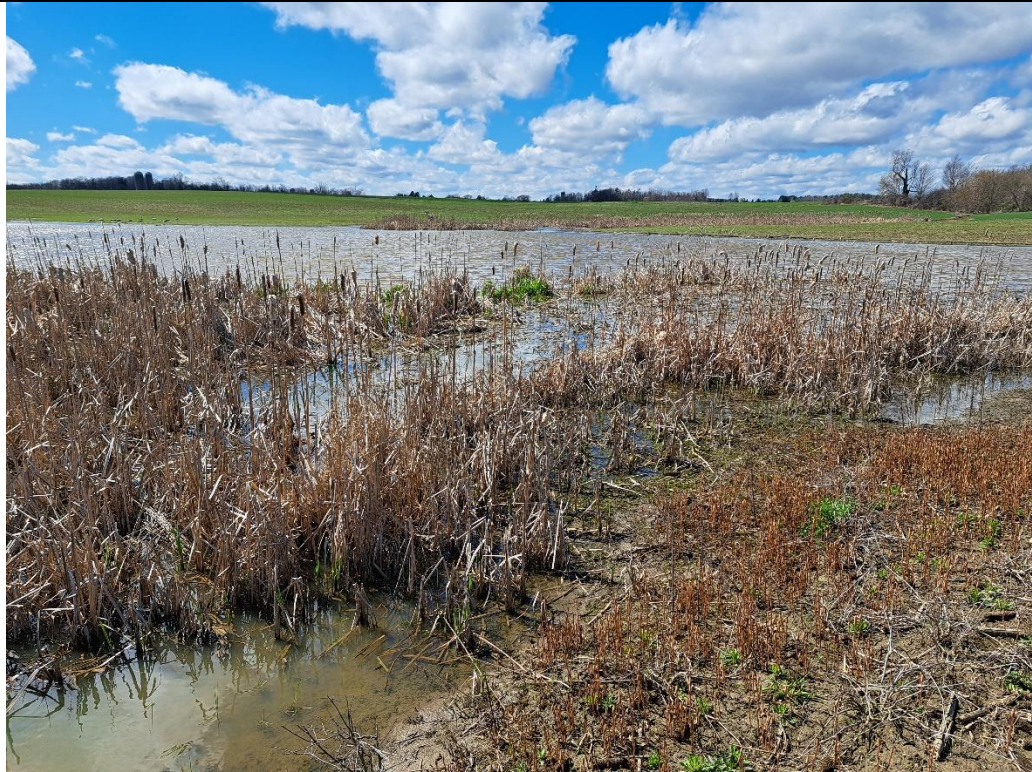
Photo 22
Tributary of the Humber River - Reach THREE-7, Caledon, Ontario

This reach consisted of ponding between two agricultural fields. The banks were gently sloping, and erosion was not observed.

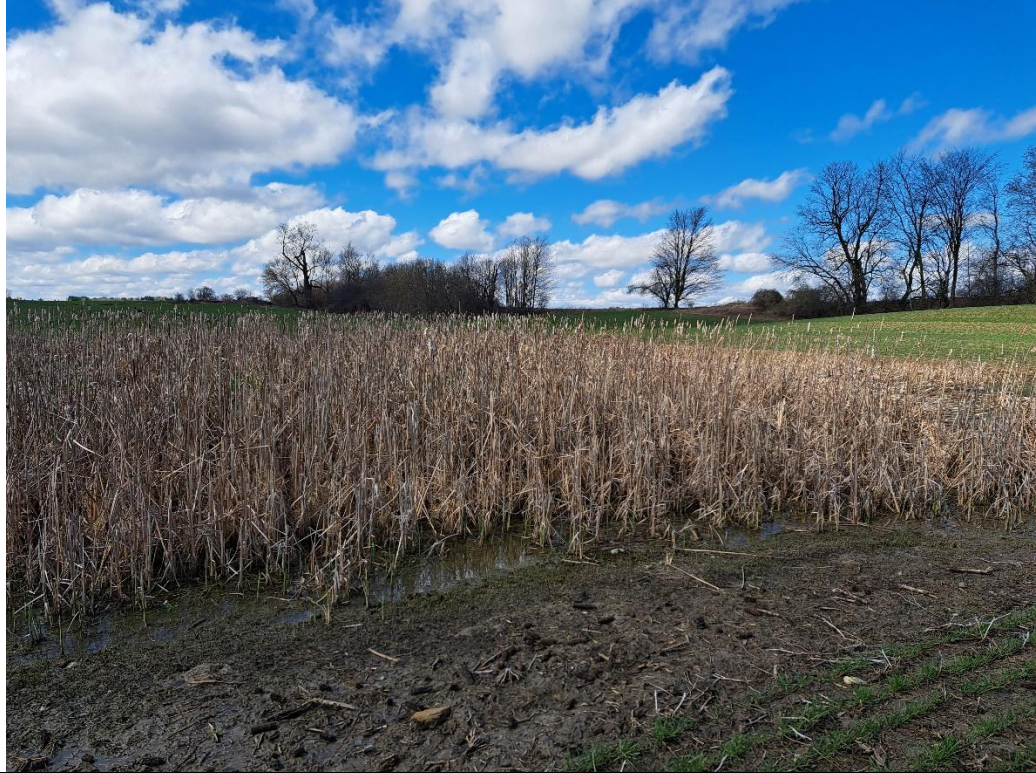
Photo 23
Tributary of the Humber River - Reach THRE-7, Caledon, Ontario

Rooted emergent instream vegetation was present throughout 65% of the reach. Large patches of cattails and wetland vegetation occurred at the inlet and outlet of the waterbody.

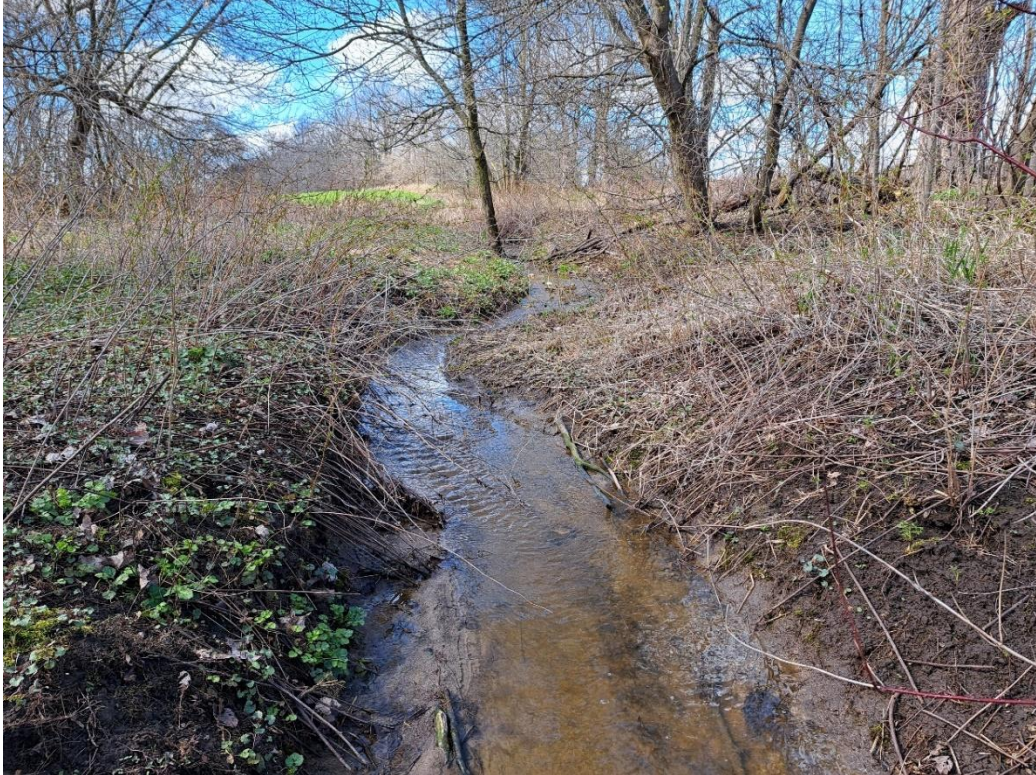
Photo 24
Tributary of the Humber River - Reach THRE-8, Caledon, Ontario

This reach was run-dominant; however, riffles and pools were observed in localized areas.

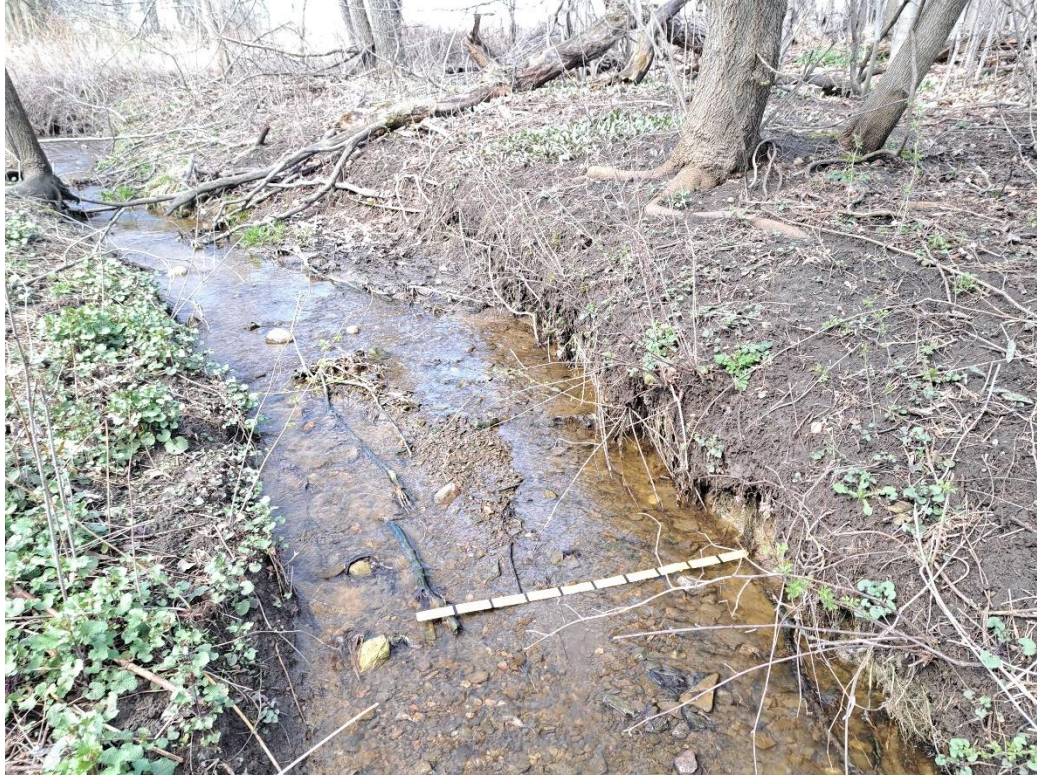
Photo 25
Tributary of the Humber River - Reach THREE-8, Caledon, Ontario

The bed substrate was comprised of clay, silt, gravel, and cobbles. The bank substrate consisted of clay, silt and sand.

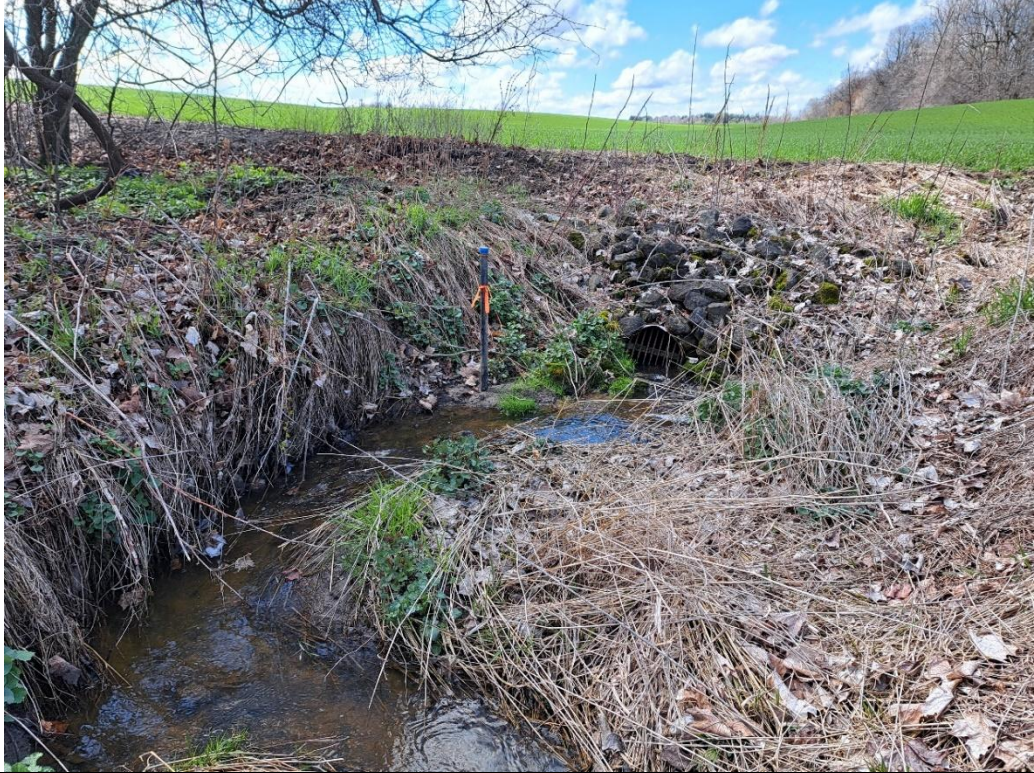
Photo 27
Tributary of the Humber River - Reach THRE-8, Caledon, Ontario

A tile drain with rip rap erosion protection was located at the upstream end of the reach. The riparian vegetation was fragmented in the upstream extent, where grasses were prevalent.

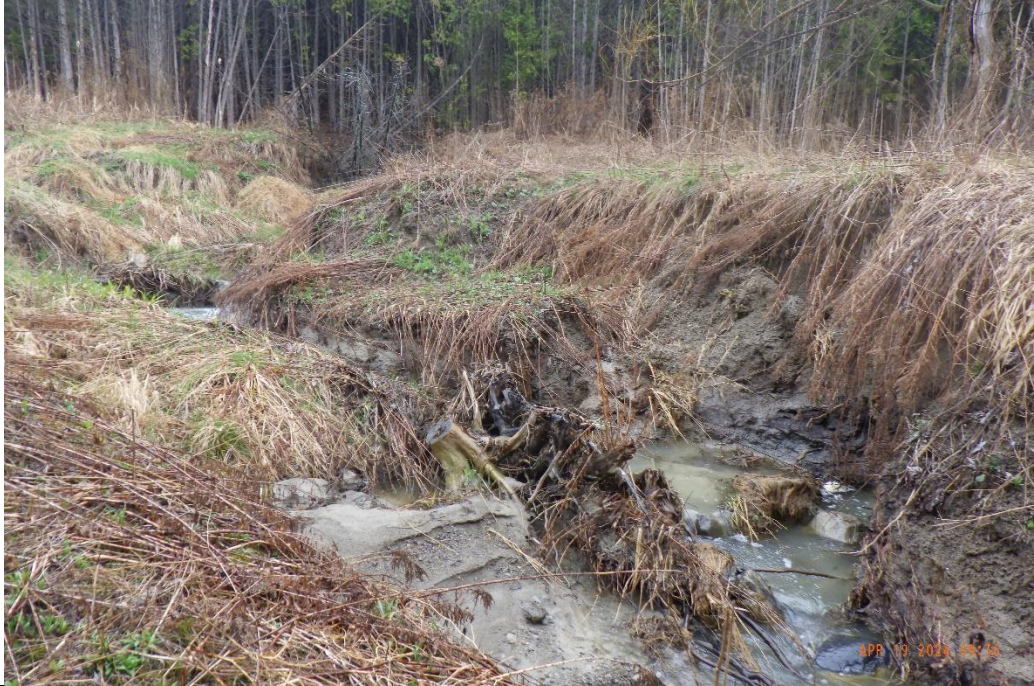
Photo 28
Tributary of the Humber River - Reach THRD-1, Caledon, Ontario

Multiple locations along the reach contained mass failures and fracture lines along the banks.

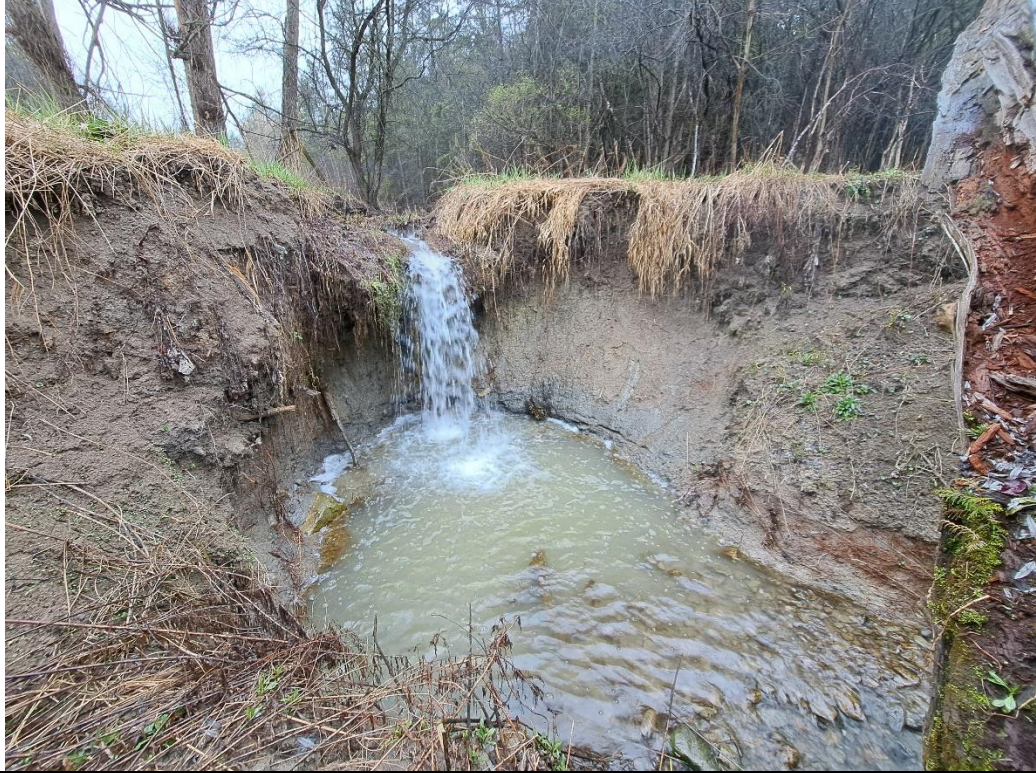
Photo 29
Tributary of the Humber River - Reach THRD-1, Caledon, Ontario

Multiple large knickpoints and scour pools occurred along the reach, indicative of channel adjustment.

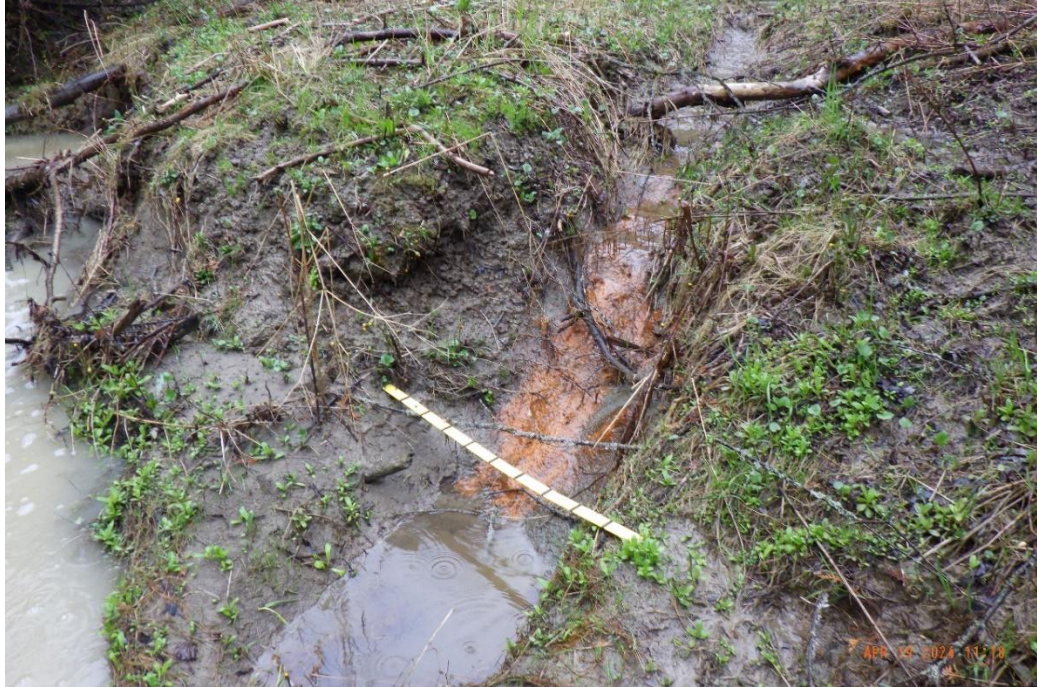
Photo 31
Tributary of the Humber River - Reach THRD-1, Caledon,
Ontario

Iron staining was present in various locations throughout the reach, indicating the presence of groundwater.

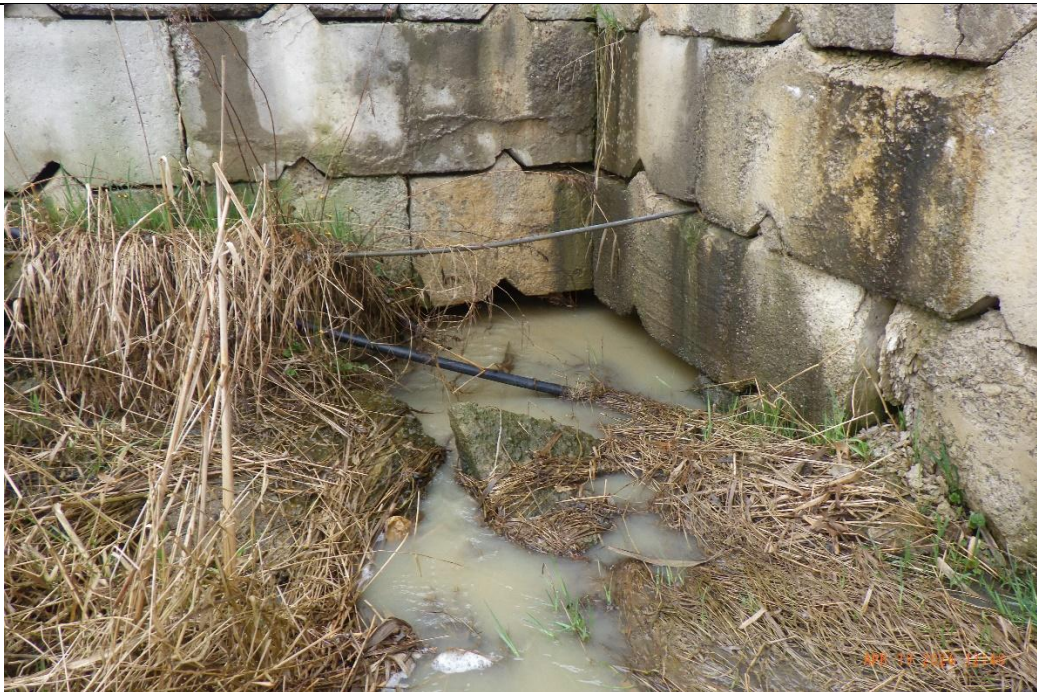
Photo 32
Tributary of the Humber River - Reach THRD-2b, Caledon,
Ontario

The downstream portion of the reach flowed under a concrete wall and was assumed to be piped. Due to access limitations, this was the furthest downstream observation collected along this reach.

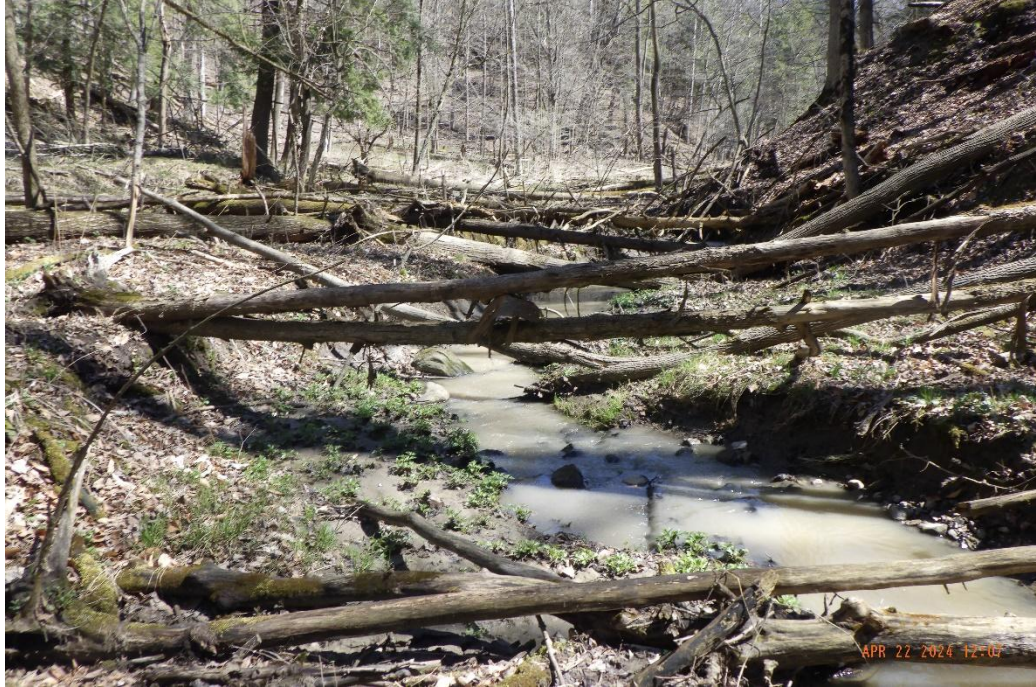
Photo 37
Tributary of the Humber River - Reach THRC-1, Caledon,
Ontario

Exposed roots, leaning and fallen trees and organic debris were observed throughout the reach.

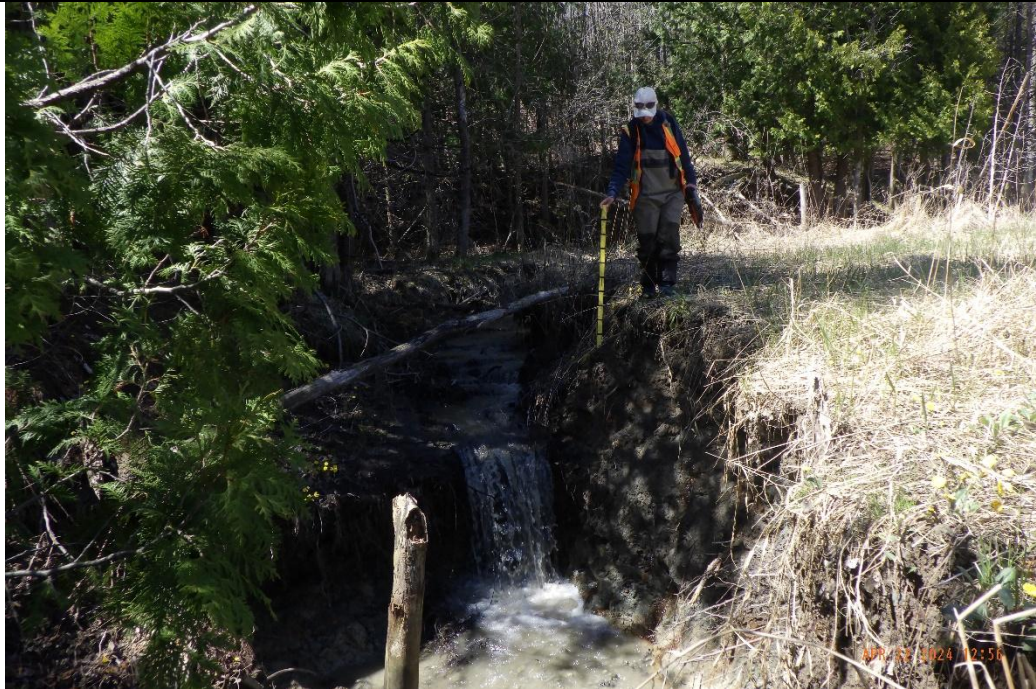
Photo 38
Tributary of the Humber River - Reach THRC-1, Caledon,
Ontario

A knickpoint and scour pool were present in the downstream portion of the reach, where increased erosion was also noted.

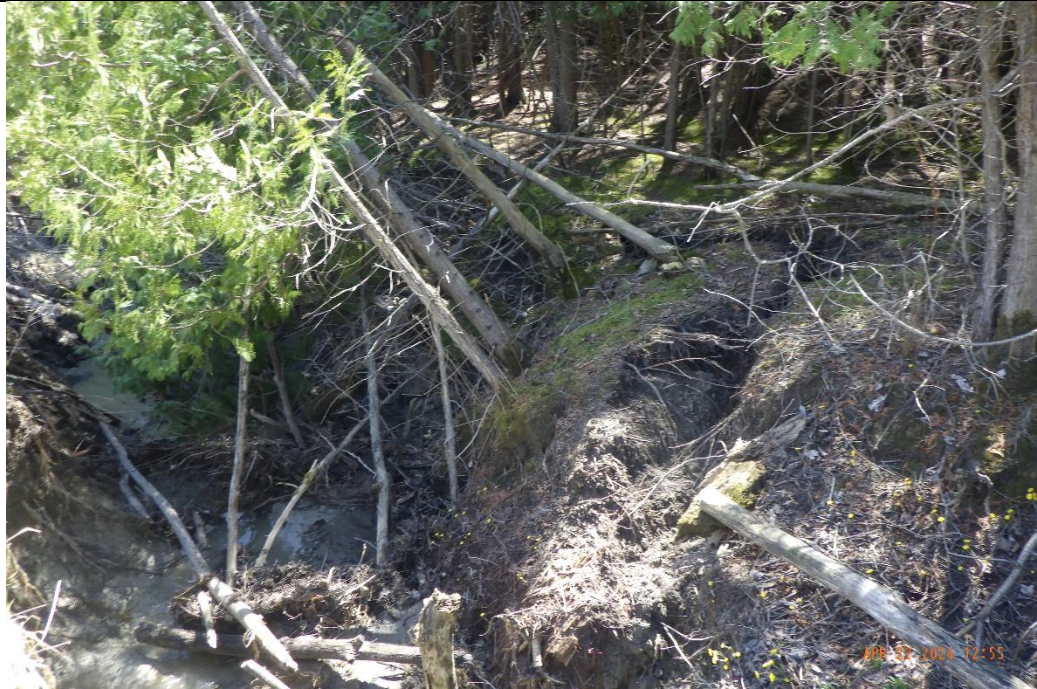
Photo 39
Tributary of the Humber River - Reach THRC-1, Caledon,
Ontario

Mass failures were observed along this reach, particularly following large knickpoints. The mass failures and valley wall contacts contributed to the woody debris in the channel.
