Humber River Tributaries Fluvial Geomorphological Assessment

**Bolton North Hill Secondary Plan Area
Local Subwatershed Study - Stage 1**
Town of Caledon, Ontario

GEO Morphix Project No. PN24084

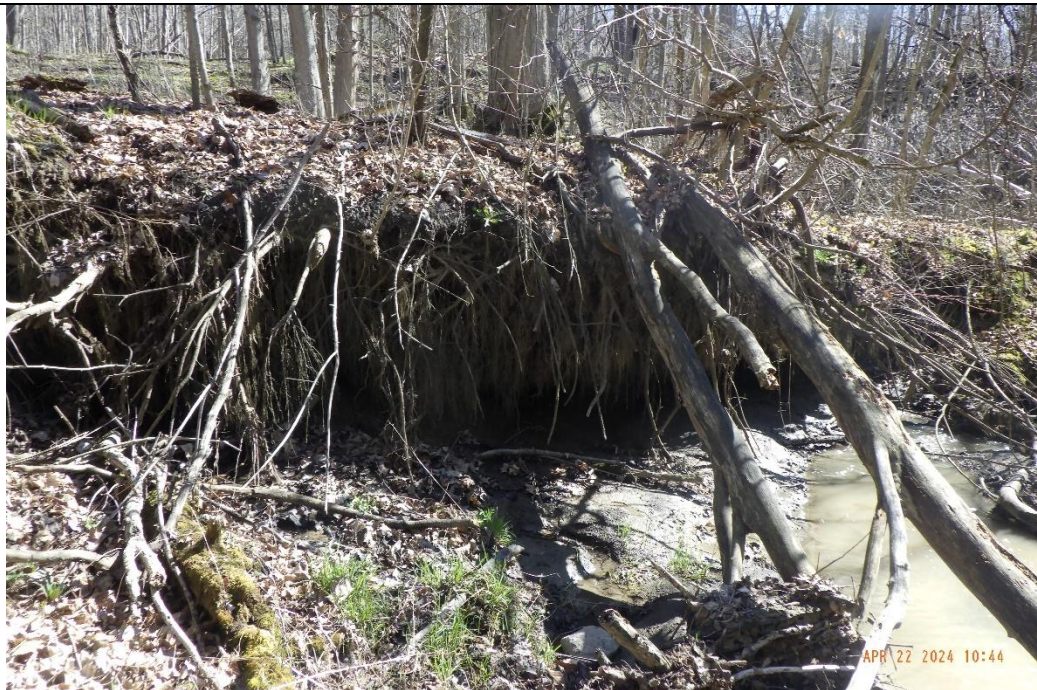
Photo 40
Tributary of the Humber River - Reach THRC-2, Caledon,
Ontario

Erosion was found throughout the reach and undercuts measured up to 1.63 m.

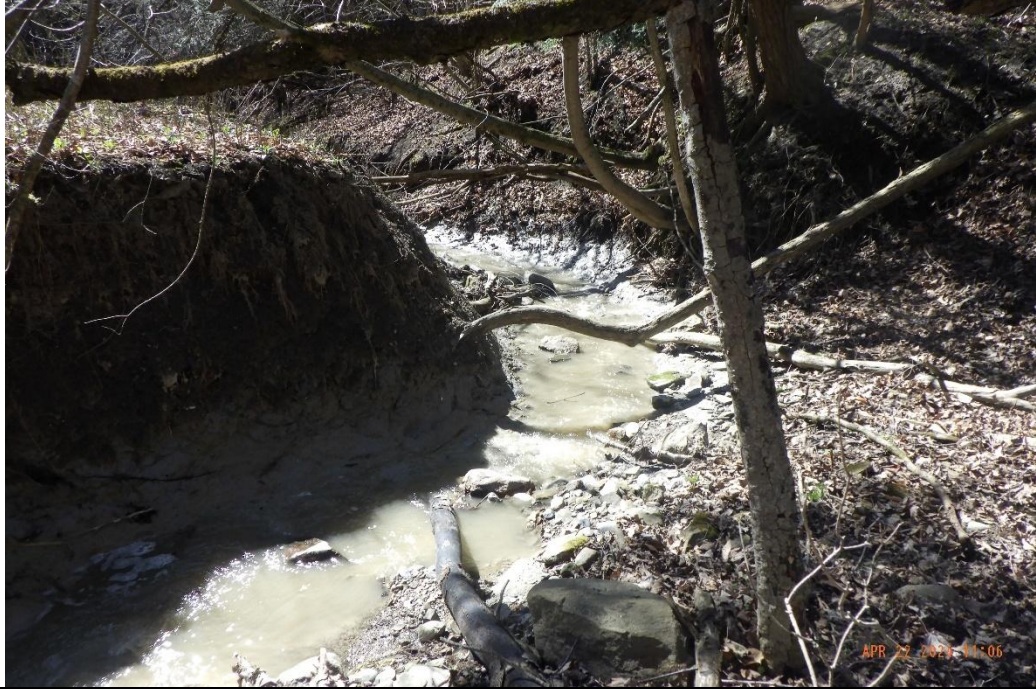
Photo 41
Tributary of the Humber River - Reach THRC-2, Caledon,
Ontario

The channel meandered within a confined valley and was highly entrenched.

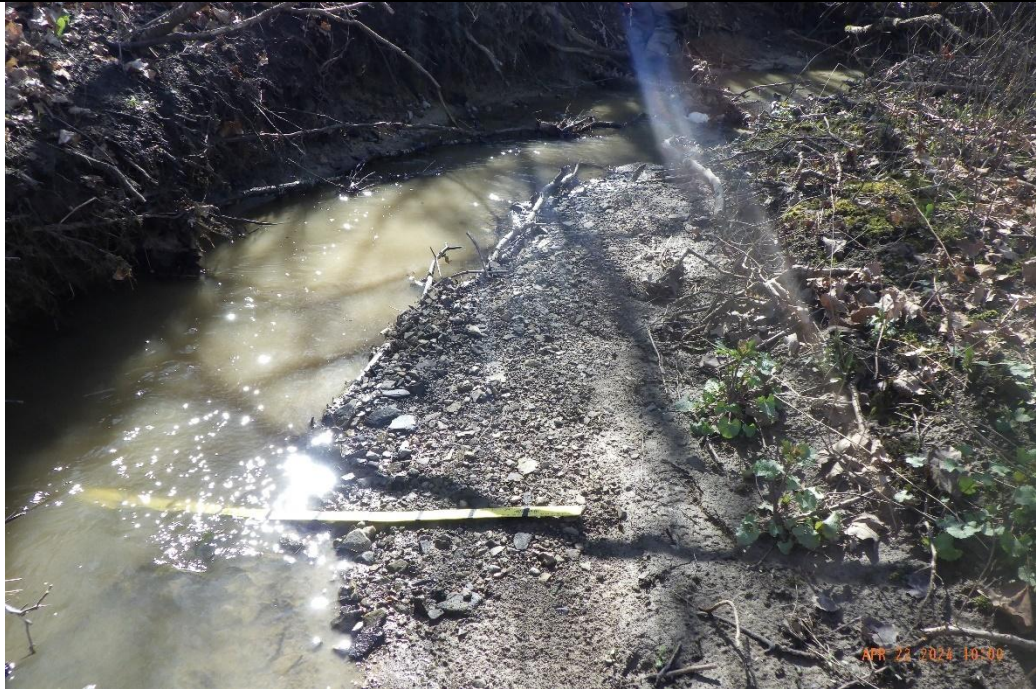
Photo 44
Tributary of the Humber River - Reach THRC-3, Caledon,
Ontario

Accretion (sand and gravel) on point bars was observed along the reach. Channel substrate was predominantly comprised of cobble.

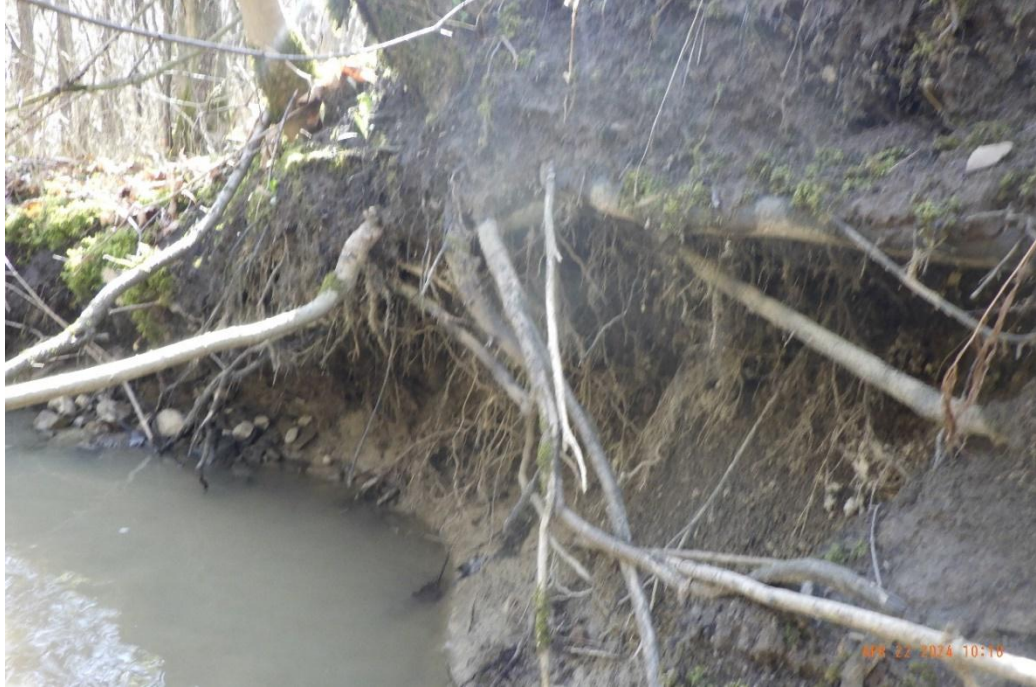
Photo 45
Tributary of the Humber River - Reach THRC-3, Caledon,
Ontario

Undercuts were observed in various locations along the reach and measured up to 0.78 m.

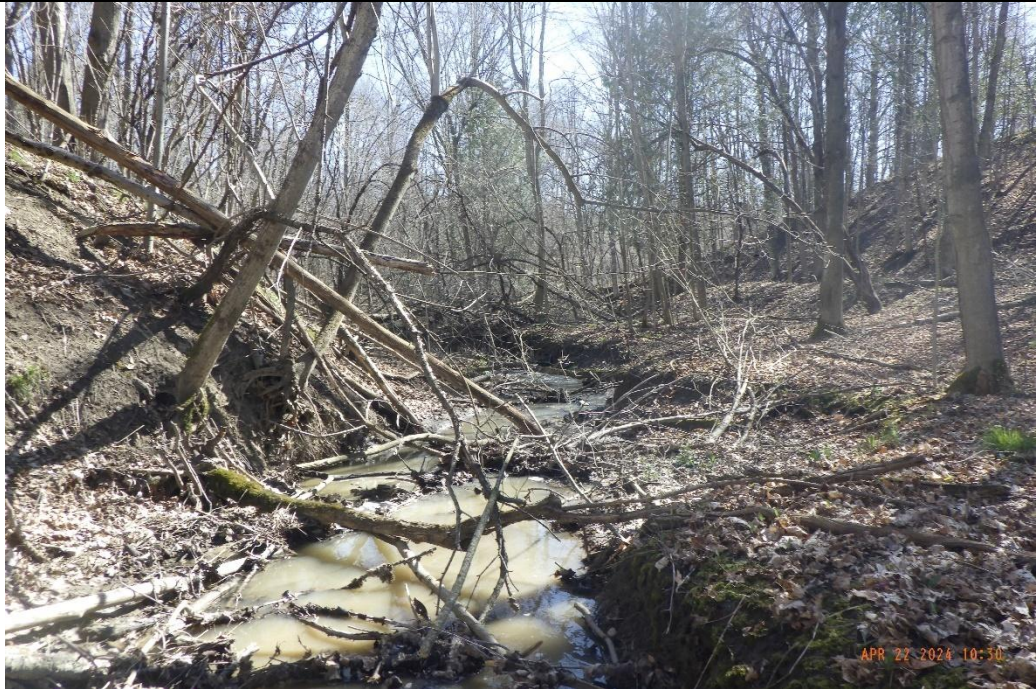
Photo 46
Tributary of the Humber River - Reach THRC-3, Caledon,
Ontario

Woody debris was observed in the channel with a few rooted emergent instream vegetation patches.

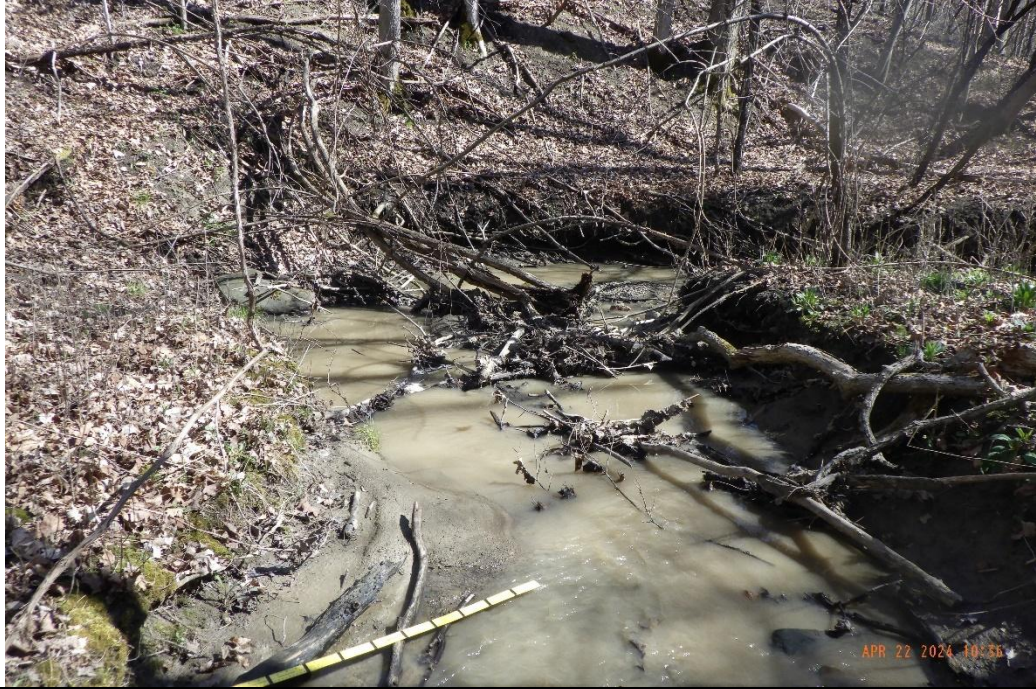
Photo 47
Tributary of the Humber River - Reach THRC-3, Caledon,
Ontario

The channel flowed through a confined valley with a forested riparian buffer.

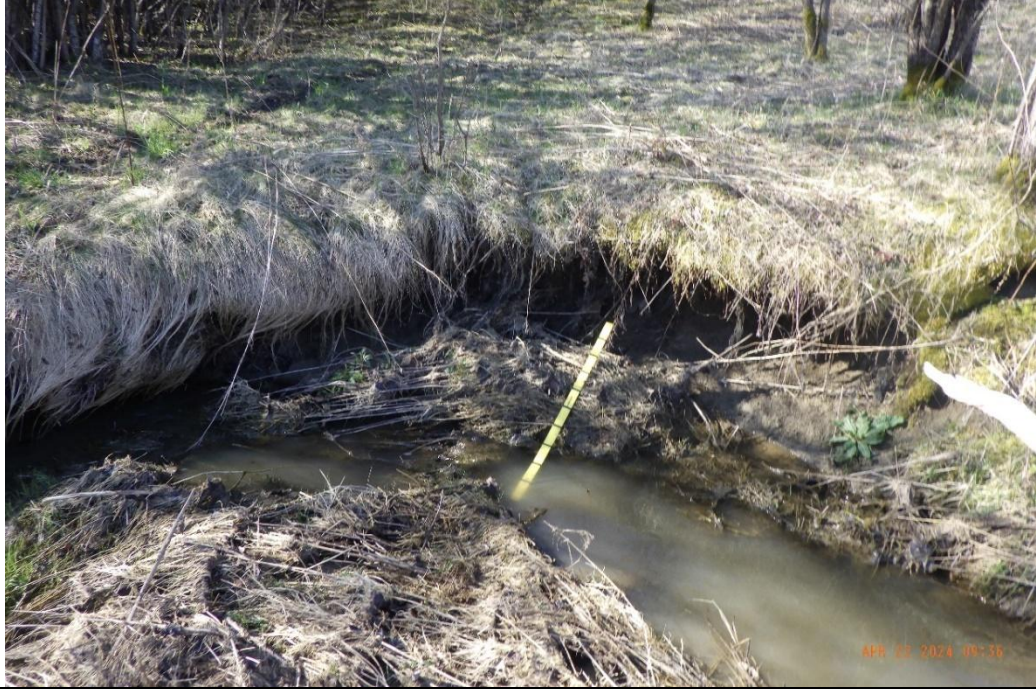
Photo 51
Tributary of the Humber River - Reach THRC-4, Caledon, Ontario

Erosion was observed throughout the reach. Meadow grasses covered the channel banks. Minor undercutting was observed.

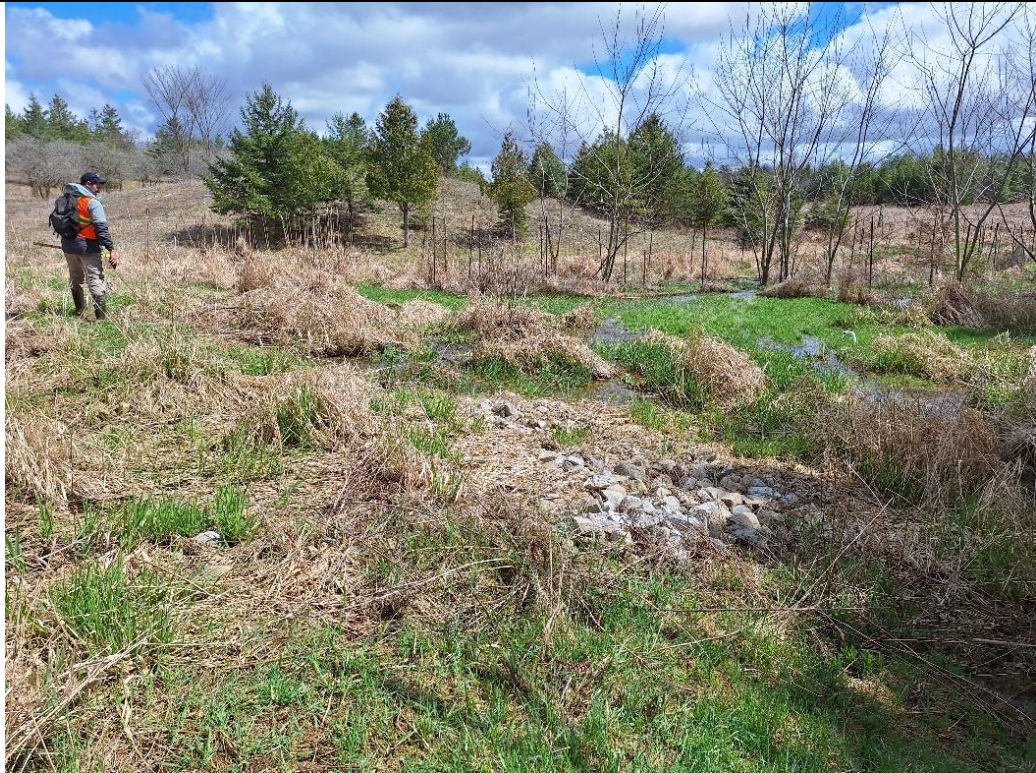
Photo 52
Tributary of the Humber River - Reach THRC-5, Caledon, Ontario

The reach contained a wetland feature that had recently been restored. Erosion control measures were placed at the outlet from a pond to the wetland feature.

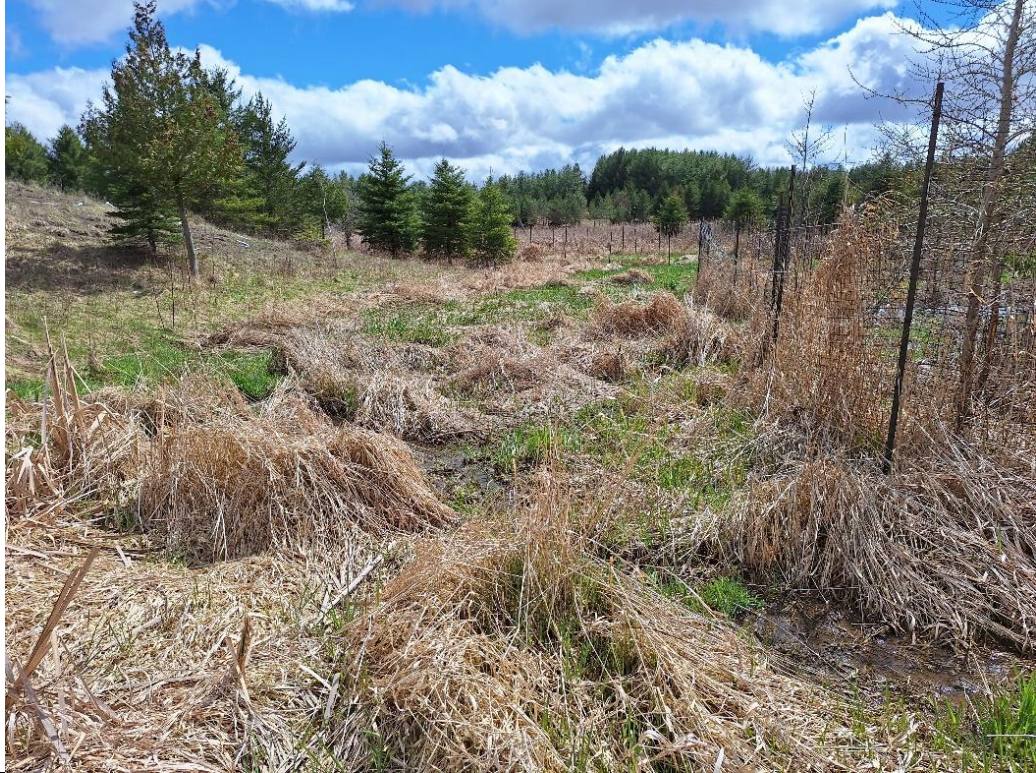
Photo 53
Tributary of the Humber River - Reach THRC-5, Caledon, Ontario

Access to the reach was limited due to recent restoration activities. Grasses were present along 90% of the reach, which contained multiple flow paths.

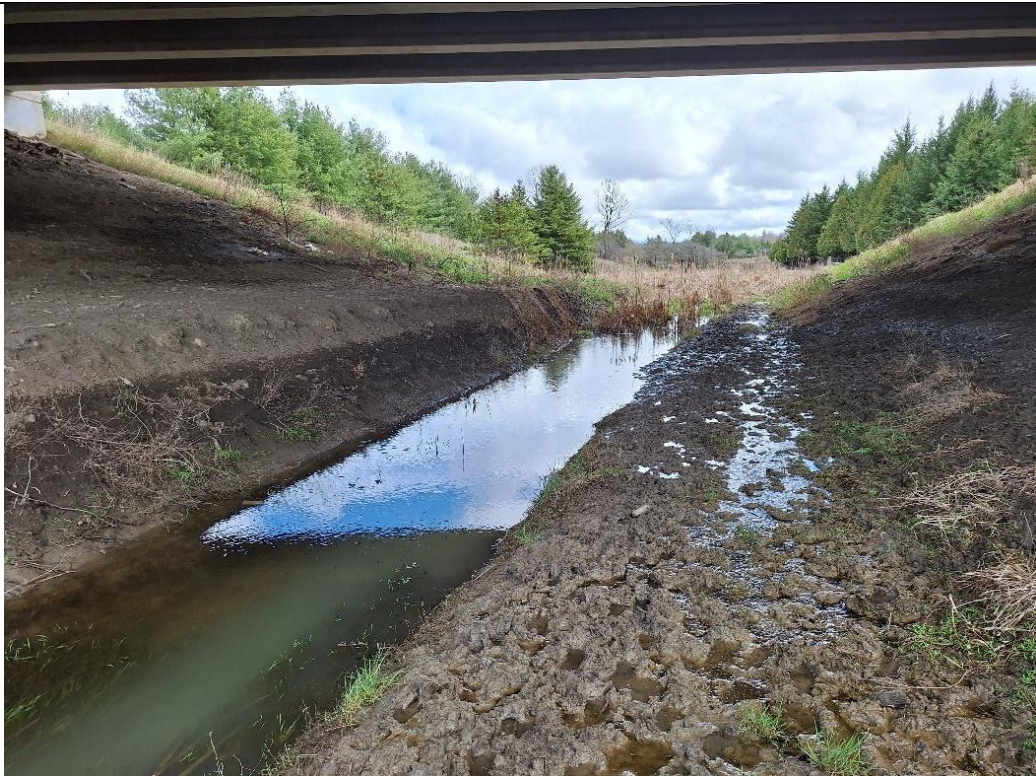
Photo 54
Tributary of the Humber River - Reach THRC-6, Caledon, Ontario

At the upstream extent of the reach the channel had been straightened under the bridge crossing.

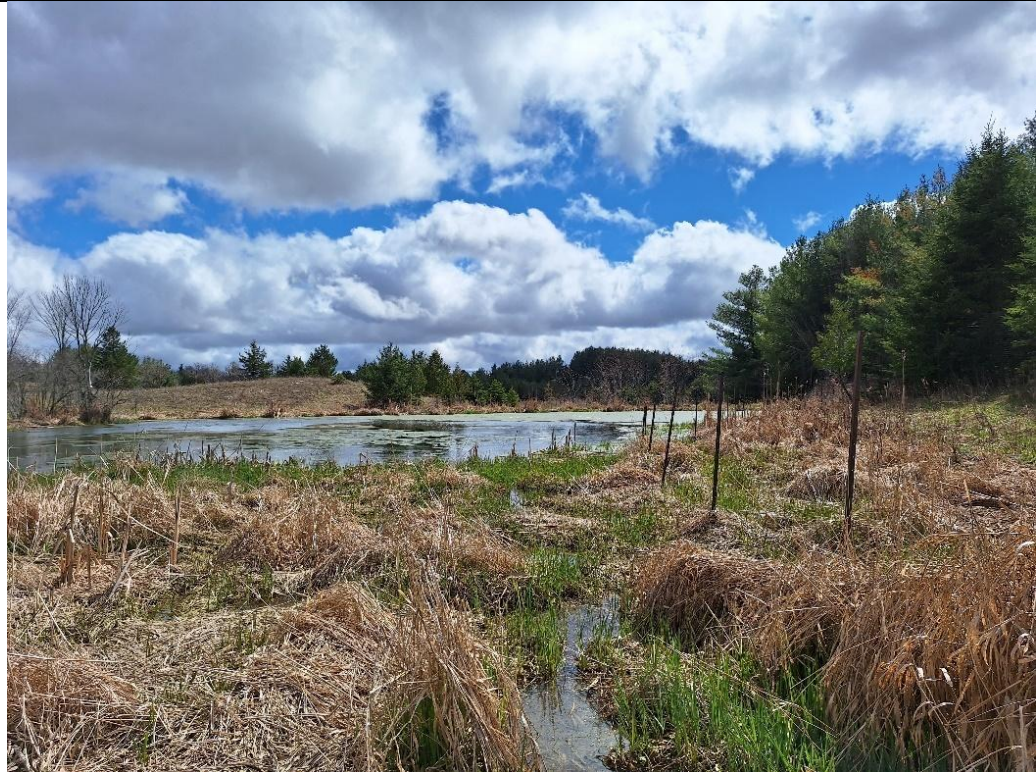
The downstream portion of the reach connected to an online wetland and was unconfined.

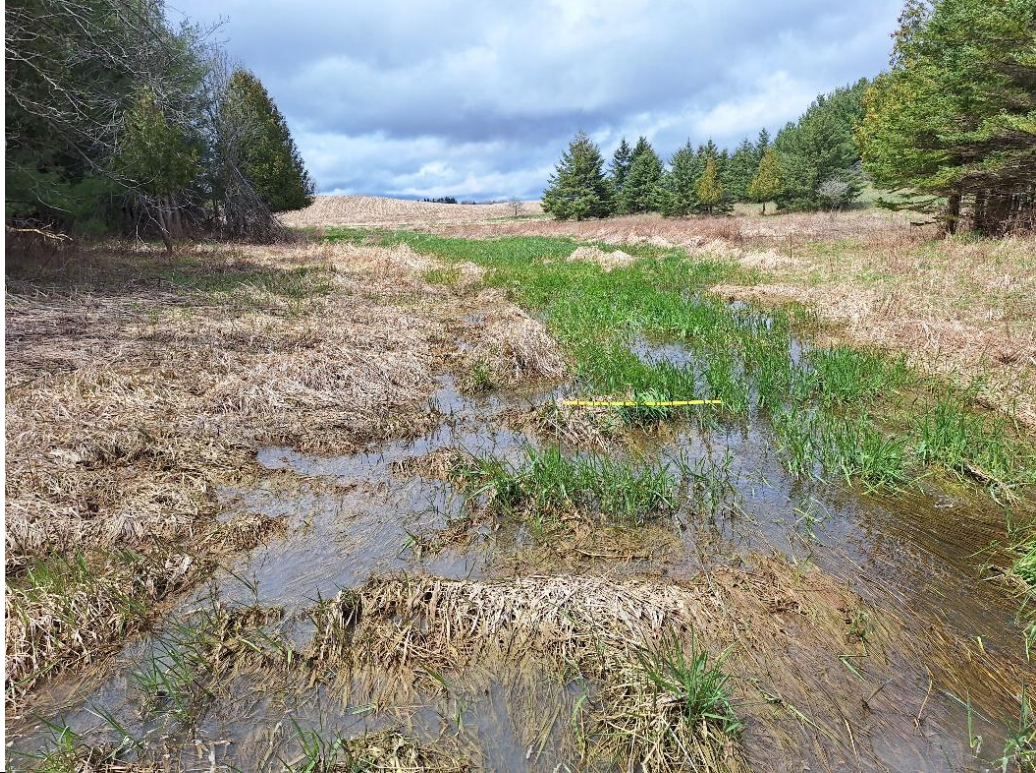
The reach contained a low gradient, multi-thread channel with shallow banks and was unconfined.

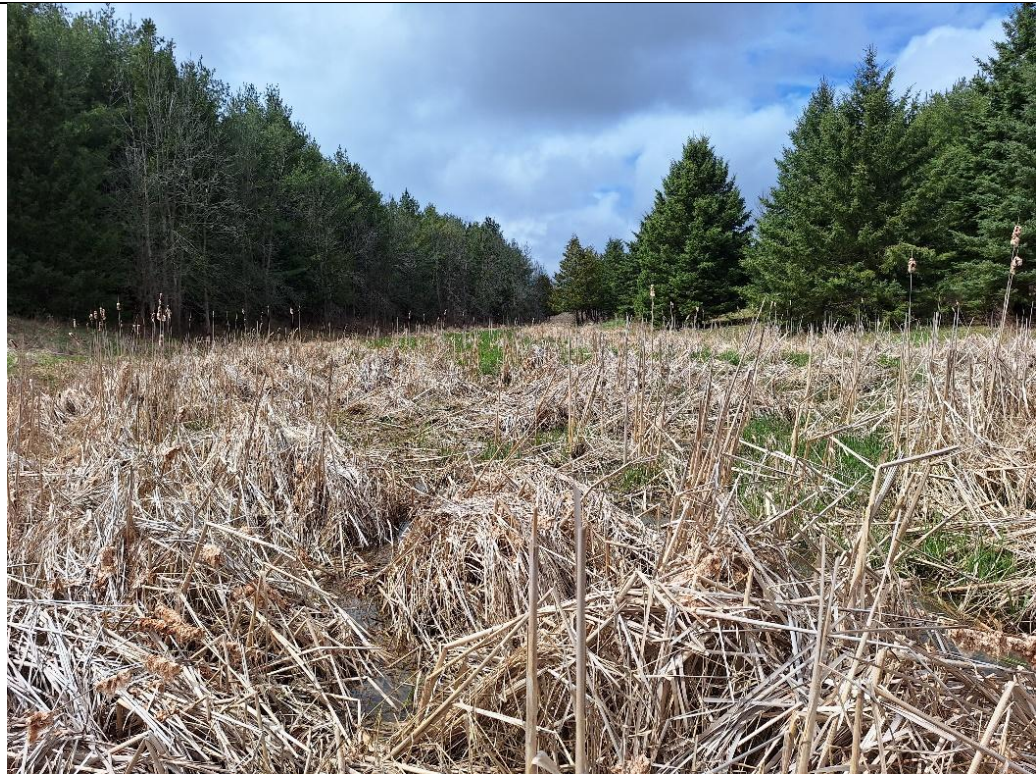
Instream vegetation generally consisted of rooted emergent species that occupied the entirety of the reach.

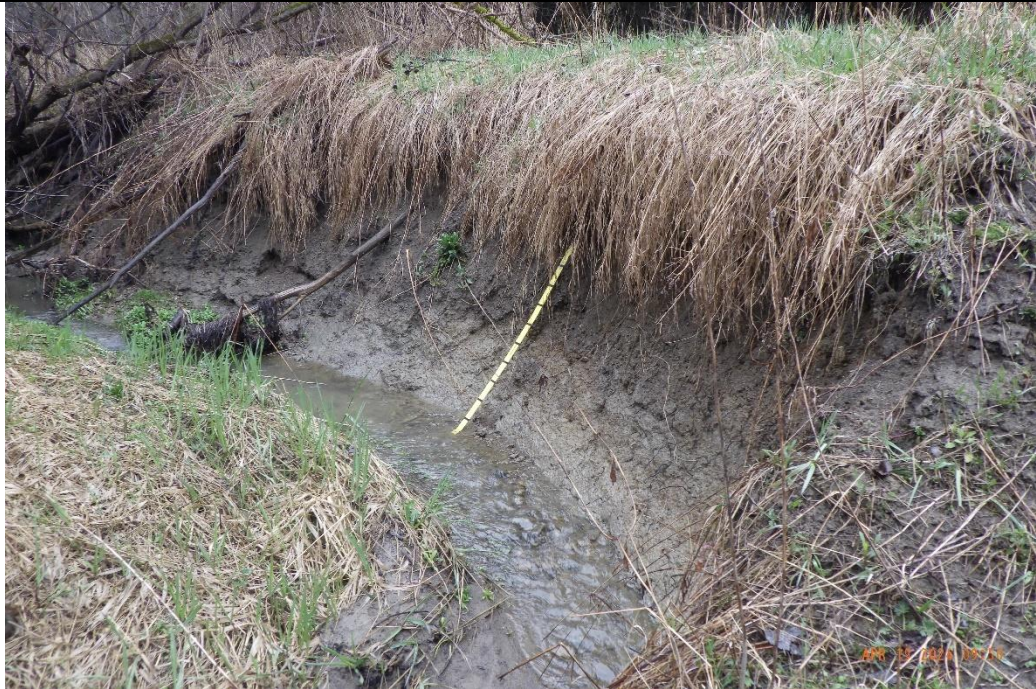
The channel had steep banks and ongoing active erosion. Valley wall contacts and bank undercutting were observed.

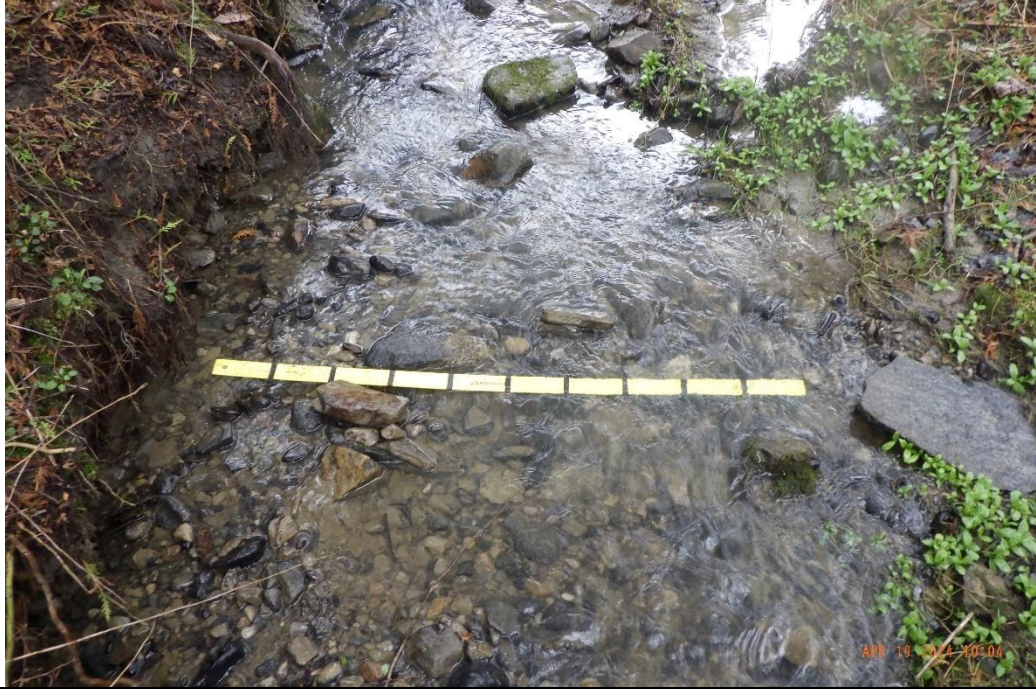
The bank substrate primarily consisted of cobbles. Instream vegetation was present in approximately 20% of the reach.

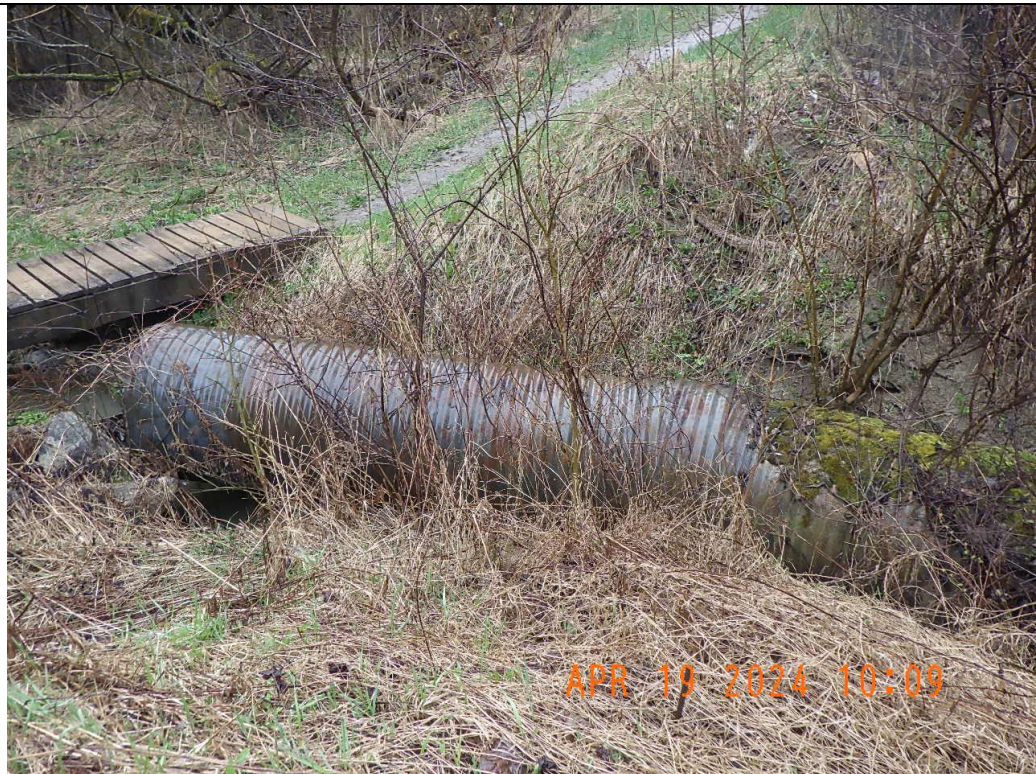
A previously buried culvert was entirely exposed upstream a small crossing.

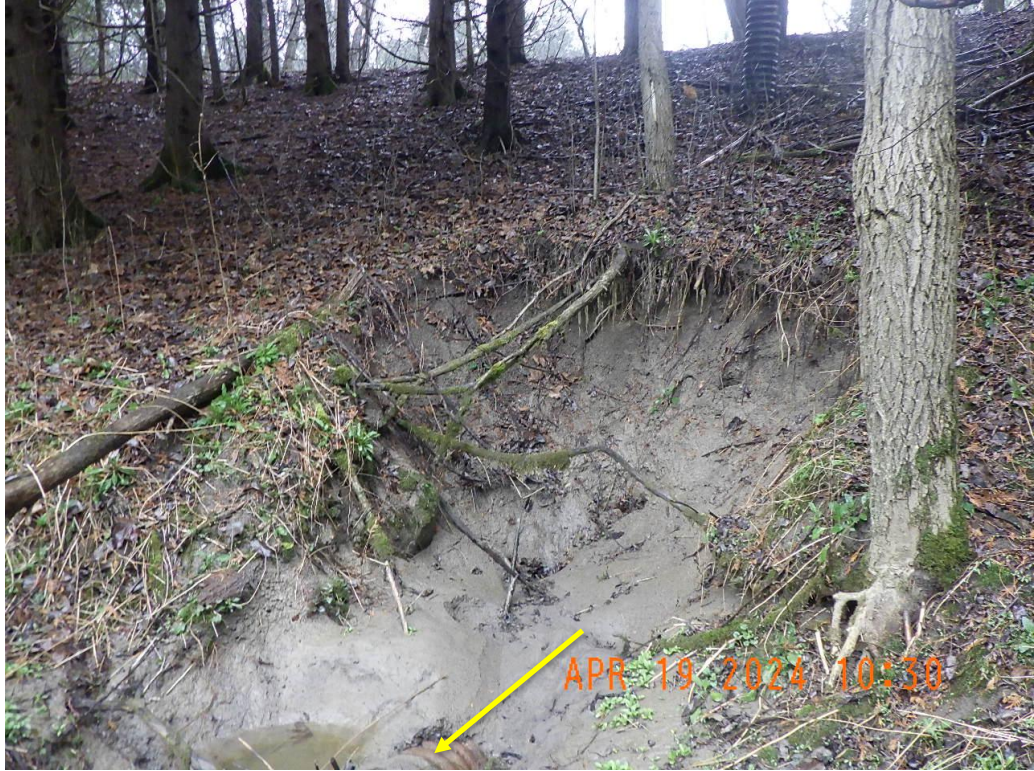
A mass failure had occurred at the downstream portion of the reach, exposing a pipe that was discharging into the channel.

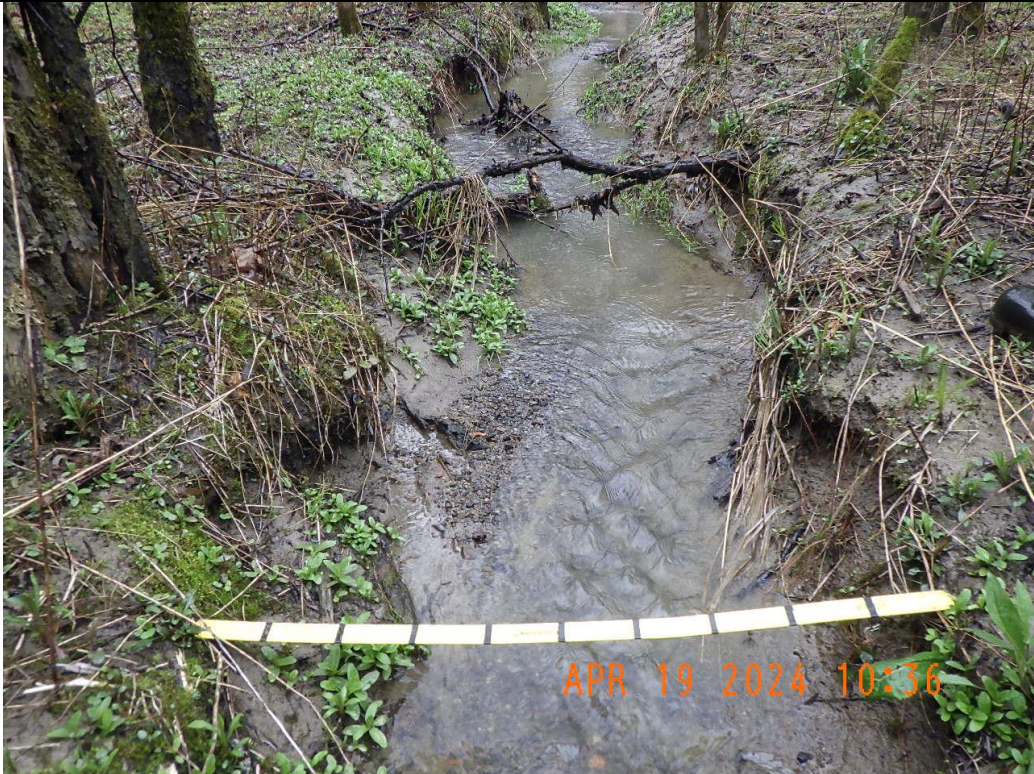
Accretion of sand and gravel on point bars was common. Deposition was also observed in the overbank zone.

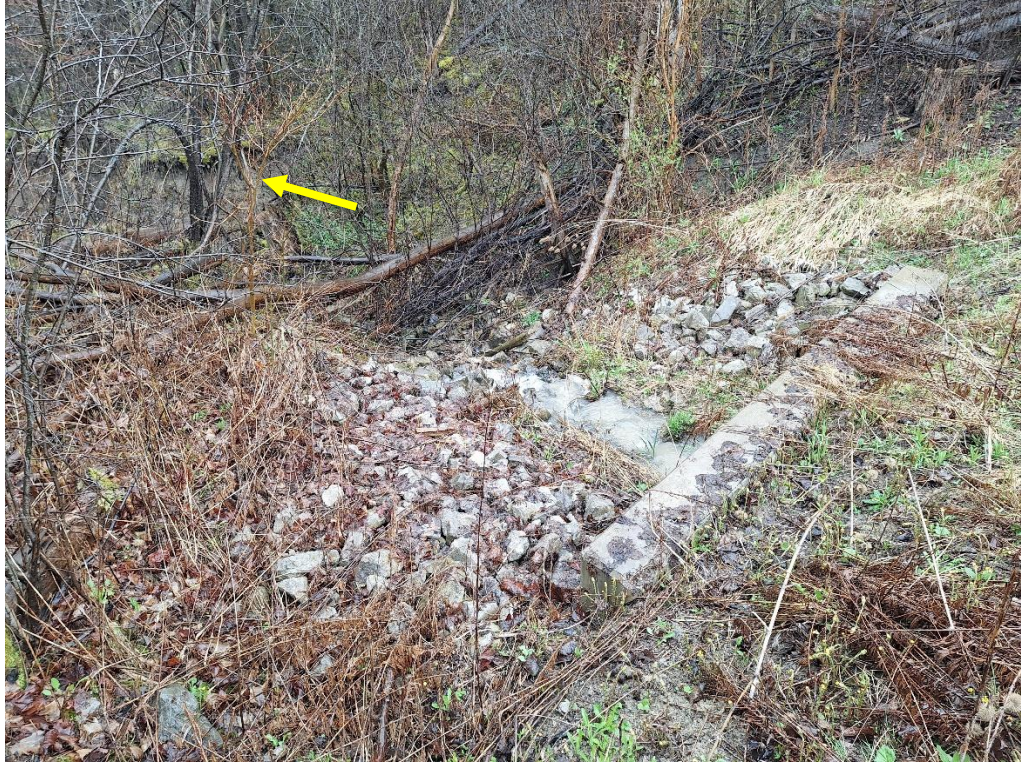
An outfall was present at the upstream extent of the reach at Duffy's Lane. Following the outfall the gradient changed significantly and erosion was observed immediately downstream (yellow arrow). Channel hardening was also present at this location.

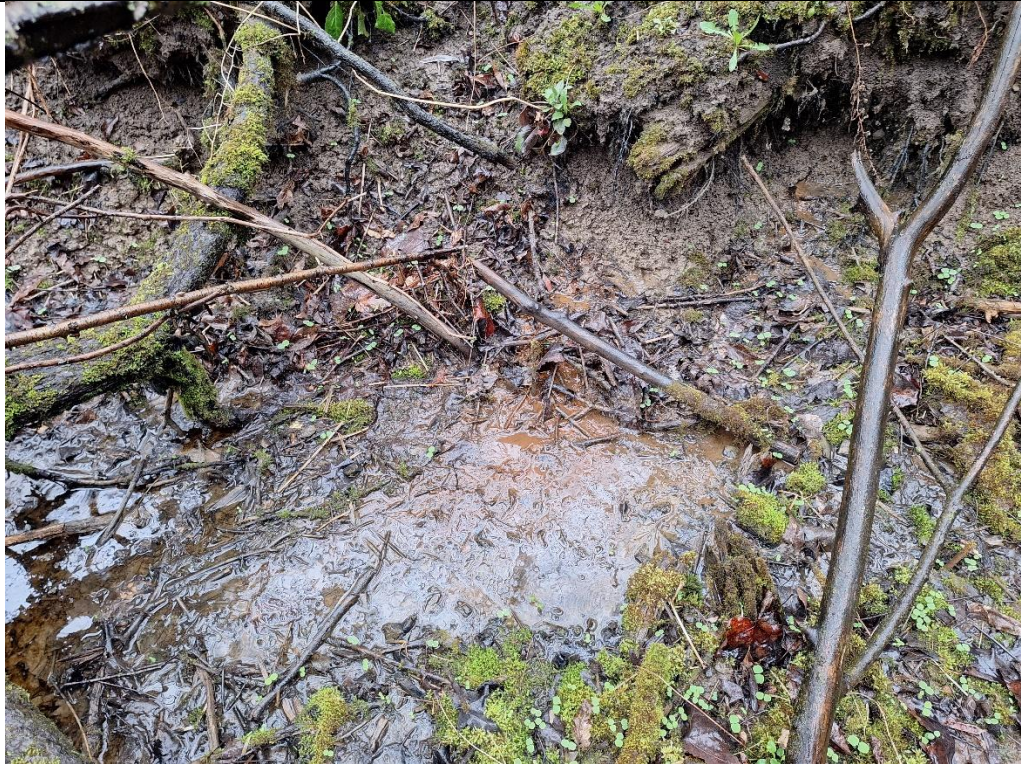
Iron staining was observed, suggesting that groundwater may be present.

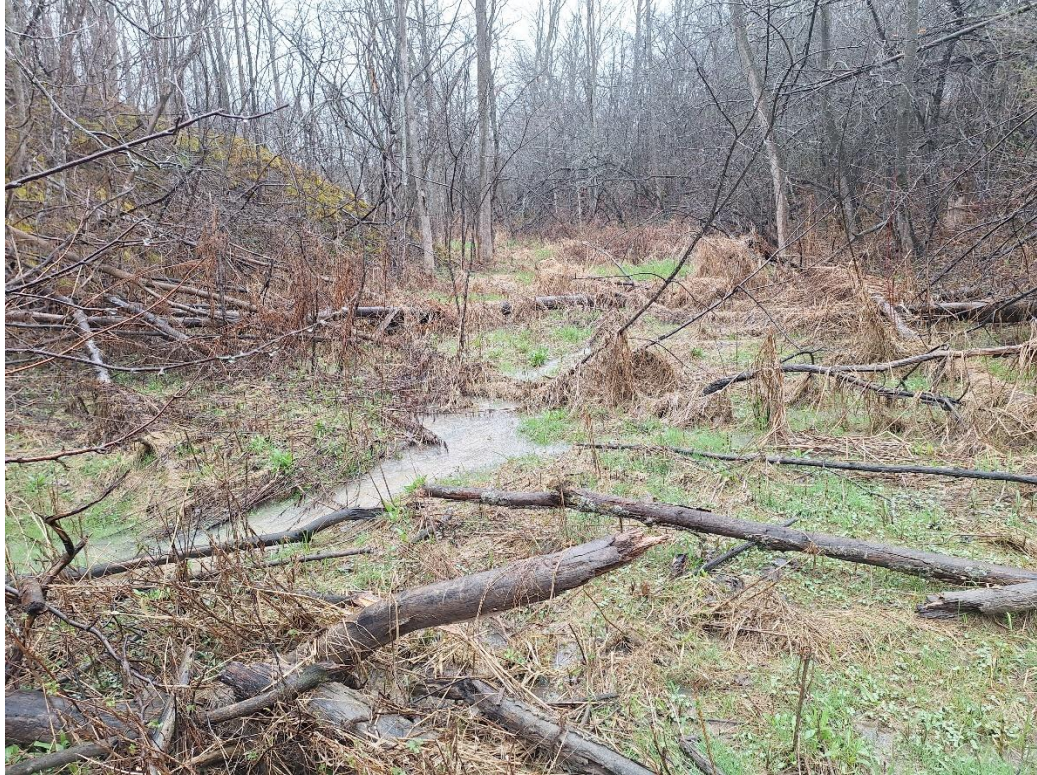
Woody and organic debris, leaning and fallen trees, and exposed roots were noted along the reach

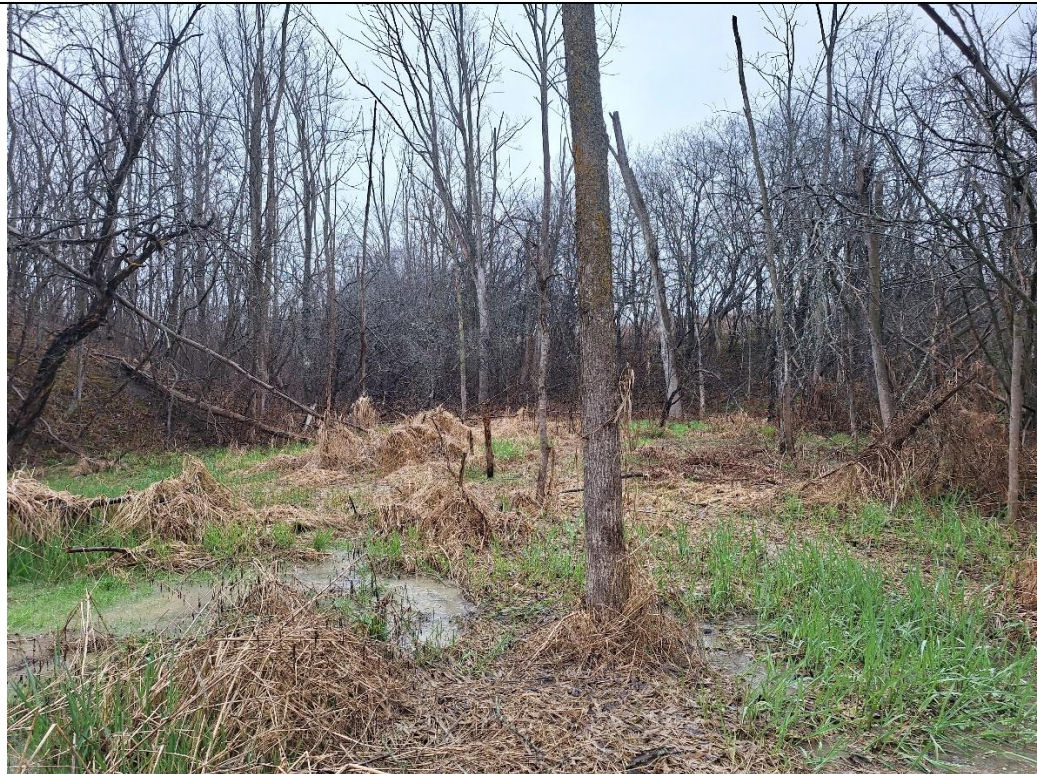
Trees and grasses heavily encroached the channel throughout the reach.

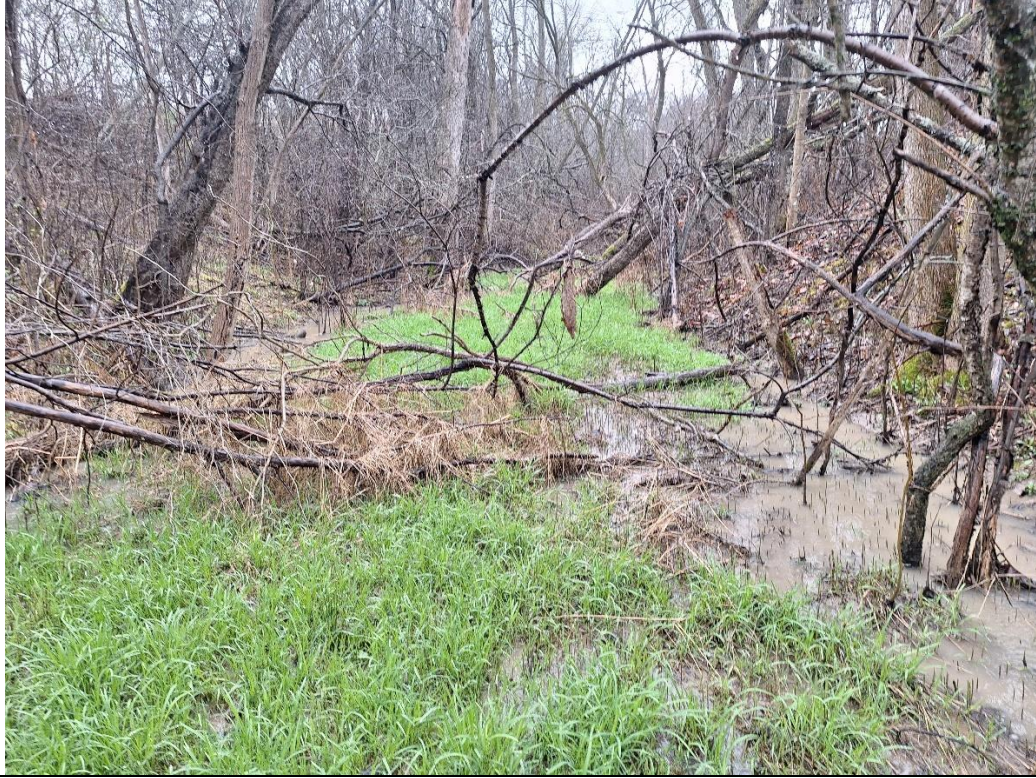
The wetland feature was confined within a forested valley.

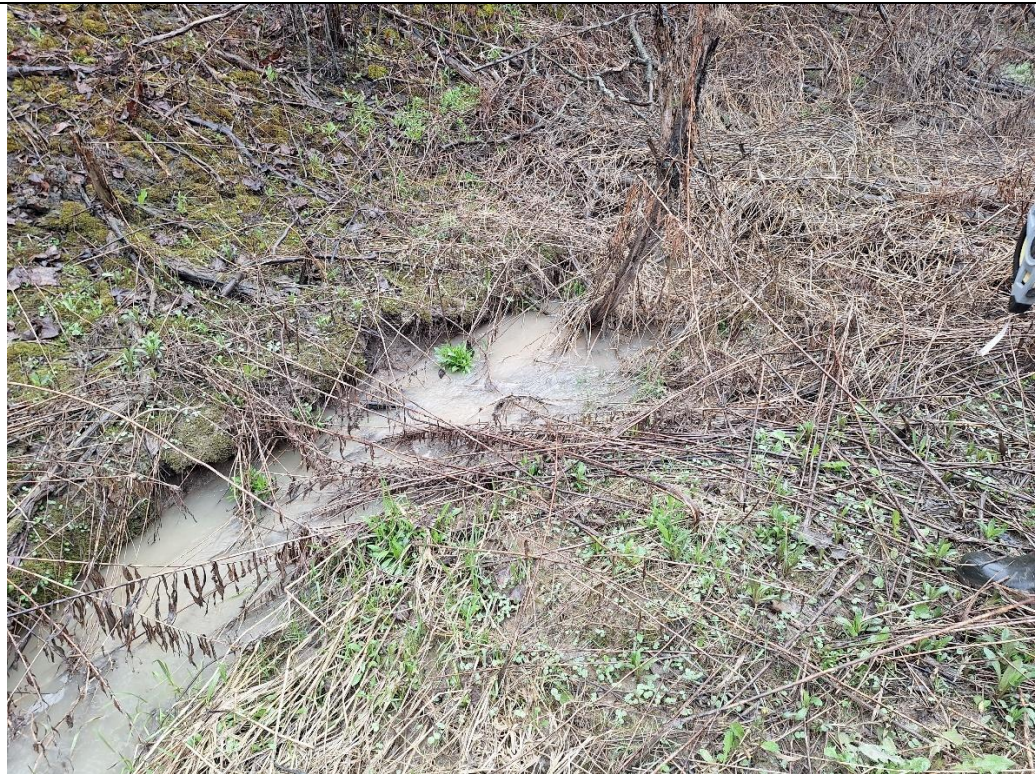
The channel transitioned from single-thread to multi-thread in the downstream direction.

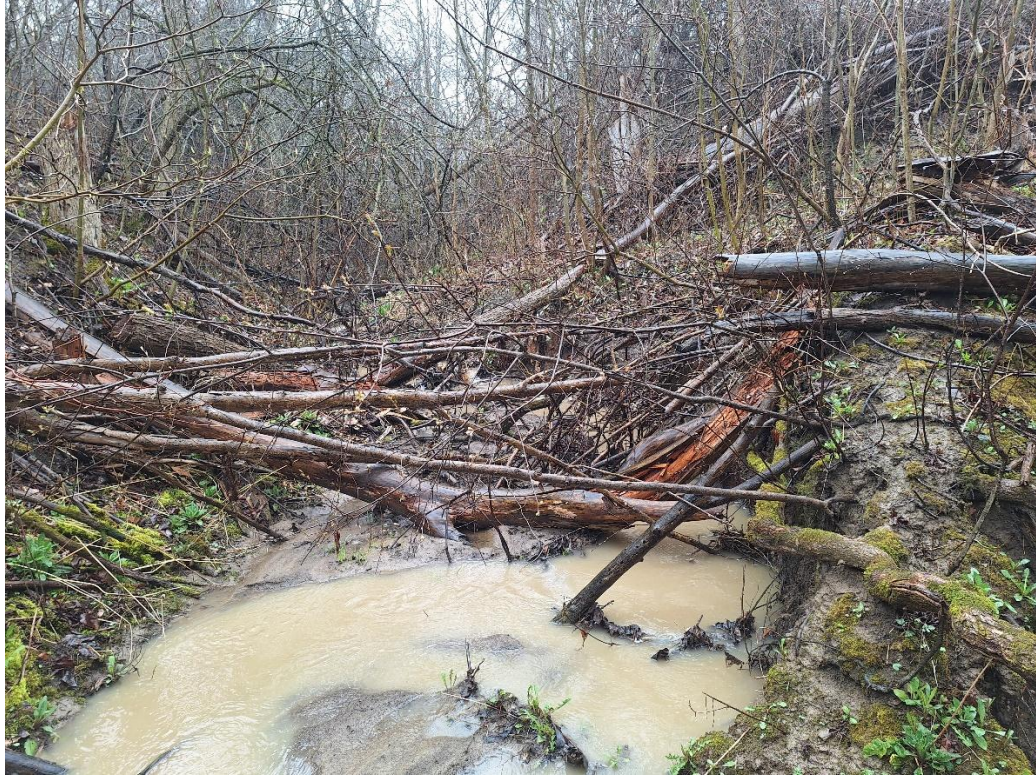
Woody debris was present throughout the reach as it flowed through a narrow, confined valley.

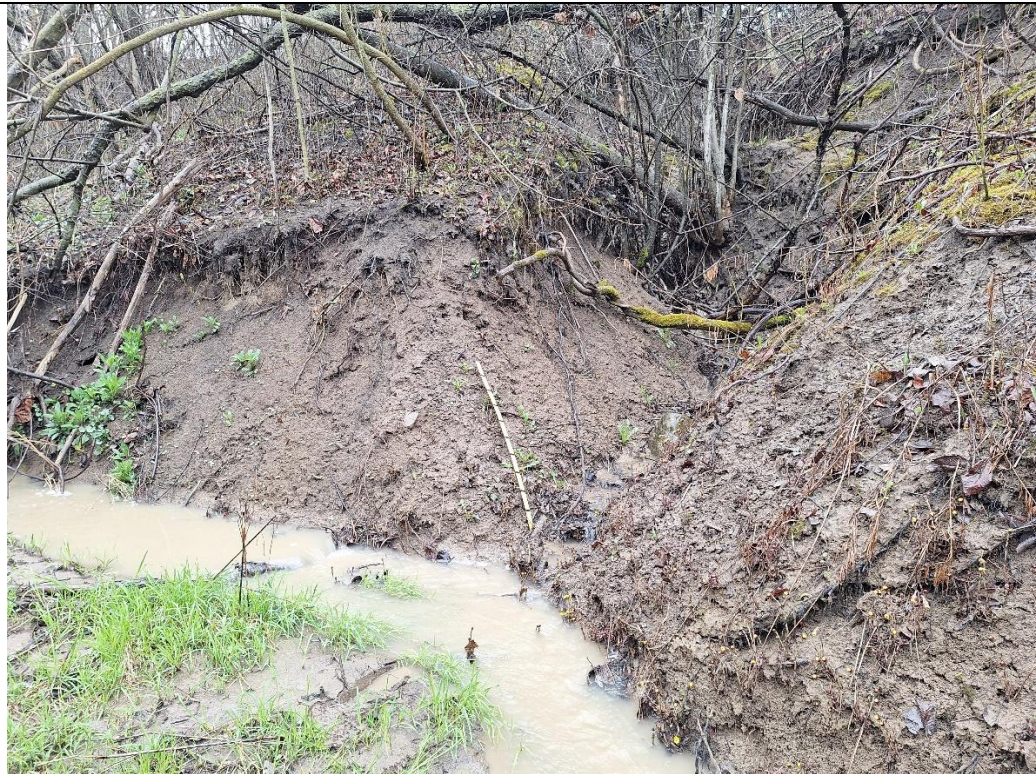
Gullies were observed cutting through the valley wall and flowing into the channel in various locations.

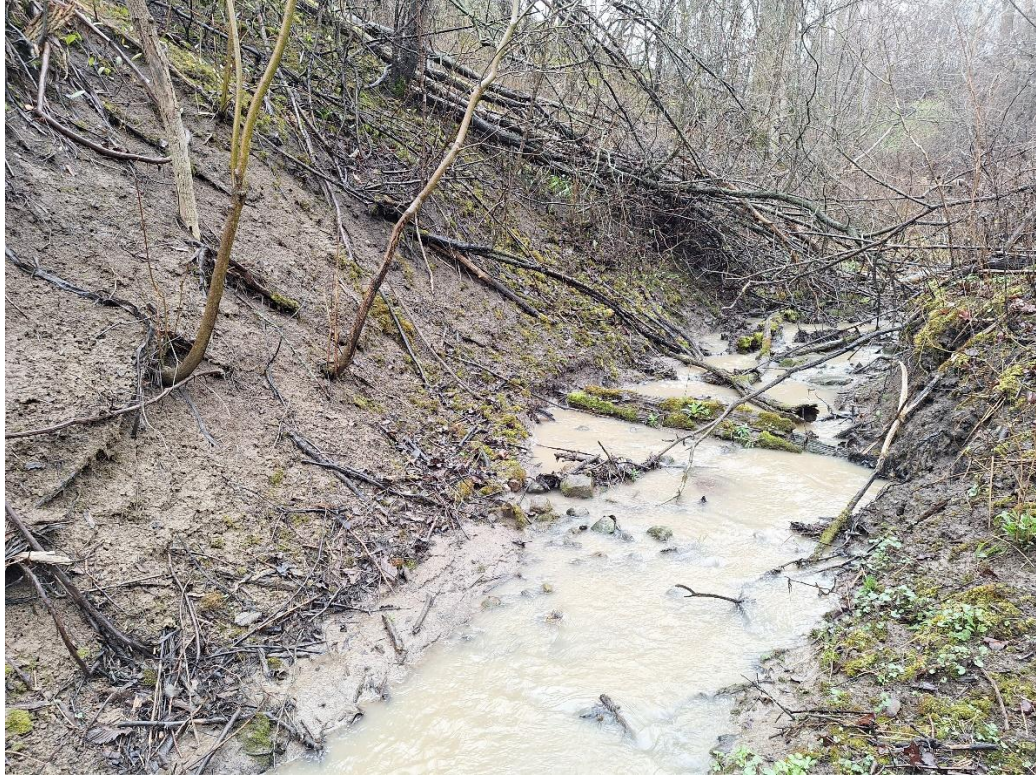
The channel bed substrate consisted of sand, gravel, and cobbles. The bank substrate was comprised of clay, silt and sand.

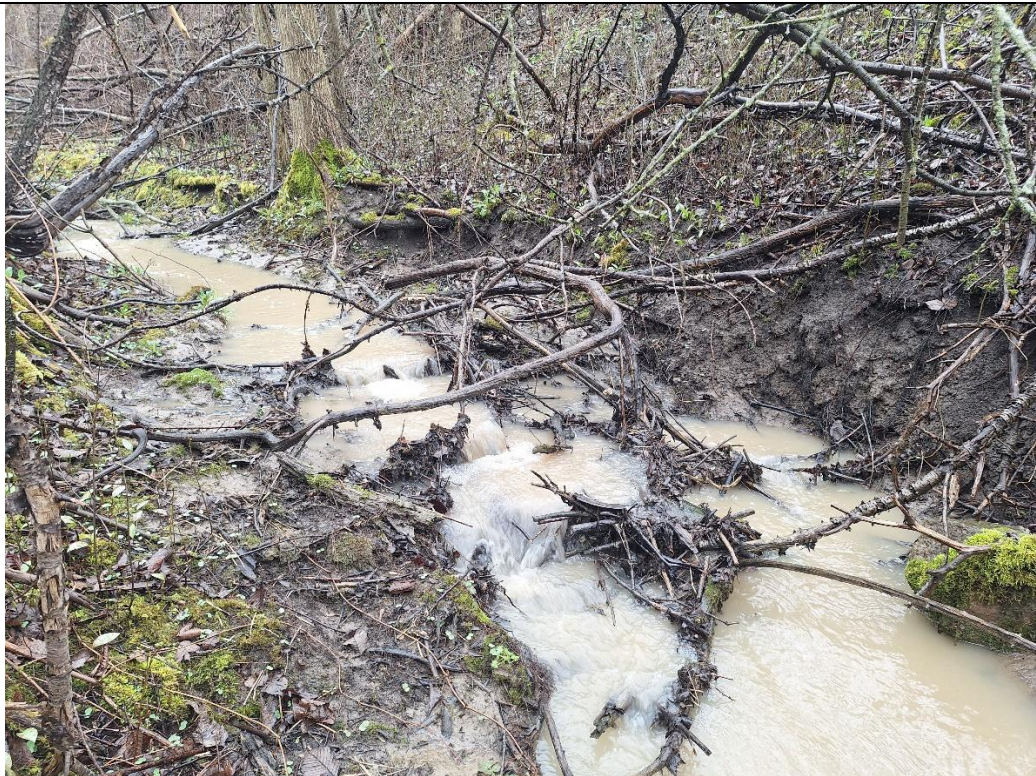
The water was turbid due to the recent rainfall and had no odour.

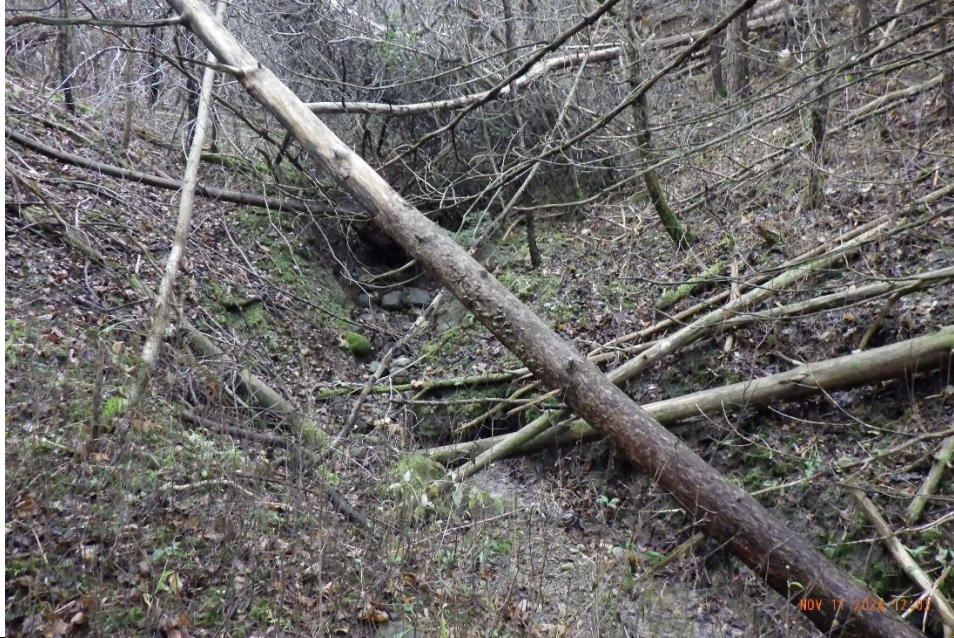
Numerous fallen and leaning trees were observed, particularly in the downstream portion of the reach.
