Humber River Tributaries Fluvial Geomorphological Assessment

**Bolton North Hill Secondary Plan Area
Local Subwatershed Study - Stage 1**
Town of Caledon, Ontario

GEO Morphix Project No. PN24084

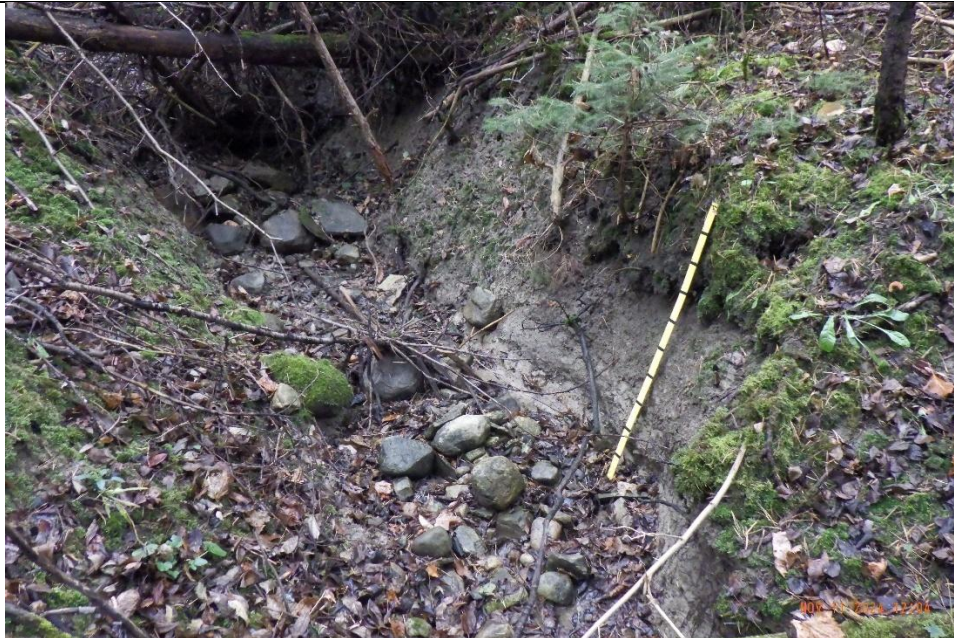
The channel bed substrate ranged from clay/silt to boulders. Channel banks were comprised of clay/silt to gravel.

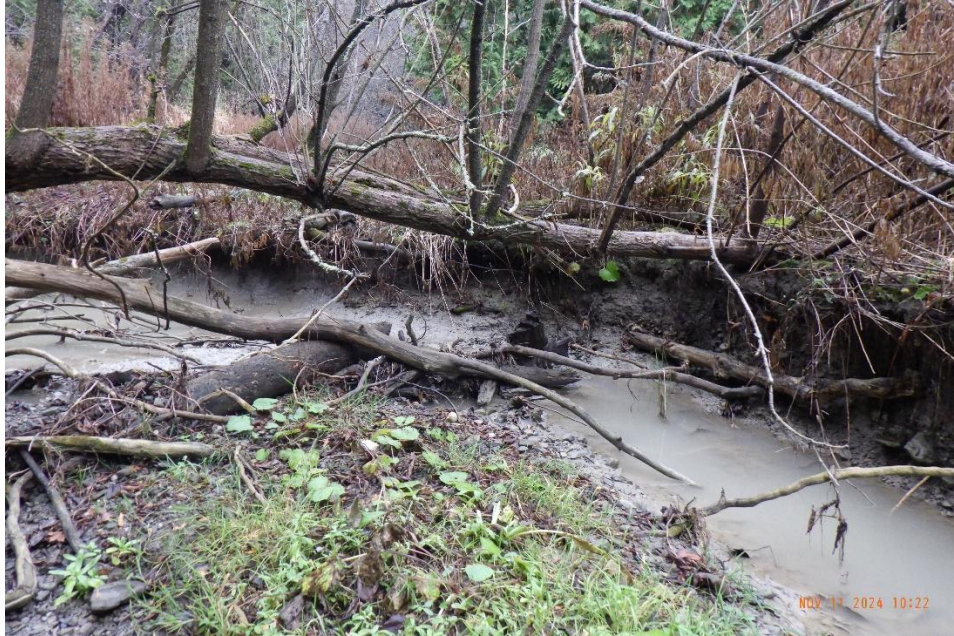
Woody debris, leaning and fallen trees, and exposed roots were commonly found in the channel and in the cutbank.
