February 14, 2025

**Re: Fluvial Geomorphic Assessment at Credit River and Tributary System in Caledon, Ontario  
Proposed CBM Caledon Pit/Quarry Project  
GEO Morphix Ltd. Project No. PN24061 – Report Version 1.0**

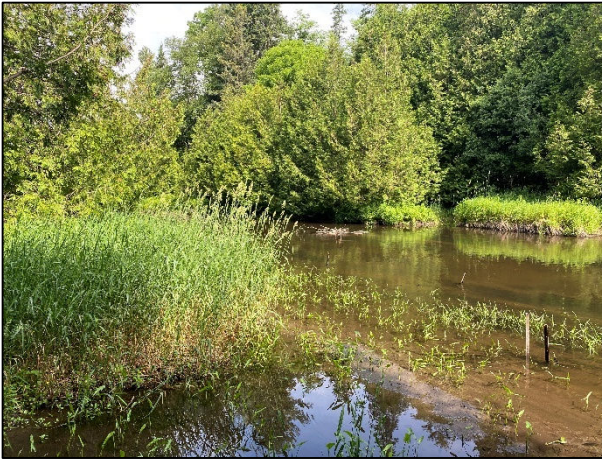
**Photograph 01:** Credit River near confluence with Tributary 4 (June 2024).

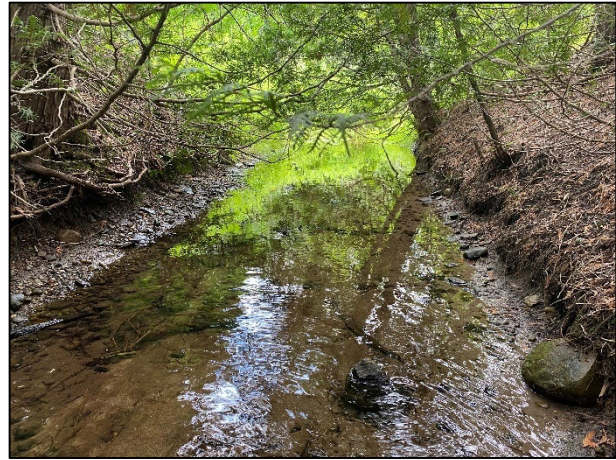
**Photograph 02:** East Ponds Outlet Channel near confluence point with Credit River (June 2024).

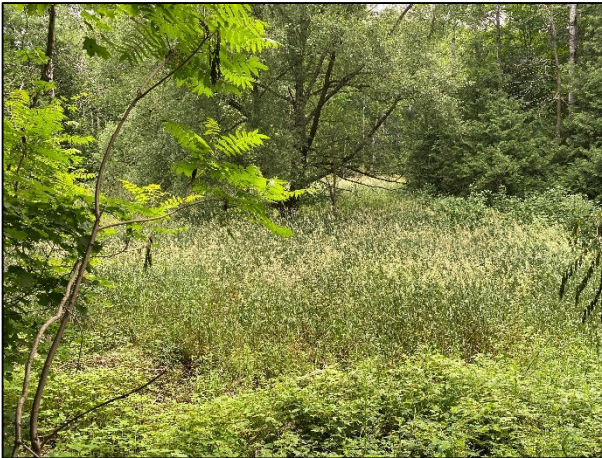
**Photograph 03:** Tributary 4 at a location downgradient of the OVGC access road (June 2024).

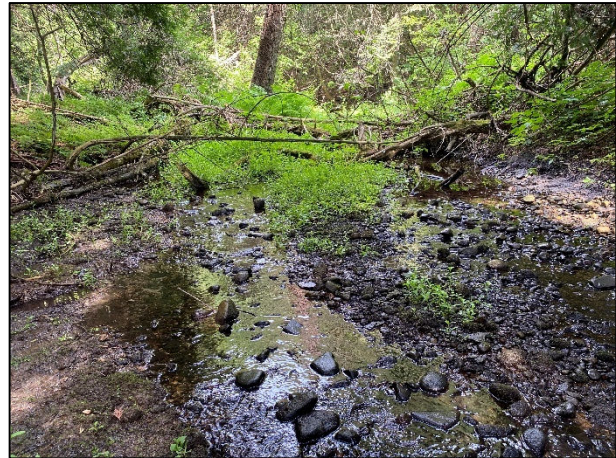
**Photograph 04:** Tributary 4 near confluence point with Credit River (June 2024).

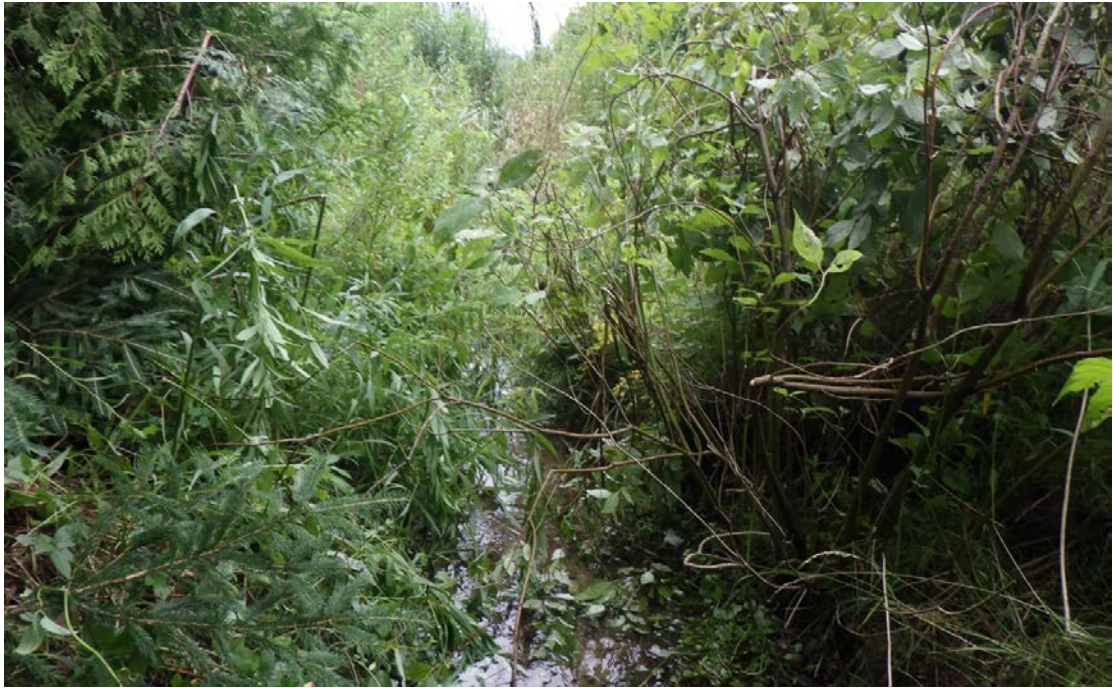
**East Ponds Outlet Channel** - facing downstream at the upstream portion of the reach. Heavy encroachment of vegetation into the channel was observed throughout the upstream extent.

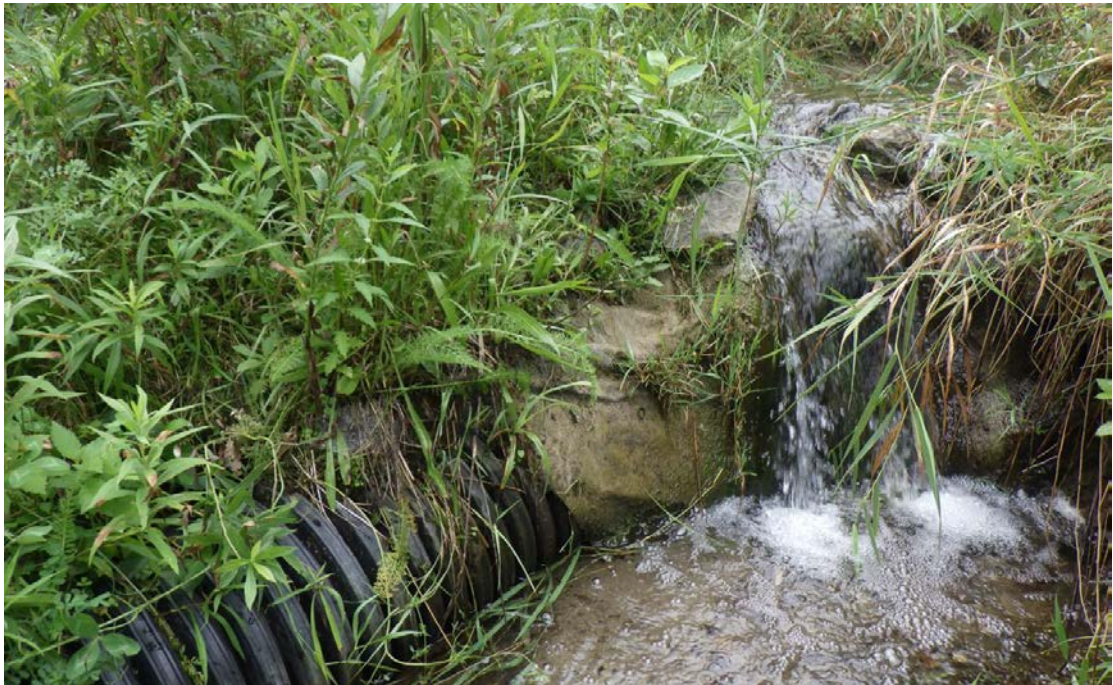
**East Ponds Outlet Channel** – facing upstream within the upstream extent. A knickpoint and culvert were identified immediately downstream of the East Ponds berm.

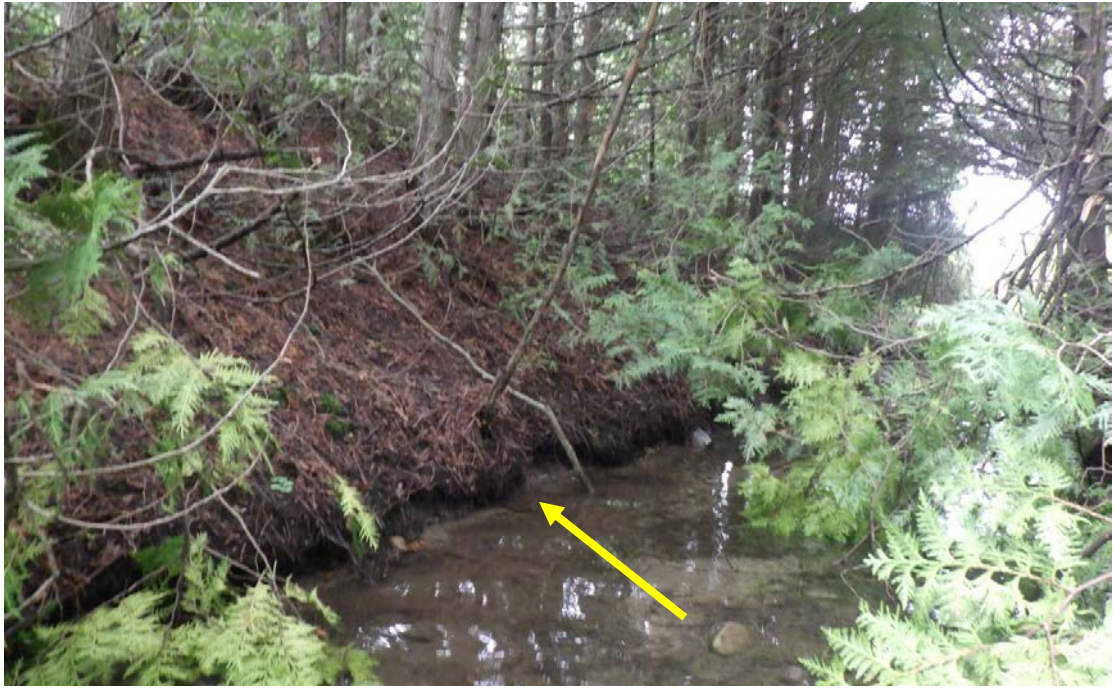
**Photo 3**  
East Ponds Outlet Channel, Caledon, ON  
July 24, 2024

**East Ponds Outlet Channel** – facing downstream. Undercutting was observed along the left bank.

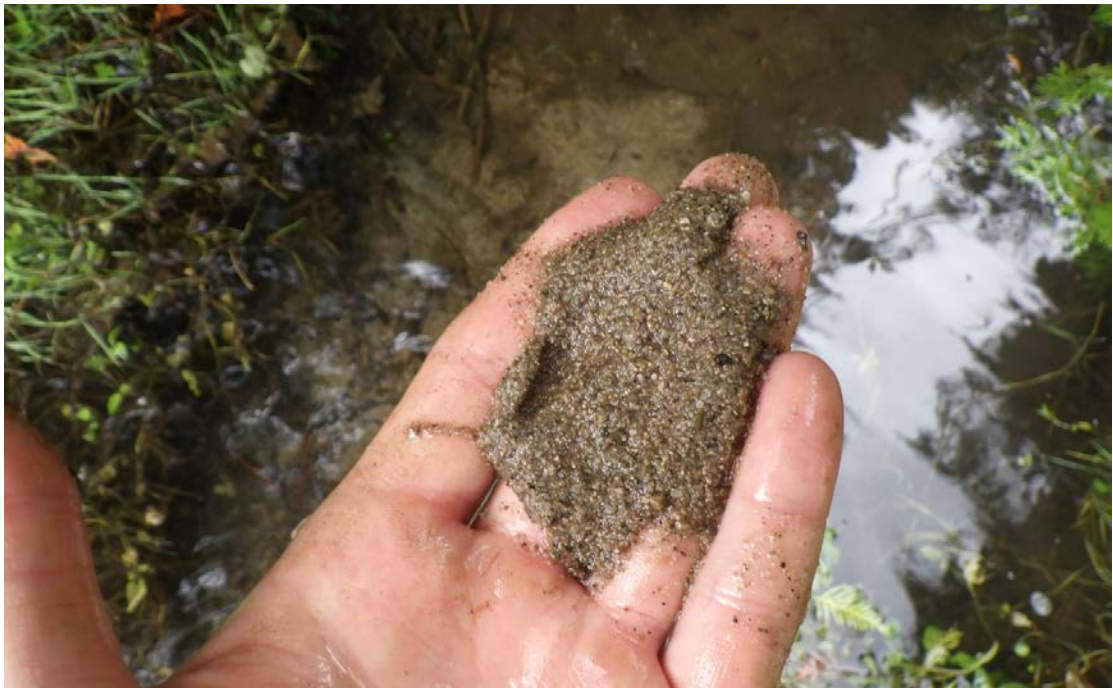
**Photo 4**  
East Ponds Outlet Channel, Caledon, ON  
July 24, 2024

**East Ponds Outlet Channel** – Bed materials consisted predominantly of medium to very coarse sand.

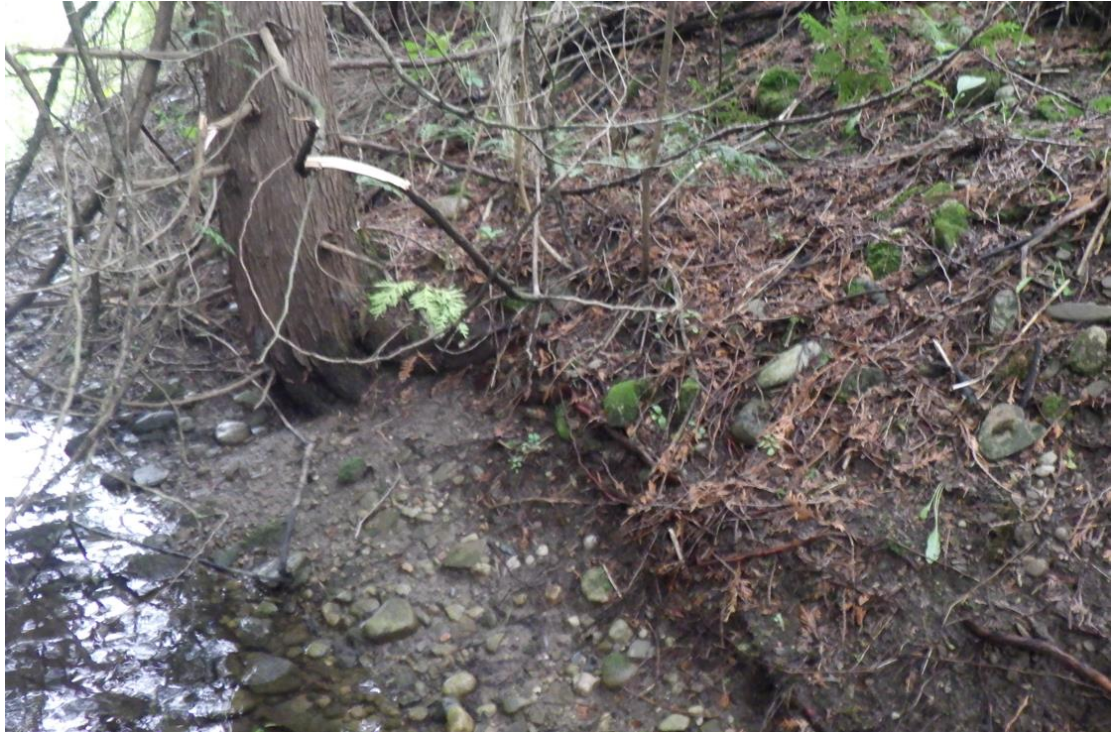
**Photo 5**  
East Ponds Outlet Channel, Caledon, ON  
July 24, 2024

**East Ponds Outlet Channel** – Bank materials consisted predominantly of silt and fine to medium sand, with small to large cobbles.

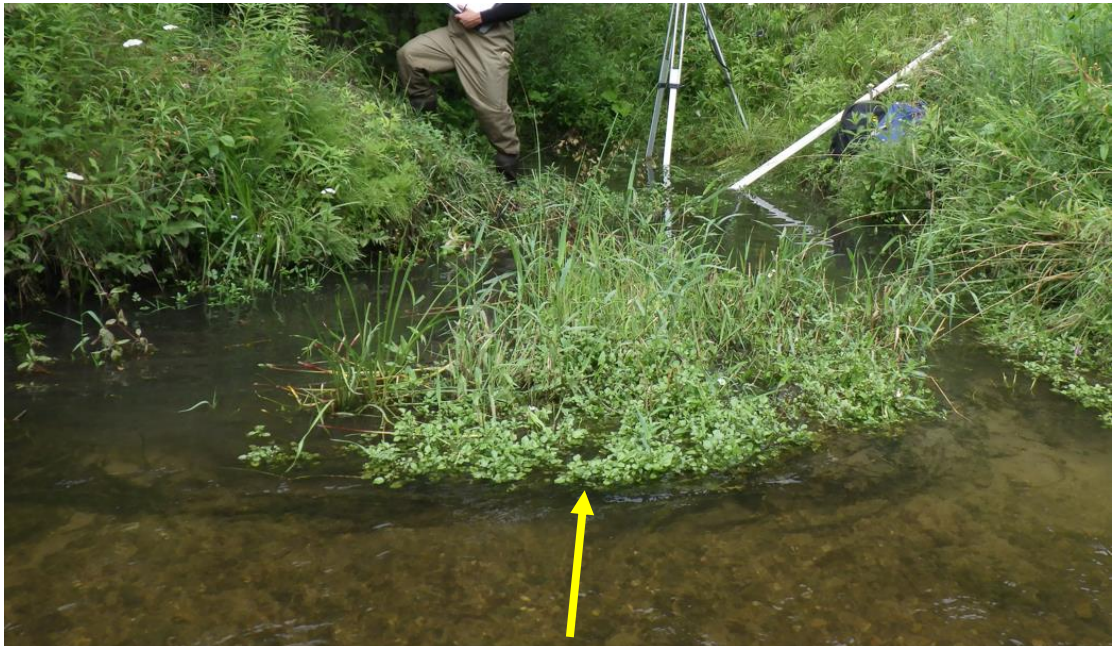
**Photo 6**  
East Ponds Outlet Channel, Caledon, ON  
July 24, 2024

**East Ponds Outlet Channel** – facing upstream at the confluence with the Credit River. A small vegetated island was present at the confluence.

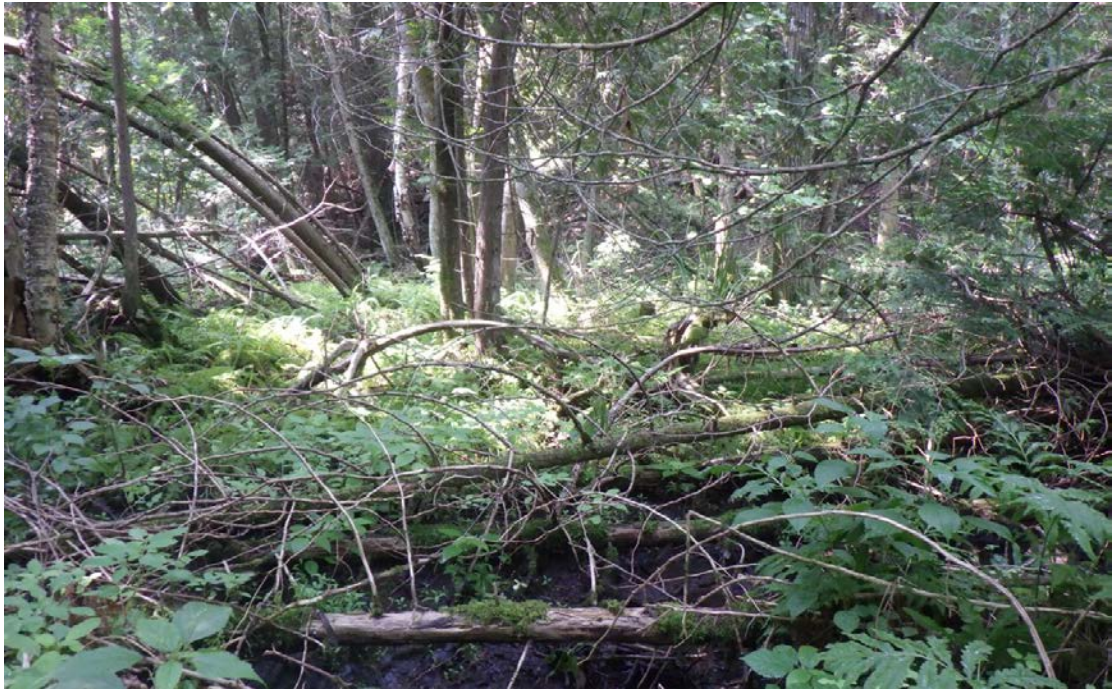
**Photo 7**  
Tributary 4, Caledon, ON  
July 23, 2024

**Tributary 4** – facing downstream at the upstream extent. A high density of woody debris was found throughout the channel.

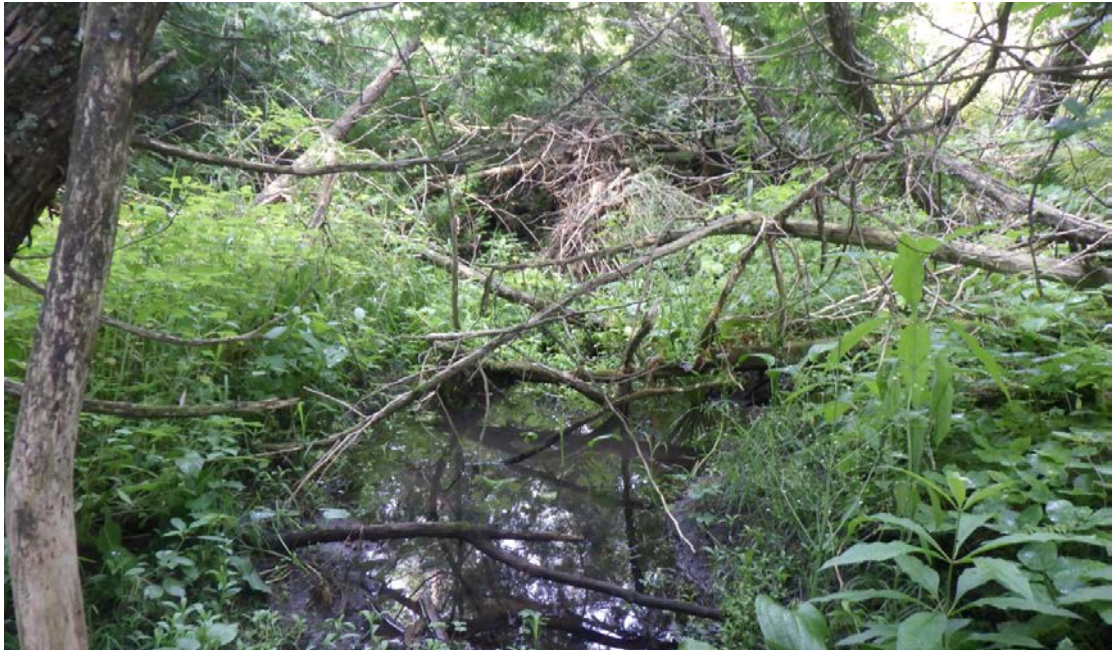
**Photo 8**  
Tributary 4, Caledon, ON  
July 23, 2024

**Tributary 4** – facing downstream. Heavy encroachment is observed throughout, with no observed evidence of erosion-sedimentation features.

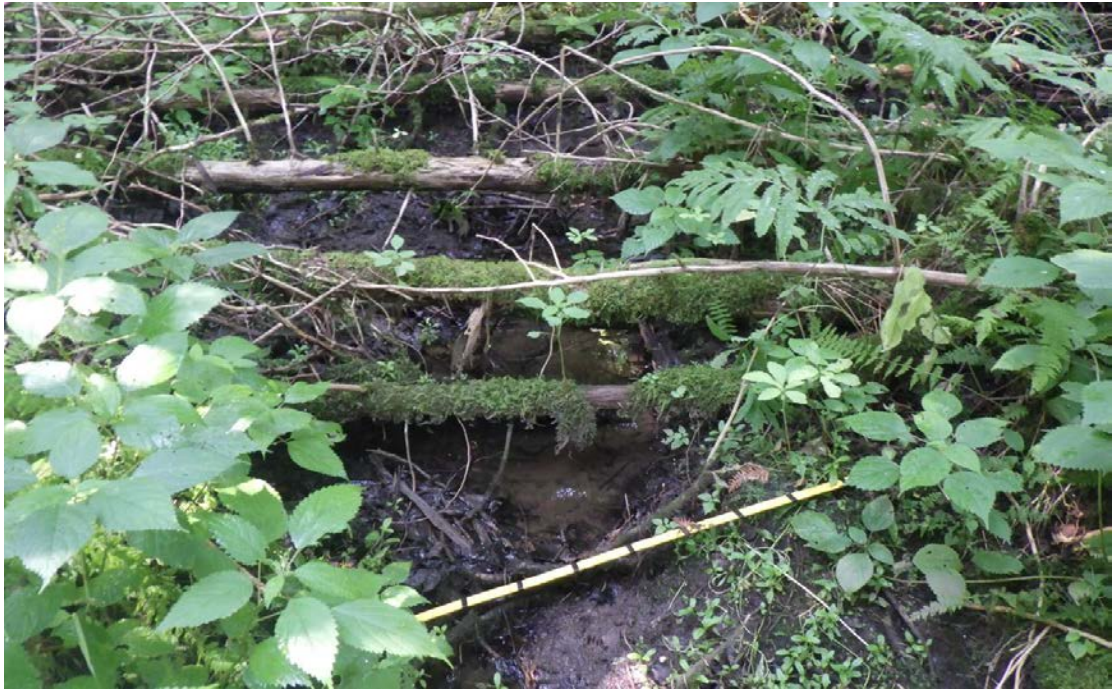
**Photo 9**  
Tributary 4, Caledon, ON  
July 23, 2024

**Tributary 4** – the channel was poorly-defined and dry at time of assessment with the upstream extent, with some ponded water found within pools.

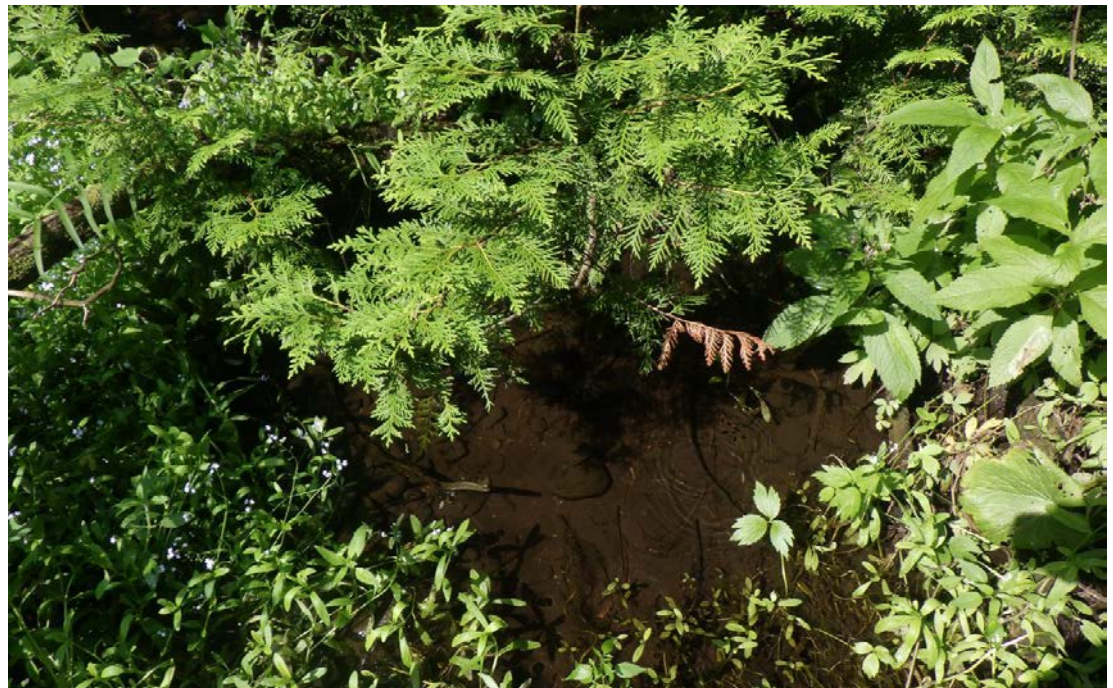
**Photo 10**  
Tributary 4, Caledon, ON  
July 23, 2024

**Tributary 4** – bed materials along the downstream extent consisted of fine to medium sand and scattered small to large cobbles.

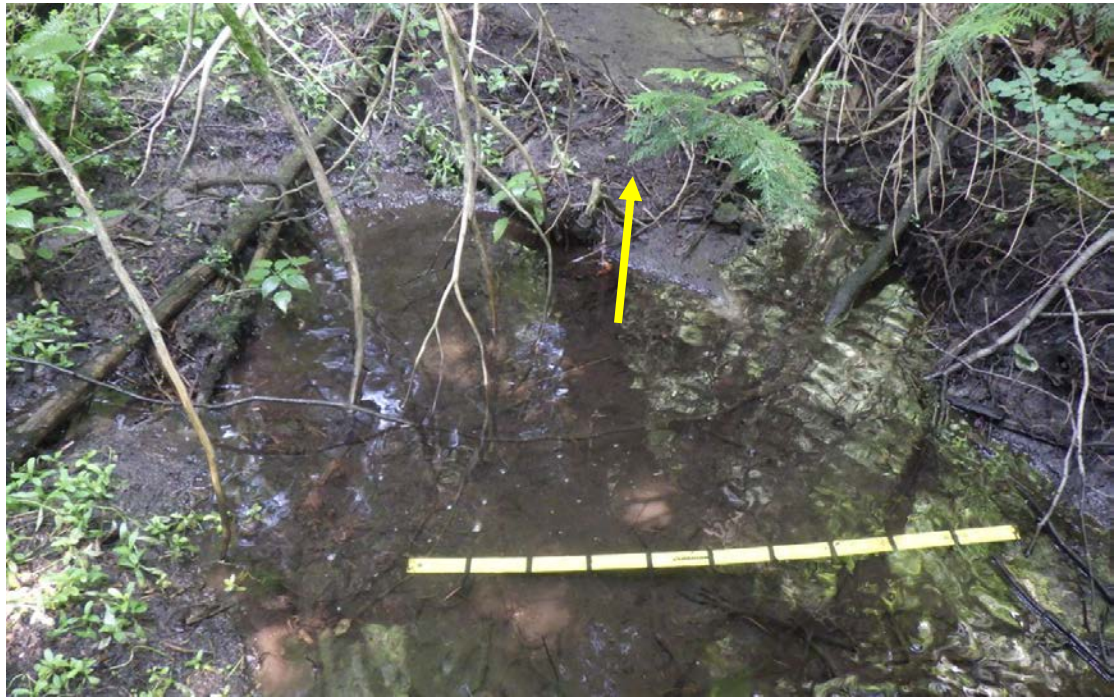
**Photo 11**  
Tributary 4, Caledon, ON  
July 23, 2024

**Tributary 4** – bank materials along the downstream extent consisted of silty-clays and very fine to coarse sand.

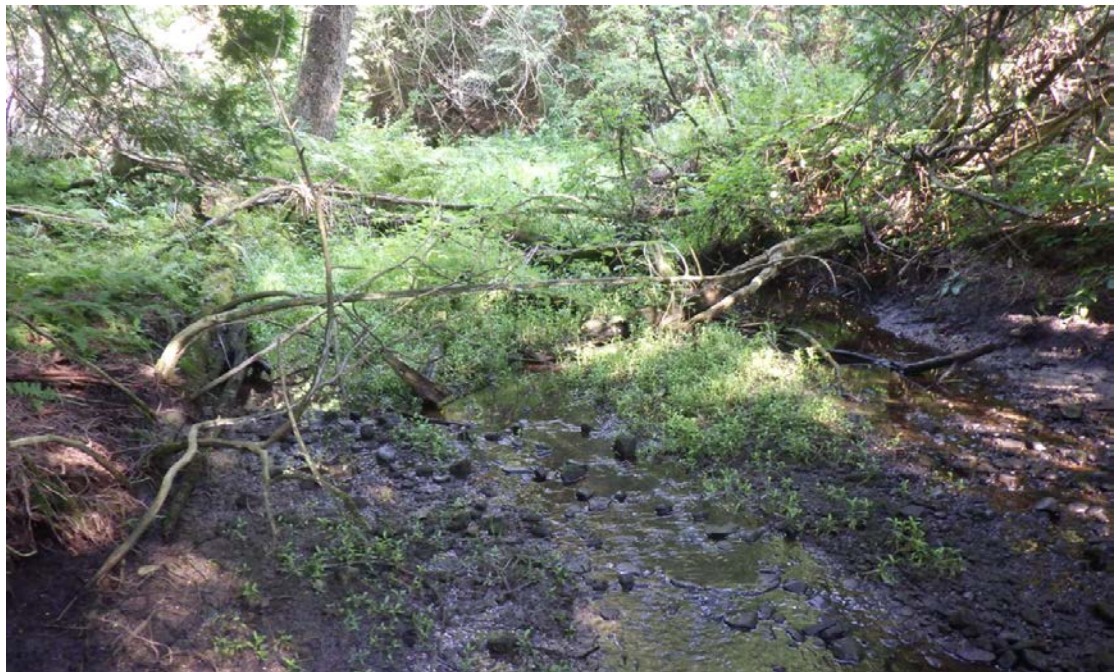
**Photo 12**  
Tributary 4, Caledon, ON  
July 23, 2024

**Tributary 4** – facing downstream near the confluence with the Credit River at the downstream extent. The channel widened and small to large cobbles were apparent along the bed.

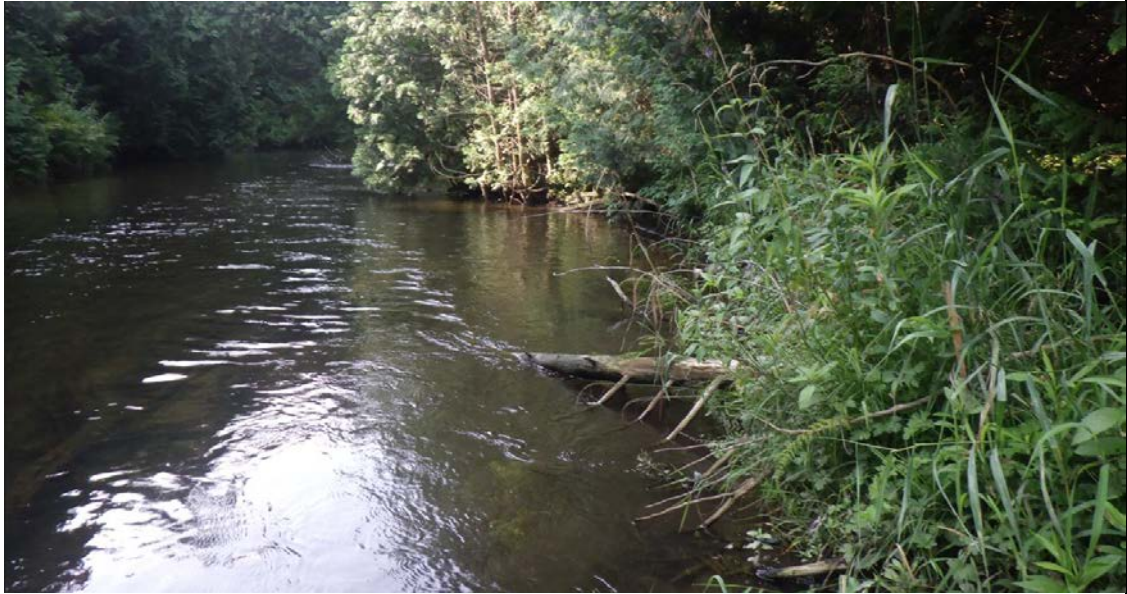
**Photo 13**  
Credit River, Caledon, ON  
July 25, 2024

**Credit River** – taken downstream of the confluence with Tributary 4, facing downstream.

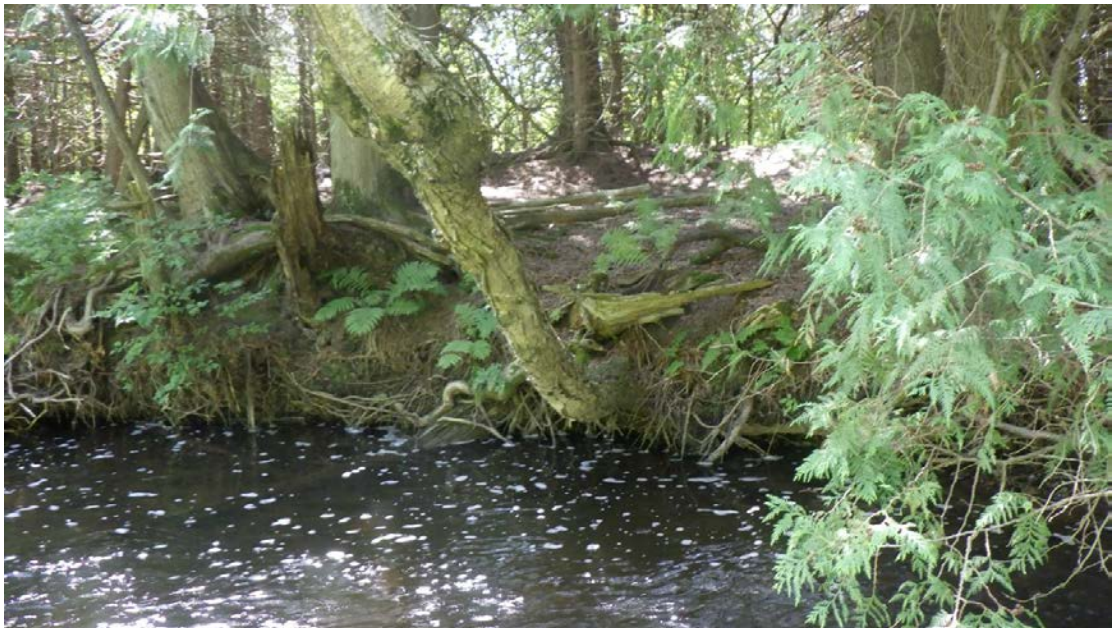
**Photo 14**  
Credit River, Caledon, ON  
July 25, 2024

**Credit River** – facing the left bank. Undercutting and exposed roots were observed downstream of the confluence with Tributary 4.

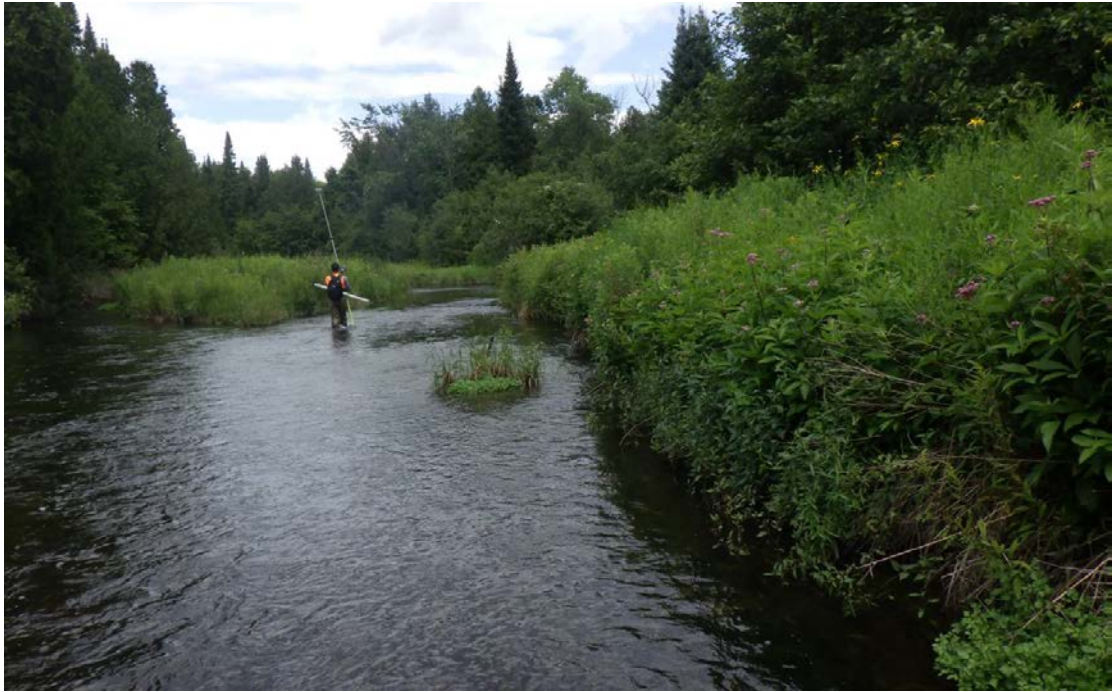
**Photo 15**  
Credit River, Caledon, ON  
July 25, 2024

**Credit River** – facing upstream. The Credit River flows through an open meadow located between the confluence with Tributary 4 and the East Ponds outlet channel.

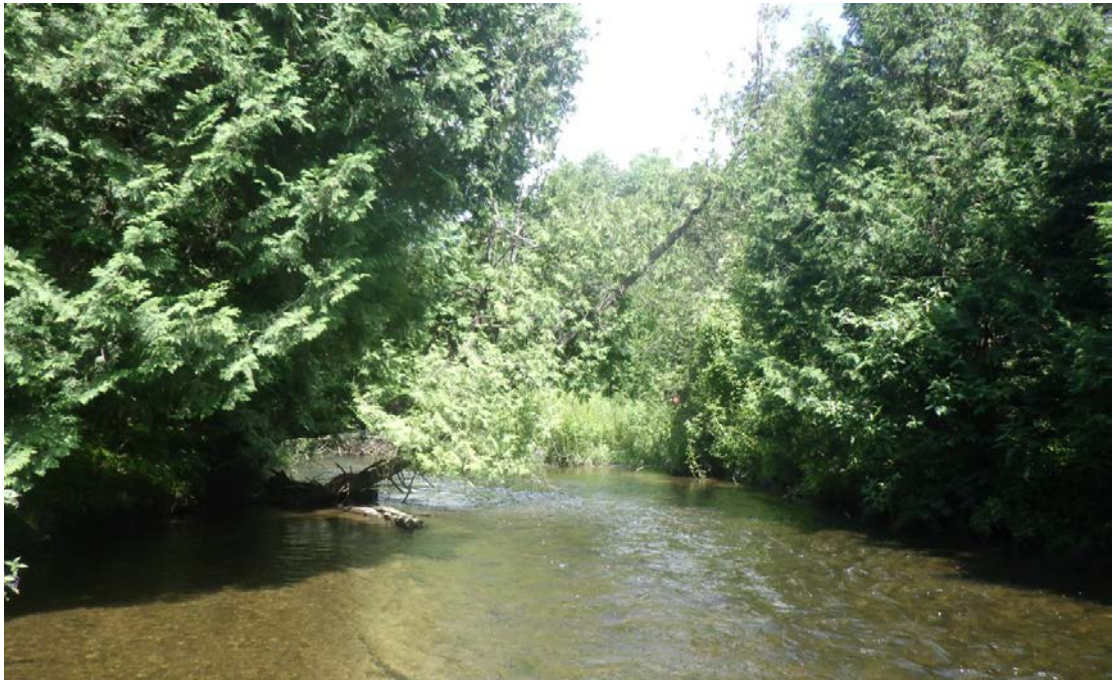
**Photo 16**  
Credit River, Caledon, ON  
July 25, 2024

**Credit River** – facing upstream, downstream of the confluence with the East Ponds outlet channel .

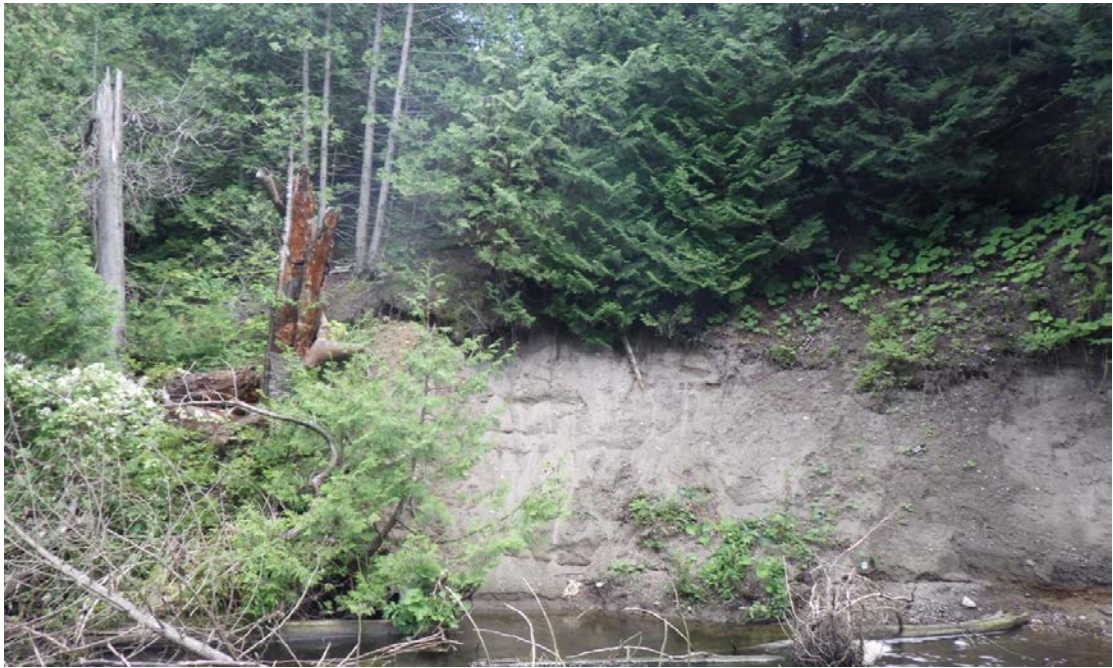
**Photo 17**  
Credit River, Caledon, ON  
July 25, 2024

**Credit River** – facing the left bank, downstream of the confluence with the East Ponds outlet channel. Valley wall contact was observed.

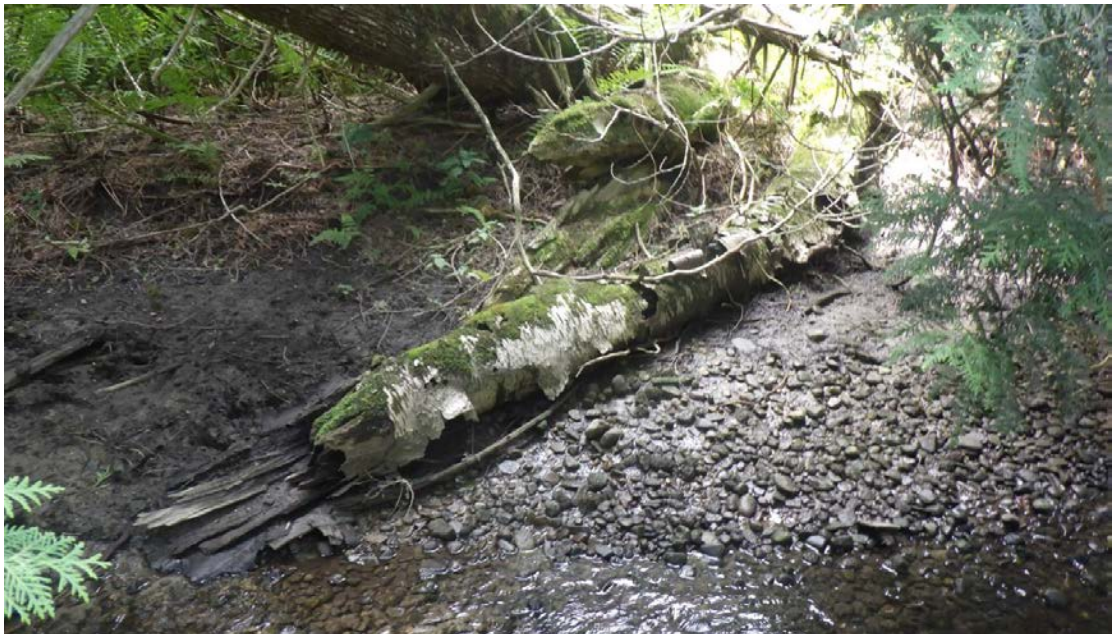
**Photo 18**  
Credit River, Caledon, ON  
July 25, 2024

**Credit River** – facing the right bank, upstream of the confluence with the East Ponds outlet channel. Bank materials consisted of fairly compact silty/sandy clays with small to large cobbles.
