# Fluvial Geomorphological Assessment and Flow Monitoring

## Tributary of Etobicoke Creek

### Snell's Hollow Secondary Plan Town of Caledon, Ontario

April 15, 2020  
PN19033

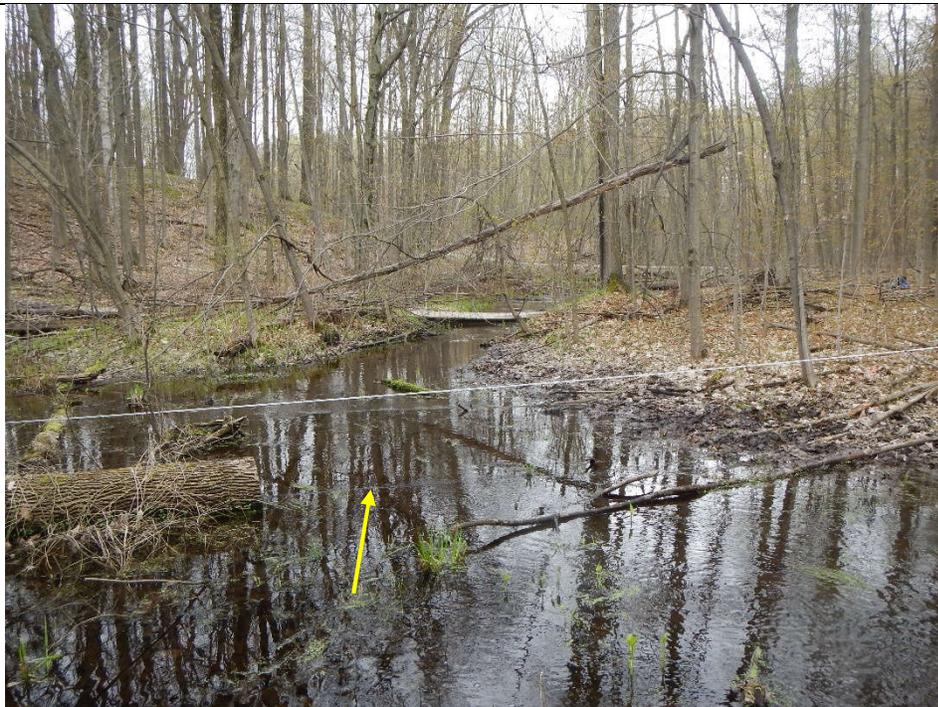
Photo 4  
Tributary of Etobicoke Creek,  
Reach EC-1 Cross section 2

Channel was wide and shallow, with low bank angles on both sides.

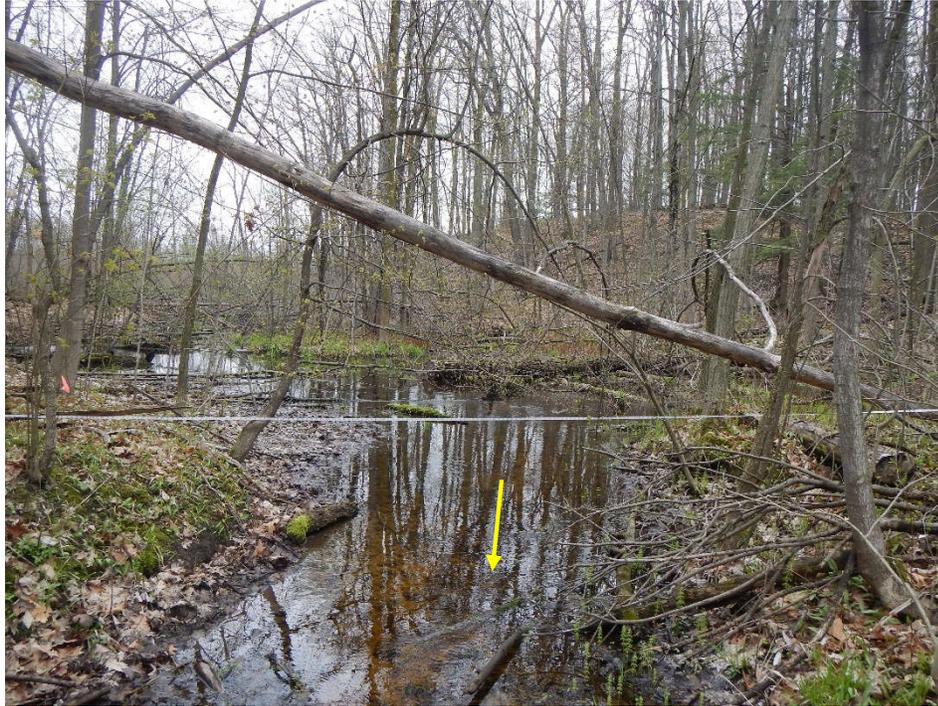
Photo 5  
Tributary of Etobicoke Creek  
Reach EC-1 Cross section 3-M

View of one of two pedestrian crossings observed in the reach.

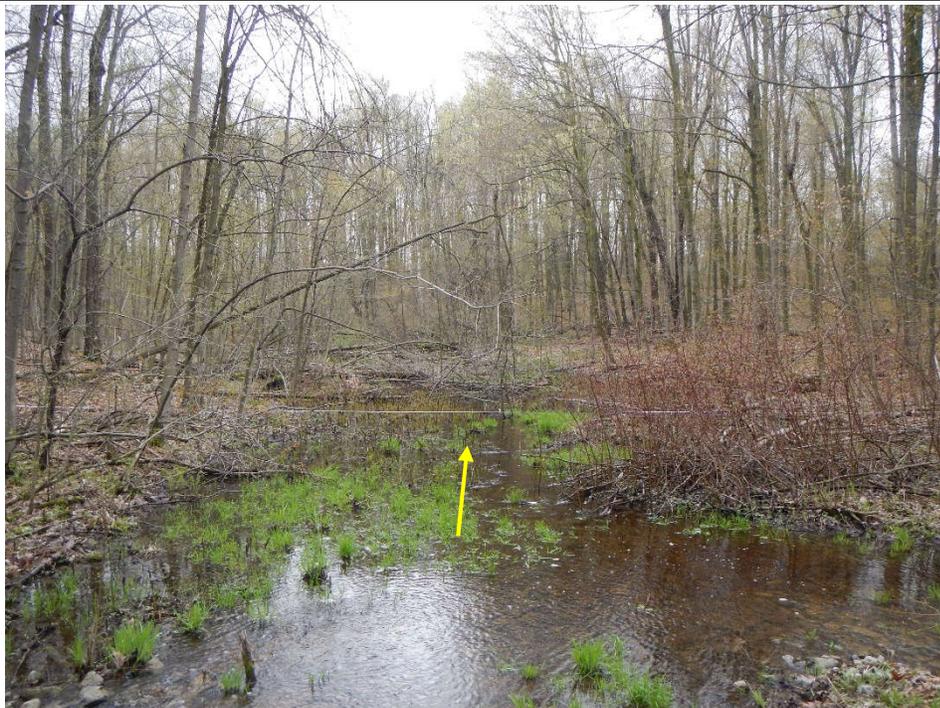
Photo 13  
Tributary of Etobicoke Creek,  
Reach EC-2

Photo taken from the trail crossing downstream into the reach.

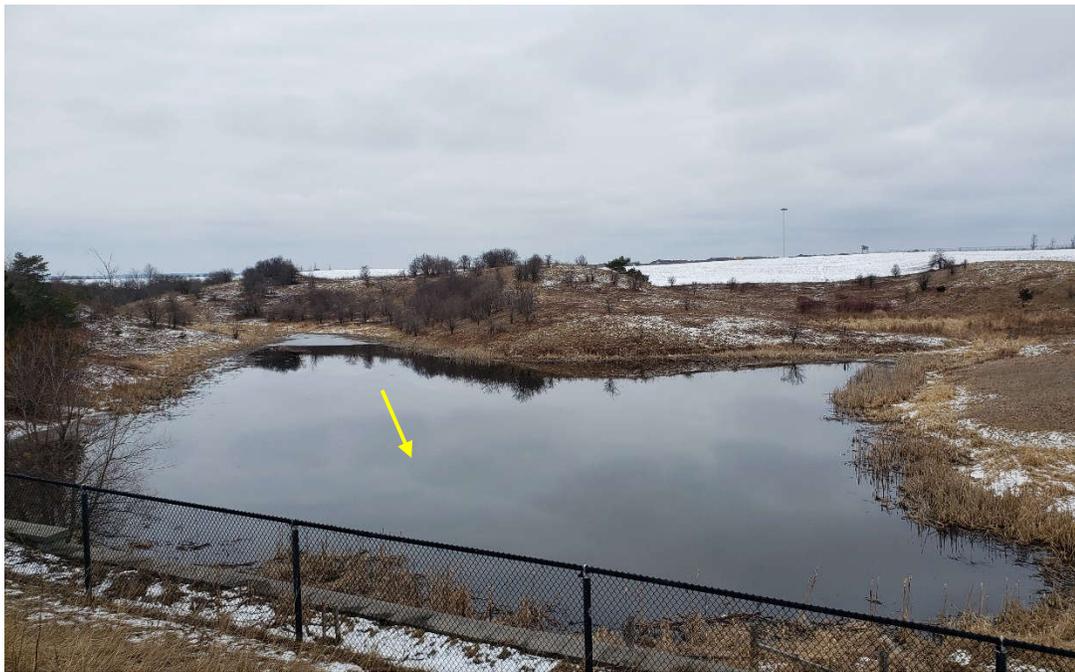
Photo 14  
Tributary of Etobicoke Creek  
Reach EC-2

Photo taken from Mayfield Road, facing north towards the pond.

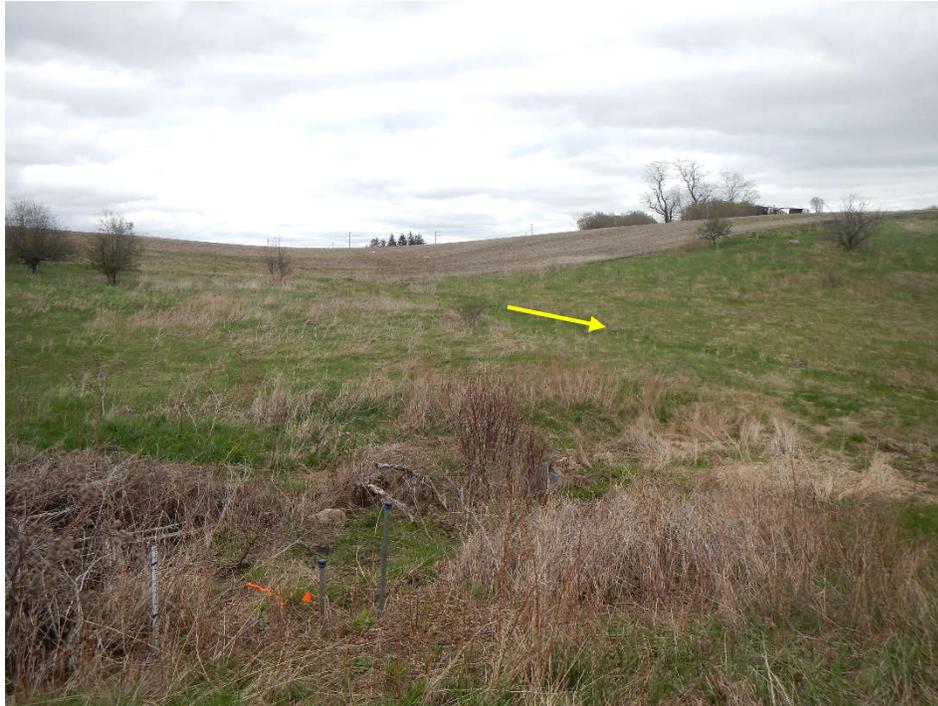
Photo 15  
Tributary of Etobicoke Creek  
Reach EC-2a

View of conditions mid-reach. Flows drain from adjacent agricultural fields and flow downslope to the pond feature.

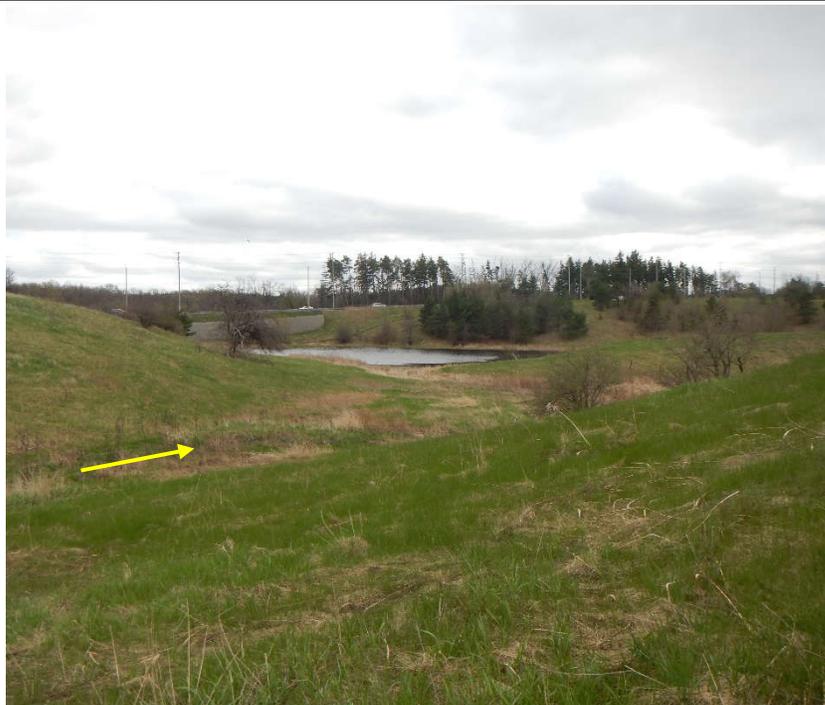
Photo 16  
Tributary of Etobicoke Creek  
Reach EC-2a

Photo taken from mid-reach towards the pond feature. The channel was poorly defined and lacked riffles and pools

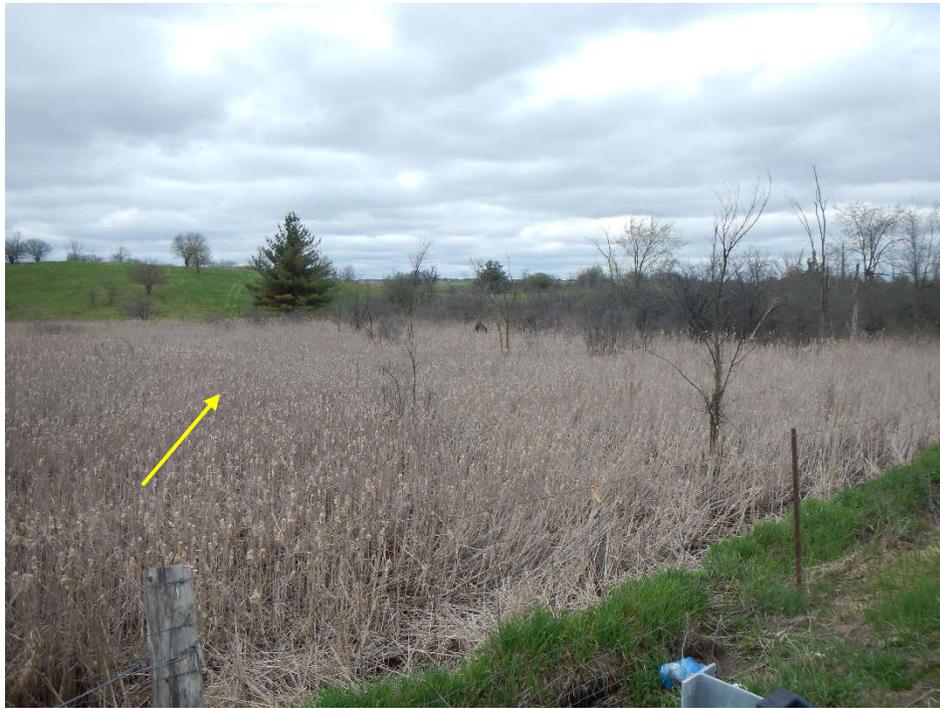
Photo 18  
Tributary of Etobicoke Creek,  
Reach EC-3

View from the southwest corner of the subject lands. The wetland receives input from an adjacent stormwater management pond.

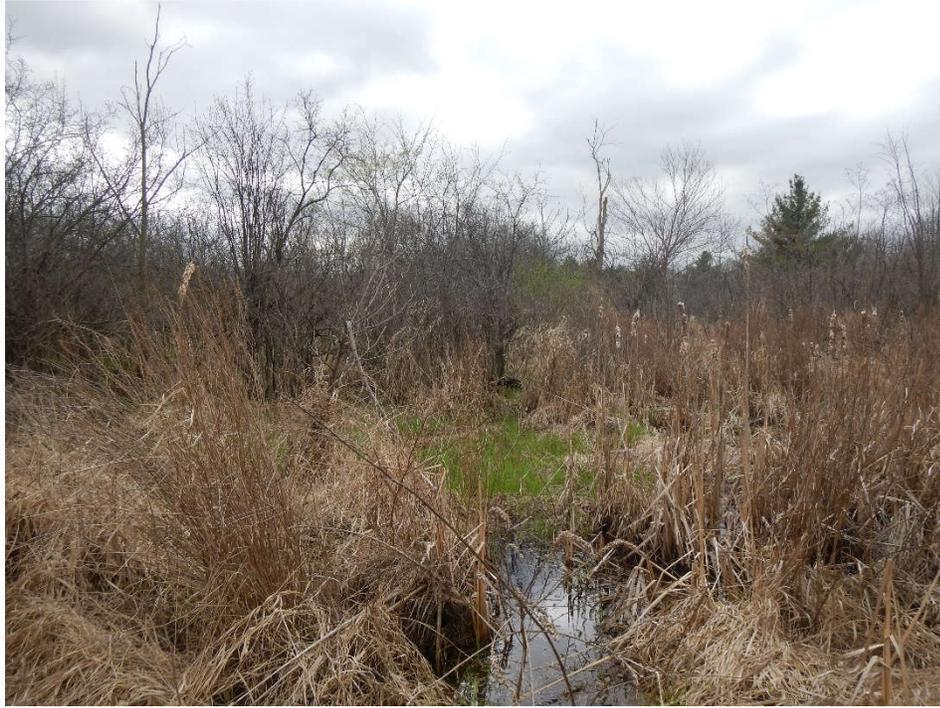
Photo 19  
Tributary of Etobicoke Creek  
Reach EC-3

Middle of the wetland feature, where standing water was present.

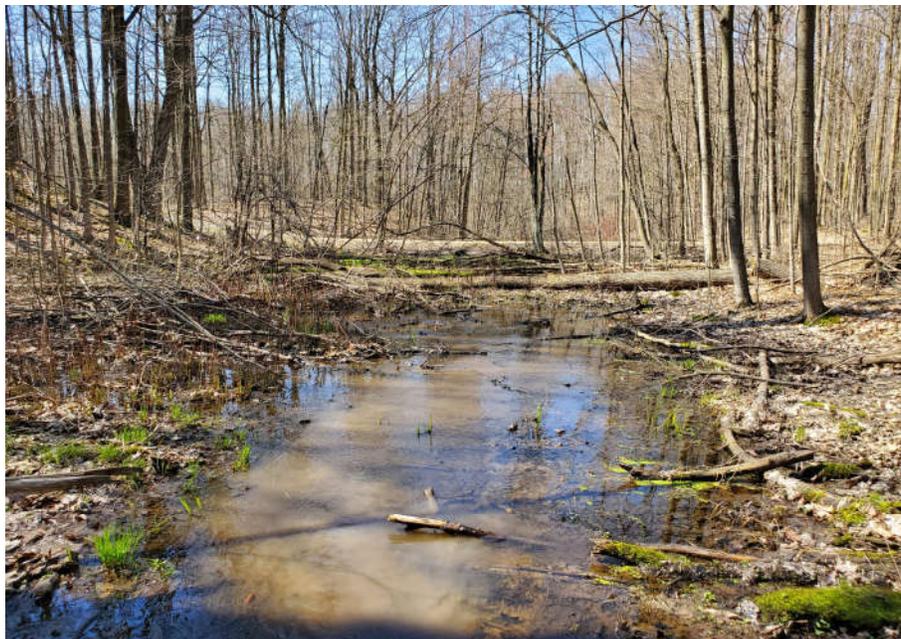
**Cross Section 4 - Facing Downstream**

Reach EC-1 consisted of a fairly straight and low gradient channel through a confined valley. The continuous and wide riparian buffer zone consisted of mature trees. The average bankfull width and depth were 17.95 m and 0.32 m. Bank materials ranged from clay to sand. Little to no bank erosion was observed. There were no riffles or pools. Bed materials consisted of organic material, clay, silt, and fine sand. Two trail crossings were present across the channel and valley. Woody debris was present within the channel but not due to the channel widening.
